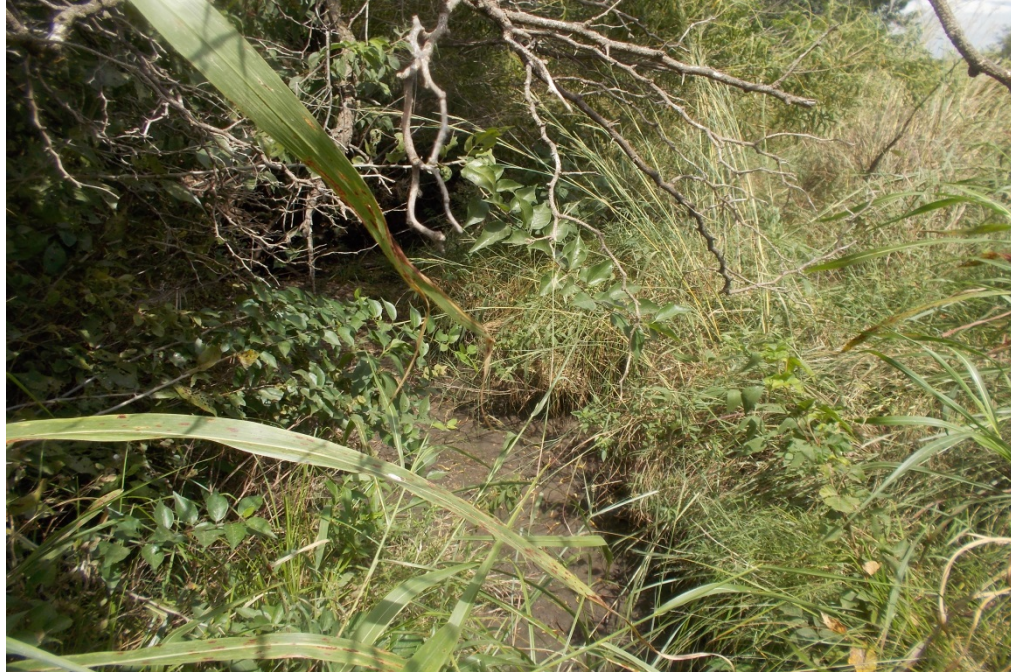
**FS-11** is identified as an intermittent stream waterway originating outside of the project area on the south and traveling north through the project area as an unnamed tributary to Chilocco Creek. The stream channel had a full bank width of 10 feet with a full bank depth of 10 feet and an 800 M of 10 feet. At the time of investigation, no water was observed within the referenced stream channel. Nevertheless, based on the stream features and a discernible 800 M, it would appear that S1000 meets the criteria necessary for jurisdictional classification by the SACE.

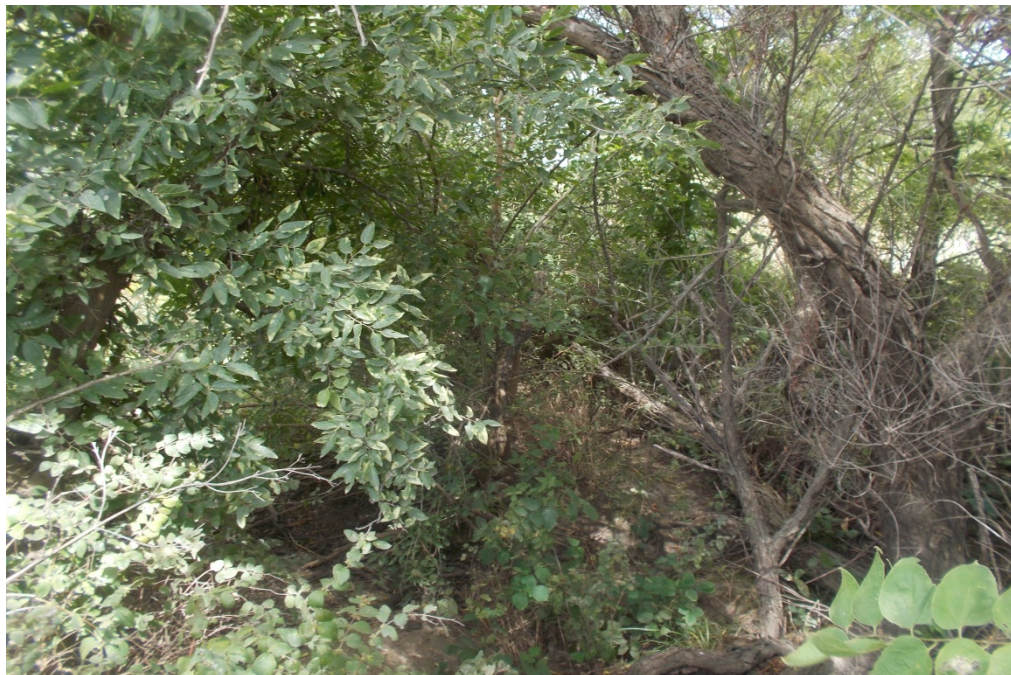
**FS-13-A**

**FS-13A** is identified as an ephemeral stream waterway located outside of the construction right-of-way. It originates outside of the project area on the north and travels south through the project area as an unnamed tributary to Chilocco Creek. The stream channel had a full channel width of 10 feet with a full channel depth of 2 feet and an M of 10 feet. At the time of investigation, no water was observed within the referenced stream channel. Nevertheless, based on the stream features and a discernible M, it would appear that S-13A meets the criteria necessary for jurisdictional classification by the SACE.

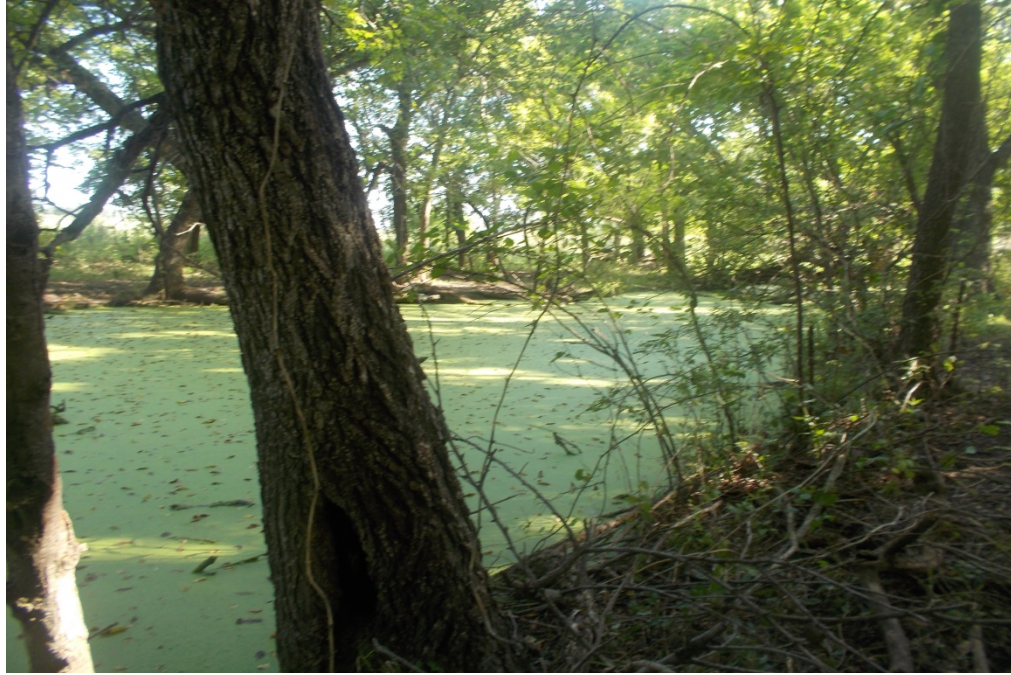
**FS-16** has been identified as a forested wetland located outside of the construction right-of-way. This area was investigated during the field survey and was found to exhibit positive indicators from each of the three parameters: hydrophytic vegetation, hydric soil, and hydrology. Dominant herbaceous vegetation in the area consisted of lac, milo, cotton, wood, elm, and reeds.

In addition, the soils observed during the site visit consisted of a layer of low chroma. Detailed soil survey maps are located in Appendix D.
