APPENDIX D

NRCS Custom Soil Resource Reports

Custom Soil Resource Report for Luna County, New Mexico

**Notification of the Finding of No Significant Impact (FONSI)
For Sapphire Energy, Inc.
Integrated Algal Biorefinery (IABR) Facility
In Columbus, New Mexico**

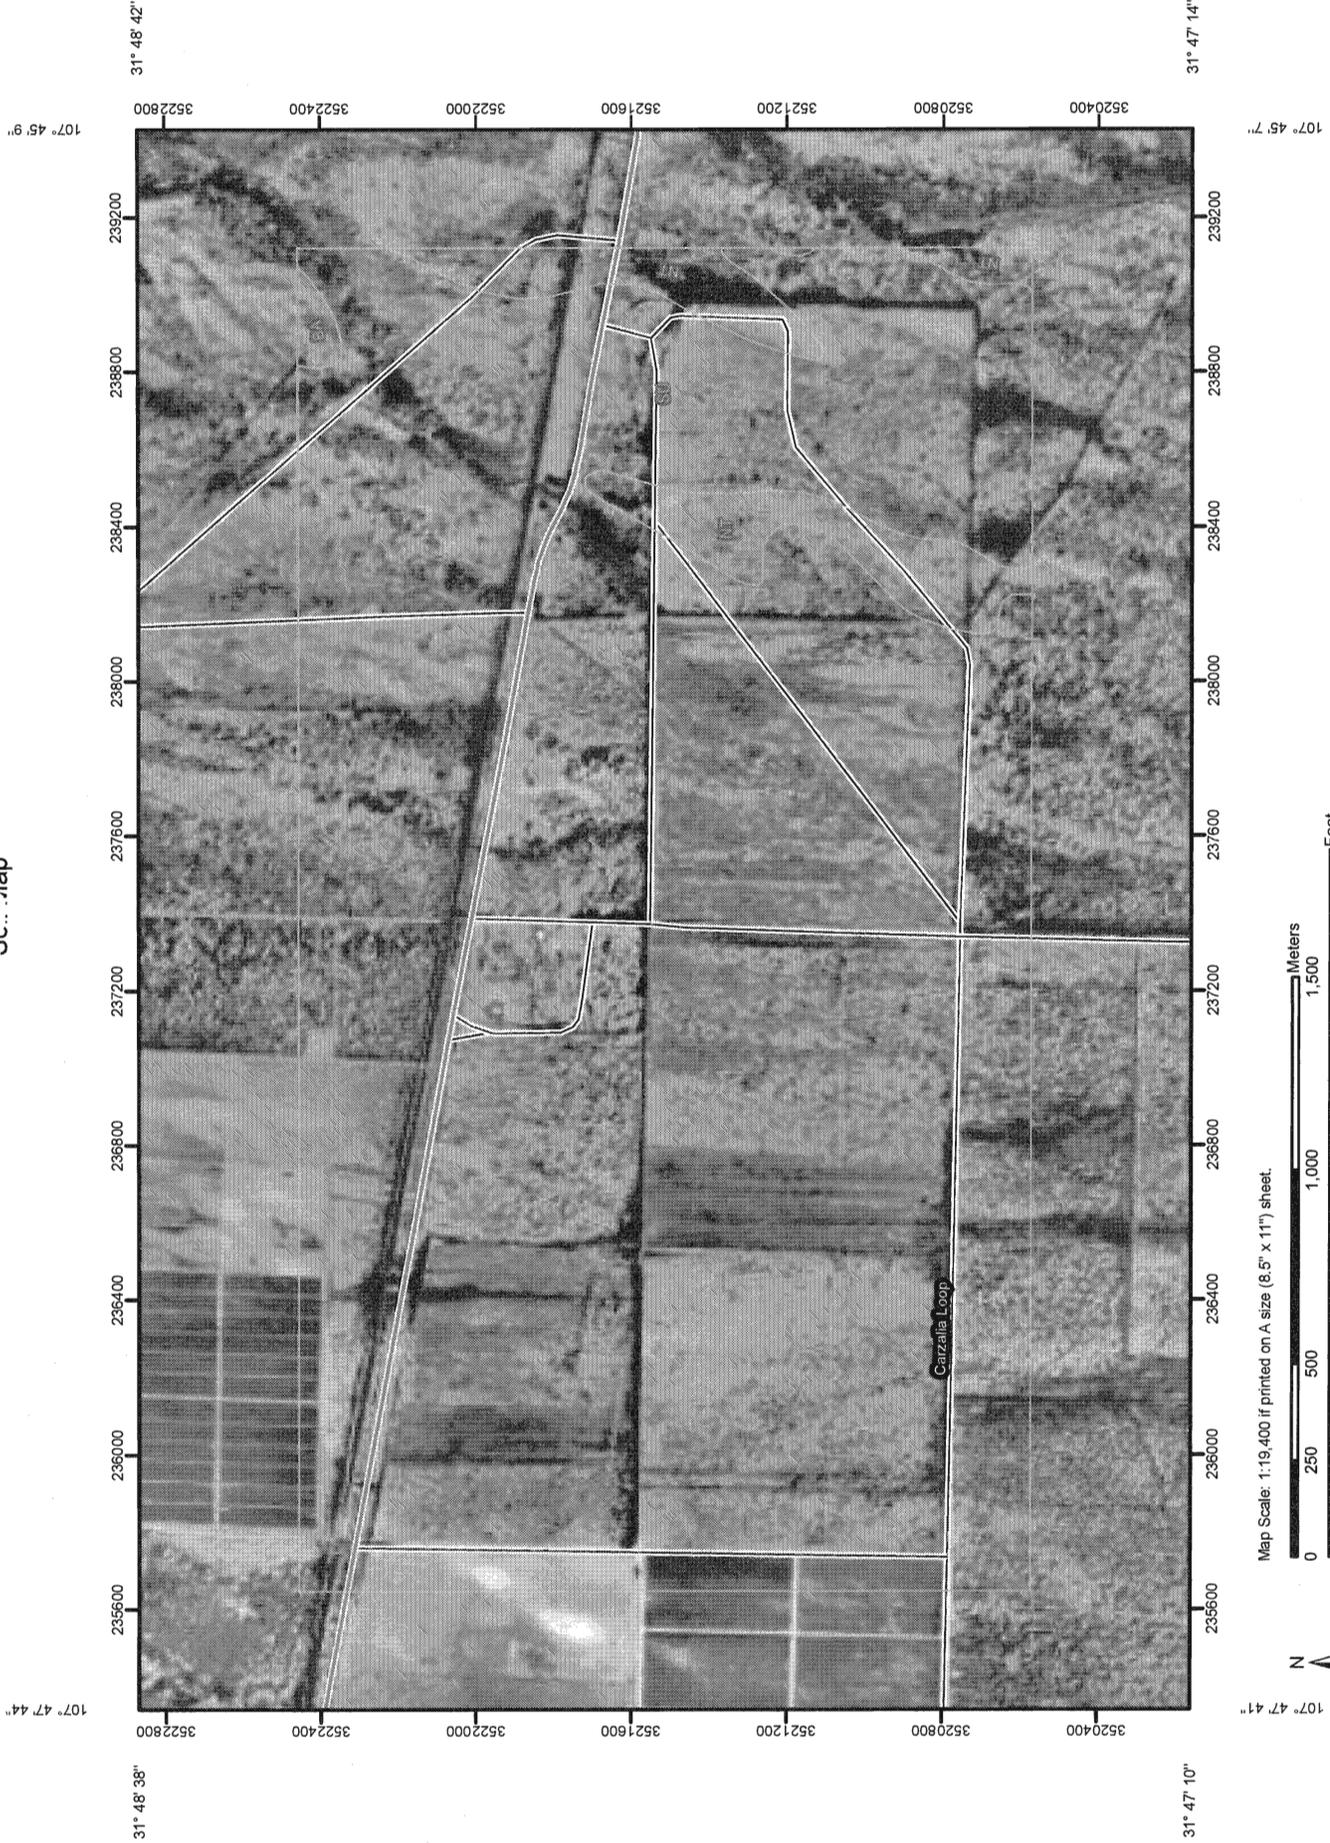
Custom Soil Source Report
Soil Map

A map unit delineation on a soil map represents an area dominated by one or more major kinds of soil or miscellaneous areas. A map unit is identified and named according to the taxonomic classification of the dominant soils. Within a taxonomic class there are precisely defined limits for the properties of the soils. On the landscape, however, the soils are natural phenomena, and they have the characteristic variability of all natural phenomena. Thus, the range of some observed properties may extend beyond the limits defined for a taxonomic class. Areas of soils of a single taxonomic class rarely, if ever, can be mapped without including areas of other taxonomic classes. Consequently, every map unit is made up of the soils or miscellaneous areas for which it is named and some minor components that belong to taxonomic classes other than those of the major soils.

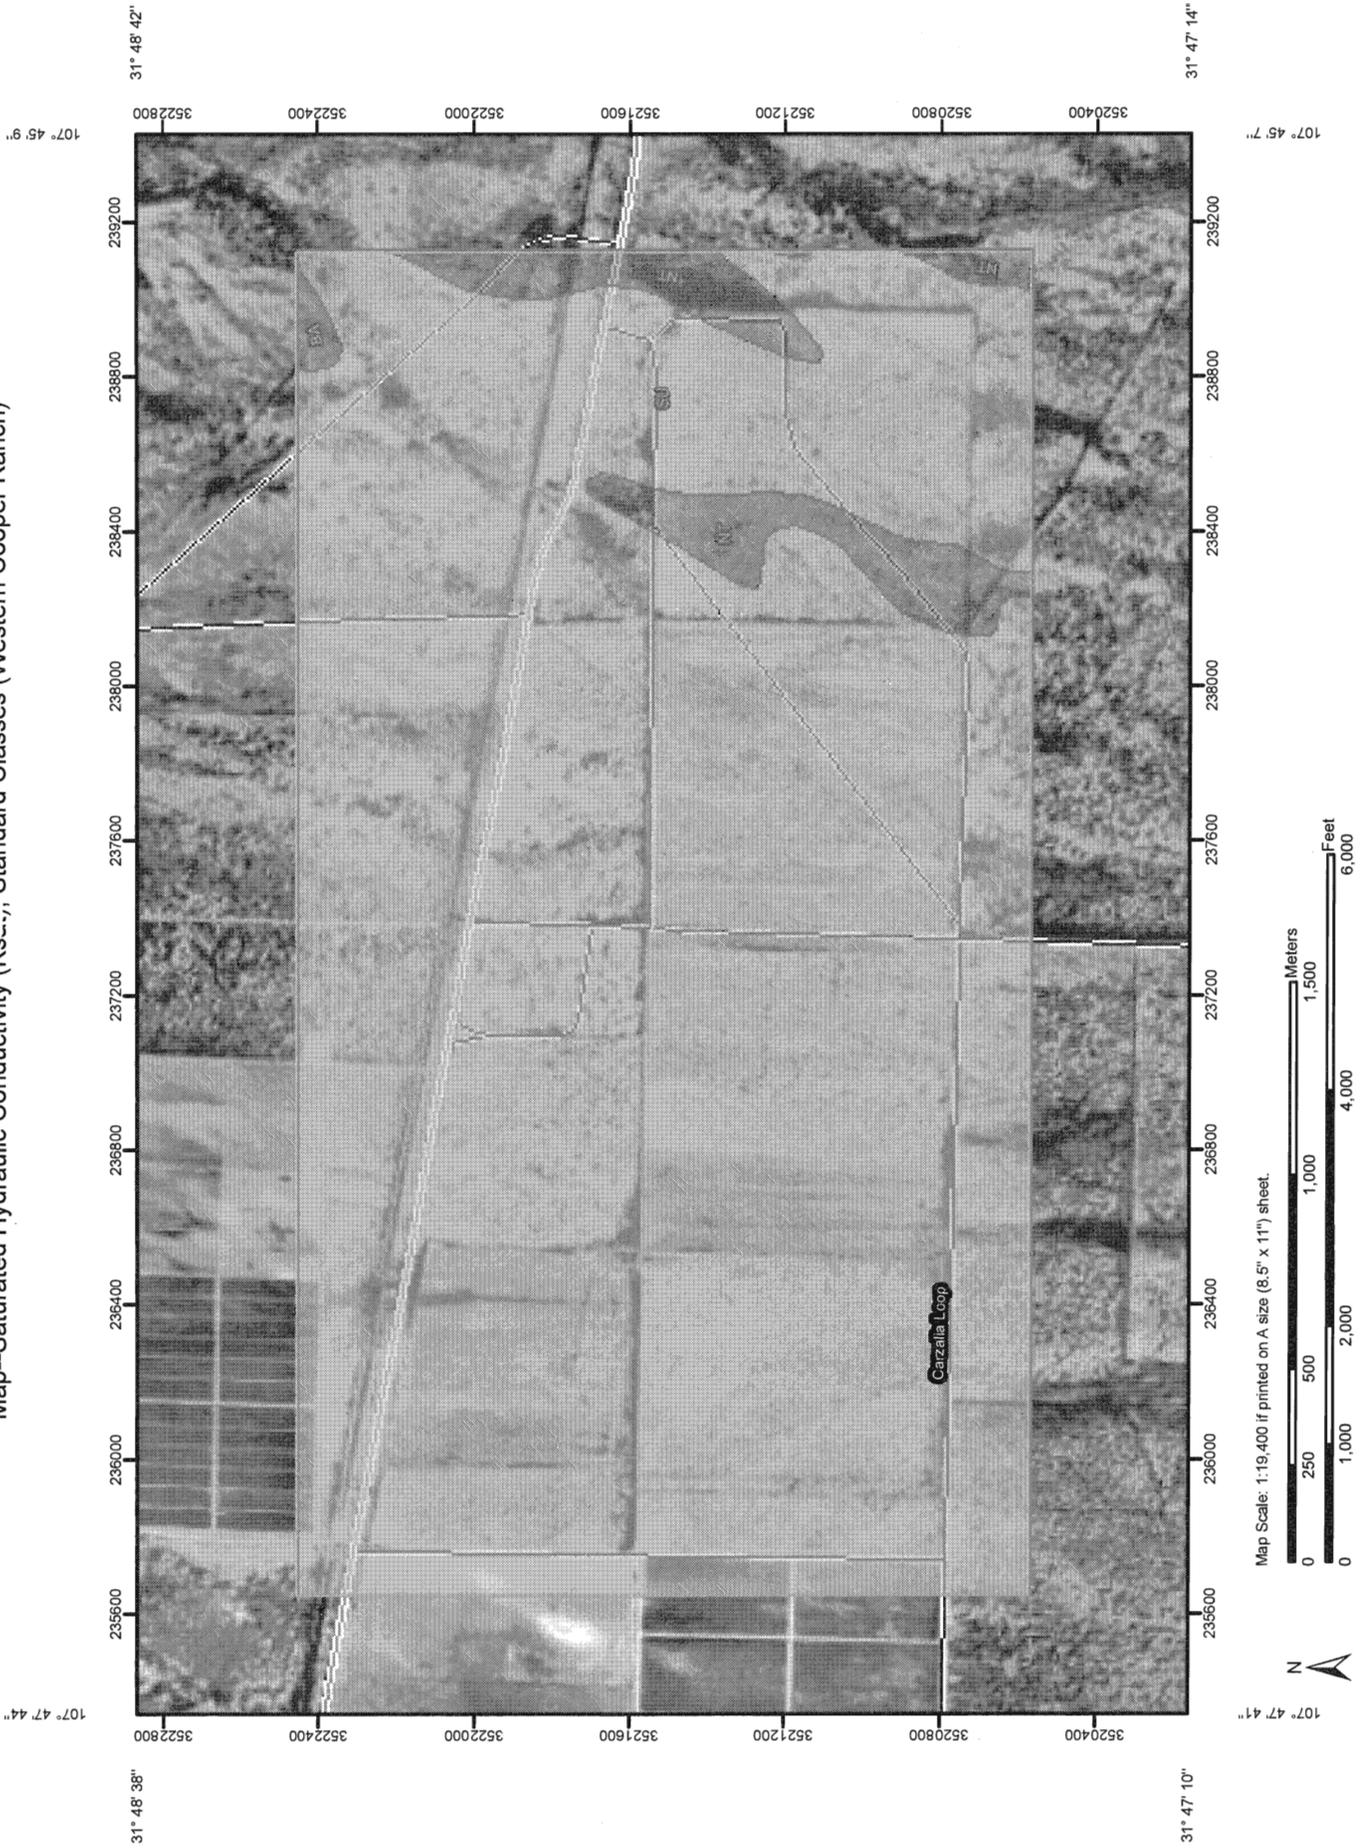
Map--Saturated Hydraulic Conductivity (Ks), Standard Classes (Western Cooper Ranch)
Custom Soil Source Report

Saturated hydraulic conductivity (Ksat) refers to the ease with which pores in a saturated soil transmit water. The estimates are expressed in terms of micrometers per second. They are based on soil characteristics observed in the field, particularly structure, porosity, and texture. Saturated hydraulic conductivity is considered in the design of soil drainage systems and septic tank absorption fields.

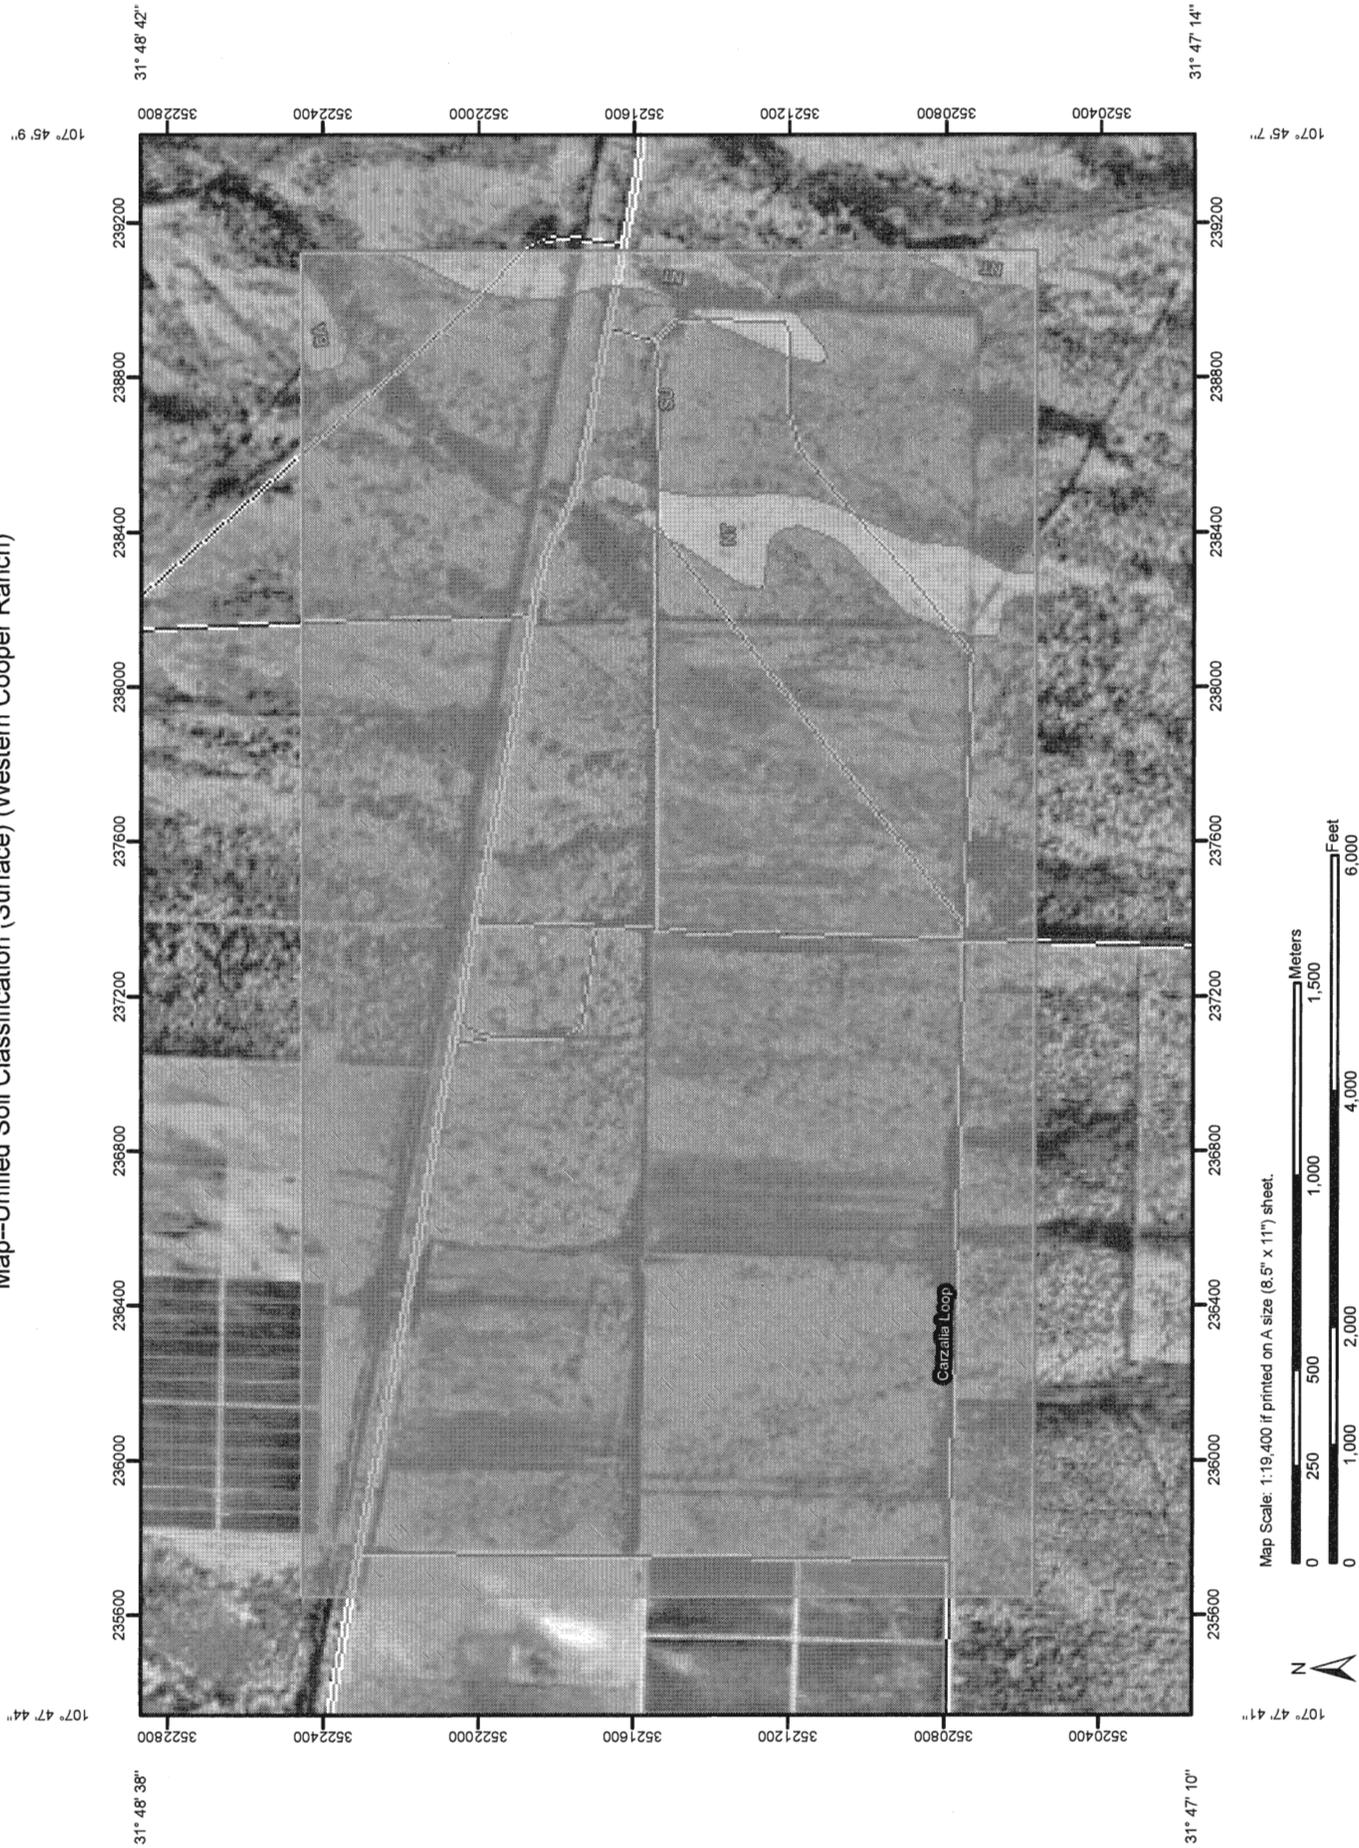
Custom Source Report
Map--Unified Soil Classification (Surface) (Western Cooper Ranch)

Soil qualities are behavior and performance attributes that are not directly measured, but are inferred from observations of dynamic conditions and from soil properties. Example soil qualities include natural drainage, and frost action. Soil features are attributes that are not directly part of the soil. Example soil features include slope and depth to restrictive layer. These features can greatly impact the use and management of the soil.

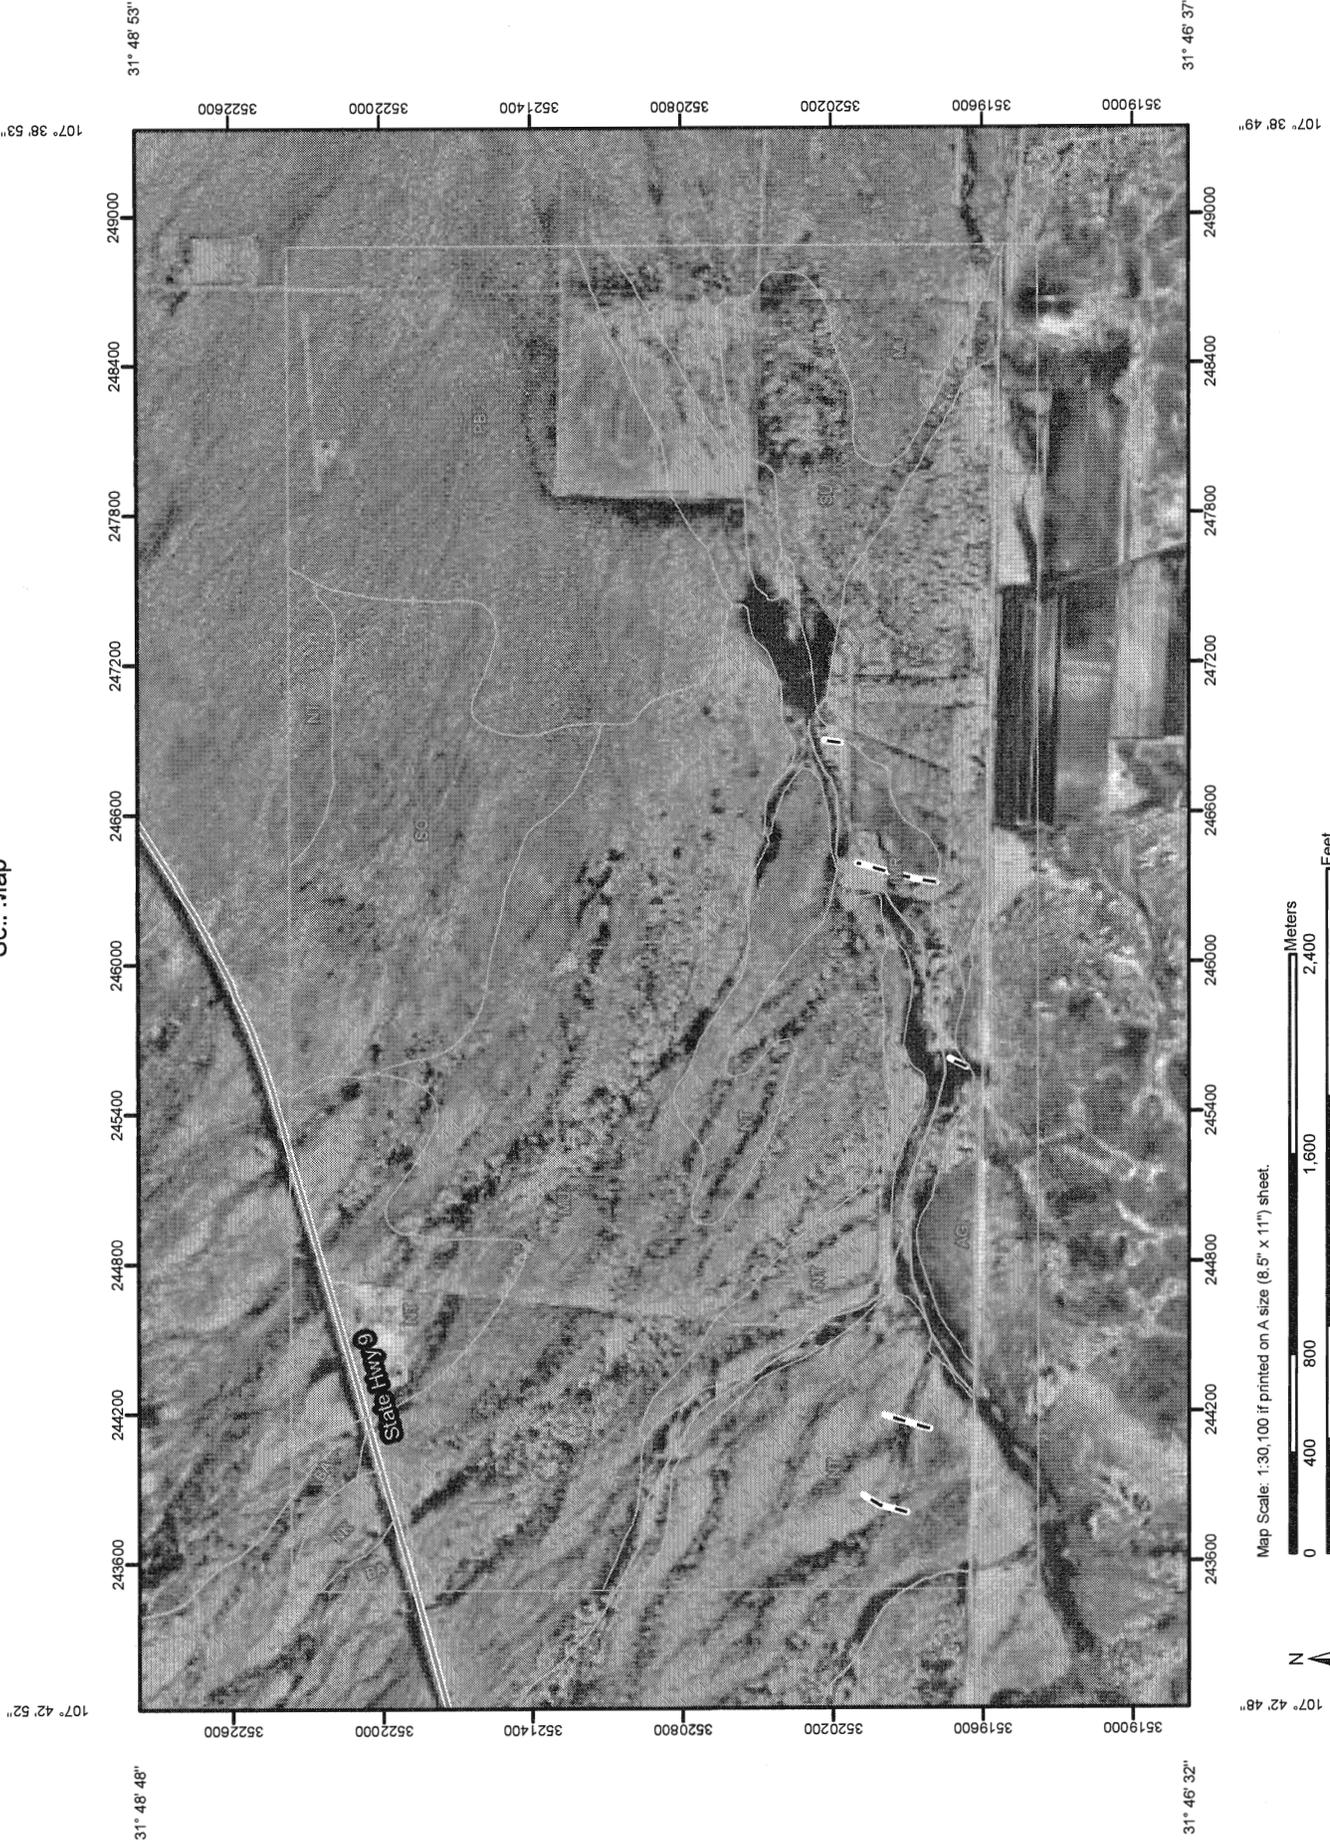
Custom Soil Source Report
Soil Map

A map unit delineation on a soil map represents an area dominated by one or more major kinds of soil or miscellaneous areas. A map unit is identified and named according to the taxonomic classification of the dominant soils. Within a taxonomic class there are precisely defined limits for the properties of the soils. On the landscape, however, the soils are natural phenomena, and they have the characteristic variability of all natural phenomena. Thus, the range of some observed properties may extend beyond the limits defined for a taxonomic class. Areas of soils of a single taxonomic class rarely, if ever, can be mapped without including areas of other taxonomic classes. Consequently, every map unit is made up of the soils or miscellaneous areas for which it is named and some minor components that belong to taxonomic classes other than those of the major soils.

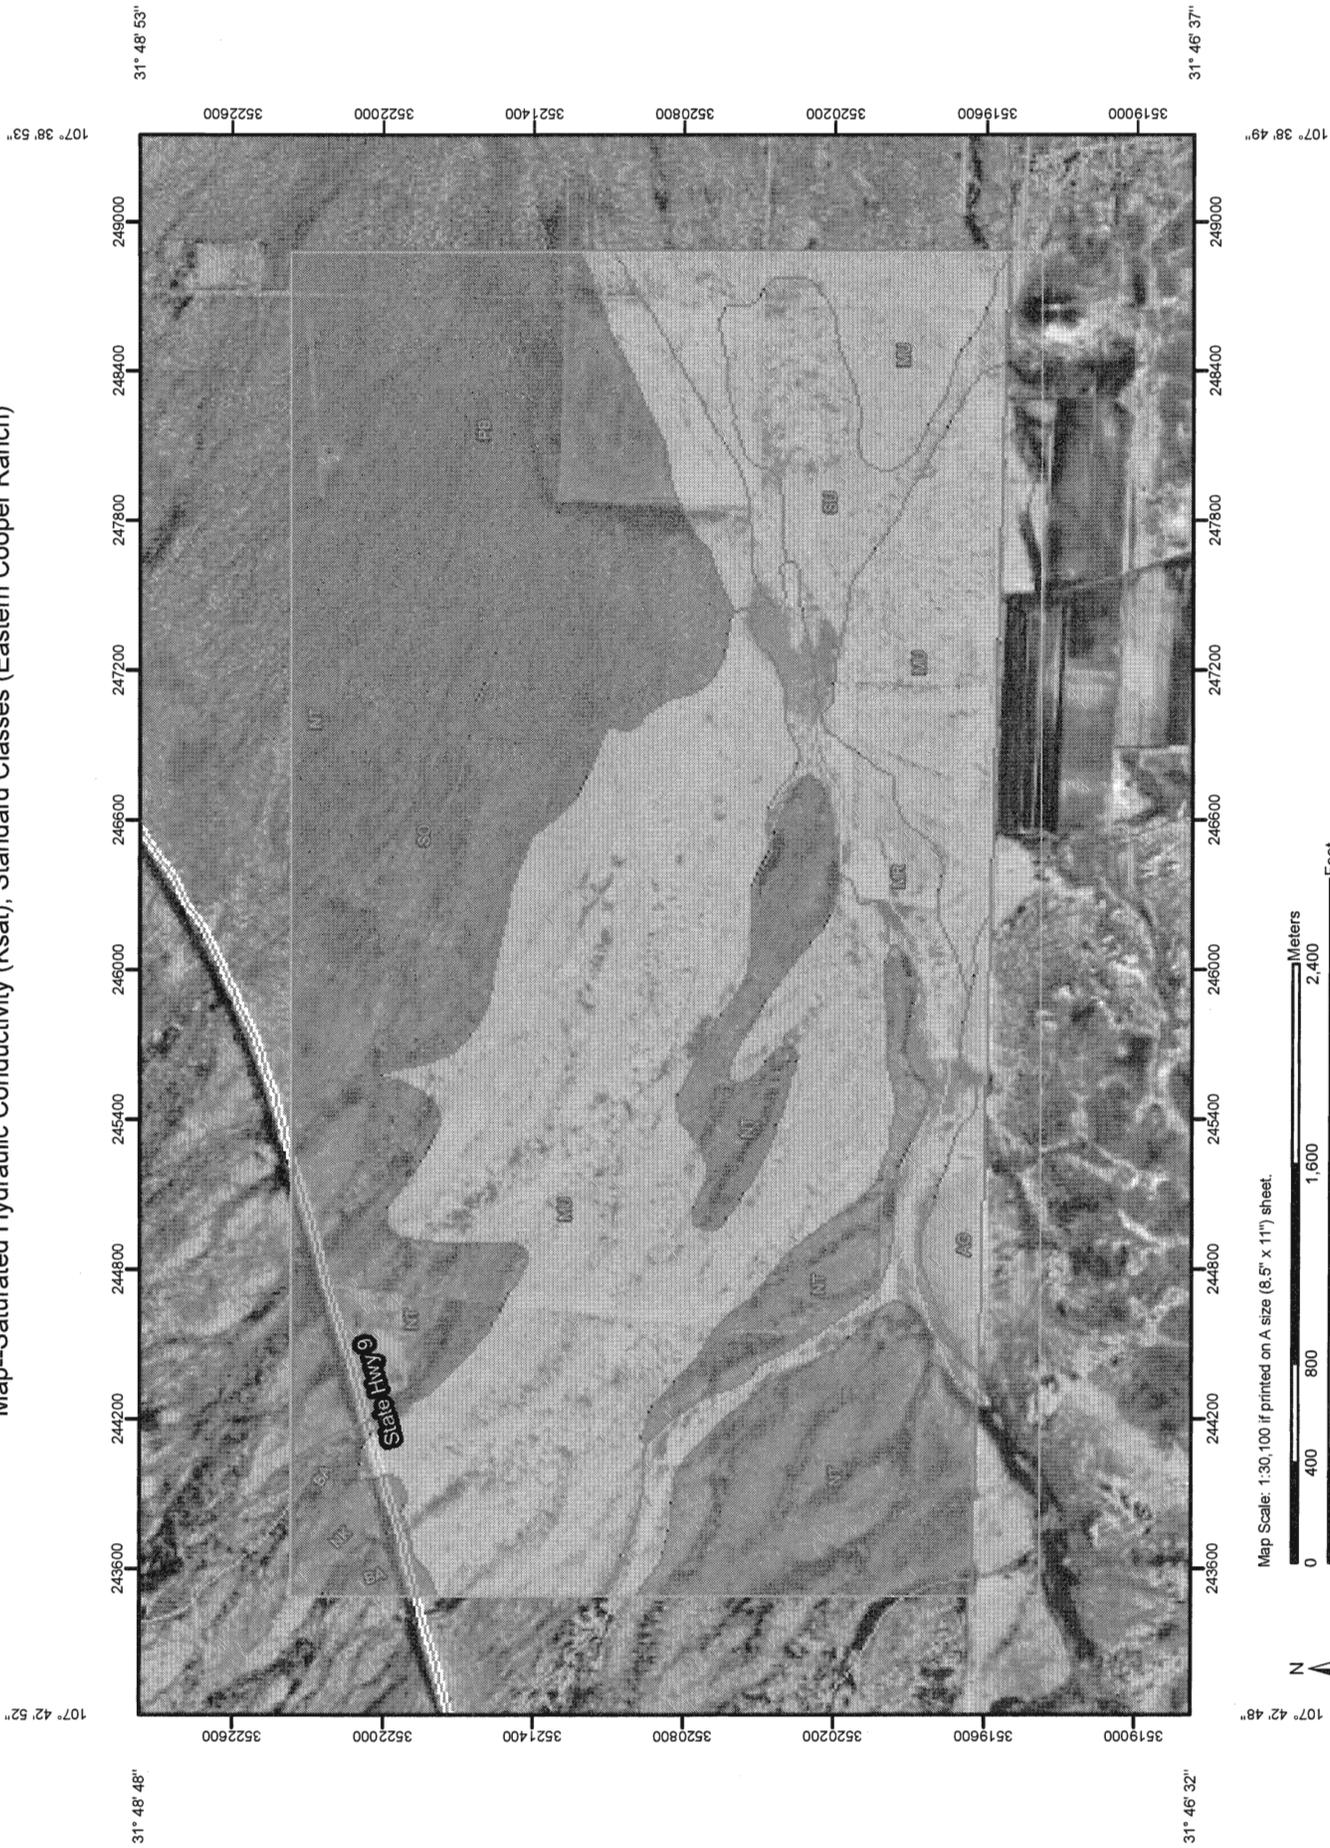
Custom Soil Source Report
Map--Saturated Hydraulic Conductivity (Ksat), Standard Classes (Eastern Cooper Ranch)

Saturated hydraulic conductivity (Ksat) refers to the ease with which pores in a saturated soil transmit water. The estimates are expressed in terms of micrometers per second. They are based on soil characteristics observed in the field, particularly structure, porosity, and texture. Saturated hydraulic conductivity is considered in the design of soil drainage systems and septic tank absorption fields.

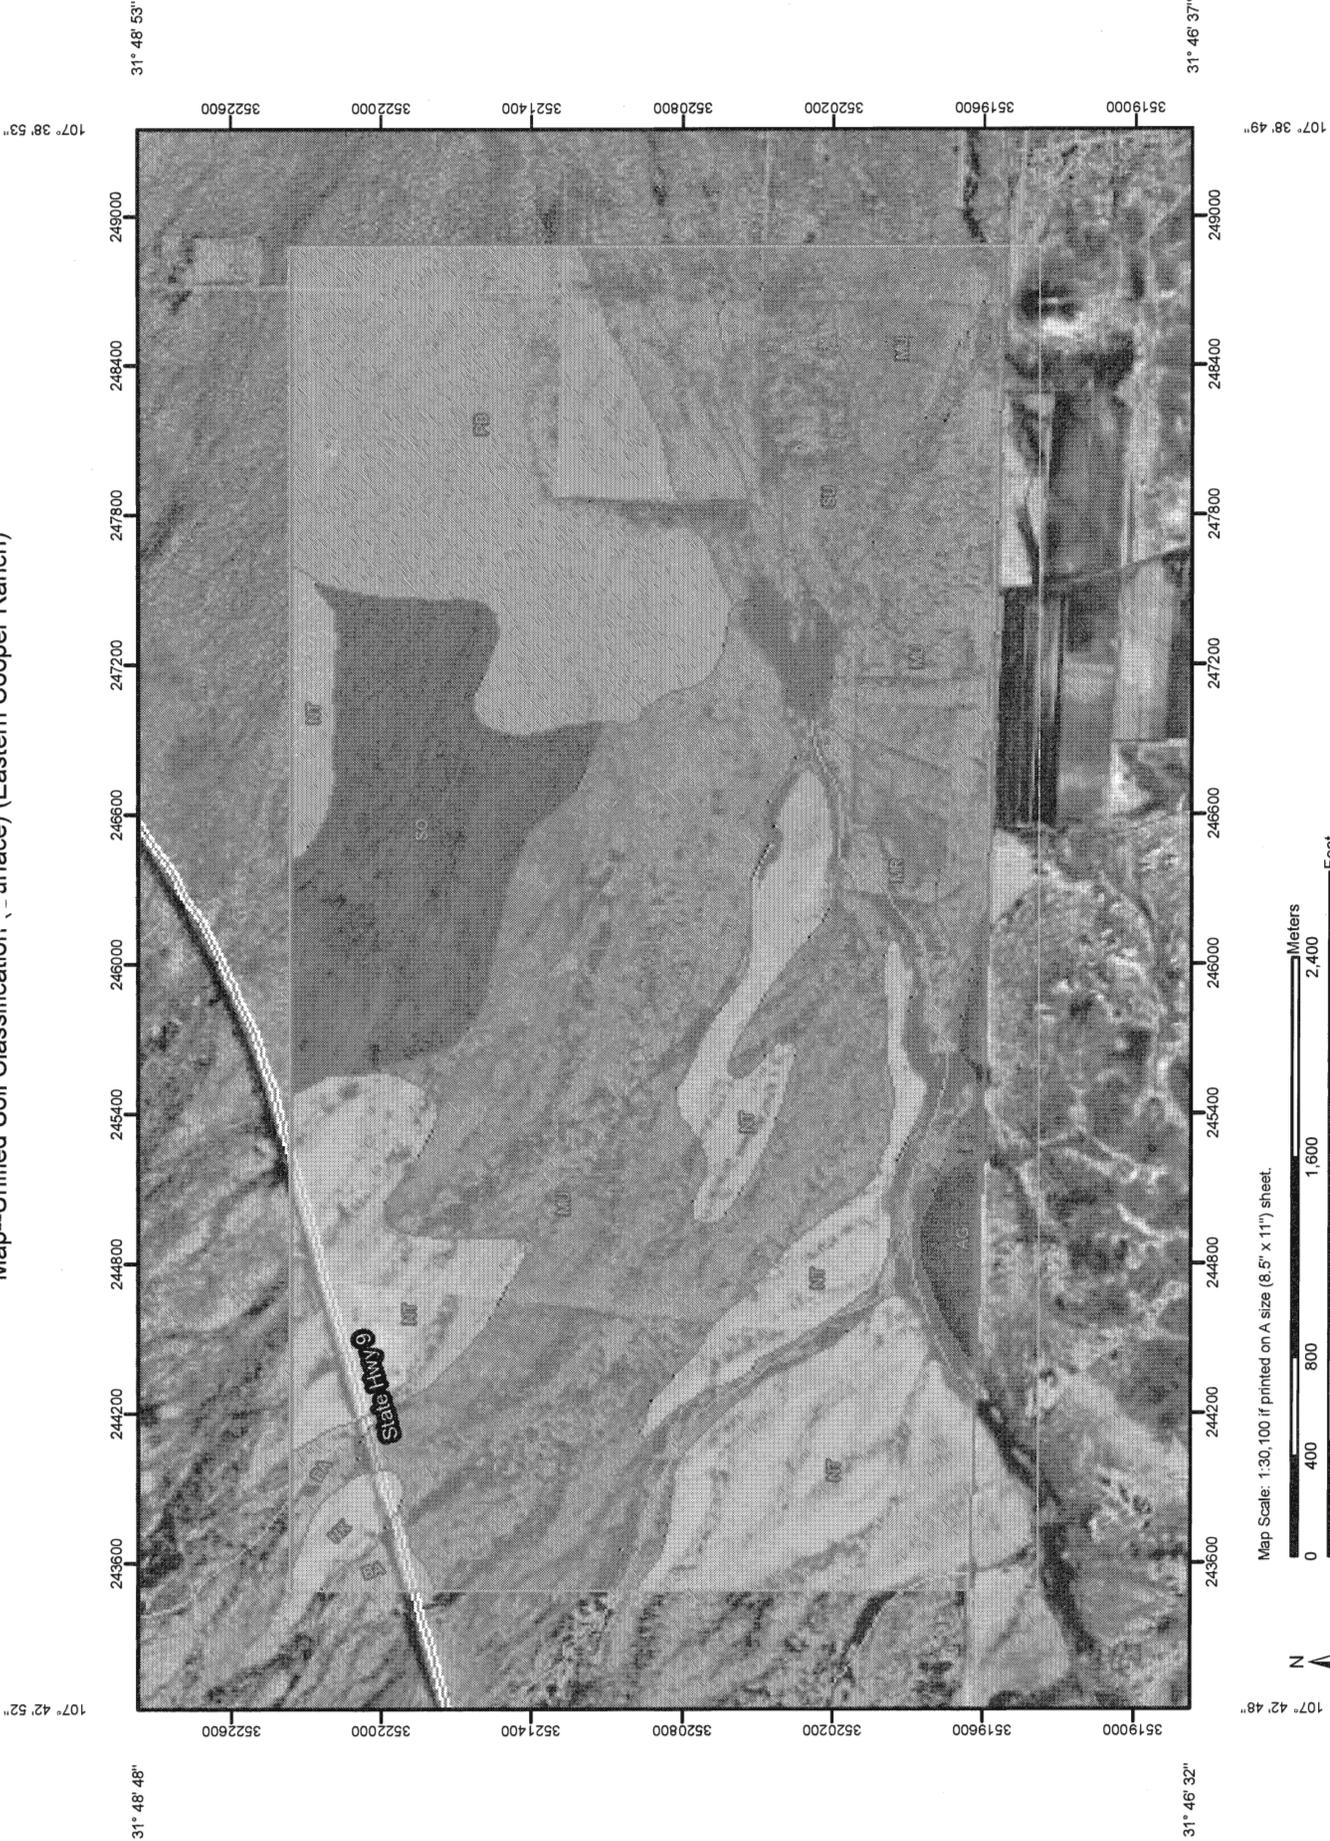
Custom Soil Source Report
Map--Unified Soil Classification, Surface (Eastern Cooper Ranch)

Soil qualities are behavior and performance attributes that are not directly measured, but are inferred from observations of dynamic conditions and from soil properties. Example soil qualities include natural drainage, and frost action. Soil features are attributes that are not directly part of the soil. Example soil features include slope and depth to restrictive layer. These features can greatly impact the use and management of the soil.

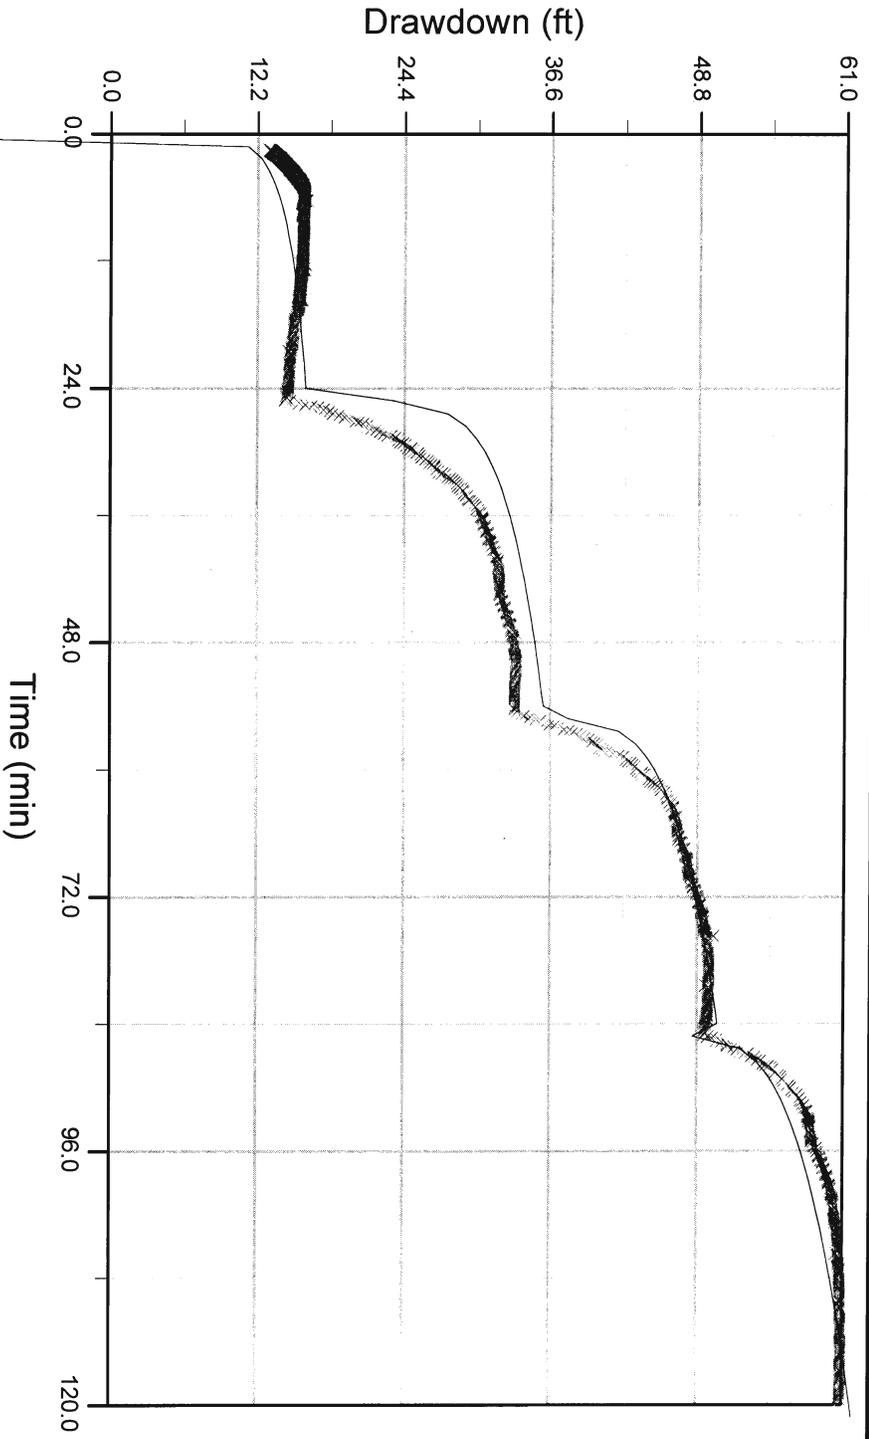
Step Test of Well: M-1933
 Pumping Rates:

Step	Rate	Maximum Drawdown
Step 1:	41	26.5
Step 2:	98	44.9
Step 3:	150	57.9
Step 4:	199	60.9

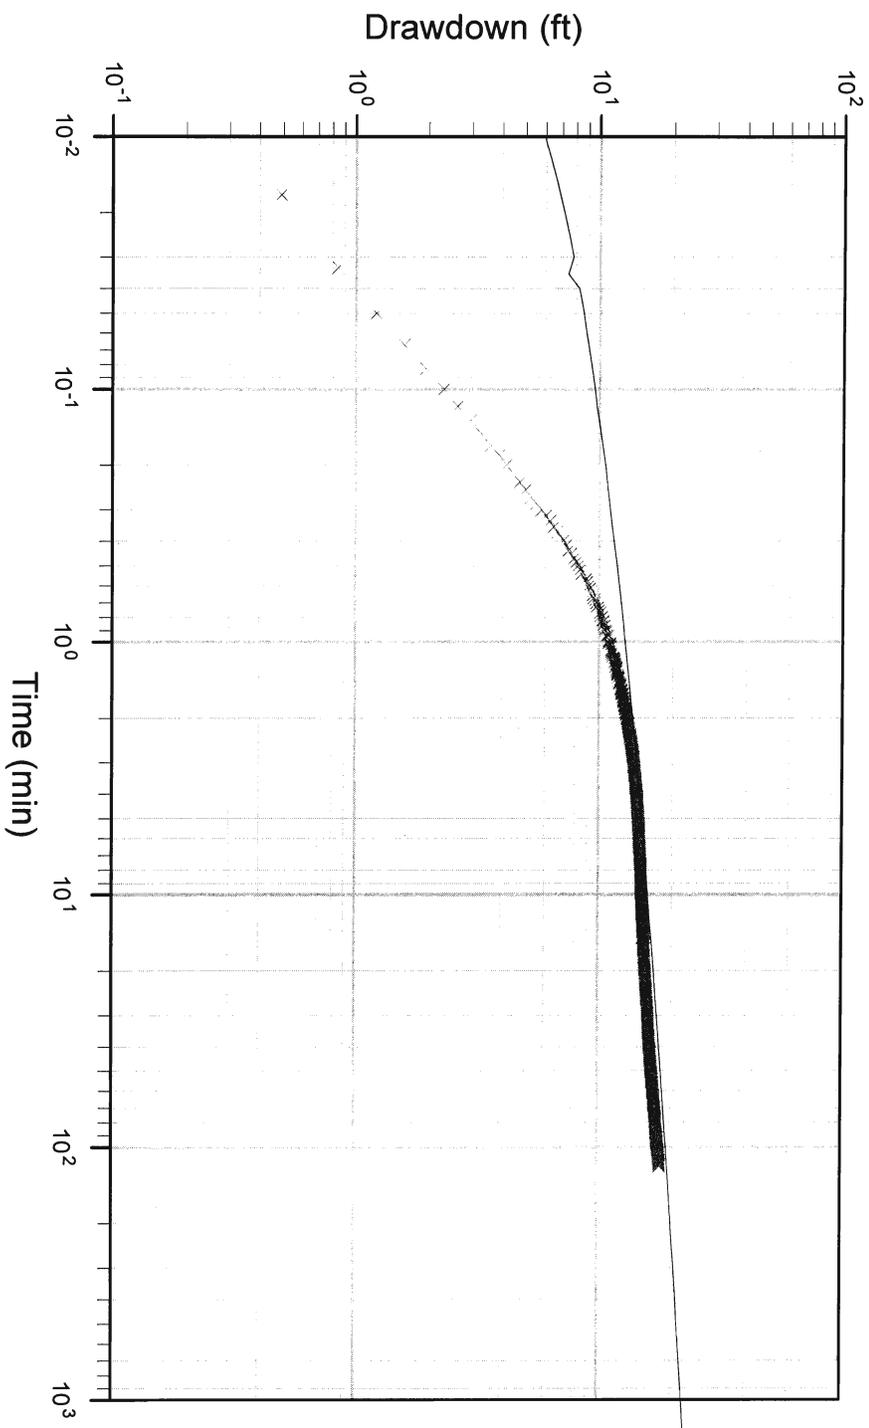
Step Test of Well: M-3668
 Pumping Rates: Step 1: 243 Step 1: 18.5

Maximum Drawdown: 18.5
 Results: Transmissivity: 3,769 sq ft/d
 Papadopolus and Cooper, 1967

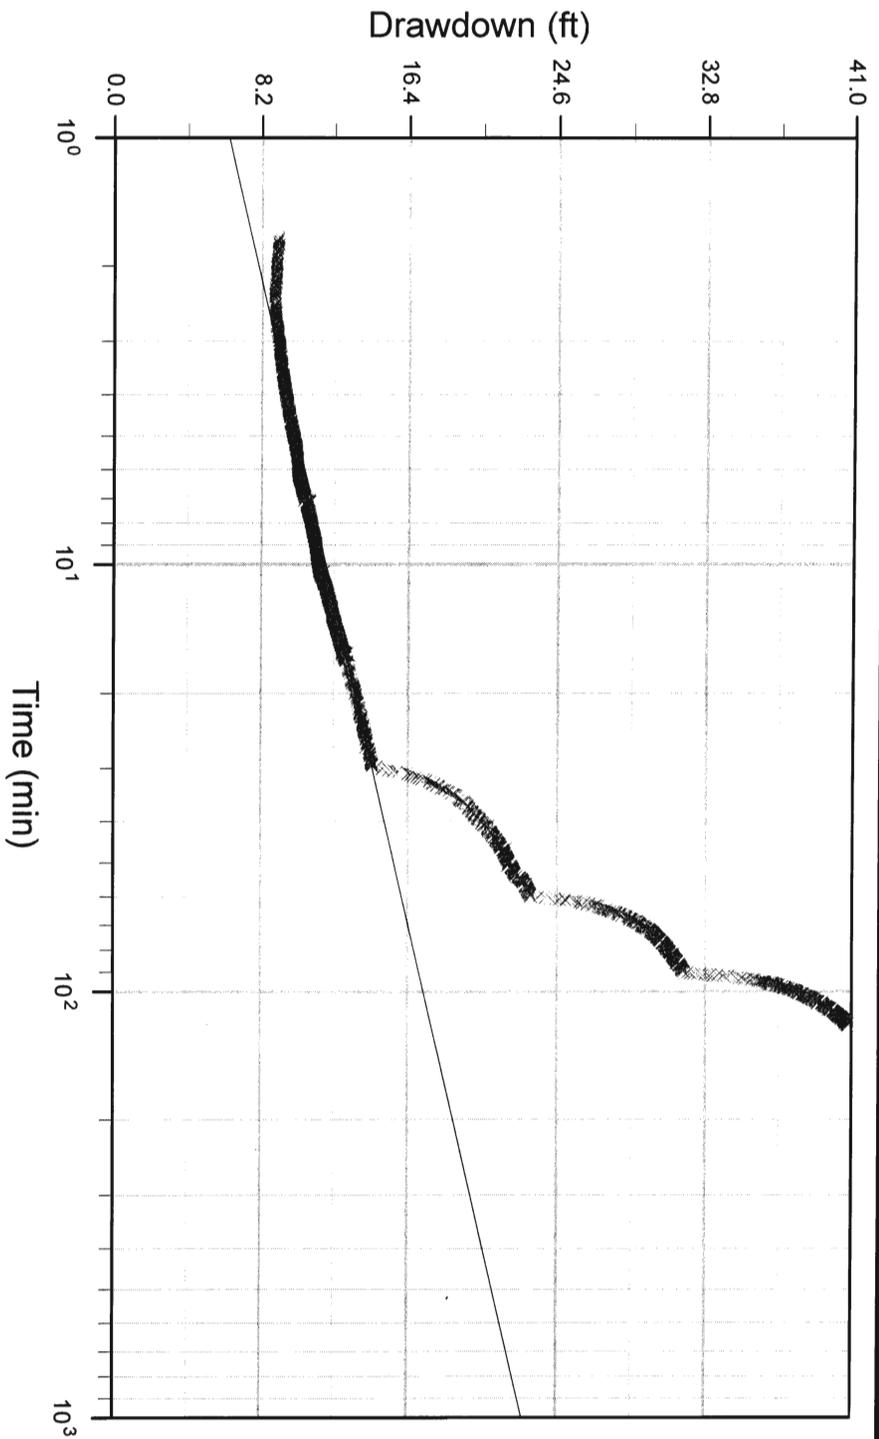
Step Test of Well: M-4748
 Pumping Rates:

Step	Rate	Maximum Drawdown
Step 1:	99	15.0
Step 2:	149	23.2
Step 3:	199	33.8
Step 4:	247	40.8

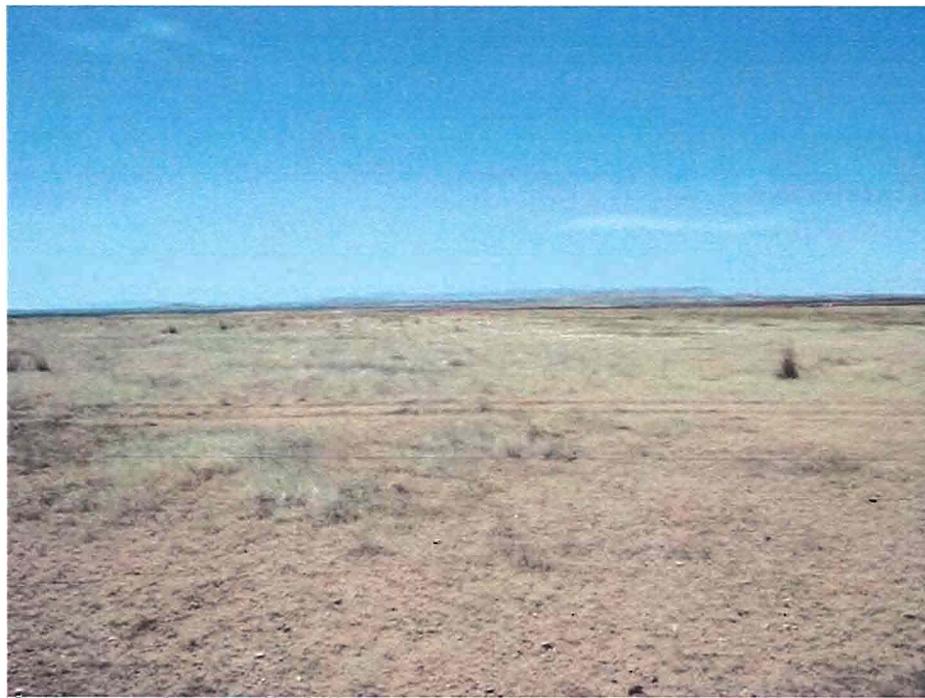
Photograph 2 – Typical view of Property (June)

discontinued and the site was allowed to colonize with invasive plants typical of soil that has been tilled. Much of the property contains dense stands of invasive species with low densities of native plants (**Photographs 1 and 2, Appendix A**). The species composition and canopy structure of vegetation on the property differs from native plant communities on adjacent state and federally managed public land (**Photograph 3 and 4, Appendix A**). Native vegetation on adjacent land is typical of the Semidesert Grassland and Chihuahuan Desertscrub (Brown 1982).

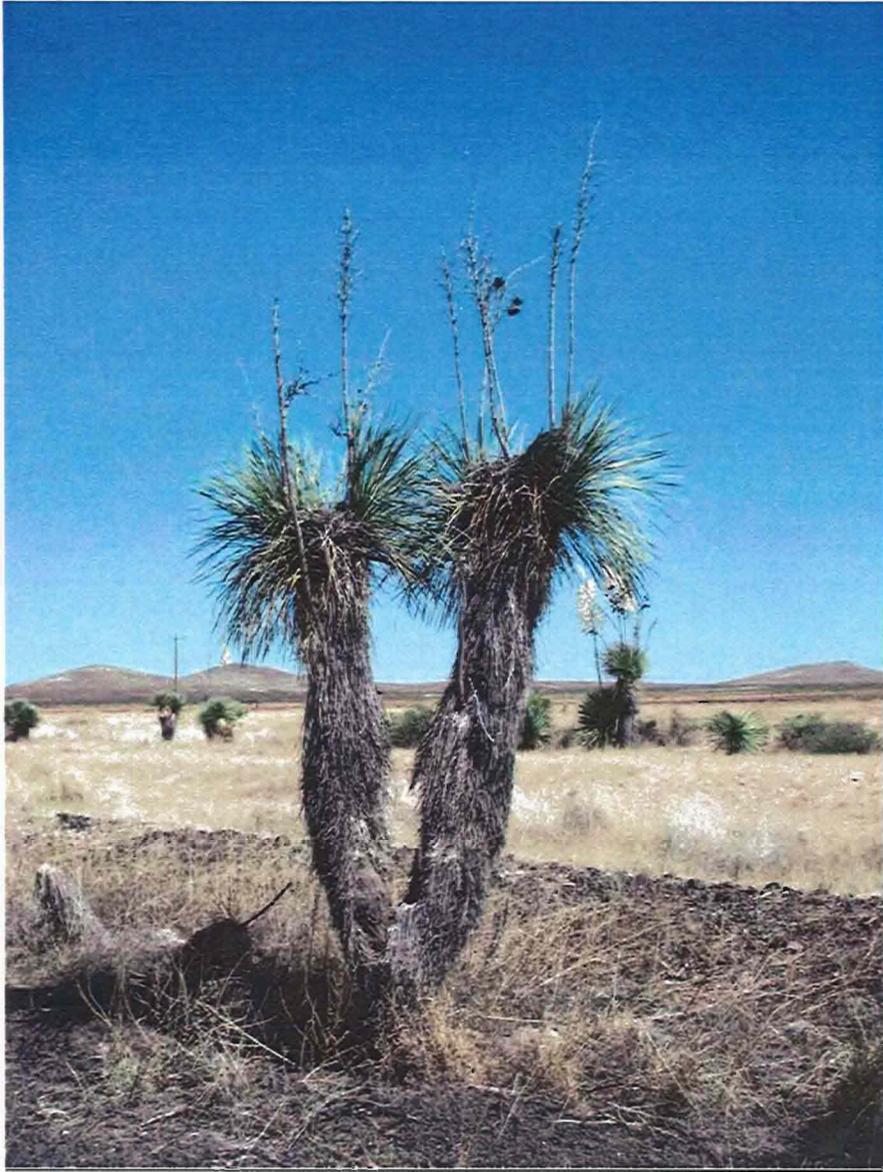
Photograph 3 – Raptor or raven nests in yucca on Property north of railroad grade

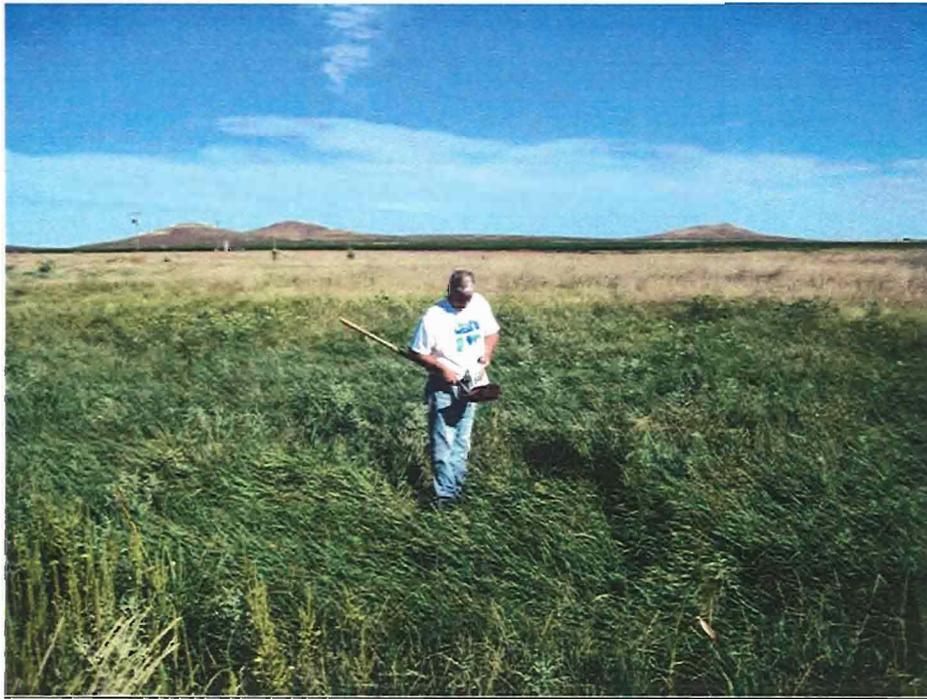
Photograph 6 – Wetland at SP-3, north of railroad grade (September)

Two potential wetlands were identified on the Property, north of Highway 9, abutting the north side of the Property (**Figure 2**). These vegetated swales (SP- 2 and SP-3, **Figure 2**) are present where surface water seasonally collects as a result of the old railroad grade intercepting surface runoff from rangeland and irrigated crop fields (**Photographs 6 and 7, Appendix A**). Wetland Determination Data Forms for these sites are included as **Appendix B**. These sites have hydrophytic vegetation but the soils do not exhibit hydric features. Plant species present on these sites include the species listed in **Table 5**.

Wetland hydrology is present at sites SP-2 and SP-3 during the monsoon season when runoff collects on the upslope side of the railroad embankment. It is likely that the soils at these sites have been altered by construction of the railroad and by erosional deposition from irrigated cropland that is immediately adjacent and upslope from the railroad grade. The soils at the SP- 3 have no horizon development to 20 inches, exhibit no redox features, and do not have a chroma that is typically associated with hydric soils. The soils at SP-3 have the same color and chroma (7.5 YR 3/3) as soils at SP-4, an adjacent upland site (**Figure 2**).
