APPENDIX D

NRCS Custom Soil Resource Reports

Custom Soil Resource Report for Luna County, New Mexico

**Notification of the Finding of No Significant Impact (FONSI)
For Sapphire Energy, Inc.
Integrated Algal Biorefinery (IABR) Facility
In Columbus, New Mexico**

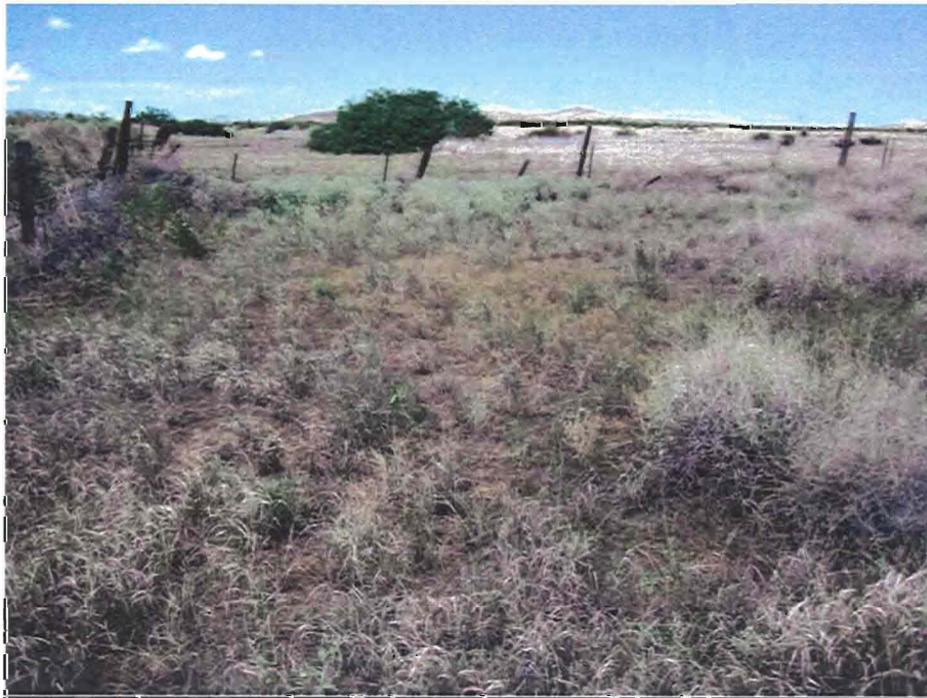
Photograph 7 – Wetland at SP-2 north of railroad grade (September)

Site SP-2 has hydrophytic vegetation and wetland hydrology during the monsoon season but like site SP-3; the soils do not exhibit hydric features. The upper 2 inches of the soil horizon has a color and chroma of 7.5 YR 3/3 and from 2-18 inches the soil color and chroma are 5YR 4/4. The soil exhibits no redox features associated with anaerobic conditions. Evaluation of site SP-1 (**Figure 2**), in a broad swale down slope from a gap in the railroad embankment, indicated that the vegetation was not hydrophytic

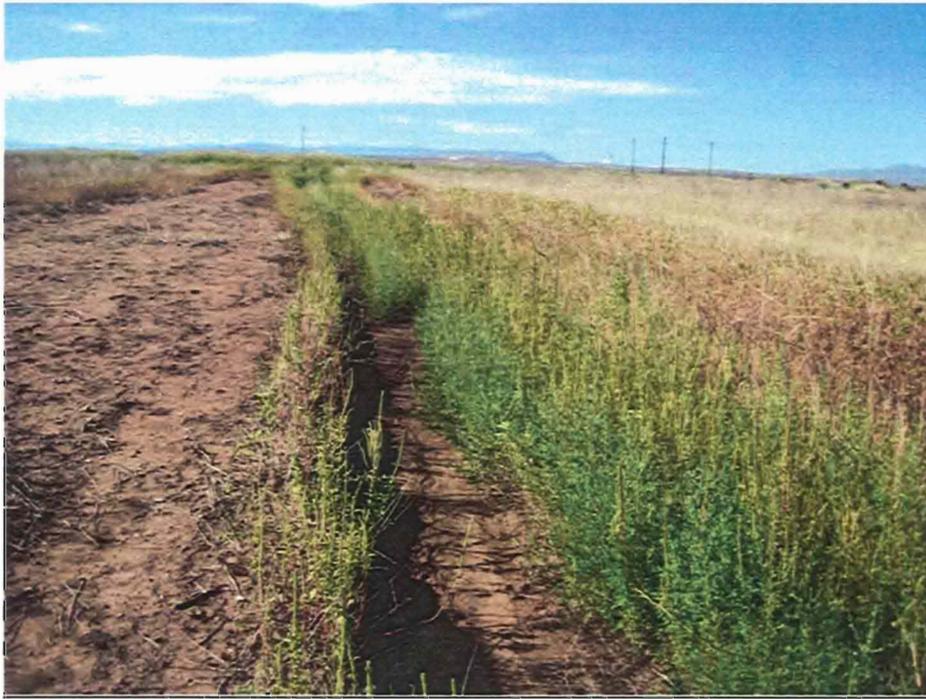
Photograph 8 – Beginning of Erosional Feature A, upslope from railroad grade (September)

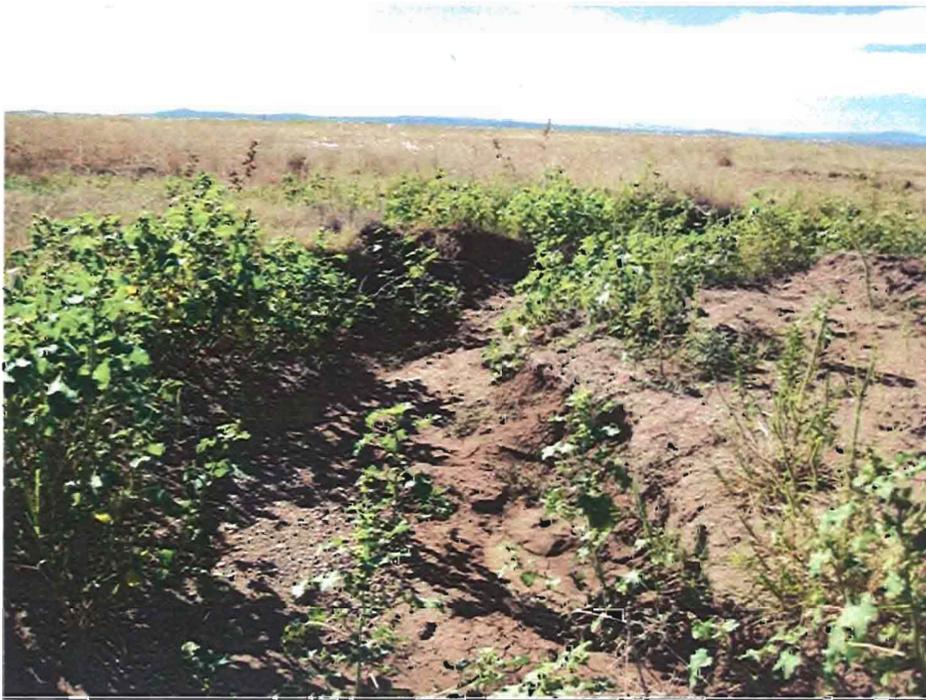
Photograph 9 – Erosional Feature A, downslope from Highway 9 and railroad (September)

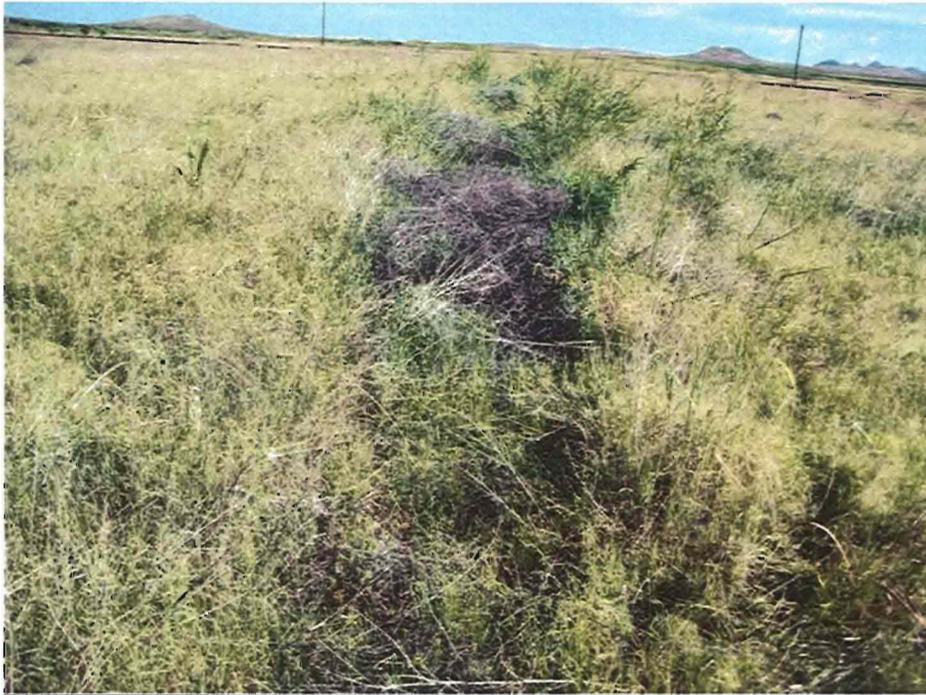
Photograph 10 – Point at which flow is not detectable in Erosion Feature A (September)

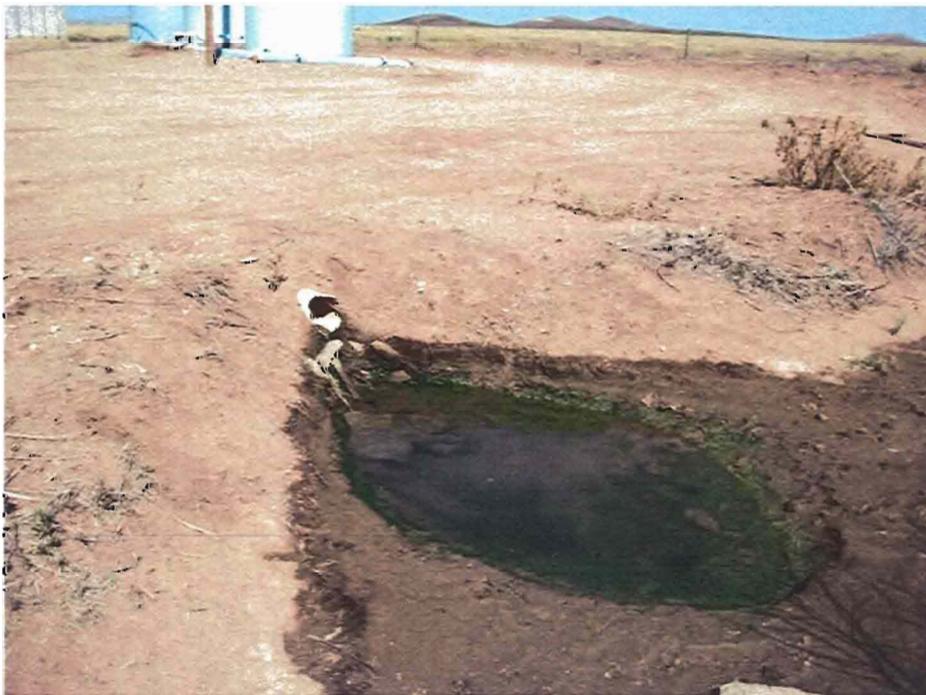
Photograph 11 – Beginning of Erosional Feature B and irrigation pump station (September)

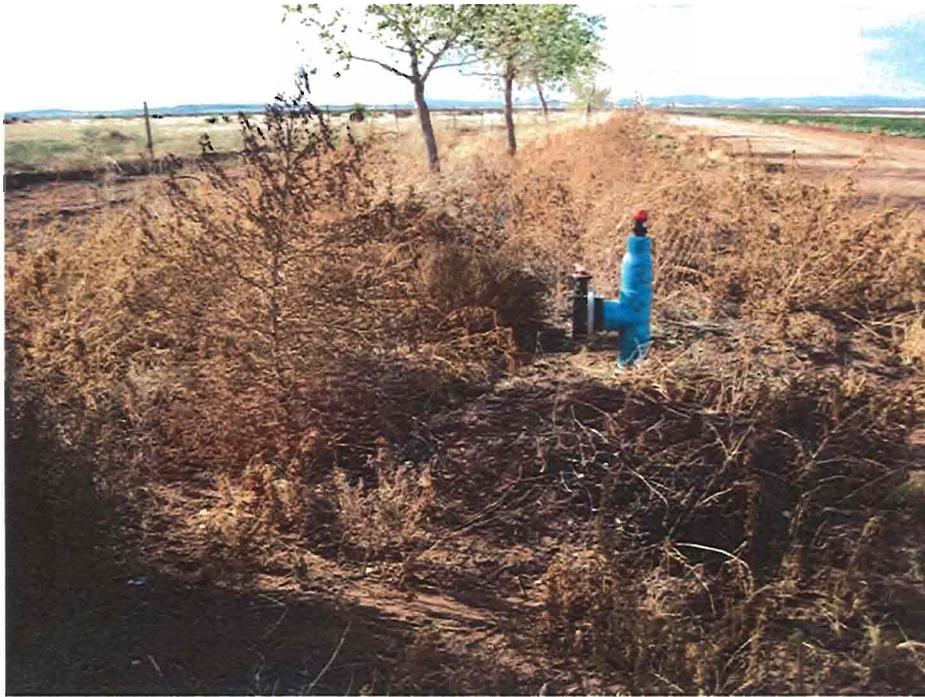
Photograph 12 – Erosional Feature B at berm with irrigation pipe (September)

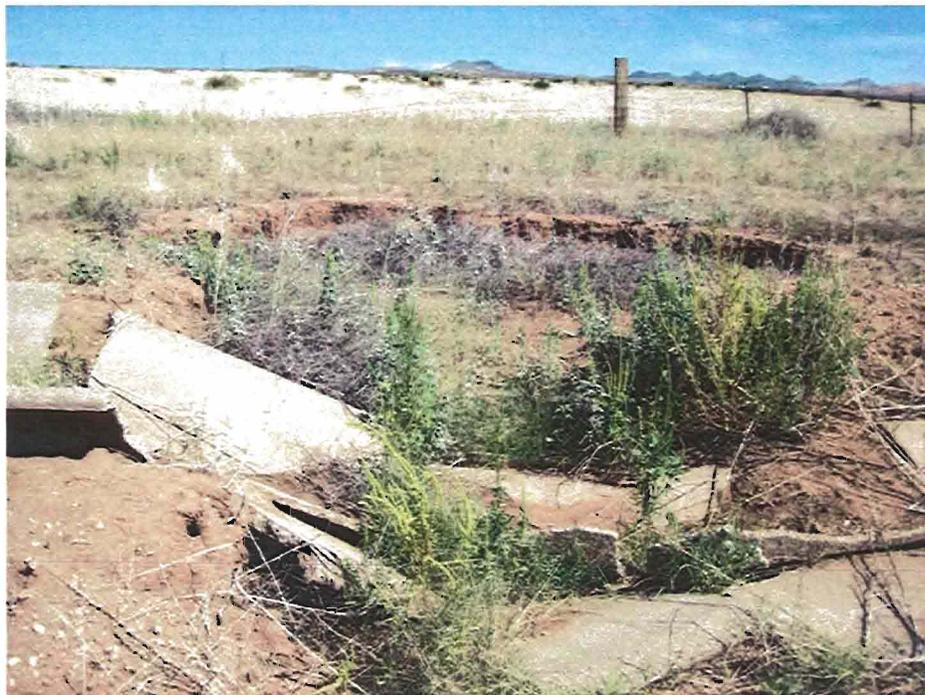
Photograph 13 – Eroded drainage feature at break in irrigation ditch (September)
Note eroded head cut from overland flow, upslope from break in ditch.

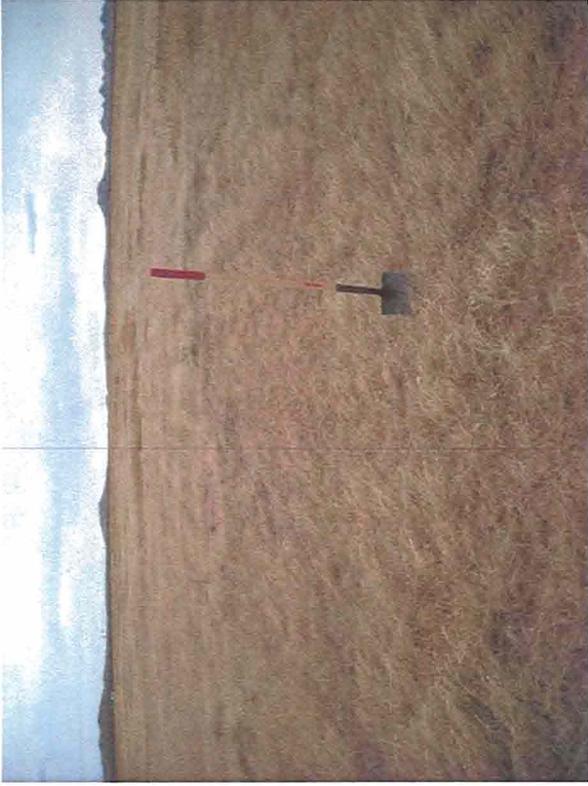
Photo 1: Plowmarks in abandoned field of the proposed project (photograph taken facing north in southwestern portion of project area).

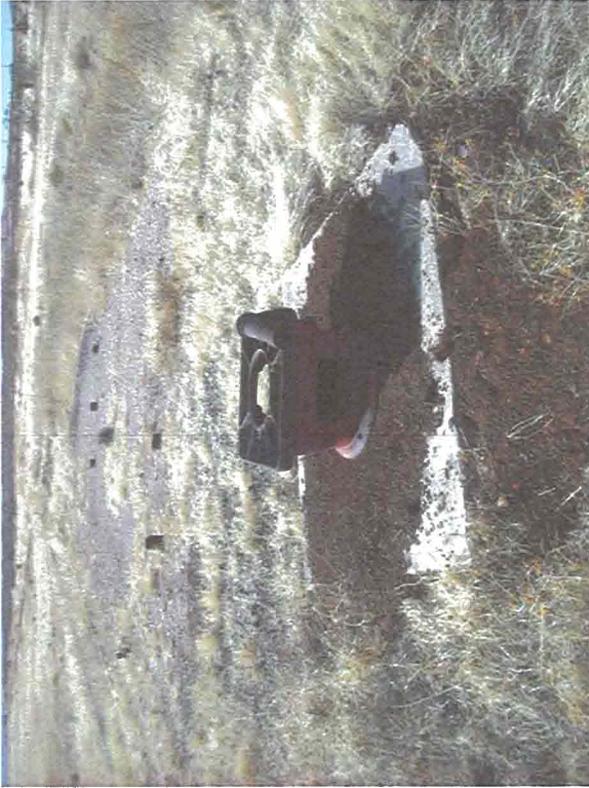
Photo 3: Well head east of proposed project (photograph taken facing west toward project area). Wells on the property have been inventoried for potential future use in the project.

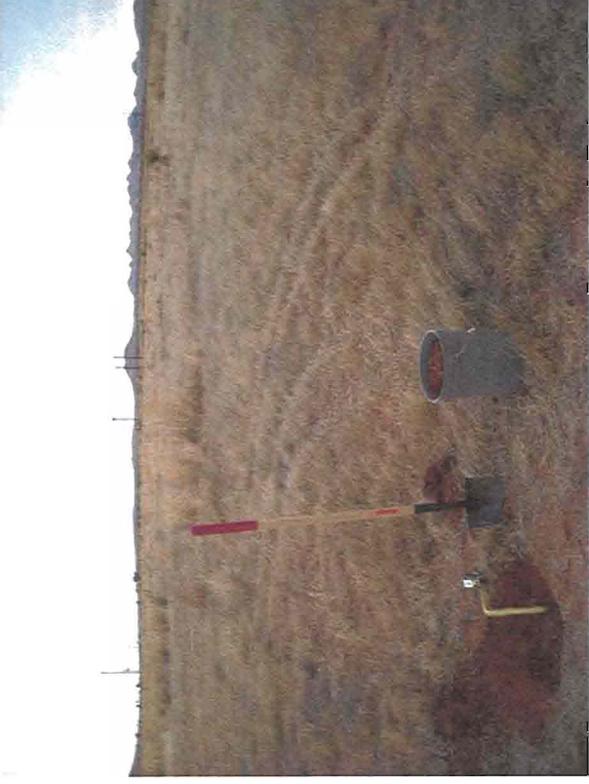
Photo 4: Powerline and abandoned field in northern portion of proposed project area (photograph taken facing north to northern edge of project area).

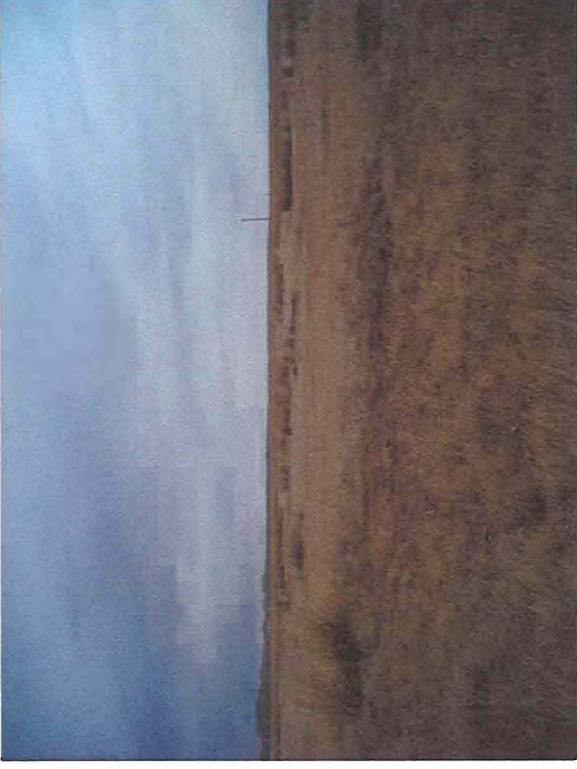
Photo 10: Powerline and abandoned field in southwestern portion of proposed project area (photograph taken facing northeast toward center of project area).

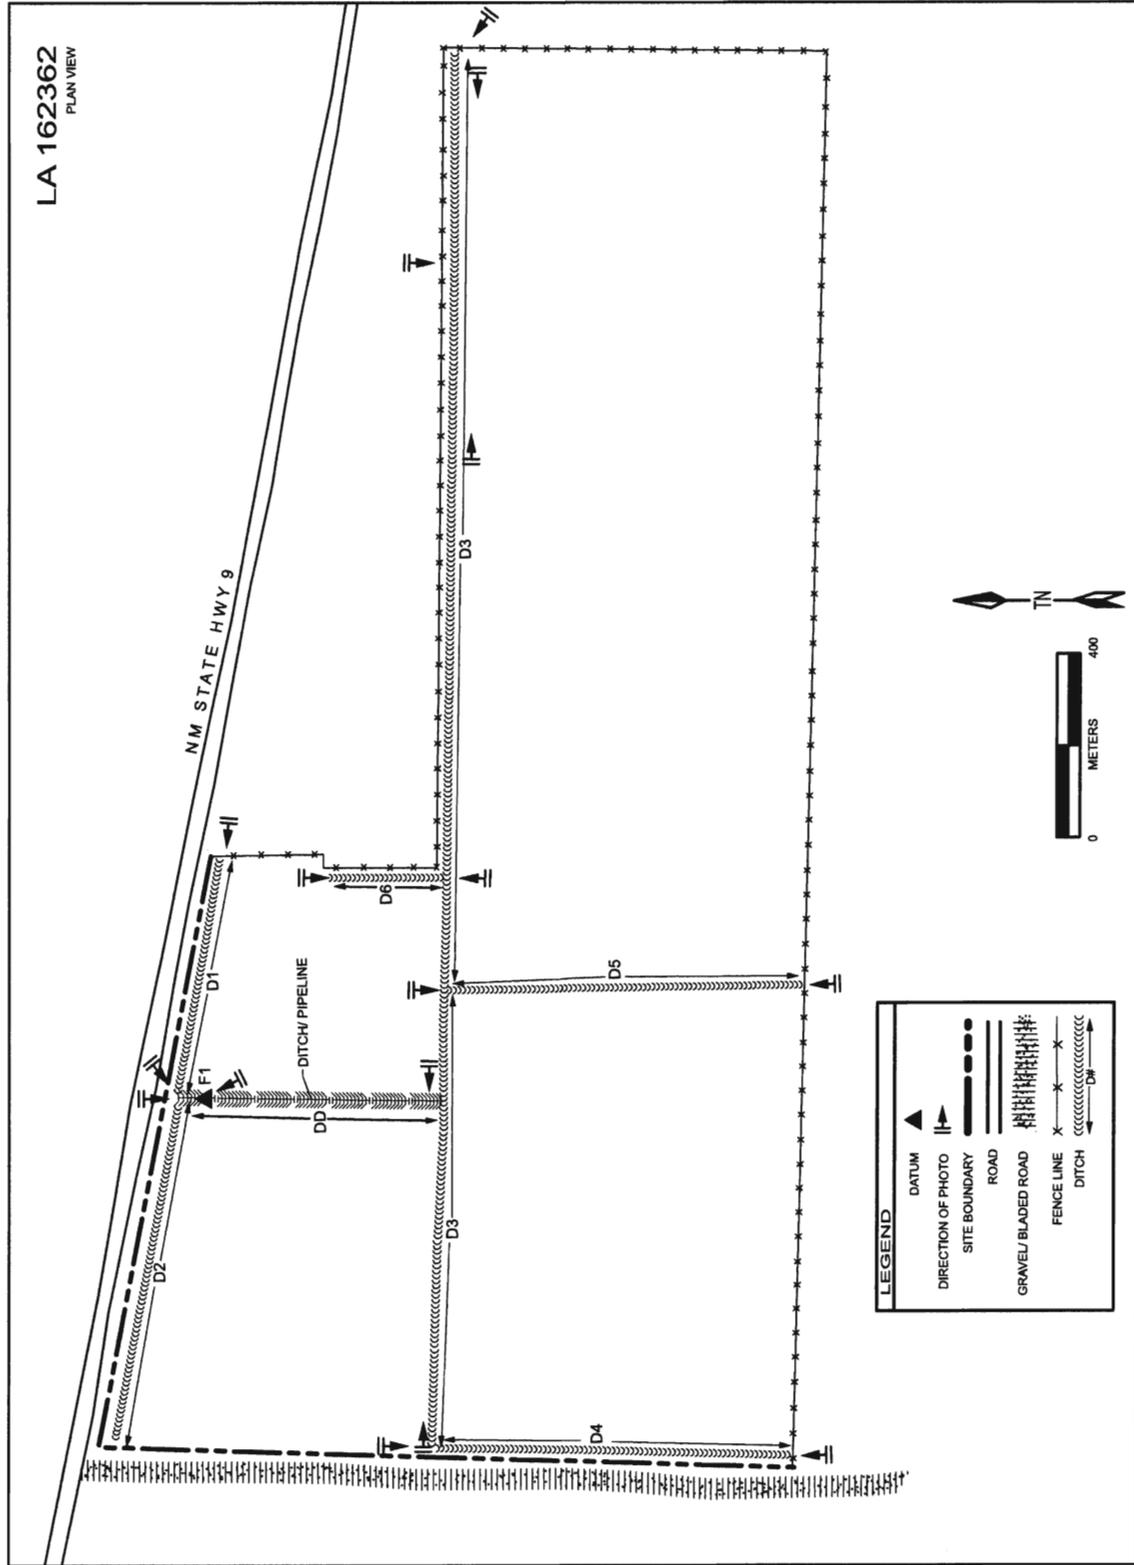
Figure 2.2: LA 162362 Plan View.

Features 2 through 8 are all irrigation ditches located south of State Highway 9. With the exception of Feature 8, which is made entirely of dirt, the ditches are all lined with cement segments. The pre-poured cement ditches are in segments that are 8 ft, 8 in long and 4 ft, 2 in wide. The outer flanges are 4½ in wide and the cement is 2½ in thick, only measurable

at the flanges. The sides and the base may be thicker. Although filled with sediment, the ditches are estimated to be between 2 ft to 2½ ft deep. There are two-track roads or bladed gravel roads or both on each side of all the ditches. Locals have been scavenging materials from the old railroad berm located north of State Highway 9, outside of the project area, for use on the gravel road. This slag and volcanic basalt is observed in many areas along the ditches. Local informants stated that the railroad was abandoned in the early 1950's, either 1951 or 1952, at the same time the cement ditches were installed. The ditches were installed by a Mr. Teague and in use until the late 1970s to early 1980s, through a succession of up to two landowners.

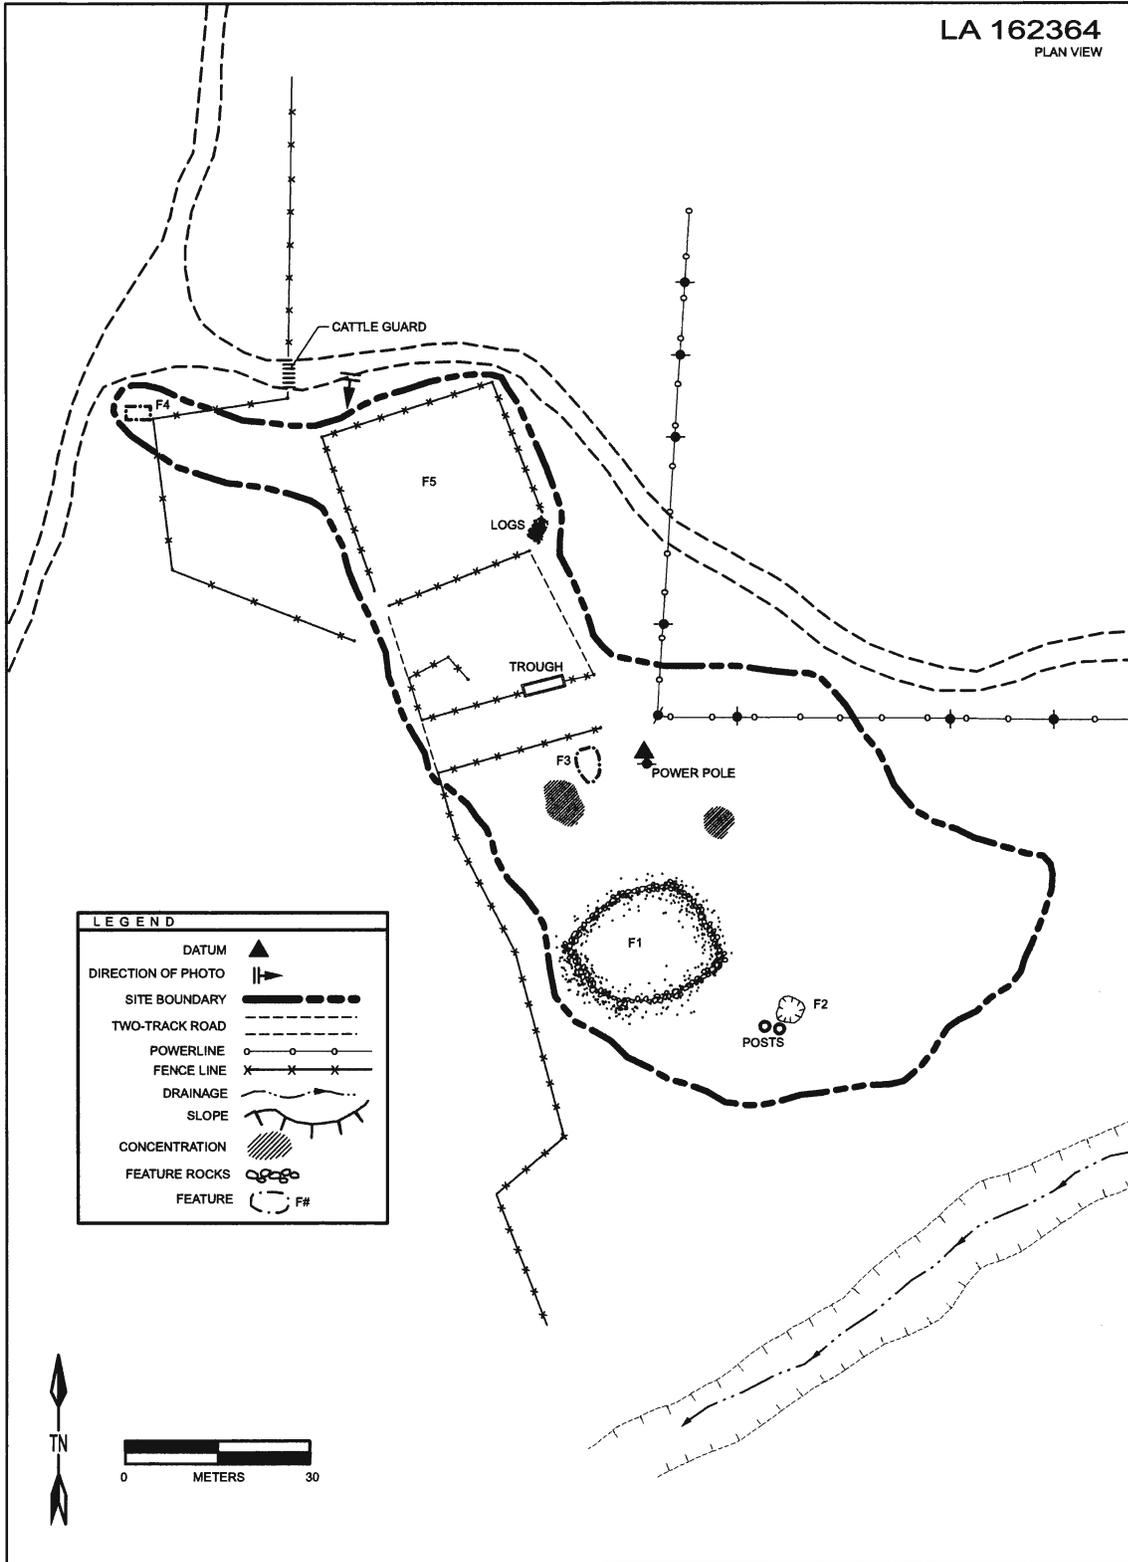
Figure 2.4: LA 162364 Plan View.

Feature 3 is an 18-in N/S by 12-in E/W by a maximum of 3-ft deep structure composed of cement over chicken wire walls and a concrete floor. This feature is approximately 50 ft northwest of F1. The walls have collapsed inward. Several fragments of milled lumber, possibly roofing supports, are scattered in the interior. Carbon stains on the cement walls and wood suggest the structure was destroyed by fire. Several 3-in wire nails protrude from the northern section of wall. No additional artifacts are present in

the interior. Glass and metal fragments are scattered outside of the structure. The feature is approximately 25 percent intact.
