**WETLAND ASSESSMENT REPORT REVISED JULY 1, 2010**

**Shell WindEnergy**  
**Hermosa West Wind Farm Project, Albany County, Wyoming**

# Wetland Assessment: Hermosa West Wind Farm Project

Project No. 0105023  
Albany County, Wyoming

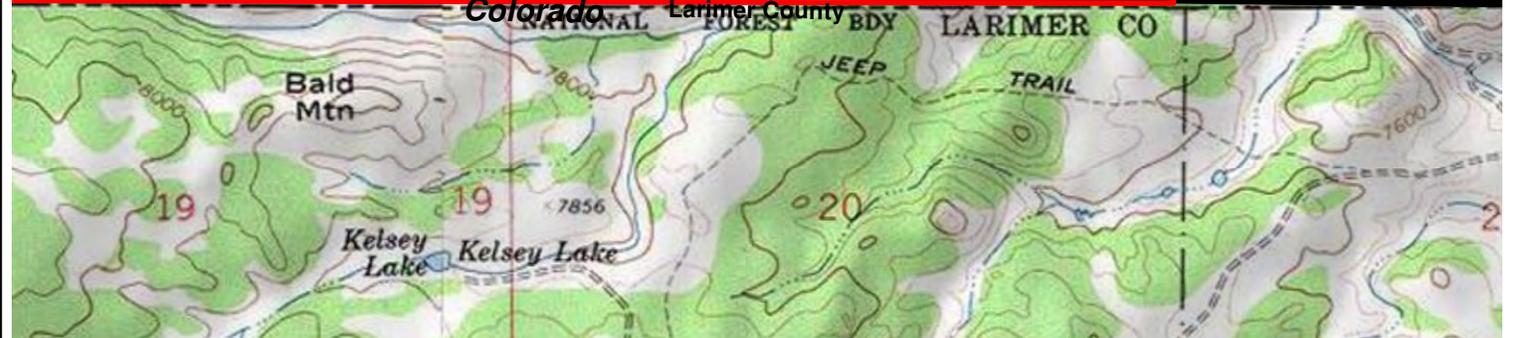
FIGURE 3-2h  
SOILS MAP  
Shell WindEnergy  
Hermosa Wind Farm Project  
Albany County, Wyoming

A desktop assessment of the soils located within the Survey Area was performed (Figure 3-2a-h). According to the USDA NRCS Soil Survey for Albany County (2008) there are 15 soil series present within the Survey Area, of these four (4) are considered partially hydric (Table 3-2). These hydric series are typically located in low-lying landforms associated with stream terraces.

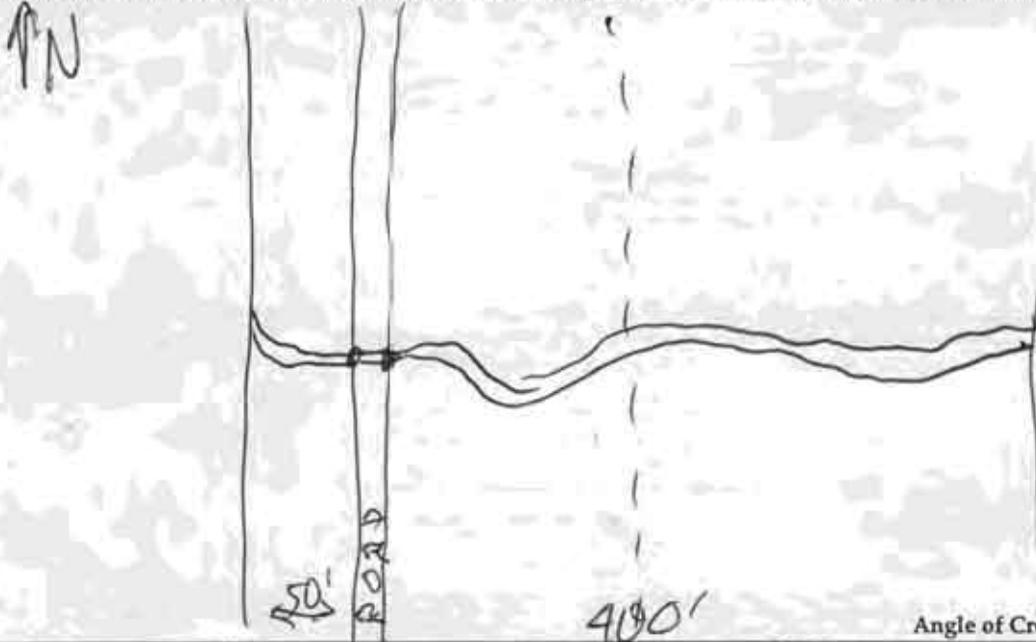
Waterbody Sketch Plan

Waterbody Type	Lake	Pond	Borrow Pit	River	<input checked="" type="checkbox"/> Stream	Ag. Ditch	Other:			
Stream Flow	Fast	<input checked="" type="checkbox"/> Moderate		Slow	Very Slow	None				
Flow type	<input checked="" type="checkbox"/> Perennial (Flows > 3 months annually)		Intermittent/Seasonal (Flows < 3 months annually)		Ephemeral (Flows only in response to rainfall)		Direction: <u>E</u> Months of estimated flow: <u>10</u>			
OHWM Indicator	Clear natural line on bank		<input checked="" type="checkbox"/> Shelving	Wrested vegetation		<input checked="" type="checkbox"/> Scour	Water Staining			
Bent, matted or missing vegetation		Soil character changes		Abrupt plant community change			Wrack line	Litter and debris		
Sinuosity	Straight		<input checked="" type="checkbox"/> Meandering		Subsurface Flow?		Yes	No	Unknown	
Stream Depth (in.)	0-3	3-6	6-12	<input checked="" type="checkbox"/> 12-18		18-24	24-36	36-48	48-60	60+

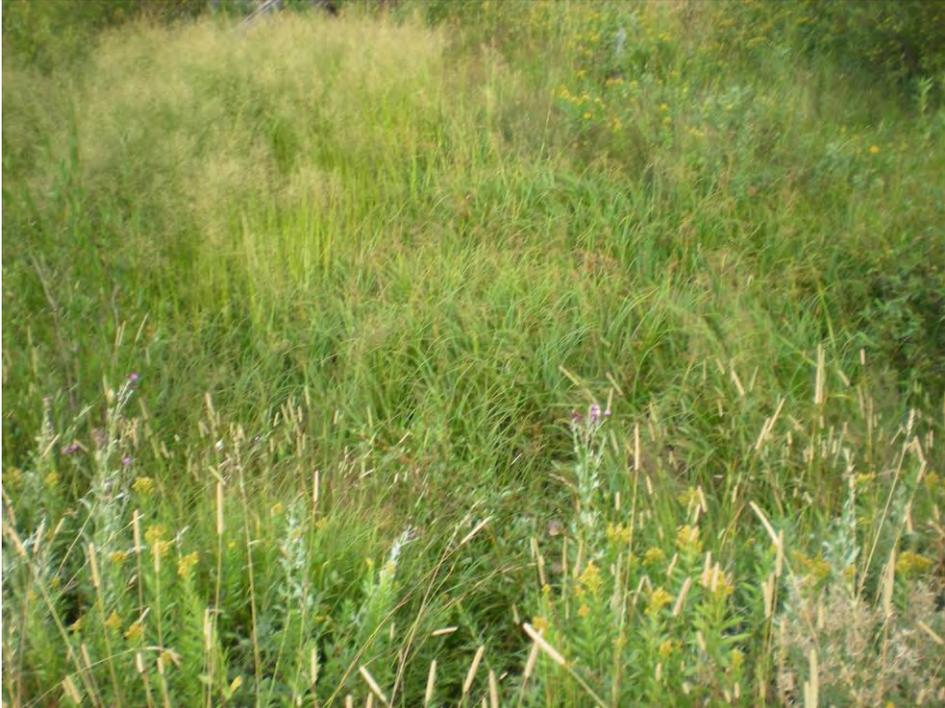
<b>Client:</b>	Shell Wind Energy	<b>Project Number:</b>	0105023
<b>Project Name:</b>	Hermosa West	<b>Location:</b>	Albany County, WY
<b>Photograph ID:</b> A35

<b>Feature:</b> WAAL001			
<b>Date:</b> 08-25-2009			
<b>Comments:</b> Looking south, this photo depicts wetland WAAL001 associated with stream SAL004 (Forest Creek).			
<b>Photograph ID:</b> A36

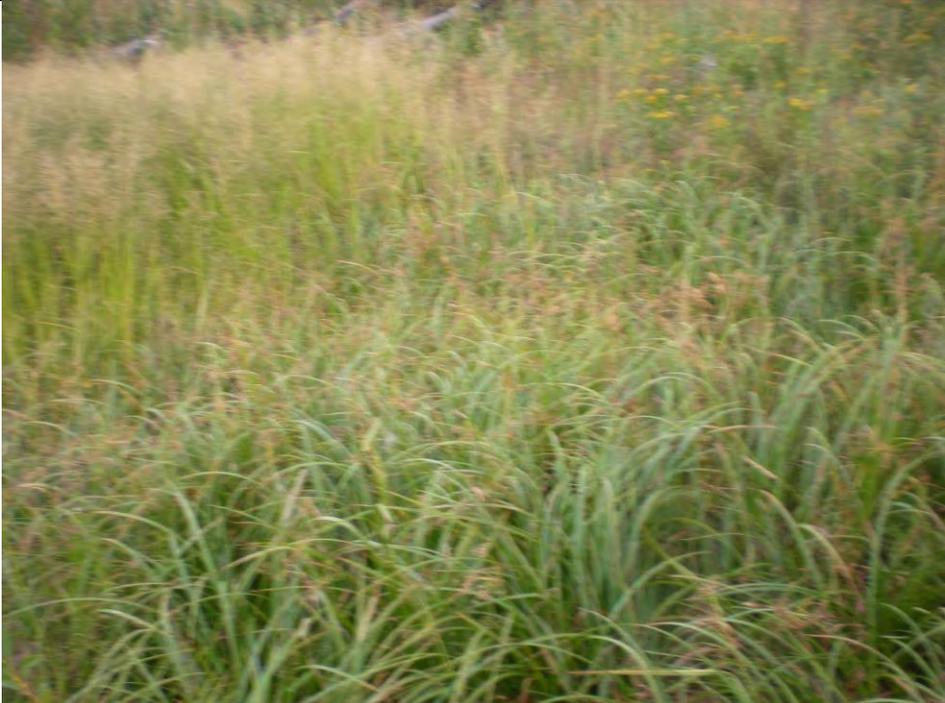
<b>Feature:</b> WAAL001			
<b>Date:</b> 08-25-2009			
<b>Comments:</b> Looking north, this image shows another view of wetland WAAL001.

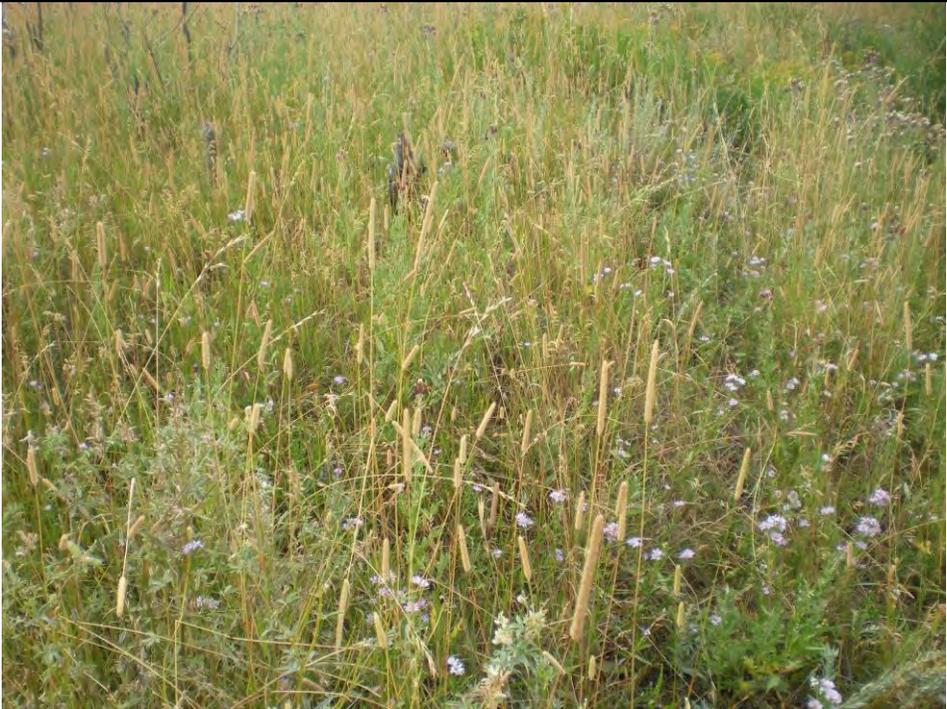
<b>Client:</b>	Shell Wind Energy	<b>Project Number:</b>	0105023
<b>Project Name:</b>	Hermosa West	<b>Location:</b>	Albany County, WY
<b>Photograph ID:</b> A37

<b>Feature:</b> WAAL001U			
<b>Date:</b> 08-25-2009			
<b>Comments:</b> Looking west, this photograph shows the upland vegetation community adjacent to wetland WAAL001.			
<b>Photograph ID:</b> A54

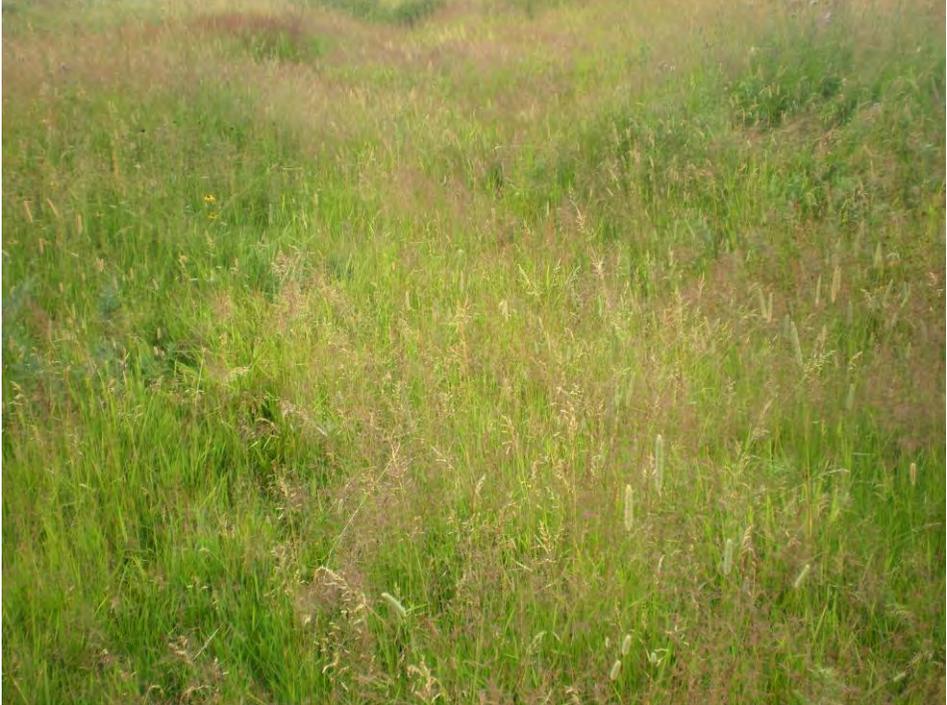
<b>Feature:</b> WAAL002			
<b>Date:</b> 08-26-2009			
<b>Comments:</b> Looking south-southwest this image shows a view of wetland WAAL002 associated with the confluence of stream SAAL008 (Boulder Creek) and SAAL009.

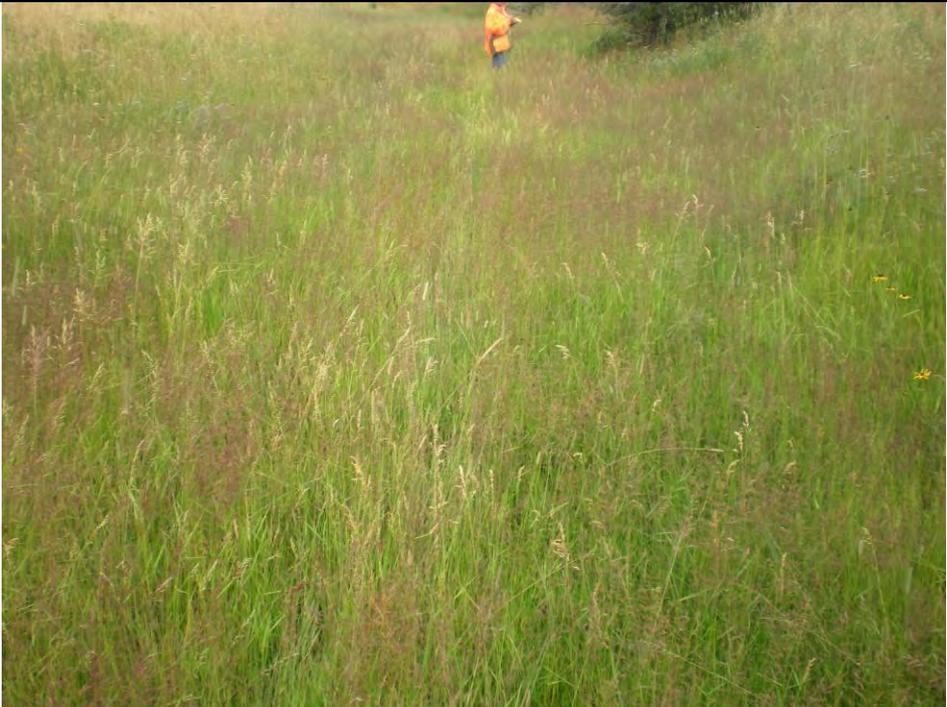
<b>Client:</b>	Shell Wind Energy	<b>Project Number:</b>	0105023
<b>Project Name:</b>	Hermosa West	<b>Location:</b>	Albany County, WY
<b>Photograph ID:</b> A55

<b>Feature:</b> WAAL002			
<b>Date:</b> 08-26-2009			
<b>Comments:</b> Looking north-northeast this photograph shows another view of wetland WAAL002.			
<b>Photograph ID:</b> A56

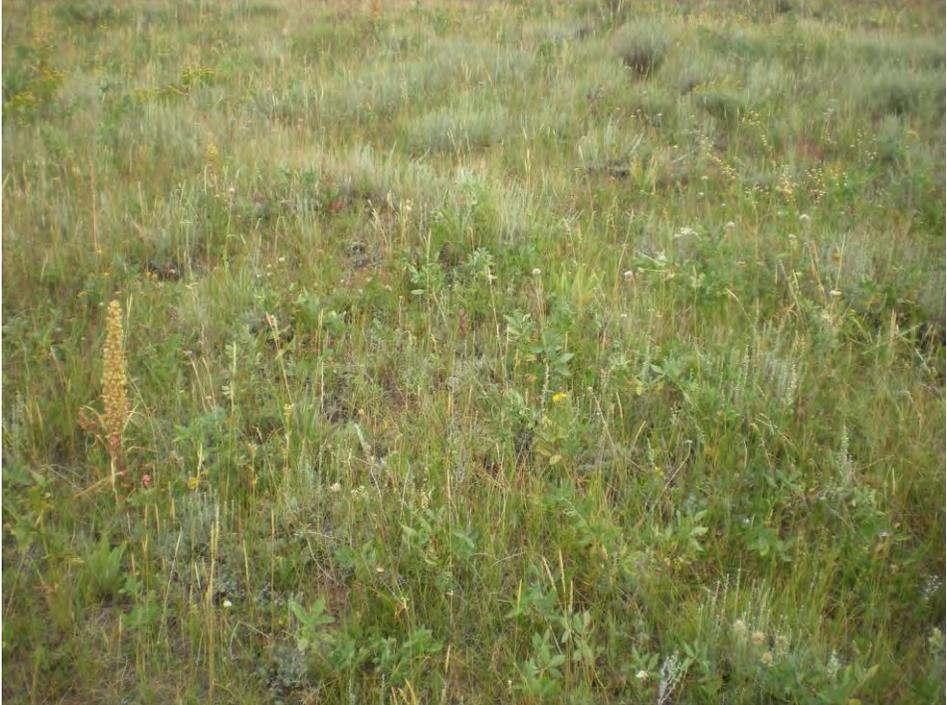
<b>Feature:</b> WAAL002U			
<b>Date:</b> 08-26-2009			
<b>Comments:</b> Looking south, this picture shows the upland plant community associated with wetland WAAL002.

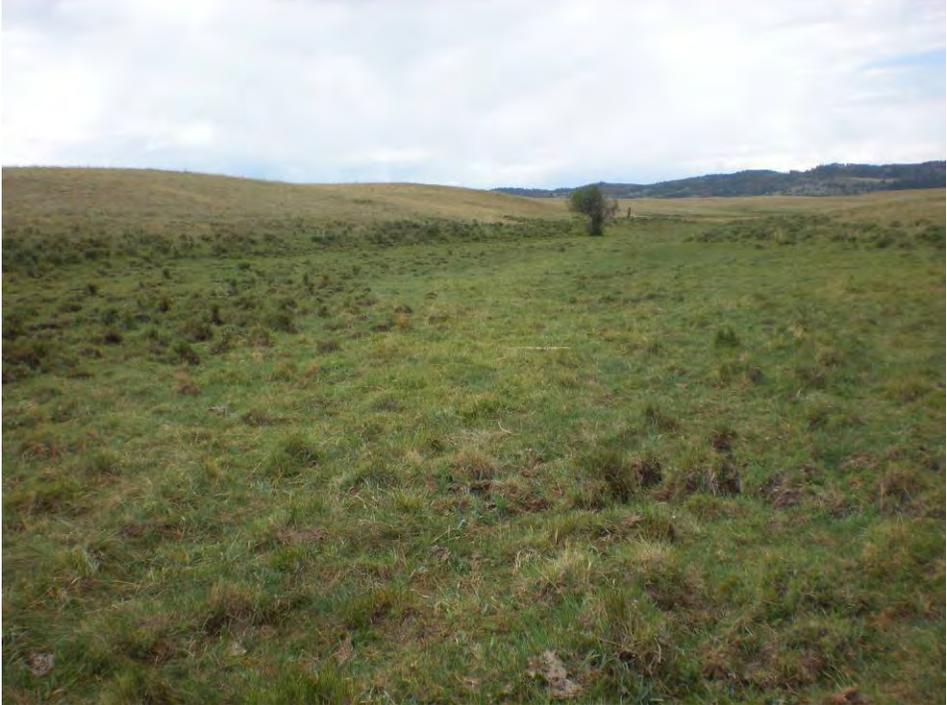
<b>Client:</b>	Shell Wind Energy	<b>Project Number:</b>	0105023
<b>Project Name:</b>	Hermosa West	<b>Location:</b>	Albany County, WY
<b>Photograph ID:</b> A65

<b>Feature:</b> WAAL003			
<b>Date:</b> 08-26-2009			
<b>Comments:</b> Looking west, this image shows wetland WAAL003. This wetland is located in a low-lying area near an offsite wetland complex associated with a tributary to Willow Creek.			
<b>Photograph ID:</b> A66

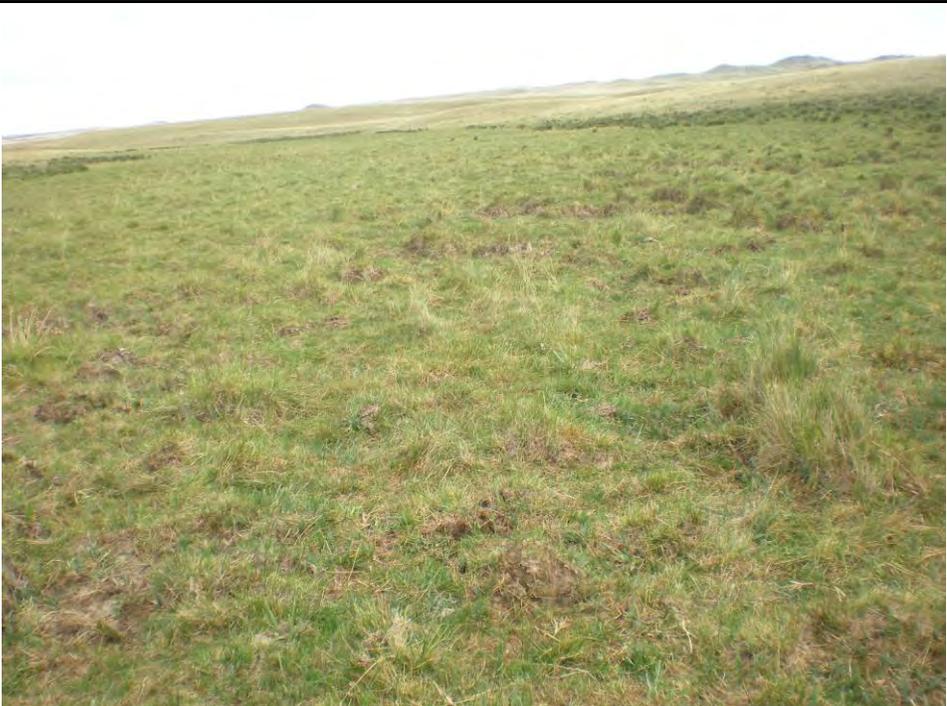
<b>Feature:</b> WAAL003			
<b>Date:</b> 08-26-2009			
<b>Comments:</b> Looking east, this image shows another view of the hummocks within wetland WAAL003.

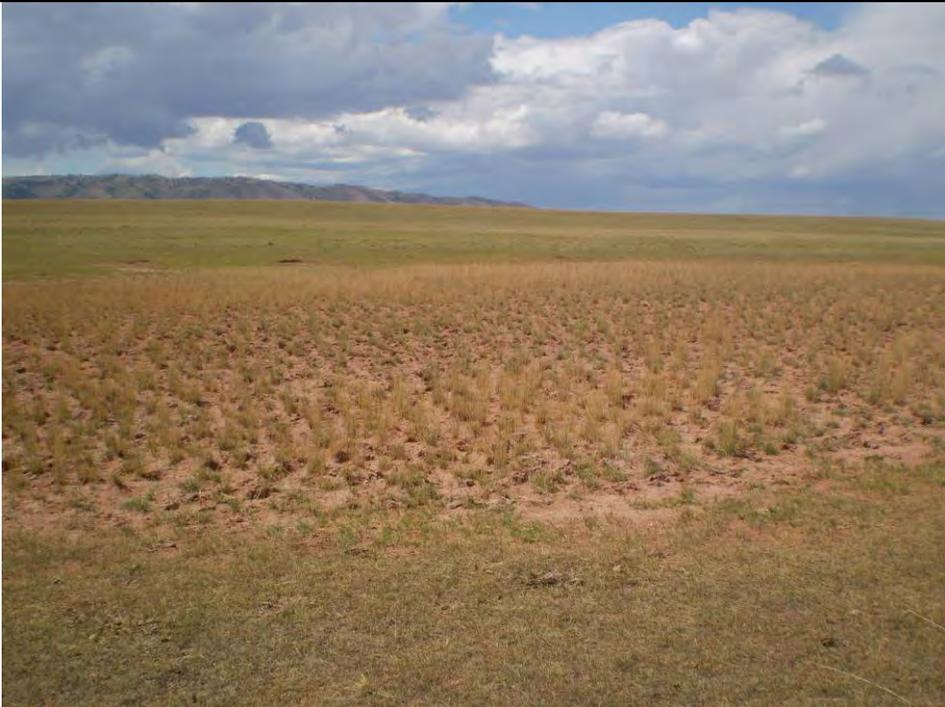
<b>Client:</b>	Shell Wind Energy	<b>Project Number:</b>	0105023
<b>Project Name:</b>	Hermosa West	<b>Location:</b>	Albany County, WY
<b>Photograph ID:</b> B17

<b>Feature:</b> WBAL002			
<b>Date:</b> 08-25-2009			
<b>Comments:</b> Isolated wetland feature facing south.			
<b>Photograph ID:</b> B29

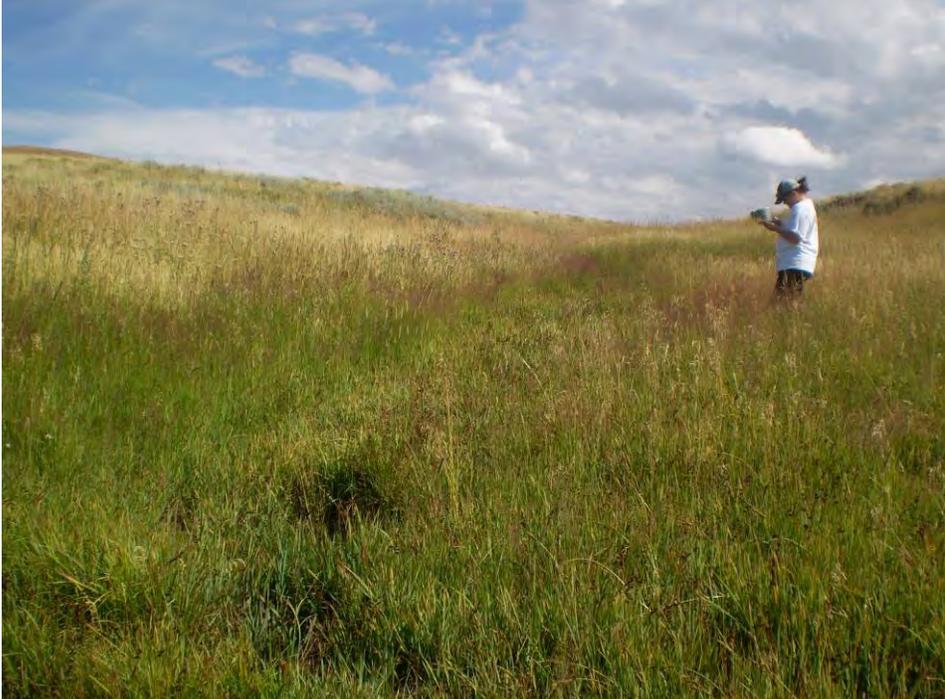
<b>Feature:</b> WBAL003			
<b>Date:</b> 08-25-2009			
<b>Comments:</b> SBAL004 facing south with fringing wetland WBAL003 at junction of SBAL004 and SBAL005.

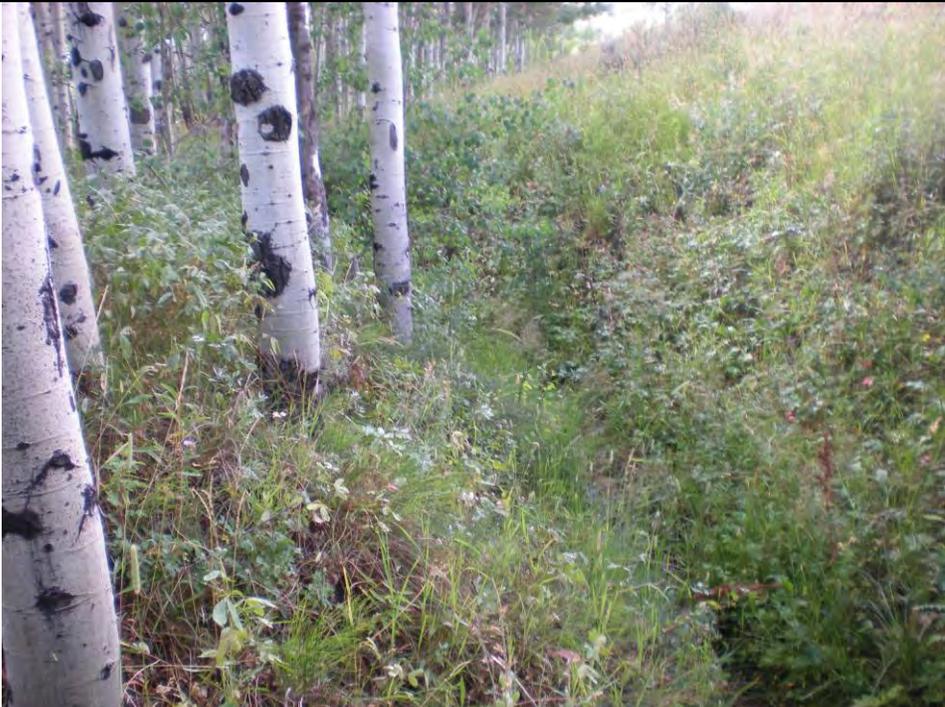
<b>Client:</b>	Shell Wind Energy	<b>Project Number:</b>	0105023
<b>Project Name:</b>	Hermosa West	<b>Location:</b>	Albany County, WY
<b>Photograph ID:</b> A11

<b>Feature:</b> SAAL001			
<b>Date:</b> 08-25-2009			
<b>Comments:</b> Looking west, this image shows the aspen lined stream banks of SAAL001 (Government Creek).			
<b>Photograph ID:</b> A12

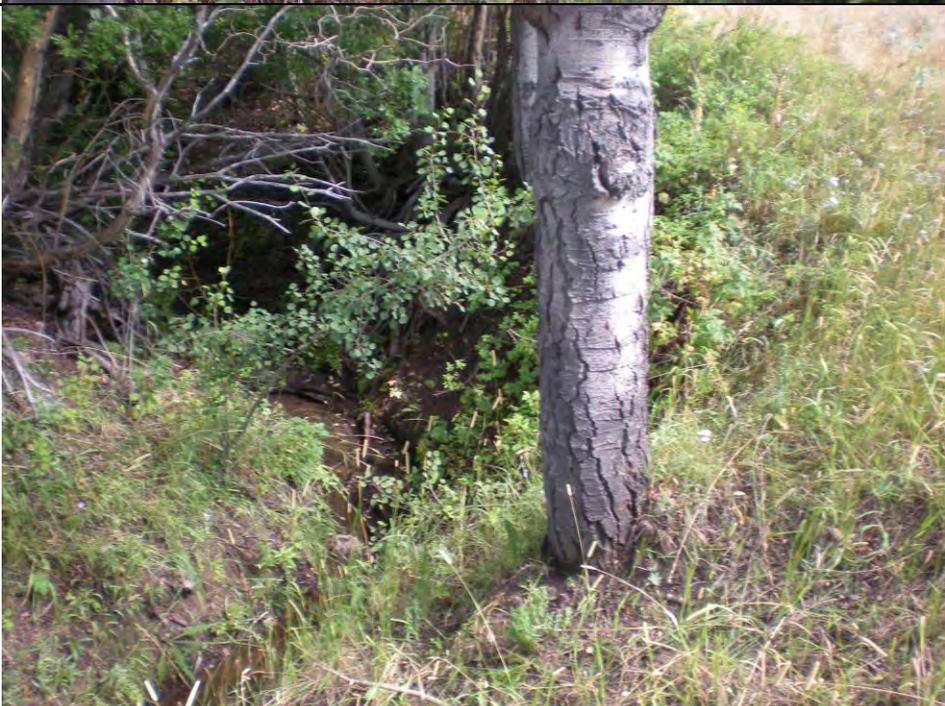
<b>Feature:</b> SAAL001			
<b>Date:</b> 08-25-2009			
<b>Comments:</b> Looking east, this photo shows another view of the perennial stream SAAL001.

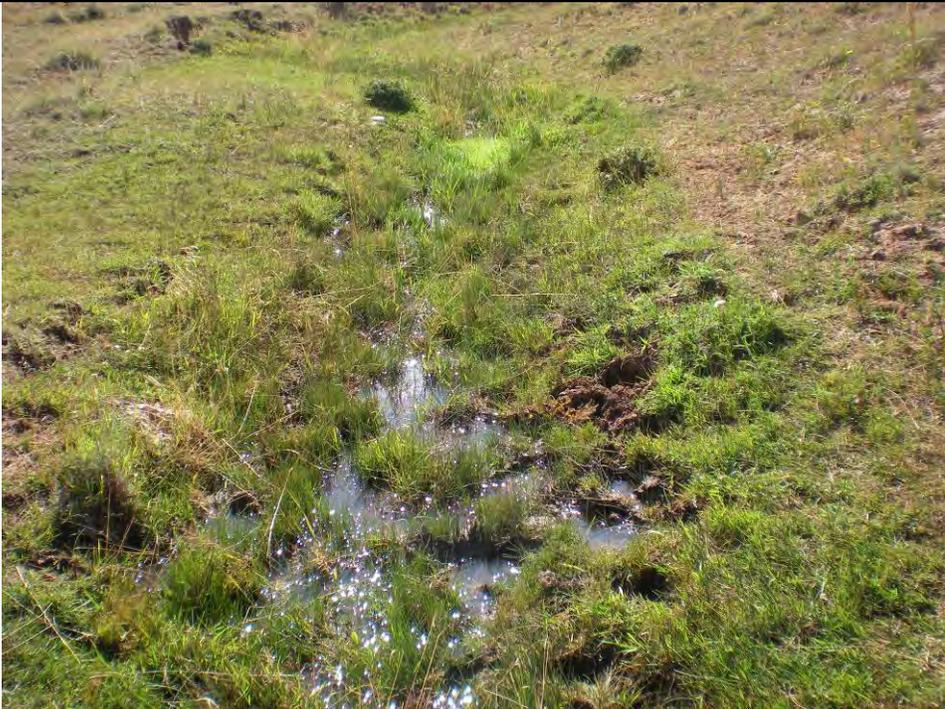
<b>Client:</b>	Shell Wind Energy	<b>Project Number:</b>	0105023
<b>Project Name:</b>	Hermosa West	<b>Location:</b>	Albany County, WY
<b>Photograph ID:</b> A21

<b>Feature:</b> SAAL002			
<b>Date:</b> 08-25-2009			
<b>Comments:</b> Looking west this image shows a view of the perennial stream SAAL002 (Government Creek).			
<b>Photograph ID:</b> A22

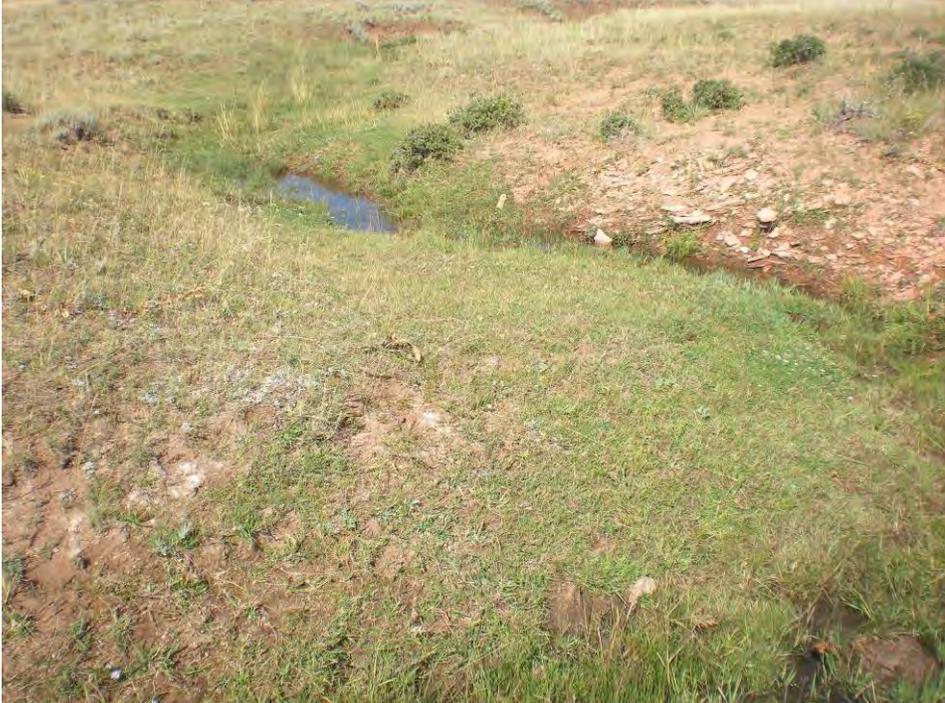
<b>Feature:</b> SAAL002			
<b>Date:</b> 08-25-2009			
<b>Comments:</b> Looking east this image shows another view of this Waterbody.

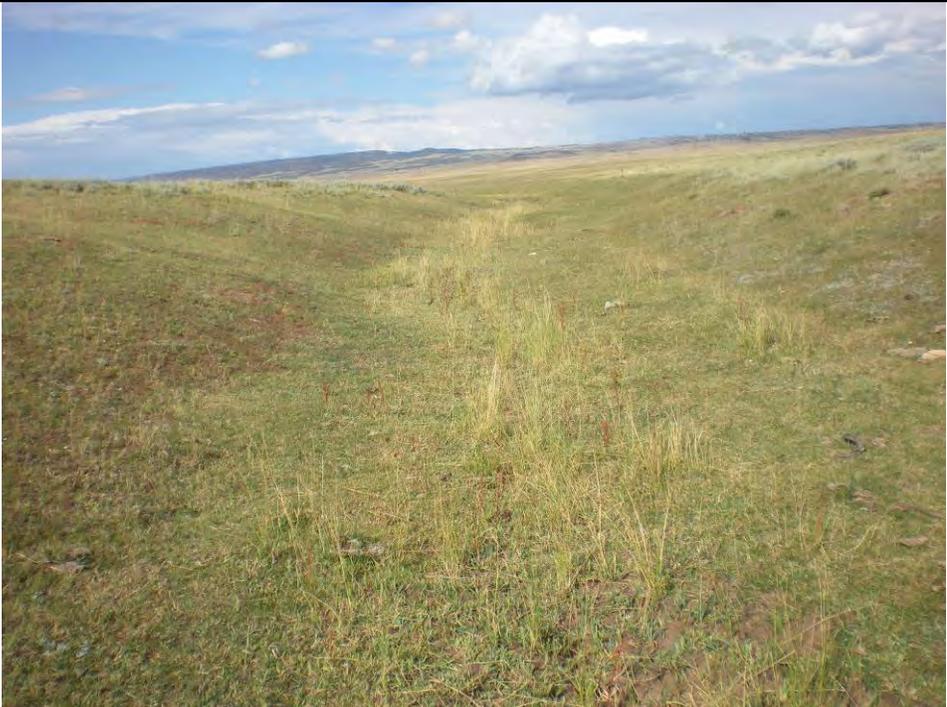
<b>Client:</b>	Shell Wind Energy	<b>Project Number:</b>	0105023
<b>Project Name:</b>	Hermosa West	<b>Location:</b>	Albany County, WY
<b>Photograph ID:</b> A25

<b>Feature:</b> SAAL003			
<b>Date:</b> 08-25-2009			
<b>Comments:</b> Looking southwest, this image shows stream SAAL003. While this is still Government Creek, this reach is considered an ephemeral creek.			
<b>Photograph ID:</b> A26

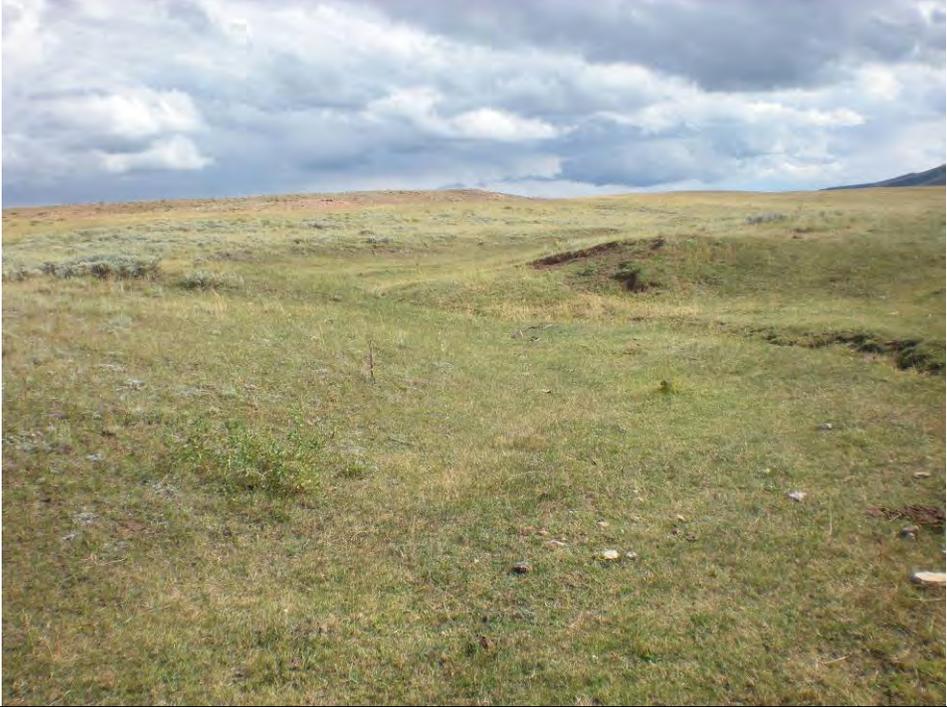
<b>Feature:</b> ESAAL003			
<b>Date:</b> 08-25-2009			
<b>Comments:</b> Looking northeast, this image shows the shelving of SAAO003.

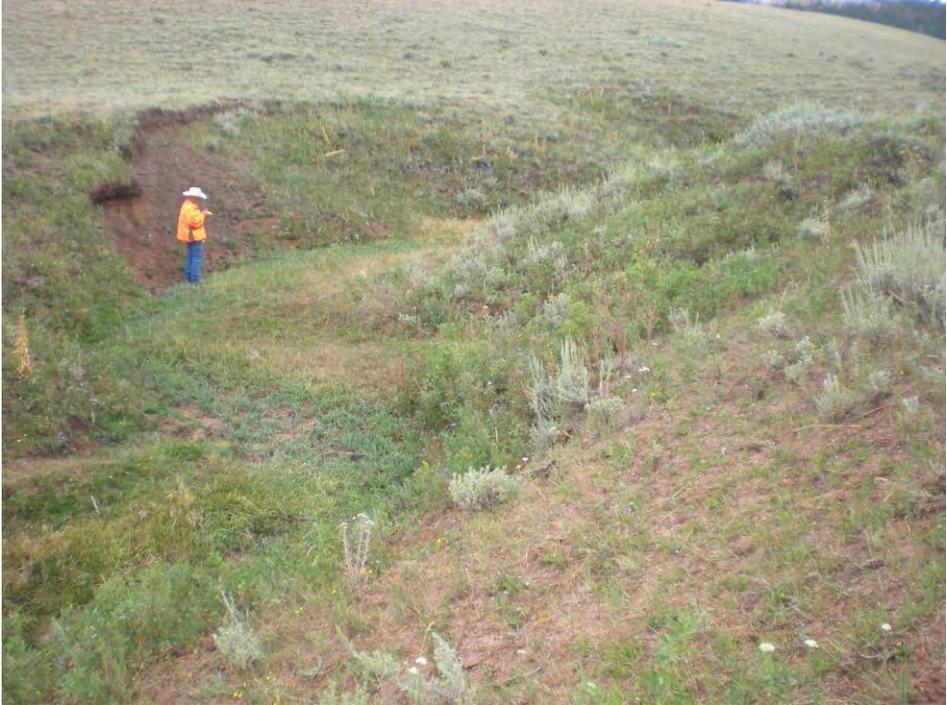
<b>Client:</b>	Shell Wind Energy	<b>Project Number:</b>	0105023
<b>Project Name:</b>	Hermosa West	<b>Location:</b>	Albany County, WY
<b>Photograph ID:</b> A38

<b>Feature:</b> SAAL005			
<b>Date:</b> 08-26-2009			
<b>Comments:</b> Looking west, this image shows the intermittent reach of Forrest Creek SAAL005.			
<b>Photograph ID:</b> A39

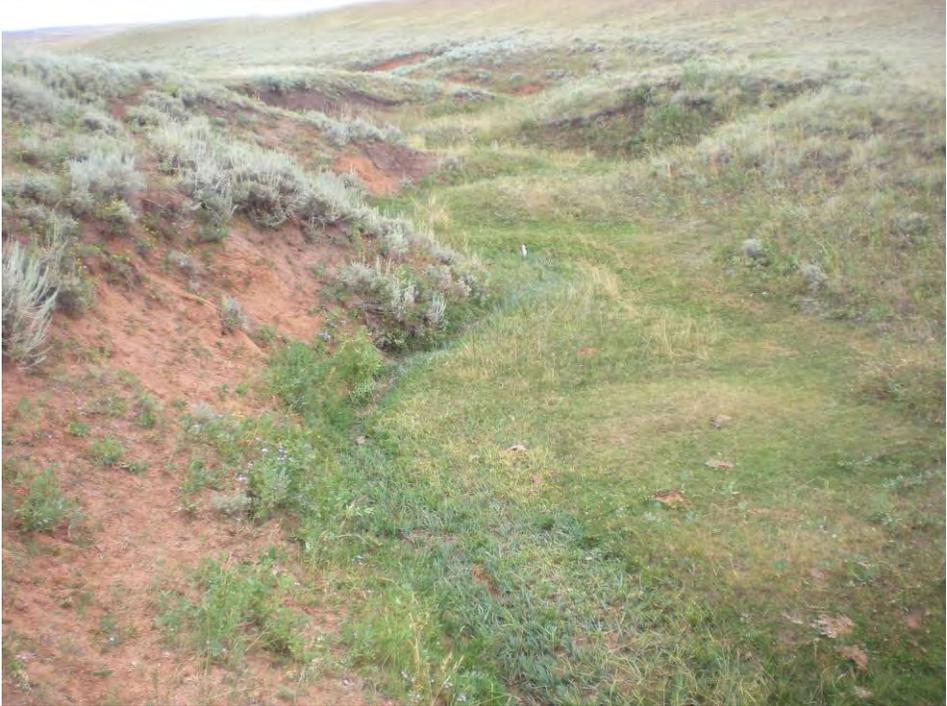
<b>Feature:</b> SAAL005			
<b>Date:</b> 08-26-2009			
<b>Comments:</b> Looking east, this image shows the shelving associated with this intermittent waterbody.

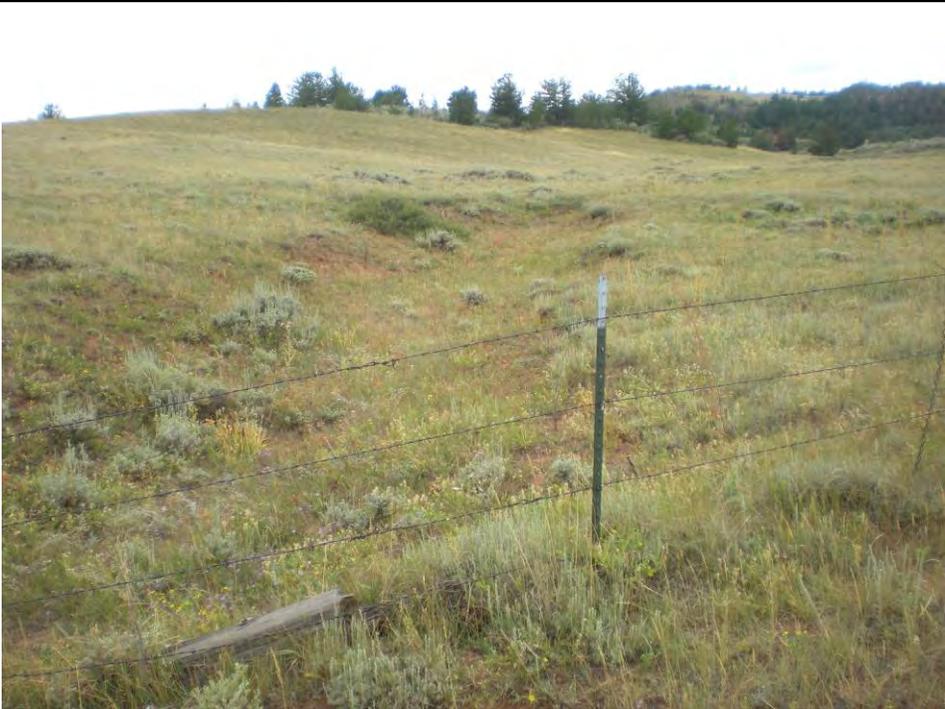
<b>Client:</b>	Shell Wind Energy	<b>Project Number:</b>	0105023
<b>Project Name:</b>	Hermosa West	<b>Location:</b>	Albany County, WY
<b>Photograph ID:</b> A52

<b>Feature:</b> SAAL007			
<b>Date:</b> 08-26-2009			
<b>Comments:</b> Looking west, this image shows the ephemeral creek SAAL007. This Waterbody is a tertiary tributary to Boulder Creek.			
<b>Photograph ID:</b> A53

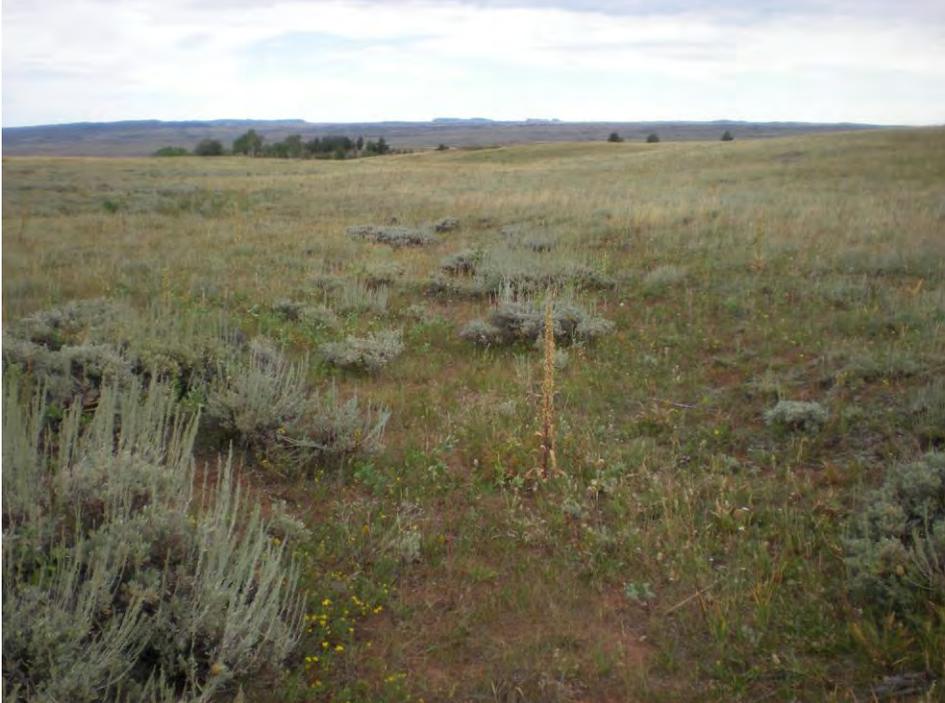
<b>Feature:</b> SAAL007			
<b>Date:</b> 08-26-2009			
<b>Comments:</b> Looking east, this image shows Boulder Creek in the distance along the tree line.

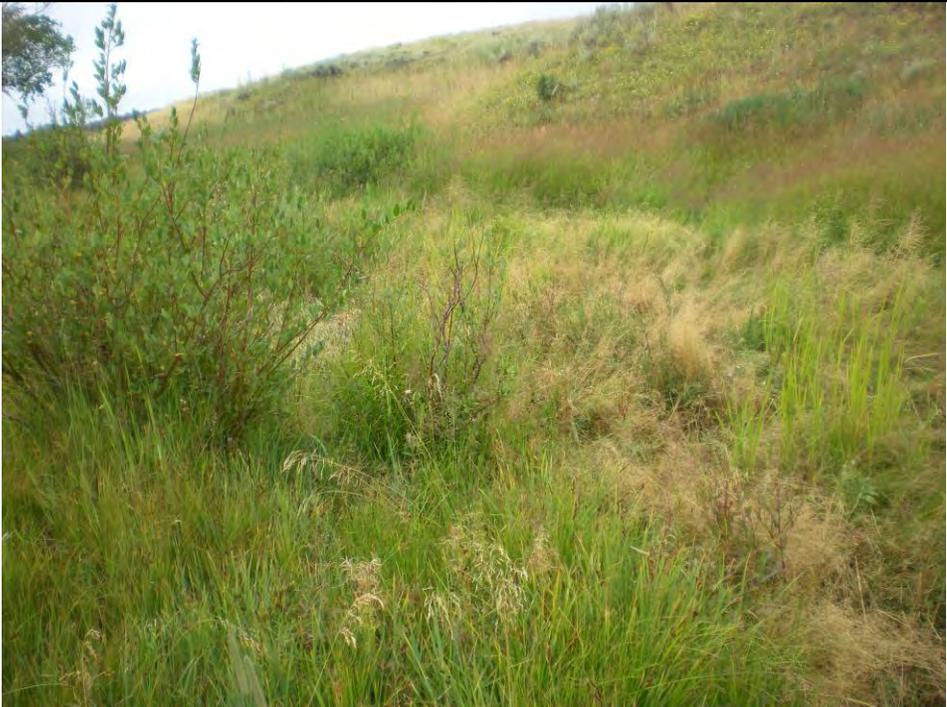
<b>Client:</b>	Shell Wind Energy	<b>Project Number:</b>	0105023
<b>Project Name:</b>	Hermosa West	<b>Location:</b>	Albany County, WY
<b>Photograph ID:</b> A59

<b>Feature:</b> SAAL009			
<b>Date:</b> 08-26-2009			
<b>Comments:</b> Looking north, this image shows the ephemeral stream SAAL009 and the associated wetland WAAL002.			
<b>Photograph ID:</b> A60

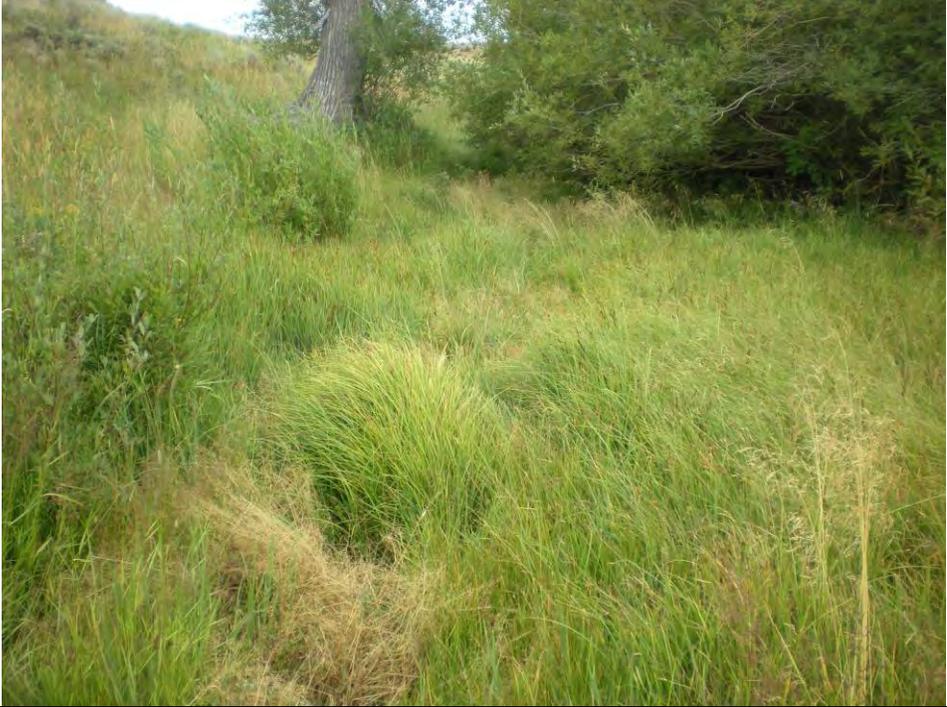
<b>Feature:</b> SAAL009			
<b>Date:</b> 08-26-2009			
<b>Comments:</b> Looking south this image provides another view of the ephemeral stream and the associated wetland.

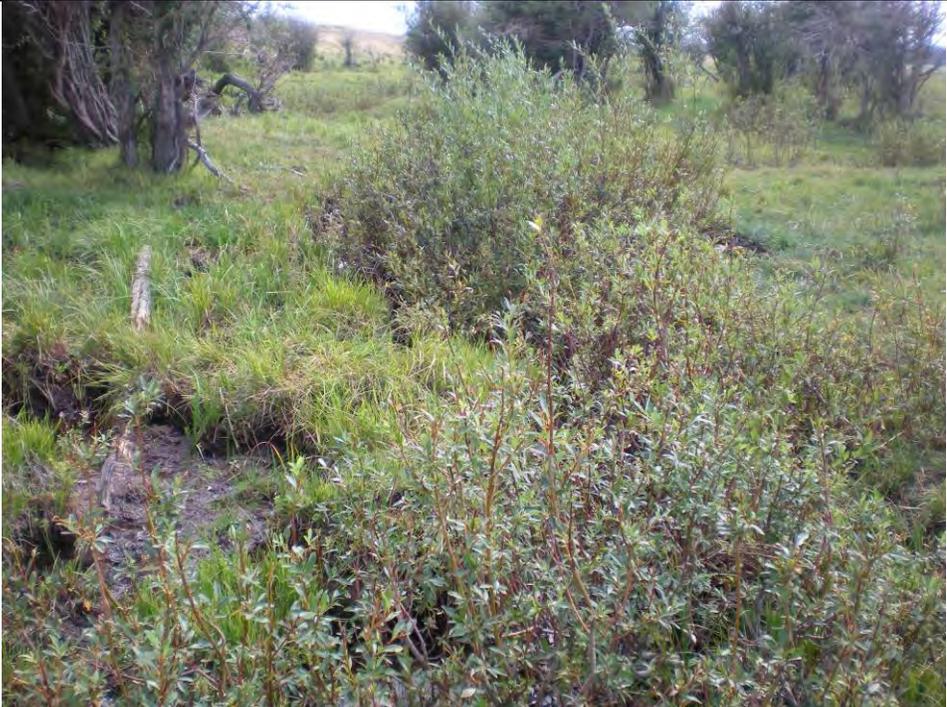
<b>Client:</b>	Shell Wind Energy	<b>Project Number:</b>	0105023
<b>Project Name:</b>	Hermosa West	<b>Location:</b>	Albany County, WY
<b>Photograph ID:</b> A77

<b>Feature:</b> SAAL012			
<b>Date:</b> 08-26-2009			
<b>Comments:</b> Looking northeast this image shows the perennial stream SAAL012. This image also provides a view of the wetland WAAL004.			
<b>Photograph ID:</b> A78

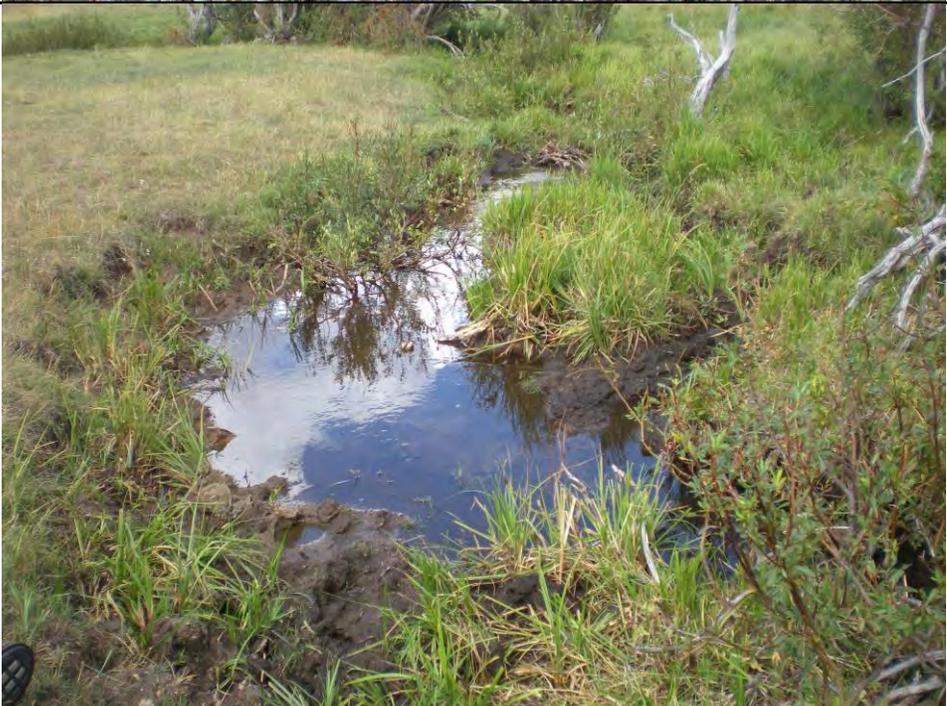
<b>Feature:</b> SAAL012			
<b>Date:</b> 08-26-2009			
<b>Comments:</b> Looking southwest, this image shows another view of SAAL012 and the associated wetland WAAL004.

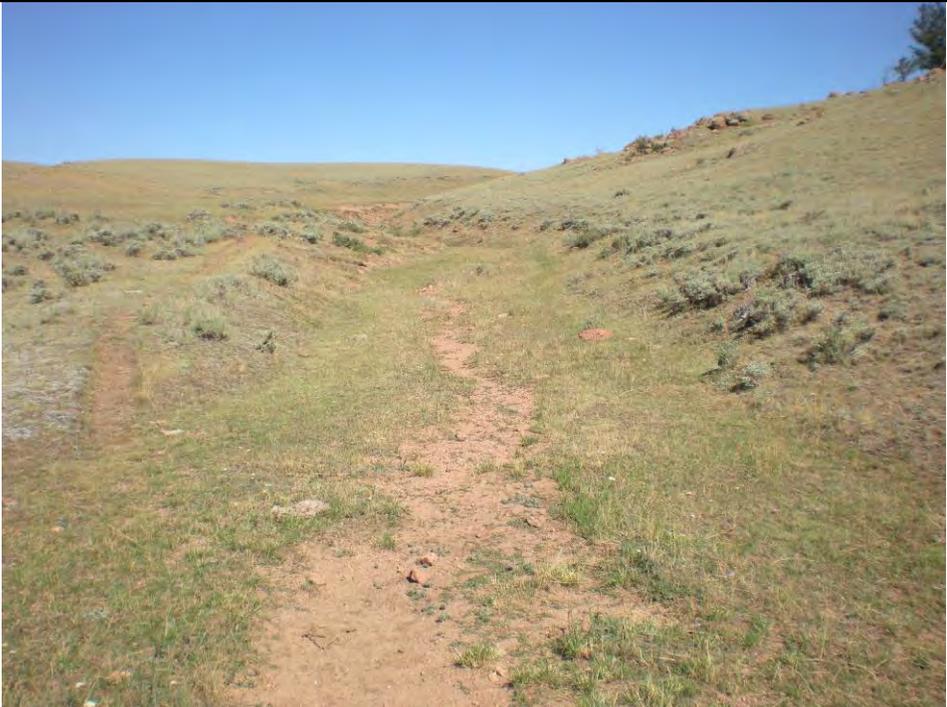
<b>Client:</b>	Shell Wind Energy	<b>Project Number:</b>	0105023
<b>Project Name:</b>	Hermosa West	<b>Location:</b>	Albany County, WY
<b>Photograph ID:</b> A93

<b>Feature:</b> SAAL015			
<b>Date:</b> 08-27-2009			
<b>Comments:</b> Looking west this image shows the shelving associated with the ephemeral stream SAAL015.			
<b>Photograph ID:</b> A94

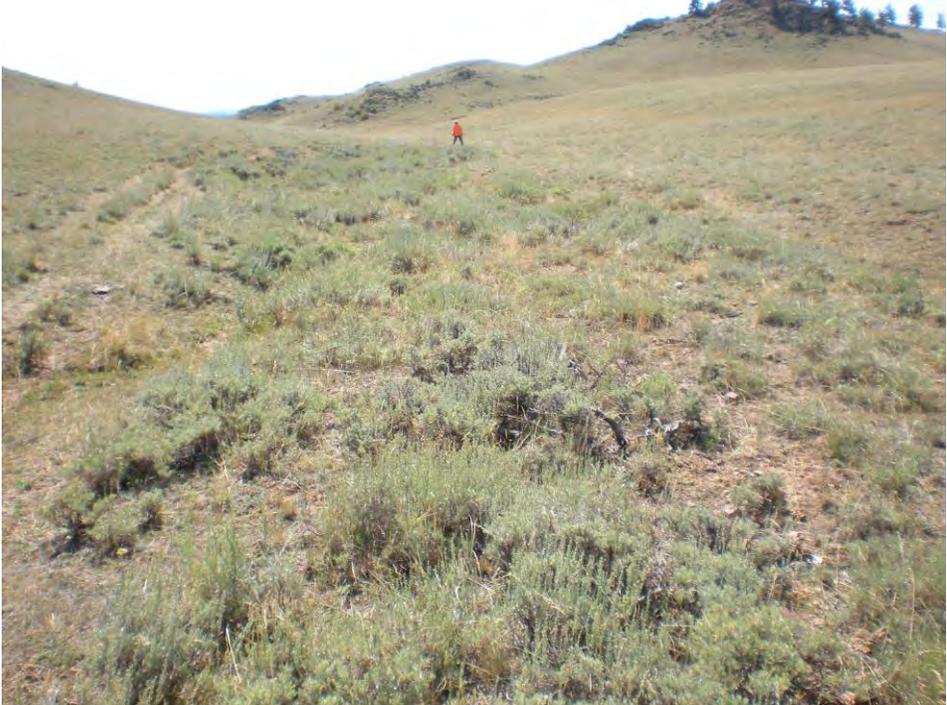
<b>Feature:</b> SAAL014			
<b>Date:</b> 08-27-2009			
<b>Comments:</b> Looking east, this photo provides another view of SAAL015.

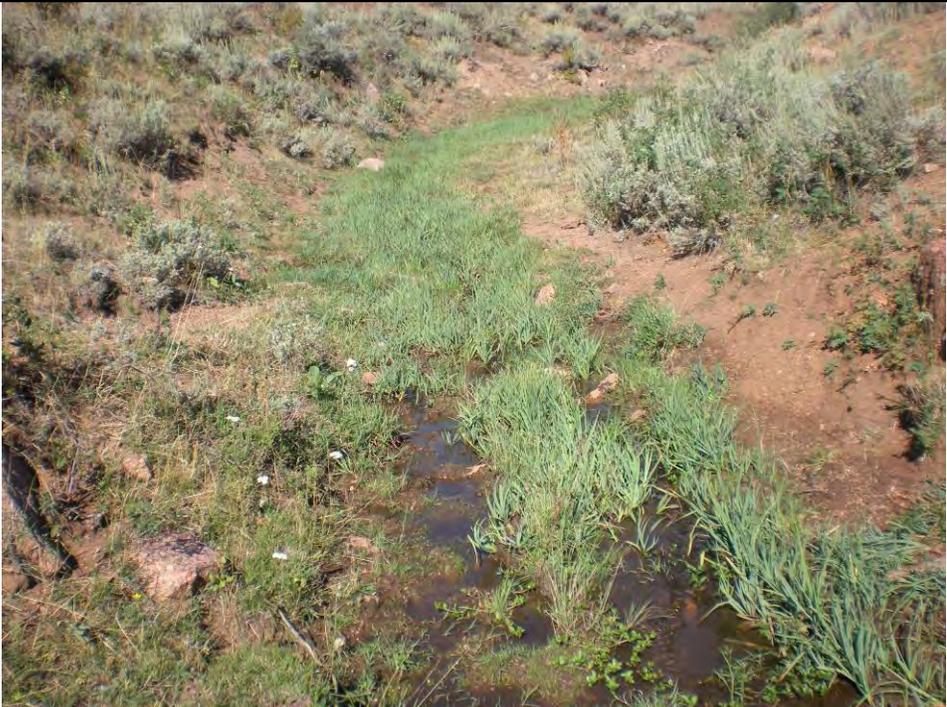
<b>Client:</b>	Shell Wind Energy	<b>Project Number:</b>	0105023
<b>Project Name:</b>	Hermosa West	<b>Location:</b>	Albany County, WY
<b>Photograph ID:</b> A95

<b>Feature:</b> SAAL014			
<b>Date:</b> 08-27-2009			
<b>Comments:</b> Looking northwest, this photo shows the perennial stream SAAL014.			
<b>Photograph ID:</b> A96

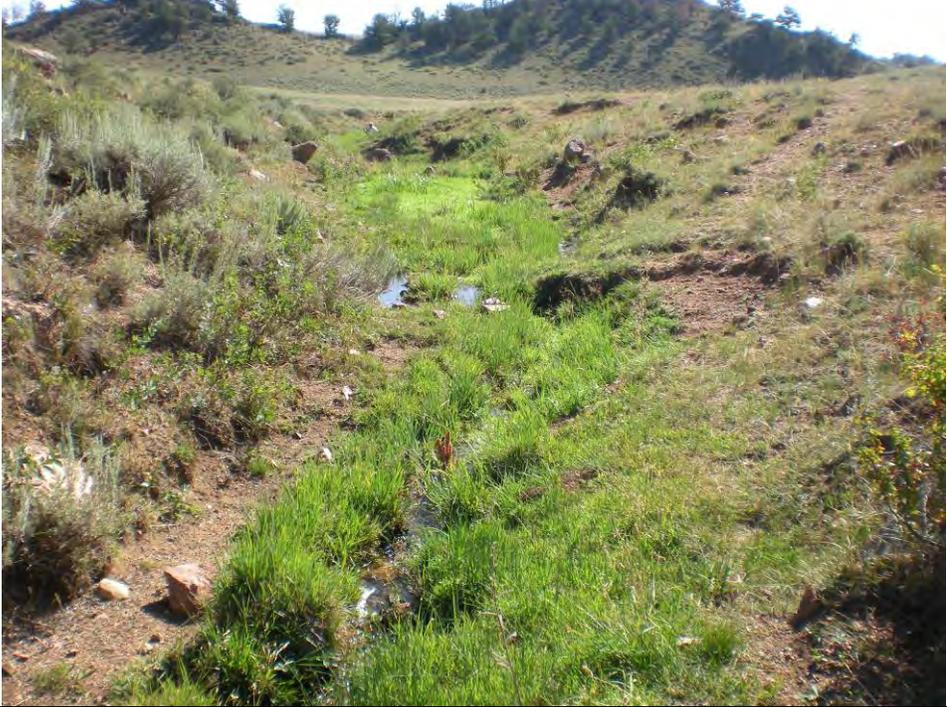
<b>Feature:</b> SAAL015			
<b>Date:</b> 08-27-2009			
<b>Comments:</b> Looking southeast this image shows another view of SAAL015.

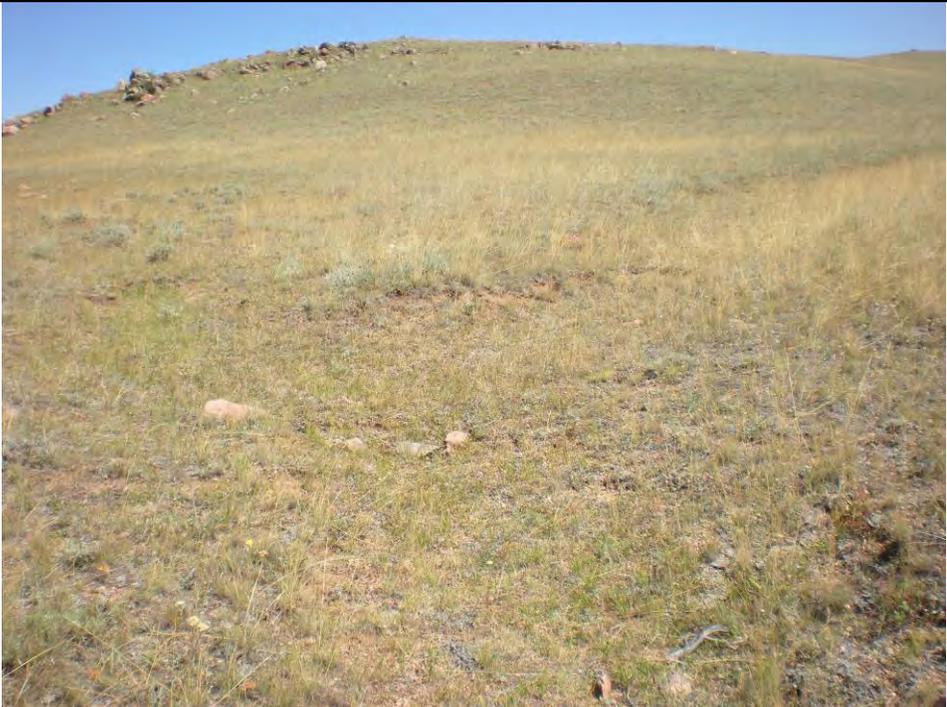
<b>Client:</b>	Shell Wind Energy	<b>Project Number:</b>	0105023
<b>Project Name:</b>	Hermosa West	<b>Location:</b>	Albany County, WY
<b>Photograph ID:</b> A101

<b>Feature:</b> SAAL016			
<b>Date:</b> 08-27-2009			
<b>Comments:</b> Looking northeast this photograph shows the ephemeral stream SAAL016.			
<b>Photograph ID:</b> A102
