**WETLAND ASSESSMENT REPORT REVISED JULY 1, 2010**

**Shell WindEnergy**  
**Hermosa West Wind Farm Project, Albany County, Wyoming**

# Wetland Assessment: Hermosa West Wind Farm Project

Project No. 0105023  
Albany County, Wyoming

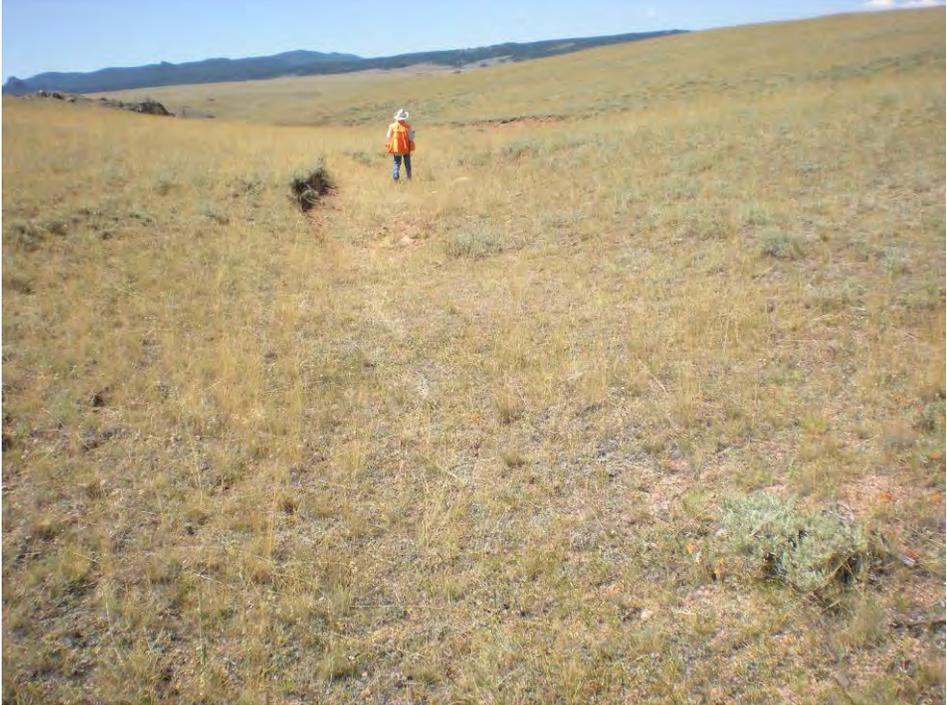
<b>Feature:</b> SAAL016			
<b>Date:</b> 08-27-2009			
<b>Comments:</b> Looking southwest this image shows the shelving associated with SAAL016.

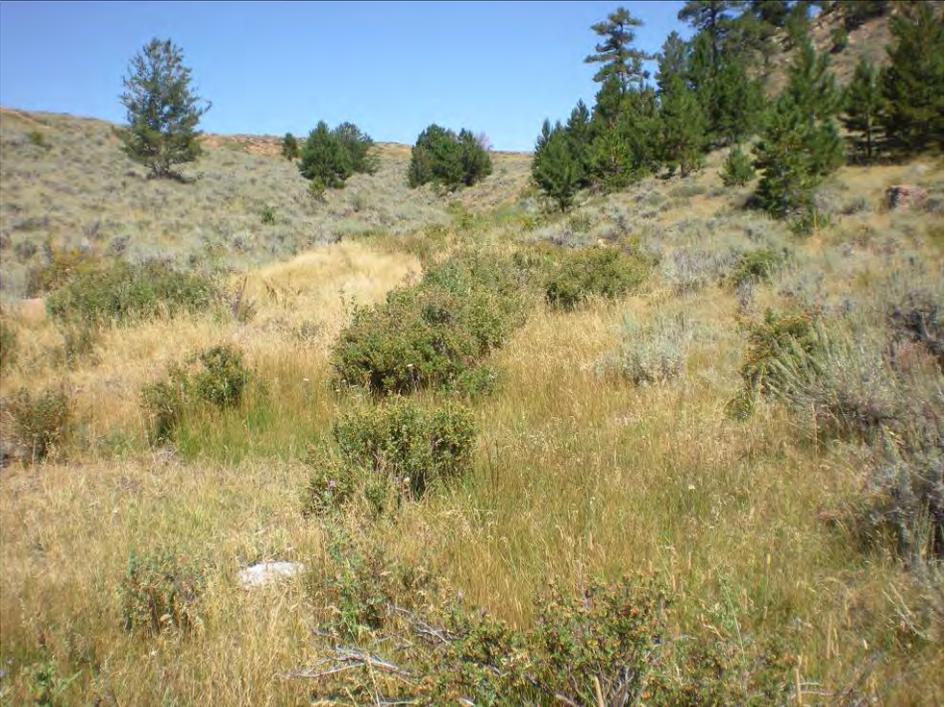
<b>Client:</b>	Shell Wind Energy	<b>Project Number:</b>	0105023
<b>Project Name:</b>	Hermosa West	<b>Location:</b>	Albany County, WY
<b>Photograph ID:</b> A103

<b>Feature:</b> SAAL017			
<b>Date:</b> 08-27-2009			
<b>Comments:</b> Looking east this image shows a view of the perennial stream SAAL017.			
<b>Photograph ID:</b> A104

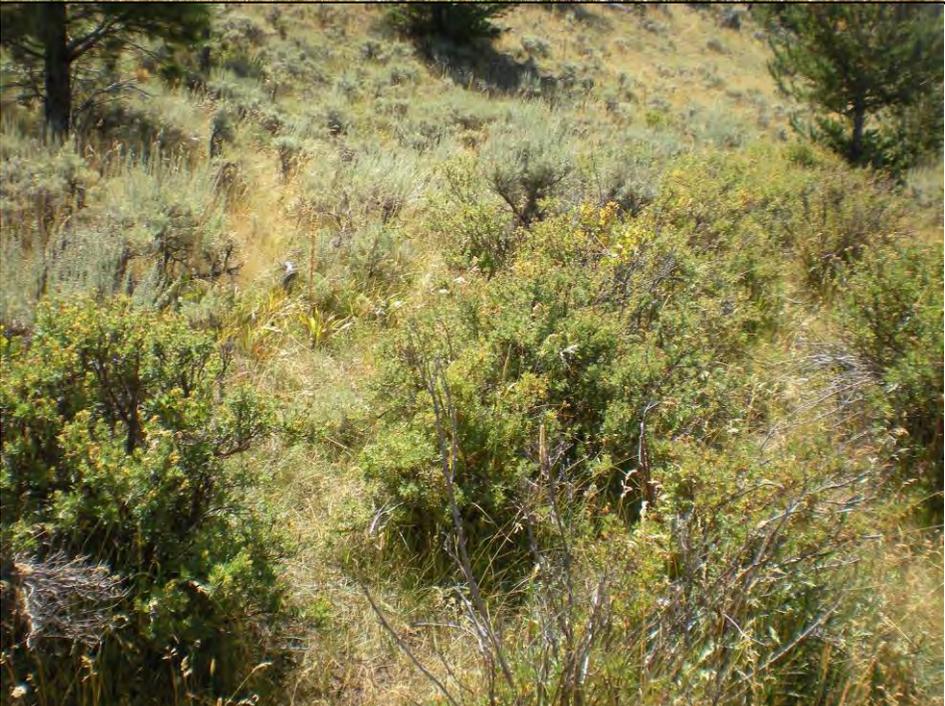
<b>Feature:</b> SAAL017			
<b>Date:</b> 08-27-2009			
<b>Comments:</b> Looking west this image shows another view of the stream course.

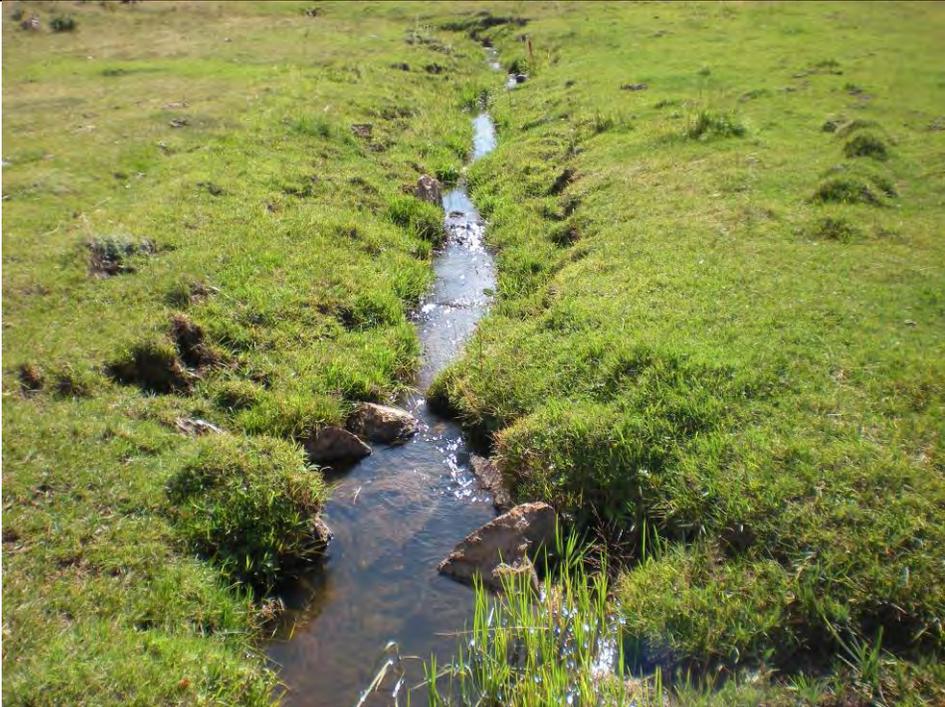
<b>Client:</b>	Shell Wind Energy	<b>Project Number:</b>	0105023
<b>Project Name:</b>	Hermosa West	<b>Location:</b>	Albany County, WY
<b>Photograph ID:</b> A114

<b>Feature:</b> SAAL019			
<b>Date:</b> 08-27-2009			
<b>Comments:</b> Looking west this photo depicts the perennial stream SAAL019 (Fish Creek).			
<b>Photograph ID:</b> A115

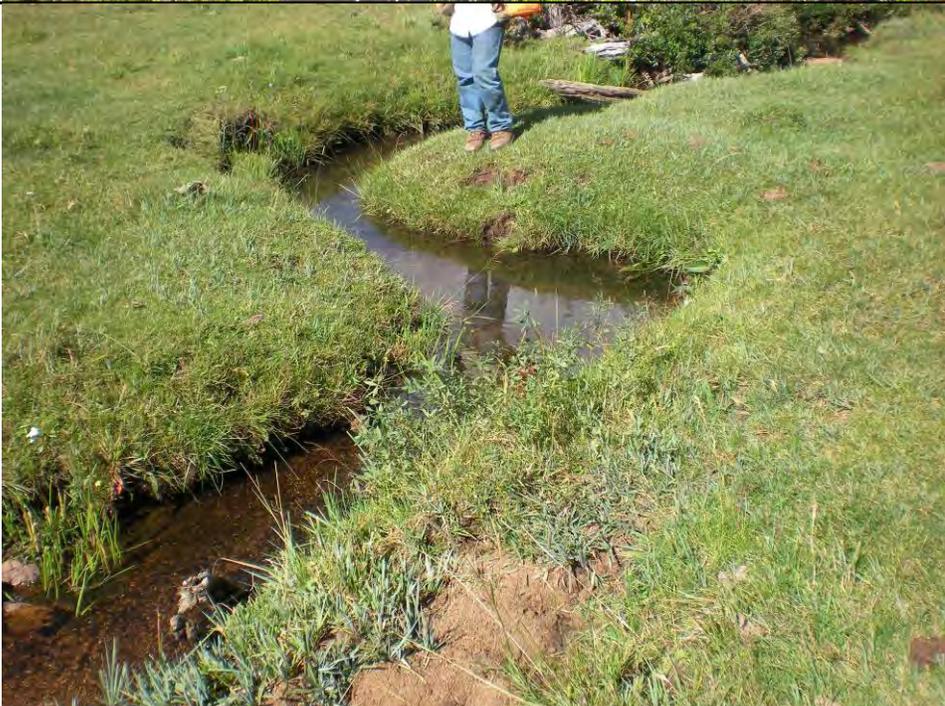
<b>Feature:</b> SAAL019			
<b>Date:</b> 08-27-2009			
<b>Comments:</b> Looking east this photo provides another view of this perennial stream.

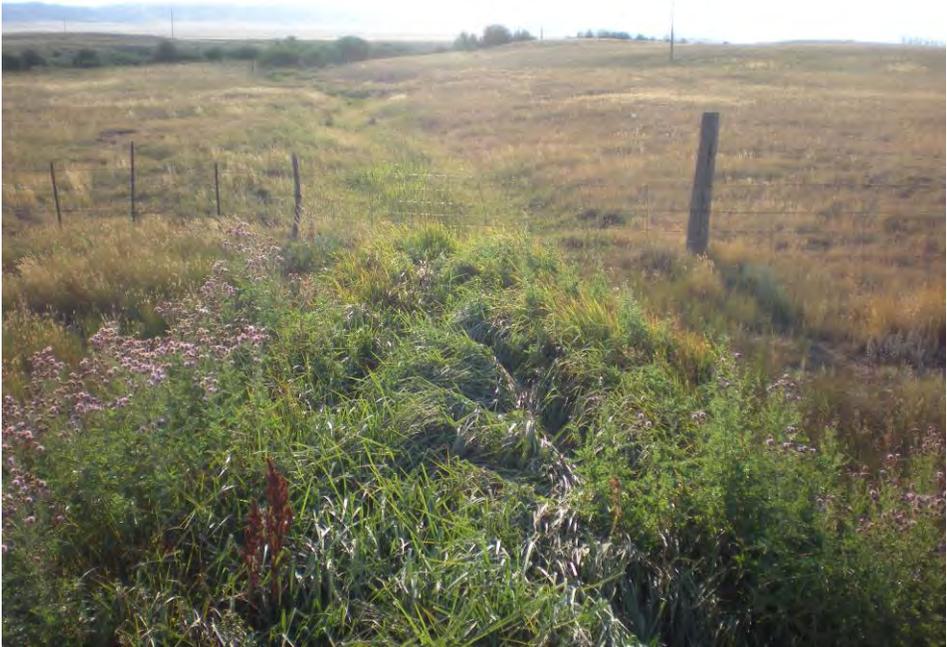
<b>Client:</b>	Shell Wind Energy	<b>Project Number:</b>	0105023
<b>Project Name:</b>	Hermosa West	<b>Location:</b>	Albany County, WY
<b>Photograph ID:</b> A124

<b>Feature:</b> SAAL022			
<b>Date:</b> 08-27-2009			
<b>Comments:</b> Looking north along the entry road, this photograph shows the intermittent stream SAAL022.			
<b>Photograph ID:</b> A125

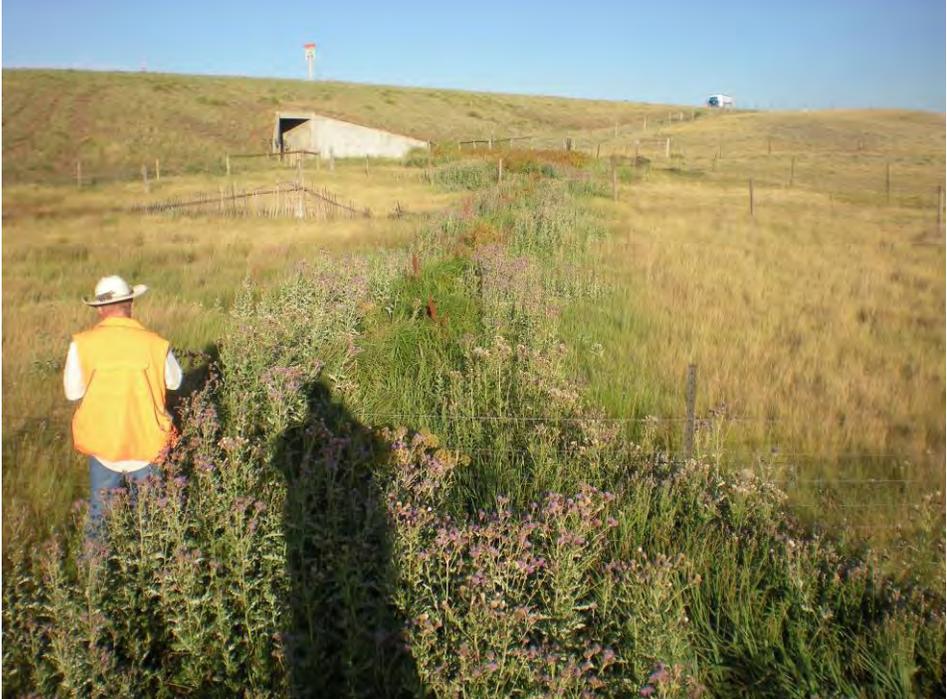
<b>Feature:</b> SAAL022			
<b>Date:</b> 08-27-2009			
<b>Comments:</b> Looking south along the entry road, this photograph shows another view of SAAL022.

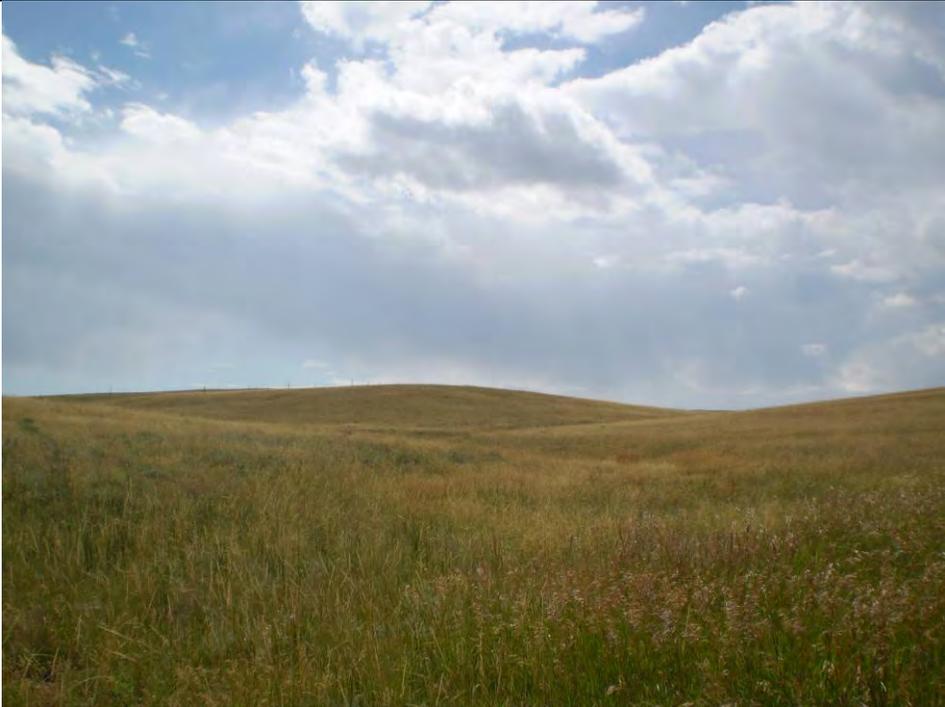
<b>Client:</b>	Shell Wind Energy	<b>Project Number:</b>	0105023
<b>Project Name:</b>	Hermosa West	<b>Location:</b>	Albany County, WY
<b>Photograph ID:</b> B5

<b>Feature:</b> SBAL001			
<b>Date:</b> 08-25-2009			
<b>Comments:</b> Stream feature facing south.			
<b>Photograph ID:</b> B8

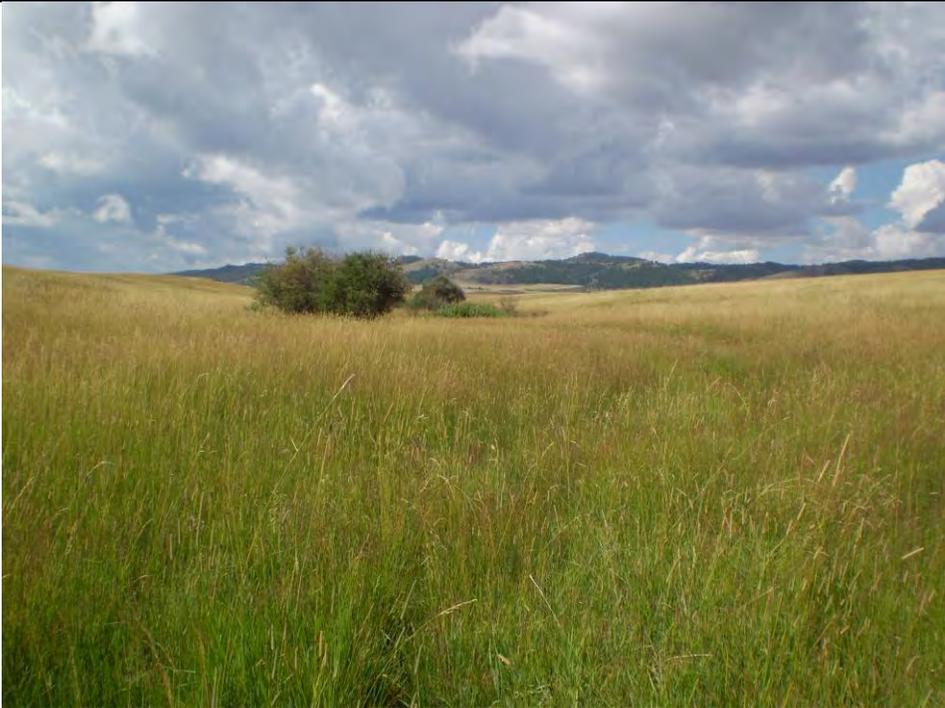
<b>Feature:</b> SBAL002			
<b>Date:</b> 08-25-2009			
<b>Comments:</b> Stream feature facing south.

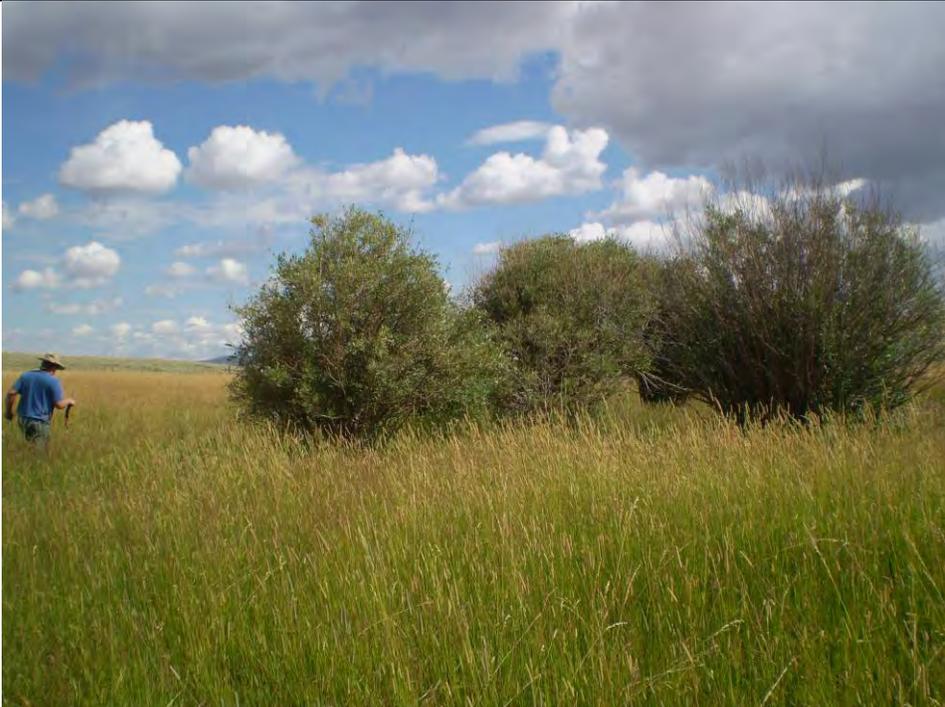
<b>Client:</b>	Shell Wind Energy	<b>Project Number:</b>	0105023
<b>Project Name:</b>	Hermosa West	<b>Location:</b>	Albany County, WY
<b>Photograph ID:</b> B9

<b>Feature:</b> SBAL002			
<b>Date:</b> 08-25-2009			
<b>Comments:</b> Stream feature on the left side of the photograph, facing north into WBAL001.			
<b>Photograph ID:</b> B10

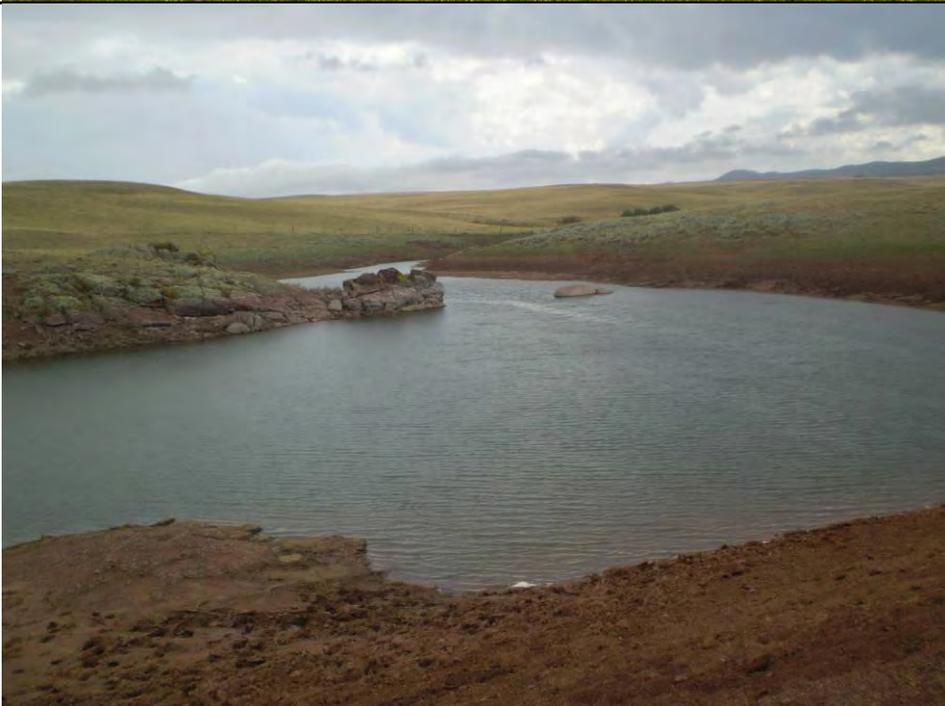
<b>Feature:</b> SBAL002			
<b>Date:</b> 08-25-2009			
<b>Comments:</b> Segment of stream feature SBAL002 to the north of previous photographs. Facing south from a berm.

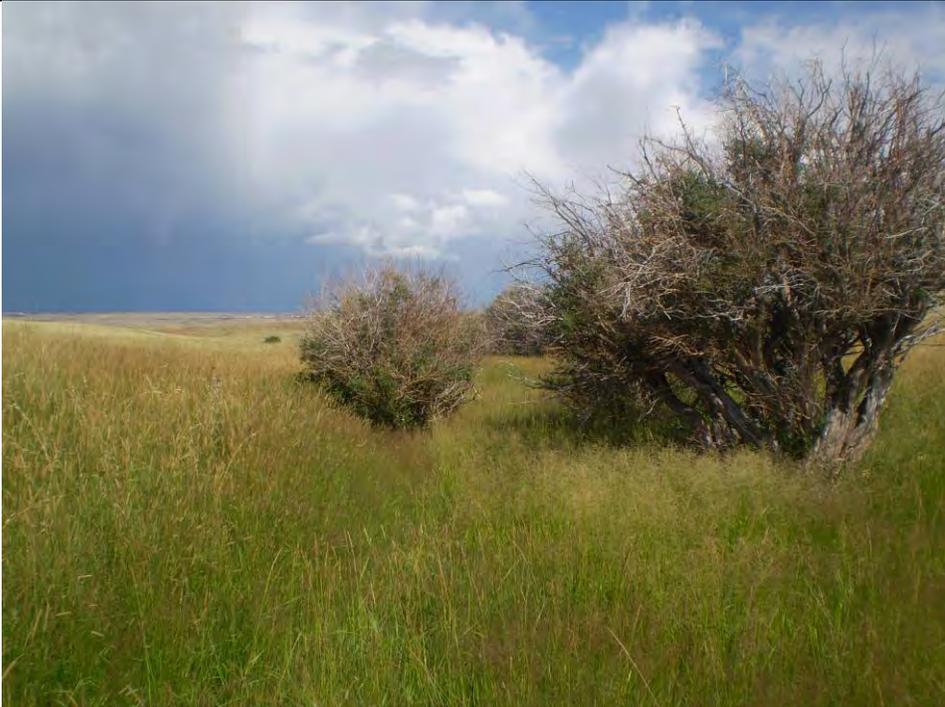
<b>Client:</b>	Shell Wind Energy	<b>Project Number:</b>	0105023
<b>Project Name:</b>	Hermosa West	<b>Location:</b>	Albany County, WY
<b>Photograph ID:</b> B25

<b>Feature:</b> SBAL003			
<b>Date:</b> 08-25-2009			
<b>Comments:</b> Stream feature facing east.			
<b>Photograph ID:</b> B26

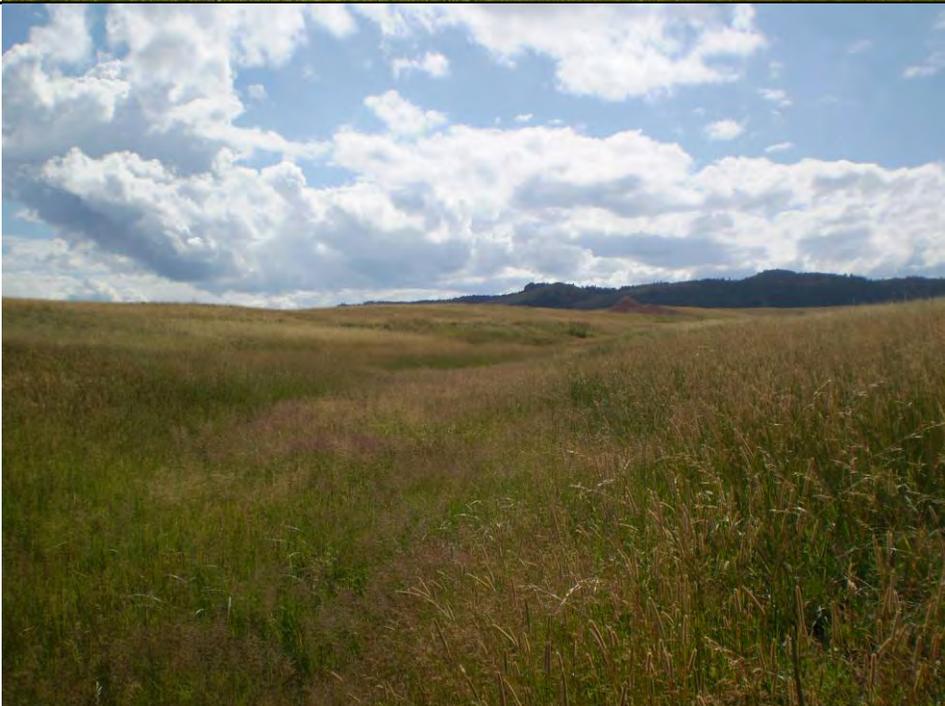
<b>Feature:</b> SBAL003			
<b>Date:</b> 08-25-2009			
<b>Comments:</b> Stream feature facing west.

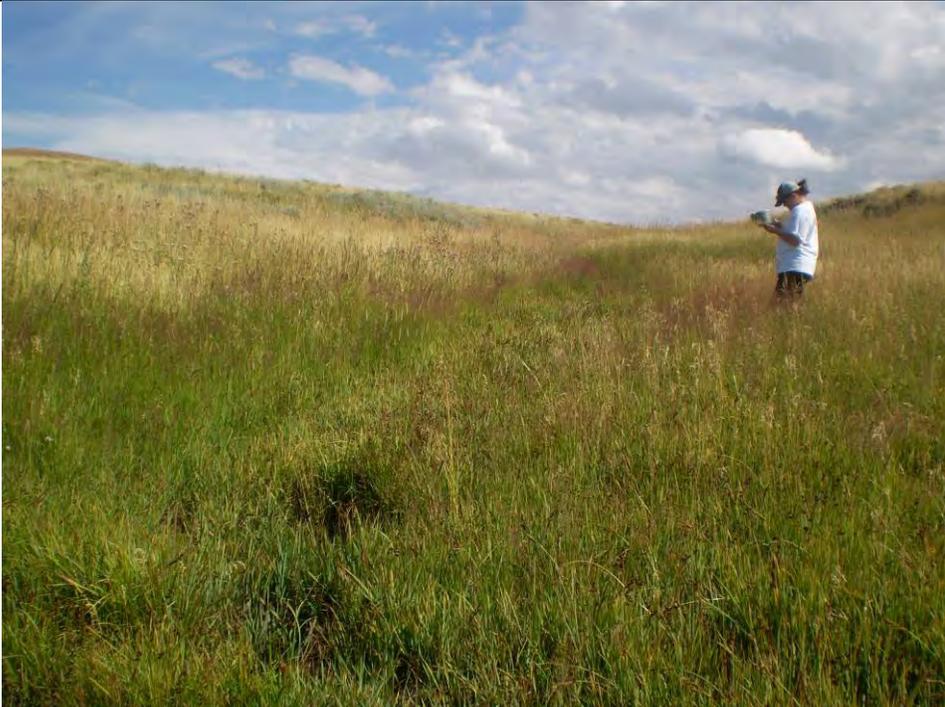
<b>Client:</b>	Shell Wind Energy	<b>Project Number:</b>	0105023
<b>Project Name:</b>	Hermosa West	<b>Location:</b>	Albany County, WY
<b>Photograph ID:</b> B29

<b>Feature:</b> SBAL005			
<b>Date:</b> 08-25-2009			
<b>Comments:</b> SBAL004 facing south with fringing wetland WBAL003 at junction of SBAL004 and SBAL005.			
<b>Photograph ID:</b> B30

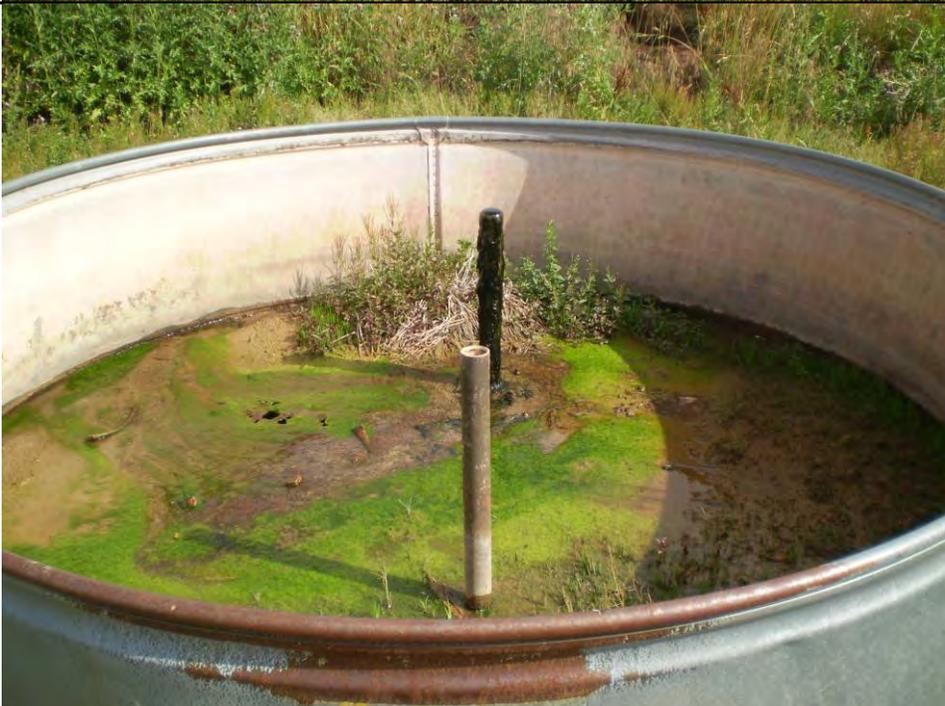
<b>Feature:</b> Metal corral			
<b>Date:</b> 08-25-2009			
<b>Comments:</b> Metal cistern with water flowing out of black pipe in center at junction of SBAL004 and SBAL005. (Located just to the left of photograph B29)

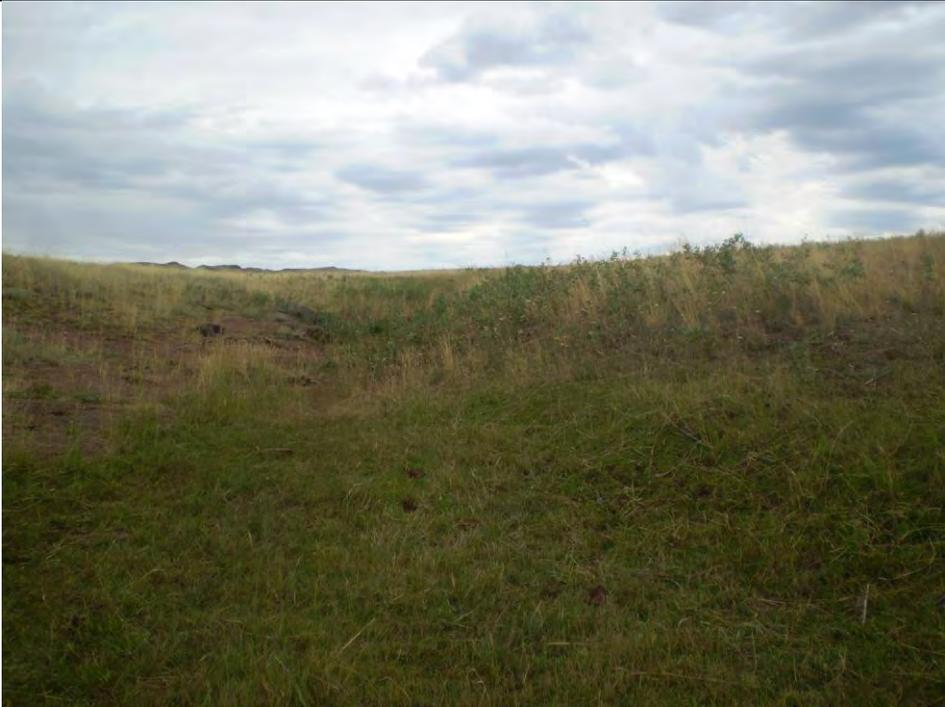
<b>Client:</b>	Shell Wind Energy	<b>Project Number:</b>	0105023
<b>Project Name:</b>	Hermosa West	<b>Location:</b>	Albany County, WY
<b>Photograph ID:</b> B59

<b>Feature:</b> SBAL007			
<b>Date:</b> 08-26-2009			
<b>Comments:</b> Stream feature facing south.			
<b>Photograph ID:</b> B60

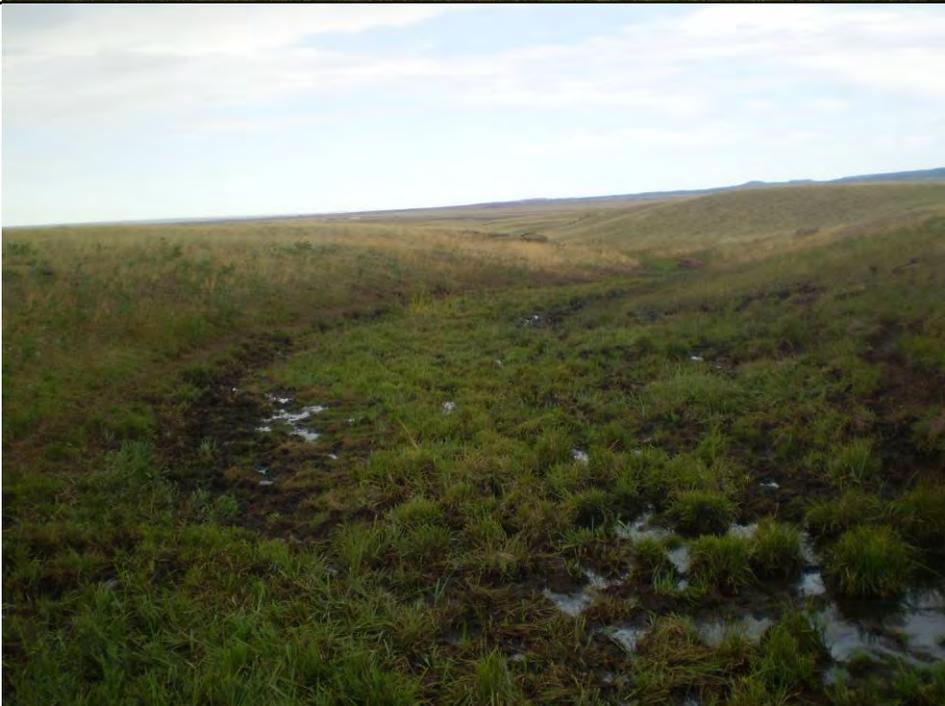
<b>Feature:</b> SBAL007			
<b>Date:</b> 08-26-2009			
<b>Comments:</b> Stream feature facing north.

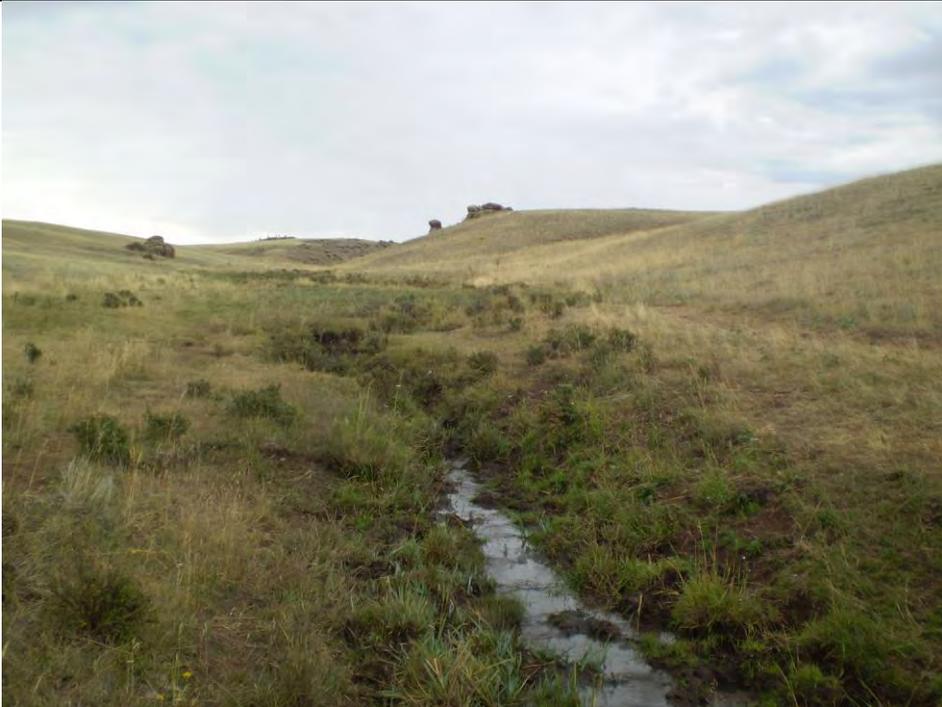
<b>Client:</b>	Shell Wind Energy	<b>Project Number:</b>	0105023
<b>Project Name:</b>	Hermosa West	<b>Location:</b>	Albany County, WY
<b>Photograph ID:</b> B63

<b>Feature:</b> SBAL008			
<b>Date:</b> 08-26-2009			
<b>Comments:</b> Stream feature facing east.			
<b>Photograph ID:</b> B64

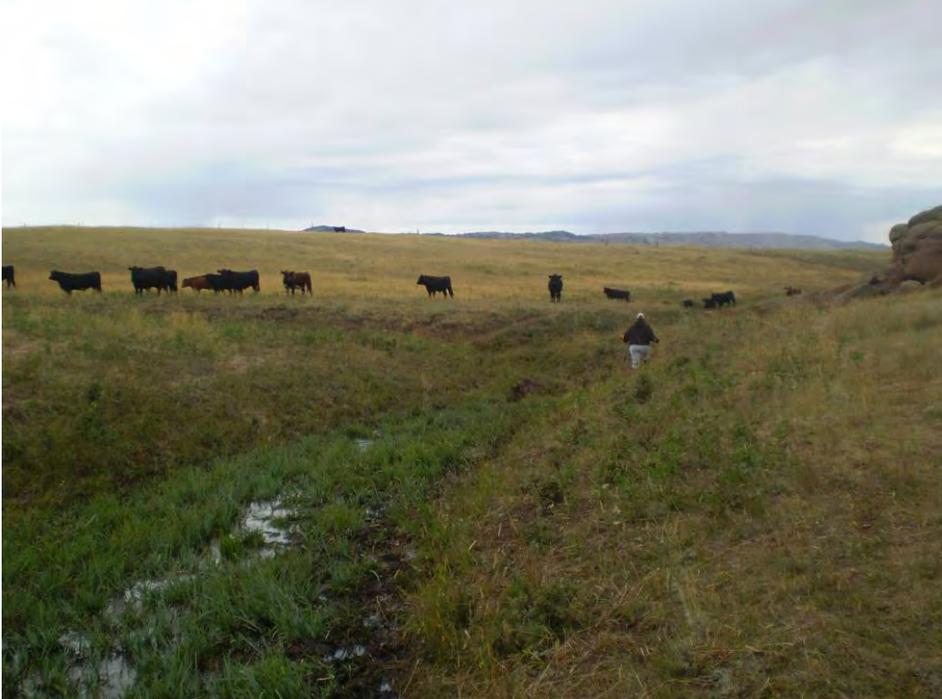
<b>Feature:</b> SBAL008			
<b>Date:</b> 08-26-2009			
<b>Comments:</b> Stream feature facing west.

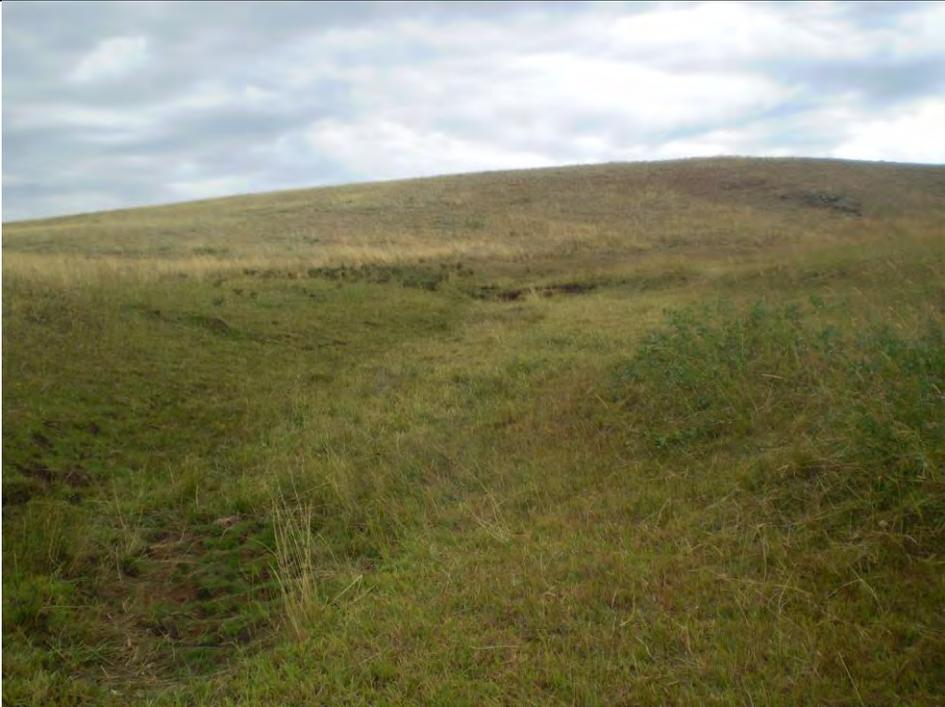
<b>Client:</b>	Shell Wind Energy	<b>Project Number:</b>	0105023
<b>Project Name:</b>	Hermosa West	<b>Location:</b>	Albany County, WY
<b>Photograph ID:</b> B65

<b>Feature:</b> SBAL009			
<b>Date:</b> 08-26-2009			
<b>Comments:</b> Stream feature facing south.			
<b>Photograph ID:</b> B66

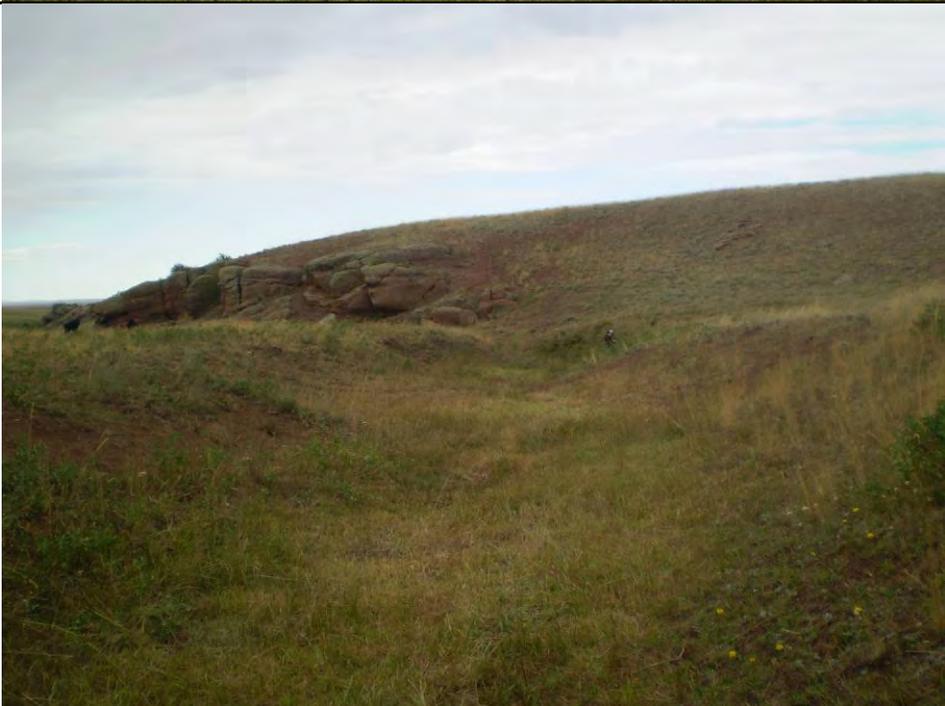
<b>Feature:</b> SBAL009			
<b>Date:</b> 08-26-2009			
<b>Comments:</b> Stream feature facing north.

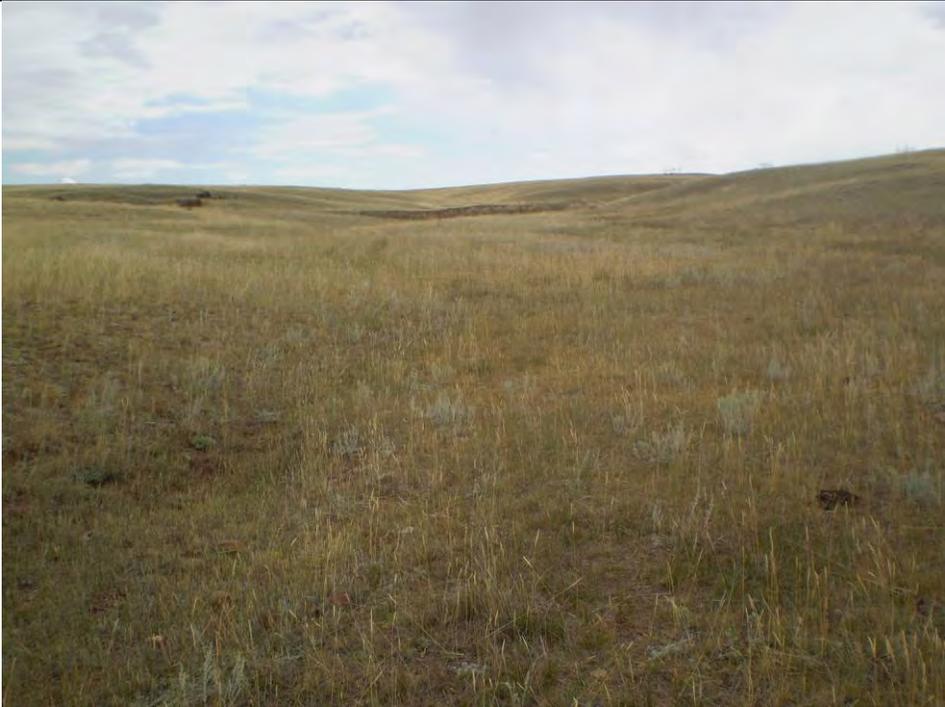
<b>Client:</b>	Shell Wind Energy	<b>Project Number:</b>	0105023
<b>Project Name:</b>	Hermosa West	<b>Location:</b>	Albany County, WY
<b>Photograph ID:</b> B76

<b>Feature:</b> SBAL010			
<b>Date:</b> 08-26-2009			
<b>Comments:</b> Looking east, into corridor from the edge of stream feature SBAL010.			
<b>Photograph ID:</b> B77

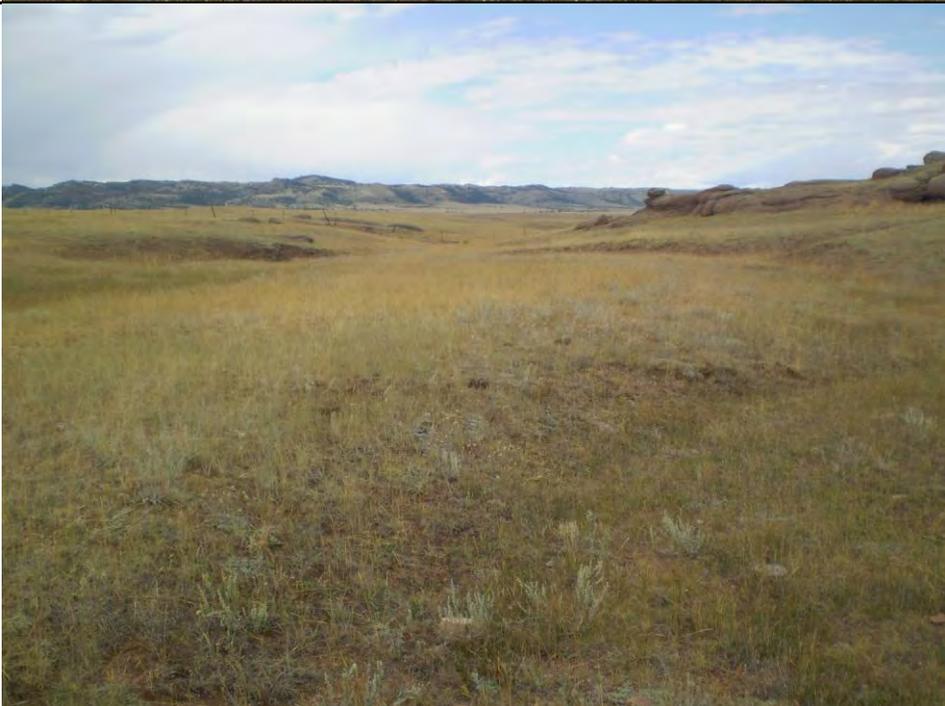
<b>Feature:</b> SBAL010			
<b>Date:</b> 08-26-2009			
<b>Comments:</b> Looking west, out of the corridor into stream feature SBAL010.

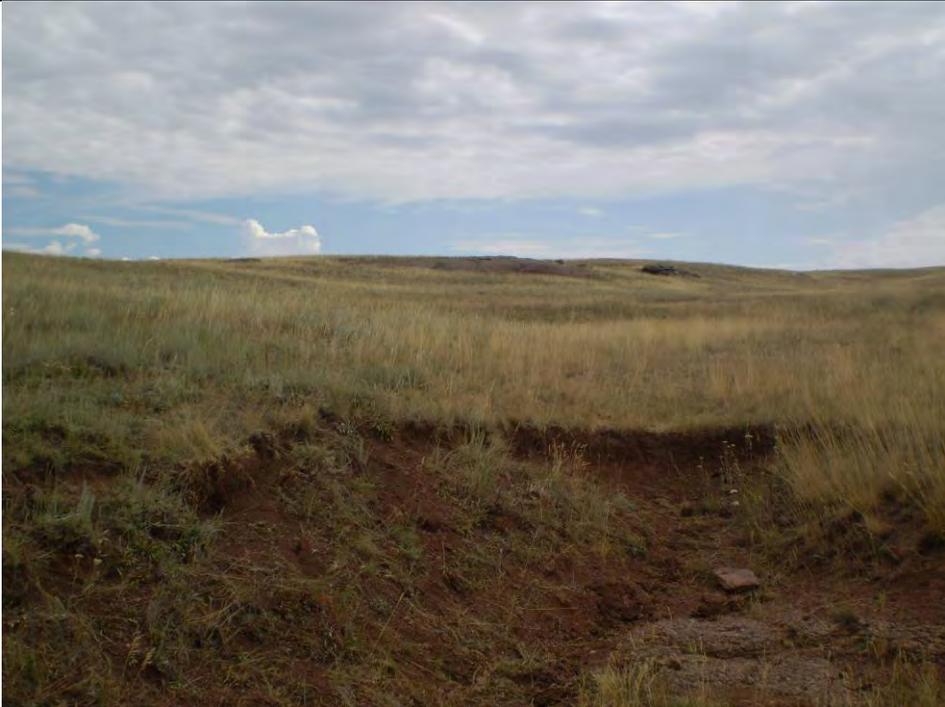
<b>Client:</b>	Shell Wind Energy	<b>Project Number:</b>	0105023
<b>Project Name:</b>	Hermosa West	<b>Location:</b>	Albany County, WY
<b>Photograph ID:</b> B80

<b>Feature:</b> SBAL012			
<b>Date:</b> 08-26-2009			
<b>Comments:</b> Stream feature facing east to the edge of the corridor.			
<b>Photograph ID:</b> B81

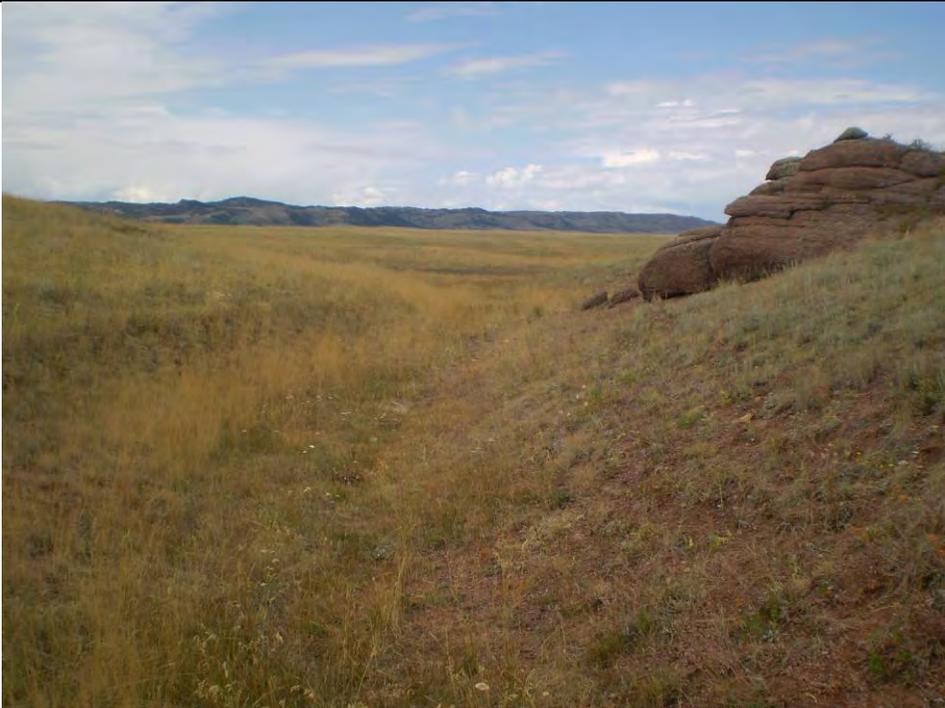
<b>Feature:</b> SBAL012			
<b>Date:</b> 08-26-2009			
<b>Comments:</b> Stream feature facing west.

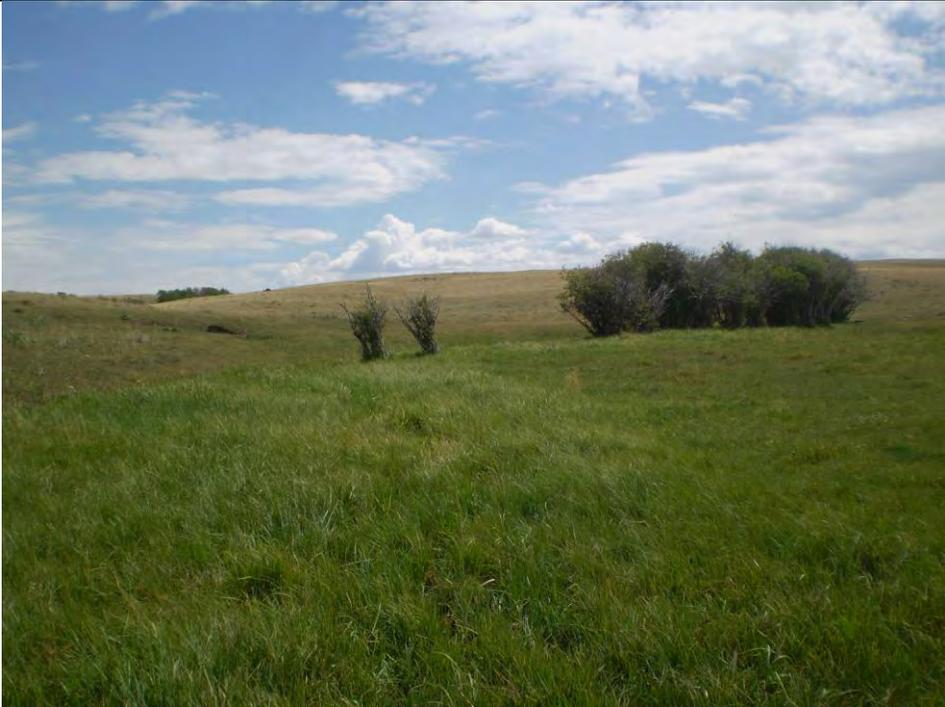
<b>Client:</b>	Shell Wind Energy	<b>Project Number:</b>	0105023
<b>Project Name:</b>	Hermosa West	<b>Location:</b>	Albany County, WY
<b>Photograph ID:</b> B85

<b>Feature:</b> SBAL013			
<b>Date:</b> 08-26-2009			
<b>Comments:</b> Stream SBAL013 and wetland feature WBAL004 facing south.			
<b>Photograph ID:</b> B86

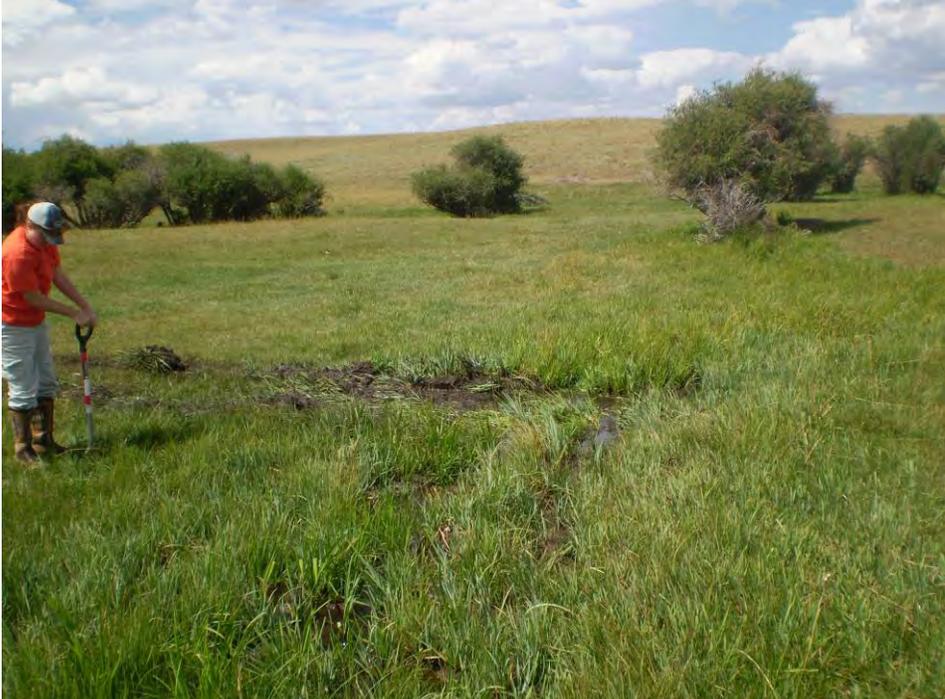
<b>Feature:</b> SBAL013			
<b>Date:</b> 08-26-2009			
<b>Comments:</b> Stream SBAL013 and wetland feature WBAL004 facing north.

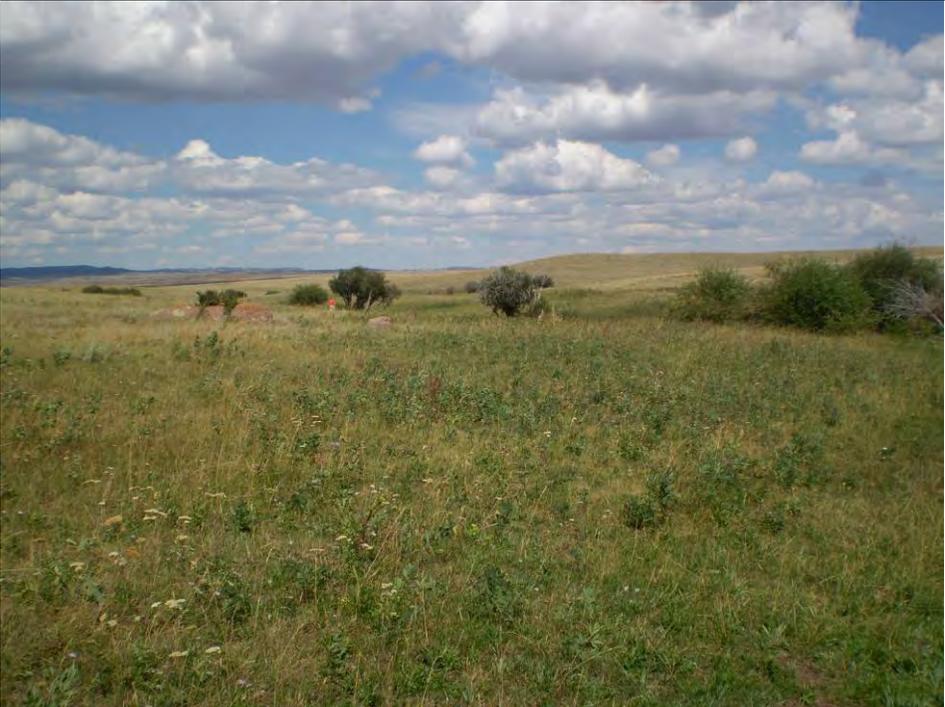
<b>Client:</b>	Shell Wind Energy	<b>Project Number:</b>	0105023
<b>Project Name:</b>	Hermosa West	<b>Location:</b>	Albany County, WY
<b>Photograph ID:</b> B91

<b>Feature:</b> SBAL014			
<b>Date:</b> 08-26-2009			
<b>Comments:</b> Stream feature facing east.			
<b>Photograph ID:</b> B92

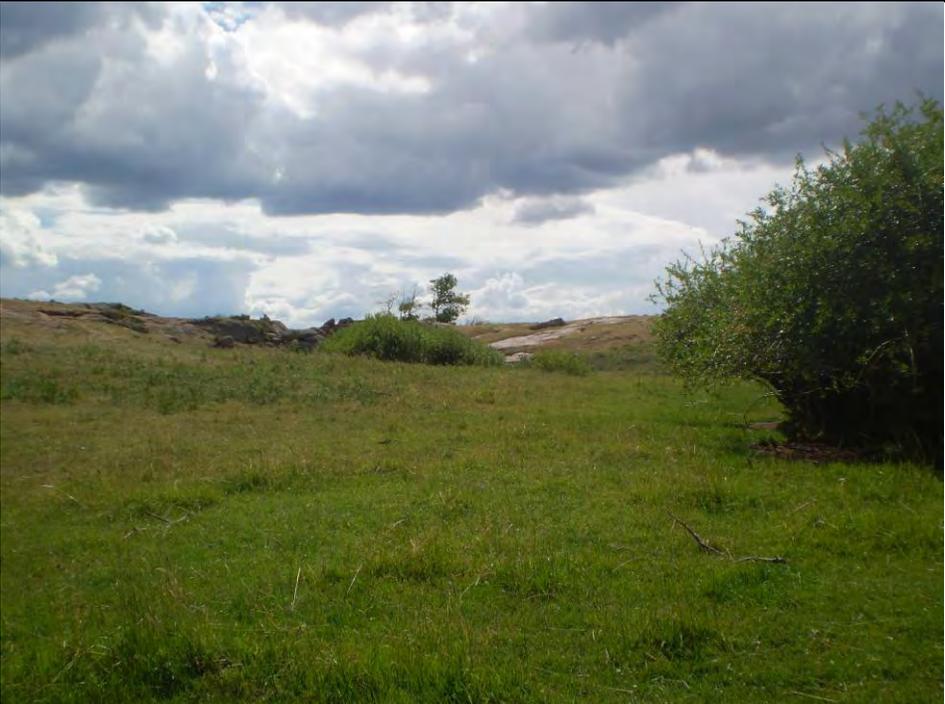
<b>Feature:</b> SBAL014			
<b>Date:</b> 08-26-2009			
<b>Comments:</b> Stream feature facing west.

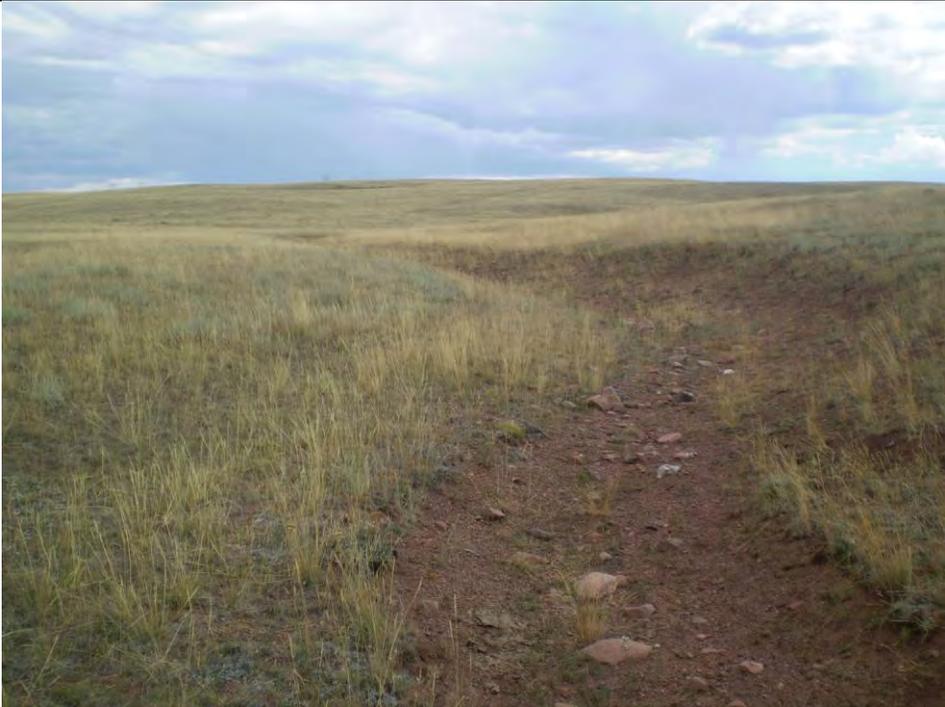
<b>Client:</b>	Shell Wind Energy	<b>Project Number:</b>	0105023
<b>Project Name:</b>	Hermosa West	<b>Location:</b>	Albany County, WY
<b>Photograph ID:</b> B100

<b>Feature:</b> SBAL015			
<b>Date:</b> 08-26-2009			
<b>Comments:</b> Stream feature facing south.			
<b>Photograph ID:</b> B101

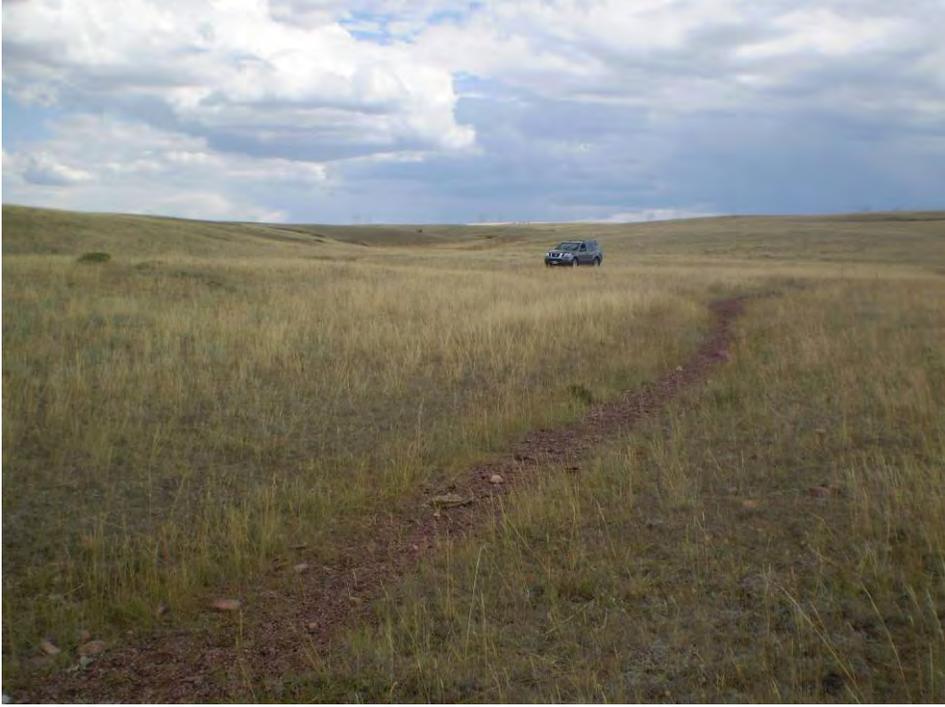
<b>Feature:</b> SBAL016			
<b>Date:</b> 08-26-2009			
<b>Comments:</b> Stream feature facing south.
