**WETLAND ASSESSMENT REPORT REVISED JULY 1, 2010**

**Shell WindEnergy**  
**Hermosa West Wind Farm Project, Albany County, Wyoming**

# Wetland Assessment: Hermosa West Wind Farm Project

Project No. 0105023  
Albany County, Wyoming

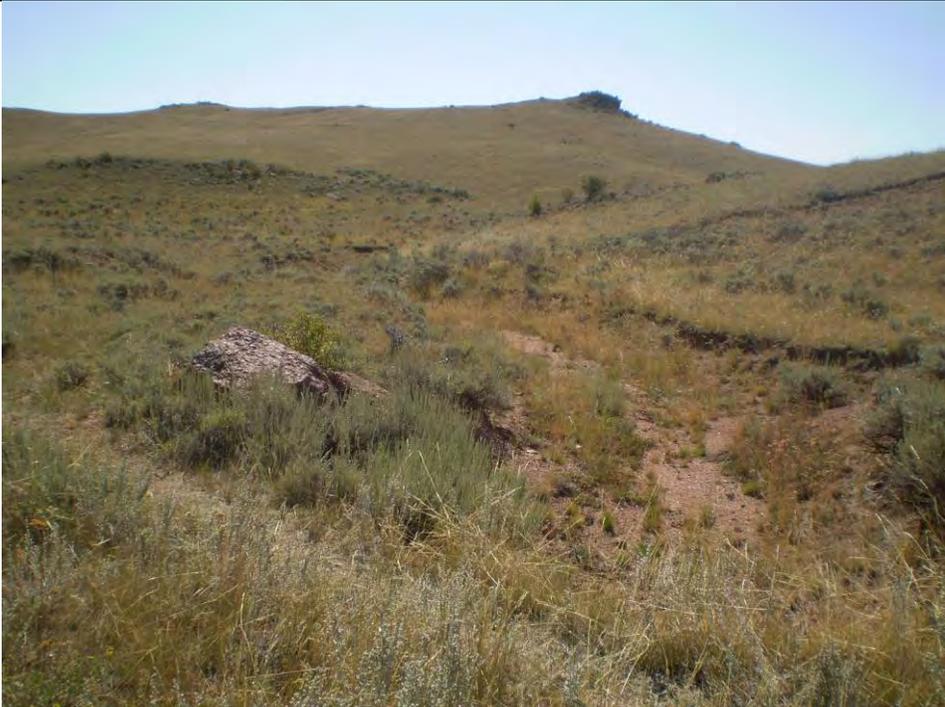
<b>Client:</b>	Shell Wind Energy	<b>Project Number:</b>	0105023
<b>Project Name:</b>	Hermosa West	<b>Location:</b>	Albany County, WY
<b>Photograph ID:</b> B104

<b>Feature:</b> SBAL017			
<b>Date:</b> 08-27-2009			
<b>Comments:</b> Stream feature facing south from existing culverted road.			
<b>Photograph ID:</b> B105

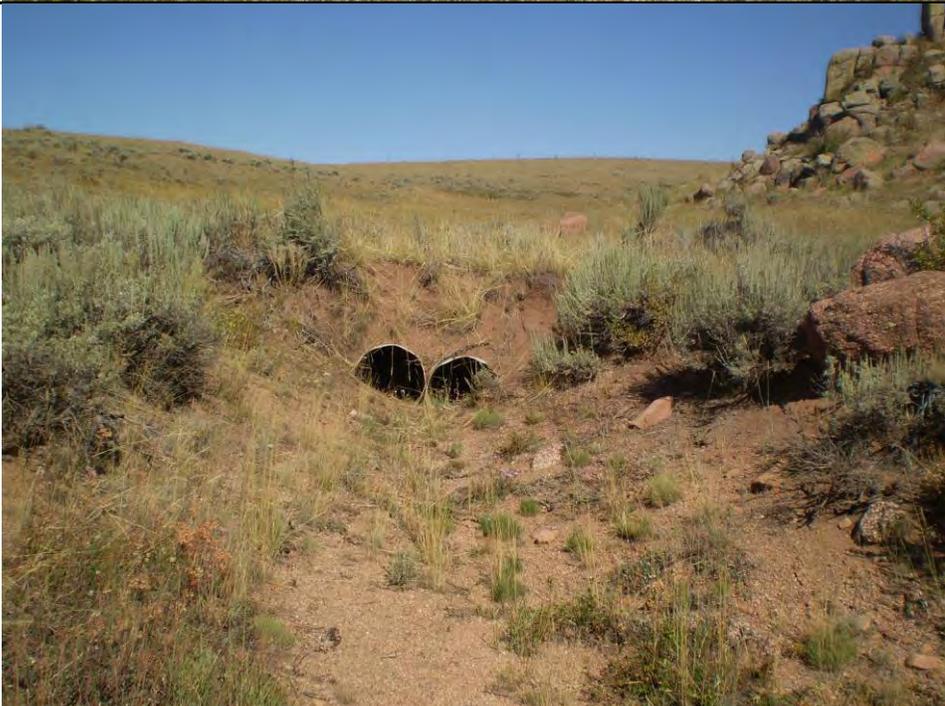
<b>Feature:</b> SBAL017			
<b>Date:</b> 08-27-2009			
<b>Comments:</b> Culverts under existing road for stream feature SBAL017, facing south.

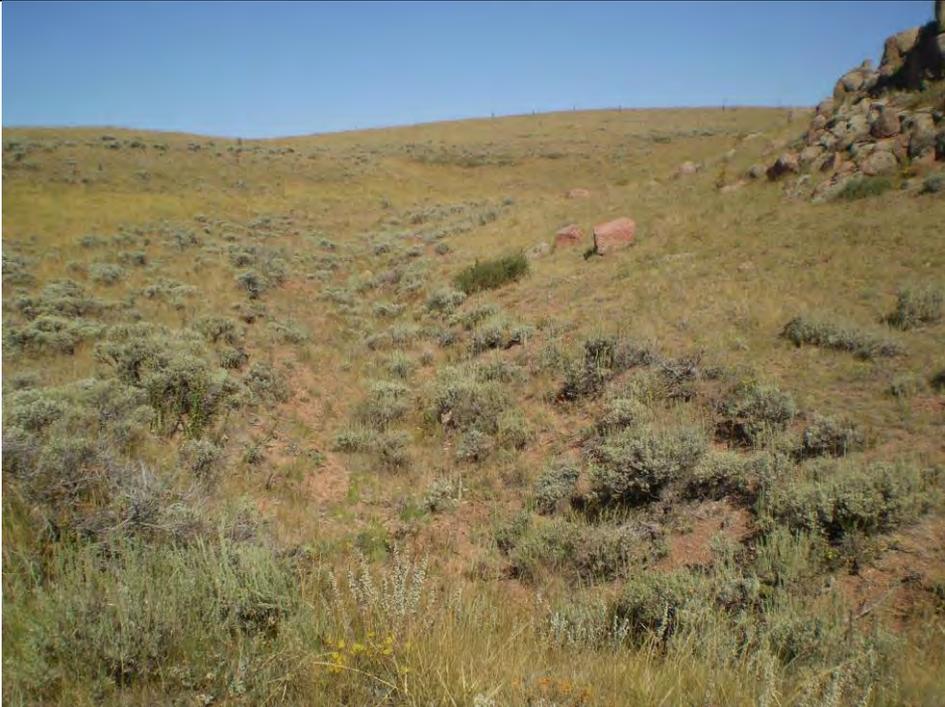
<b>Client:</b>	Shell Wind Energy	<b>Project Number:</b>	0105023
<b>Project Name:</b>	Hermosa West	<b>Location:</b>	Albany County, WY
<b>Photograph ID:</b> B106

<b>Feature:</b> SBAL017			
<b>Date:</b> 08-27-2009			
<b>Comments:</b> Stream feature facing north while standing on existing road.			
<b>Photograph ID:</b> B107

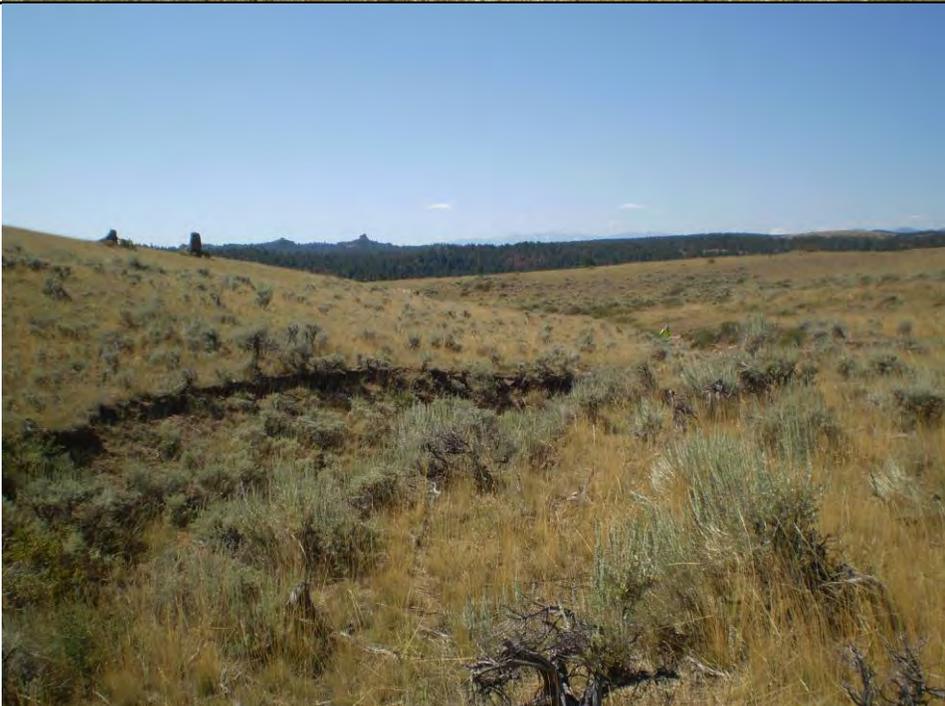
<b>Feature:</b> SBAL017			
<b>Date:</b> 08-27-2009			
<b>Comments:</b> Further north on stream feature SBAL017.

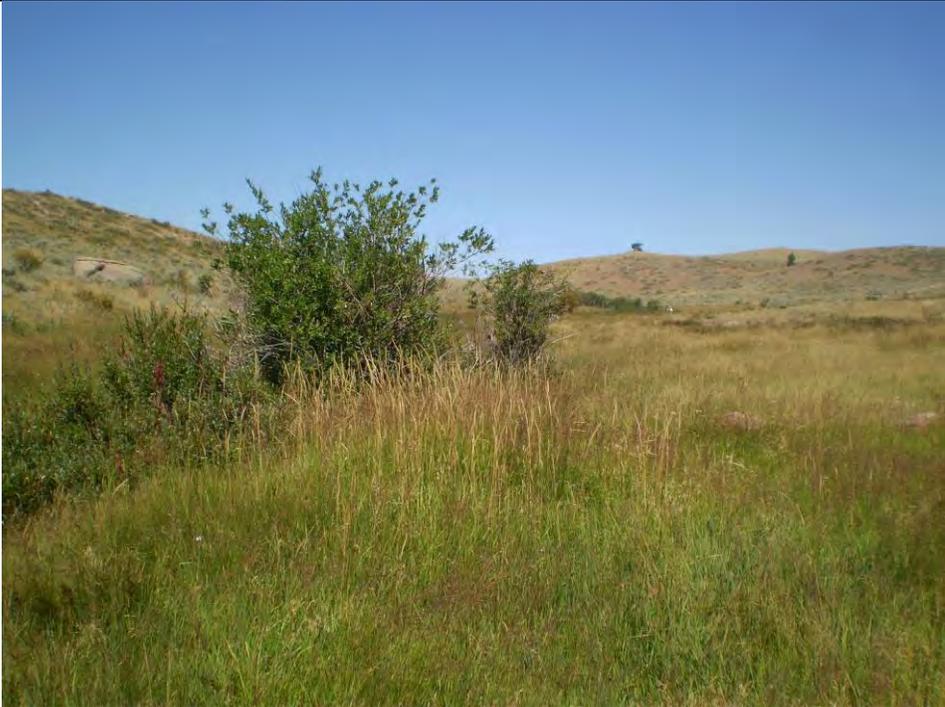
<b>Client:</b>	Shell Wind Energy	<b>Project Number:</b>	0105023
<b>Project Name:</b>	Hermosa West	<b>Location:</b>	Albany County, WY
<b>Photograph ID:</b> B108

<b>Feature:</b> SBAL018			
<b>Date:</b> 08-27-2009			
<b>Comments:</b> Photograph taken just north of an existing access road and wood fence facing northwest towards the end of the corridor. An existing road parallels the stream along the north (unseen to the right).			
<b>Photograph ID:</b> B109

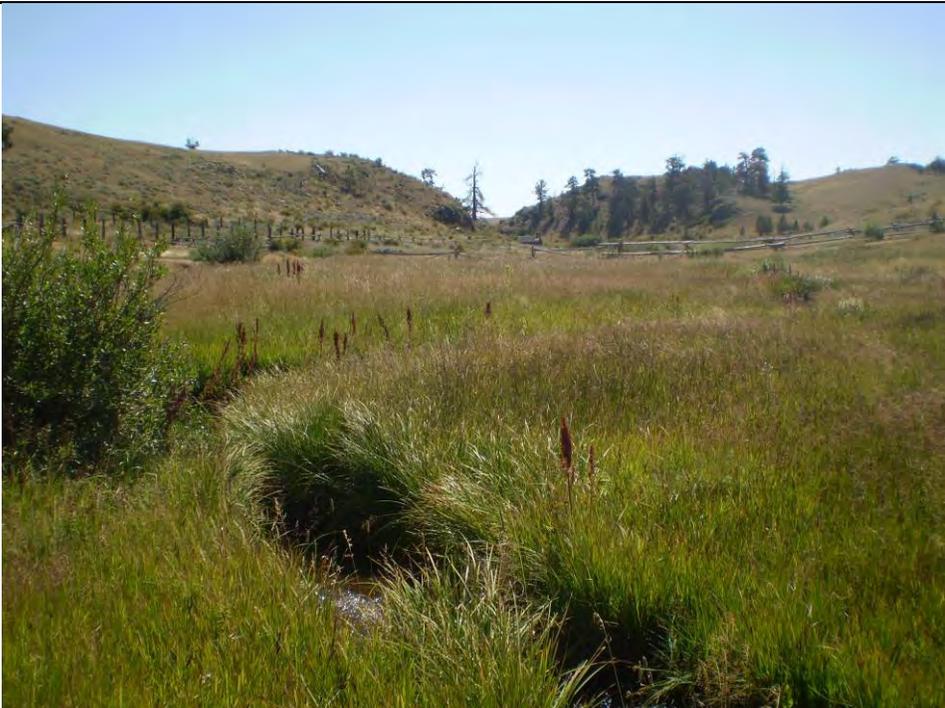
<b>Feature:</b> SBAL018			
<b>Date:</b> 08-27-2009			
<b>Comments:</b> Same position as previous photograph, facing east towards the access road and wooden fence.

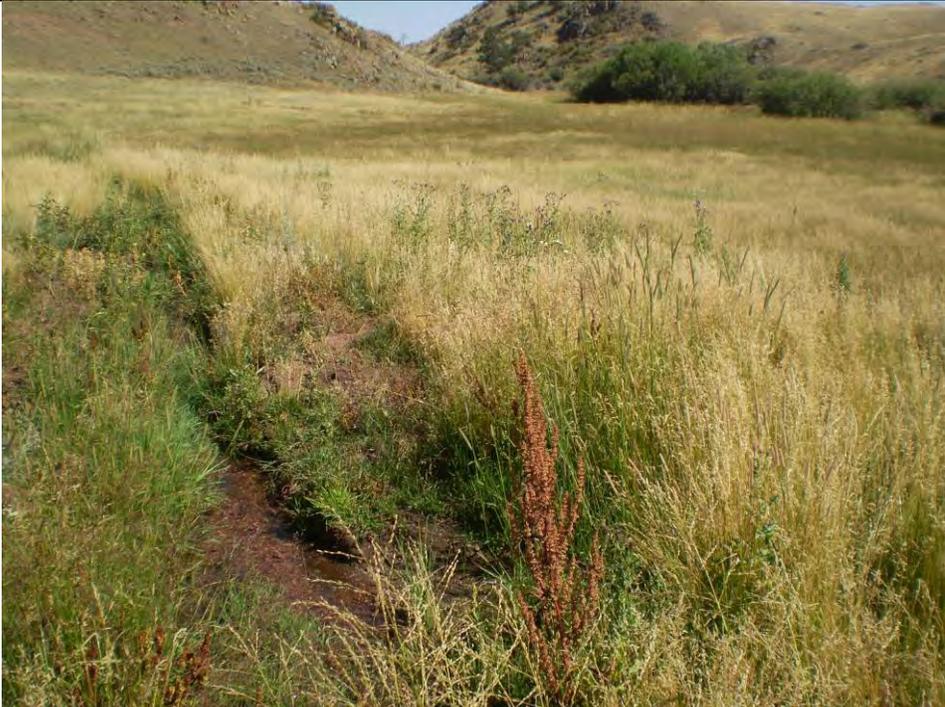
<b>Client:</b>	Shell Wind Energy	<b>Project Number:</b>	0105023
<b>Project Name:</b>	Hermosa West	<b>Location:</b>	Albany County, WY
<b>Photograph ID:</b> B112

<b>Feature:</b> SBAL019			
<b>Date:</b> 08-27-2009			
<b>Comments:</b> Photograph taken facing southwest from a fence. Stream feature is channelized and appears to be man-made.			
<b>Photograph ID:</b> B113

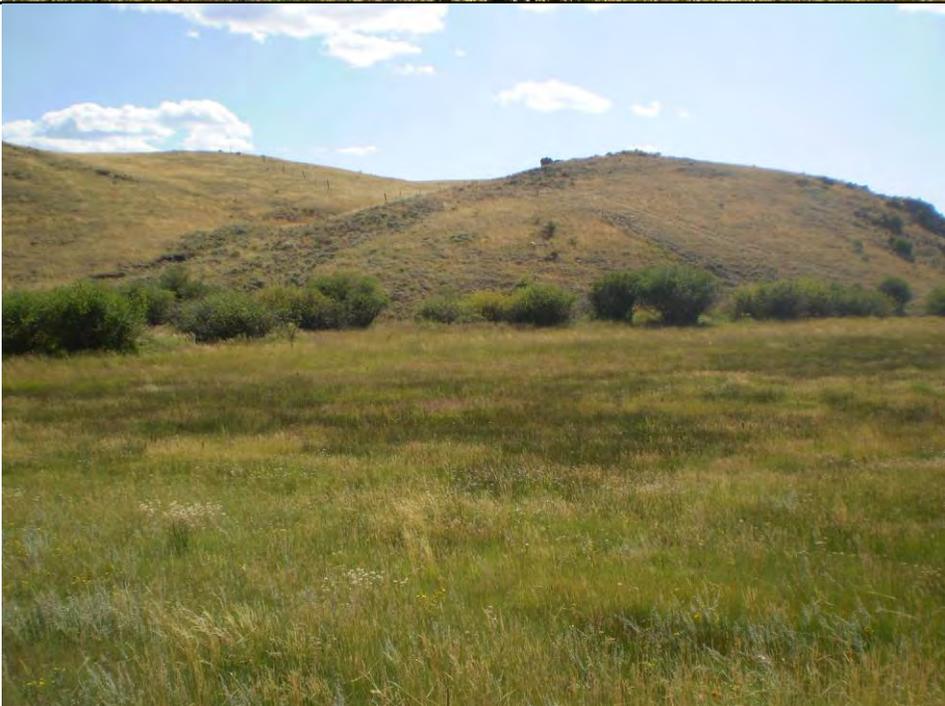
<b>Feature:</b> SBAL020			
<b>Date:</b> 08-27-2009			
<b>Comments:</b> Photograph taken from SBAL019 looking towards wetland WBAL005 with stream SBAL020 following the line of shrubs in the distance.

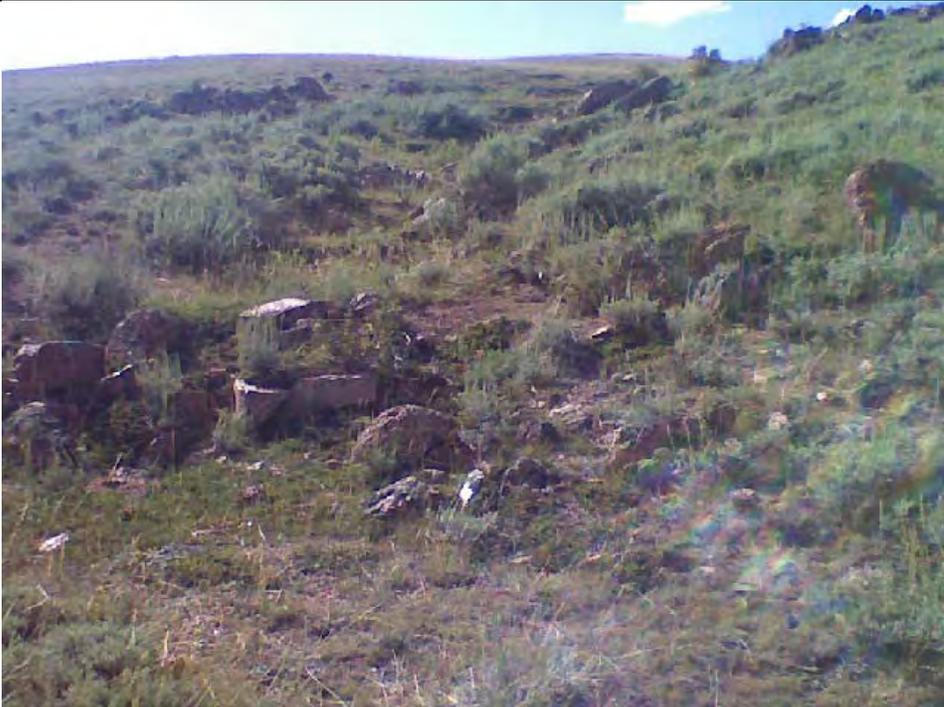
<b>Client:</b>	Shell Wind Energy	<b>Project Number:</b>	0105023
<b>Project Name:</b>	Hermosa West	<b>Location:</b>	Albany County, WY
<b>Photograph ID:</b> B116

<b>Feature:</b> SBAL021			
<b>Date:</b> 08-27-2009			
<b>Comments:</b> Stream feature facing north. Tributary to Fish Creek			
<b>Photograph ID:</b> B117

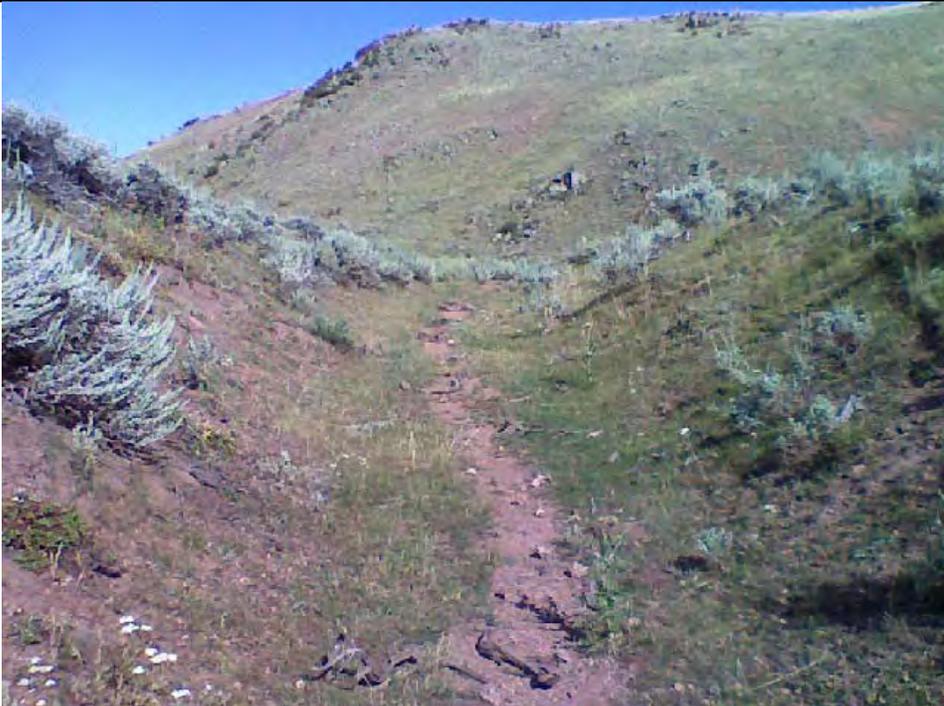
<b>Feature:</b> SBAL021			
<b>Date:</b> 08-27-2009			
<b>Comments:</b> Stream feature facing south. Tributary to Fish Creek

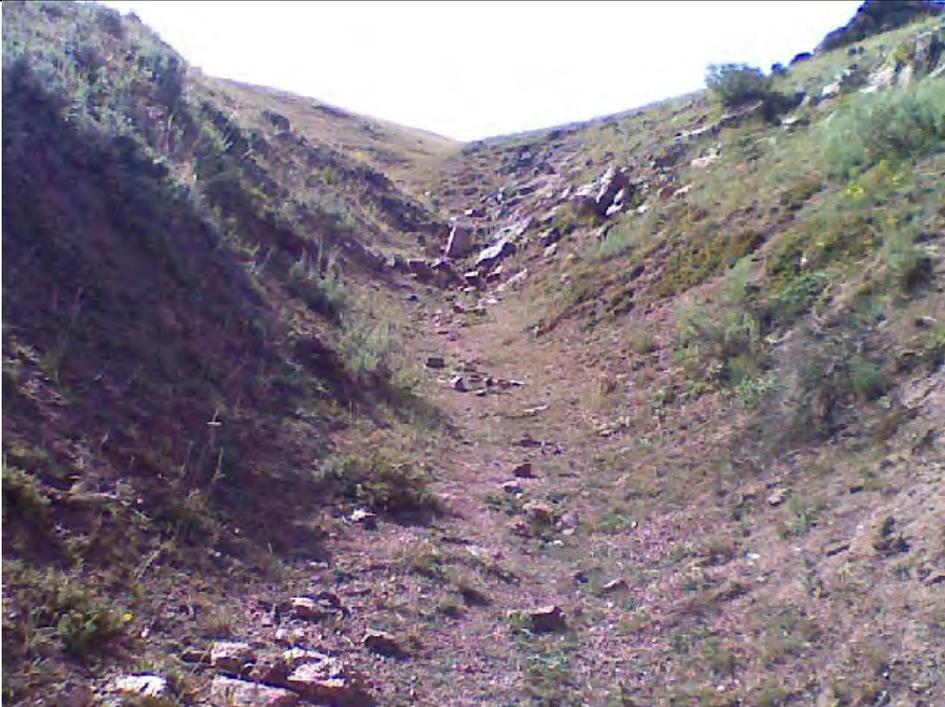
<b>Client:</b>	Shell Wind Energy	<b>Project Number:</b>	0105023
<b>Project Name:</b>	Hermosa West	<b>Location:</b>	Albany County, WY
<b>Photograph ID:</b> B118

<b>Feature:</b> SBAL022			
<b>Date:</b> 08-27-2009			
<b>Comments:</b> Stream feature facing north. Tributary to Fish Creek			
<b>Photograph ID:</b>	[INTENTIONALLY LEFT BLANK]		
<b>Feature:</b>			
<b>Date:</b>			
<b>Comments:</b>

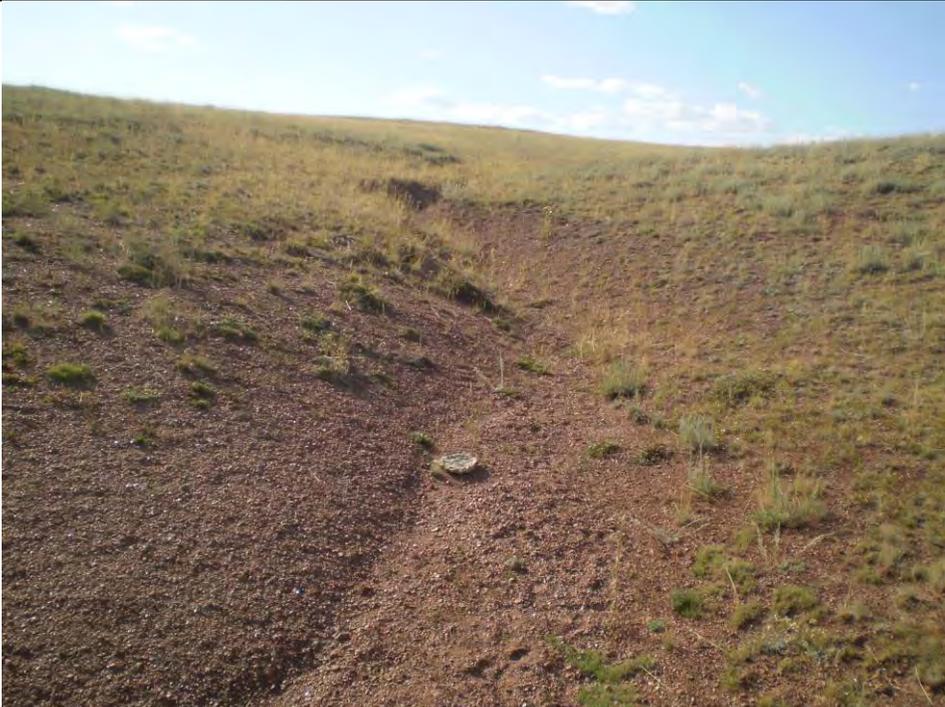
<b>Client:</b>	Shell Wind Energy	<b>Project Number:</b>	0105023
<b>Project Name:</b>	Hermosa West	<b>Location:</b>	Albany County, WY
<b>Photograph ID:</b> B123

<b>Feature:</b> SBAL023			
<b>Date:</b> 08-27-2009			
<b>Comments:</b> Stream feature facing northwest.			
<b>Photograph ID:</b> B124

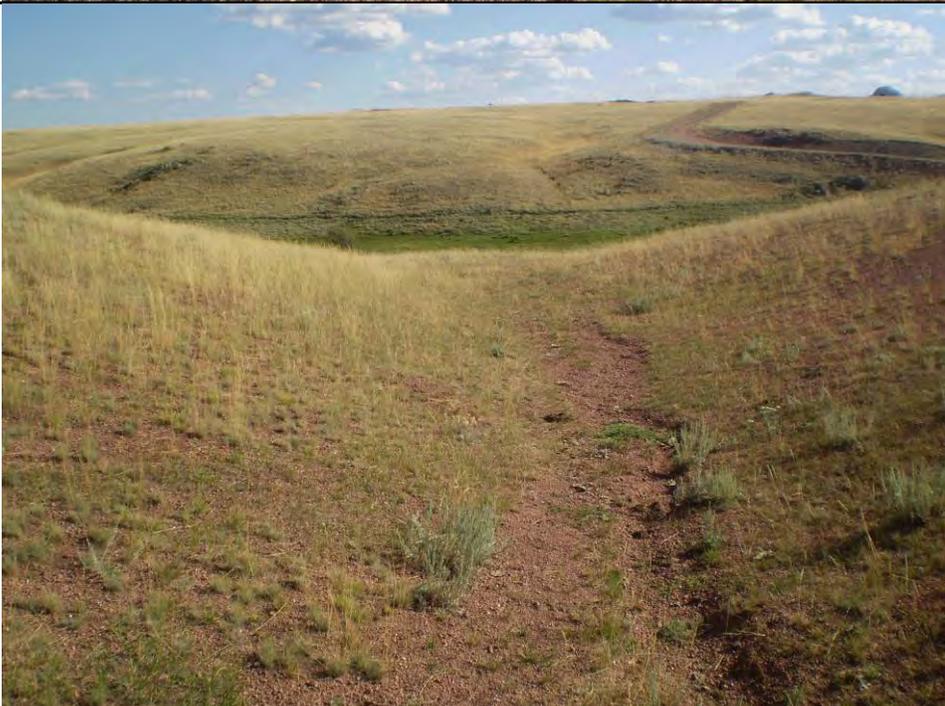
<b>Feature:</b> SBAL023			
<b>Date:</b> 08-27-2009			
<b>Comments:</b> Stream feature facing southwest.

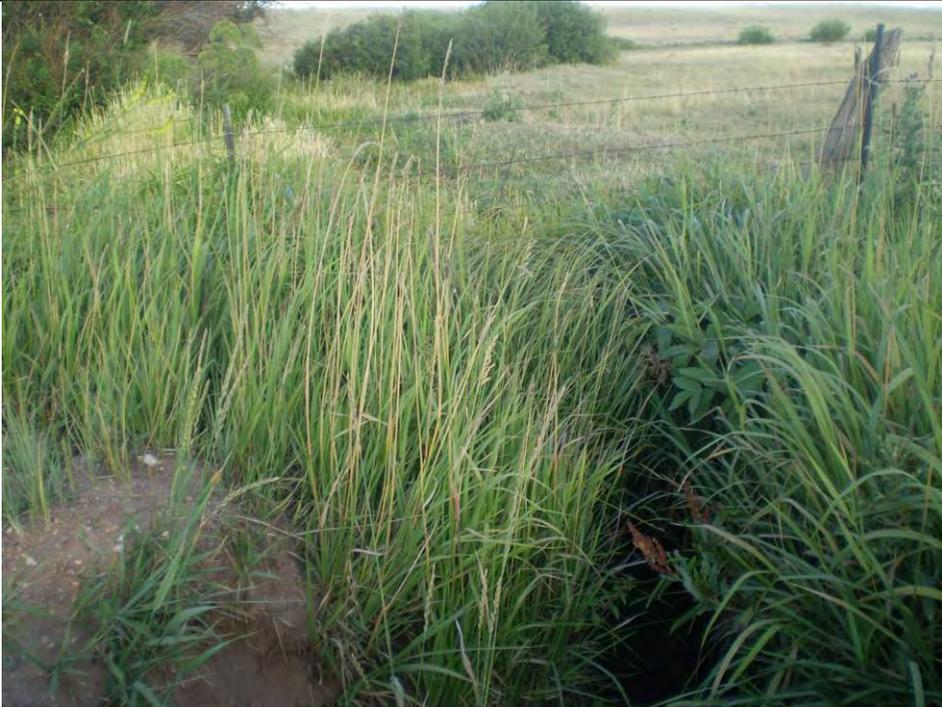
<b>Client:</b>	Shell Wind Energy	<b>Project Number:</b>	0105023
<b>Project Name:</b>	Hermosa West	<b>Location:</b>	Albany County, WY
<b>Photograph ID:</b> B127

<b>Feature:</b> SBAL024			
<b>Date:</b> 08-27-2009			
<b>Comments:</b> Stream feature facing south from existing culverted road.			
<b>Photograph ID:</b> B128

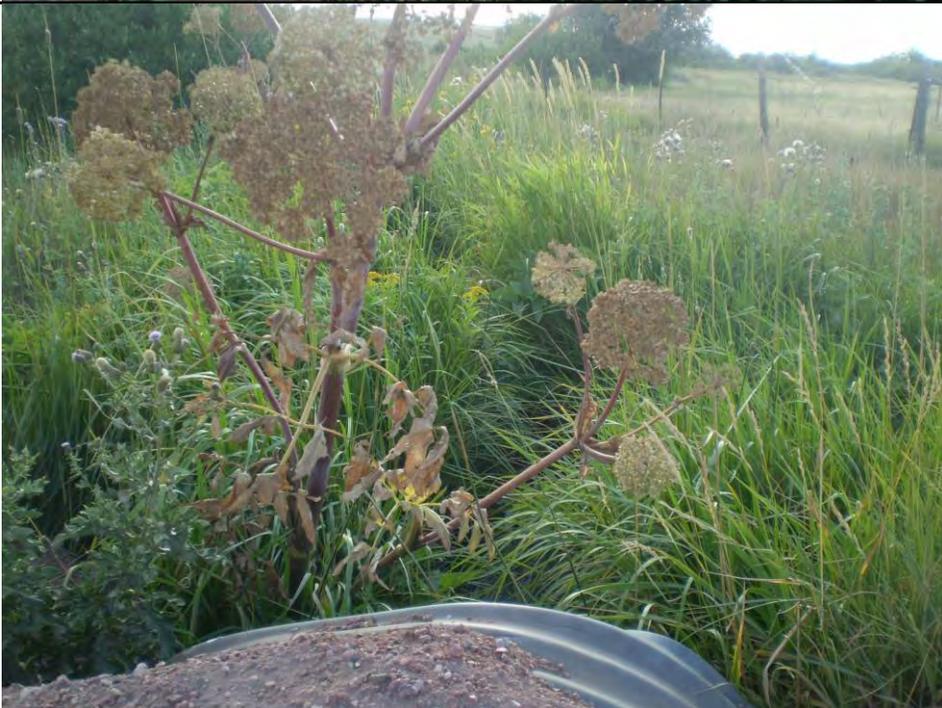
<b>Feature:</b> SBAL024			
<b>Date:</b> 08-27-2009			
<b>Comments:</b> Stream feature facing north from existing culverted road.

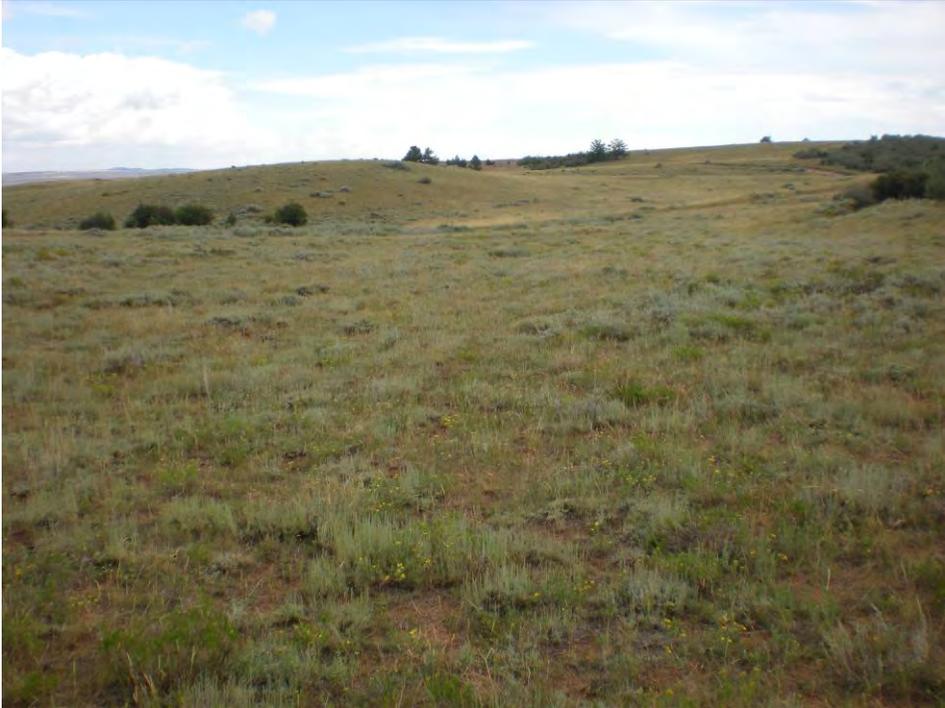
<b>Client:</b>	Shell Wind Energy	<b>Project Number:</b>	0105023
<b>Project Name:</b>	Hermosa West	<b>Location:</b>	Albany County, WY
<b>Photograph ID:</b> A1

<b>Feature:</b> ESAAL001			
<b>Date:</b> 08-25-2009			
<b>Comments:</b> Erosional swale (determined not to be a water body), facing northeast.			
<b>Photograph ID:</b> A2

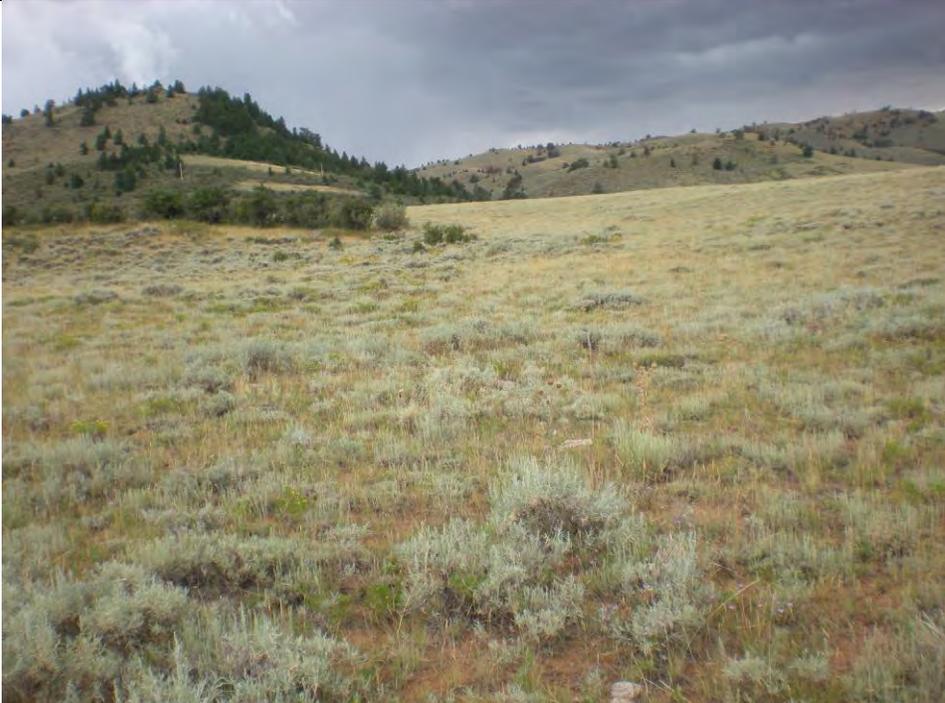
<b>Feature:</b> ESAAL001			
<b>Date:</b> 08-25-2009			
<b>Comments:</b> Swale facing southwest.

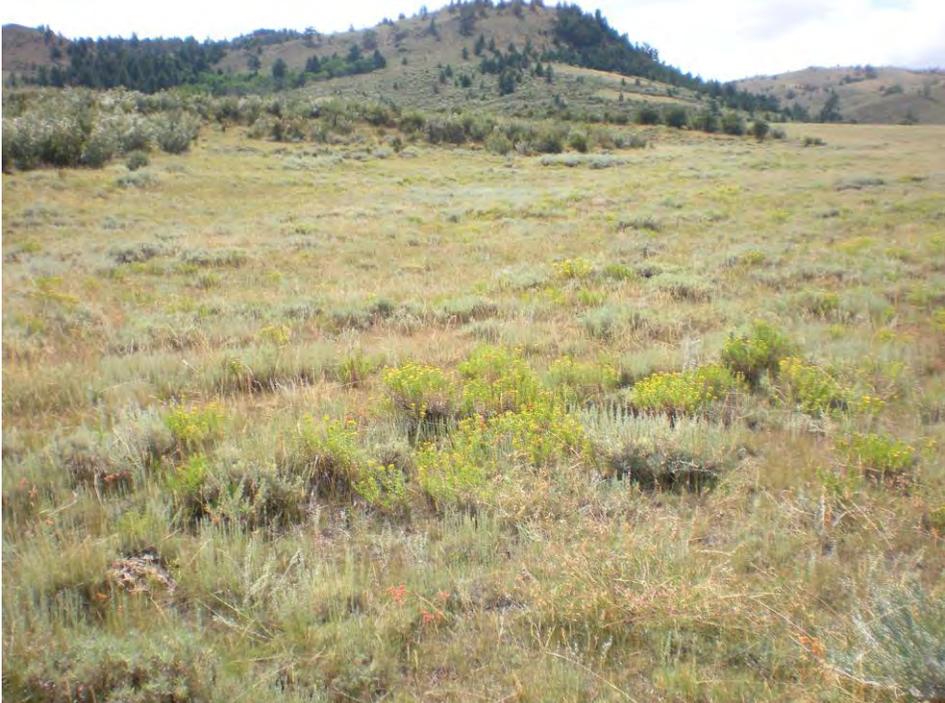
<b>Client:</b>	Shell Wind Energy	<b>Project Number:</b>	0105023
<b>Project Name:</b>	Hermosa West	<b>Location:</b>	Albany County, WY
<b>Photograph ID:</b> A13

<b>Feature:</b> ESAAL006			
<b>Date:</b> 08-25-2009			
<b>Comments:</b> Swale facing west.			
<b>Photograph ID:</b> A14

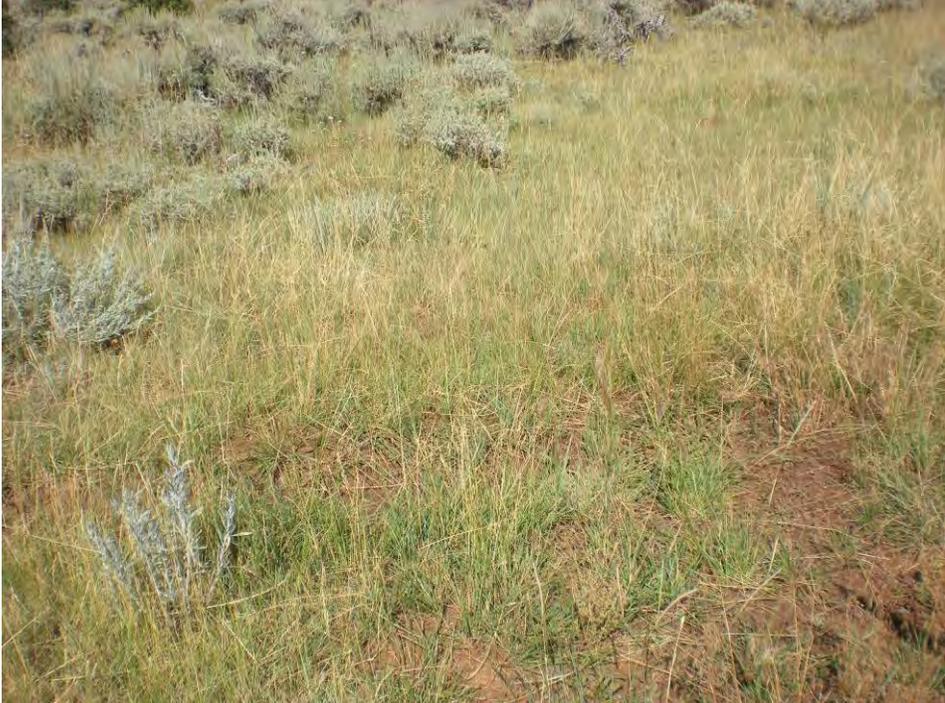
<b>Feature:</b> ESAAL006			
<b>Date:</b> 08-25-2009			
<b>Comments:</b> Swale facing east.

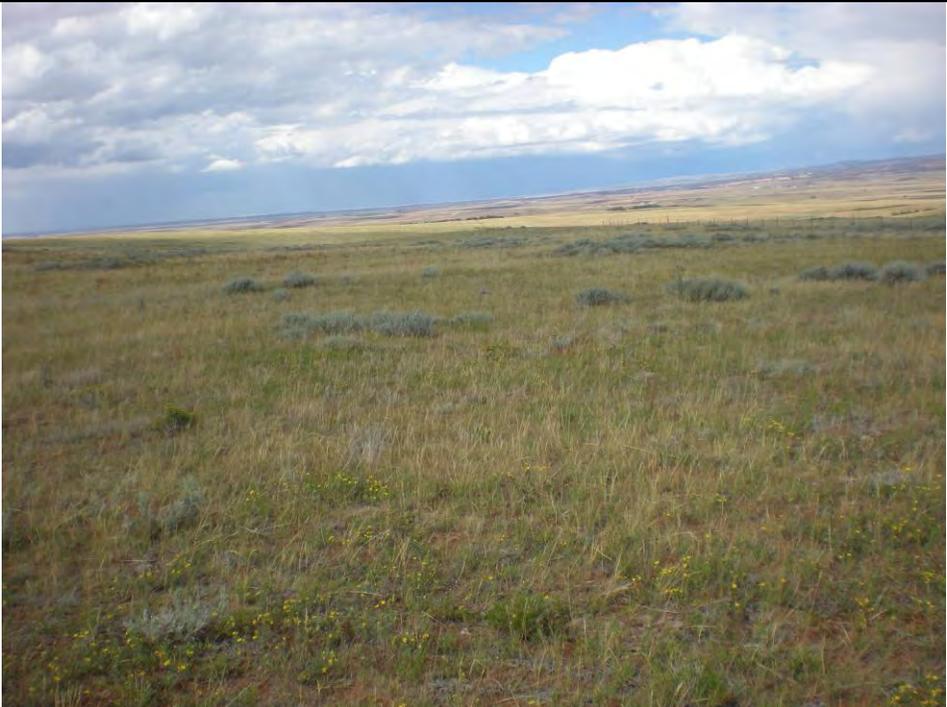
<b>Client:</b>	Shell Wind Energy	<b>Project Number:</b>	0105023
<b>Project Name:</b>	Hermosa West	<b>Location:</b>	Albany County, WY
<b>Photograph ID:</b> A17

<b>Feature:</b> ESAAL008			
<b>Date:</b> 08-25-2009			
<b>Comments:</b> Swale facing northeast.			
<b>Photograph ID:</b> A18

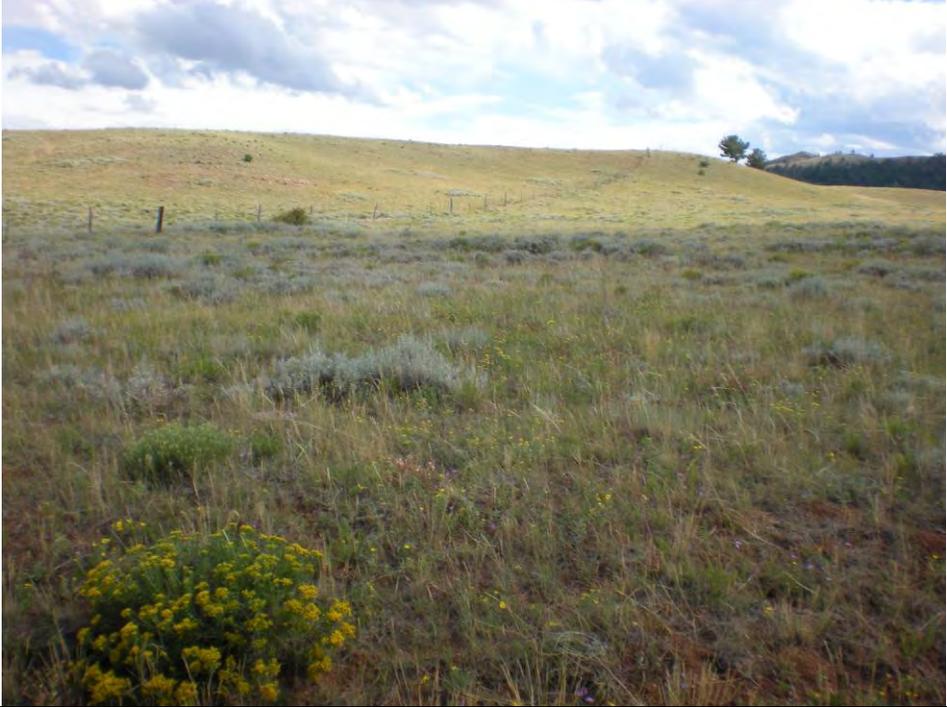
<b>Feature:</b> ESAAL008			
<b>Date:</b> 08-25-2009			
<b>Comments:</b> Swale facing southwest.

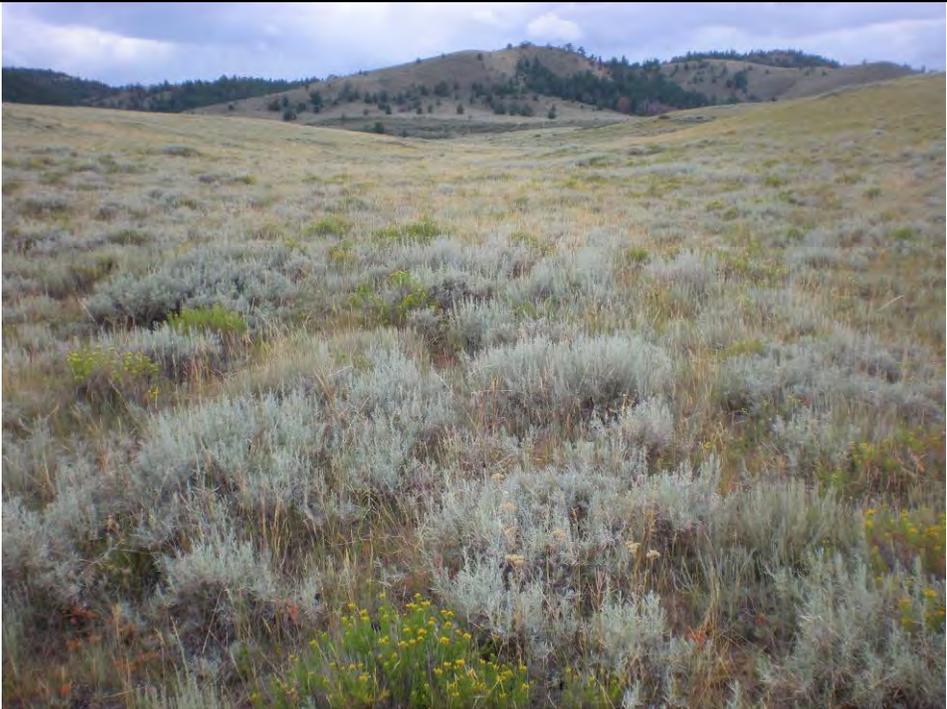
<b>Client:</b>	Shell Wind Energy	<b>Project Number:</b>	0105023
<b>Project Name:</b>	Hermosa West	<b>Location:</b>	Albany County, WY
<b>Photograph ID:</b> A31

<b>Feature:</b> ESAAL013			
<b>Date:</b> 08-25-2009			
<b>Comments:</b> Swale facing west.			
<b>Photograph ID:</b> A32

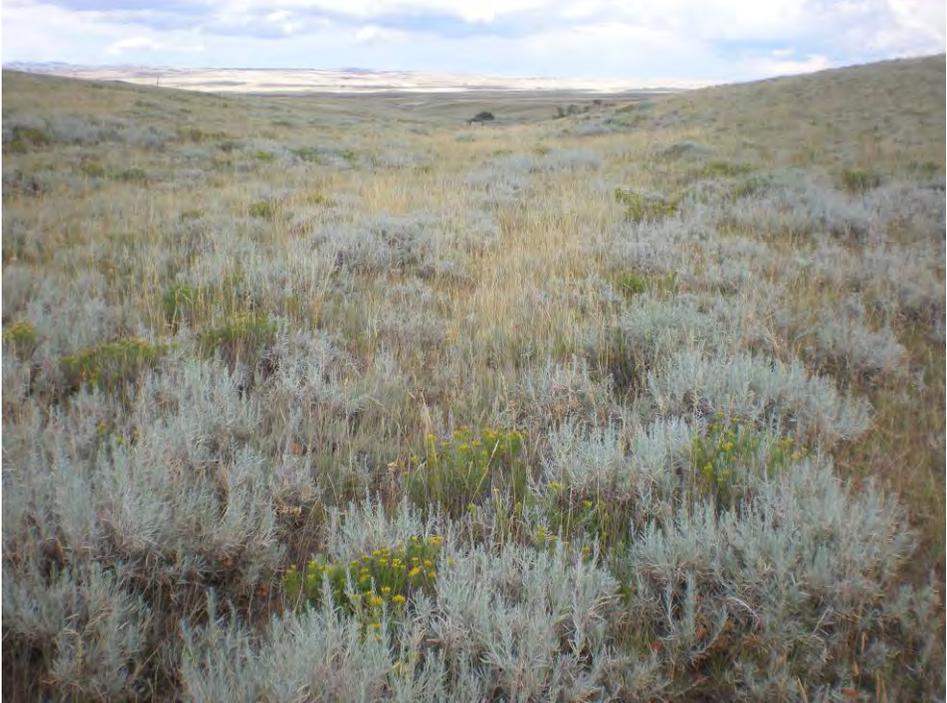
<b>Feature:</b> ESAAL013			
<b>Date:</b> 08-25-2009			
<b>Comments:</b> Swale facing east.

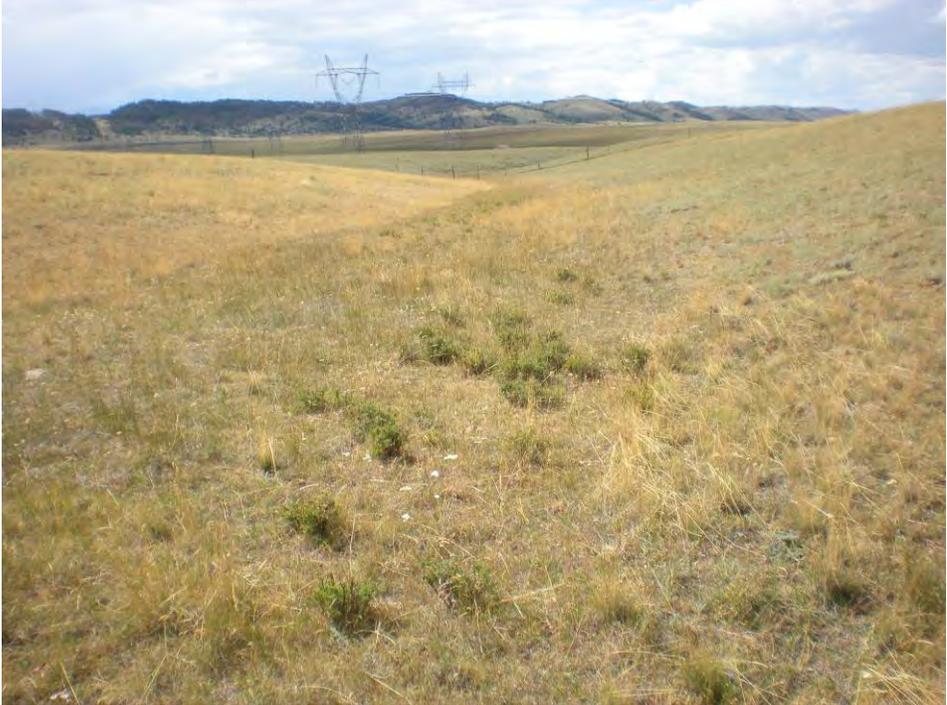
<b>Client:</b>	Shell Wind Energy	<b>Project Number:</b>	0105023
<b>Project Name:</b>	Hermosa West	<b>Location:</b>	Albany County, WY
<b>Photograph ID:</b> A81

<b>Feature:</b> ESAAL023			
<b>Date:</b> 08-26-2009			
<b>Comments:</b> Swale facing west.			
<b>Photograph ID:</b> A82

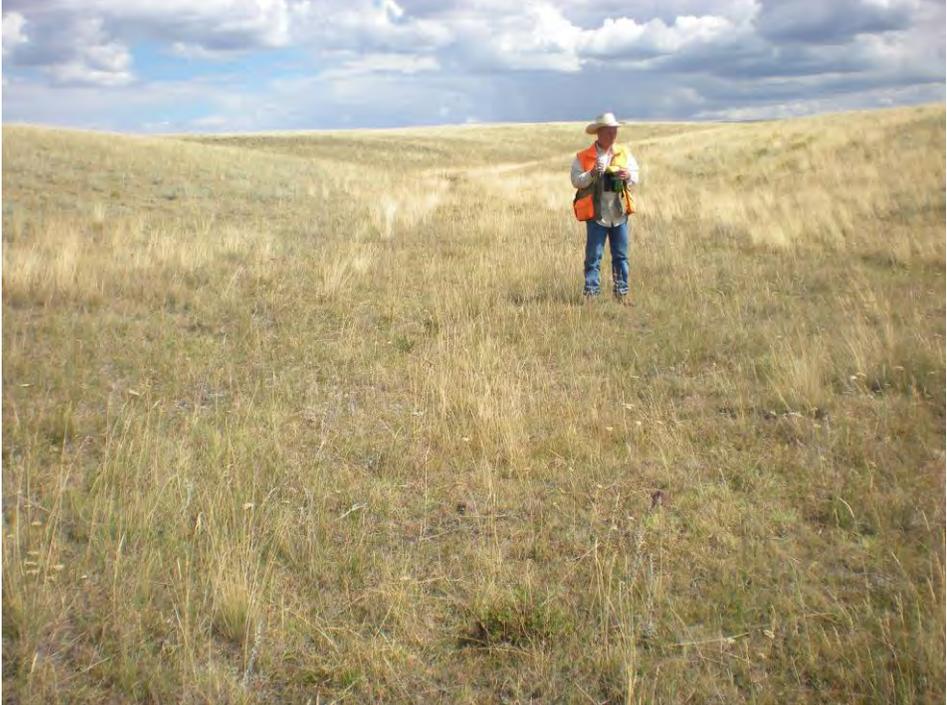
<b>Feature:</b> ESAAL023			
<b>Date:</b> 08-26-2009			
<b>Comments:</b> Swale facing east.

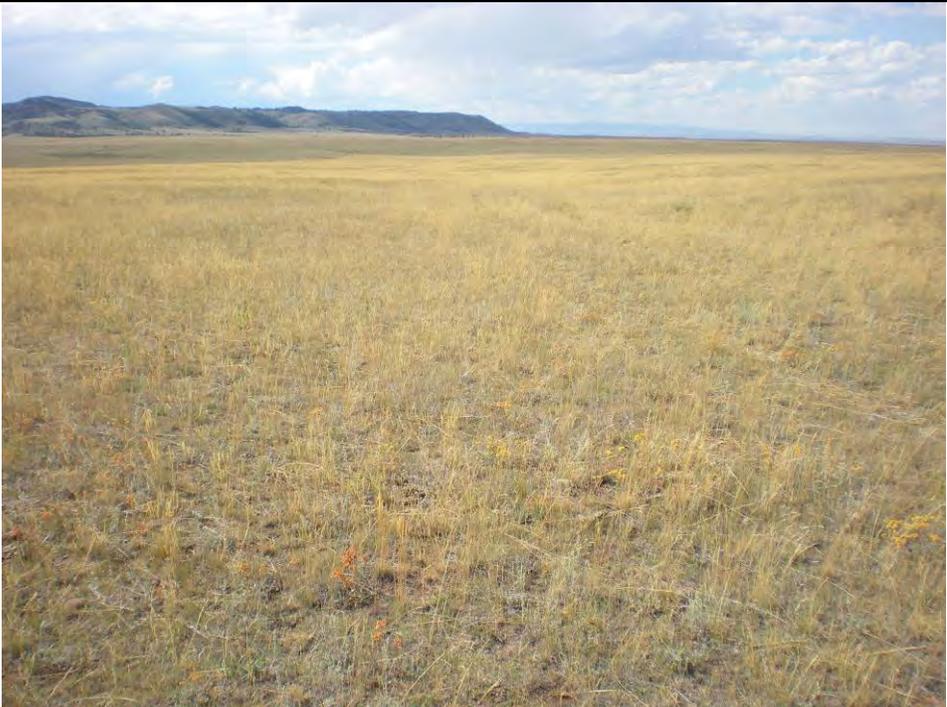
<b>Client:</b>	Shell Wind Energy	<b>Project Number:</b>	0105023
<b>Project Name:</b>	Hermosa West	<b>Location:</b>	Albany County, WY
<b>Photograph ID:</b> A83

<b>Feature:</b> ESAAL024			
<b>Date:</b> 08-26-2009			
<b>Comments:</b> Swale facing northeast.			
<b>Photograph ID:</b> A84

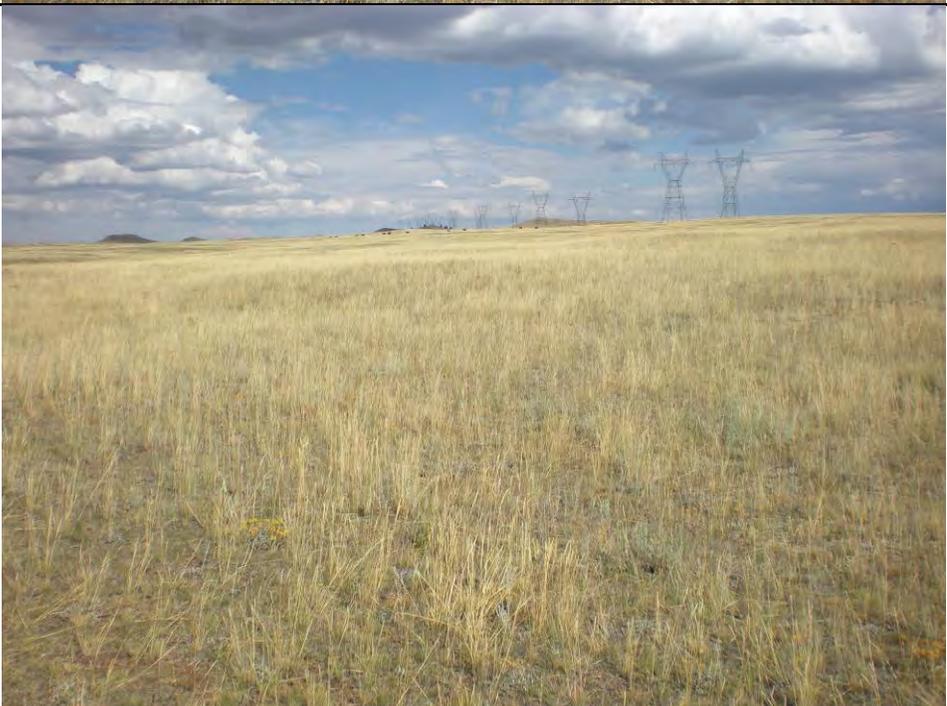
<b>Feature:</b> ESAAL024			
<b>Date:</b> 08-26-2009			
<b>Comments:</b> Swale facing southwest.

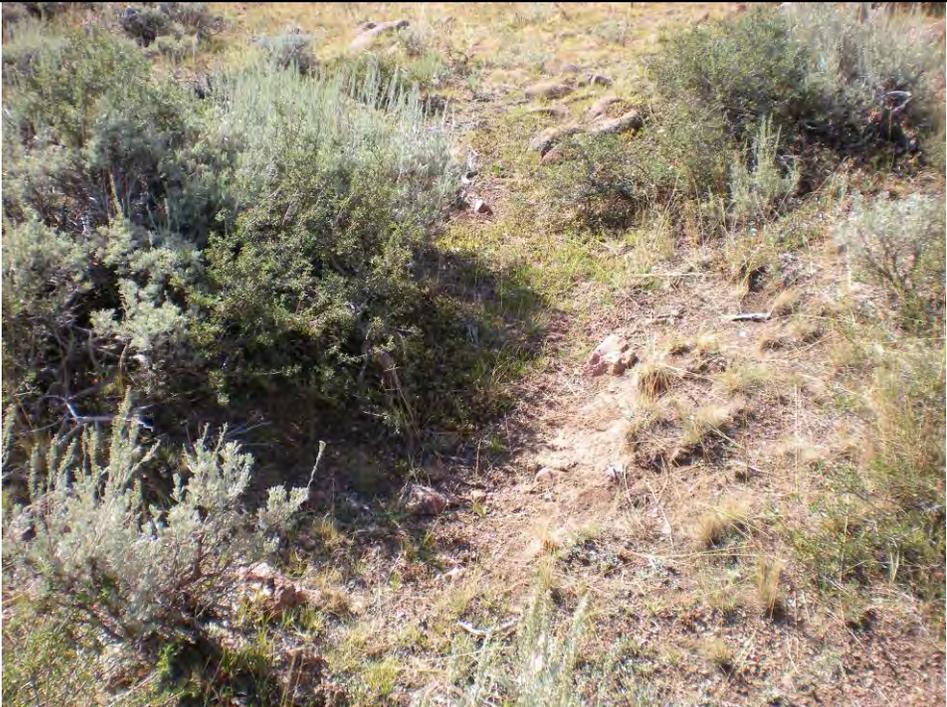
<b>Client:</b>	Shell Wind Energy	<b>Project Number:</b>	0105023
<b>Project Name:</b>	Hermosa West	<b>Location:</b>	Albany County, WY
<b>Photograph ID:</b> A89

<b>Feature:</b> ESAAL026			
<b>Date:</b> 08-27-2009			
<b>Comments:</b> Swale facing southeast.			
<b>Photograph ID:</b> A90

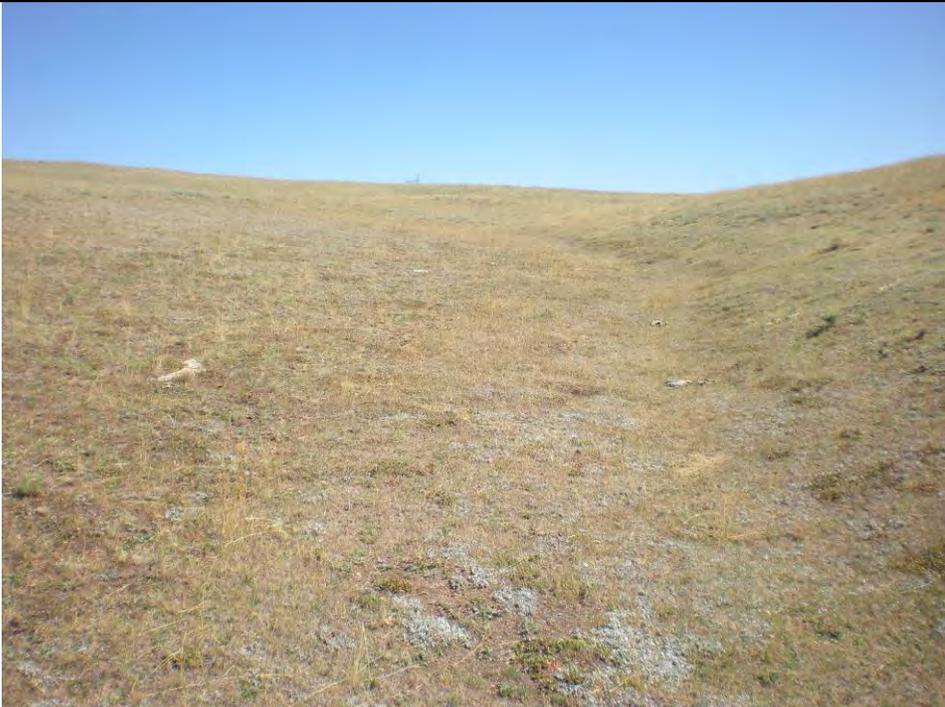
<b>Client:</b>	Shell Wind Energy	<b>Project Number:</b>	0105023
<b>Project Name:</b>	Hermosa West	<b>Location:</b>	Albany County, WY
<b>Photograph ID:</b> A97

<b>Feature:</b> ESAAL028			
<b>Date:</b> 08-27-2009			
<b>Comments:</b> Swale facing north-northeast.			
<b>Photograph ID:</b> A98

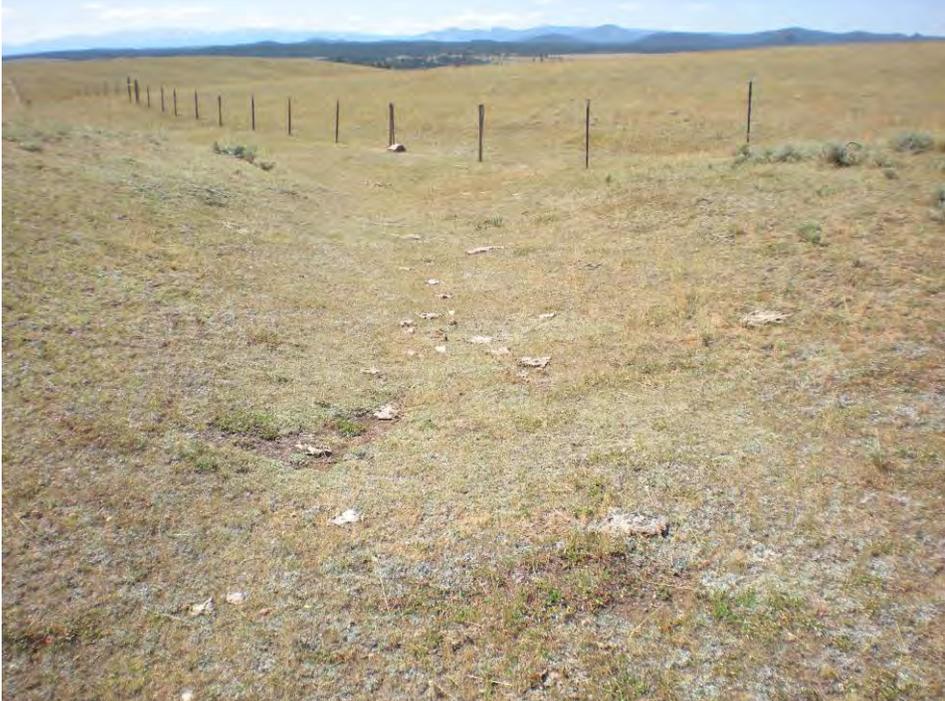
<b>Feature:</b> ESAAL028			
<b>Date:</b> 08-27-2009			
<b>Comments:</b> Swale facing south-southwest.

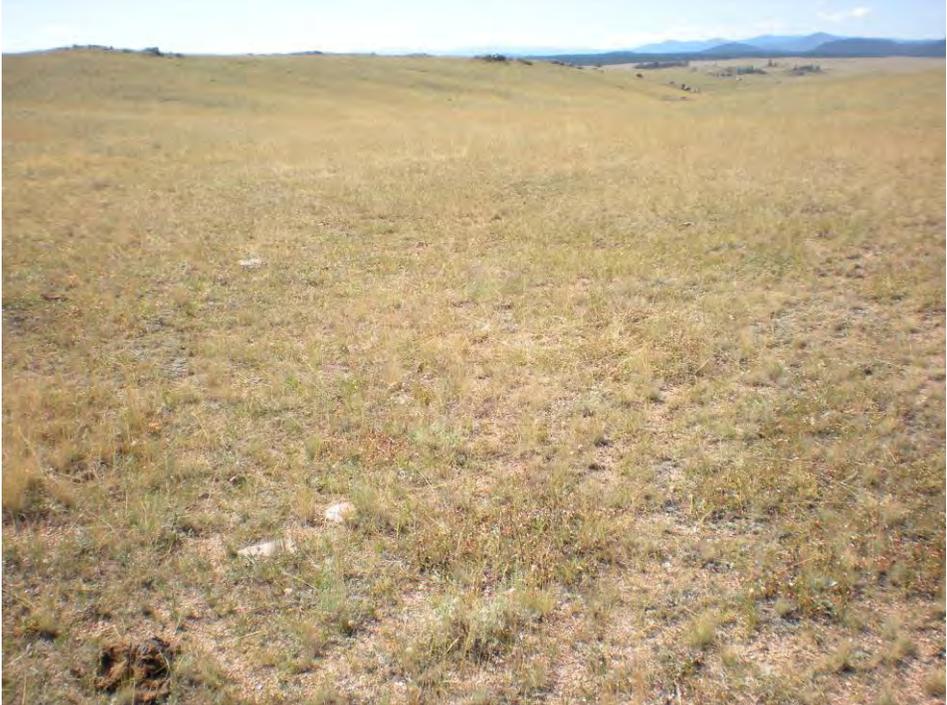
<b>Client:</b>	Shell Wind Energy	<b>Project Number:</b>	0105023
<b>Project Name:</b>	Hermosa West	<b>Location:</b>	Albany County, WY
<b>Photograph ID:</b> A99

<b>Feature:</b> ESAAL029			
<b>Date:</b> 08-27-2009			
<b>Comments:</b> Swale facing west.			
<b>Photograph ID:</b> A100
