**WETLAND ASSESSMENT REPORT REVISED JULY 1, 2010**

**Shell WindEnergy**  
**Hermosa West Wind Farm Project, Albany County, Wyoming**

# Wetland Assessment: Hermosa West Wind Farm Project

Project No. 0105023  
Albany County, Wyoming

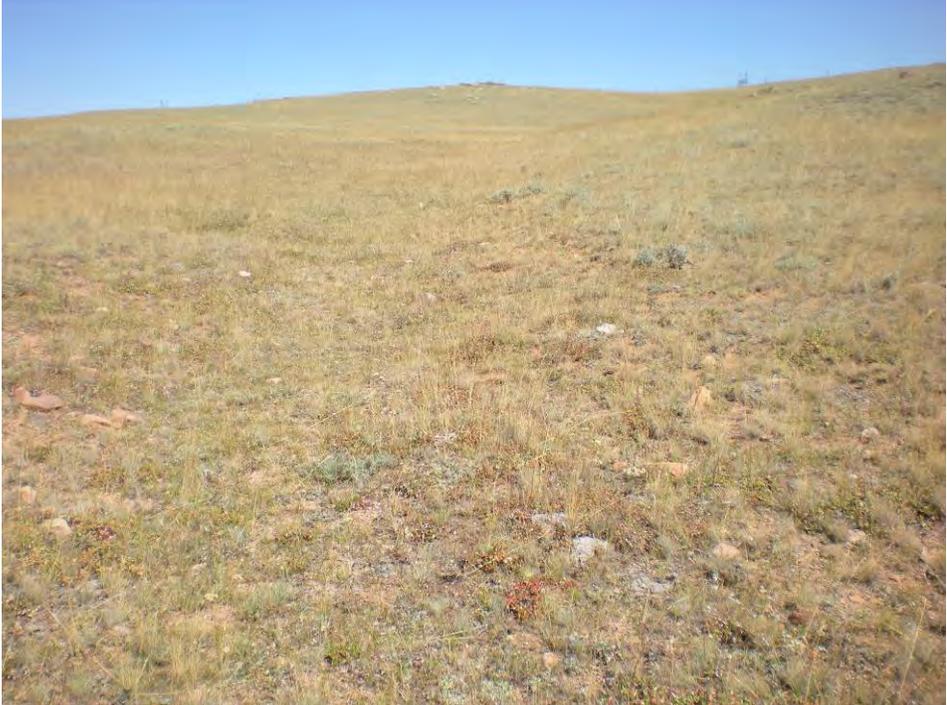
<b>Feature:</b> ESAAL029			
<b>Date:</b> 08-27-2009			
<b>Comments:</b> Swale facing east.

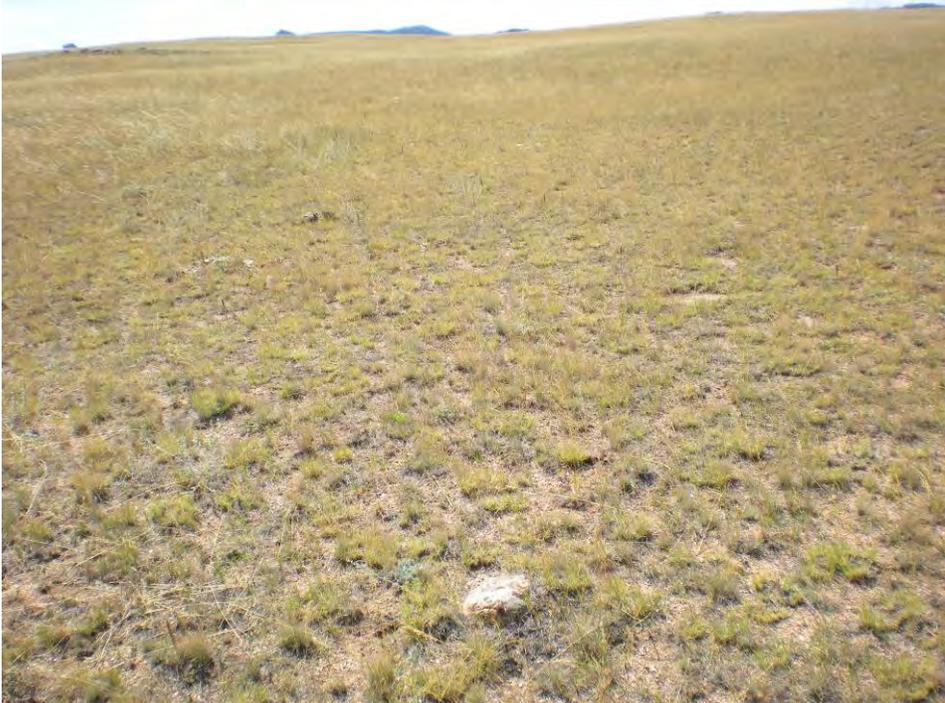
<b>Client:</b>	Shell Wind Energy	<b>Project Number:</b>	0105023
<b>Project Name:</b>	Hermosa West	<b>Location:</b>	Albany County, WY
<b>Photograph ID:</b> A105

<b>Feature:</b> ESAAL030			
<b>Date:</b> 08-27-2009			
<b>Comments:</b> Swale facing west.			
<b>Photograph ID:</b> A106

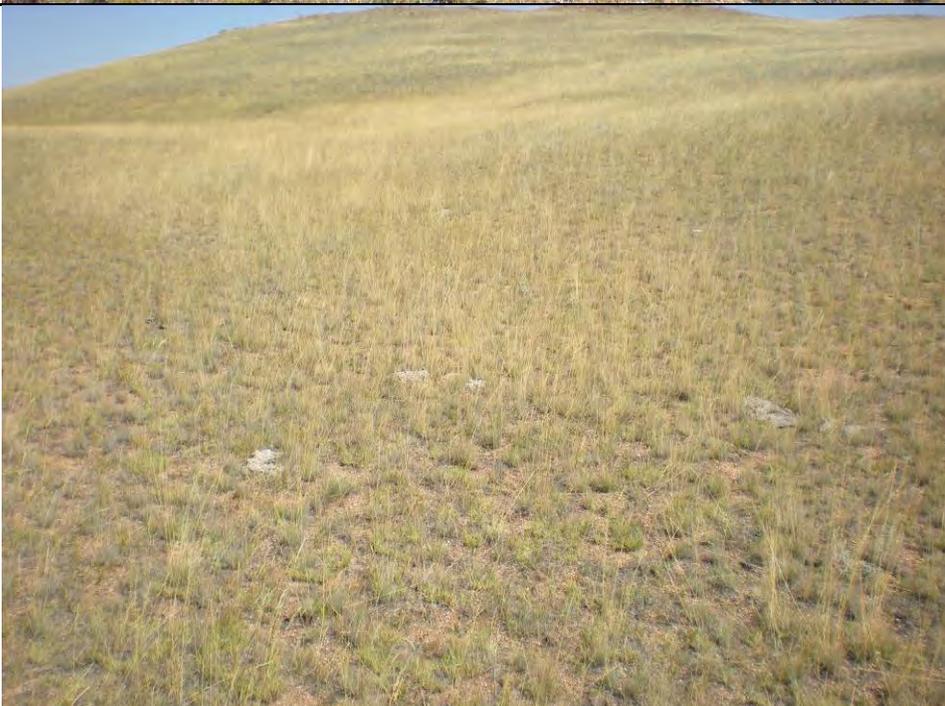
<b>Feature:</b> ESAAL030			
<b>Date:</b> 08-27-2009			
<b>Comments:</b> Swale facing east.

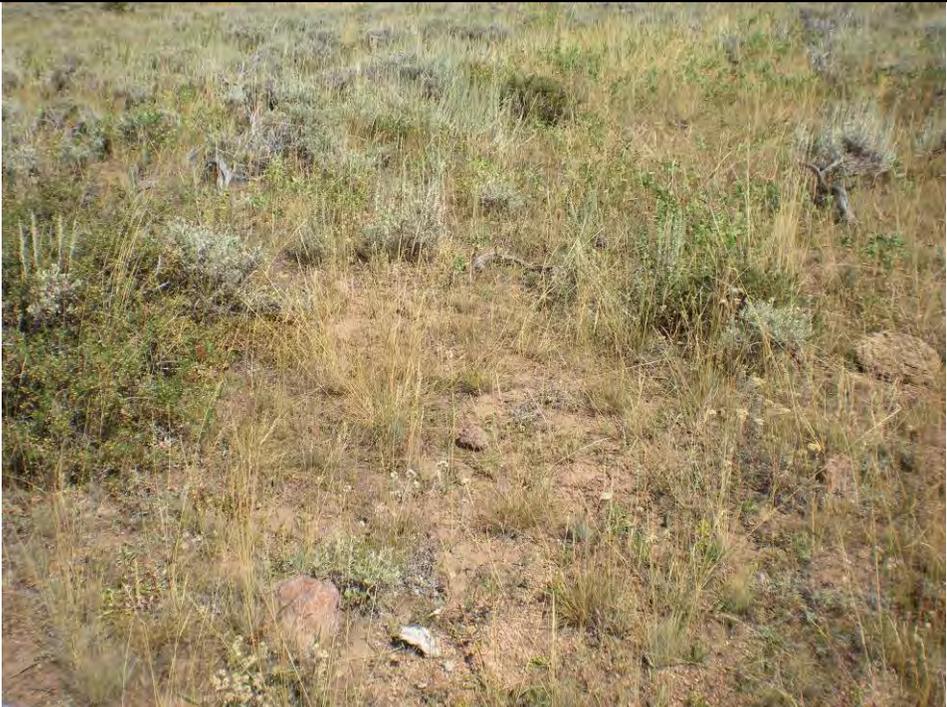
<b>Client:</b>	Shell Wind Energy	<b>Project Number:</b>	0105023
<b>Project Name:</b>	Hermosa West	<b>Location:</b>	Albany County, WY
<b>Photograph ID:</b> A107

<b>Feature:</b> ESAAL031			
<b>Date:</b> 08-27-2009			
<b>Comments:</b> Swale facing west.			
<b>Photograph ID:</b> A108

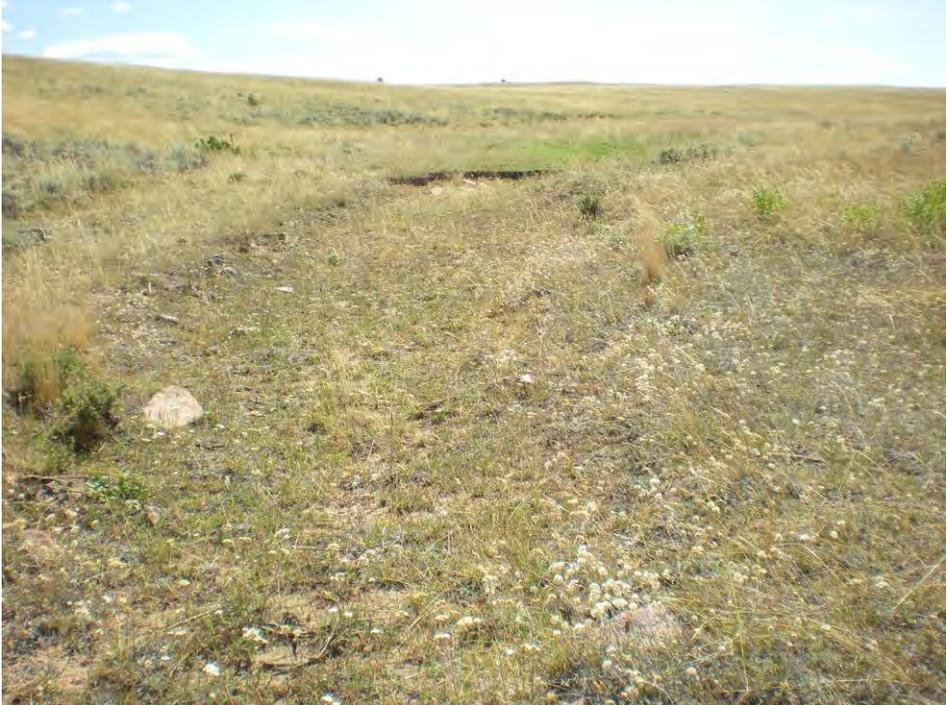
<b>Feature:</b> ESAAL031			
<b>Date:</b> 08-27-2009			
<b>Comments:</b> Swale facing east.

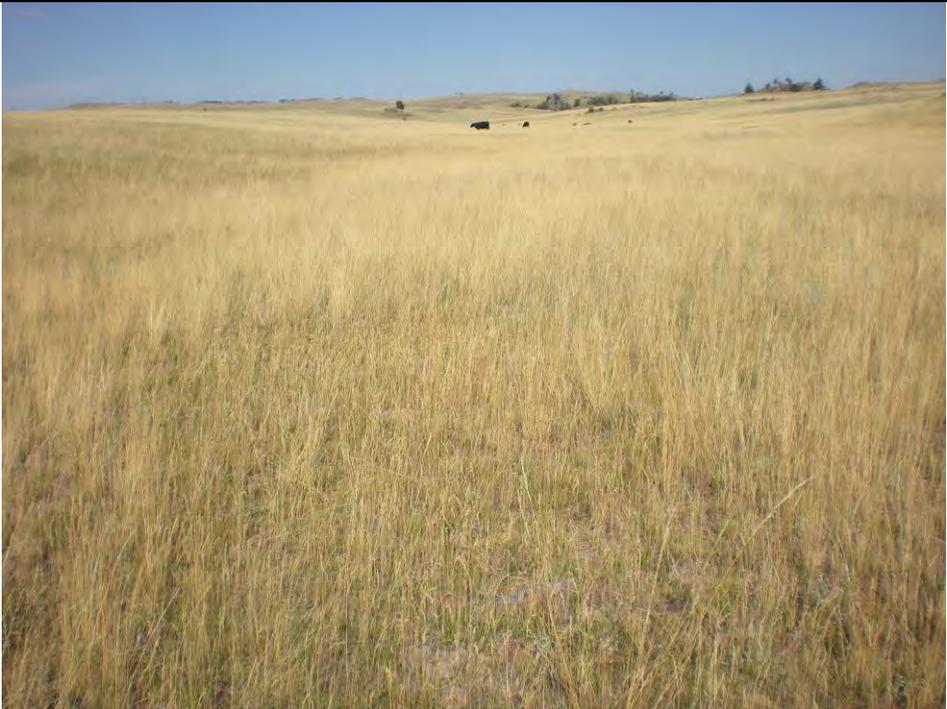
<b>Client:</b>	Shell Wind Energy	<b>Project Number:</b>	0105023
<b>Project Name:</b>	Hermosa West	<b>Location:</b>	Albany County, WY
<b>Photograph ID:</b> A116

<b>Feature:</b> ESAAL033			
<b>Date:</b> 08-27-2009			
<b>Comments:</b> Swale facing west.			
<b>Photograph ID:</b> A117

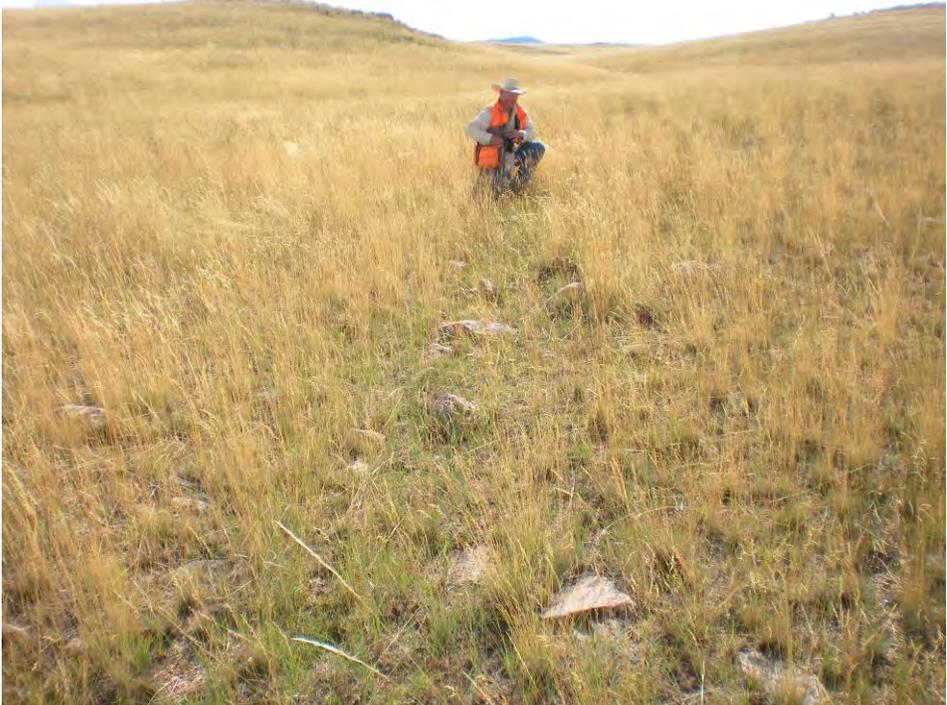
<b>Feature:</b> ESAAL033			
<b>Date:</b> 08-27-2009			
<b>Comments:</b> Swale facing east.

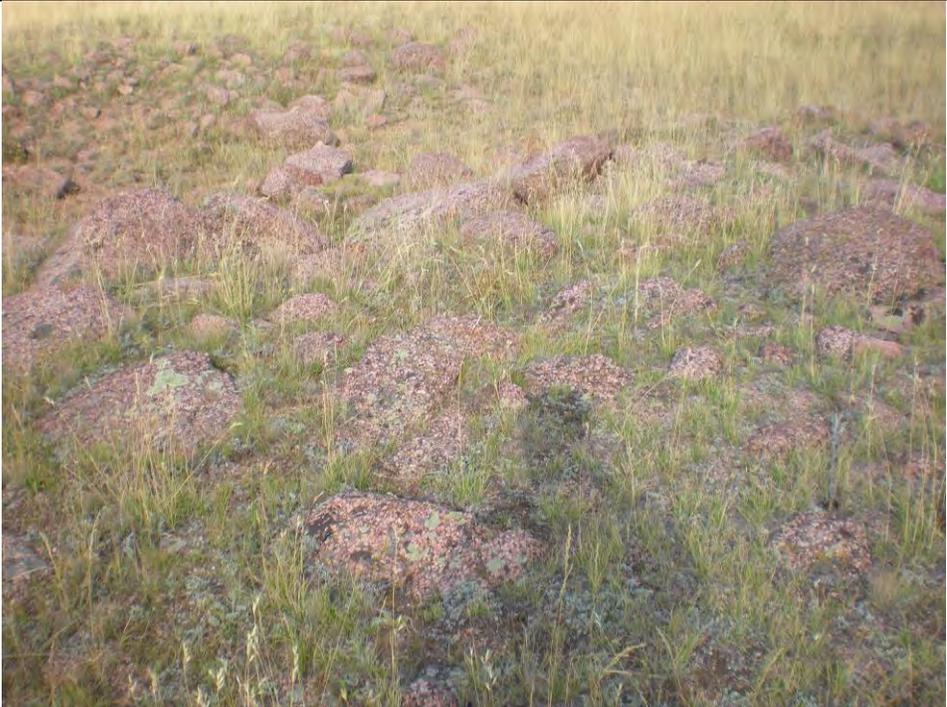
<b>Client:</b>	Shell Wind Energy	<b>Project Number:</b>	0105023
<b>Project Name:</b>	Hermosa West	<b>Location:</b>	Albany County, WY
<b>Photograph ID:</b> A118

<b>Feature:</b> ESAAL034			
<b>Date:</b> 08-27-2009			
<b>Comments:</b> Swale facing east.			
<b>Photograph ID:</b> A119

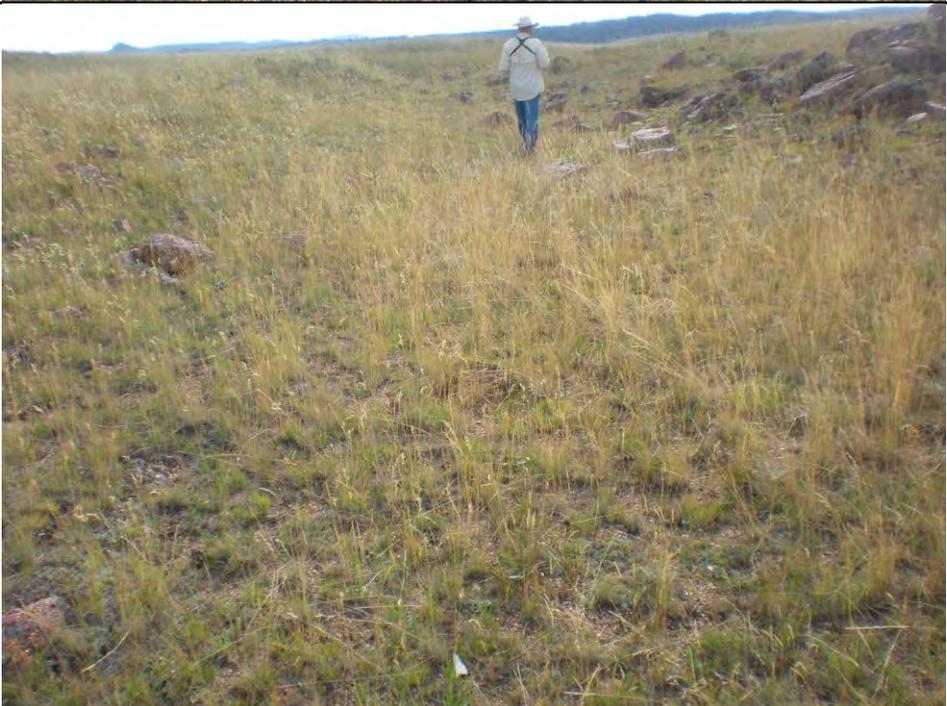
<b>Feature:</b> ESAAL034			
<b>Date:</b> 08-27-2009			
<b>Comments:</b> Swale facing west.

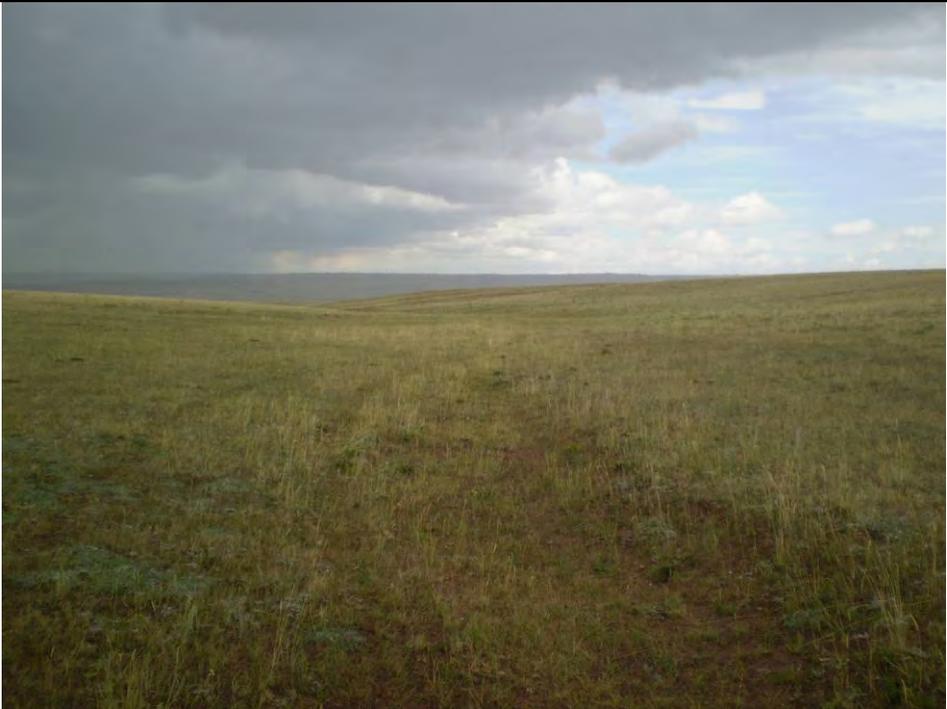
<b>Client:</b>	Shell Wind Energy	<b>Project Number:</b>	0105023
<b>Project Name:</b>	Hermosa West	<b>Location:</b>	Albany County, WY
<b>Photograph ID:</b> B24

<b>Feature:</b> ESBAL007			
<b>Date:</b> 08-25-2009			
<b>Comments:</b> Swale facing east			
<b>Photograph ID:</b>	[INTENTIONALLY LEFT BLANK]		
<b>Feature:</b>			
<b>Date:</b>			
<b>Comments:</b>

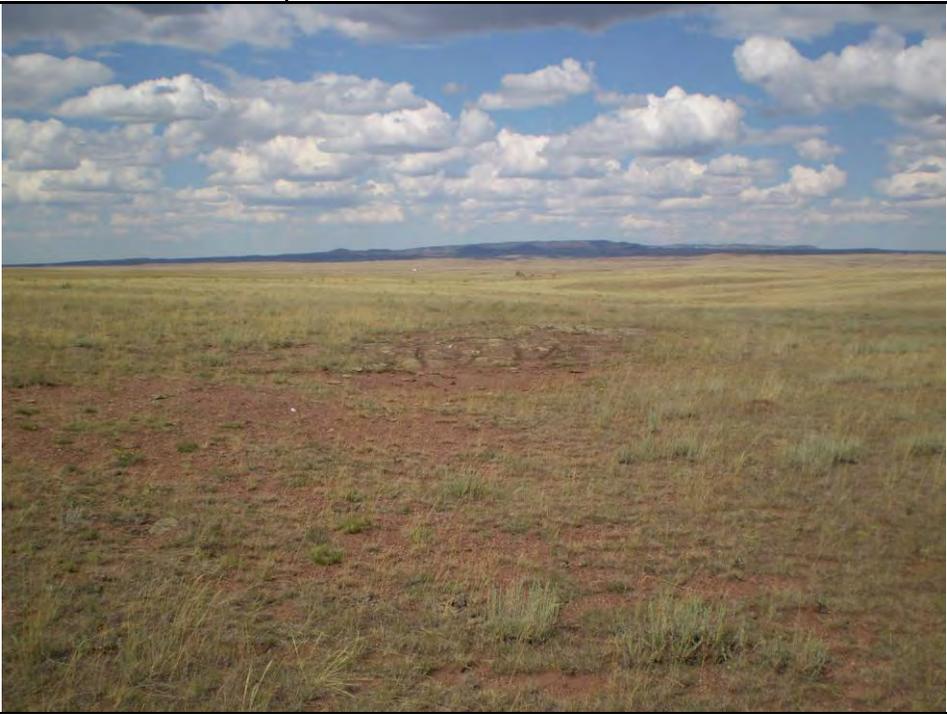
<b>Client:</b>	Shell Wind Energy	<b>Project Number:</b>	0105023
<b>Project Name:</b>	Hermosa West	<b>Location:</b>	Albany County, WY
<b>Photograph ID:</b> B97

<b>Feature:</b> ESBAL032			
<b>Date:</b> 08-26-2009			
<b>Comments:</b> Swale facing north.			
<b>Photograph ID:</b> B98

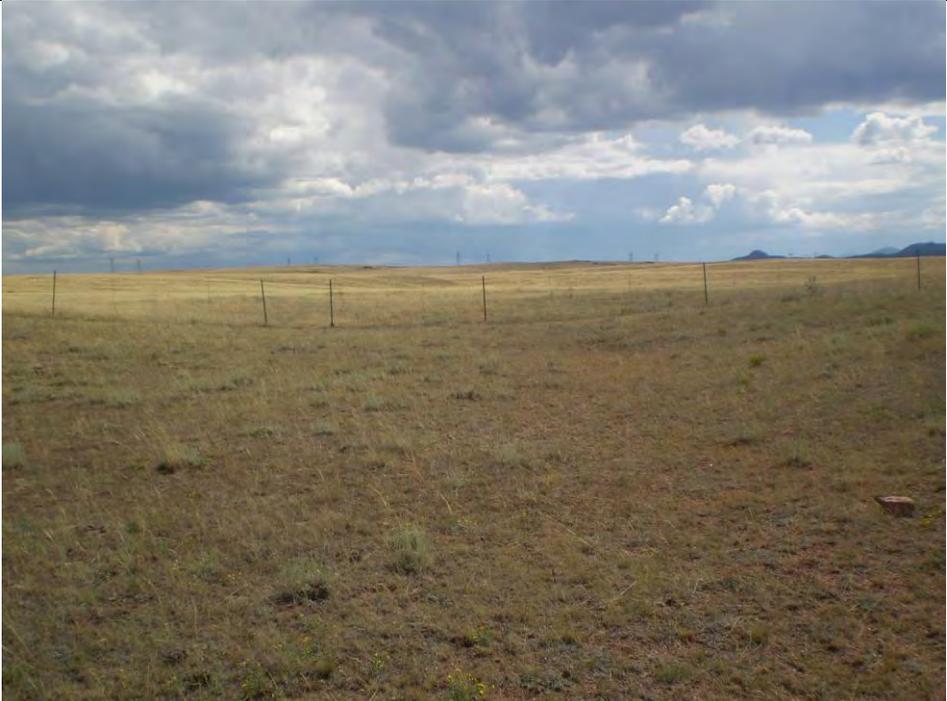
<b>Feature:</b> ESBAL032			
<b>Date:</b> 08-26-2009			
<b>Comments:</b> Swale facing south.

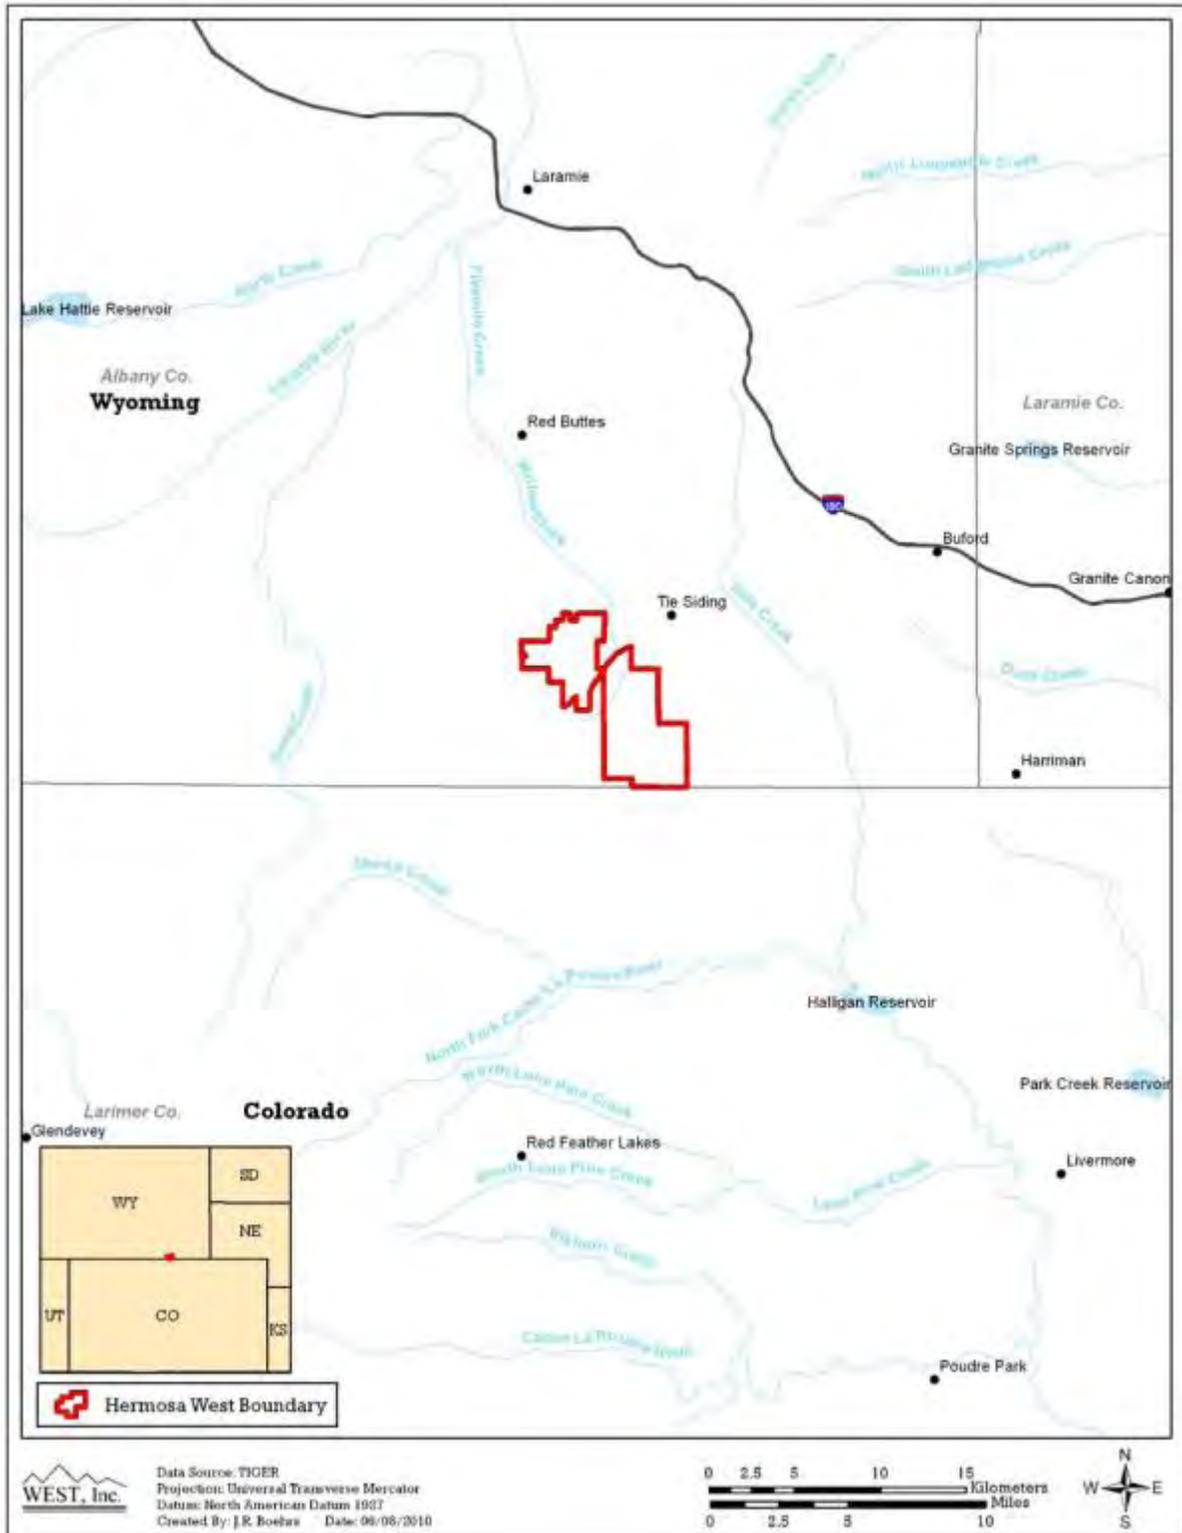
Figure 1. Location of the Hermosa West Wind Resource Area.

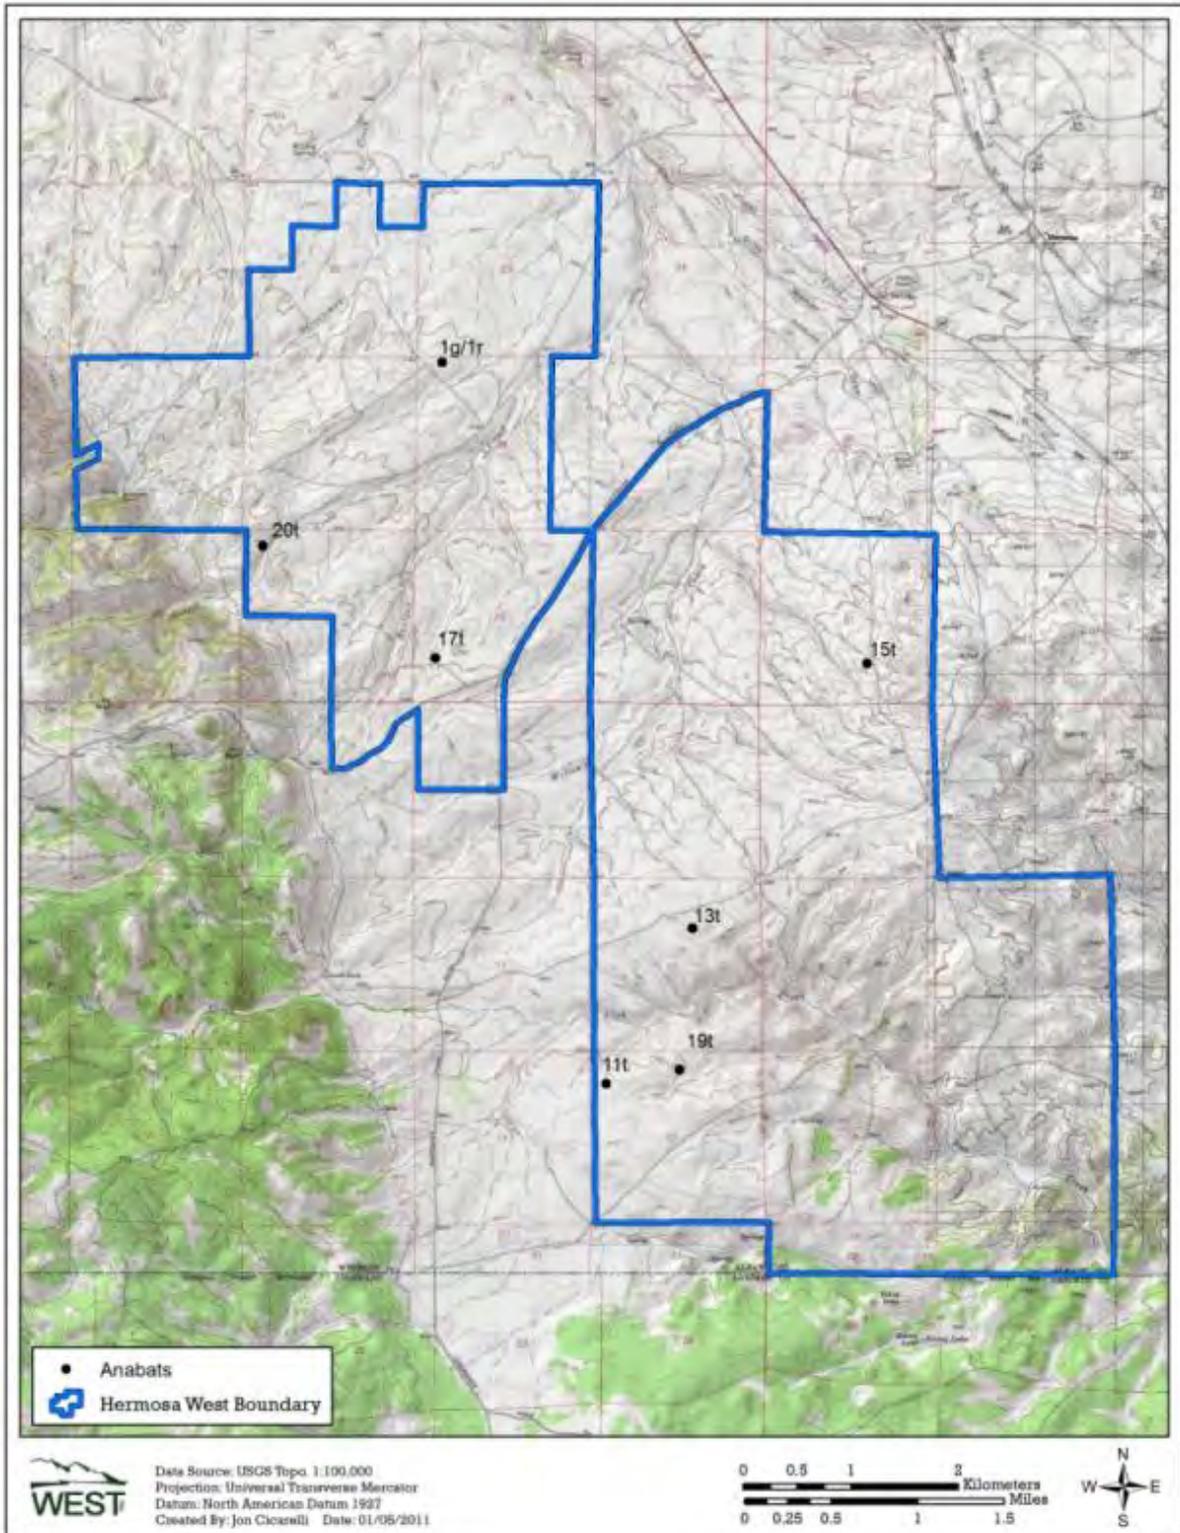
Figure 5. Study area map and Anabat sampling stations at the Hermosa West Wind Resource Area.

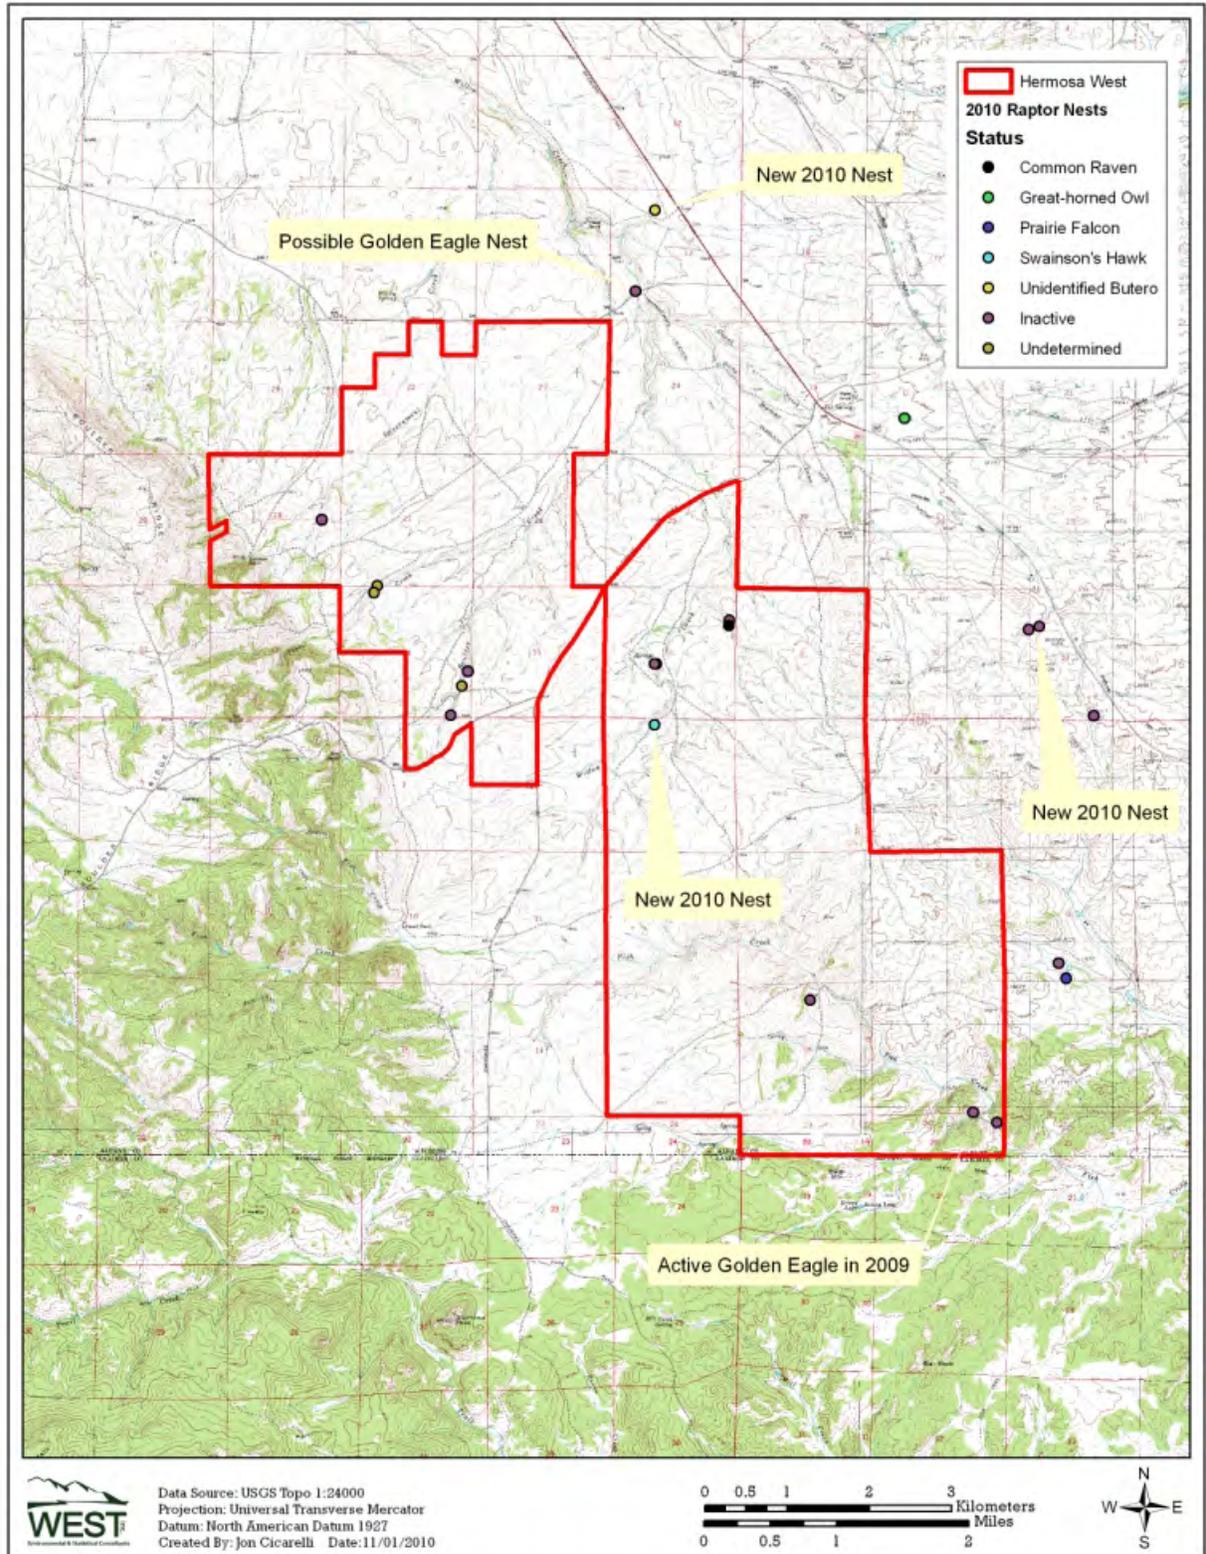
Figure 8. Locations of raptor nests identified during the 2010 raptor nest search within the Hermosa West Wind Resource Area and surrounding 1-mile buffer.

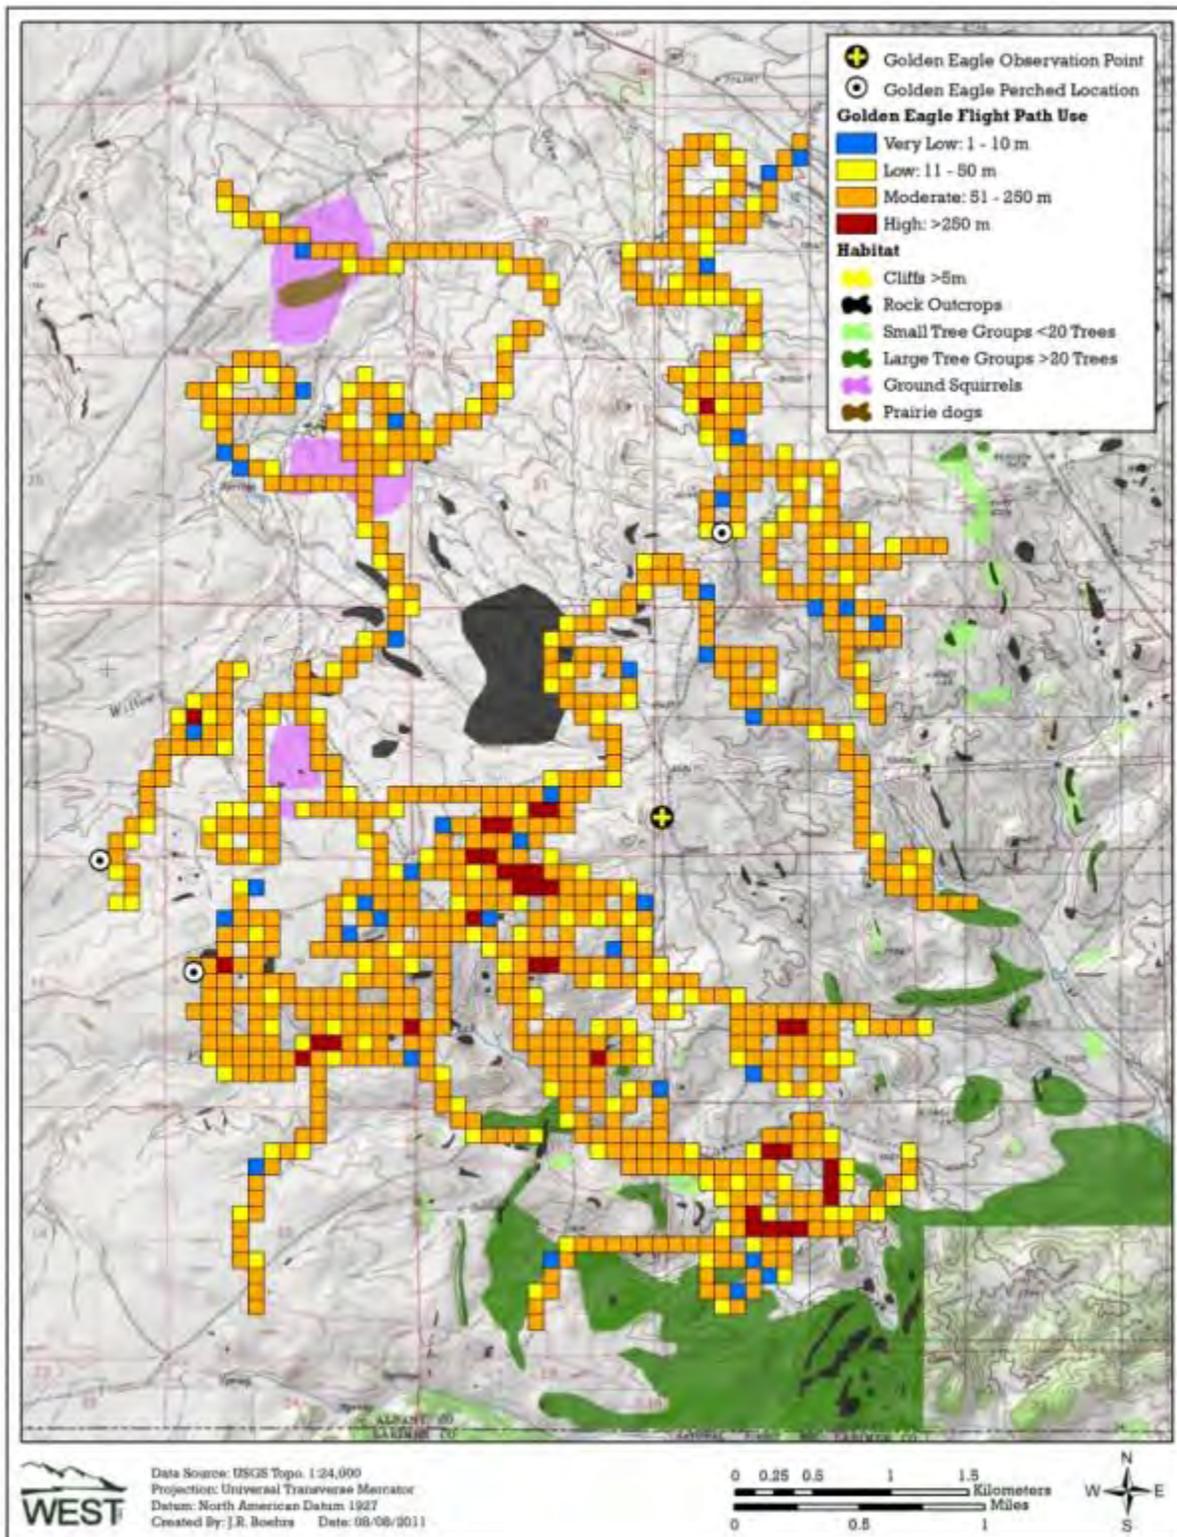
Figure 9. The 100 X 100 grid depicting golden eagle flight paths mapped against golden eagle perch locations, raptor habitat mapping, and topography from the raptor observations conducted at the Hermosa West Wind Resource Area.

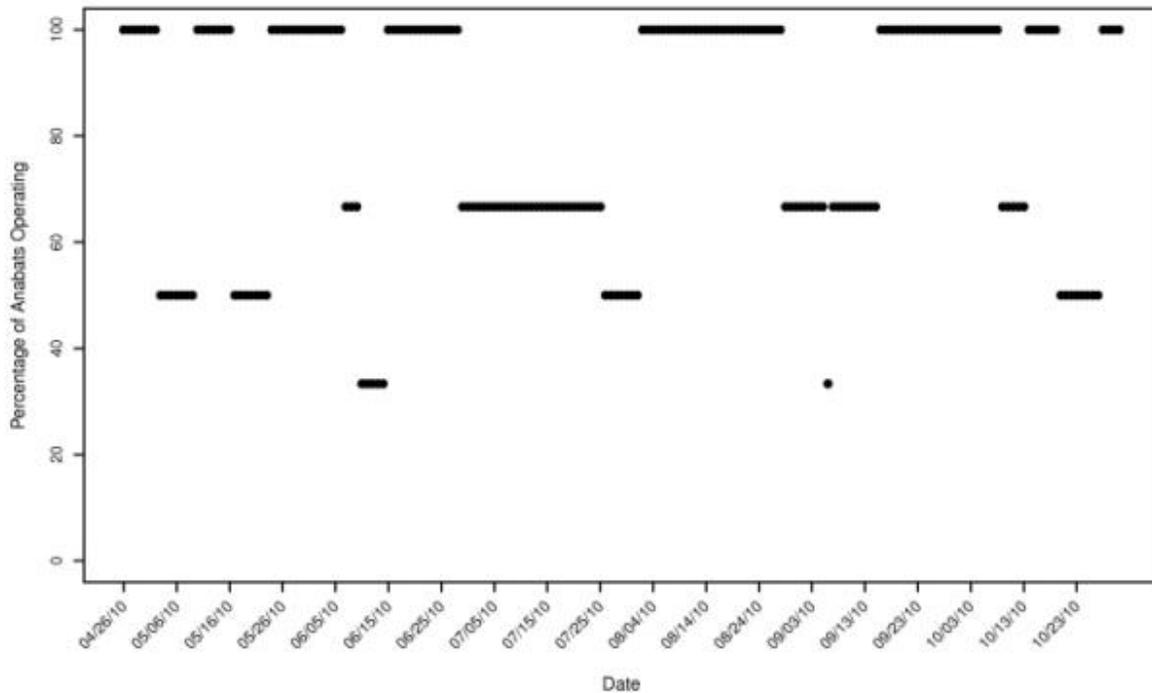
Figure 11. Percentage of Anabat detectors (n = 3) at the Hermosa West Wind Resource Area operating during each night of the study period April 26 – October 31, 2010.
