# *Citizens Advisory Board Presentation*

## *Integrated Waste Treatment Unit*

*14 November 2012*

# OGF—Filter Bundle, Before and After

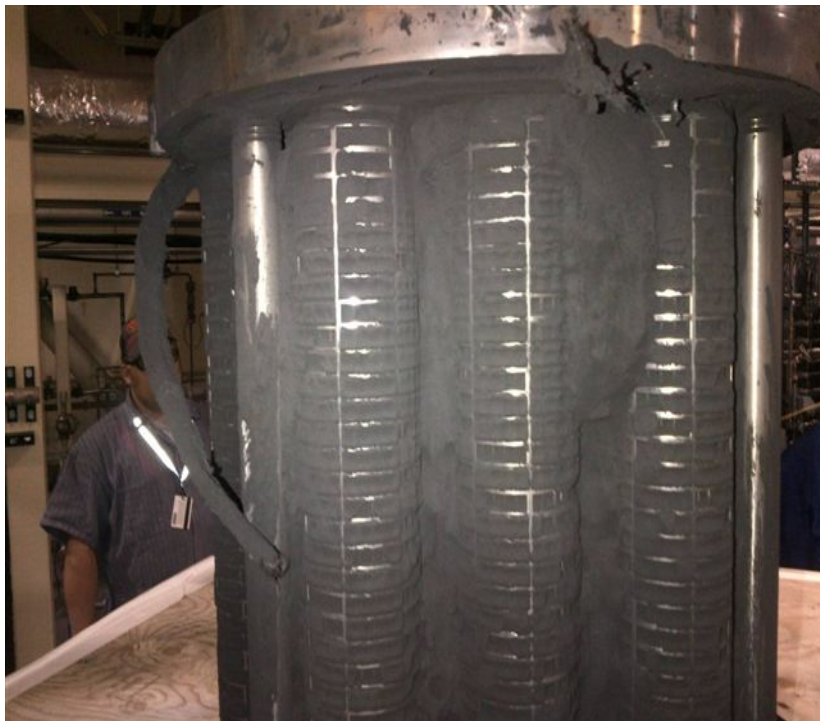
Clogged OGF Filter

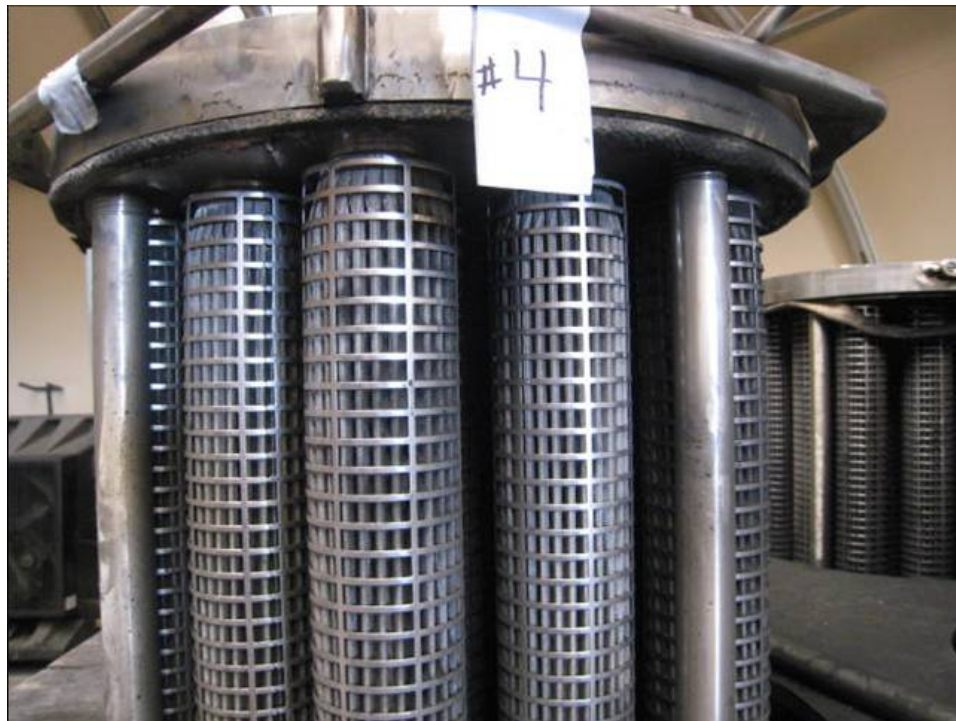
Cleaned OGF Filter
