## Mexican Hat, Utah | Disposal Site

### AN UMTRCA TITLE I SITE

This fact sheet provides information about the **Mexican Hat disposal site**. This site is managed by the **U.S. Department of Energy Office of Legacy Management** under **Title I** of the **Uranium Mill Tailings Radiation Control Act of 1978**.

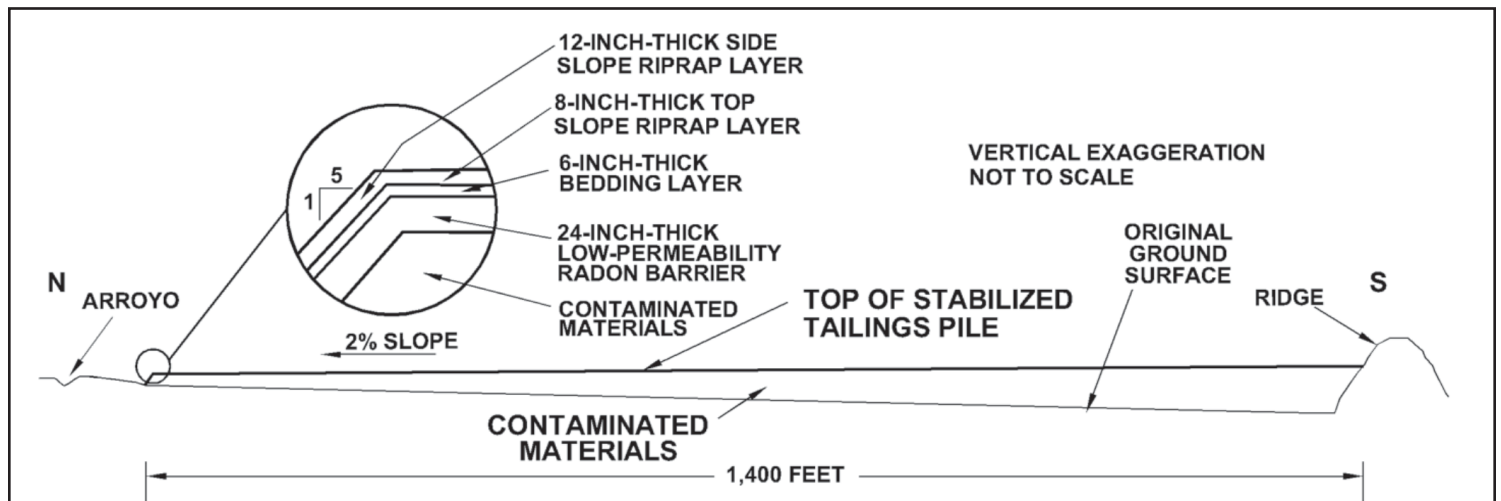
*Typical north-south cross section of the Mexican Hat disposal cell.*

The cover is composed of (1) a low-permeability radon barrier (first layer placed over compacted tailings), (2) a bedding layer of sand and gravel placed as a capillary break, and (3) a rock (riprap) erosion protection layer. The cell design promotes rapid runoff of precipitation to minimize leachate. The cell cover was constructed with a 2 percent grade sloping to the north and east. Runoff water flows down the 20 percent side slopes into the surrounding rock apron and exits the cell via three engineered toe drains that drain into existing arroyos north and east of the cell.

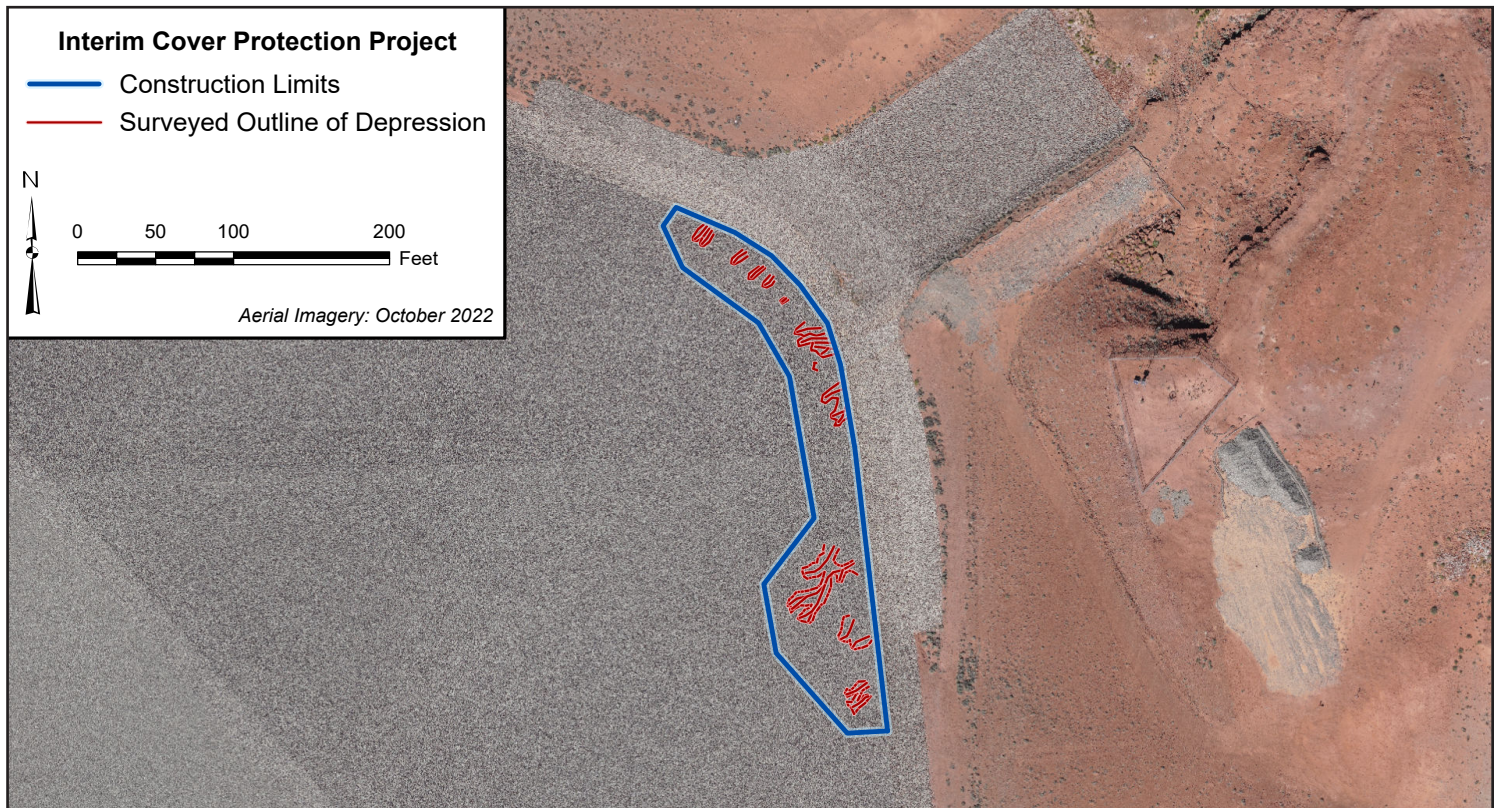
*Depression features on northeast side slope and approximate area of interim cover protection project.*

In 2016, multiple subtle depressions were identified in the rock cover along the toe and lower portions of the northeast side slope of the disposal cell. As a result of limited field investigations in 2017 and 2018, erosion into the surface of radon barrier was identified along the lower portions of the north and northeast side slopes of the disposal cell. These observations indicate the disposal cell erosion protection system is not performing as designed. Field observations and supporting radiological scans of the depression features show radioactive materials have neither been released nor exposed, and the disposal cell remains protective of human health and the environment.

and to determine the appropriate corrective measures needed to ensure that the design life of the disposal cell meets the requirements under UMTRCA. A comprehensive interim cover protection project was also performed in 2019, which restored a 20,000 square foot area on the northeast side slope back to the original design specifications to ensure protection of human health and the environment until a final long-term solution is implemented.

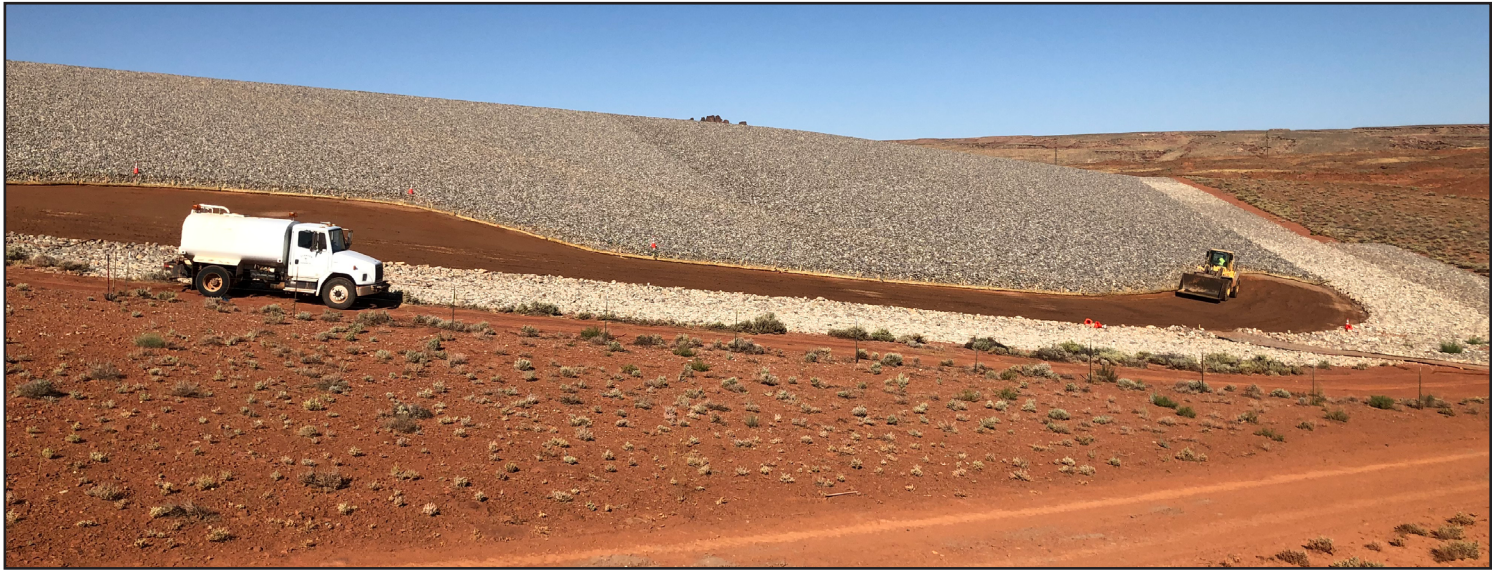
*Mexican Hat Interim Cover Protection Project.*
