APPENDIX M

Biological Assessment

Subject: Demolition and Cleanup of National Aeronautics and Space Administration-
Administered Portions of the Santa Susana Field Laboratory, Ventura County,
California

Figure 3-1
 Site Location Map
 Biological Assessment for Proposed Demolition and Cleanup Project
 NASA - Santa Susana Field Laboratory

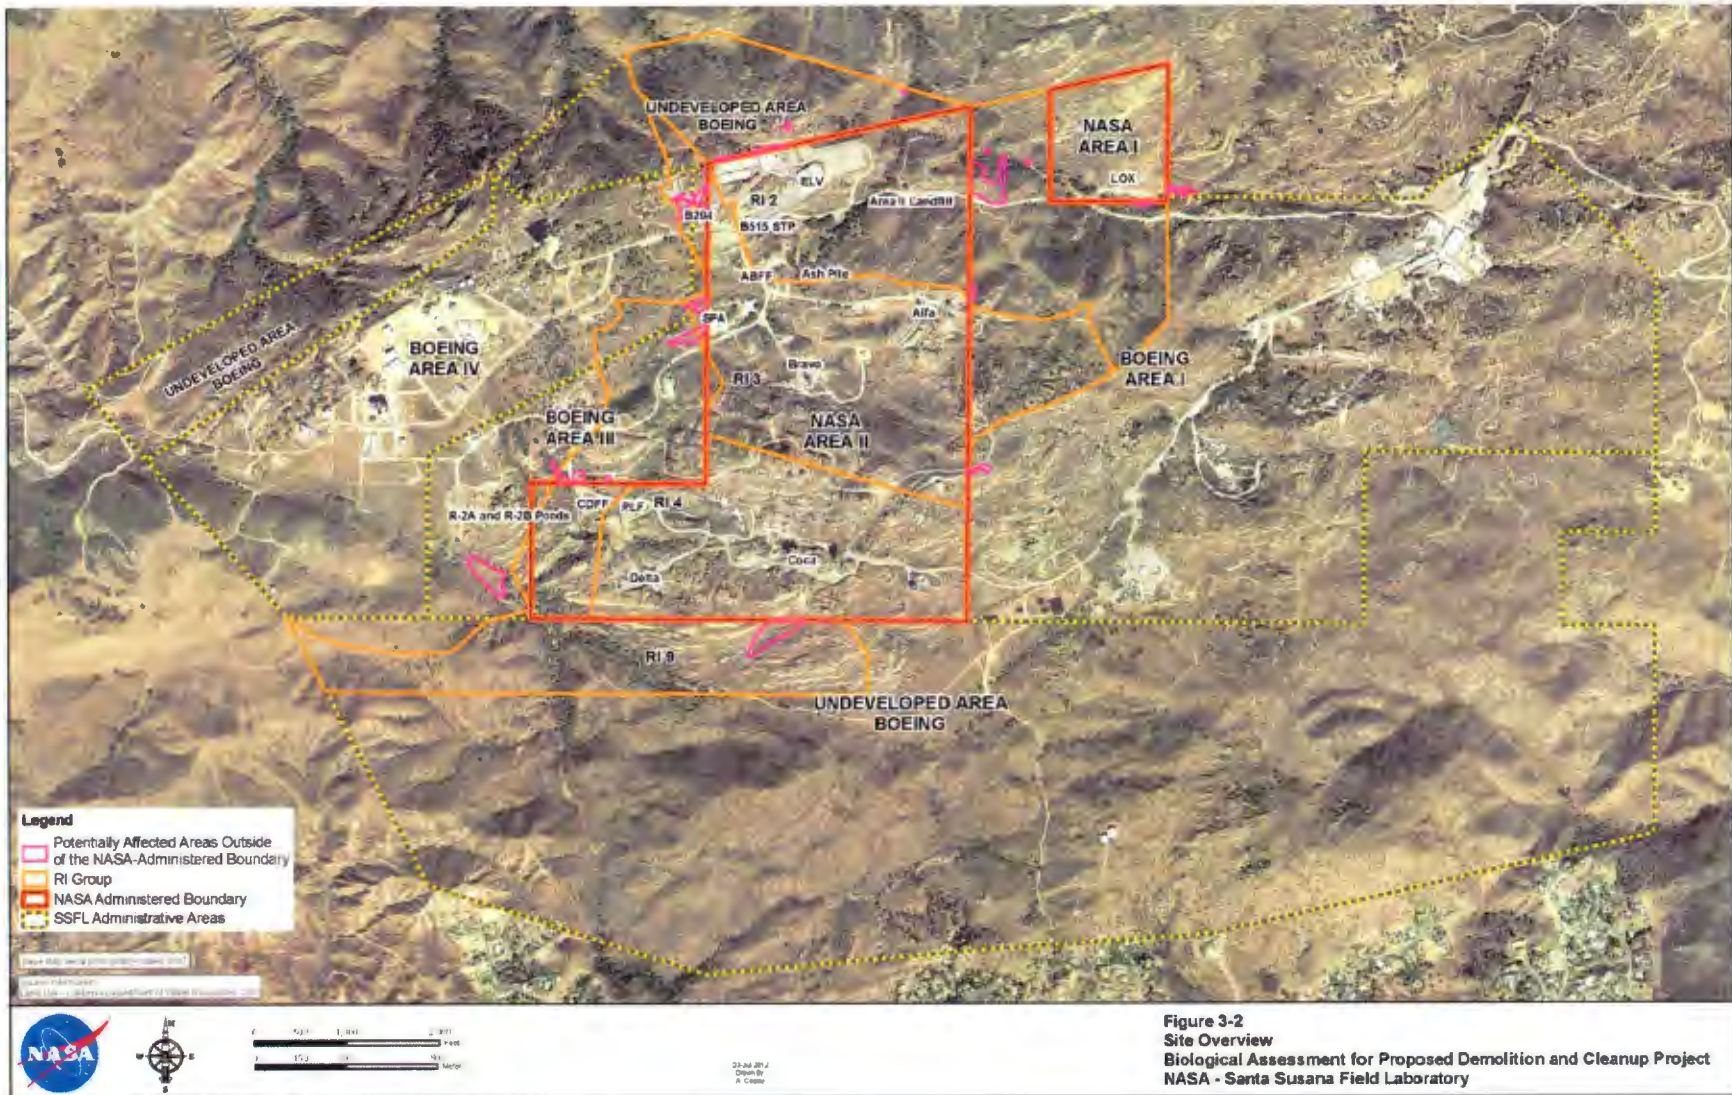
Figure 1. Site overview with NASA-administered lands outlined in Red (NASA 2013).

areas of SSFL to background concentrations. The cleanup of groundwater beneath SSFL and of surface water is not stipulated in the AOC. In December 2009 the Regional Water Quality Control Board issued an order to NASA and Boeing to improve the quality of storm water discharges by removing contaminated sediments associated with two outfalls. Storm water from the NASA-administered property exits SSFL through one of the two outfalls. Demolition and cleanup activities would occur on 451.2 acres, designated as Area I, the Liquid Oxygen Area II, as well as additional outlying areas that would be affected by NASA's proposed activities (Figure 1).

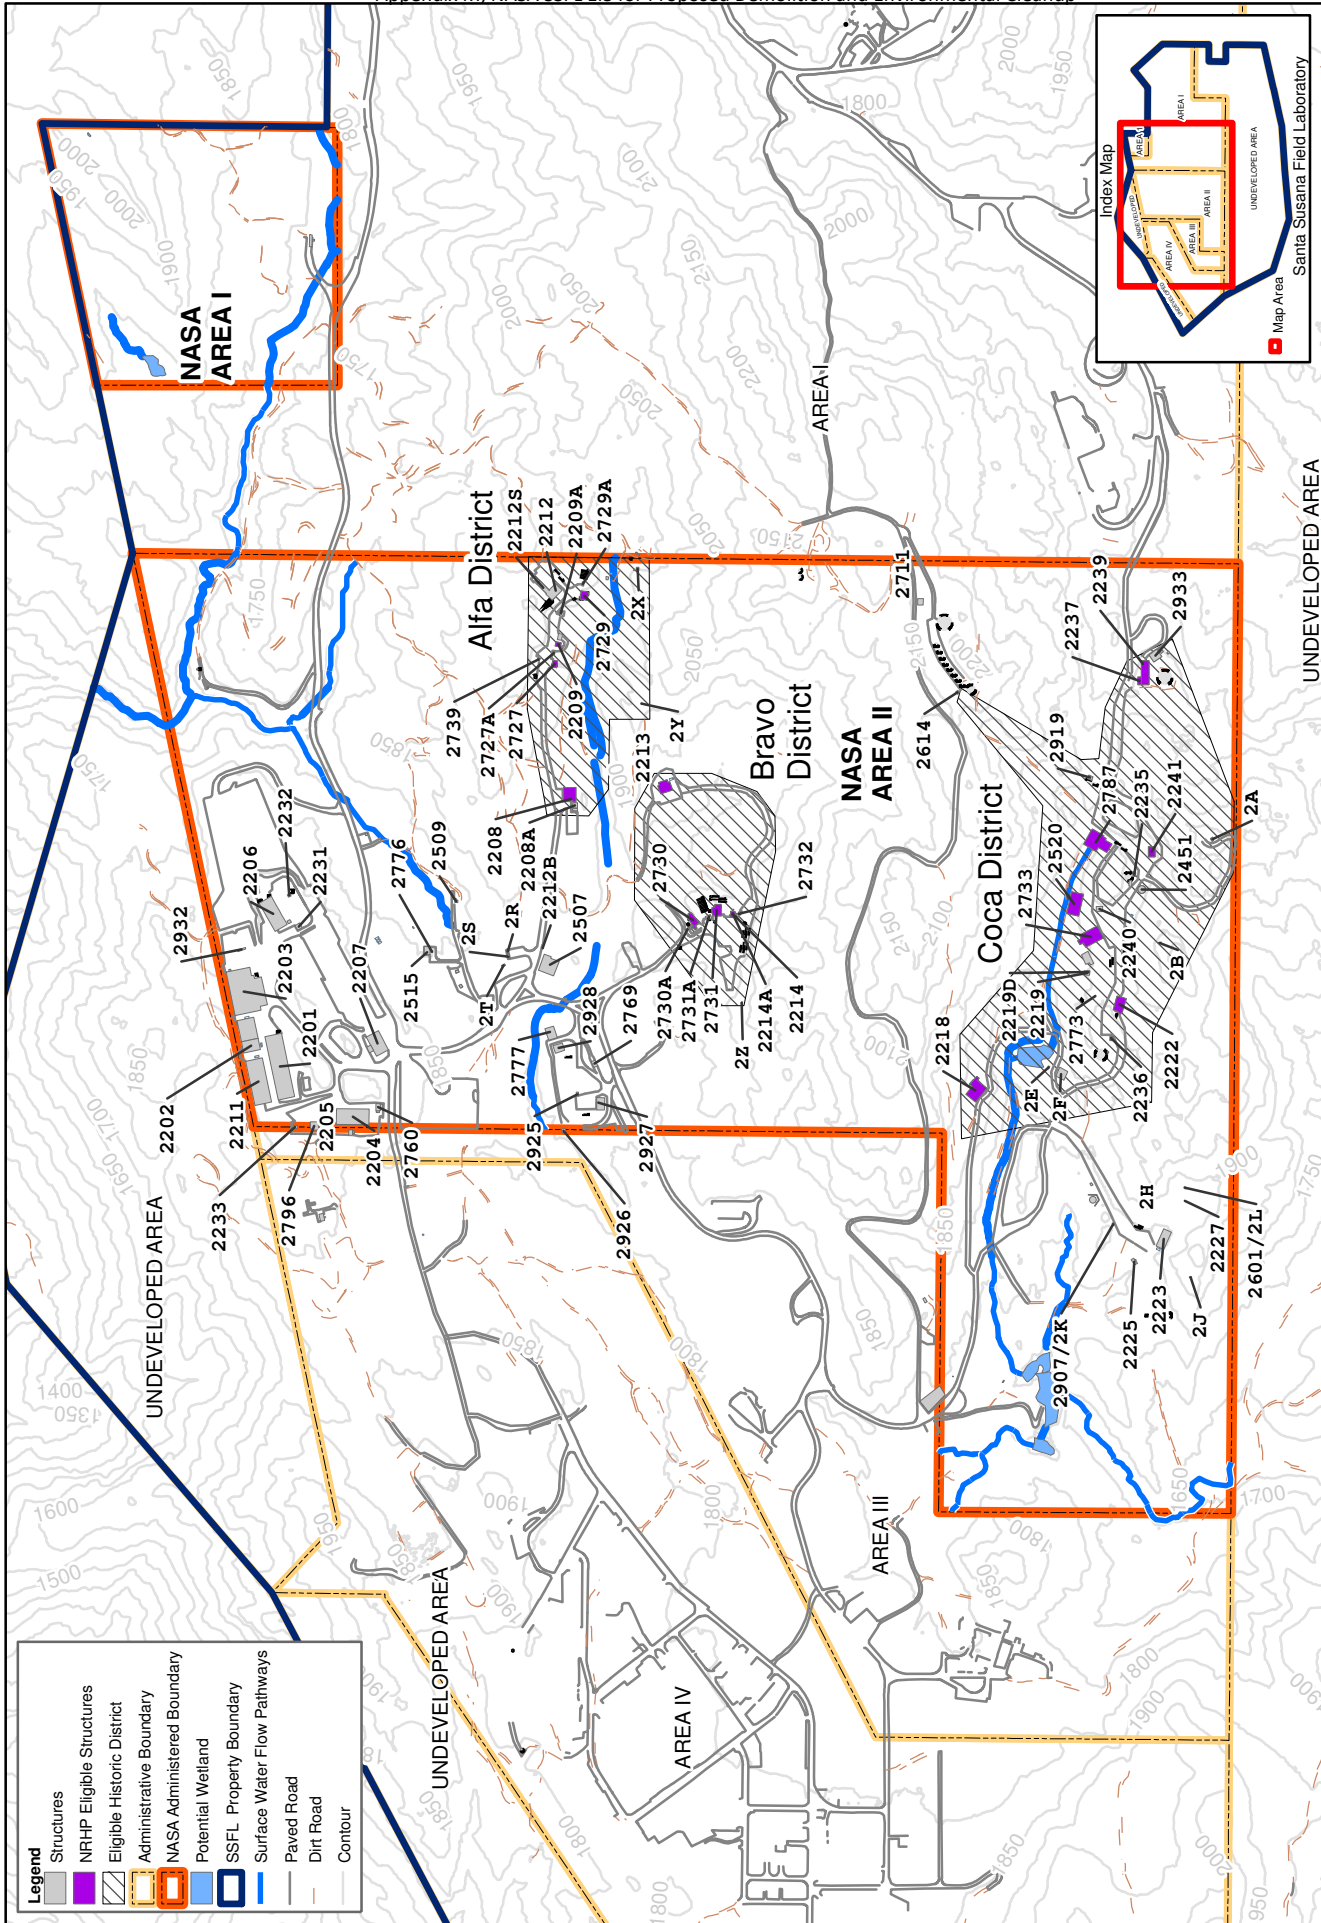
Figure 3-3
 NASA-Administered Structures Proposed for Demolition
 Biological Assessment for Proposed Demolition and Cleanup Project
 NASA - Santa Susana Field Laboratory

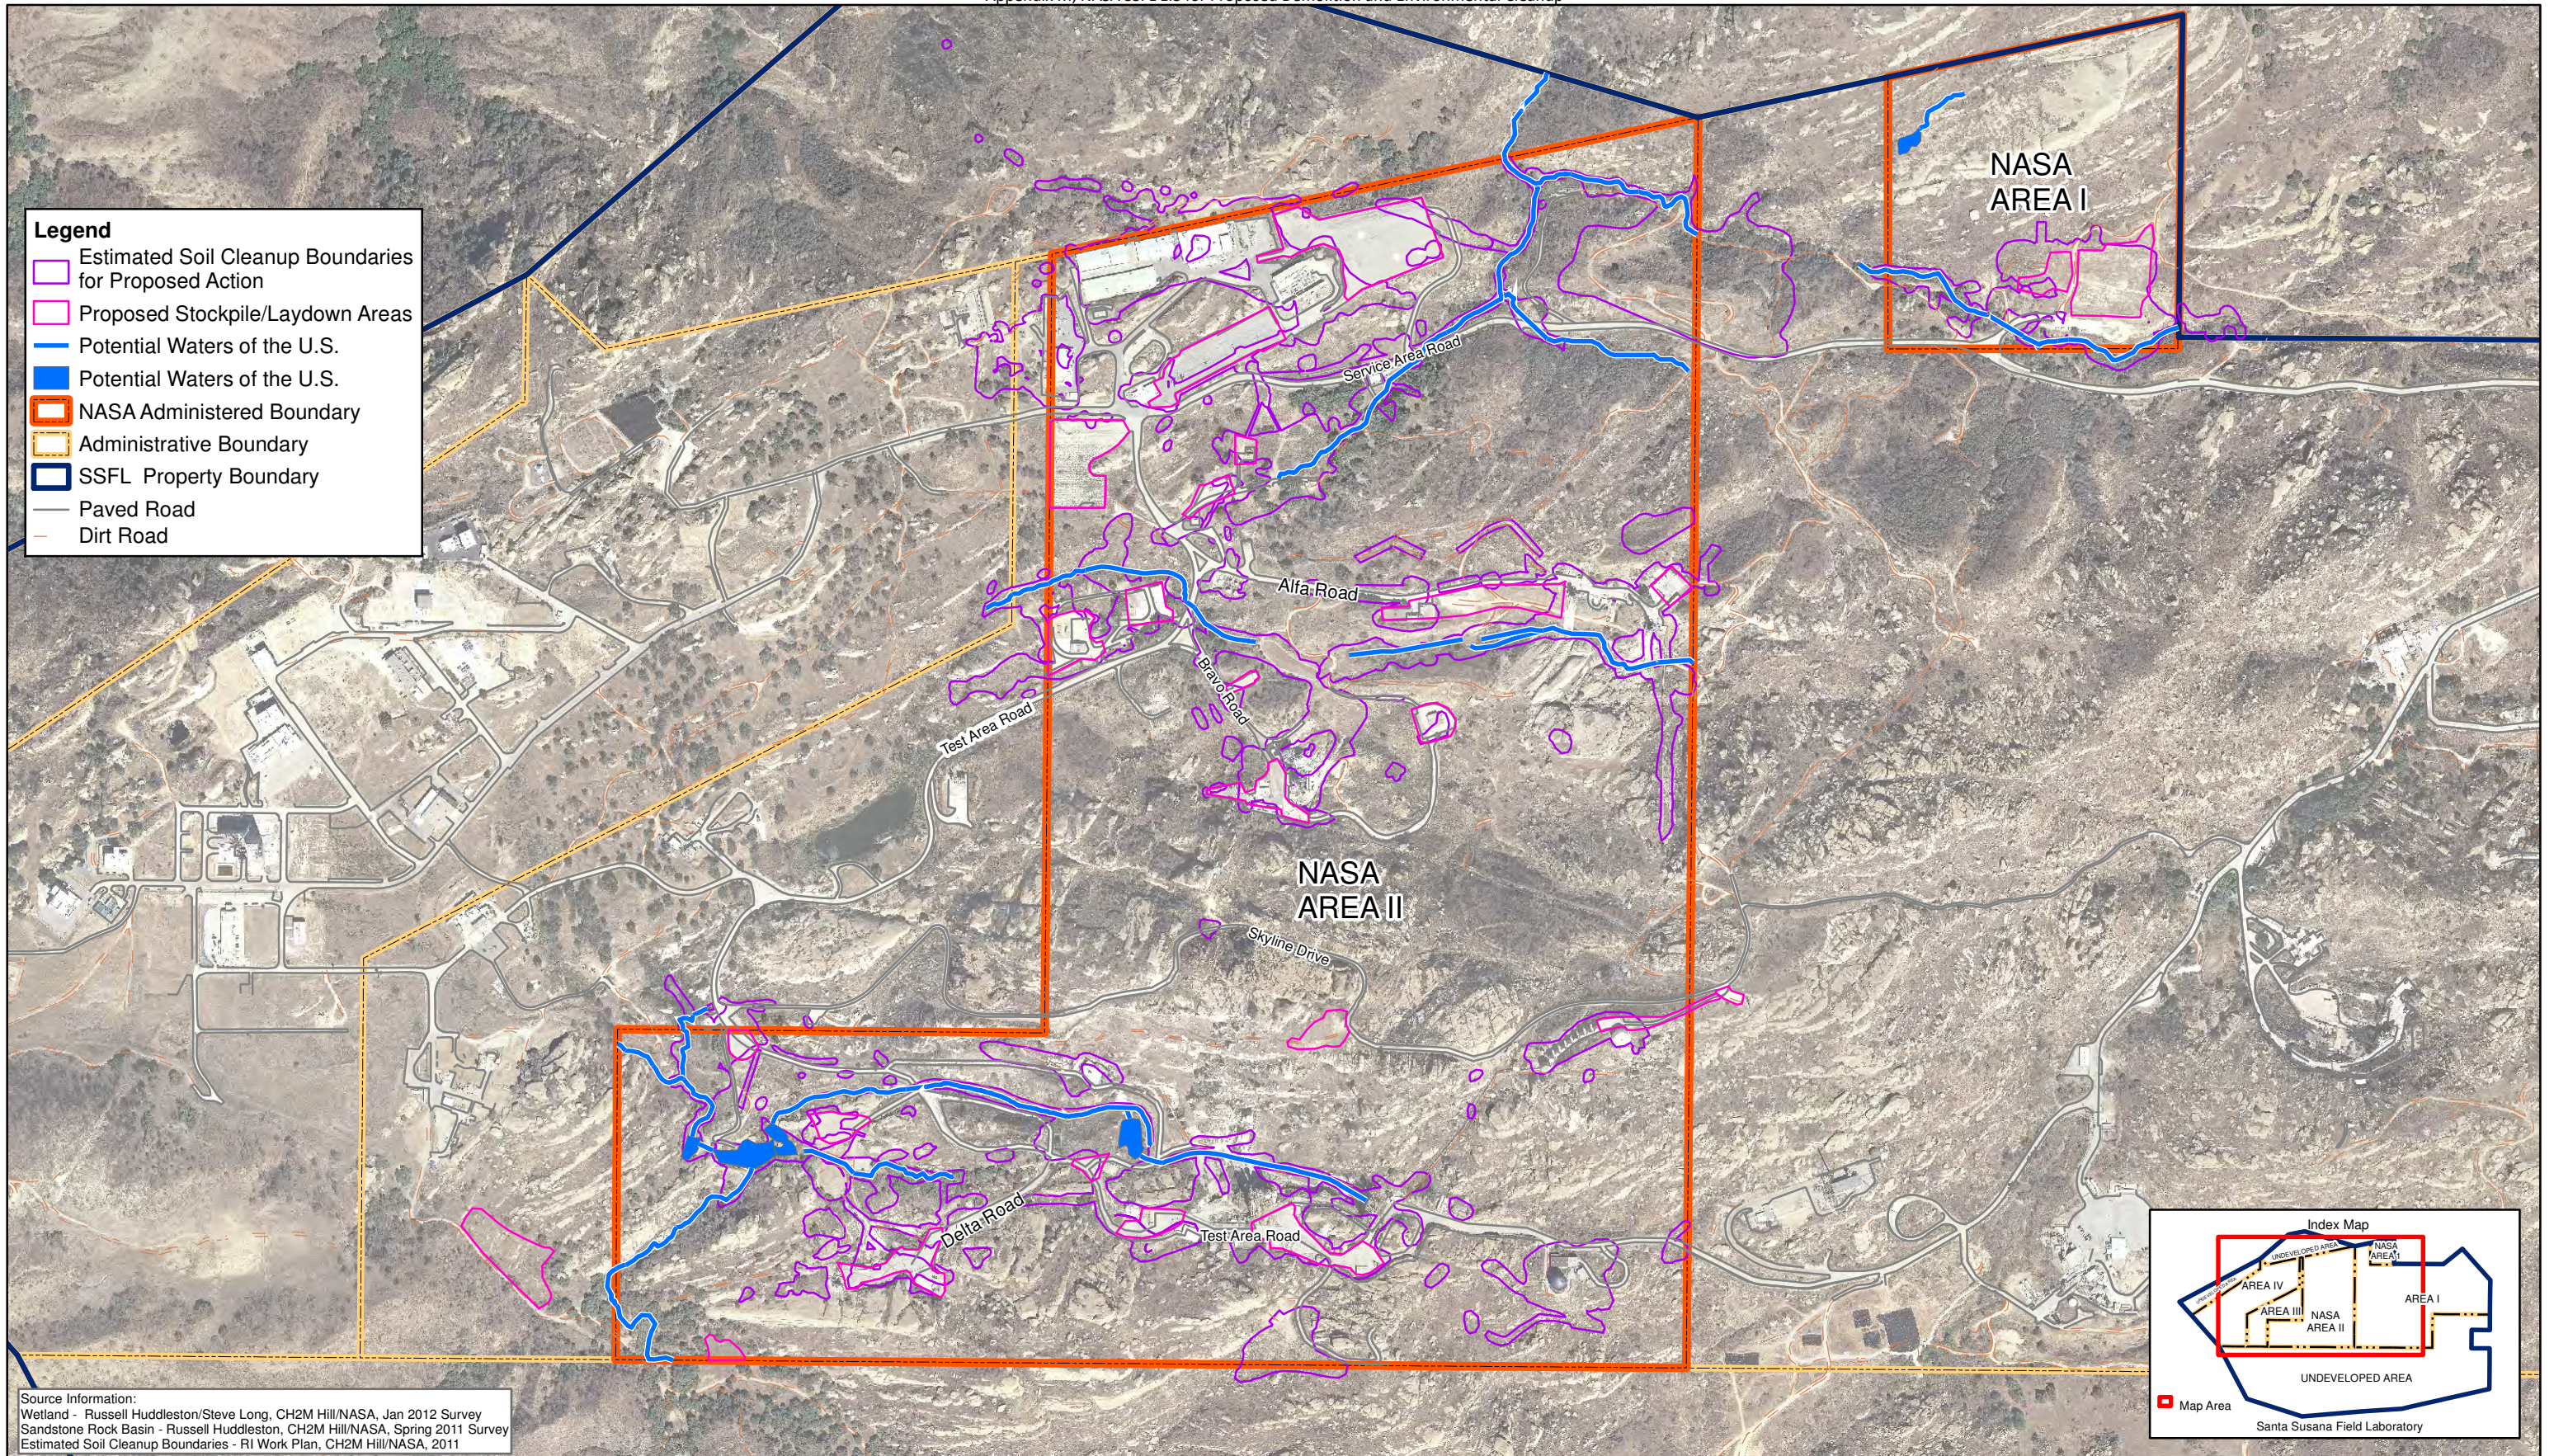
- ▭ Estimated Soil Cleanup Boundaries for Proposed Action
- ▭ Proposed Stockpile/Laydown Areas
- ▬ Potential Waters of the U.S.
- ▬ Potential Waters of the U.S.
- NASA Administered Boundary
- Administrative Boundary
- SSFL Property Boundary
- ▬ Paved Road
- ▬ Dirt Road

Figure 3-4 shows the general footprints of the proposed remediation areas under the Proposed Action. The soil depth that would require cleanup generally would be less than 1.5 m (5 ft), but could reach 6 m (20 ft) in some areas. Viable cleanup technologies were identified based on their effectiveness to clean up the specific contaminants within the Action Area under the environmental conditions present at SSFL. These technologies are identified in the RIs (NASA, 2008, 2009a, 2009b; MWH, 2007, 2009). The soil cleanup methods evaluated in this BA, therefore, represent a broad array of possible cleanup approaches for the Proposed Action. Each of these technologies is described in this subsection, including the contaminant analyses group each addresses, the approach and application of technology implementation, and the general timeline. Table 3-3 generally compares the soil cleanup technologies. NASA might apply one or a combination of these technologies.

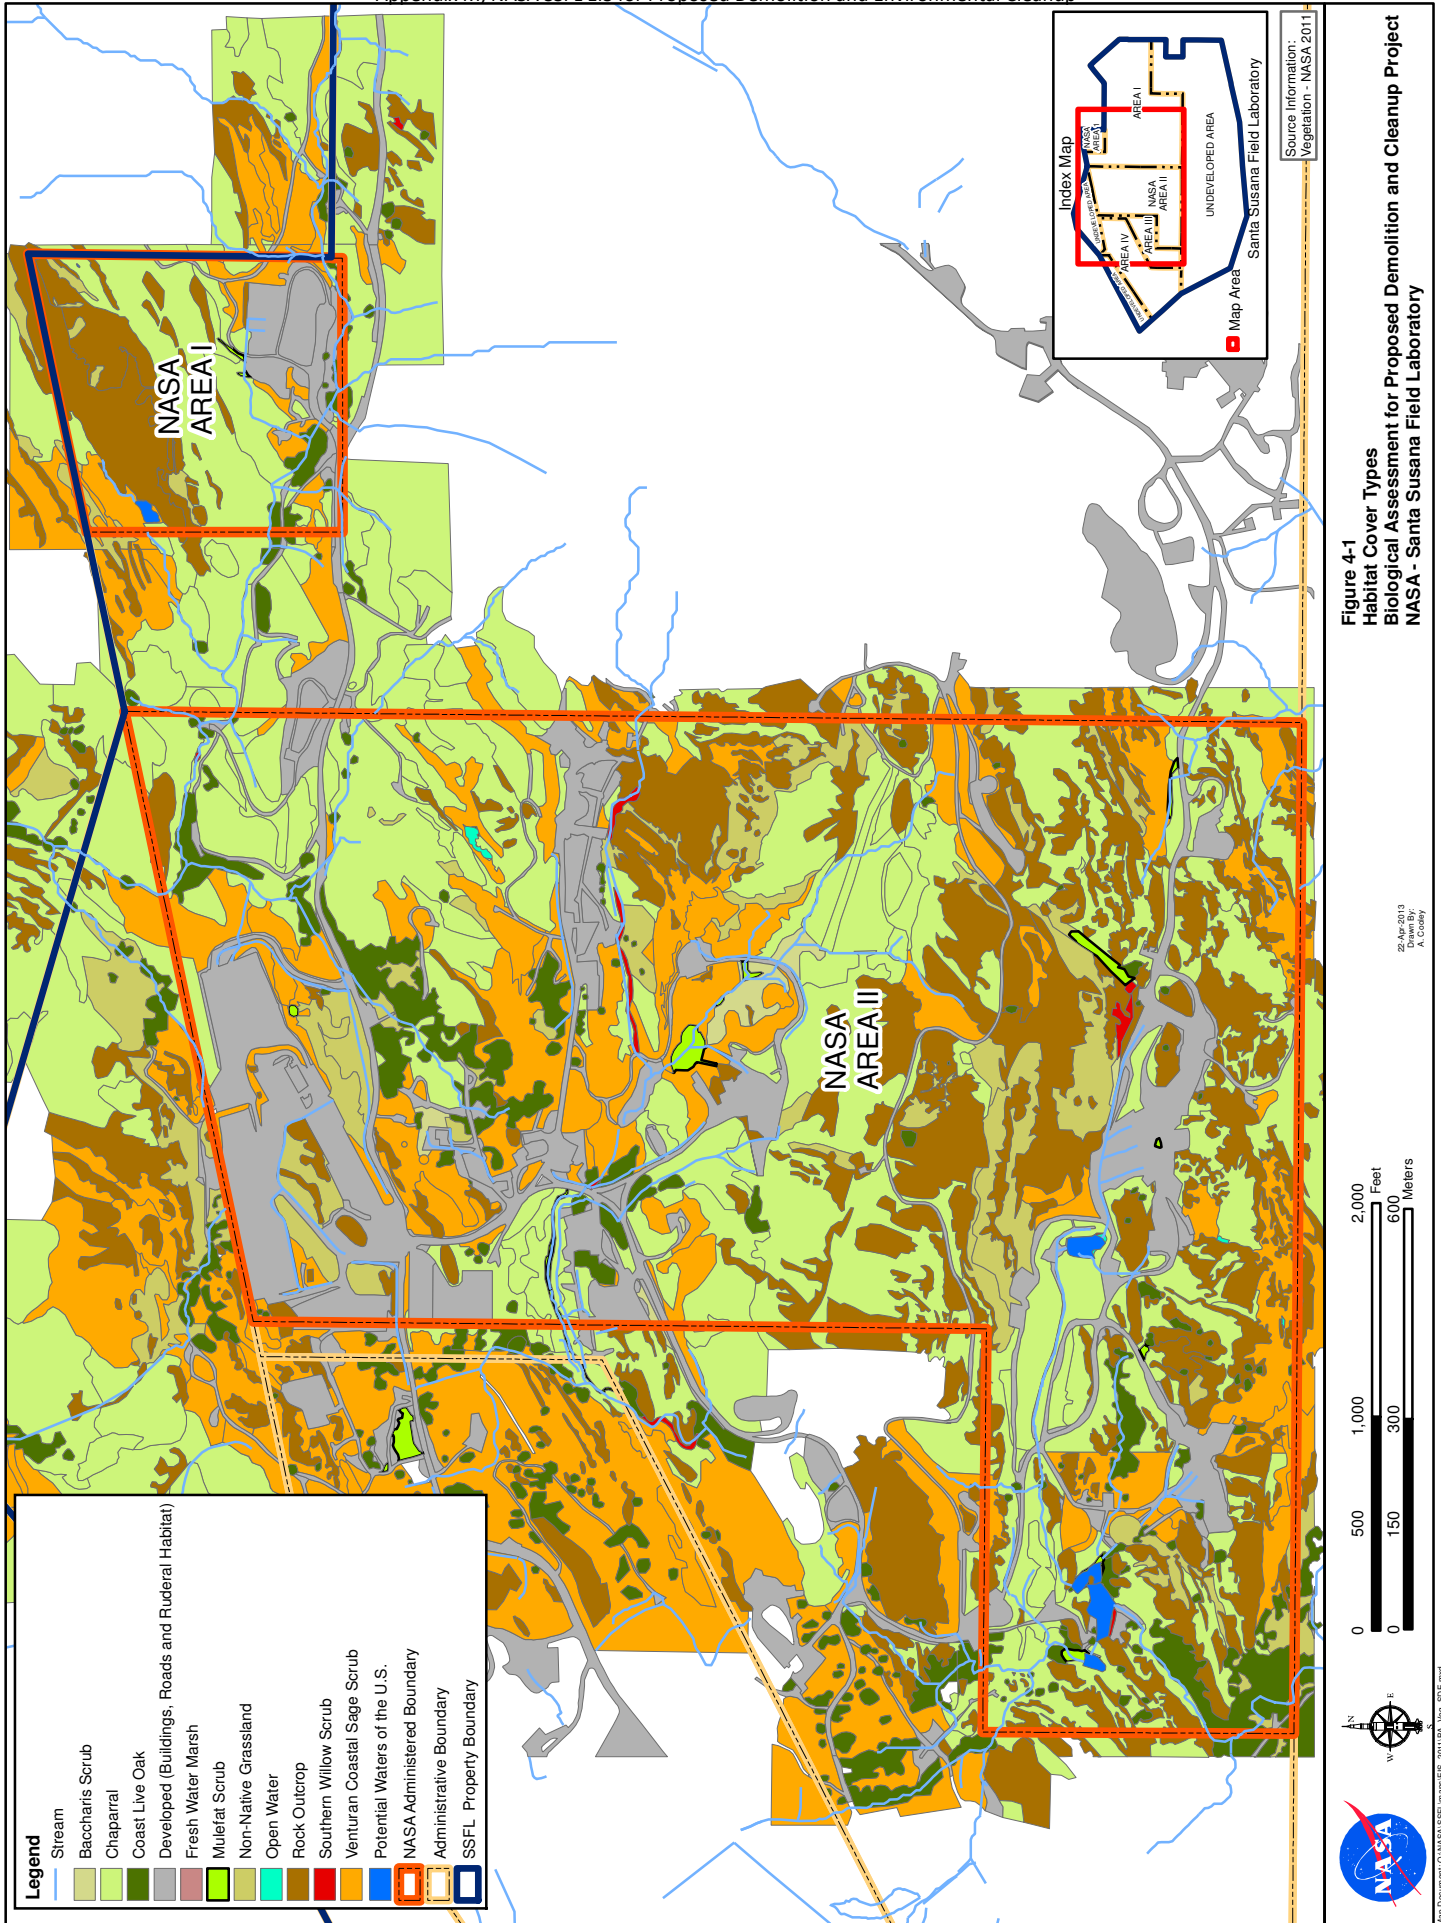
Figure 4-1
Habitat Cover Types
Biological Assessment for Proposed Demolition and Cleanup Project
NASA - Santa Susana Field Laboratory

Coast live oak woodland is distributed widely across the site but only makes up 5.3 ha (13.2 acres) (approximately 3 percent) of the NASA-administered property. This habitat is characterized by mature coast live oak (*Quercus agrifolia*) trees. The understory generally consists of annual grasses such as ripgut brome and slender oat, with occasional native grasses including blue wildrye (*Elymus glaucus*) and California brome (*Bromus carinatus*). The understory shrub layer is poorly developed and, where present, generally consists of scattered Pacific poison oak (*Toxicodendron diversilobum*).

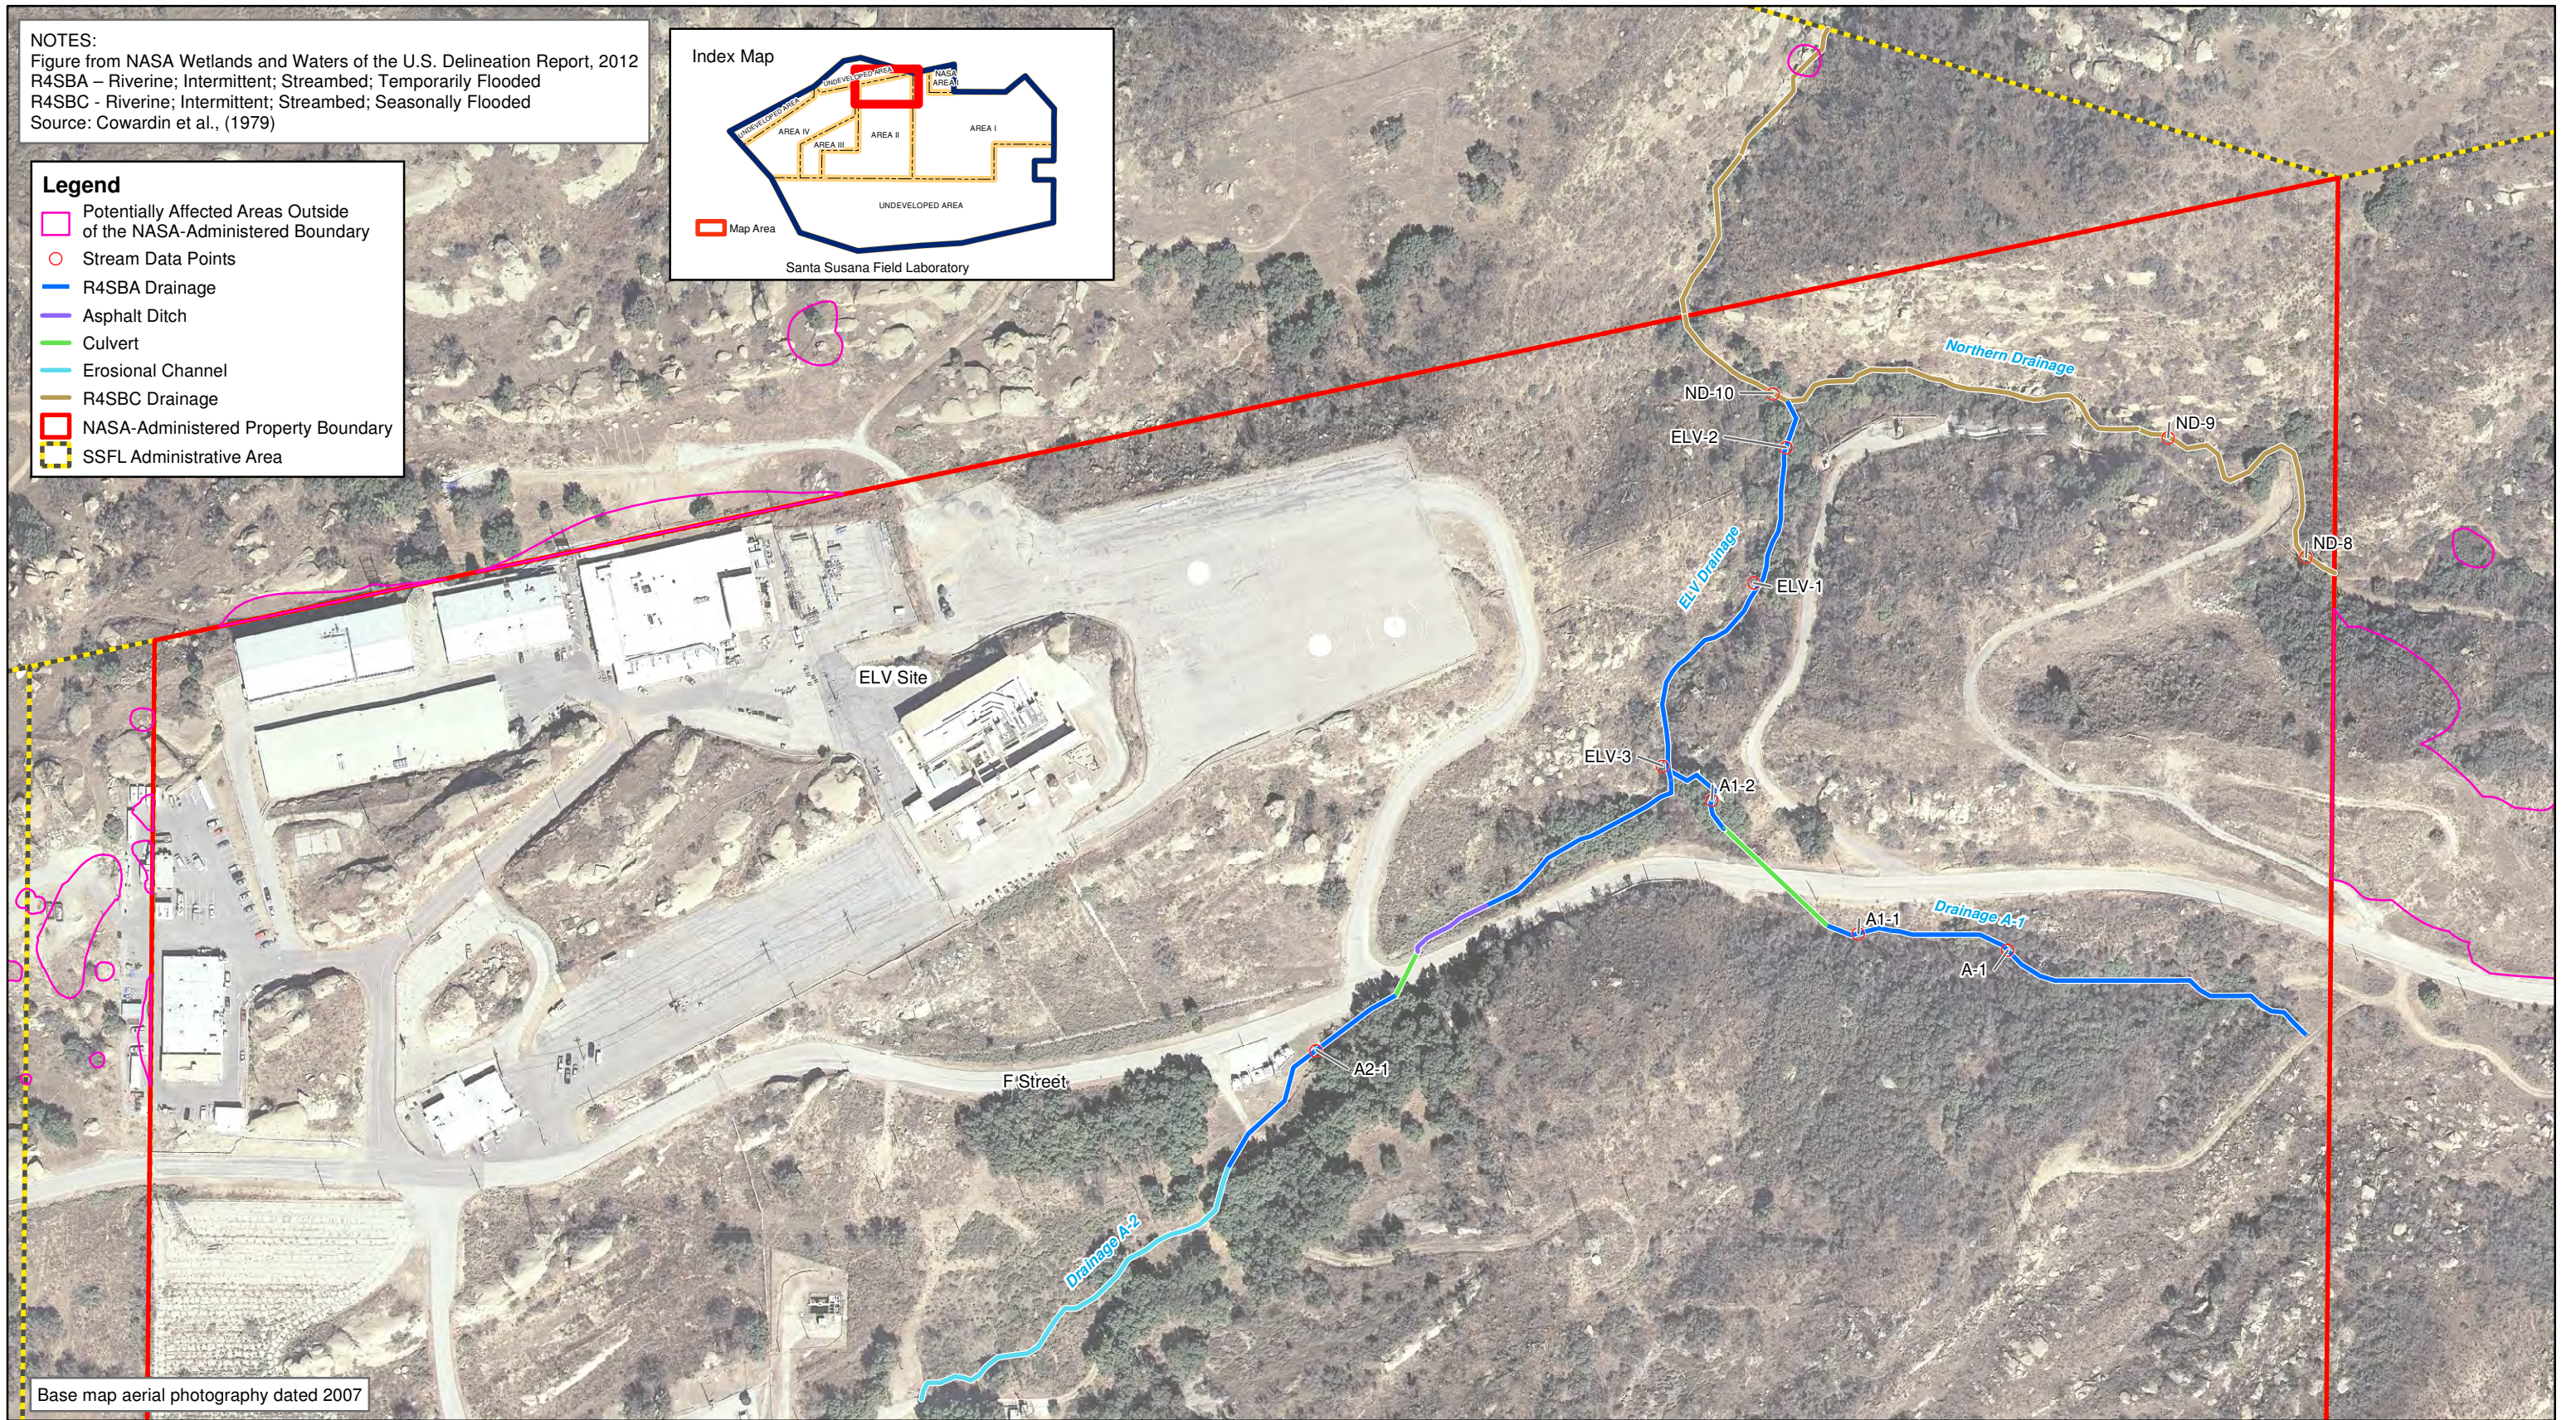
Figure 4-3
Area II - North
NASA Wetlands and Waters of the U.S. Delineation
Biological Assessment for Proposed Demolition and Cleanup Project
NASA - Santa Susana Field Laboratory

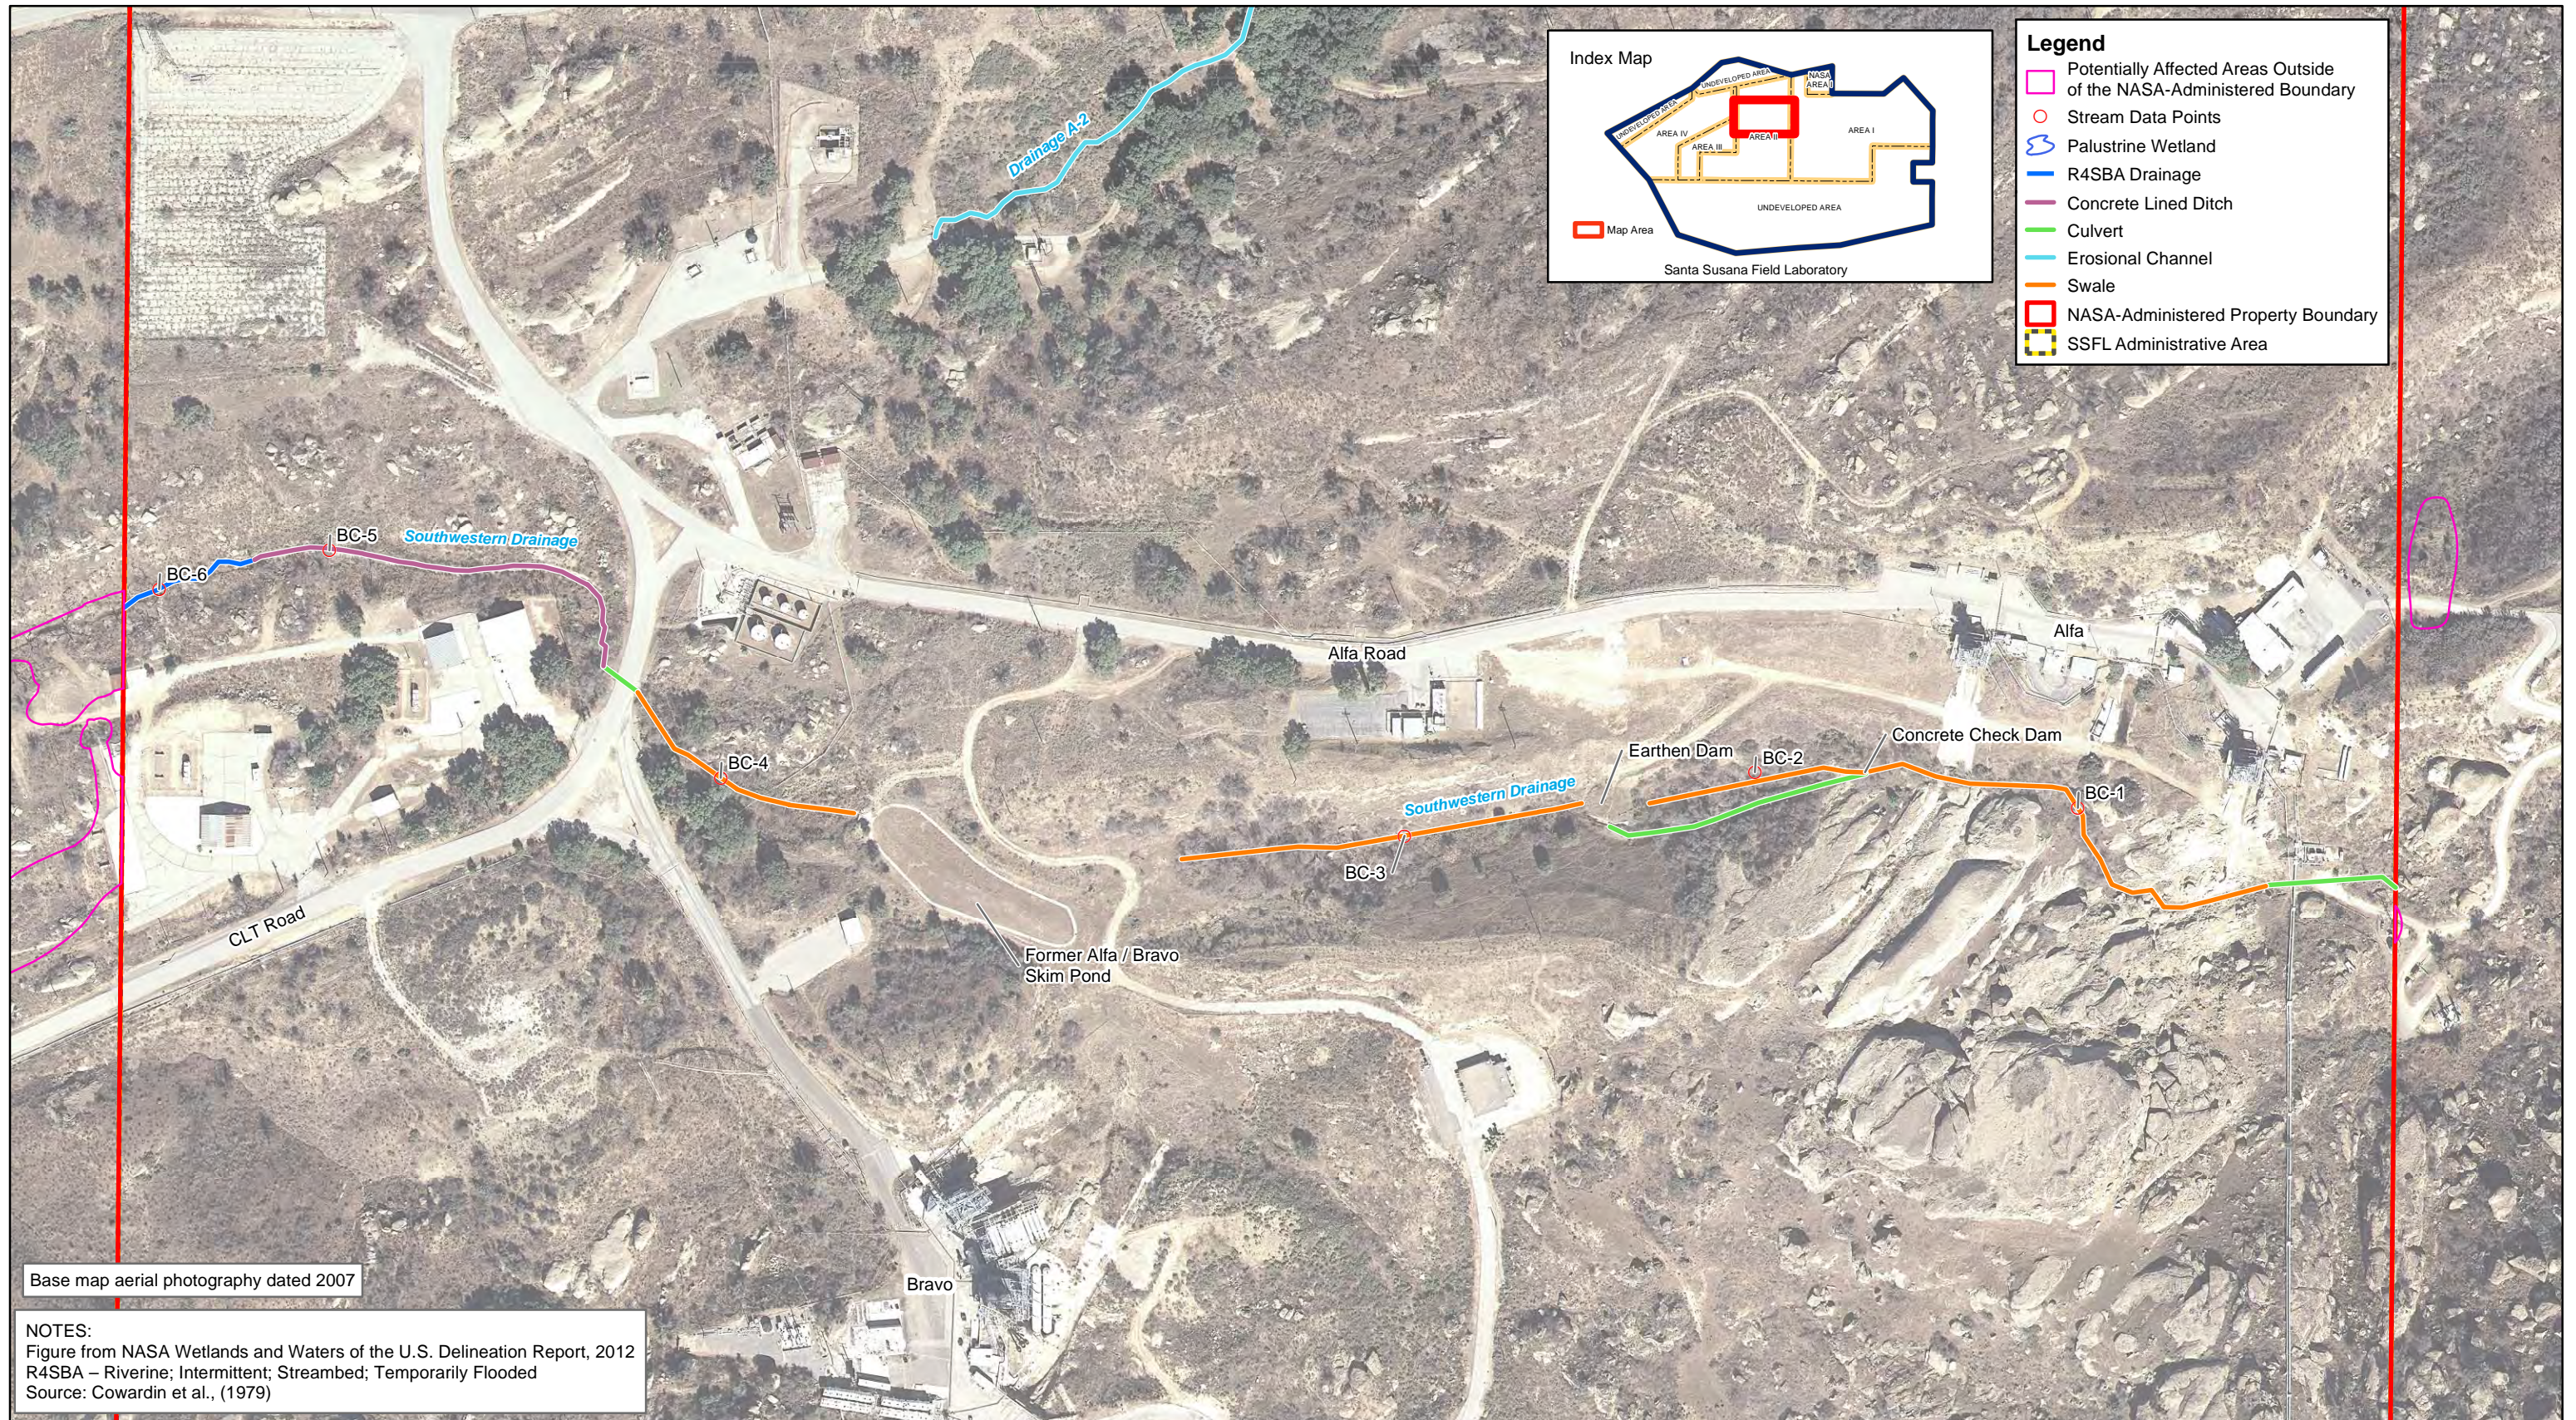
NOTES:
 Figure from NASA Wetlands and Waters of the U.S. Delineation Report, 2012
 R4SBA – Riverine; Intermittent; Streambed; Temporarily Flooded
 Source: Cowardin et al., (1979)

Figure 4-4
Area II - Central North
NASA Wetlands and Waters of the U.S. Delineation
Biological Assessment for Proposed Demolition and Cleanup Project
NASA - Santa Susana Field Laboratory

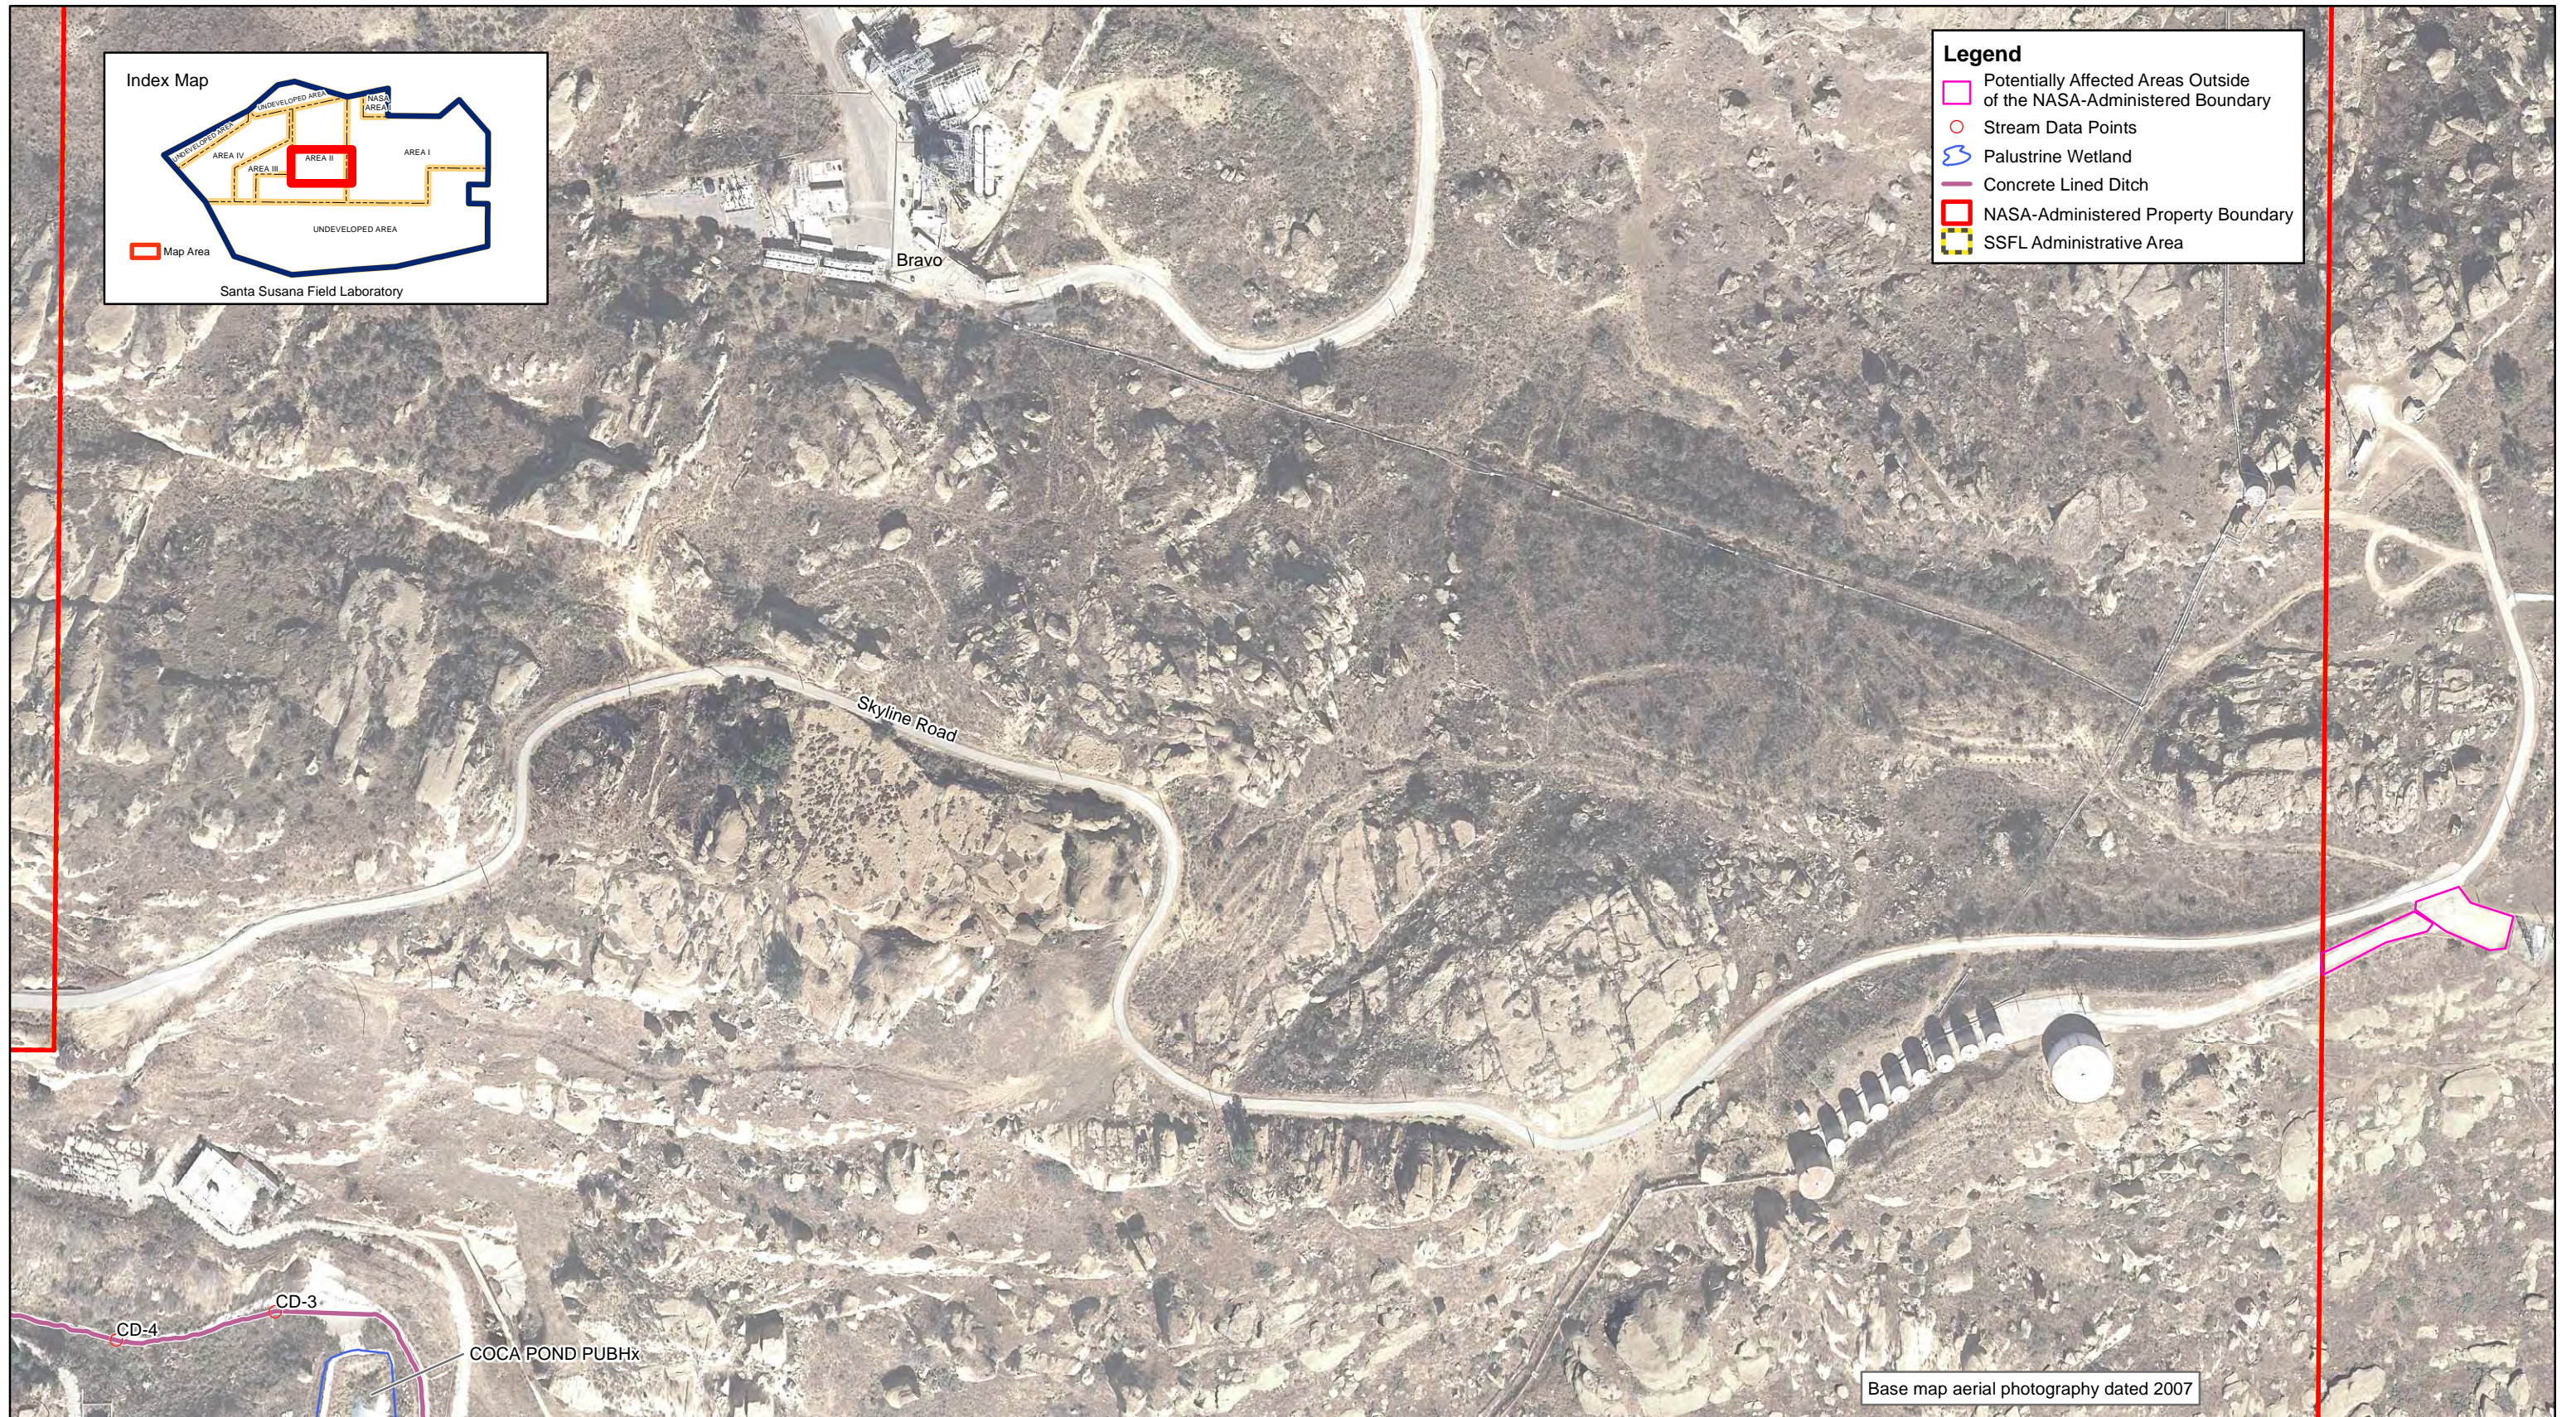
Figure 4-5
Area II - Central South
NASA Wetlands and Waters of the U.S. Delineation
Biological Assessment for Proposed Demolition and Cleanup Project
NASA - Santa Susana Field Laboratory
