APPENDIX M

Biological Assessment

Subject: Demolition and Cleanup of National Aeronautics and Space Administration-
Administered Portions of the Santa Susana Field Laboratory, Ventura County,
California

Figure 3-1
 Site Location Map
 Biological Assessment for Proposed Demolition and Cleanup Project
 NASA - Santa Susana Field Laboratory

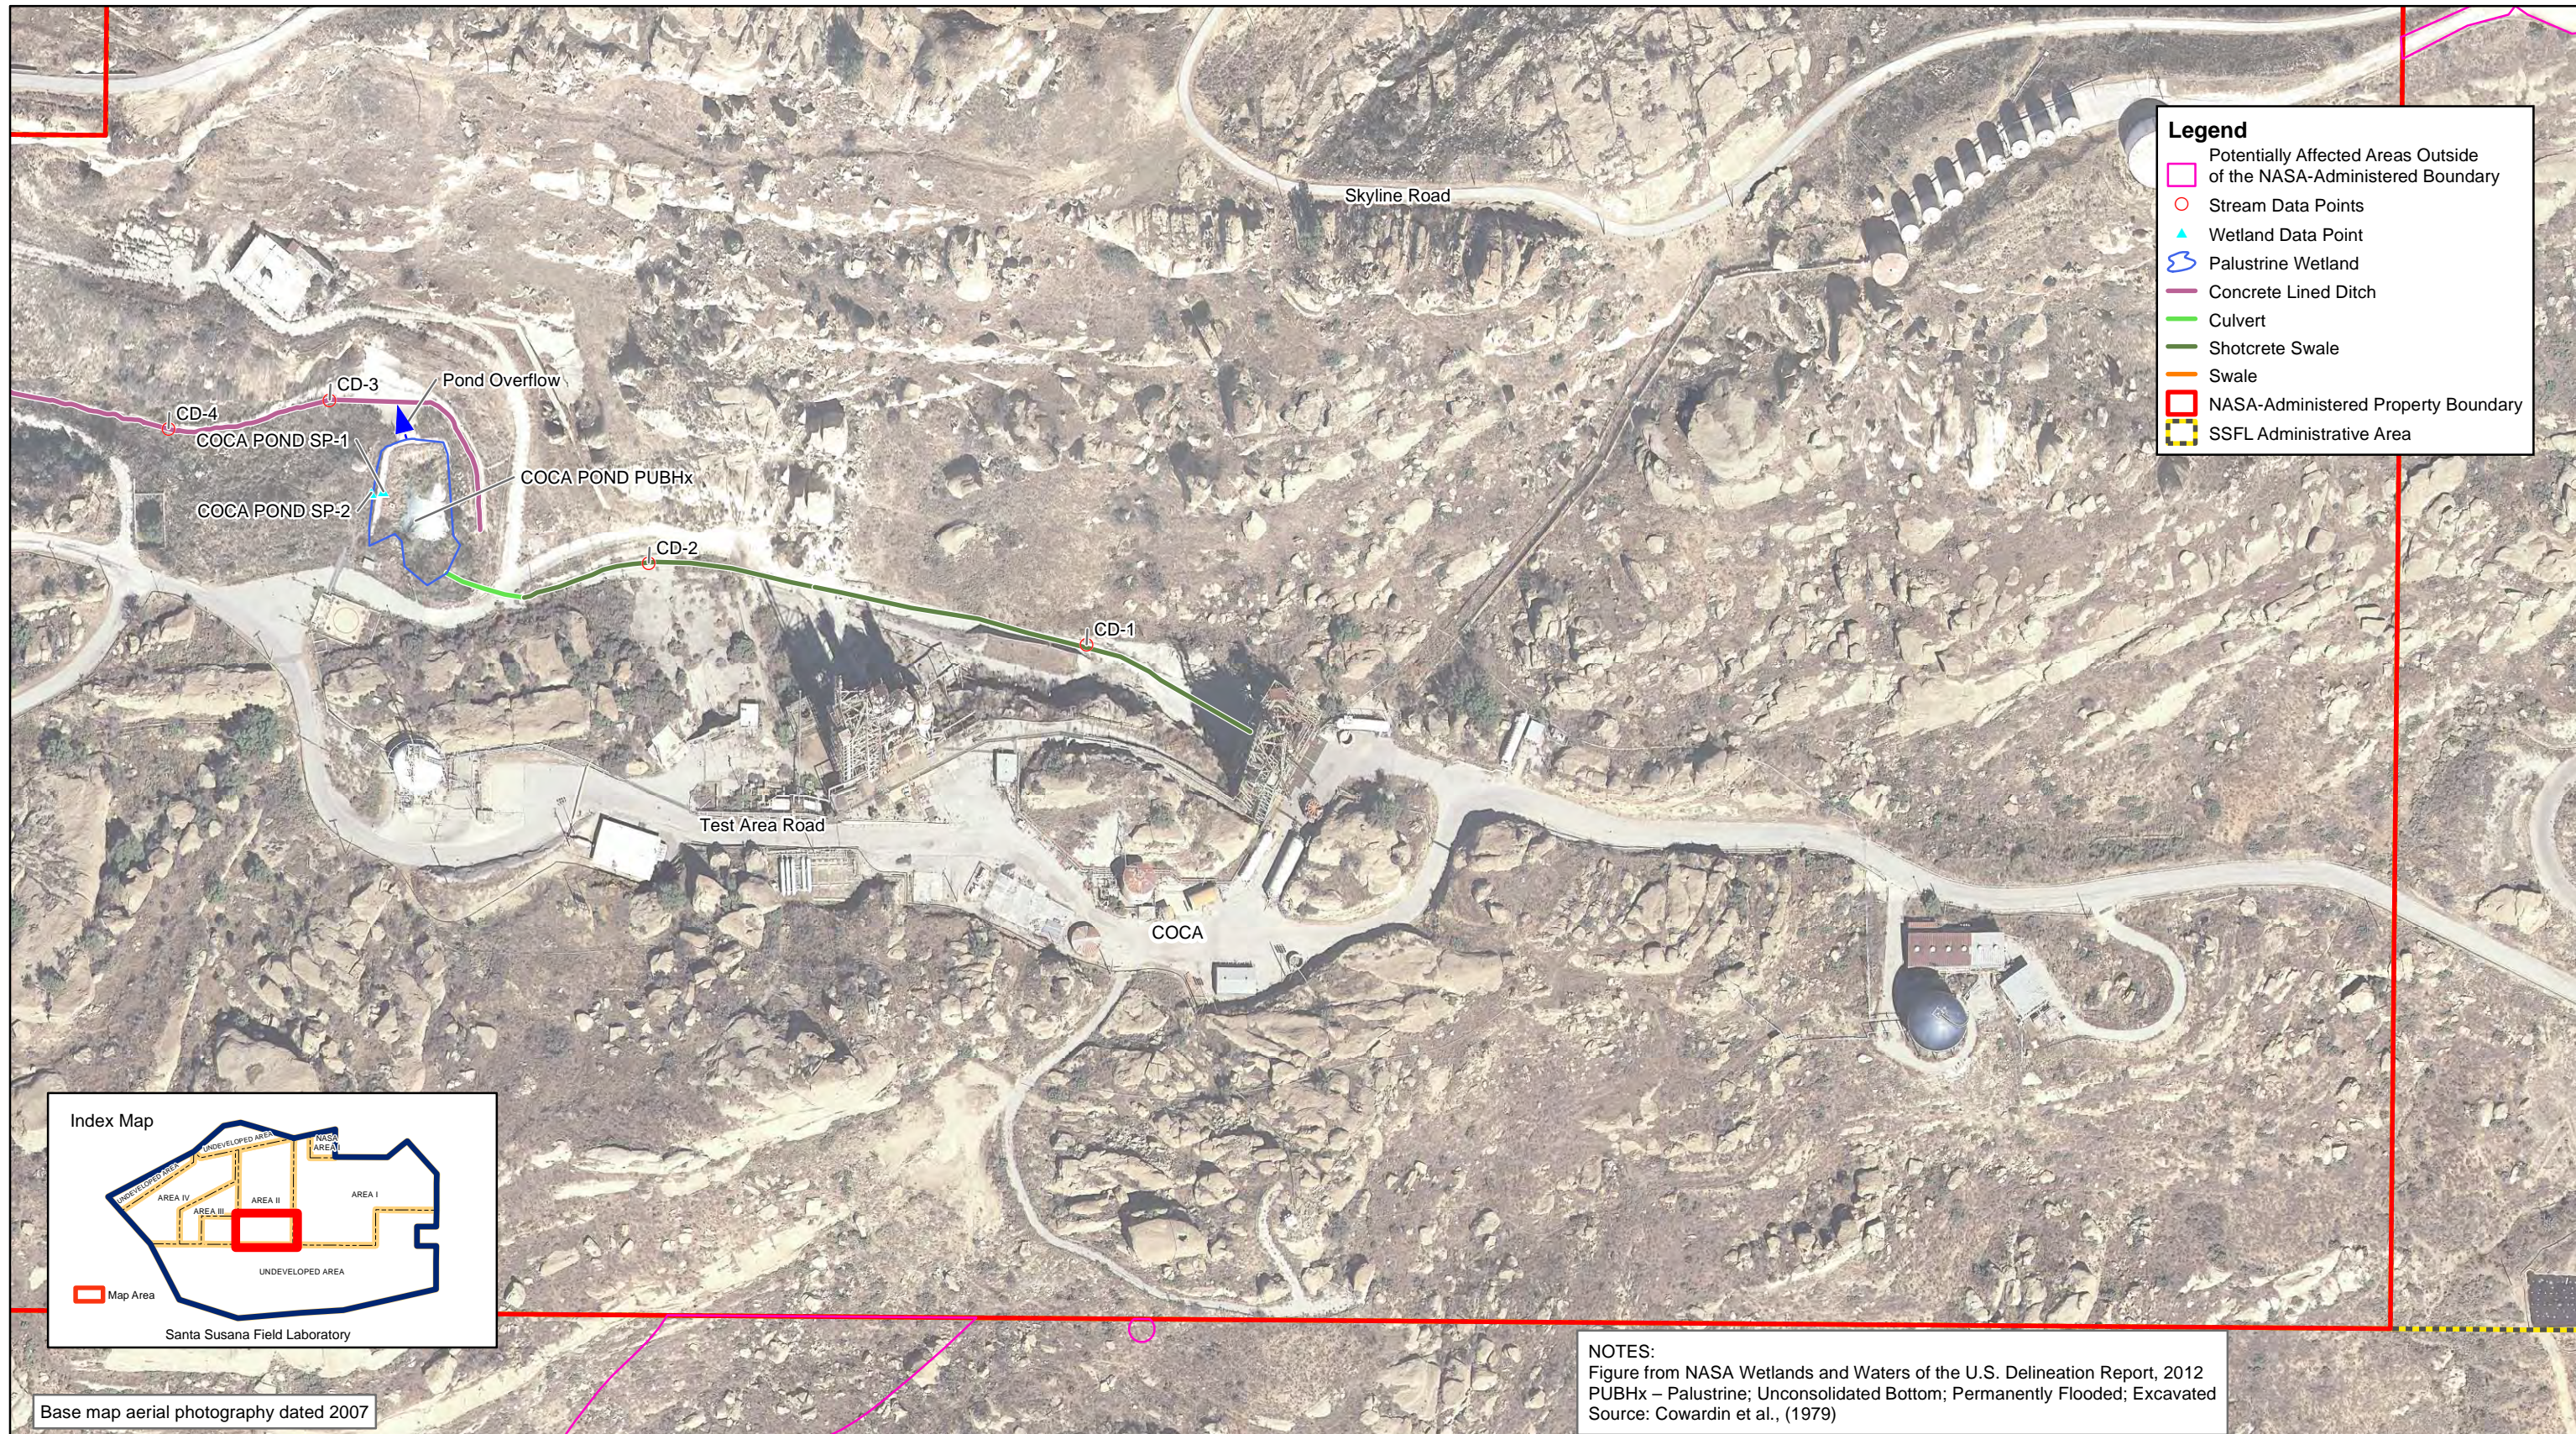
Figure 4-6
Area II - Southeast
NASA Wetlands and Waters of the U.S. Delineation
Biological Assessment for Proposed Demolition and Cleanup Project
NASA - Santa Susana Field Laboratory

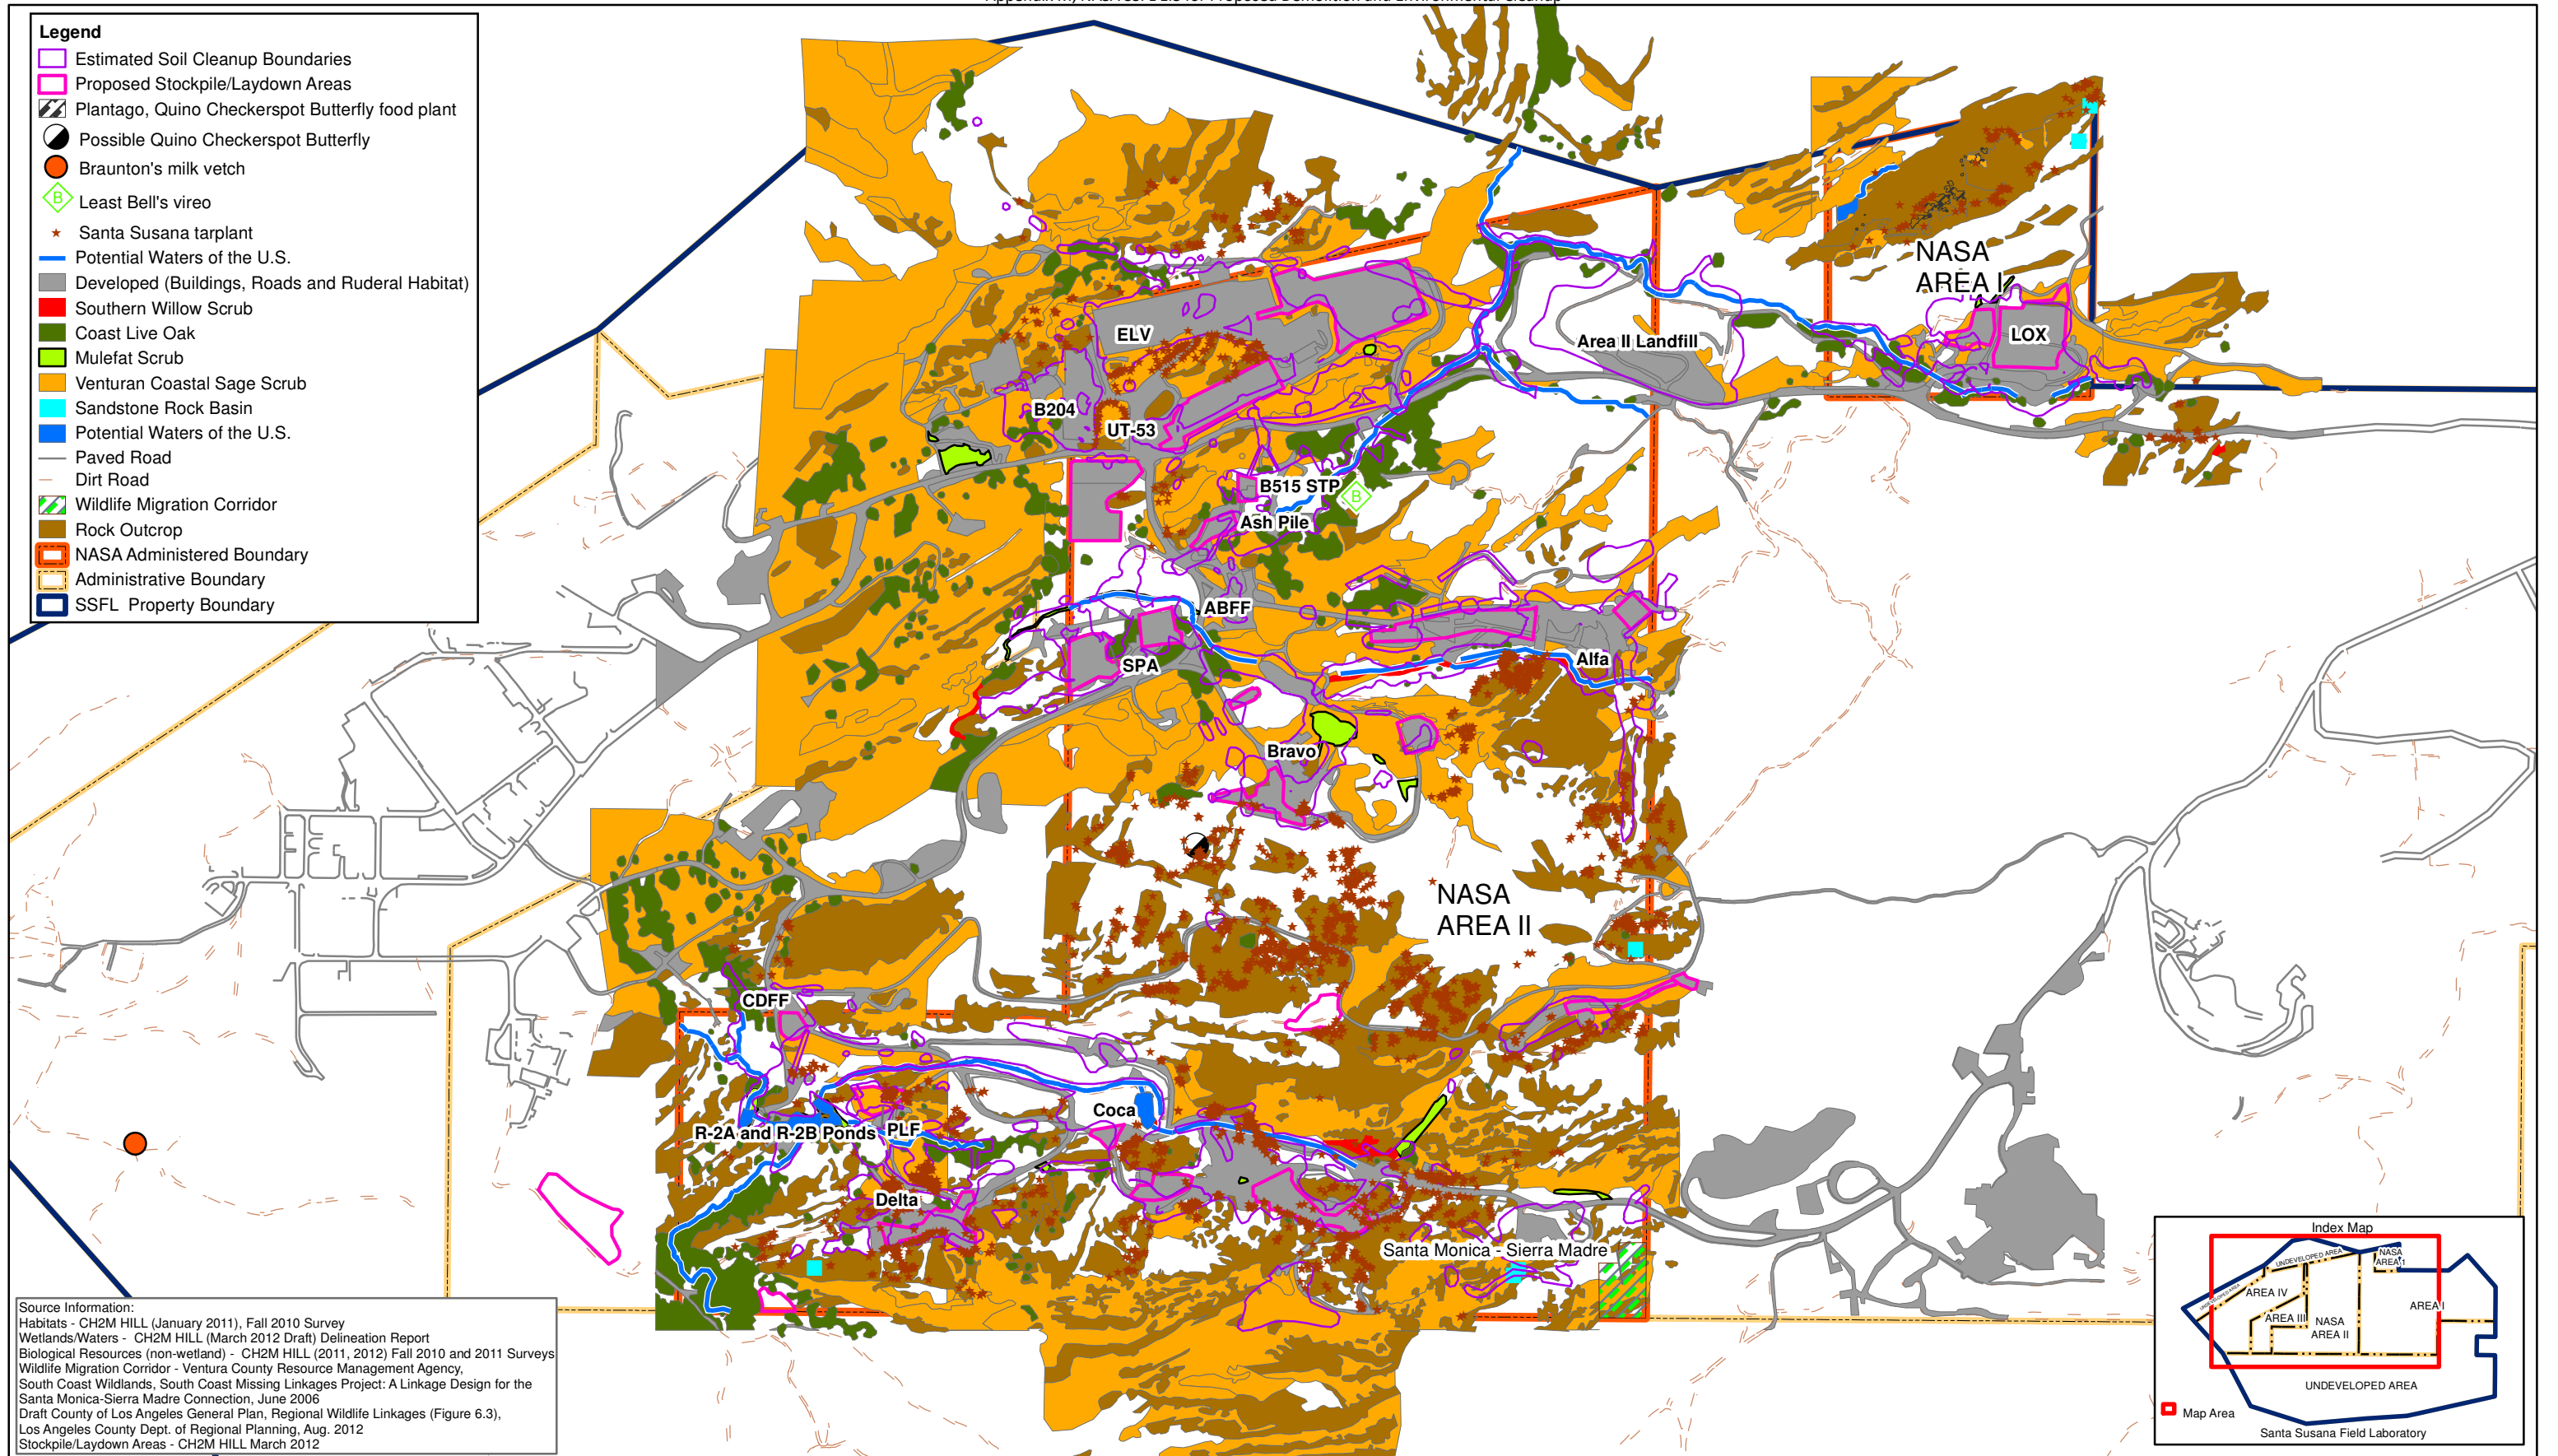
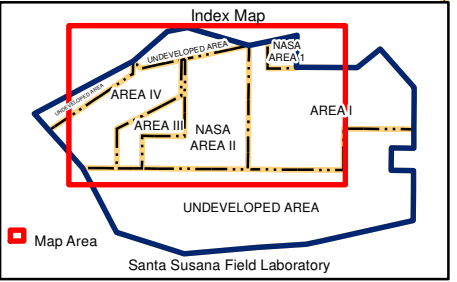
- Legend**
- Estimated Soil Cleanup Boundaries
 - Proposed Stockpile/Laydown Areas
 - Plantago, Quino Checkerspot Butterfly food plant
 - Possible Quino Checkerspot Butterfly
 - Braunton's milk vetch
 - Least Bell's vireo
 - Santa Susana tarplant
 - Potential Waters of the U.S.
 - Developed (Buildings, Roads and Ruderal Habitat)
 - Southern Willow Scrub
 - Coast Live Oak
 - Mulefat Scrub
 - Venturan Coastal Sage Scrub
 - Sandstone Rock Basin
 - Potential Waters of the U.S.
 - Paved Road
 - Dirt Road
 - Wildlife Migration Corridor
 - Rock Outcrop
 - NASA Administered Boundary
 - Administrative Boundary
 - SSFL Property Boundary

Figure 7-1
Impacts to Sensitive Resources due to Cleanup Activities
Biological Assessment for Proposed Demolition and Cleanup Project
NASA - Santa Susana Field Laboratory
