**SEPARATIONS PROCESS RESEARCH UNIT (SPRU)  
DISPOSITION PROJECT (DP)**

**SPRU PM-20-001**

**DEMOLITION COMPLETION REPORT  
FOR SPRU FACILITY**

**AECOM Energy & Construction, Inc.**

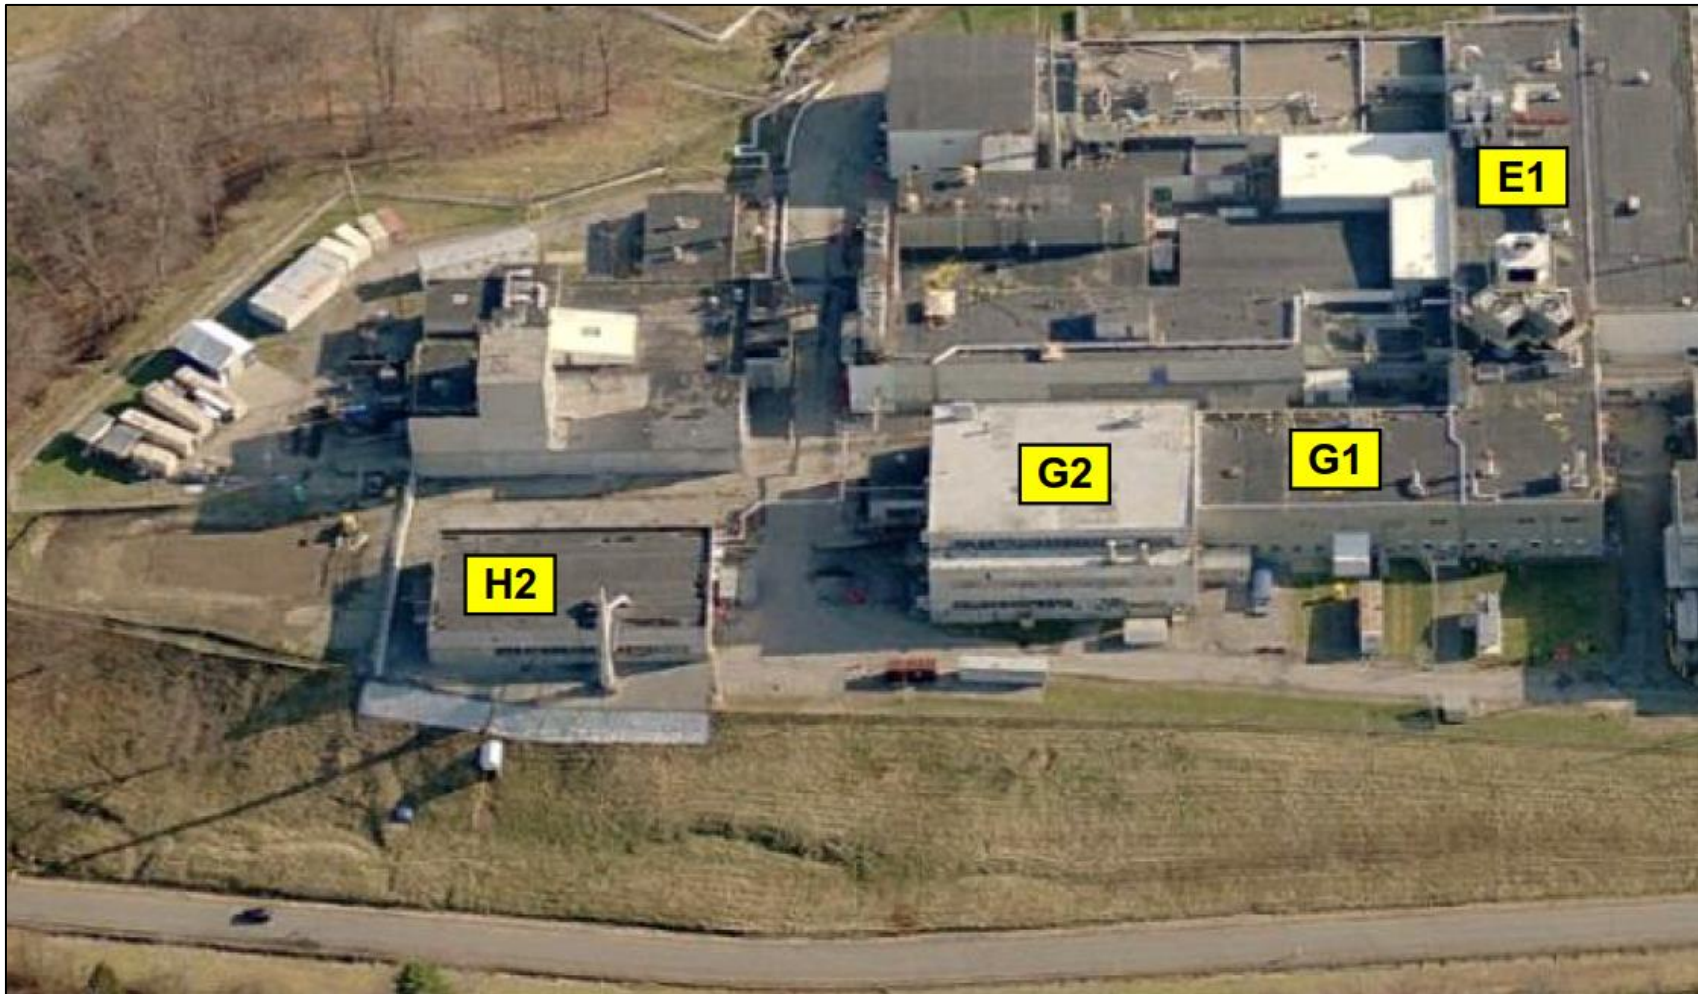
Figure 1. SPRU Upper Level Facilities (2009)

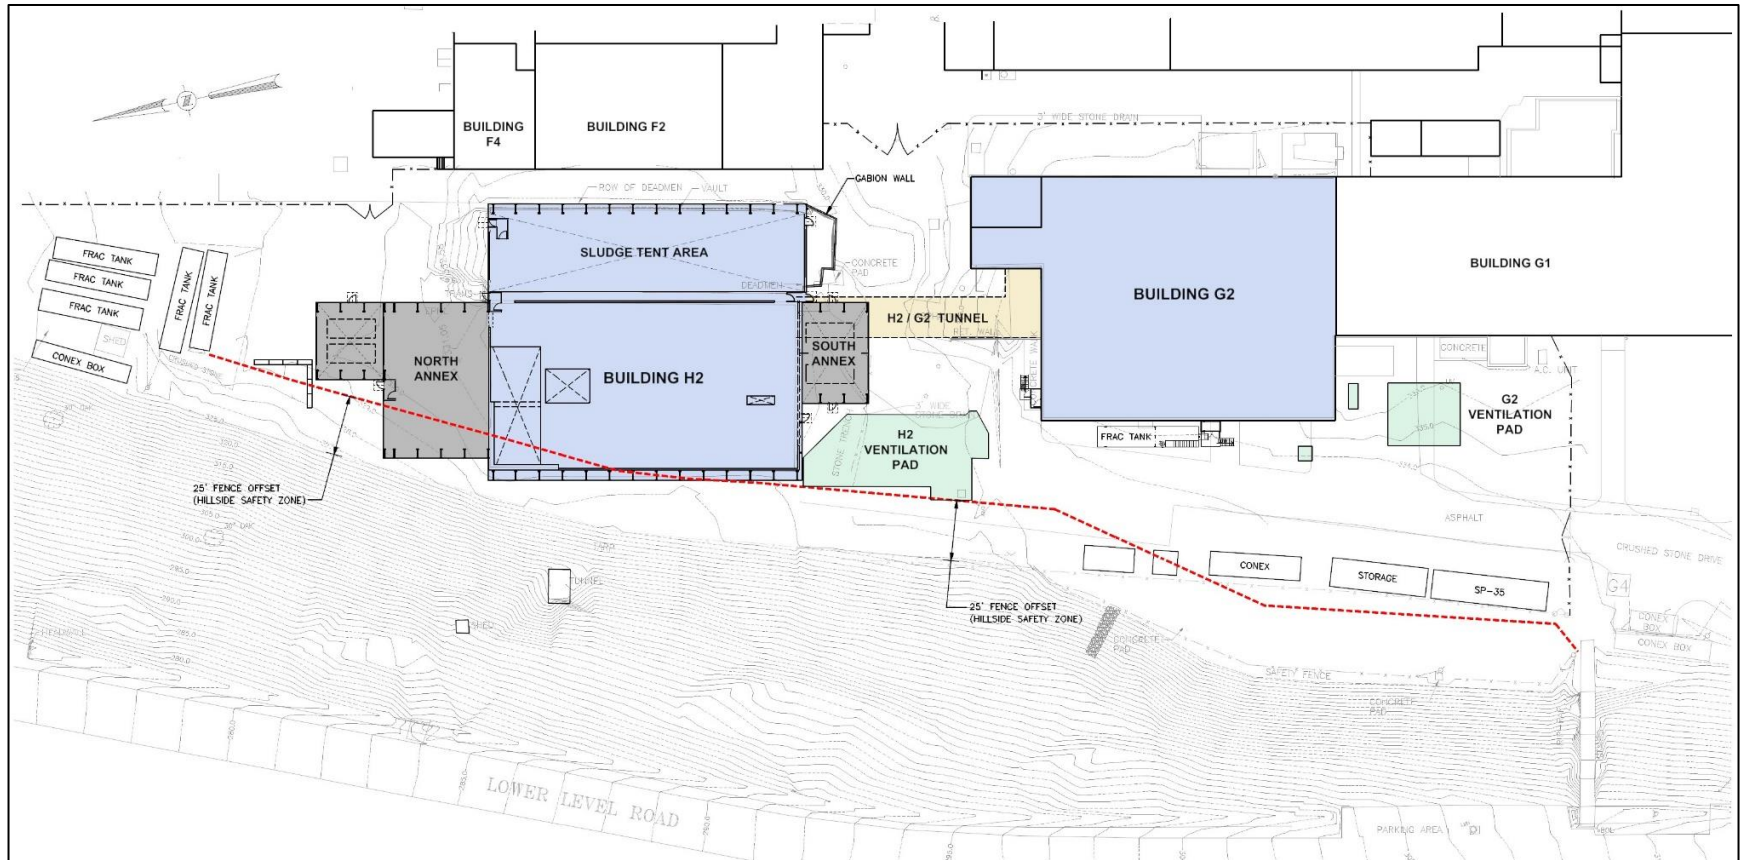
Figure 2. SPRU Upper Level Layout with Enclosures in Place

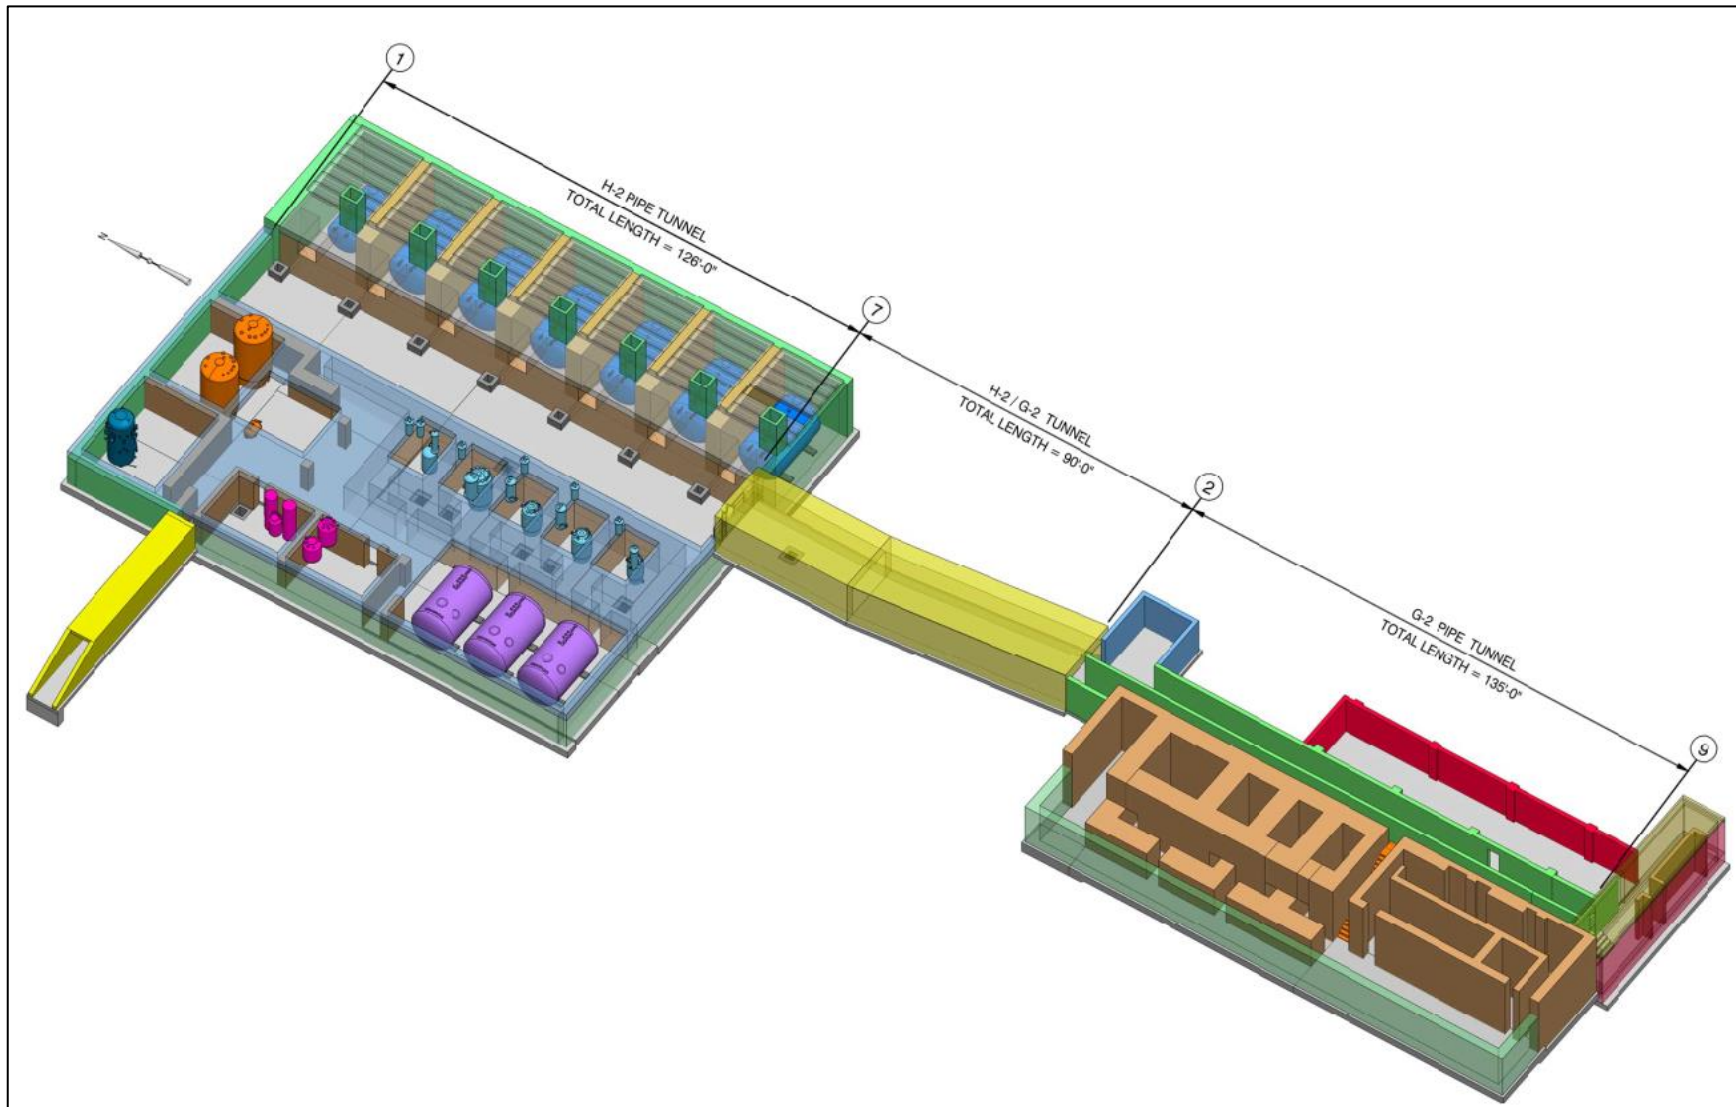
Figure 3. Isometric View of SPRU Building Complex

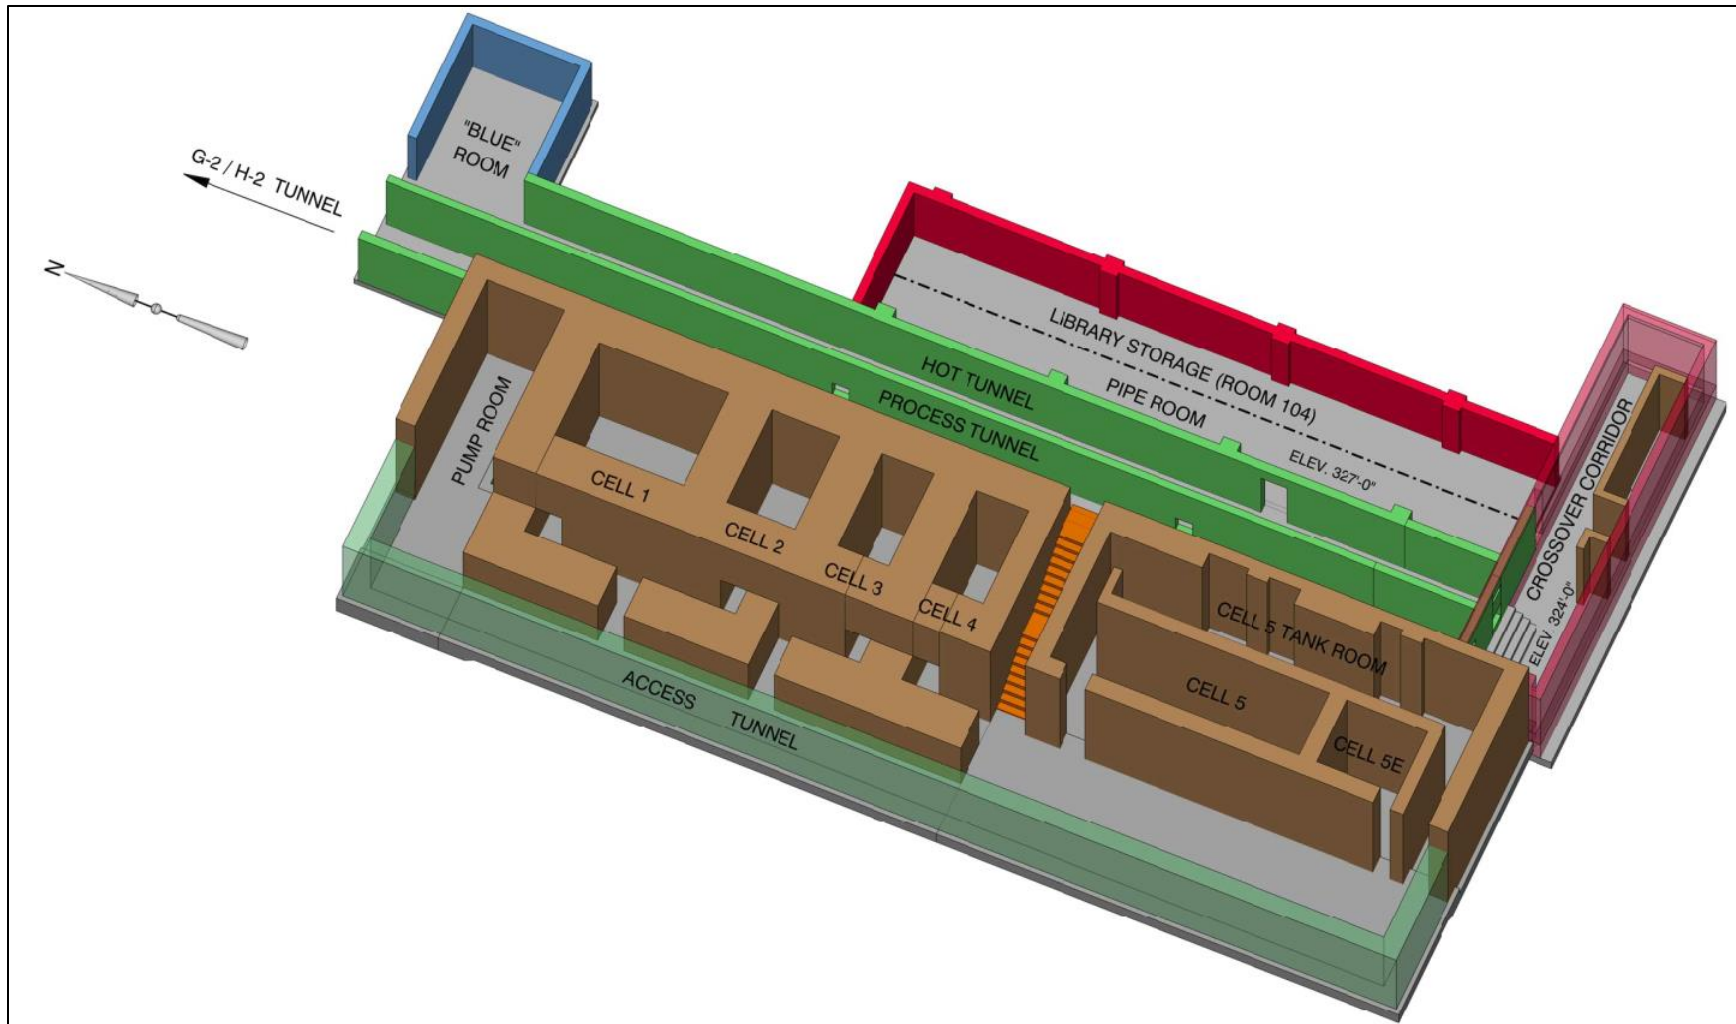
Figure 4. Isometric view of G2 building structure

Building G2 consisted of a steel-framed, transite-sided building containing heavily shielded concrete cells. The building was a multistory 150-foot long structure (north-south), 100 feet wide (east-west), 35 feet high at the northeast corner, and 45 feet high at the southwest corner with five levels at elevations of 325 feet above mean sea level (amsl), 337 feet (ground level), 348 feet, 355 feet, and 357 feet. Figure 4 shows an isometric view of the G2 structural layout. Figure 5 is a figure from the Historical Site Assessment [DOE 2006, April 2006] showing the building in greater detail. The greyed-out components had been removed as of November 2004.

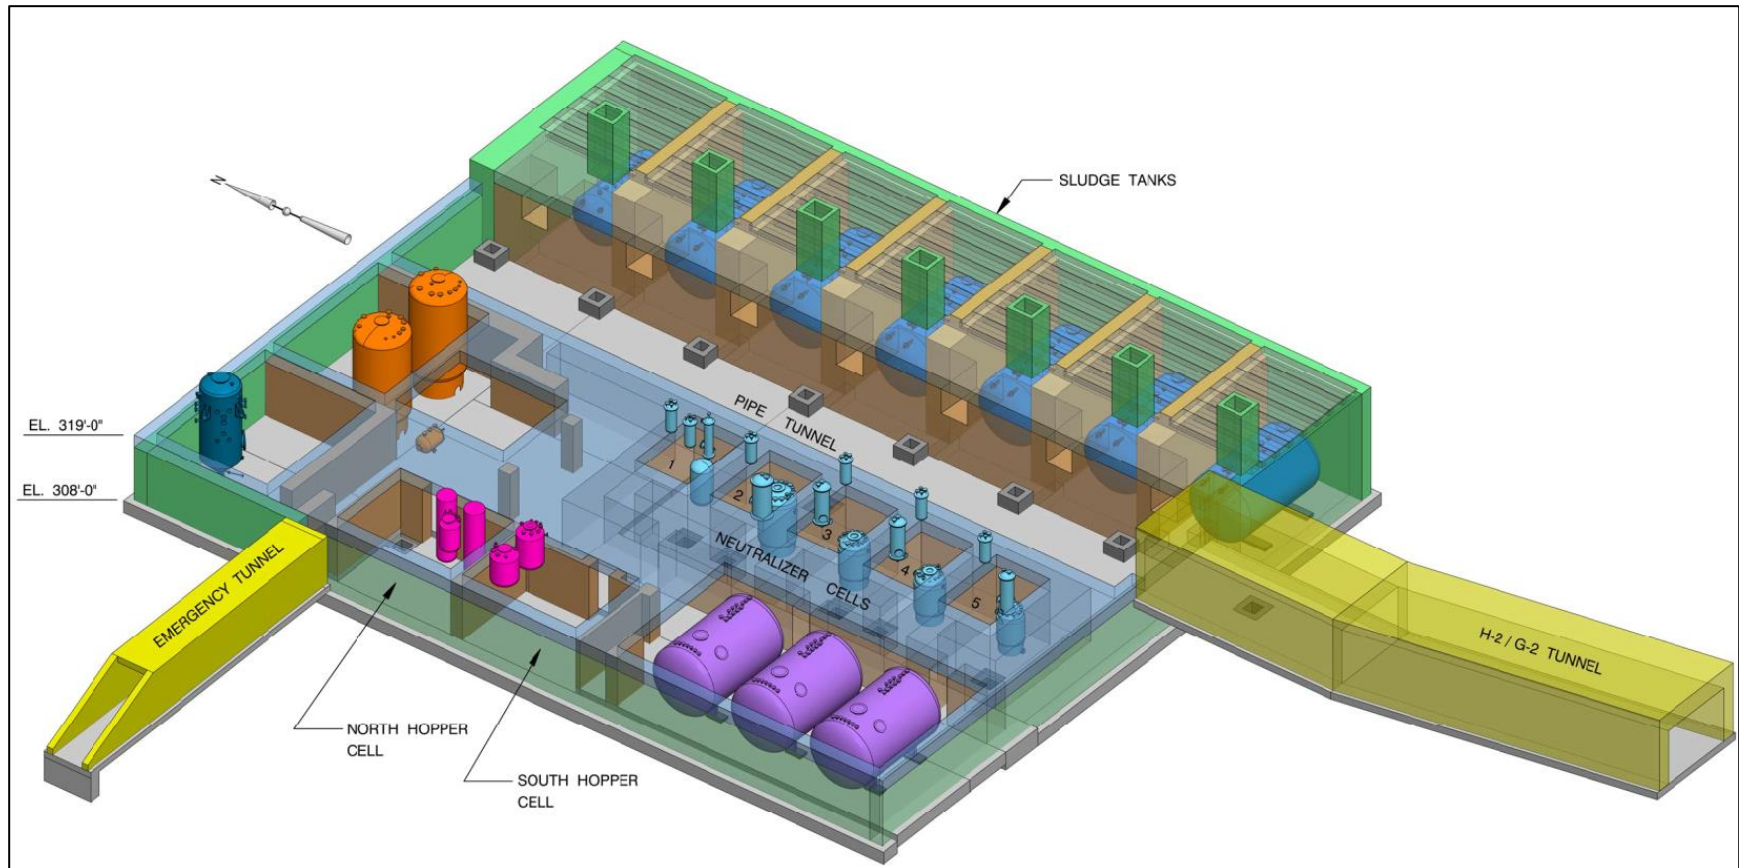
Figure 6. Isometric view of H2 building and G2/H2 Pipe Tunnel structure

The G2/H2 Pipe Tunnel housed the piping that connected the waste transfer and utility piping between the G2 and H2 Buildings. The G2/H2 tunnel consisted of a 90-foot long reinforced concrete structure 9 feet high by 12 feet wide, with a 3 feet thick roof, 2 feet thick walls, and 14 inch-thick floor slab. The floor sloped to a sump located approximately 15 feet from Building H2. The tunnel contained fire protection lines and a gas analyzer system. Two stainless steel drain lines transferred radioactive waste from the radioactive materials laboratory, chemistry, and Building D4 complex to the Building H2 liquid waste collection tanks. Two other heavy-duty plastic supply lines transferred clean processed reuse water to the laboratories. The elevation view in Figure 8 shows the connection between the buildings.

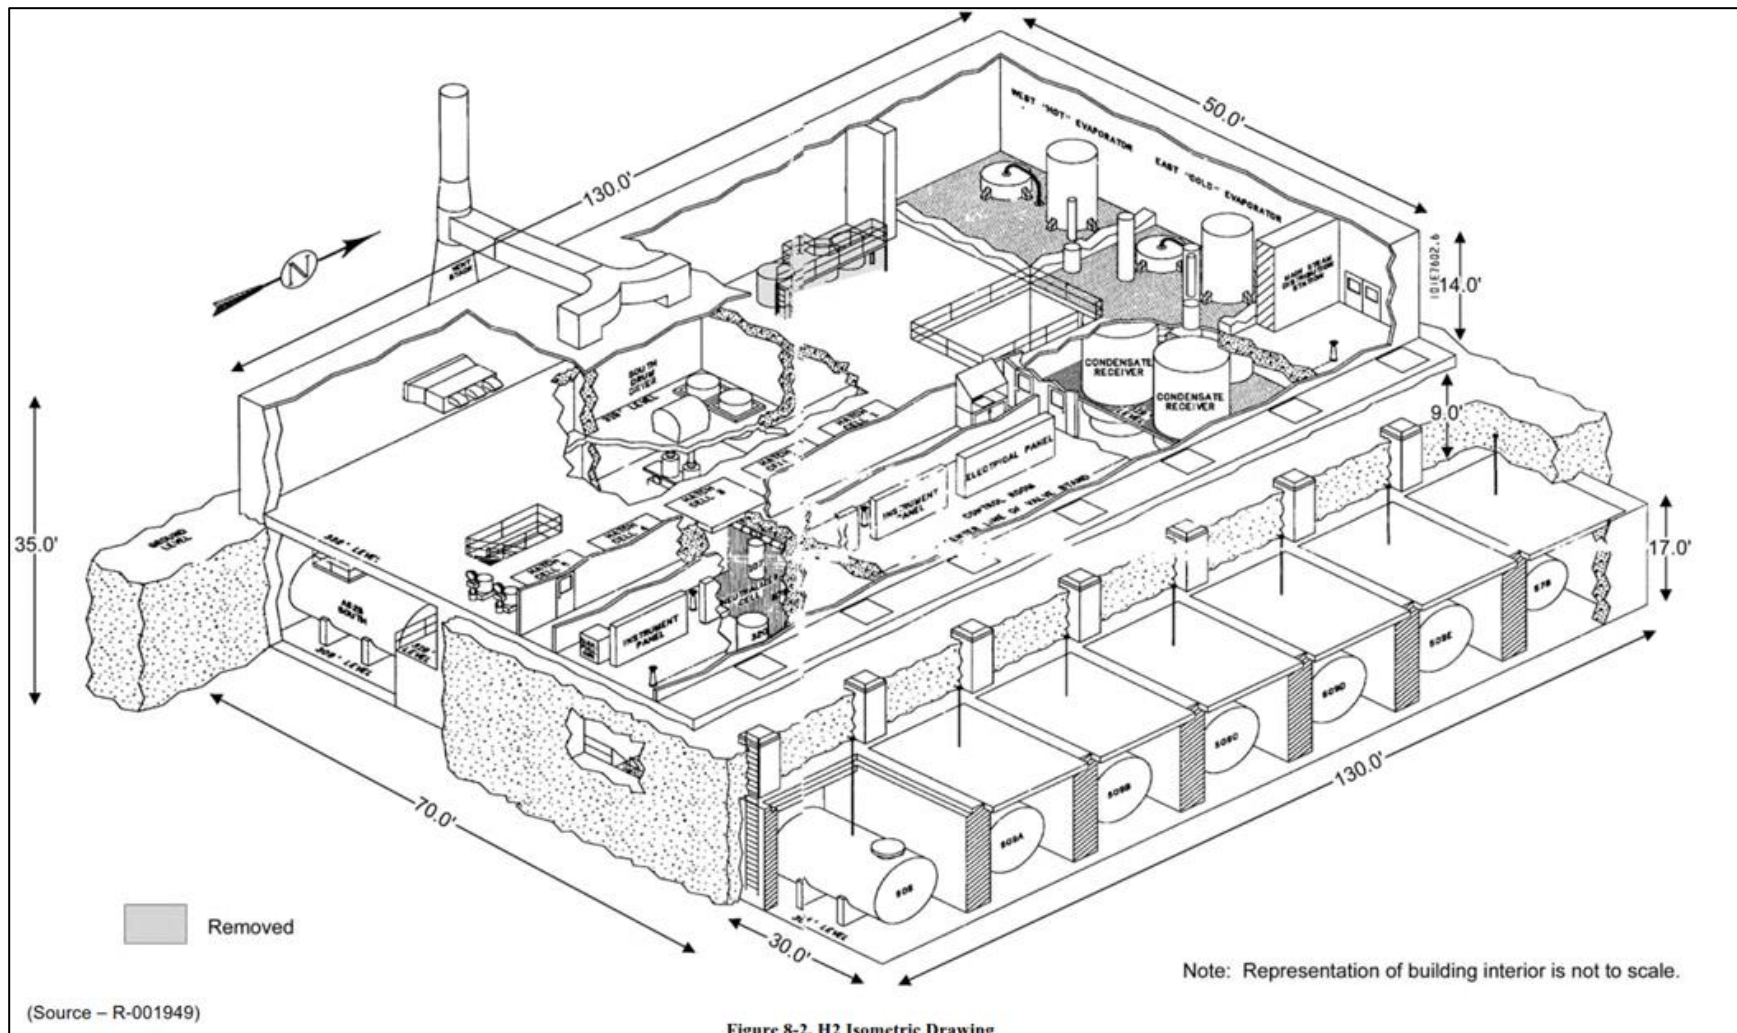
Figure 7. Detailed schematic of H2 Building (Figure 8-2 from HSA)

The H2 Building was located approximately 90 feet north of the G2 Building and contained approximately 27,900 square feet of floor space on three levels (elevation 309, 319, and 332 feet). Approximately 70% of Building H2 (309-foot and 319-foot levels) was located below ground level and was defined by concrete walls 2 feet thick on the north, south, and west sides, and 8 feet thick between the tank farm and pipe tunnel on the east, with a 2-foot thick concrete foundation. The above grade portion of Building H2 was constructed of structural steel with corrugated transite siding.

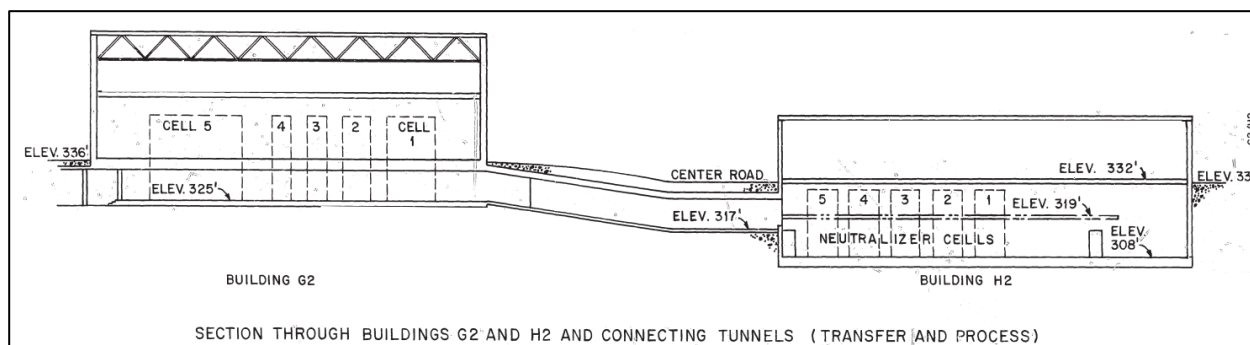
Figure 8. Elevation of G2 and H2 Buildings (view from east)

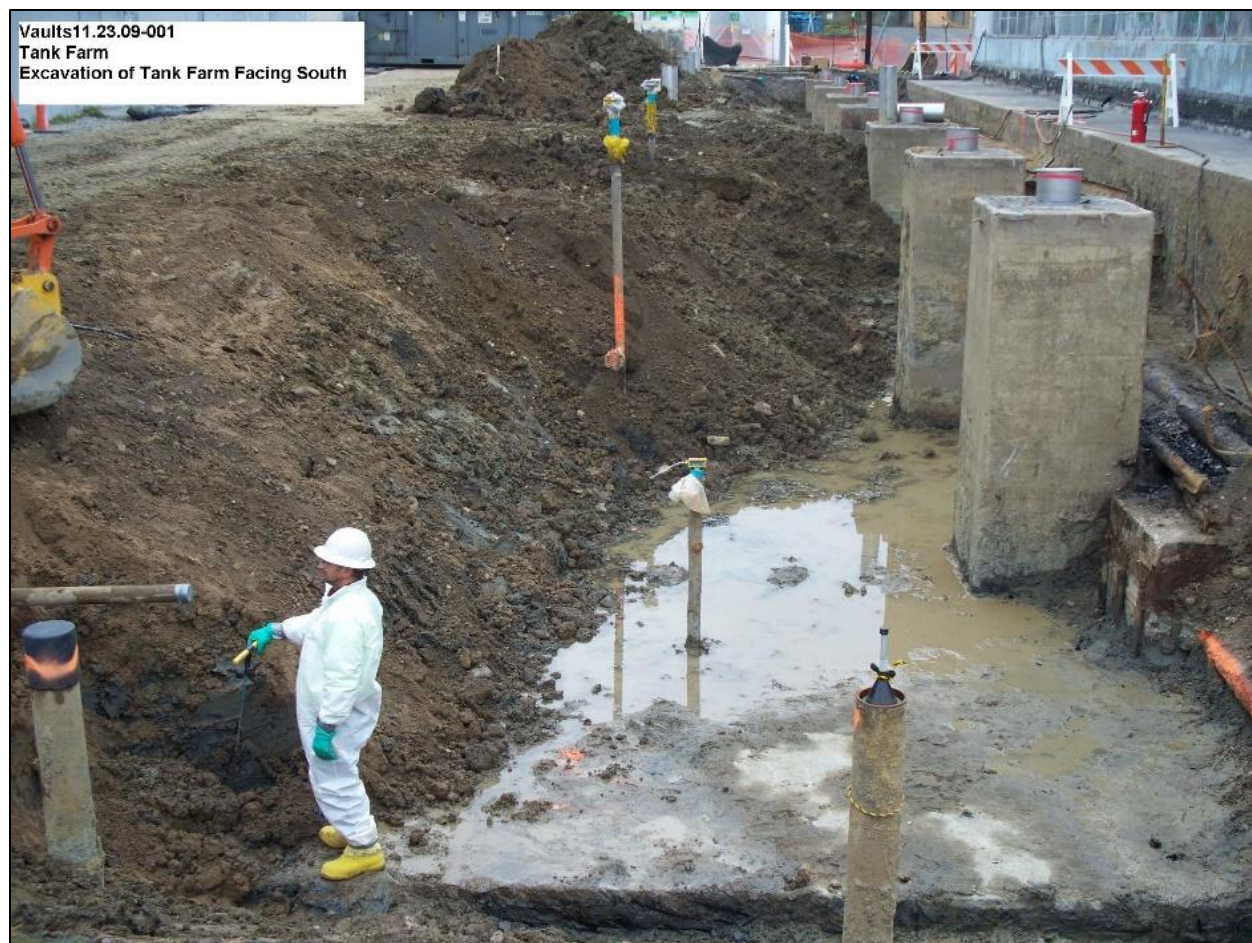
**Figure 9 Excavation of H2 Vault Area. Looking South on November 23, 2009**

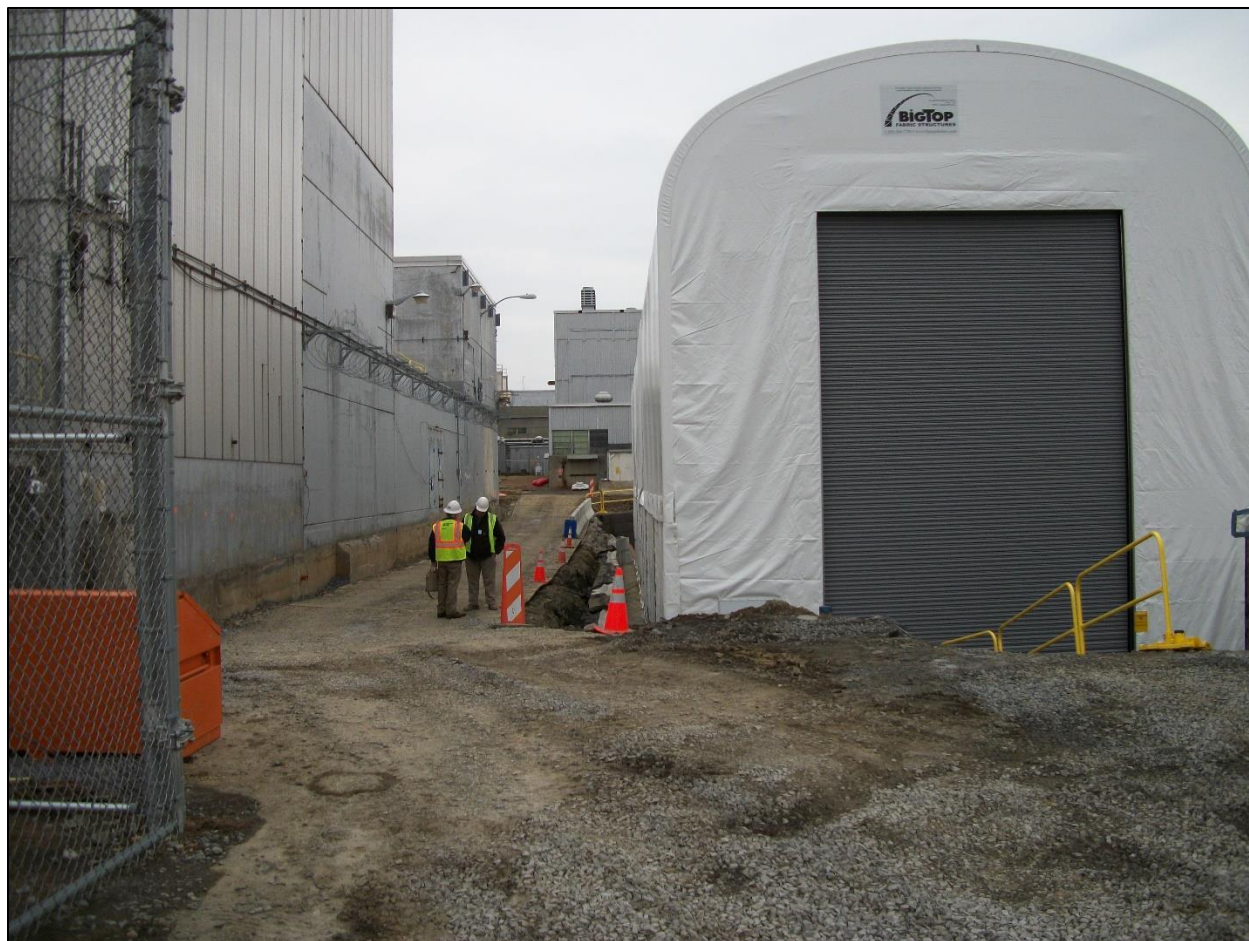
Figure 10 H2 Vault Enclosure (“Big Top”) looking south - March 11, 2010

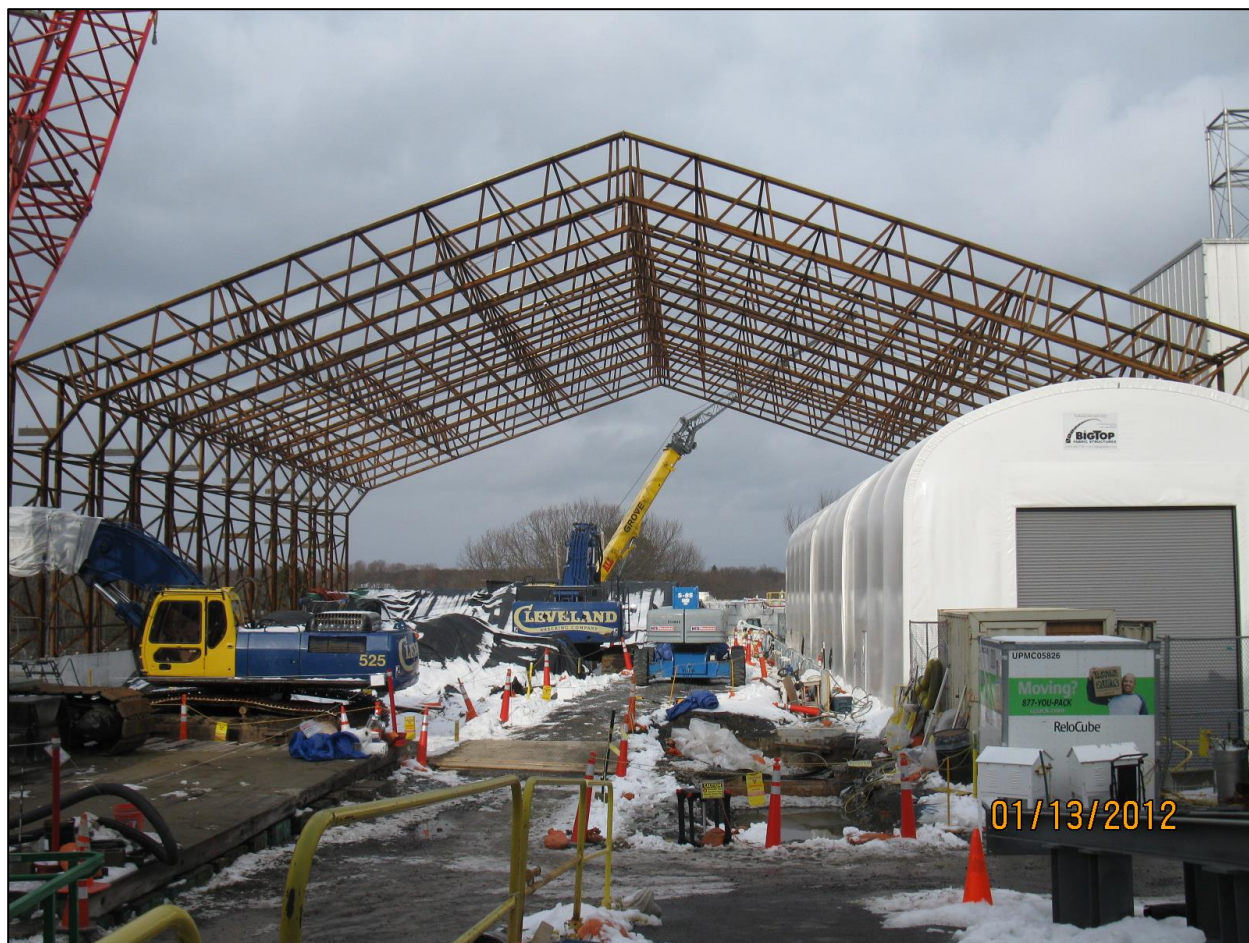
Figure 11. Construction of the steel frame for the H2 enclosure

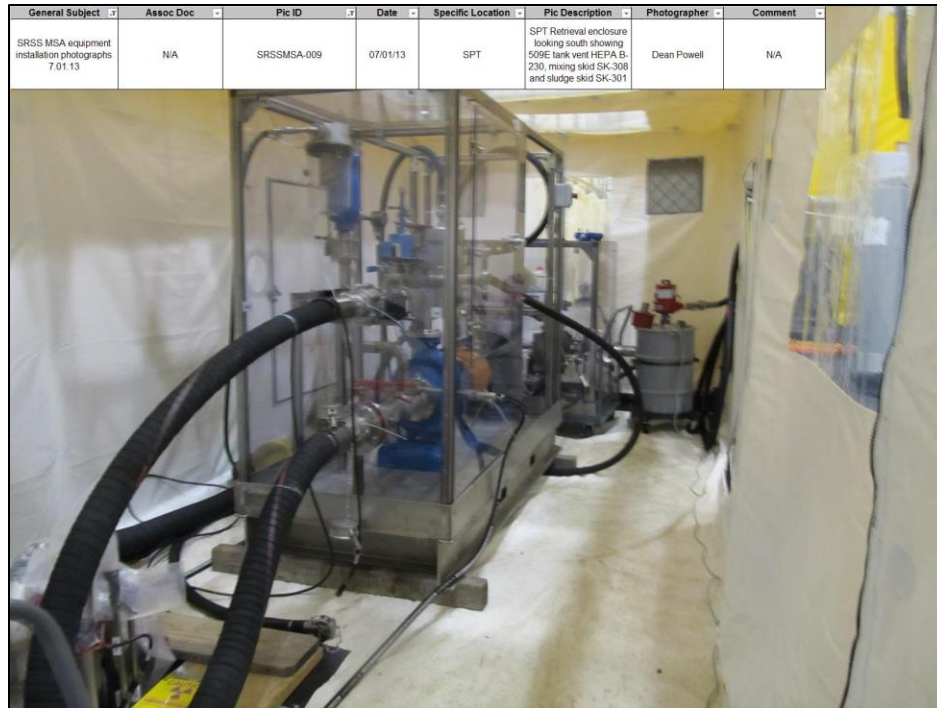
**Figure 12. SRSS skids installed within containment enclosure inside the SPT**

The processing system was designed to retrieve the waste from the 509E tank and transfer it to a container where the sludge could be mixed with the solidification agent, allowed to cure, and then sealed for shipment. In order to obtain relatively consistent batches as the sludge was pumped from the tank, a mixing system was installed to agitate and recirculate the waste, and thus resuspend the solids that would settle out. The sludge was then pumped to a day tank from which it could be sampled to ensure that the batch was within the target limits from a radiological perspective. If it exceeded the limits, the waste could be returned to Tank 509E for further mixing. Otherwise, the waste would be moved to a solidification liner, which had a mixing blade pre-installed. After blending with the dry mix, the blade would be detached and left in the liner. The Solidification Liner functioned as the shipping container for transport of the solidified waste sludge to the disposal facility. This liner was designed to meet all required DOT (49 CFR), Class 7 waste criteria for transport and disposal. Figure 14 shows a filled liner being placed down for surveying prior to shipment. A total of 14 shipments were made, with two liners per flatbed (Figure 15).

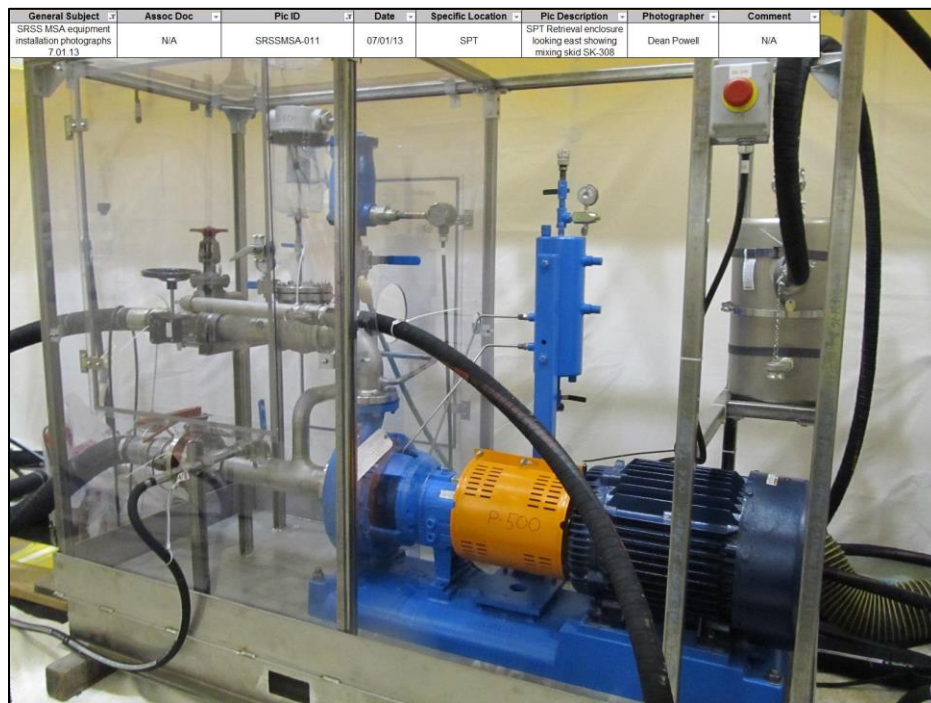
**Figure 13. Mixing skid for the Sludge Retrieval and Solidification System**

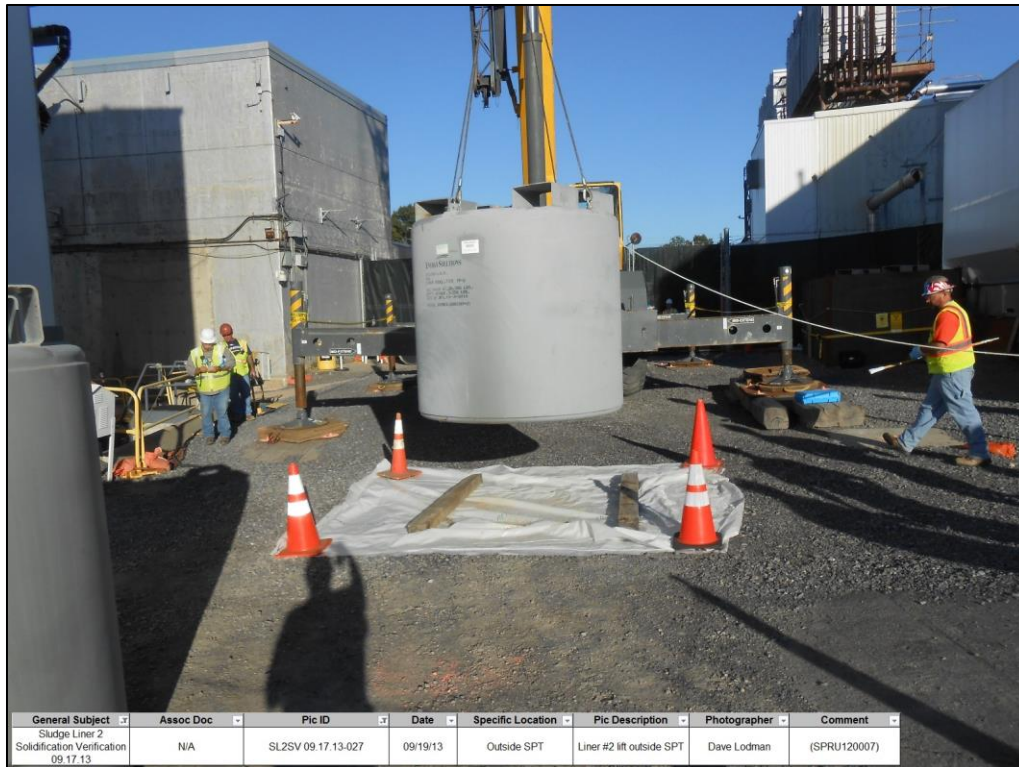
Figure 14. Loaded sludge liner being placed for survey and inspection

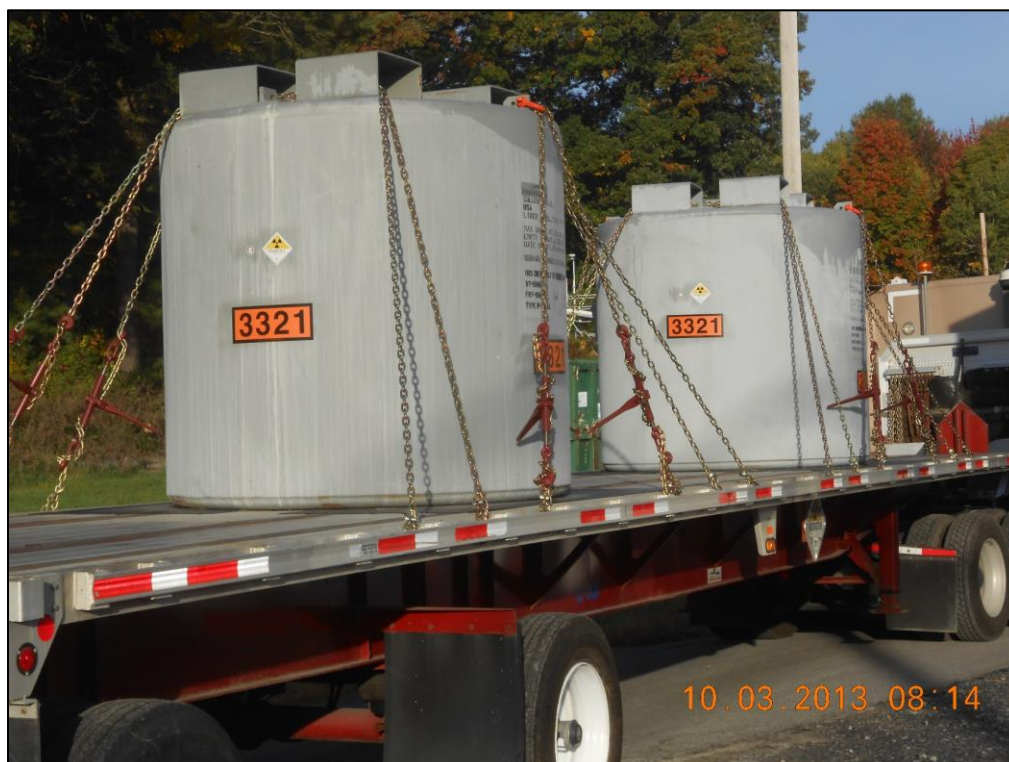
Figure 15. Flatbed shipment of two tank sludge liners

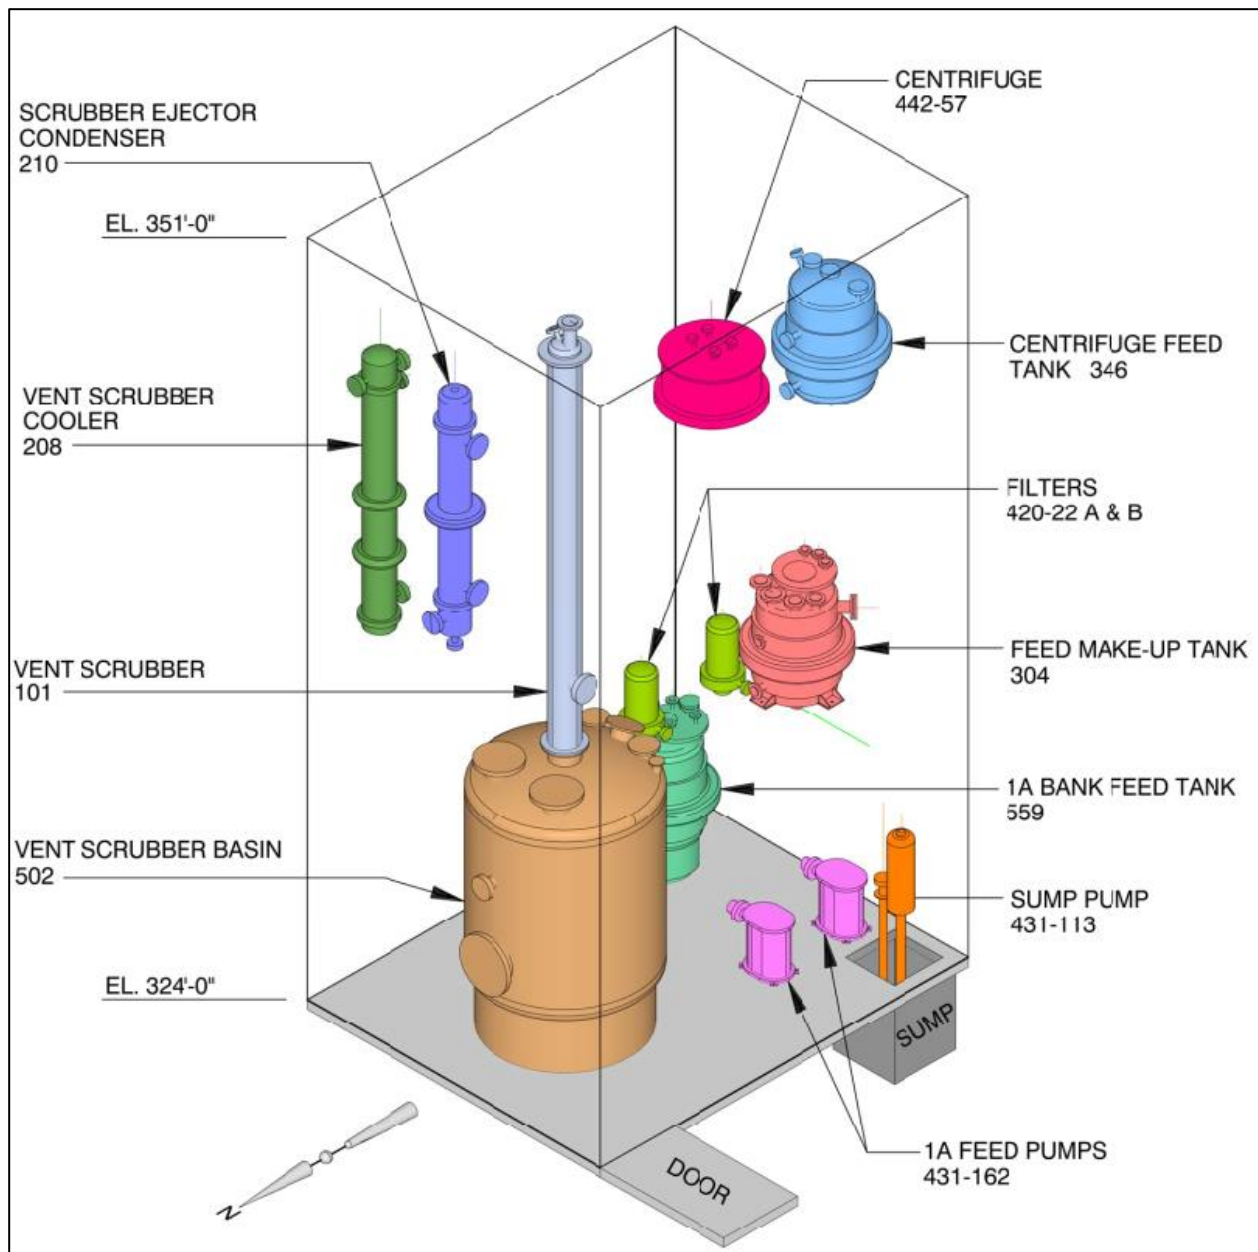
Figure 16. Schematic of equipment in G2 Cell 1

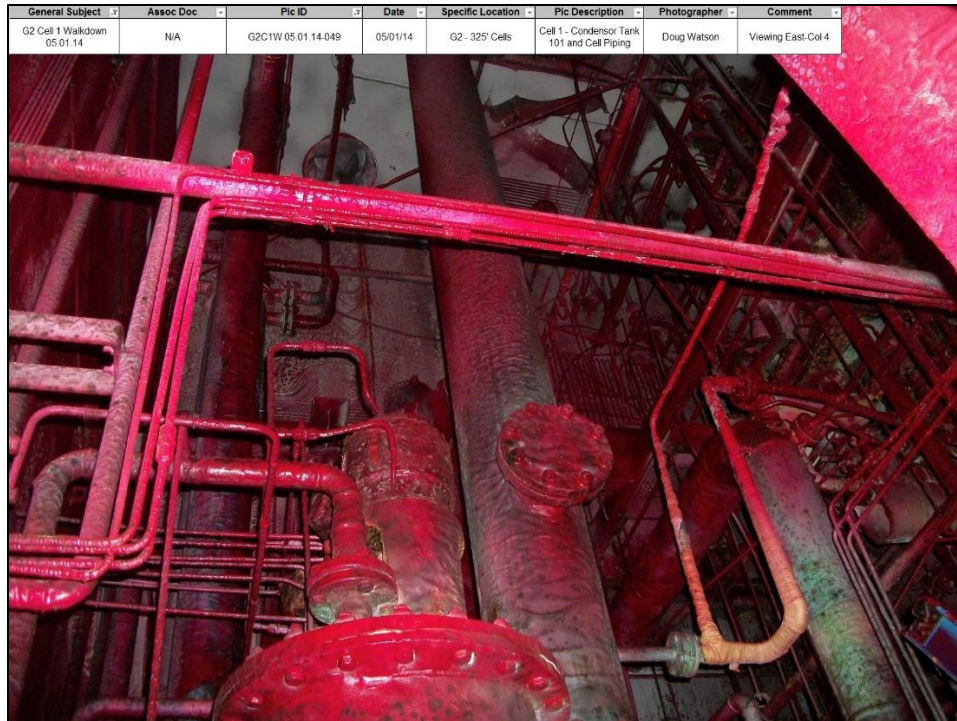
Figure 17. Process equipment and piping in G2 Cell 1

In order to meet the DOE requirements for loose contamination on the walls and in any remaining equipment or piping, it was deemed necessary to remove the process equipment and the majority of the piping from the cells and scabble the walls down to the required levels. As an example, Figure 16 shows a schematic of the equipment that was present in G2 Cell 1, the room with the highest dose rates. Figure 17 is a photograph of the cell in May 2014, prior to the start of equipment removal. The red coating is a contamination fixative applied during the 2010 decommissioning activities. Some of the piping that ran from G2 over to H2 in the basement pipe tunnels is shown in Figure 18.

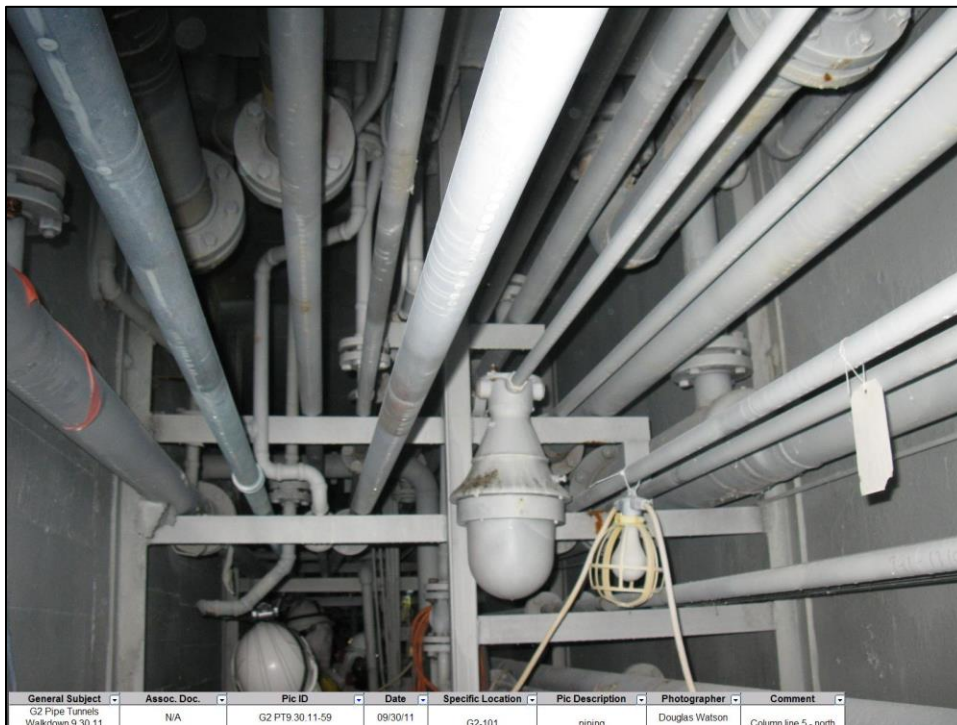
Figure 18. Piping in G2 Pipe tunnel (September 2011)

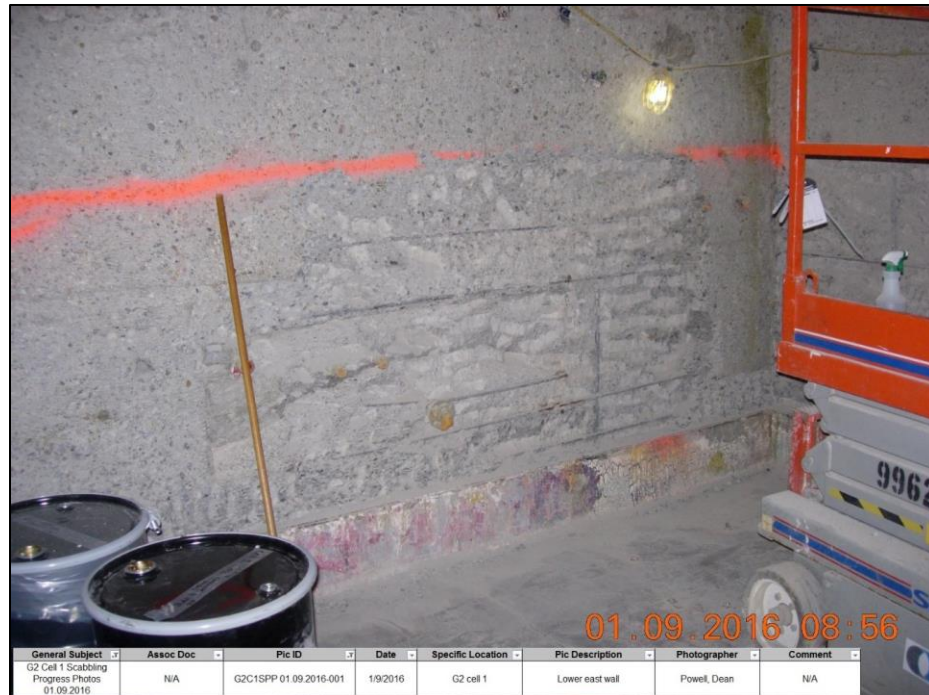
Figure 19. Scabbled walls in empty G2 Cell 1

After equipment and piping was removed from each area, walls were scraped or scabbled to decontaminate down to the loose limits. Demolition activities conducted under the enclosure were limited to hot spots and those areas that could not be easily decontaminated to meet open air criteria.

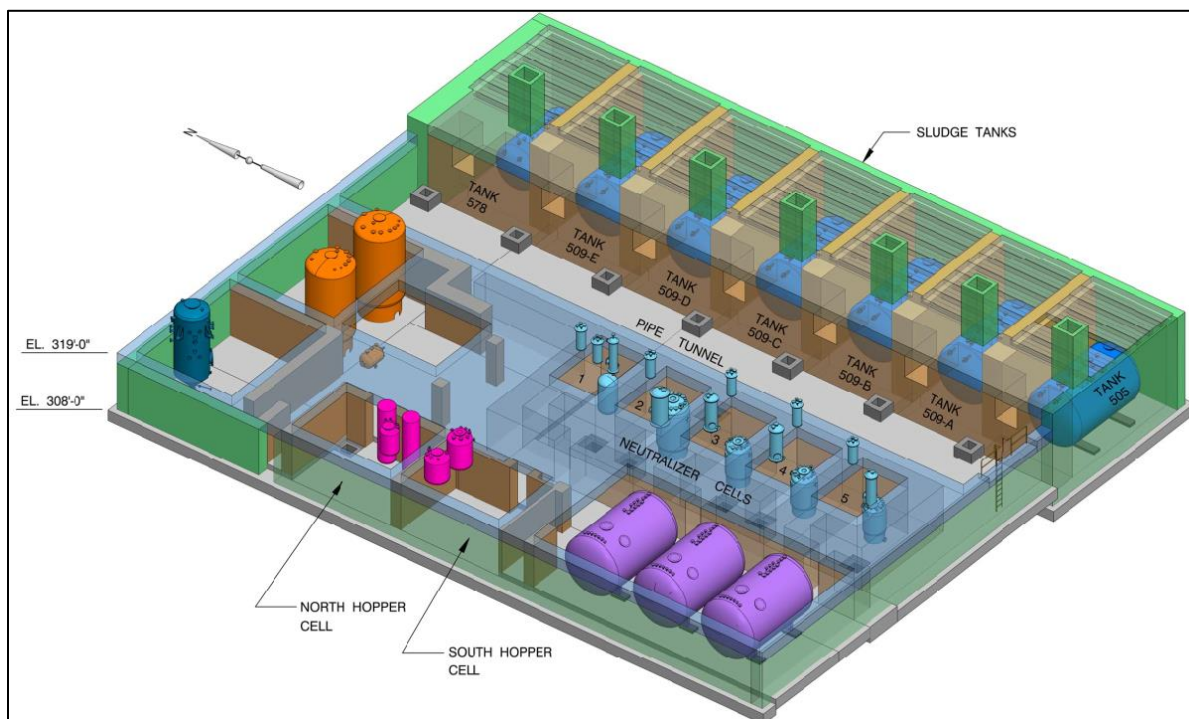
Figure 20. Building H2 schematic showing major equipment
