**SEPARATIONS PROCESS RESEARCH UNIT (SPRU)  
DISPOSITION PROJECT (DP)**

**SPRU PM-20-001**

**DEMOLITION COMPLETION REPORT  
FOR SPRU FACILITY**

**AECOM Energy & Construction, Inc.**

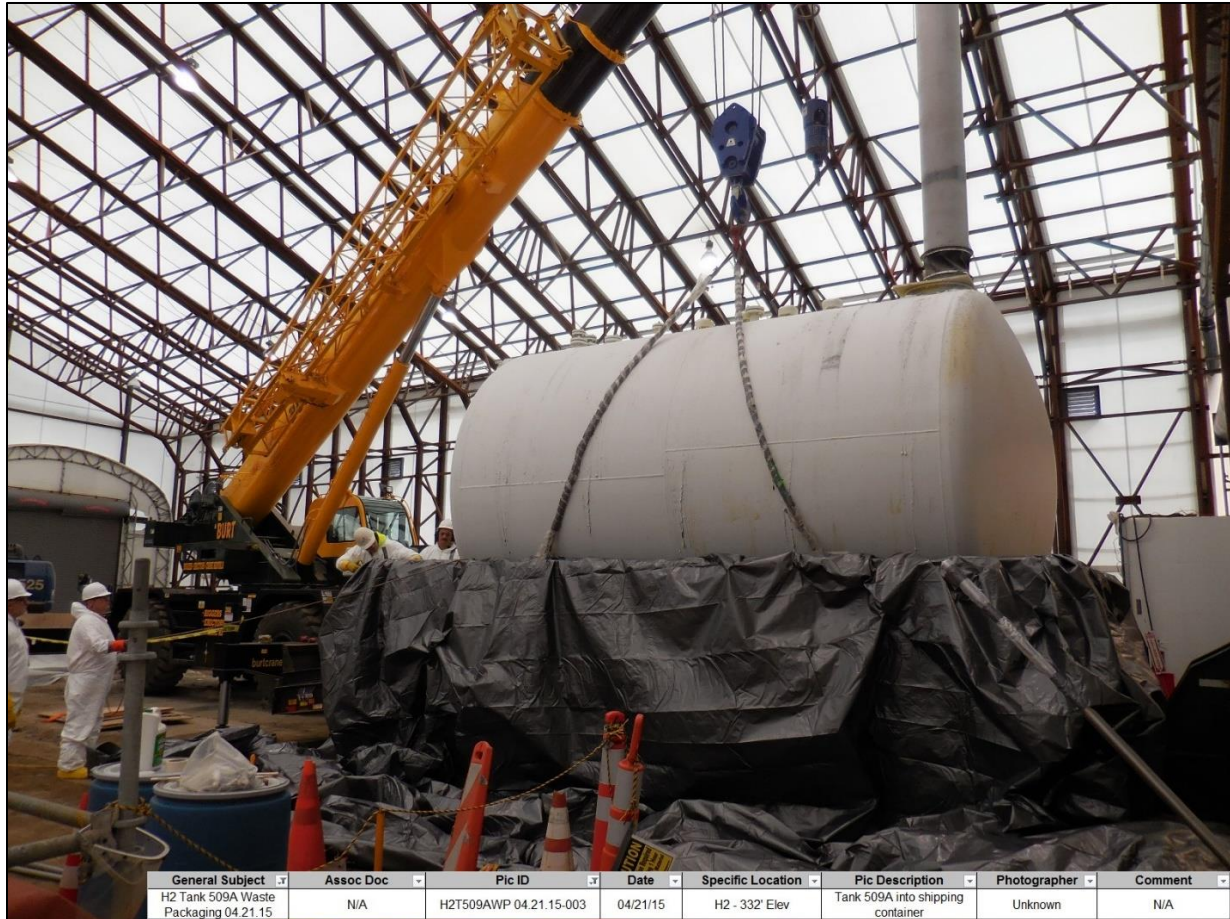
Figure 21. Tank 509A being loaded into custom shipping container

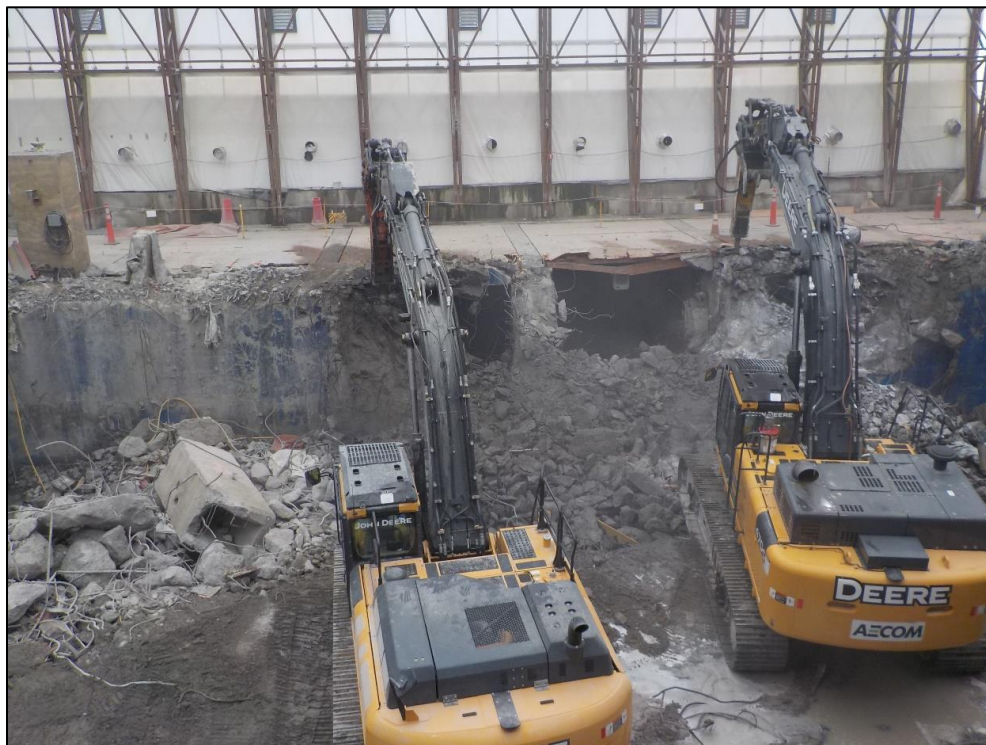
Figure 23. Demolition of H2 tank vaults under enclosure

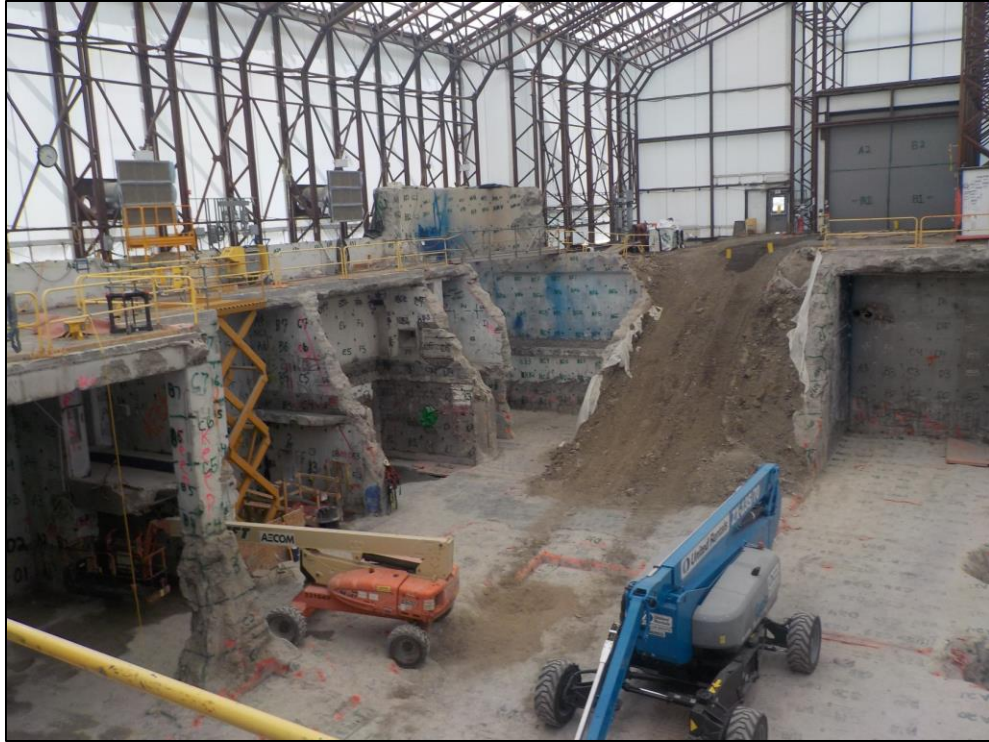
**Figure 24. West side of H2 basement after completion of "inside" demolition**

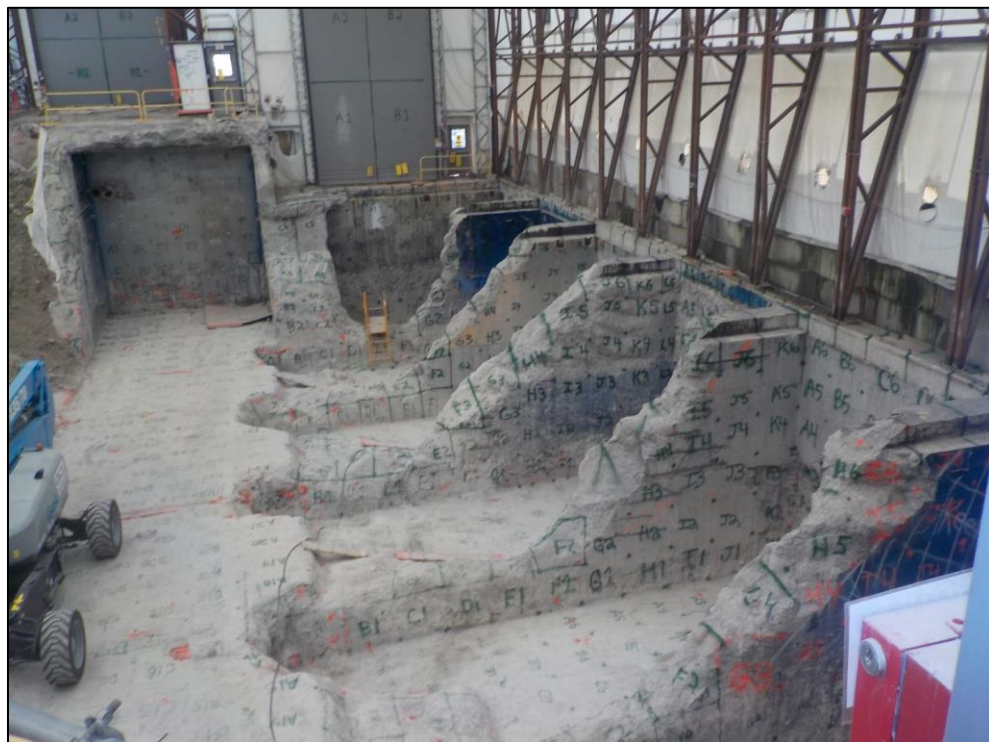
**Figure 25. H2 tank vaults ready for open air demolition**

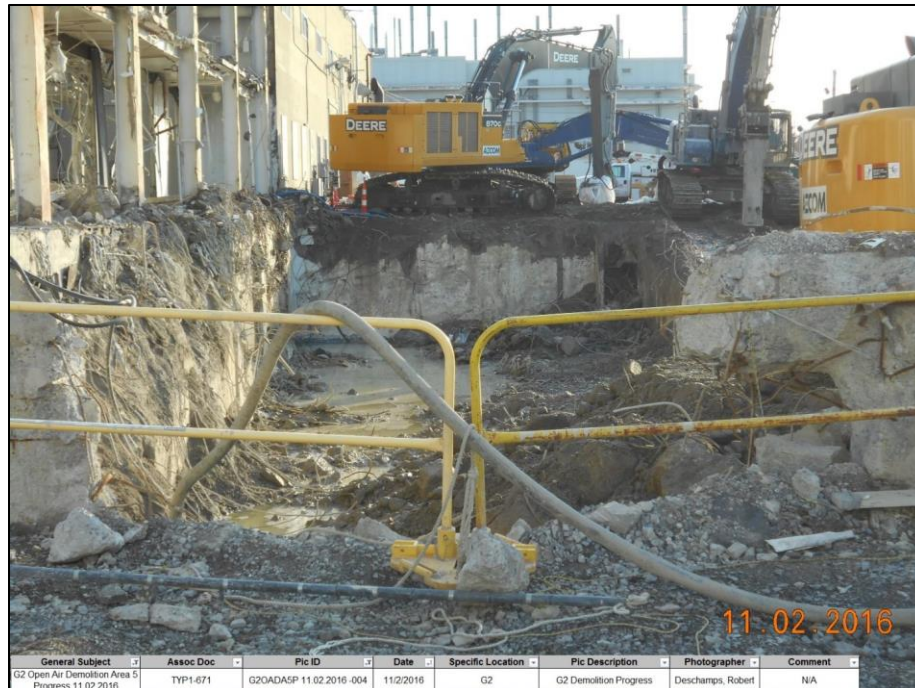
Figure 26. View of the G2 basement after removal of the G2 cells

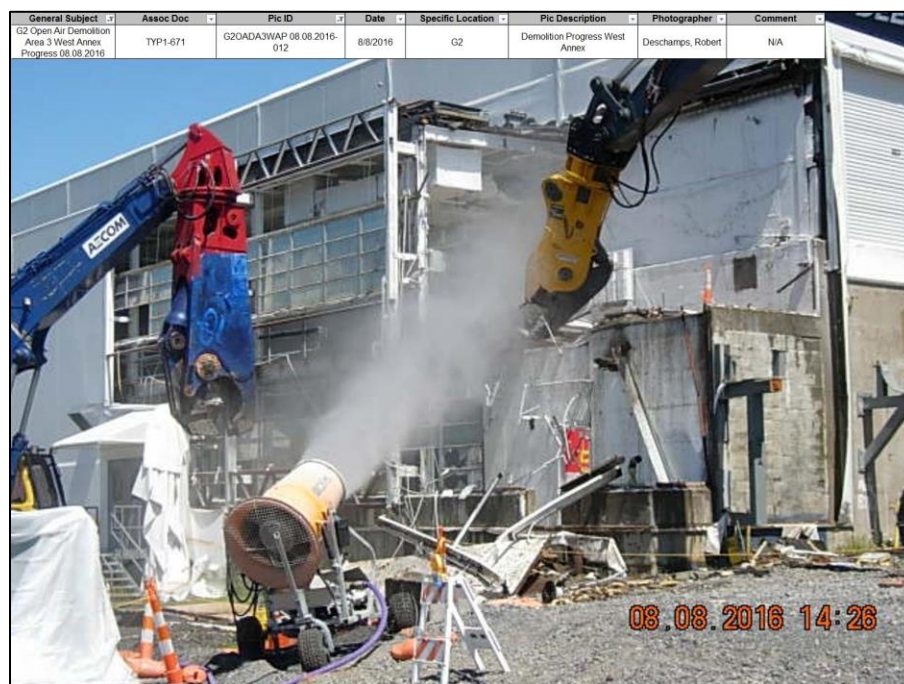
Figure 27. Open air demolition of the west side of G2 using mister for dust suppression

Demolition of the G2 structure and concrete was performed primarily using processors and hydraulic hammers, respectively. Dust suppression controls involved water cannons and misters as seen in Figure 27 during the demolition of the west side of G2. A berm around the G2 area was used to contain the dust control water and precipitation. Water that collected in the basement and subsequent excavation was collected in frac tanks for ultimate shipment to an off-site disposal facility. The demolition debris – steel beams, concrete, and cell floor liners - was piled and size reduced on the G2 footprint, and loaded into intermodal waste containers. The intermodals were then moved to the LLRB and staged for offsite disposal.

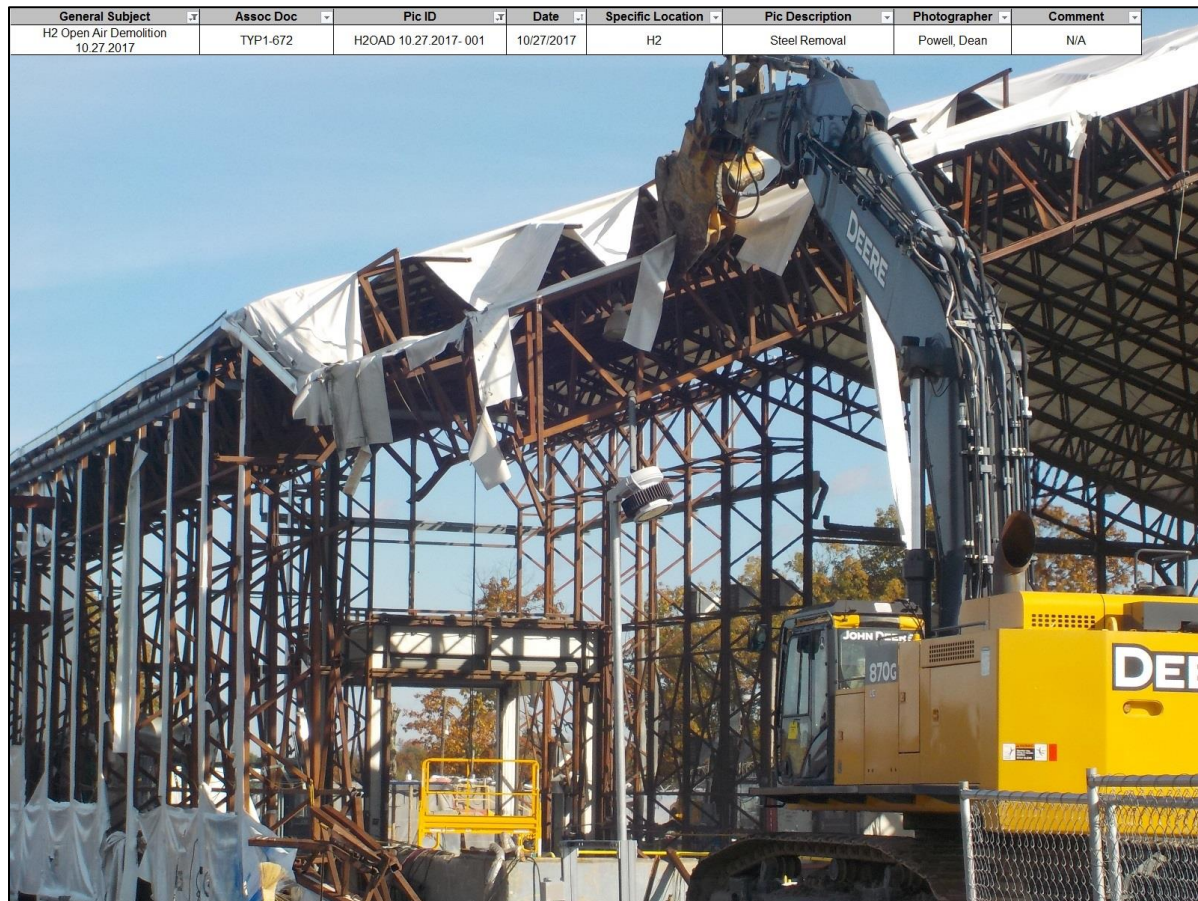
**Figure 28. Demolition of H2 enclosure steel frame**

As with the G2 Building, the open air demolition of H2 started with the shutdown and removal of the ventilation system. After the enclosure fabric was cut down from the framing, shears were used to cripple and bring down the steel structure starting at the south end (Figure 28). The beams were then size reduced to fit into the intermodals for disposal.

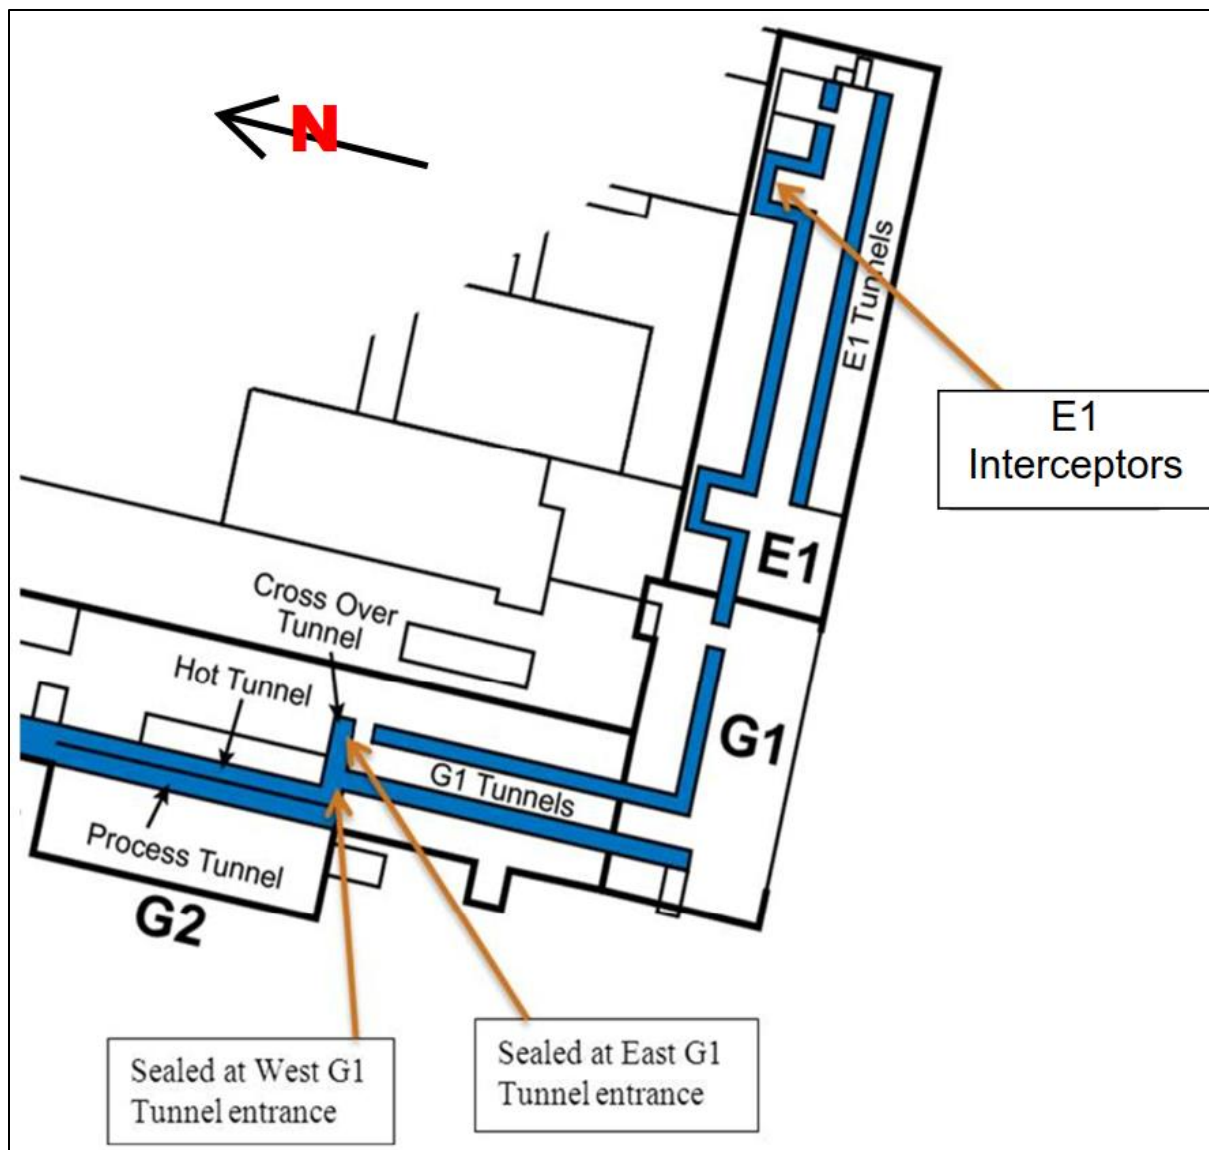
**Figure 29. Tunnel layout in Buildings E1 and G1**

The tunnels are pipe runs with walls, ceilings, and foundations that are at least 1 foot thick reinforced concrete. In E1 and G1, a pair of pipe tunnels are separated by a tunnel-aisle walkway, also referred to as a corridor, to allow personnel access. Waste and process piping within the tunnels is mounted along the walls or suspended from ceiling supports.

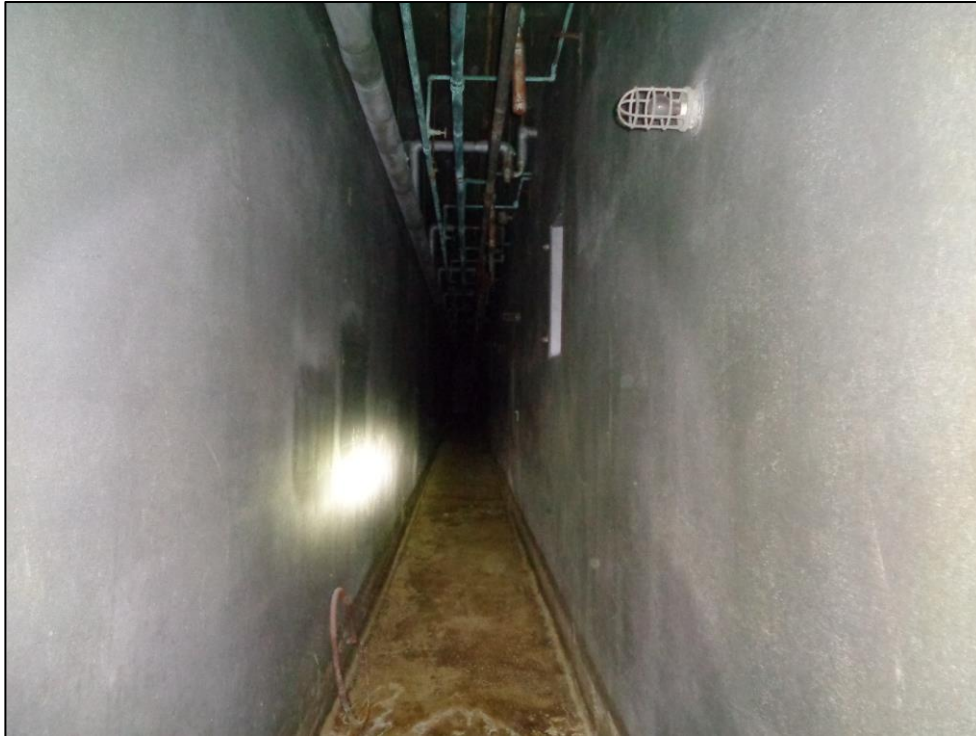
**Figure 30. E1 Tunnel prior to decontamination**

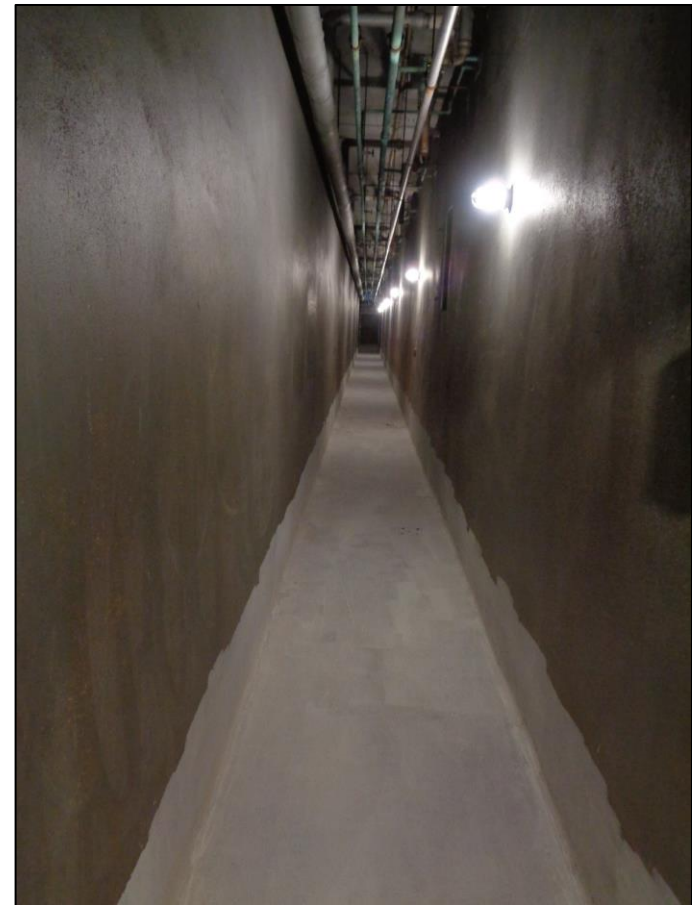
**Figure 31. E1 Tunnel post-decontamination**

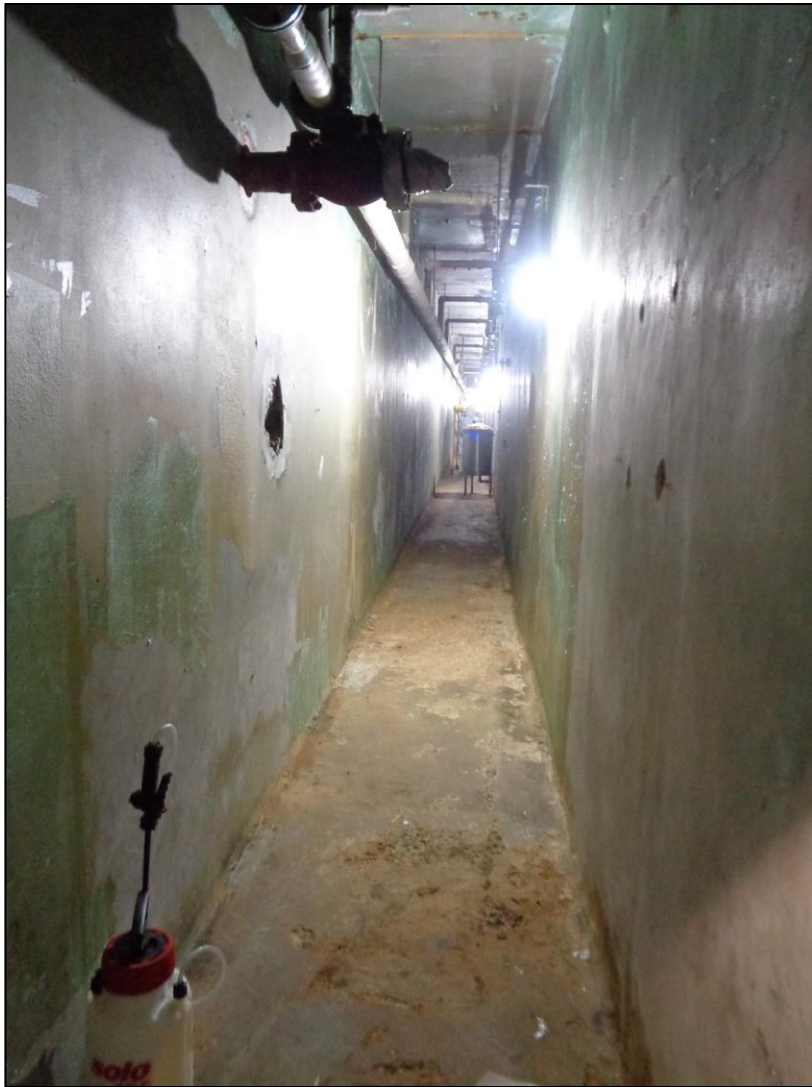
**Figure 32. G1 Tunnel with interceptor in place**

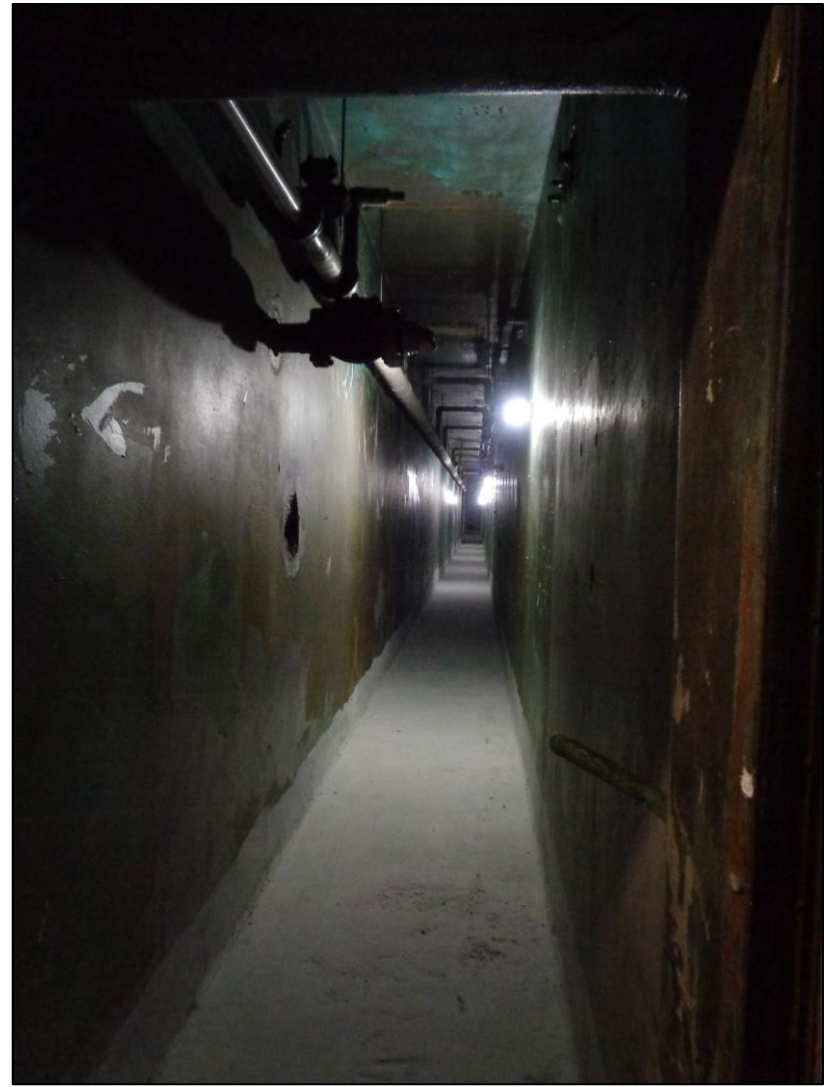
**Figure 33. G1 Tunnel after interceptor removal and fixative applied**

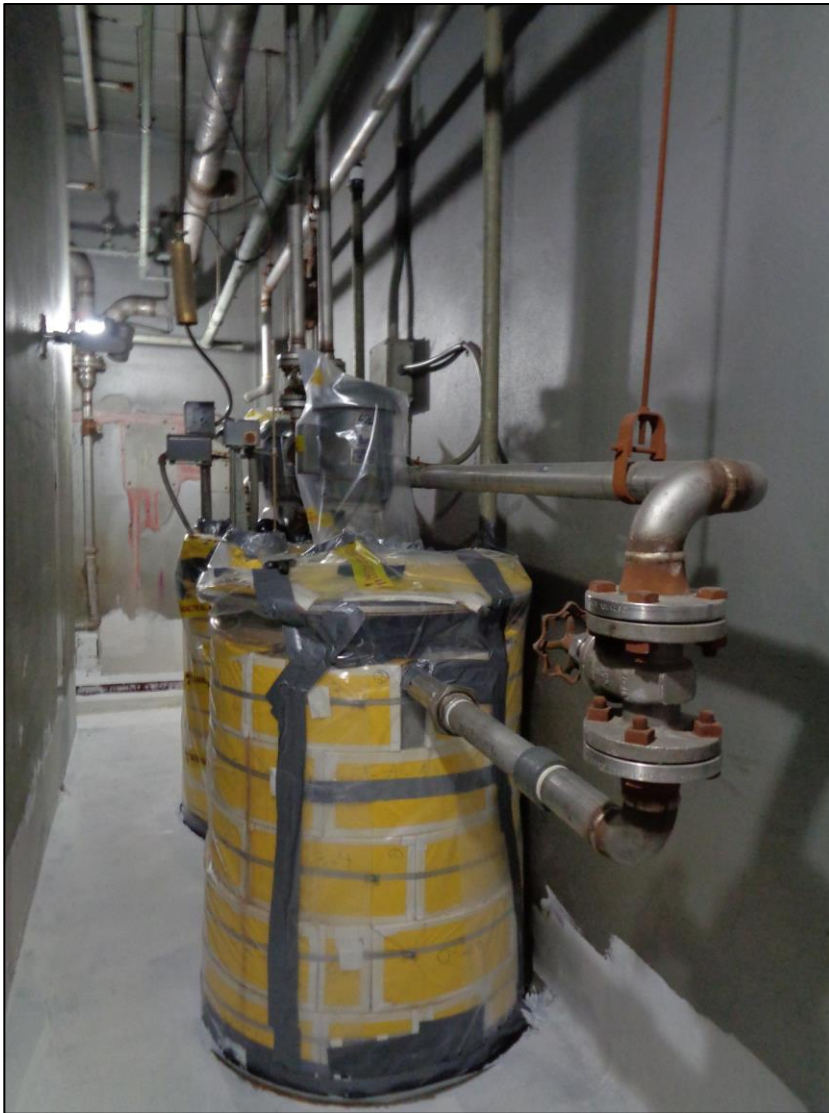
Figure 34. E1 Interceptors as-left condition. View from west

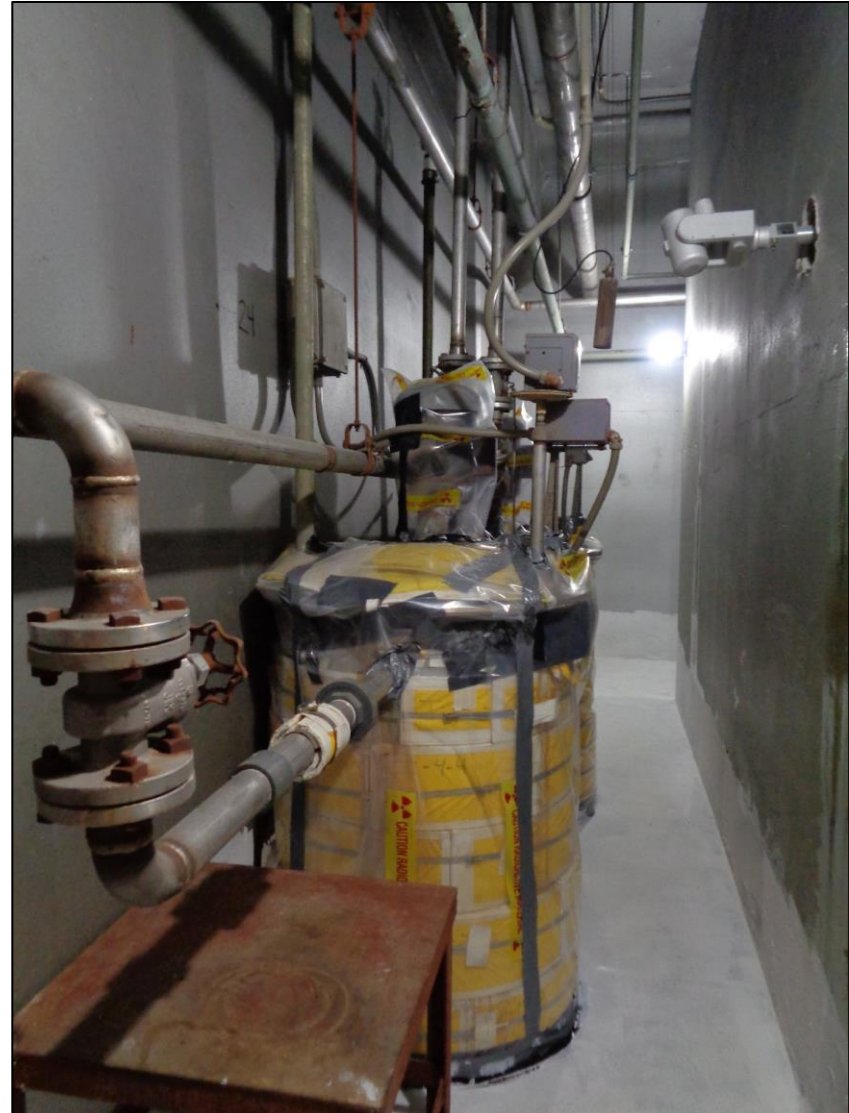
Figure 35. E1 Interceptors as-left condition. View from east

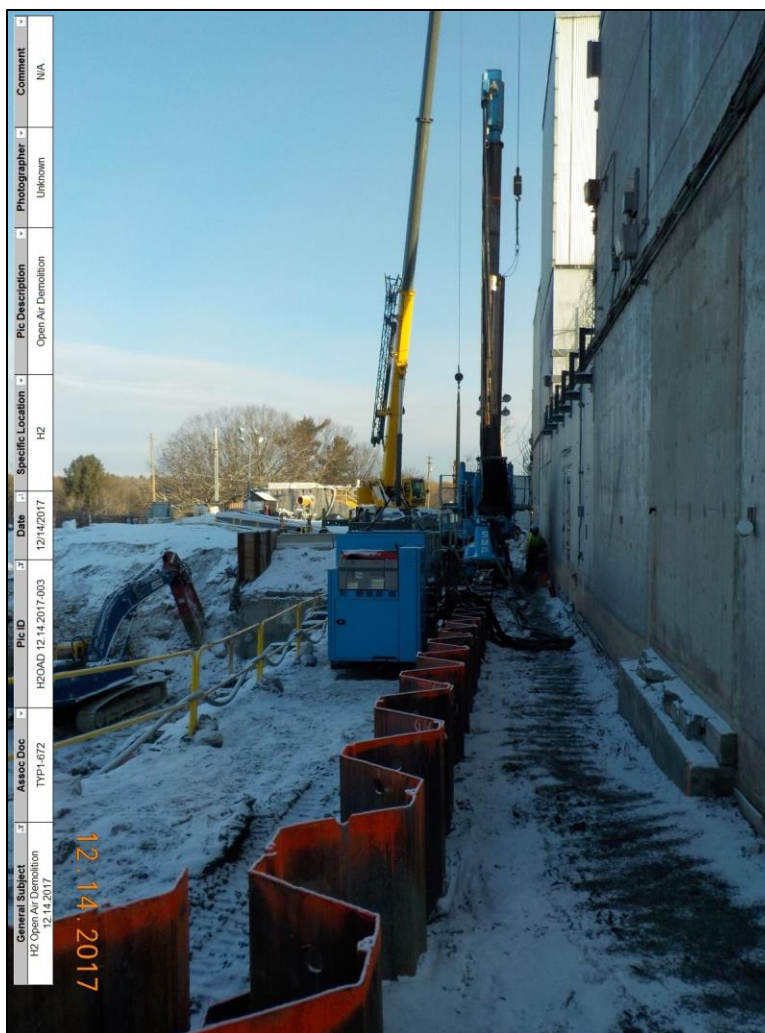
Figure 36. Installation of sheet pile wall west of F Buildings

A sheet pile wall between H2 and the F Buildings was installed during the start of H2 open air demolition but before any demolition of the H2 Tank Farm to provide the necessary stabilization for the F Buildings foundation. This would allow for removal of the east wall of the H2 tank vaults and the contaminated soil associated with the H2 Building footer drains without undermining the F Buildings. Prior to installation of the sheet piles, underground utility lines at the northeast corner of H2 were exposed, cut, and capped to remove the obstructions. All capped lines were terminated to the east of the sheet pile wall path. Use of the Silent Piler augering technology was needed to get the sheets deep enough into the very stiff native till. Two level of tiebacks were installed along the wall as the tank vault wall and soil were removed. Figure 36 shows the installation of the wall in progress. The sheets were left in place after site restoration in anticipation of providing some support during the future demolition of the F Buildings. The tops of the sheets were cut to be at least two feet below the final grade and the tiebacks, which extended beneath the F Buildings, were detensioned as the backfill was placed on the east side and provided the necessary support.

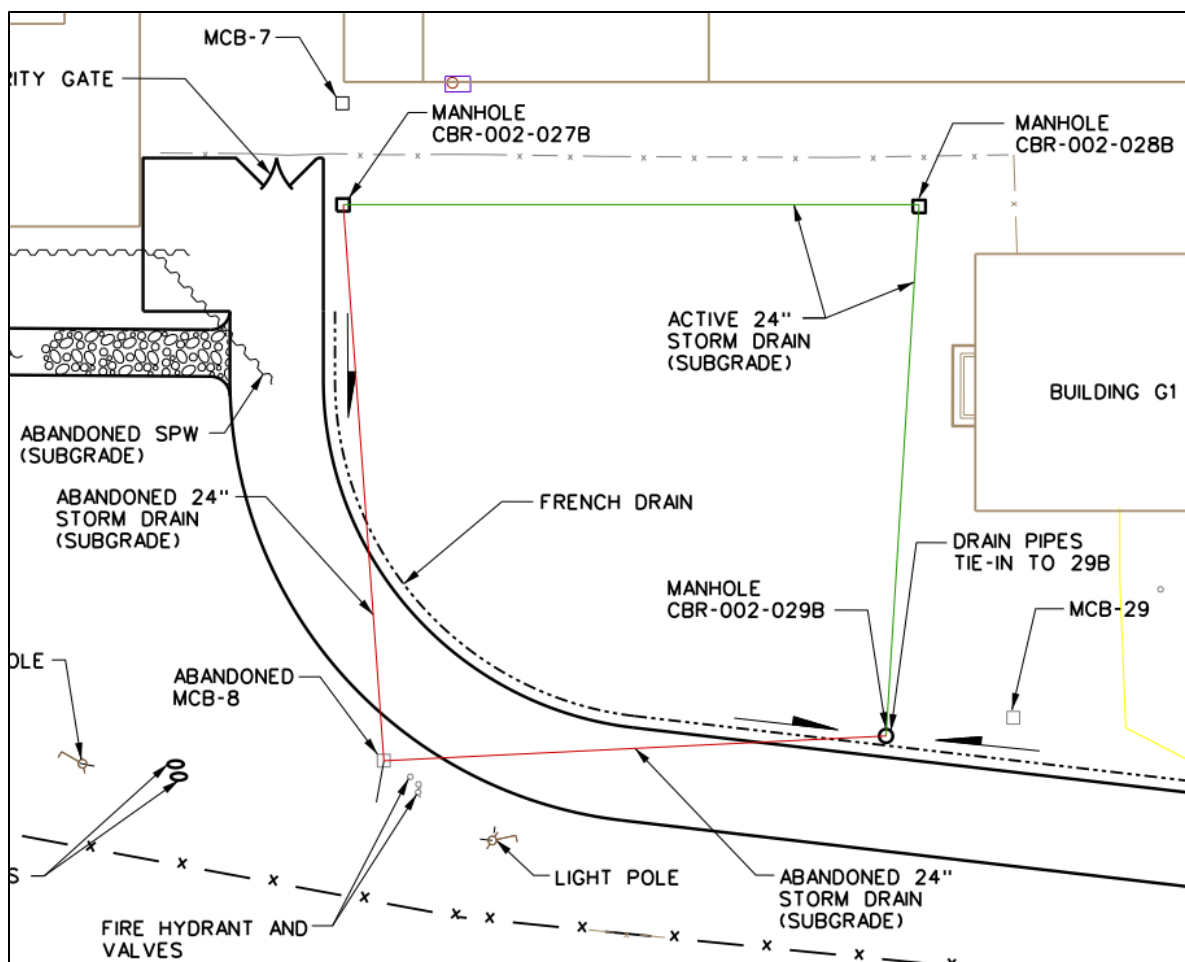
Figure 37. Final SPRU Site Plan showing Storm Drain Line

The stormwater drain in the SPRU area ran south to north along the west side of the G2 Building and then turned east between the G2 and H2 Buildings towards the KAPL site, passing under the G2/H2 Tunnel. Because the 24" diameter drain line passed through an area with volatile organic compound (VOC) contamination and was at risk of damage during the tunnel demolition, it was decided that a new section of drain would be constructed that would avoid those areas. The new storm drain line was installed to reroute the flow from the existing path from MCB-29 to MCB-8 to MCB-7 (KAPL side). The new (green) and abandoned (red) storm lines are shown in Figure 37, which is part of the final site plan drawing 29463-00-11-500 (Figure 44). New manholes (29B, 28B, and 27B) were installed to run the drain line east near the remaining G1 Building towards the KAPL E Buildings and then north along the SPRU-KAPL boundary fence to intersect with the existing drain line. The installation was done after the remediated G2 footprint had been backfilled.

The G2 Building connections to and from storm sewer drain catch basin MCB-29 were removed and capped during soil excavation. MCB-30 was filled with grout prior to initiating D&D activities and was removed during demolition. The drain line from MCB-30 to the storm sewer system was located, cut and capped to prevent any surface water from inadvertently entering the system.

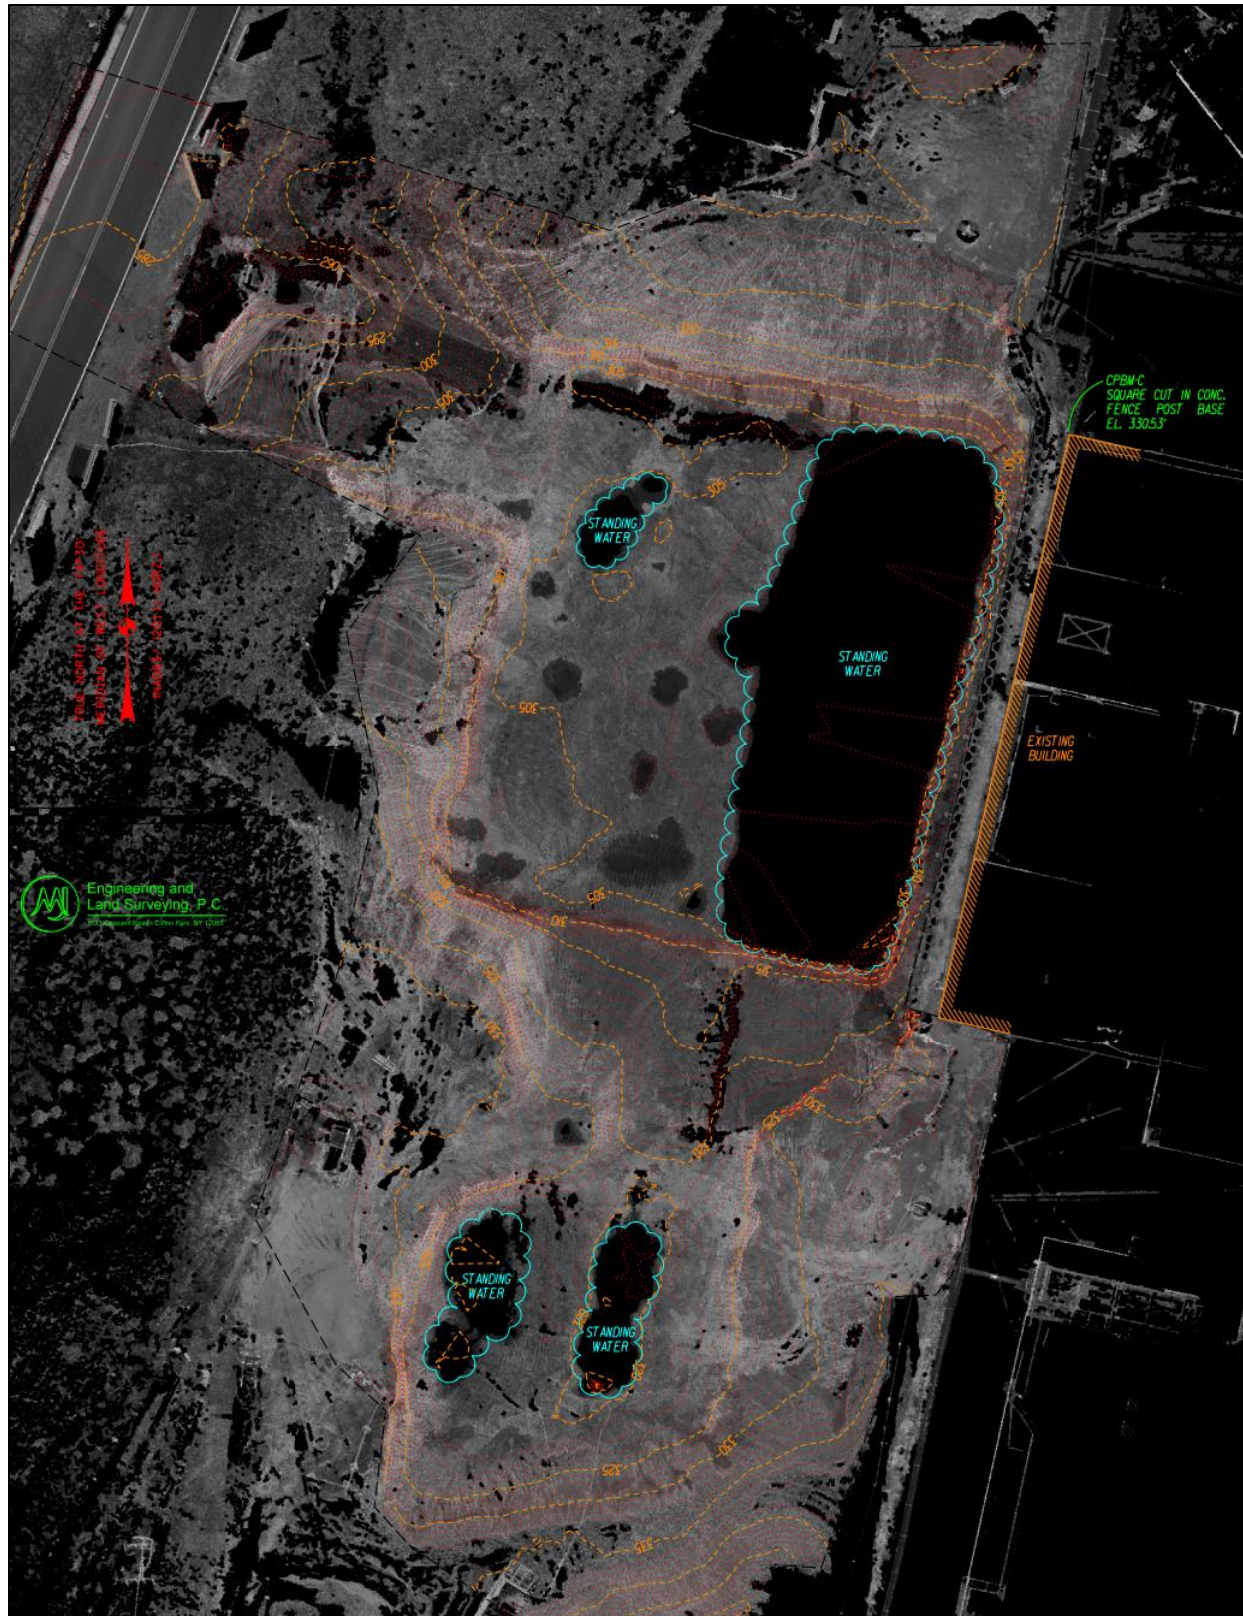
Figure 38. Contour map of SPRU Upper Level from LIDAR survey Sept. 2018

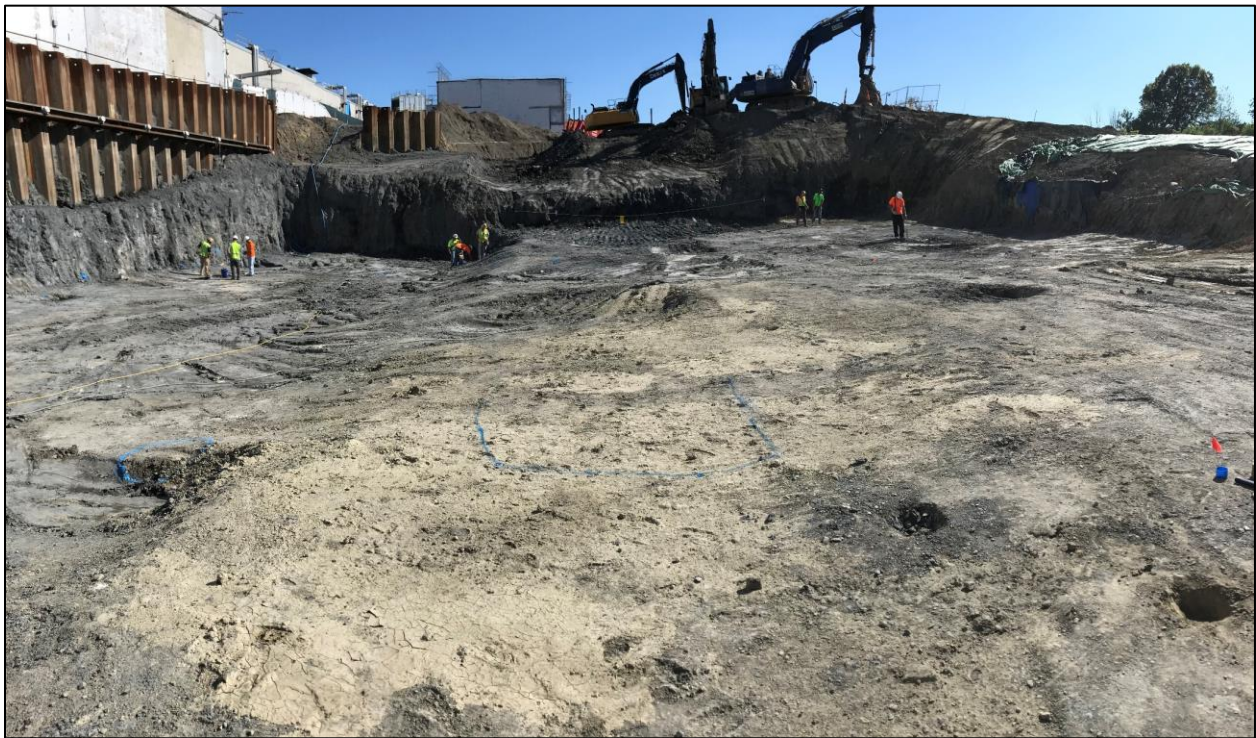
**Figure 39. H2 excavation during radiological and chemical verification sampling**

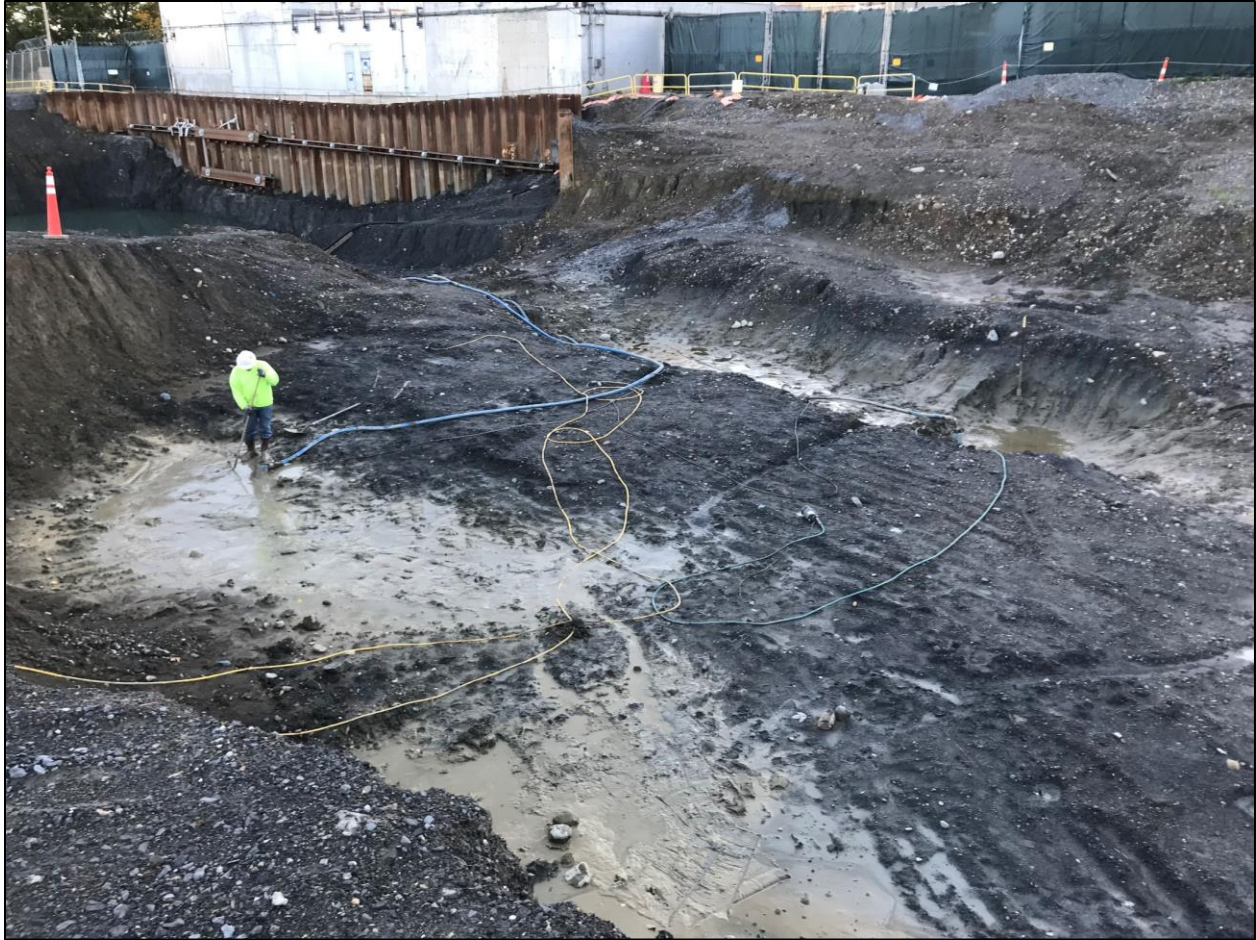
**Figure 40. G2 excavation being dewatered prior to backfill**

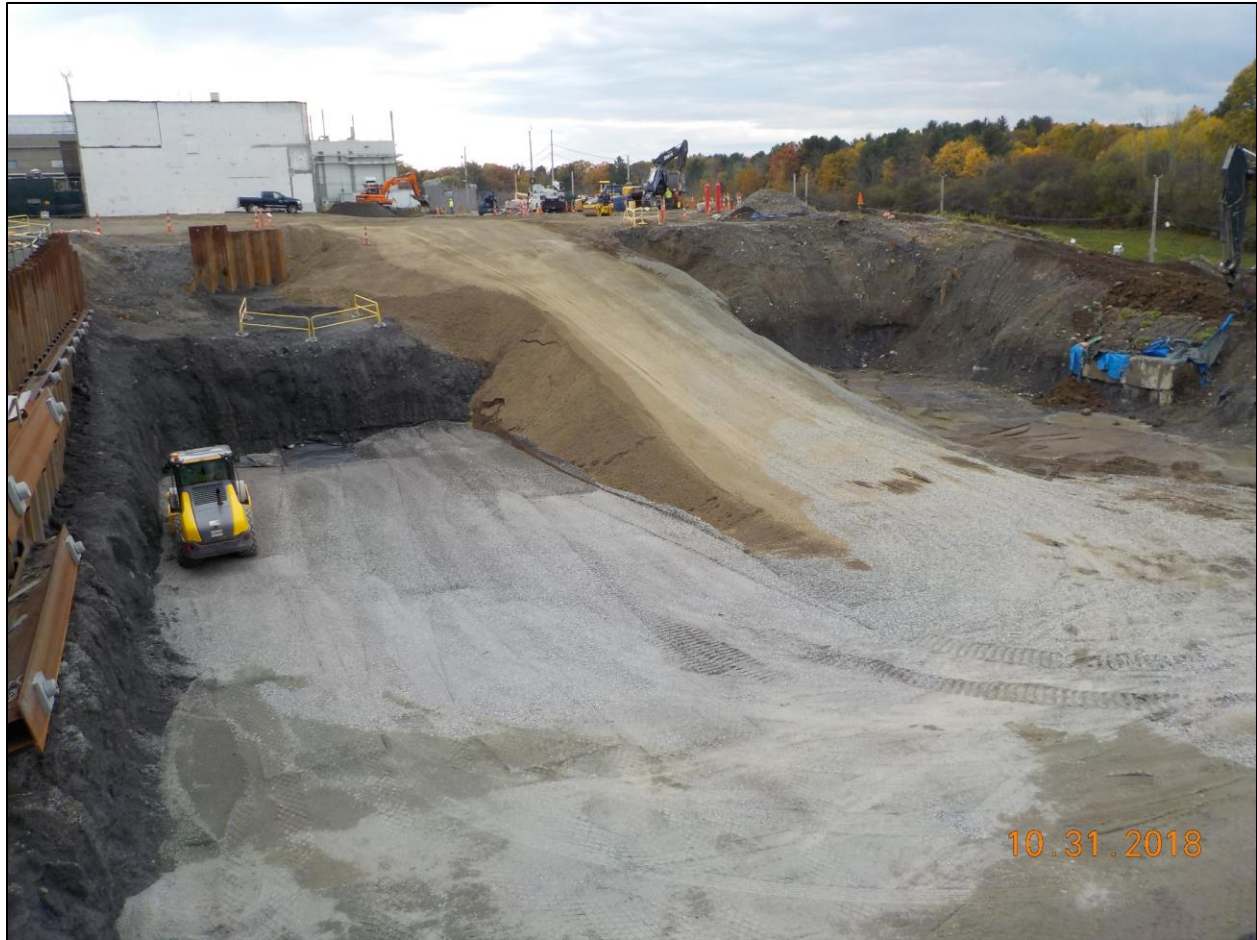
**Figure 41. H2 backfill using access ramp from G2 area**

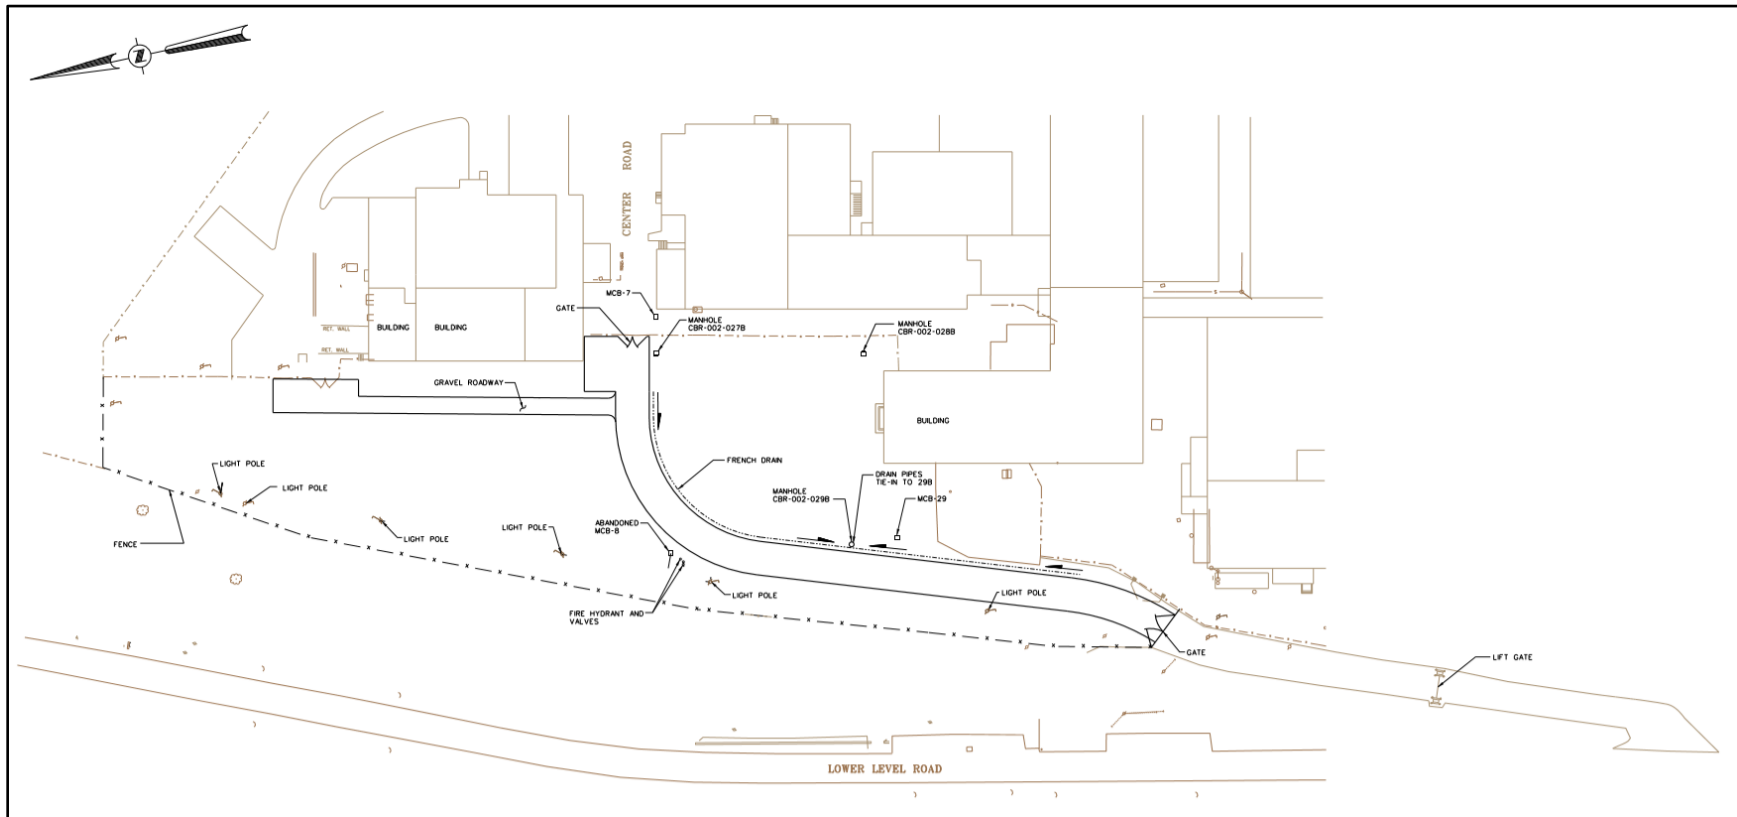
Figure 42. SPRU Upper Level layout after site restoration
