**SEPARATIONS PROCESS RESEARCH UNIT (SPRU)  
DISPOSITION PROJECT (DP)**

**SPRU PM-20-001**

**DEMOLITION COMPLETION REPORT  
FOR SPRU FACILITY**

**AECOM Energy & Construction, Inc.**

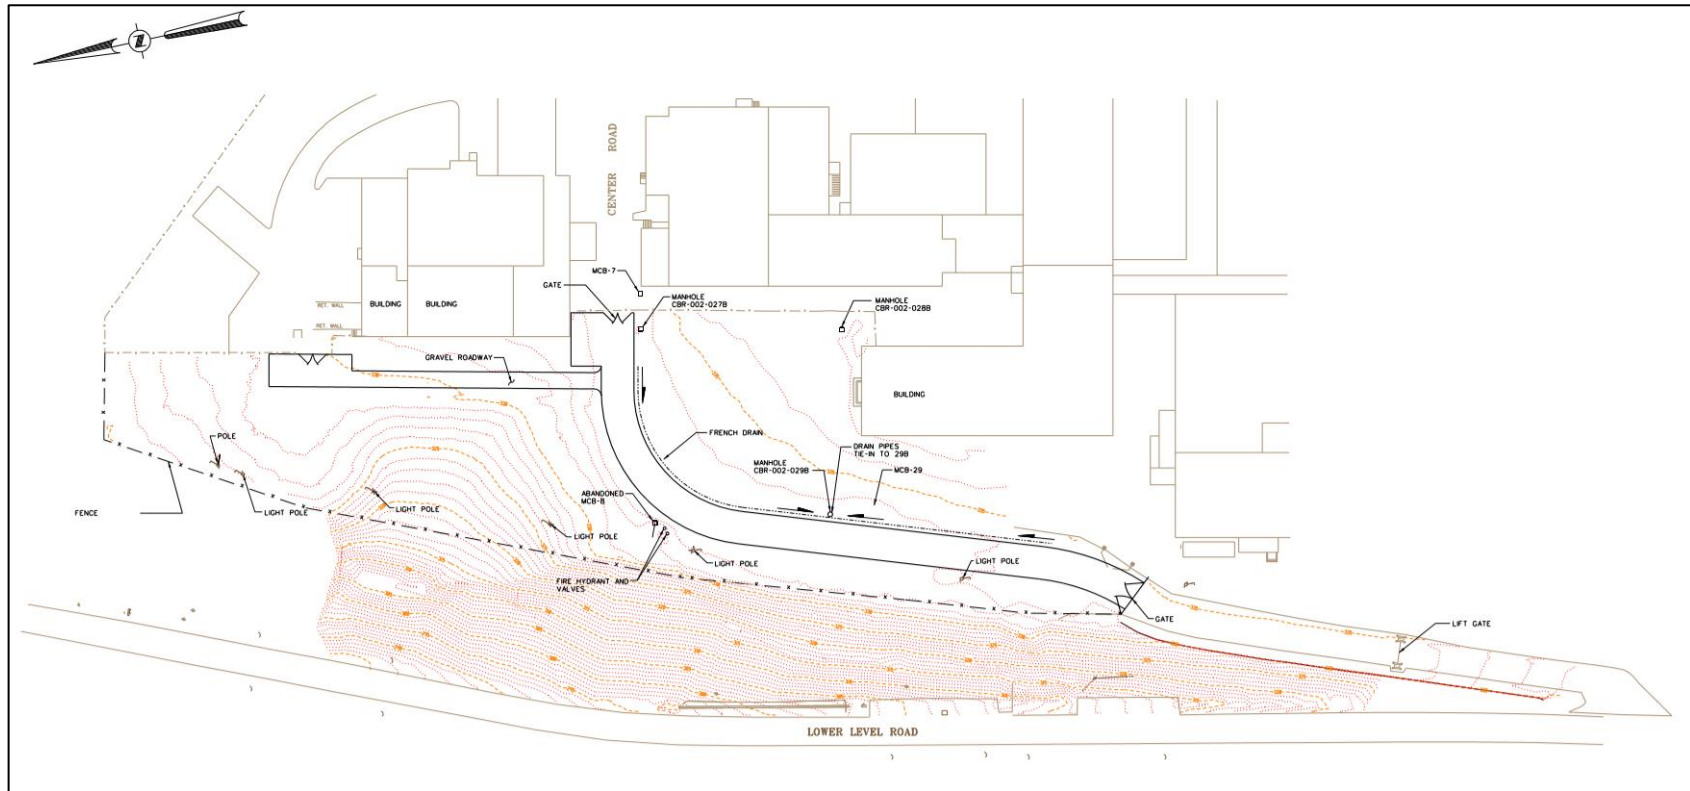
Figure 43. SPRU Upper Level contour map after site restoration

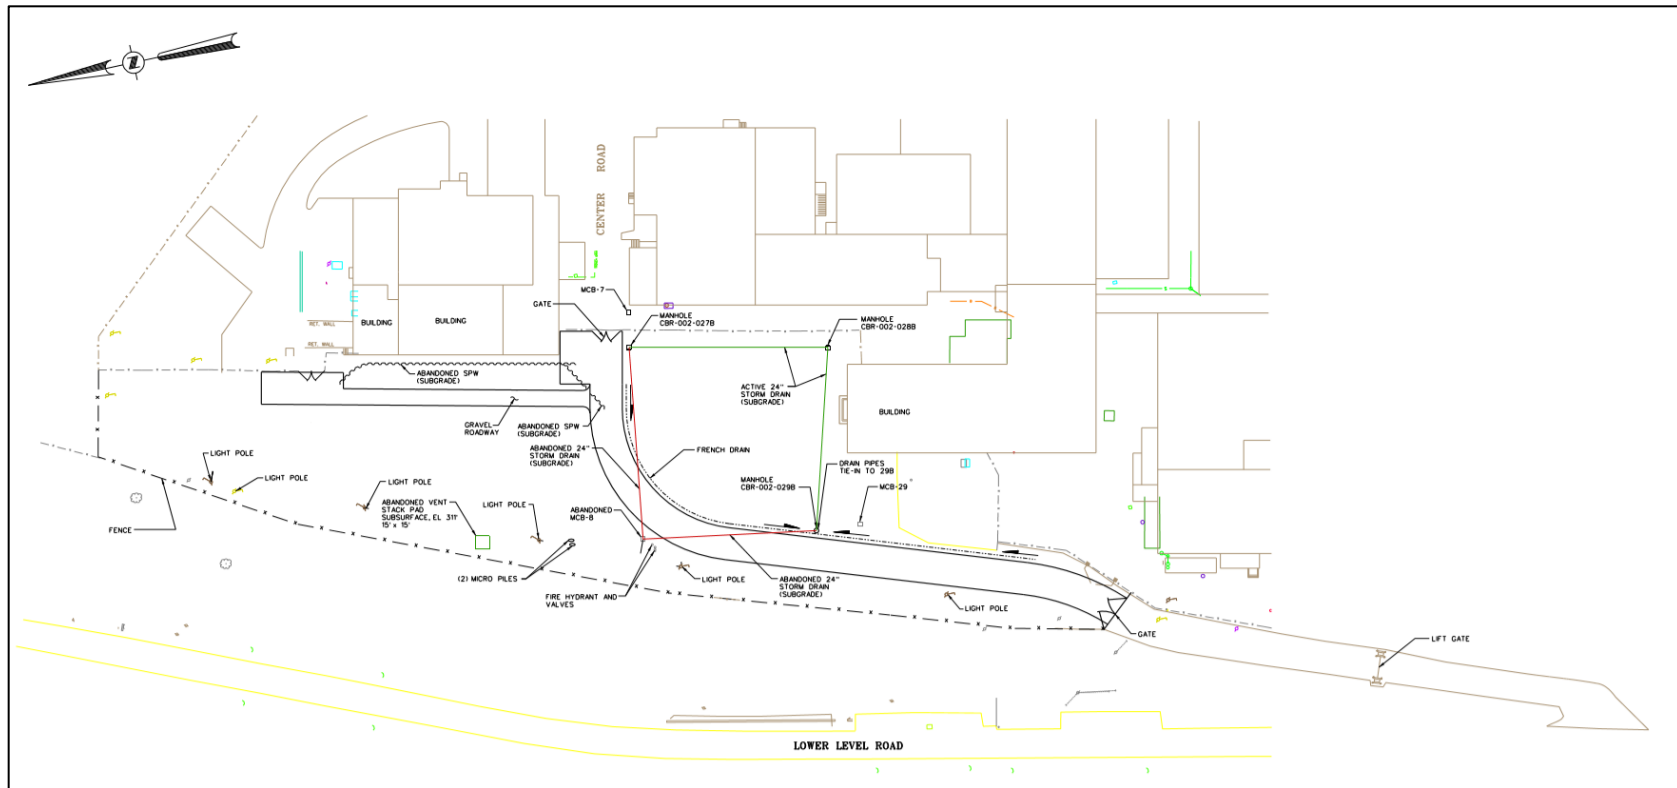
Figure 44. SPRU Upper Level showing sub-surface features remaining after restoration

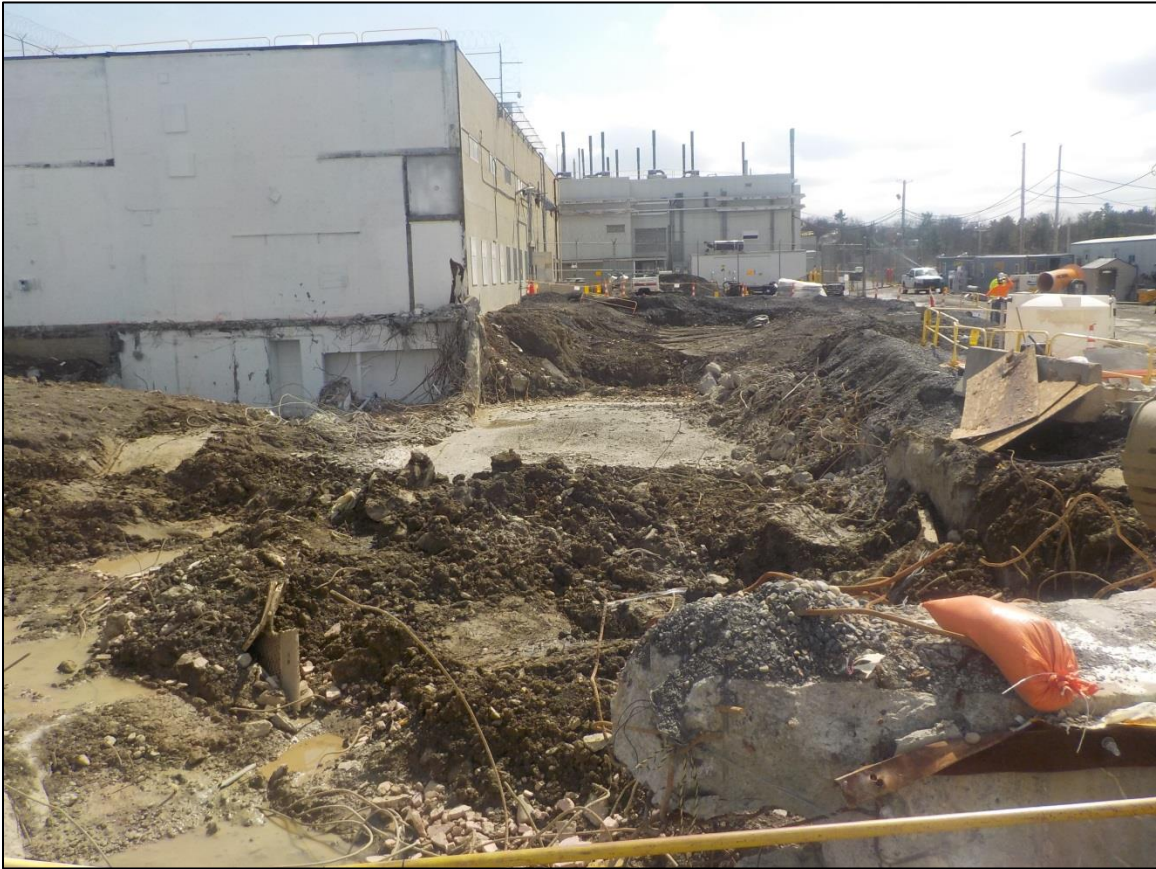
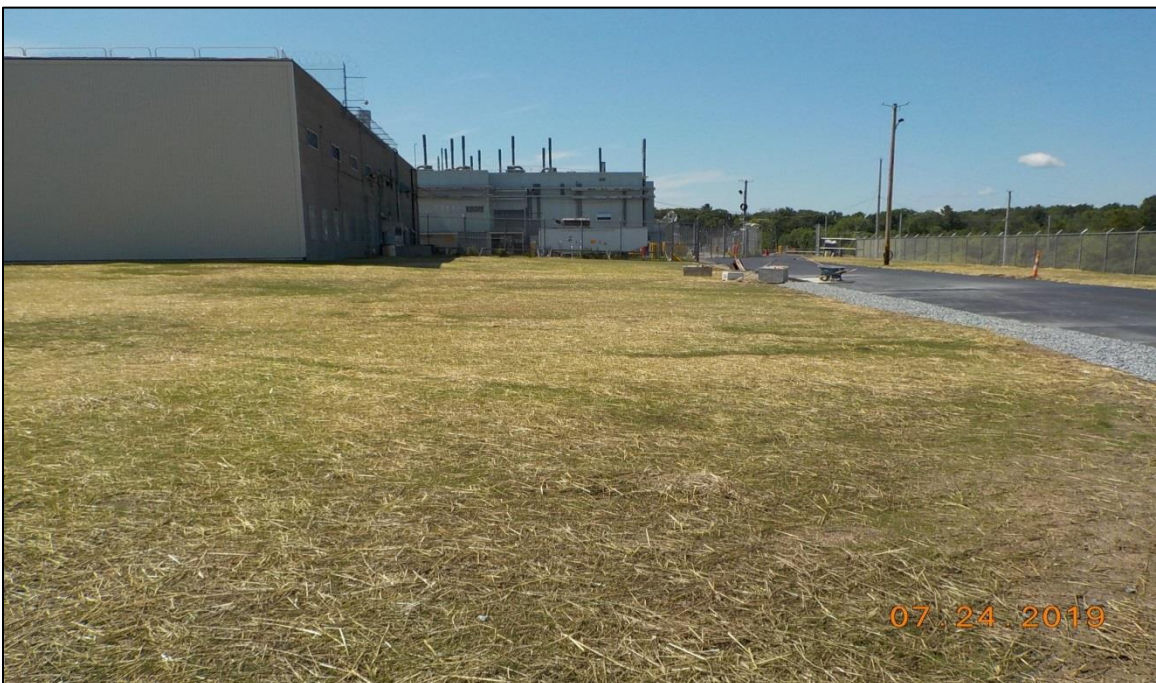
1. G2 area looking south at G1 April 12, 2017

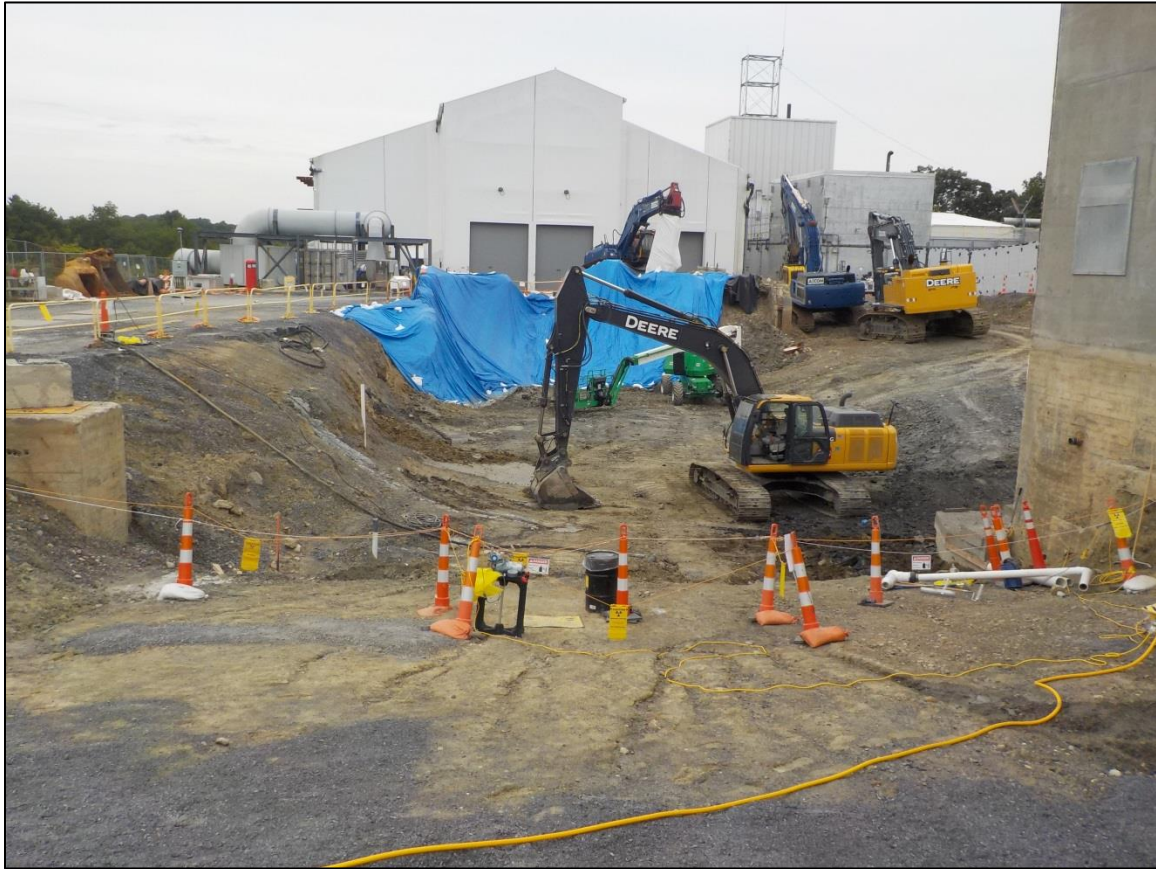
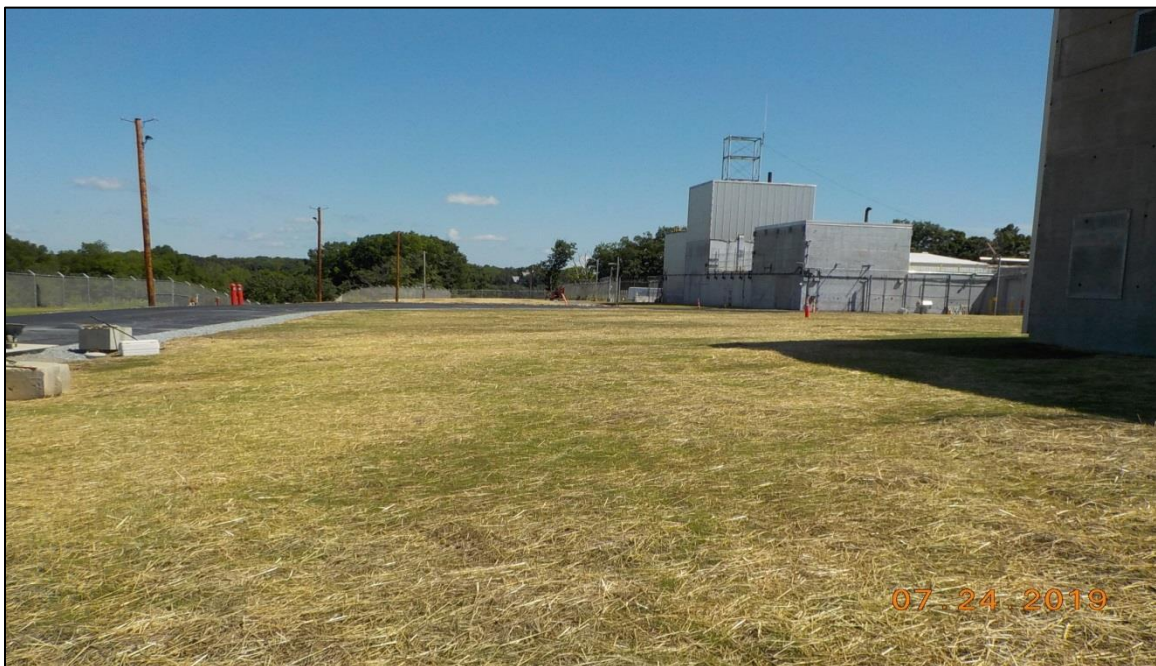
2. H2 Enclosure looking north over G2 area August 29, 2017

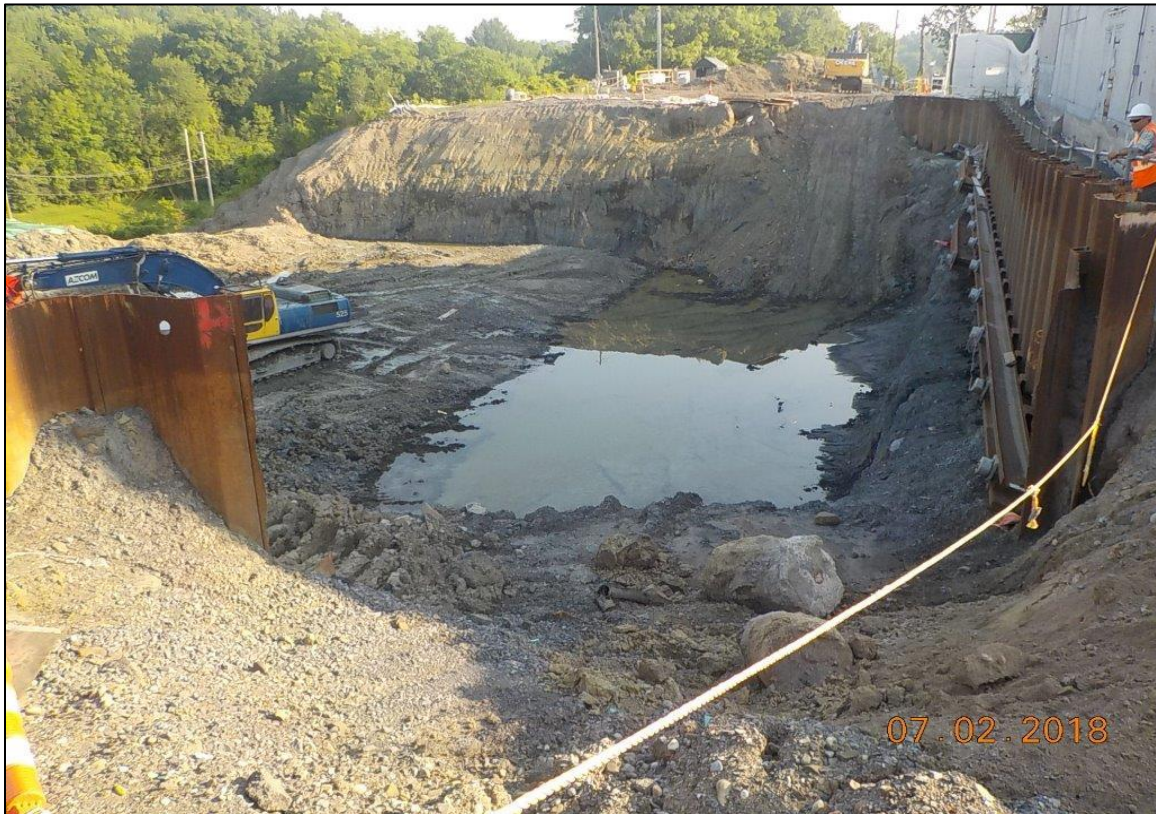
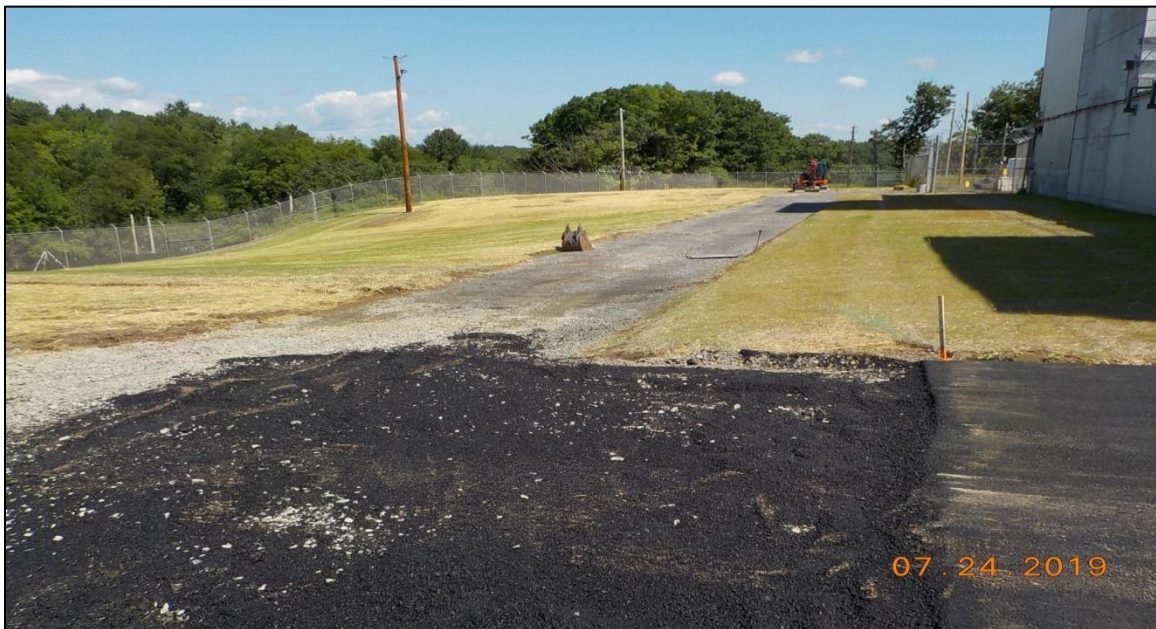
3. H2 Area looking north July 3, 2018

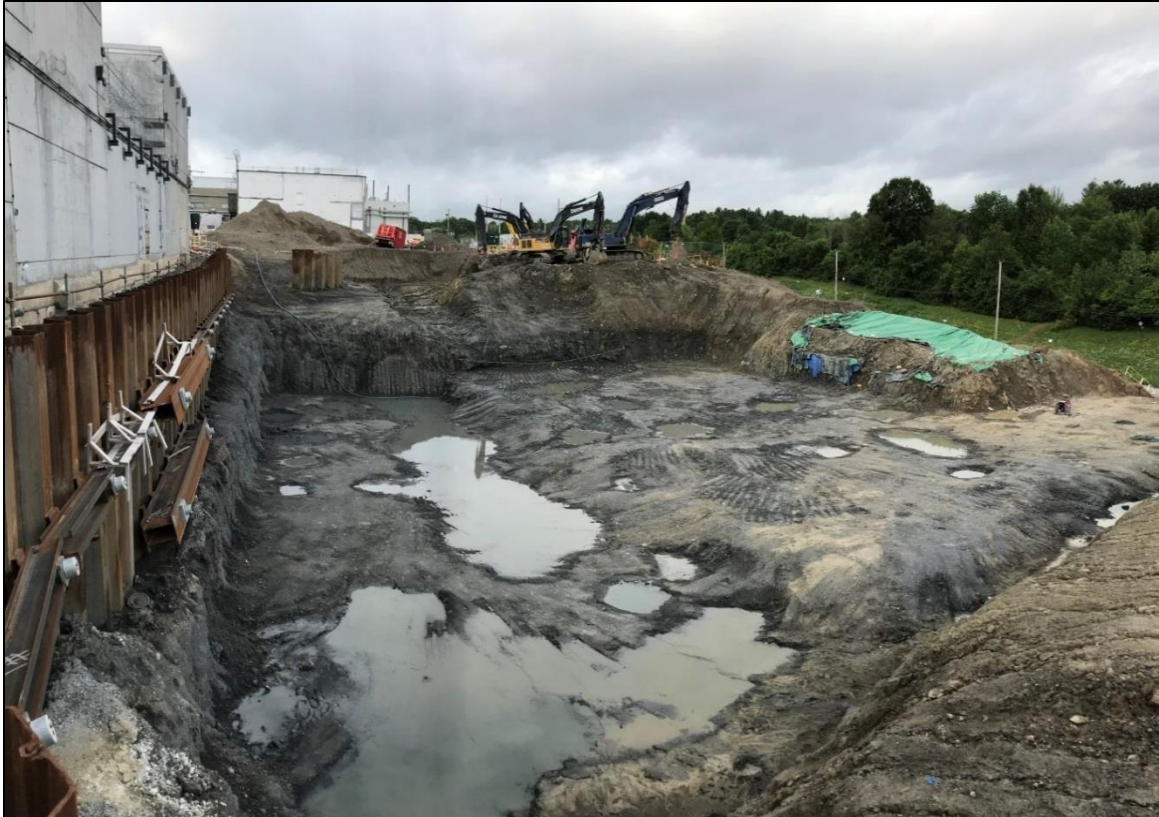
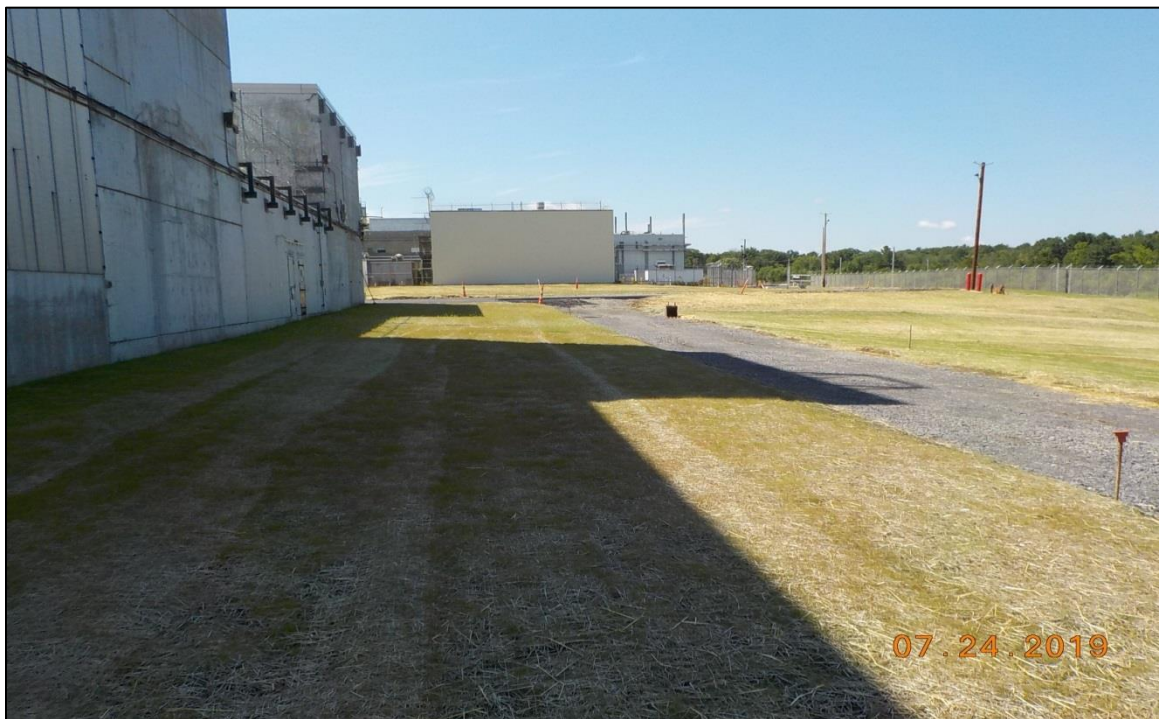
4. H2 footprint looking south July 25, 2018

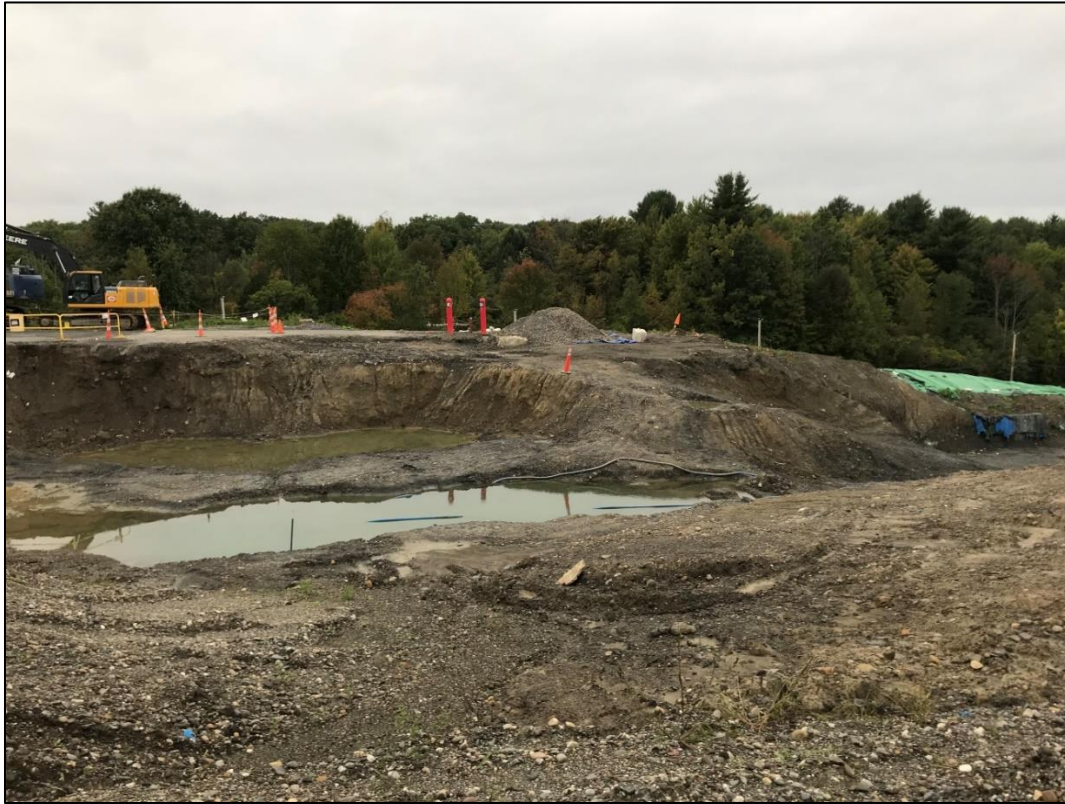
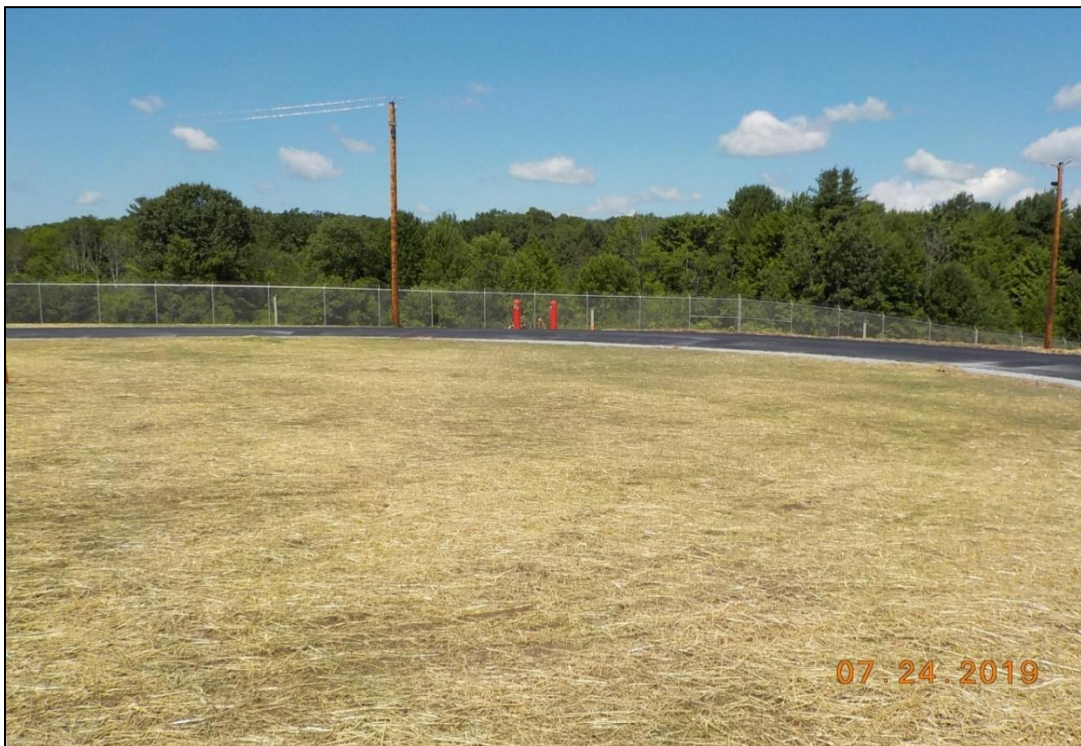
5. G2 Foot Print 10/1/2018

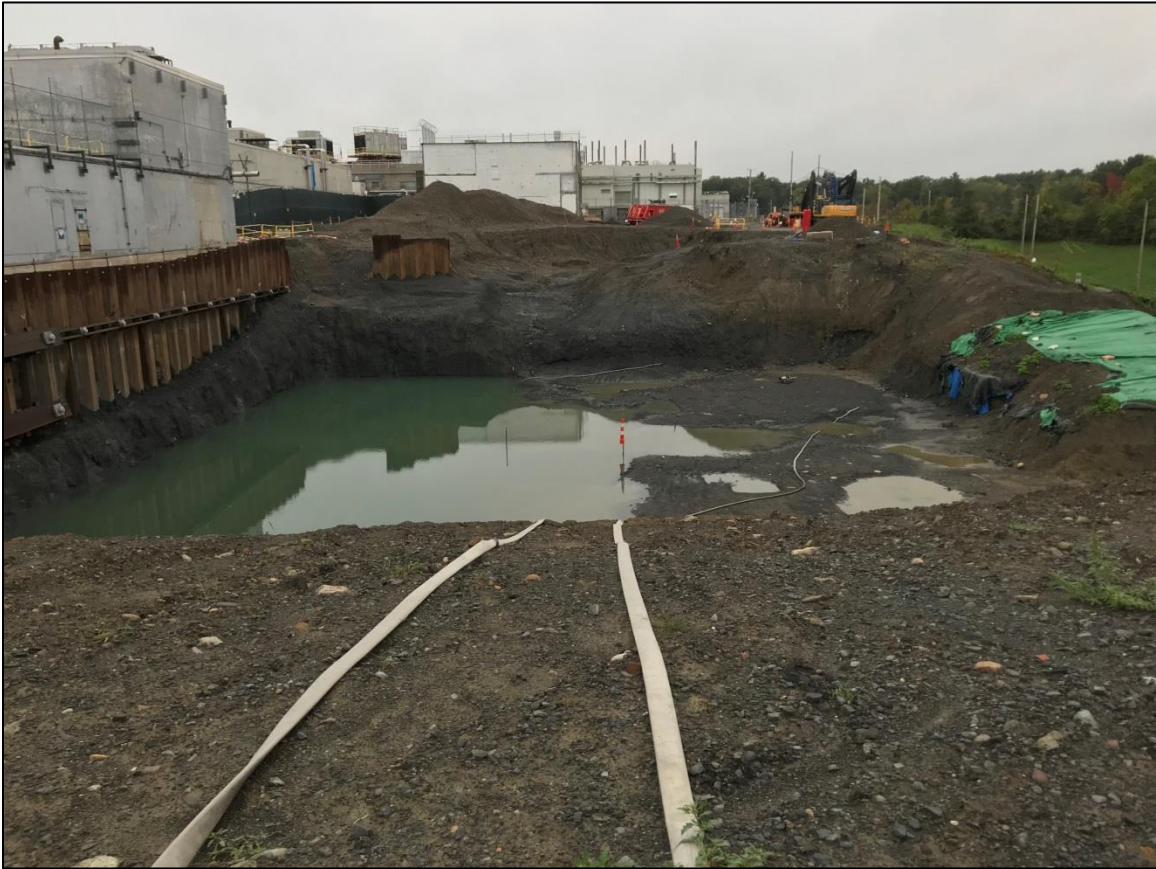
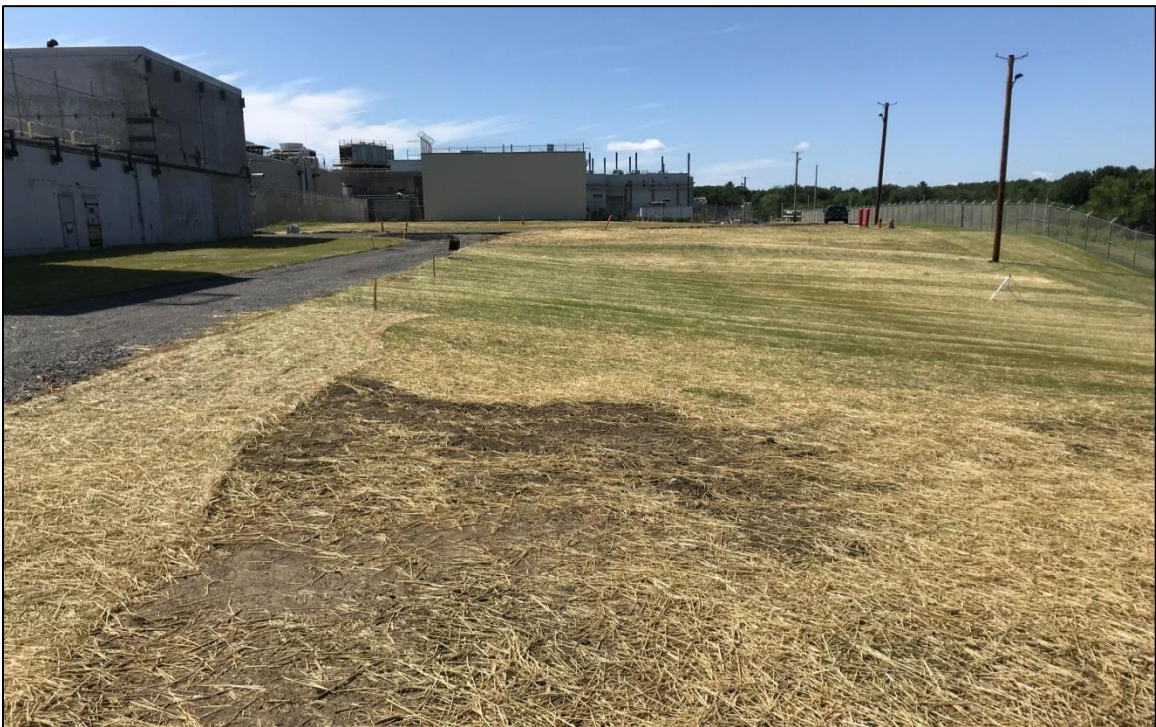
6. H2 Foot Print looking south October 4, 2018
