**SEPARATIONS PROCESS RESEARCH UNIT DISPOSITION PROJECT**

**SEPARATIONS PROCESS RESEARCH UNIT  
RADIOLOGICAL CLEANUP REPORT**

**SPRU EEC-20-002**

**April 23, 2020**

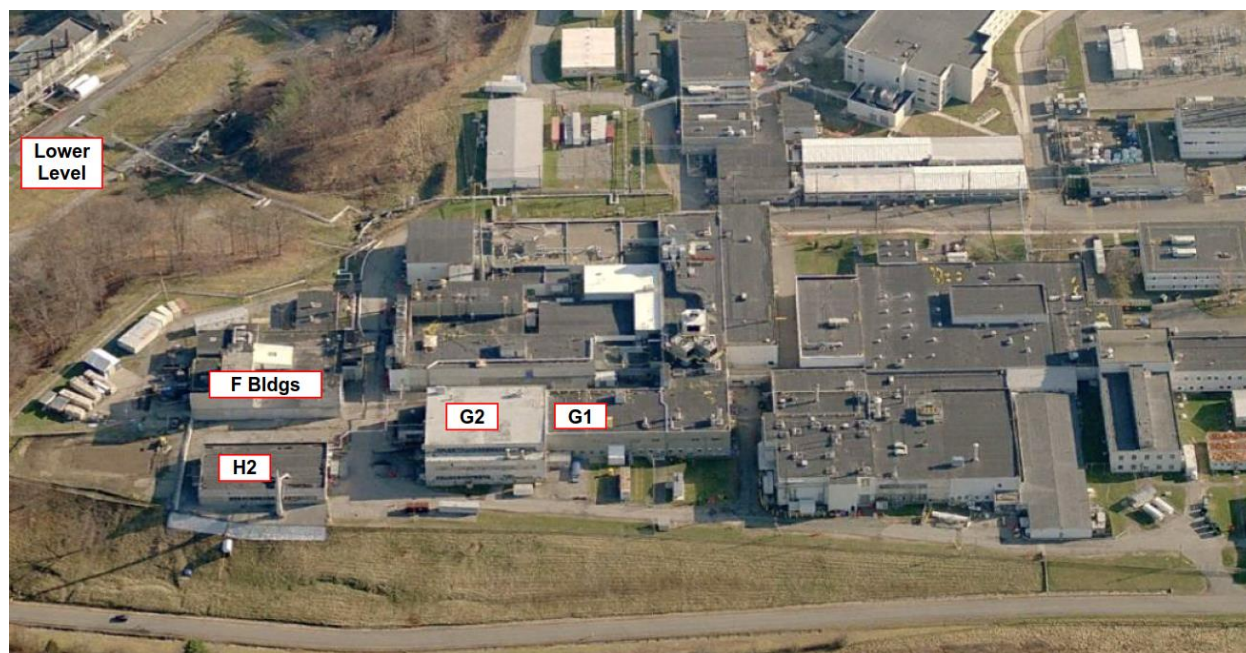
Figure 1. SPRU Site Prior to Decommissioning Project

SPRU facilities were constructed and operated from the late 1940s to the early 1950s at the Knolls Atomic Power Laboratory (KAPL) in Niskayuna, NY. SPRU consisted primarily of two Upper Level buildings, G2 and H2, to conduct research on the chemical separation of plutonium and uranium. After discontinuing operations in October 1953, SPRU was maintained in “caretaking status” until decommissioning began in 2000. The SPRU Upper Level site includes Buildings G2 and H2, surrounding asphalt and gravel roadways, and the hillside to the west as shown in the photograph in Figure 1.

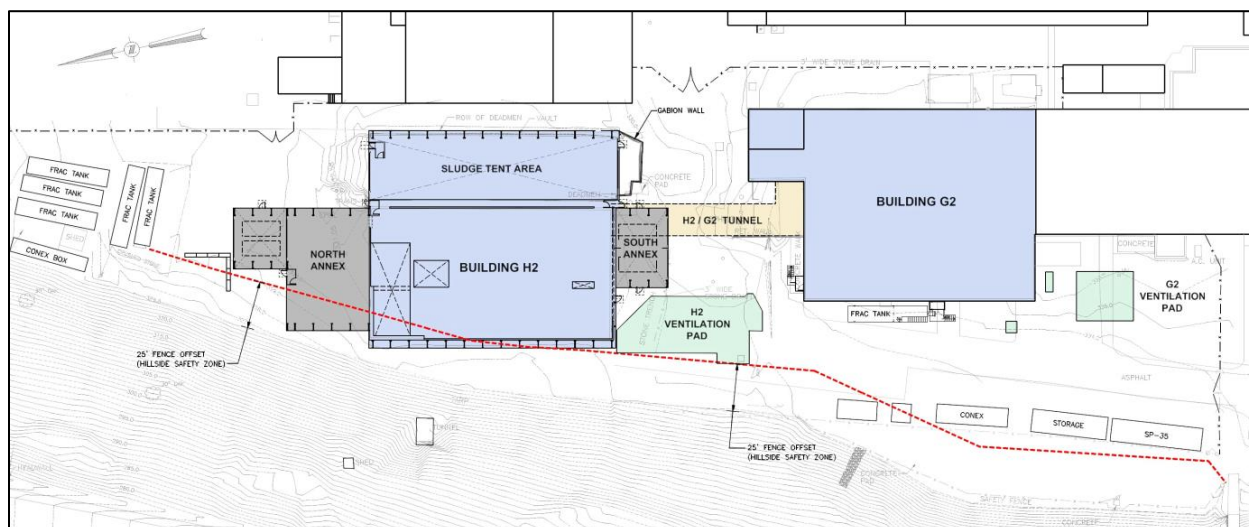
Figure 2. SPRU Upper Level Layout after Enclosure Construction

Initial decommissioning activities of the G2 and H2 buildings were started in 2010 using an open air approach for all structural demolition and remediation. After re-evaluation of the demolition approach and contamination control requirements, enclosures with filtered ventilation were constructed over both buildings in 2011–2013. Sludge from the H2 Vault tanks was processed and shipped for off-site disposal in 2013 and 2014. Equipment removal and decontamination of the G2 building interior and research cells was completed by June 2016, allowing for open air demolition of the remaining G2 structure. The first phase of the G2 demolition and remediation of the associated soil in the south end of the footprint was finished in July 2017. This area was surveyed and sampled as Survey Unit SU-51. Approval for backfill of the area was granted by DOE, and the area was backfilled in November 2017.

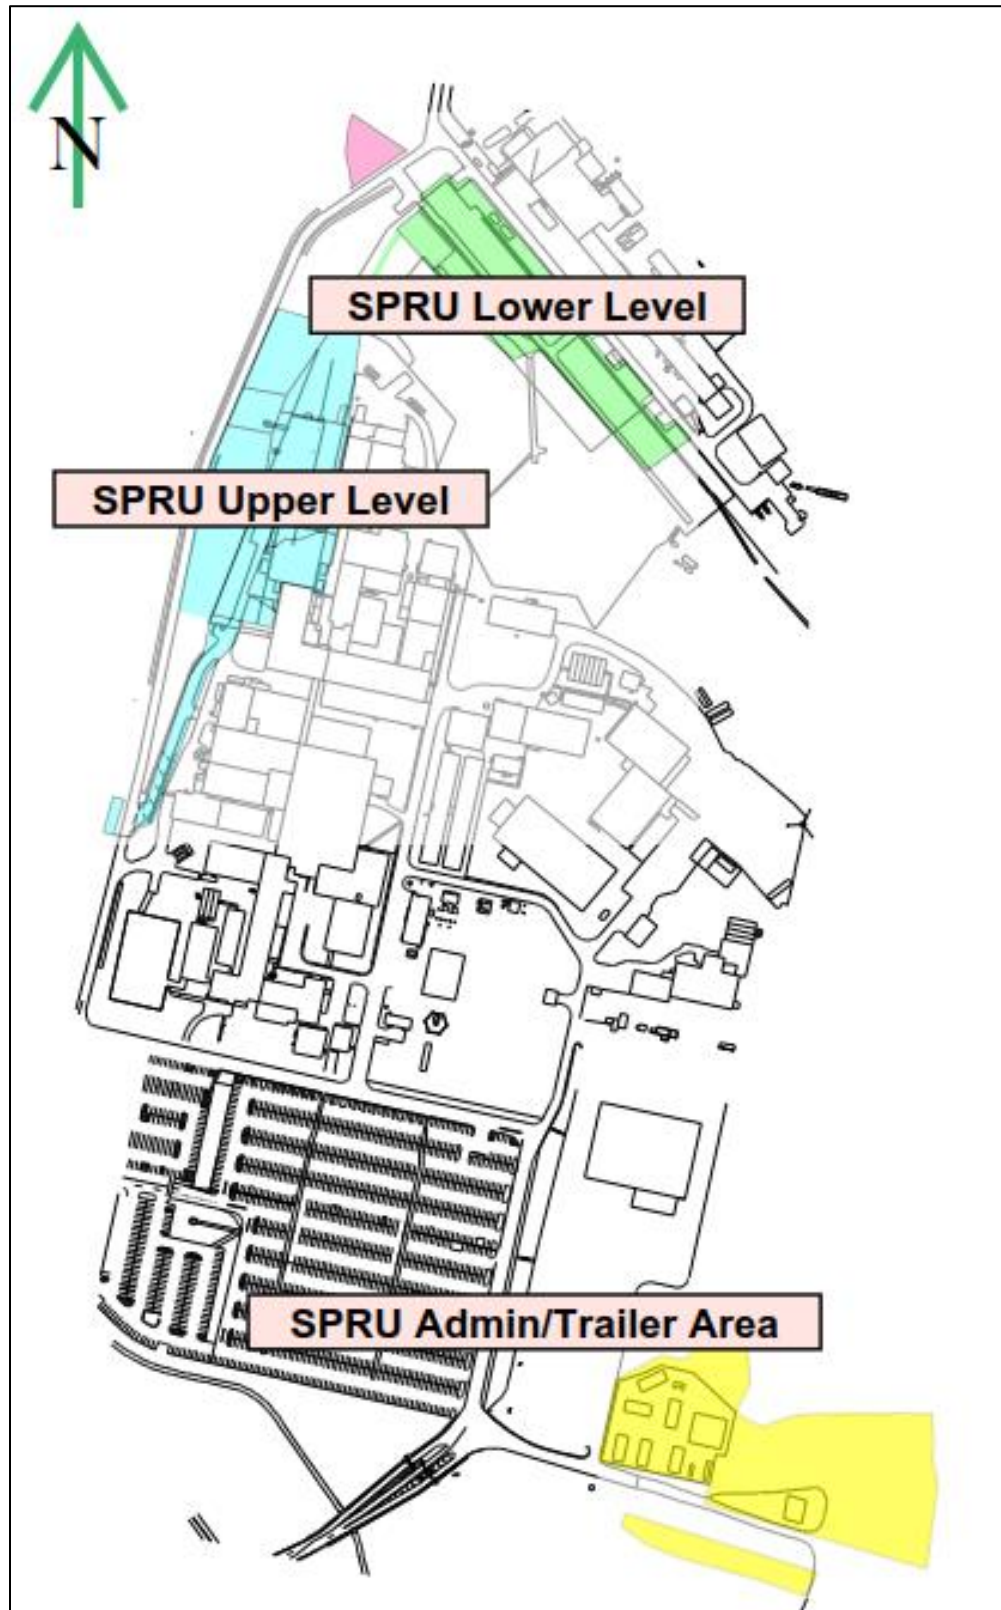
Figure 3. KAPL Site with SPRU areas in color

Surveys and sampling of the SPRU areas were performed to verify that the residual radioactivity remaining at the SPRU-DP site is below the levels specified in the Task Order. Sampling and Analysis Plans (SAPs) were developed for each survey unit in accordance with SPRU-RC-012, *Final Status Survey and Confirmation Sampling and Analysis Plan (FSS/CSAP)*. Figure 3 shows the KAPL site with the SPRU areas shown in color. The SPRU operational areas in the northwest are shown in greater detail in Figure 4. All of the administrative area in the southeast portion of the KAPL site is covered in Survey Unit 70, and is depicted in Figure 5.

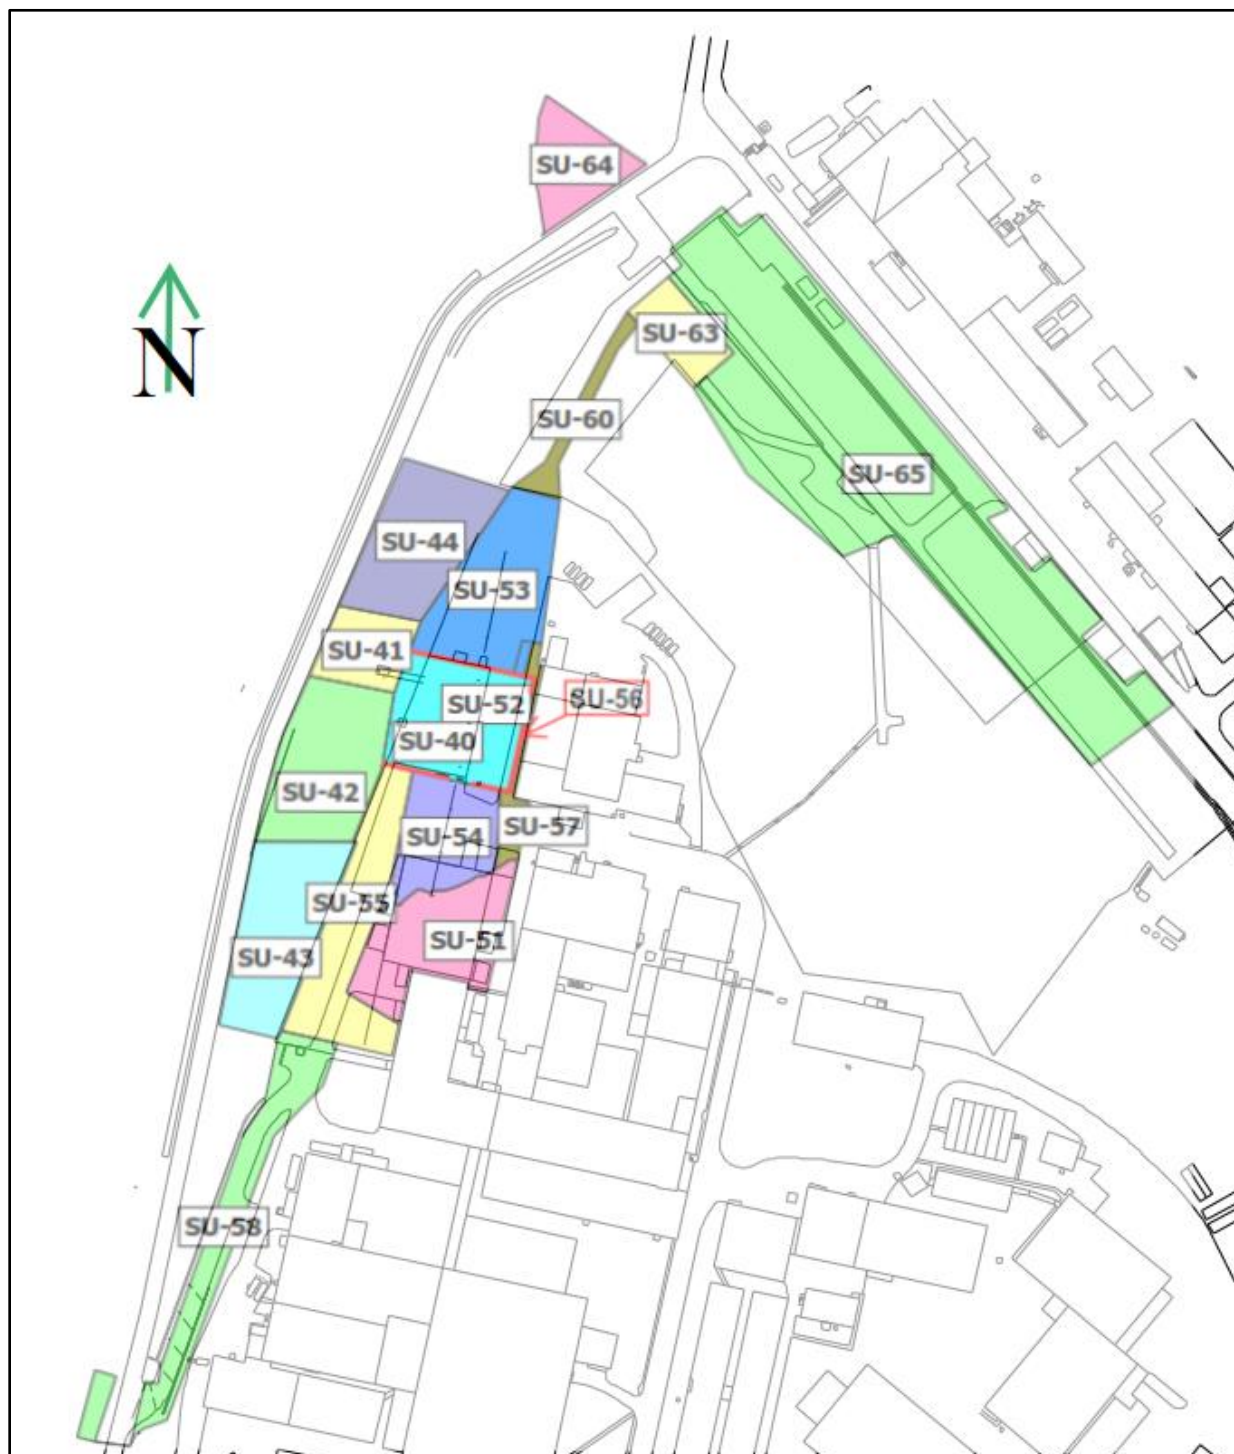
Figure 4. Survey Units in SPRU Operations Areas

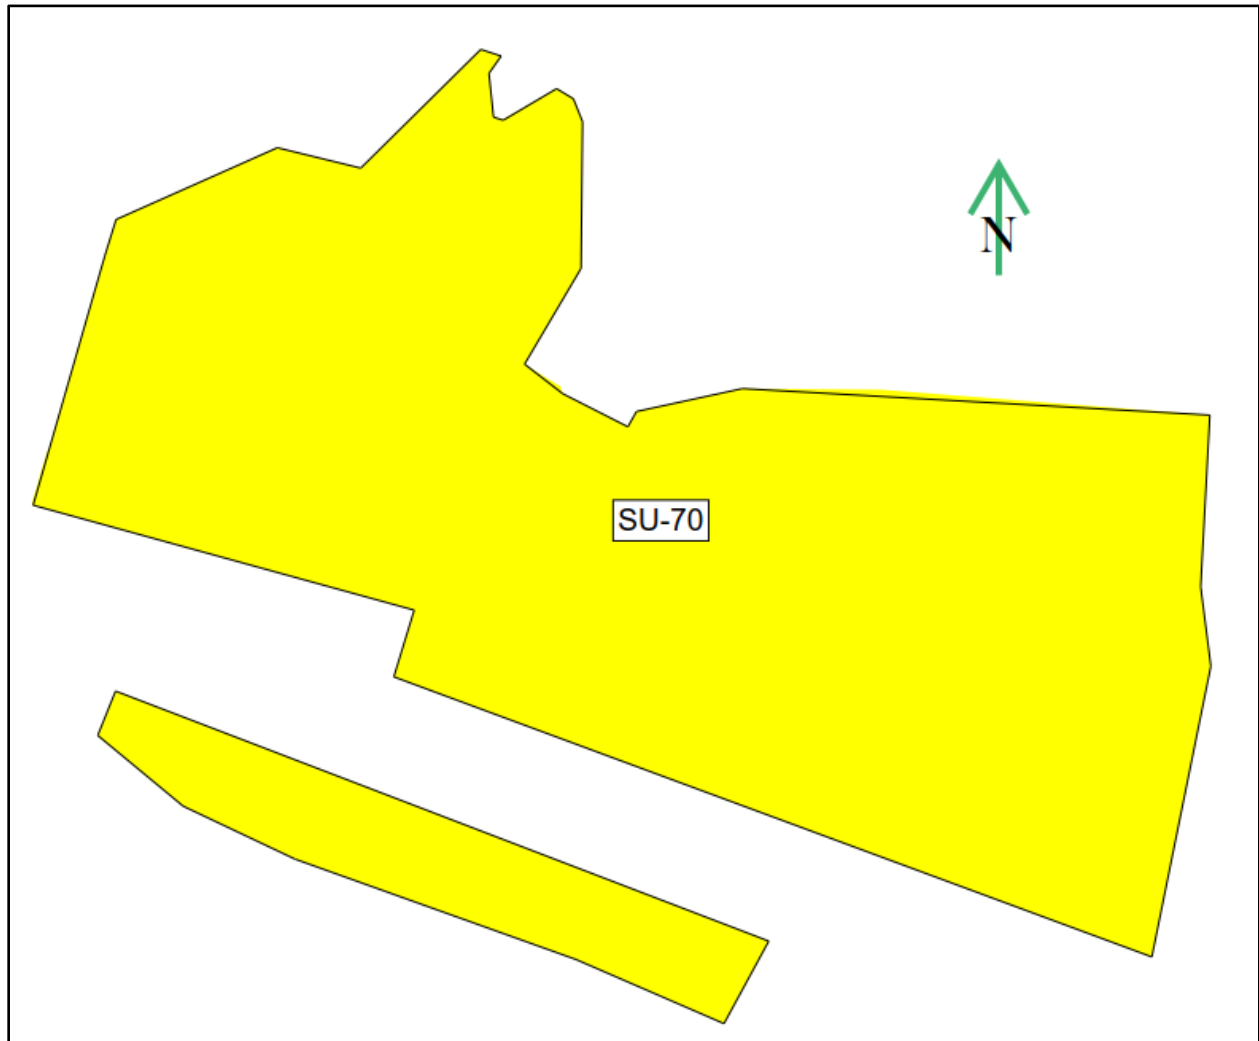
*Figure 5. Survey Unit SU-70 in Administrative - Trailer Area*
