**SEPARATIONS PROCESS RESEARCH UNIT  
DISPOSITION PROJECT**

**SPRU EEC-20-001**

**RCRA INTERIM CORRECTIVE MEASURES REPORT  
FOR UPPER LEVEL SWMUs and AOC**

**NYSDEC Hazardous Waste Facility Permit  
No. 4-4224-00024/00055**

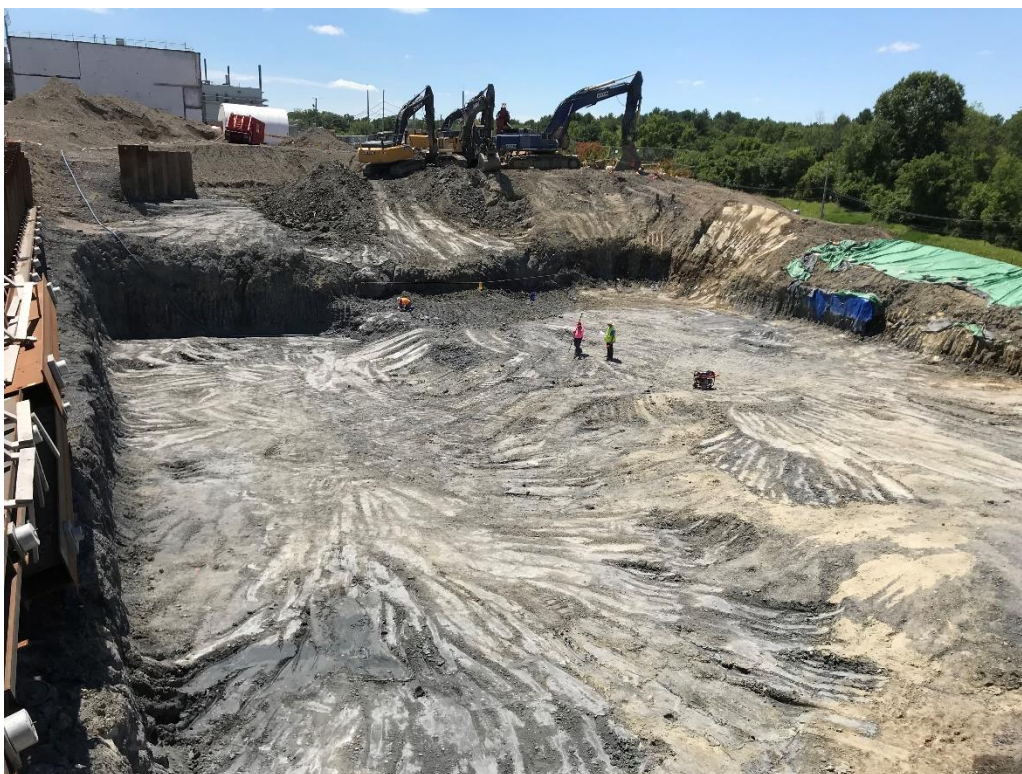
**Figure 8. H2 Excavation During Confirmation Sampling (July 21, 2018)**

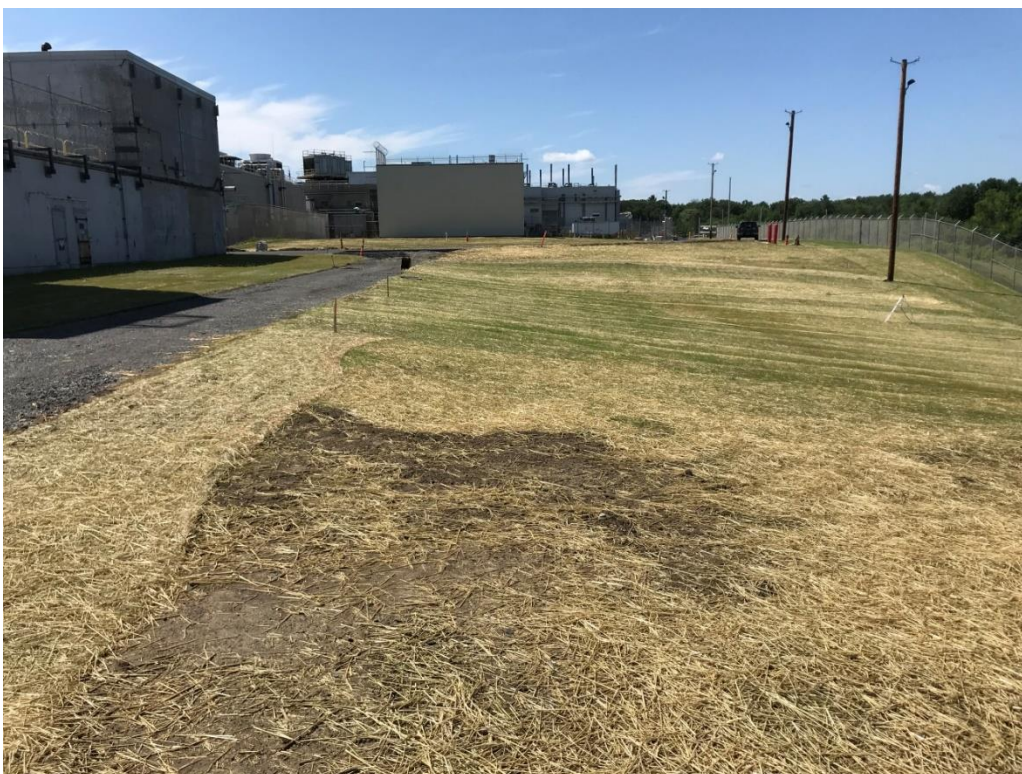
**Figure 9. H2 Footprint After Site Restoration (July 26, 2019)**

The layout of the restored Upper Level is shown in Figure 14, which can be compared to the pre-demolition site layout shown in Figure 2. For site restoration, an electronic file (D-size plot) of the final site layout and grading is provided in Appendix 2. This documents the final site conditions as required per DER-10 Section 5.8(b)(8). Photographs of the restored Upper Level SWMUs (H2 area) and the G2 AOC are provided in Figure 9 and Figure 11, respectively.

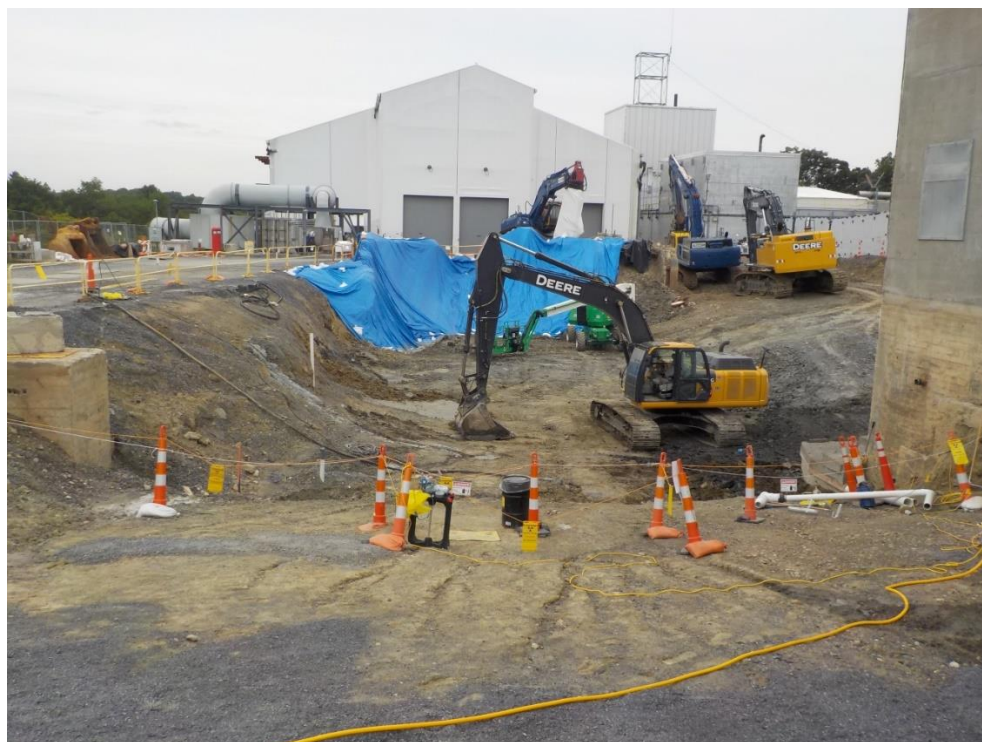
**Figure 10. G2 Excavation, Phase 1 (August 29, 2017)**

The G2 basement level concrete slab and contaminated soil were removed as part of corrective measure activities for the AOC. The entire G2 slab was removed except for a portion of the crossover corridor adjoining the G1 Building as shown in the G2 Work Plan. That portion of the G2 slab was left to avoid damage to the G1 Building and to support the new concrete walls installed to seal the previous entrances to the G1 basement. VOC samples collected from beneath this portion of the G2 slab did not exceed the SCO of 700 ppb (maximum toluene concentration was 55.8 ppb). Removal of the G2 basement slab and external walls on the north and west sides was conducted in two phases to maintain access on the roadway passing north of G2. Phase 1 of the excavation involved removing the southern part of the basement area and western wall to within approximately 10 to 15 feet south of the northwest corner (Figure 10). Phase 2 of the excavation involved removing the remaining slab and walls at the same time as the H2/G2 tunnel (SWMU-057) excavation and removal. Engineering controls were conducted during excavation, including benching of the slope embankment, to minimize intrusion into the adjoining KAPL VOC AOC. Figure 11 shows the G2 Area after final restoration.

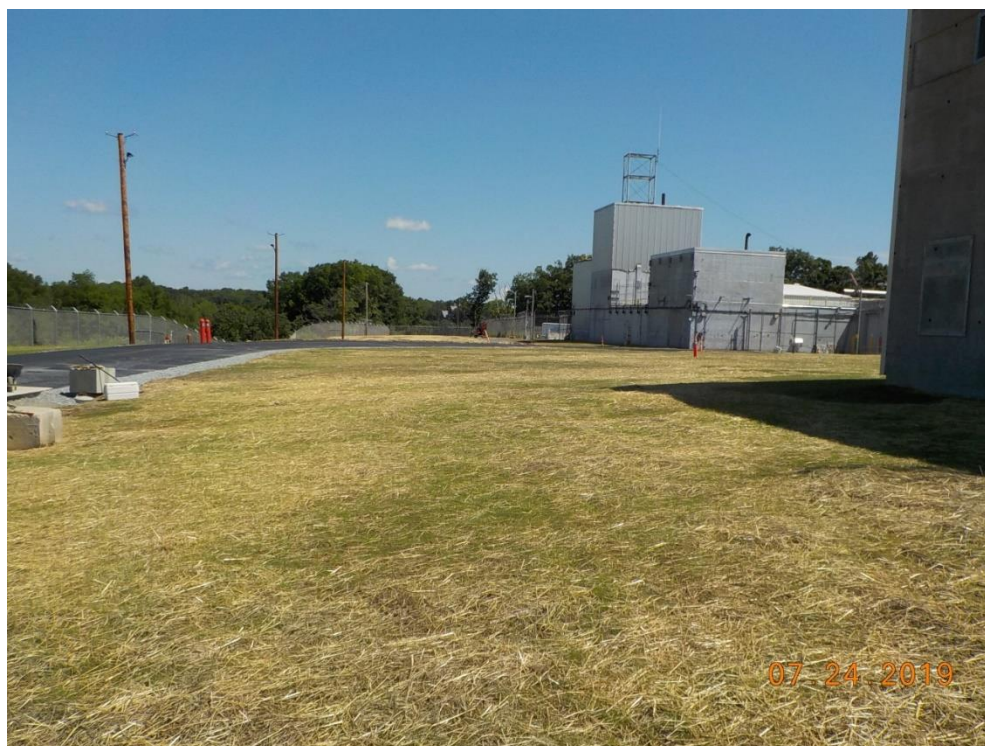
**Figure 11. G2 Area After Final Restoration (July 24, 2019)**
