**FINAL
TECHNICAL MEMORANDUM
SUBAREA HSA-5B
HISTORICAL SITE ASSESSMENT
SANTA SUSANA FIELD LABORATORY SITE
AREA IV RADIOLOGICAL STUDY
VENTURA COUNTY, CALIFORNIA**

**EPA Contract Number EP-S7-05-05
Task Order Number: 0038**

**HydroGeoLogic, Inc.
Northway 10 Executive Park
313 Ushers Road
Ballston Lake, New York 12019**

October 2012

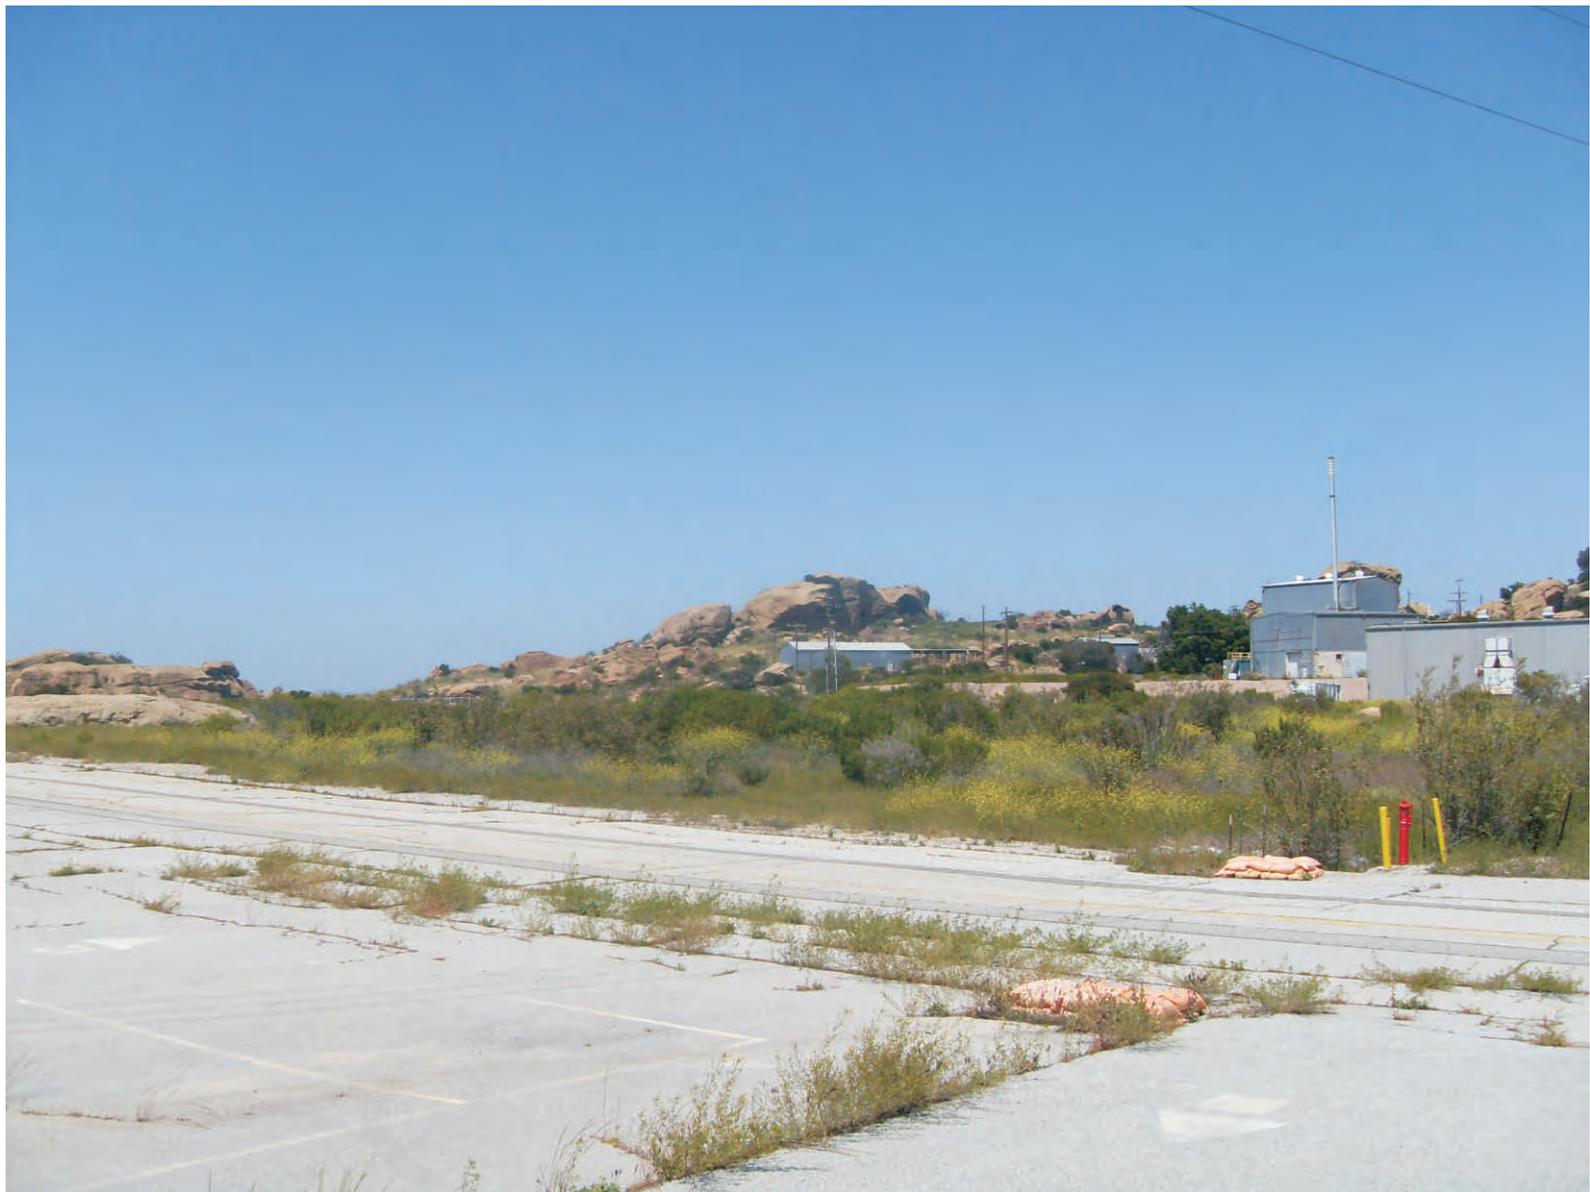
Figure 2.5.1a
Building 4334
Site Photograph

Site Description: The Building 4334 area comprises Building 4334 and the land surrounding it east of 20th Street. Building 4334 was constructed in 1991 as part of the Kalina Cycle Demonstration Power Plant.¹ Building 4334 was the Kalina Control Room and Office Building. It was located near Kalina Turbine Generator Building 4335, which is discussed later in this section.² Together, Buildings 4334 and 4335 were known as the Kalina Complex. Figure 2.5.1a provides a current photograph. The research team was unable to find building-specific drawing(s). The Kalina Complex was located southwest of Small Component Test Loop Buildings 4026 and 4226. These buildings are discussed elsewhere in this section. No as-built drawings were located for Building 4334. Plate 1 presents a summary of all identified features for this site.

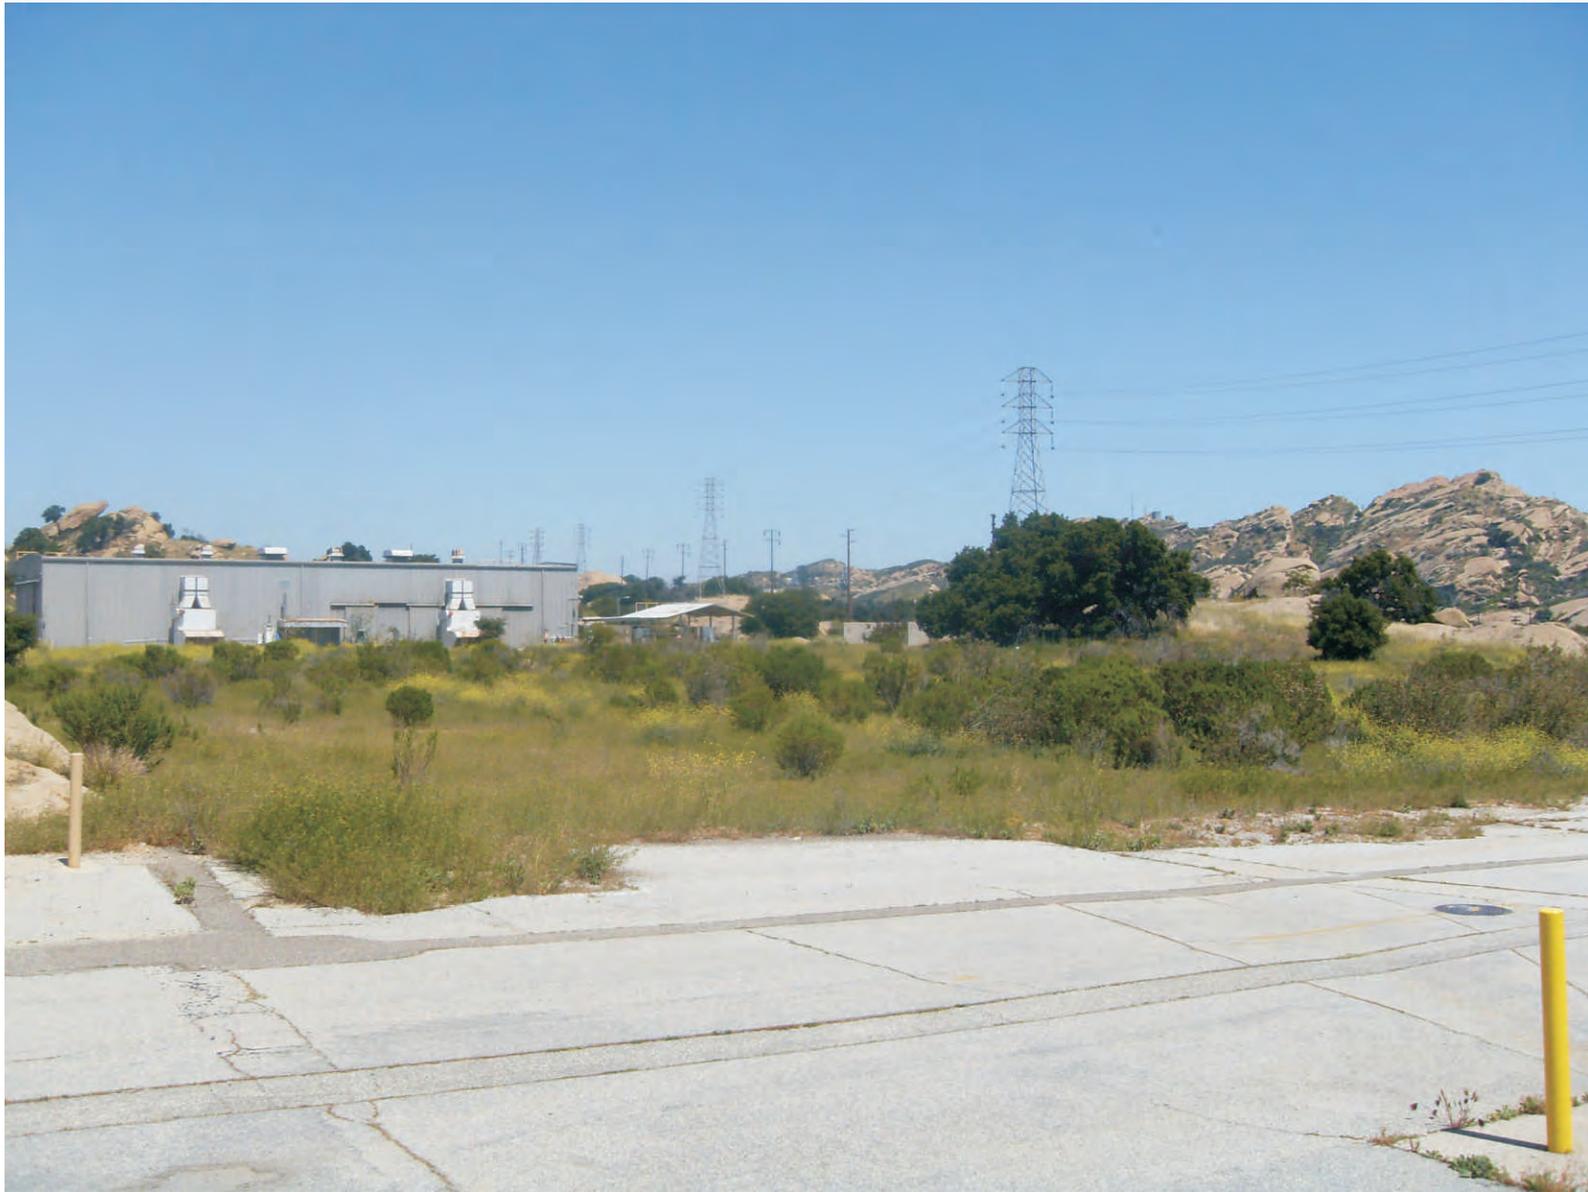
Figure 2.5.2a
Building 4335
Site Photograph

section.¹ Together, Buildings 4334 and 4335 were known as the Kalina Complex. Figure 2.5.2a provides a current photograph. The research team was unable to find building-specific drawing(s). The Kalina Complex was located southwest of Small Component Test Loop Buildings 4026 and 4226. These buildings are discussed elsewhere in this section. No as-built drawings were located for Building 4335. Plate 1 presents a summary of all identified features for this site.
