**20 ELEMENTS OF THE SANTA SUSANA FIELD LABORATORY
SITE CONCEPTUAL MODEL OF CONTAMINANT TRANSPORT**

SITE CONCEPTUAL MODEL ELEMENT DOCUMENT 4-1

Characteristics of Joints at the Santa Susana Field Laboratory, Simi, California

Date: December 10, 2009

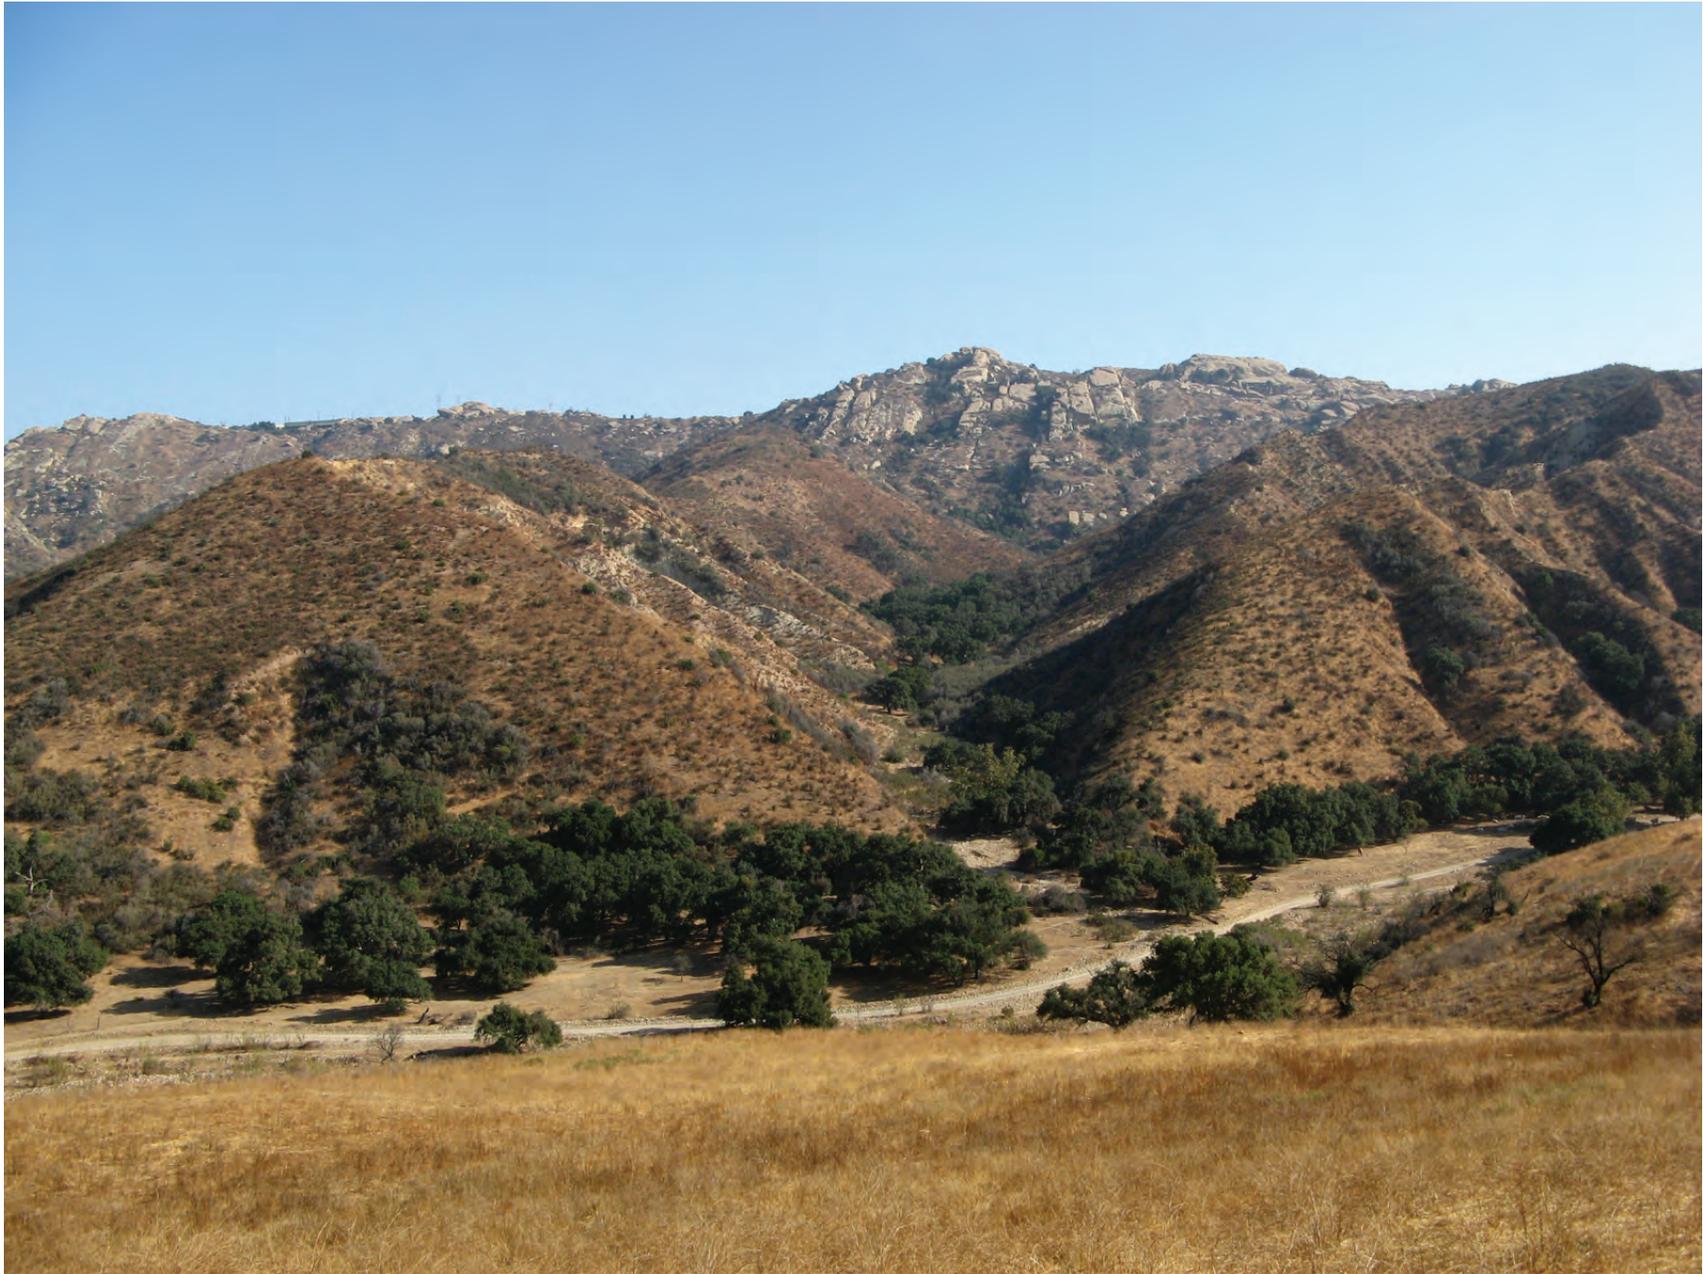
Figure 7. Field photo MP4219. View S10E from Meier Canyon towards Chatsworth sandstone along the north boundary of SSFL. This sandstone, with its prominent north trending joint set, is also shown in the Figure 6 Google Earth™ image.

Unimodal Joint Pattern The simplest joint pattern in the Chatsworth sandstone is that of joints with a single trend (unimodal joint pattern). Such a pattern is characteristic of the thick sandstone in the uppermost part of the Chatsworth Formation exposed along the northern perimeter of the SSFL. Here, as shown on **Figure 6**, the thick sandstone beds have a well-developed set of NNW joints. The sandstone here forms a dip slope (a slope parallel to the bedding dip) and the joints trend down-dip with visible lengths up to 400 ft and with a few visible joints oriented ENE across this trend. Field photo MP4219 (**Fig. 7**) shows a ground view of this dip slope from the north.

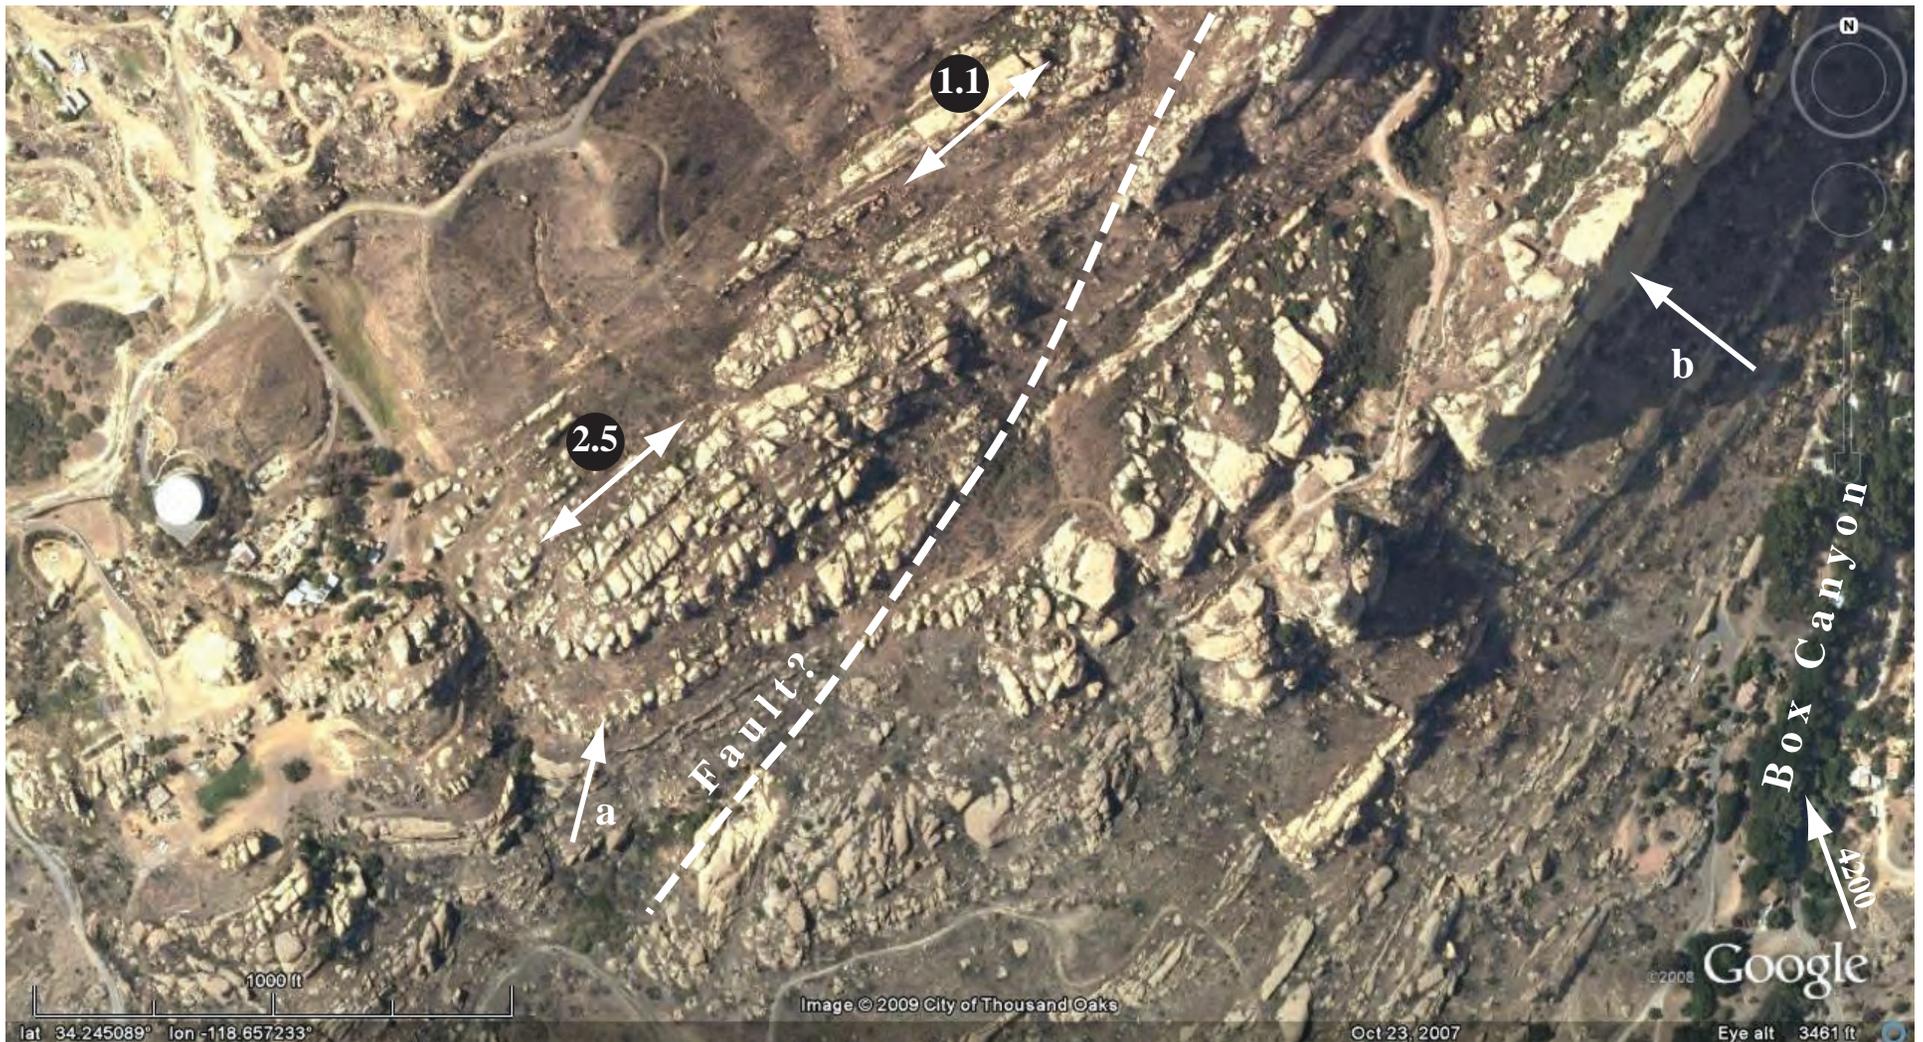
Figure 8. Google Earth™ image location 8 (see Fig. 5 for location). This image shows the joint patterns in the area just west of Box Canyon. Note strong joint pattern in the west central part of this Google Earth image. Here the NE trending joints are the best expressed with the NW trending set possibly representing a later set of joints forming between the more dominant NE trending set. The “a” arrow points to a bed of Chatsworth sandstone that thickens northeast-ward. Note that the joint density in this bed decreases from ~2.5/100 ft on the west to ~1.1/100 ft on the east where the bed appears to be thicker. The “b” arrow points to an ~120 ft thick bed of sandstone with a very low joint density (<0.1/100 ft) in the vicinity of the arrow but with a gradually increasing density southwestward. Possibly this increased density is related to the minor fault (?) crossing the SW end of the thick sandstone bed. The arrow in the lower right corner is the view direction of field photo MP4200 (see Fig. 9).

outcrops to the northeast of the SSFL north of Woolsey Canyon Road. This area is shown in the **Figure 8** Google Earth™ image and another view is shown in field photo MP4200 (**Fig. 9**). In the **Figure 8** area, exposed on bare dip slopes, joints trend both ENE parallel to bedding strike and NNW in the down dip direction.

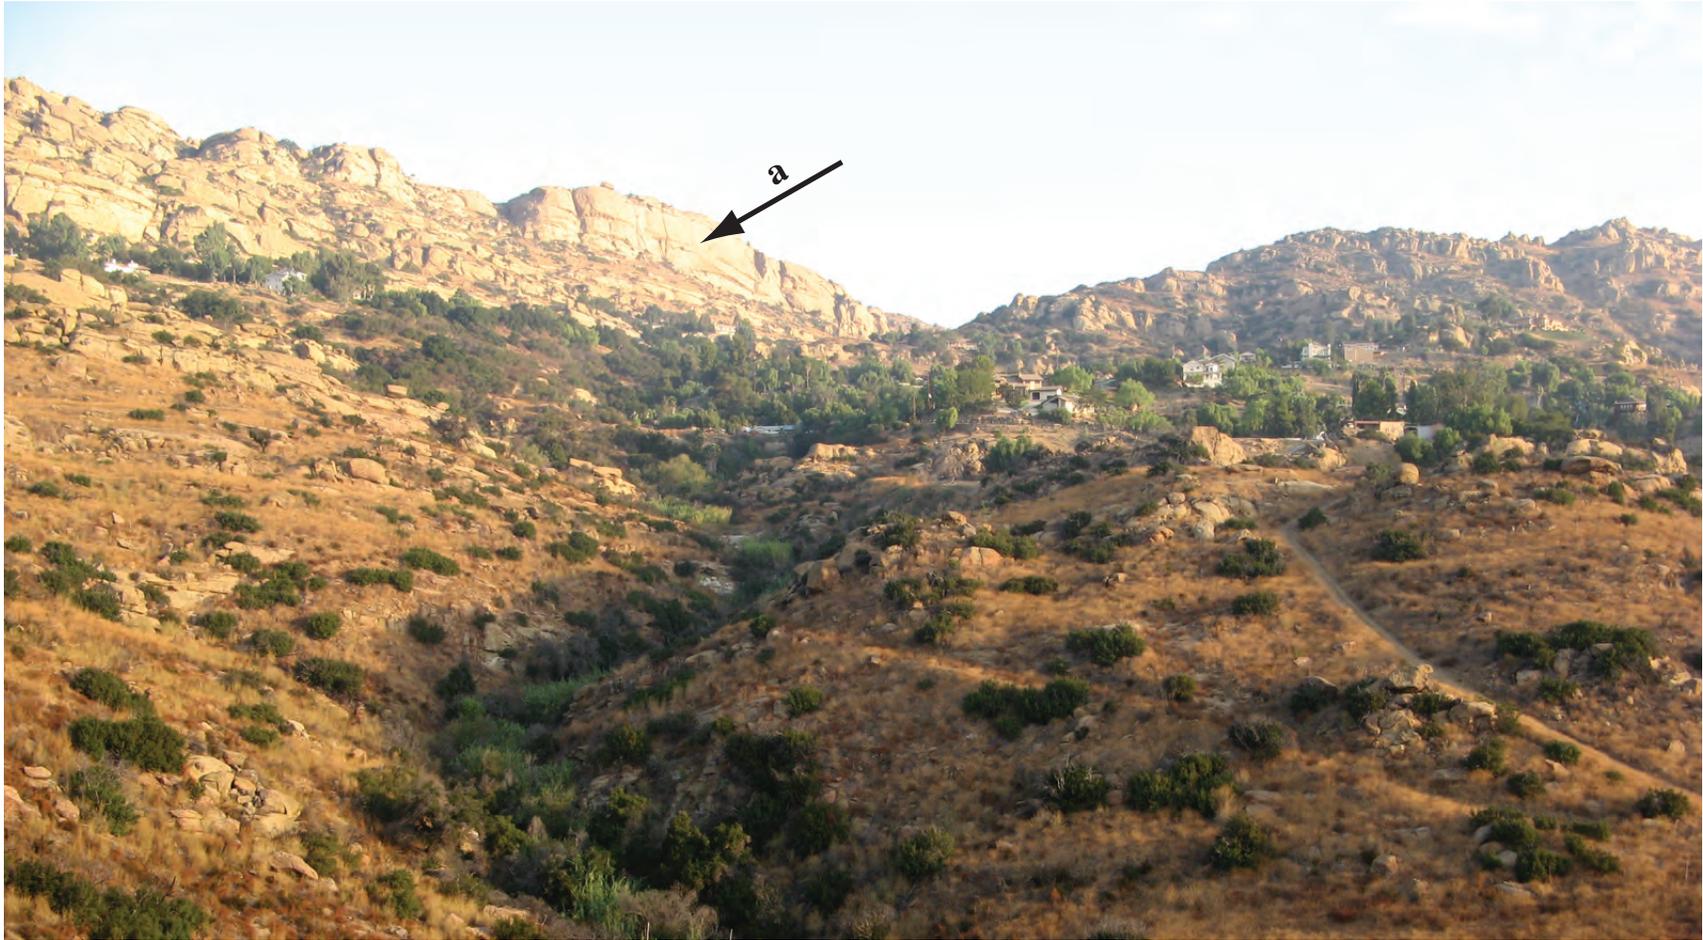
Figure 9. Field photo MP4200. View N20W from Woolsey Canyon Road towards the very thick, sparsely jointed Chatsworth sandstone. The arrow “b” above points to the same sandstone pointed to by arrow “b” in Figure 8.

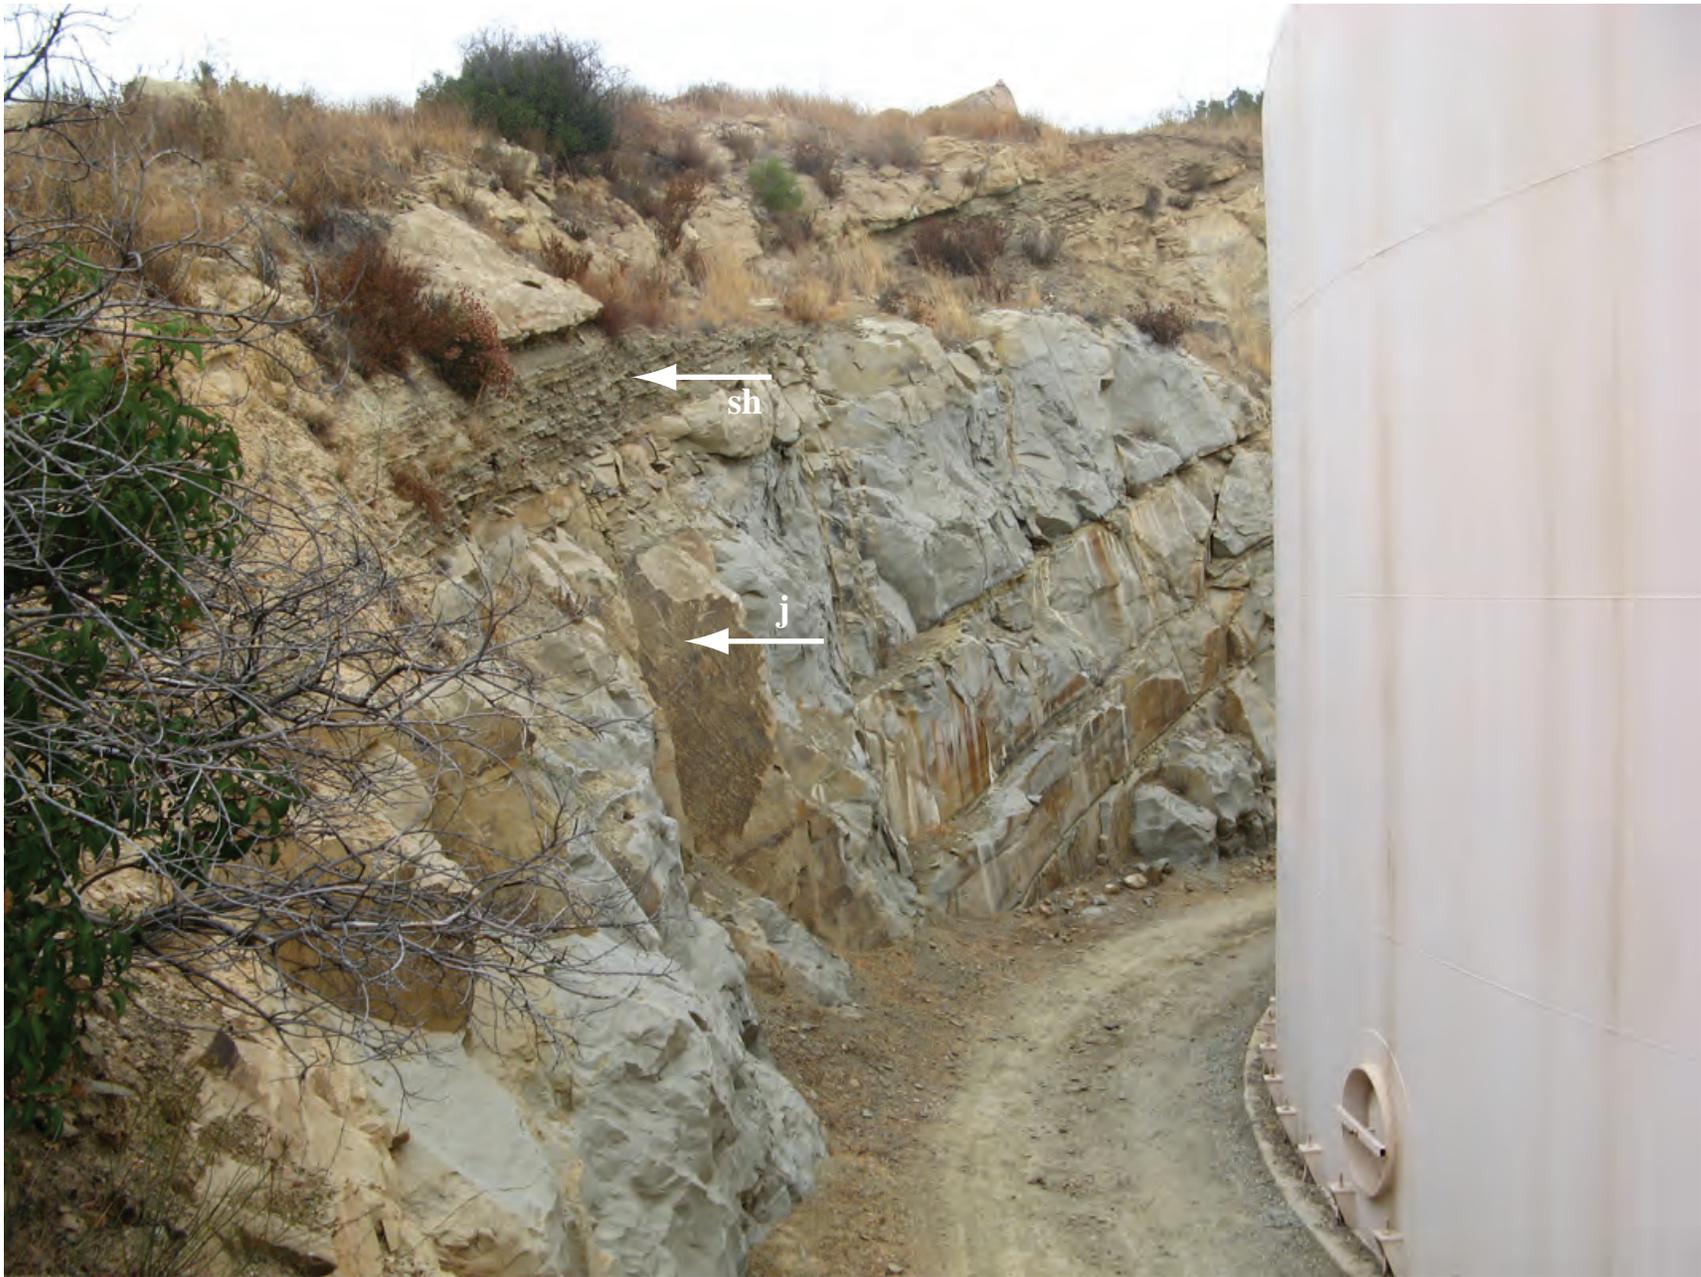
Figure 12. Field photo MP4148 showing water tank cut exposures at the north end of the cut (see Fig. 10). Weathered sandstone and shale (arrow “sh”) seen at the top of this photo. Deeper in the cut are gray unweathered sandstone (~ 3 to 8 ft thick) with thin (<0.5 ft), lenticular shale interbeds. Well developed joints (arrow “j”) terminate at the ~3 ft thick shale near the top of the cut.

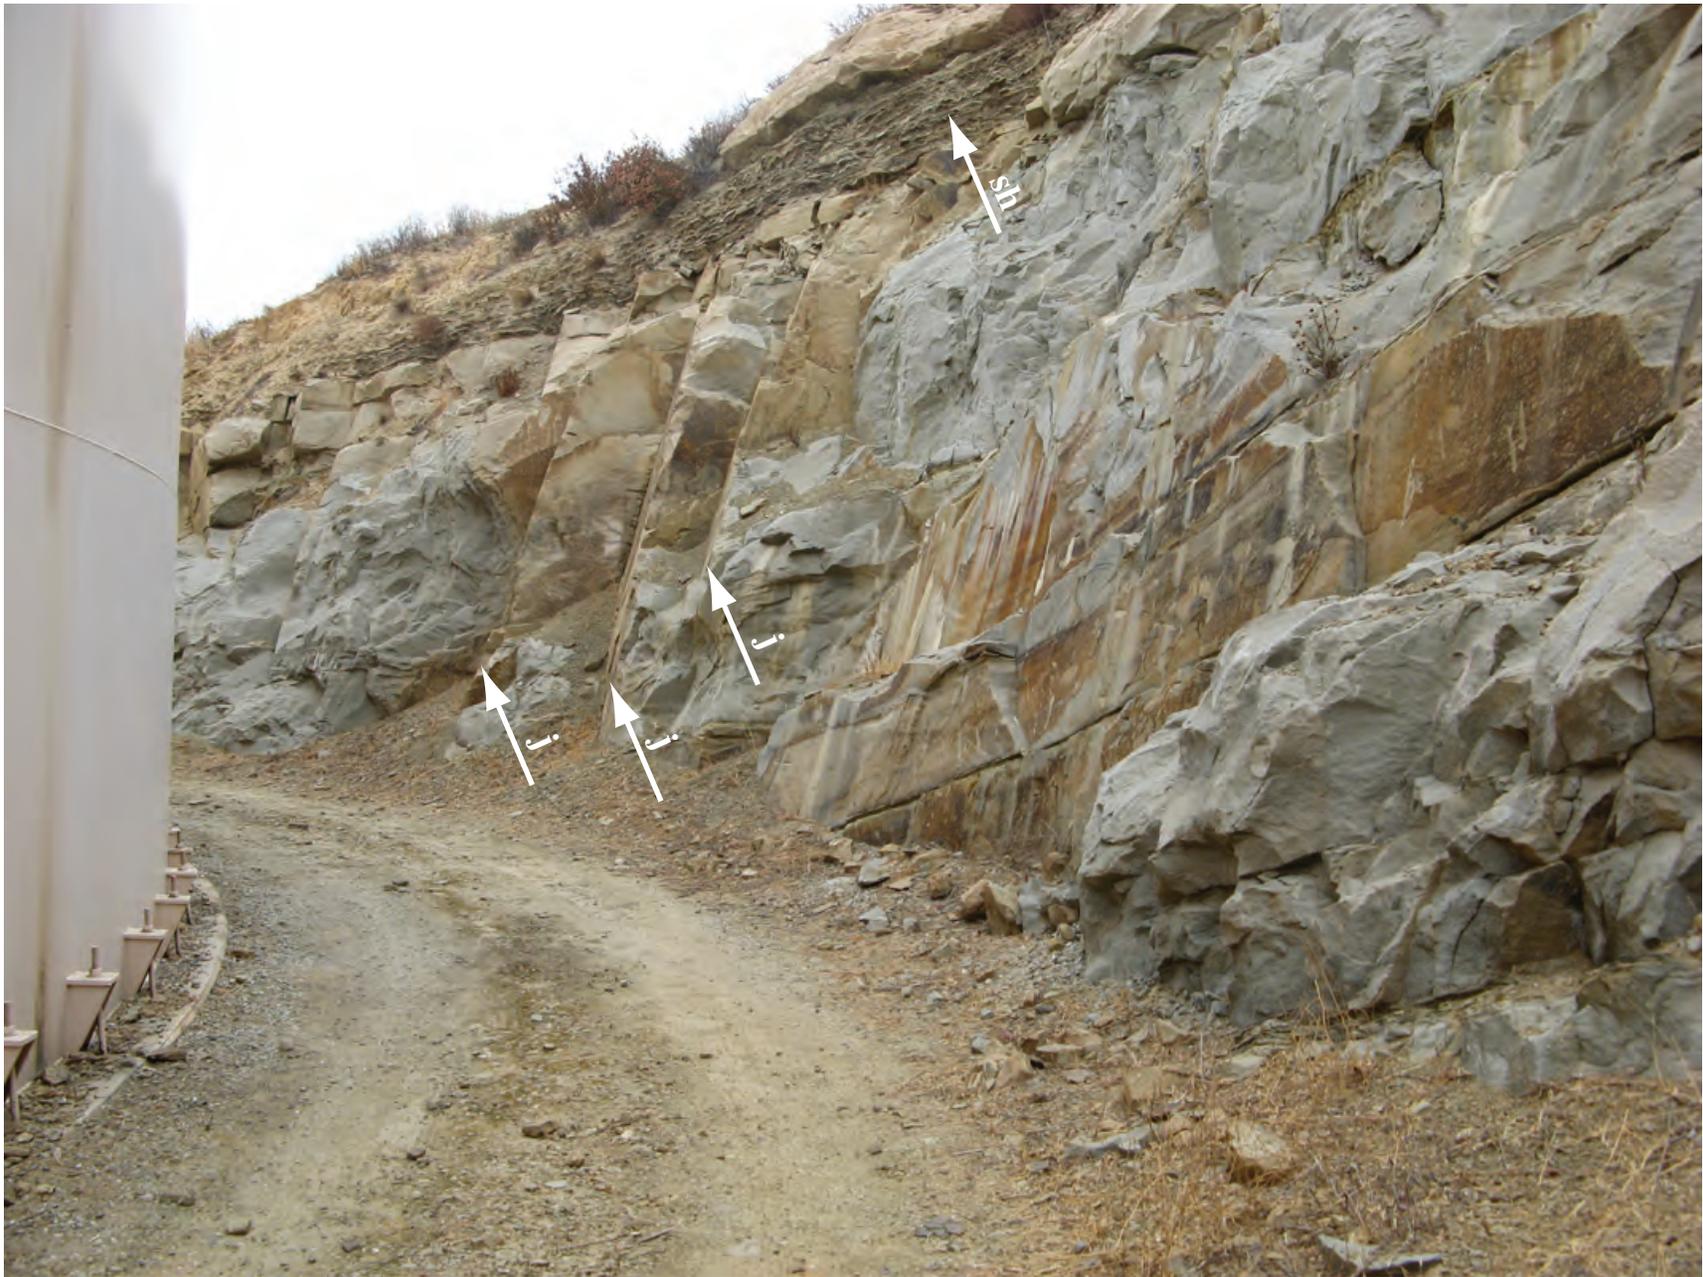
Figure 13. Field photo MP4143. View to north showing area seen in Figure 12. This view shows prominent joints (arrows “j”) in the thick unweathered Chatsworth sandstone terminating at the base of the 3 ft shale (arrow “sh”).

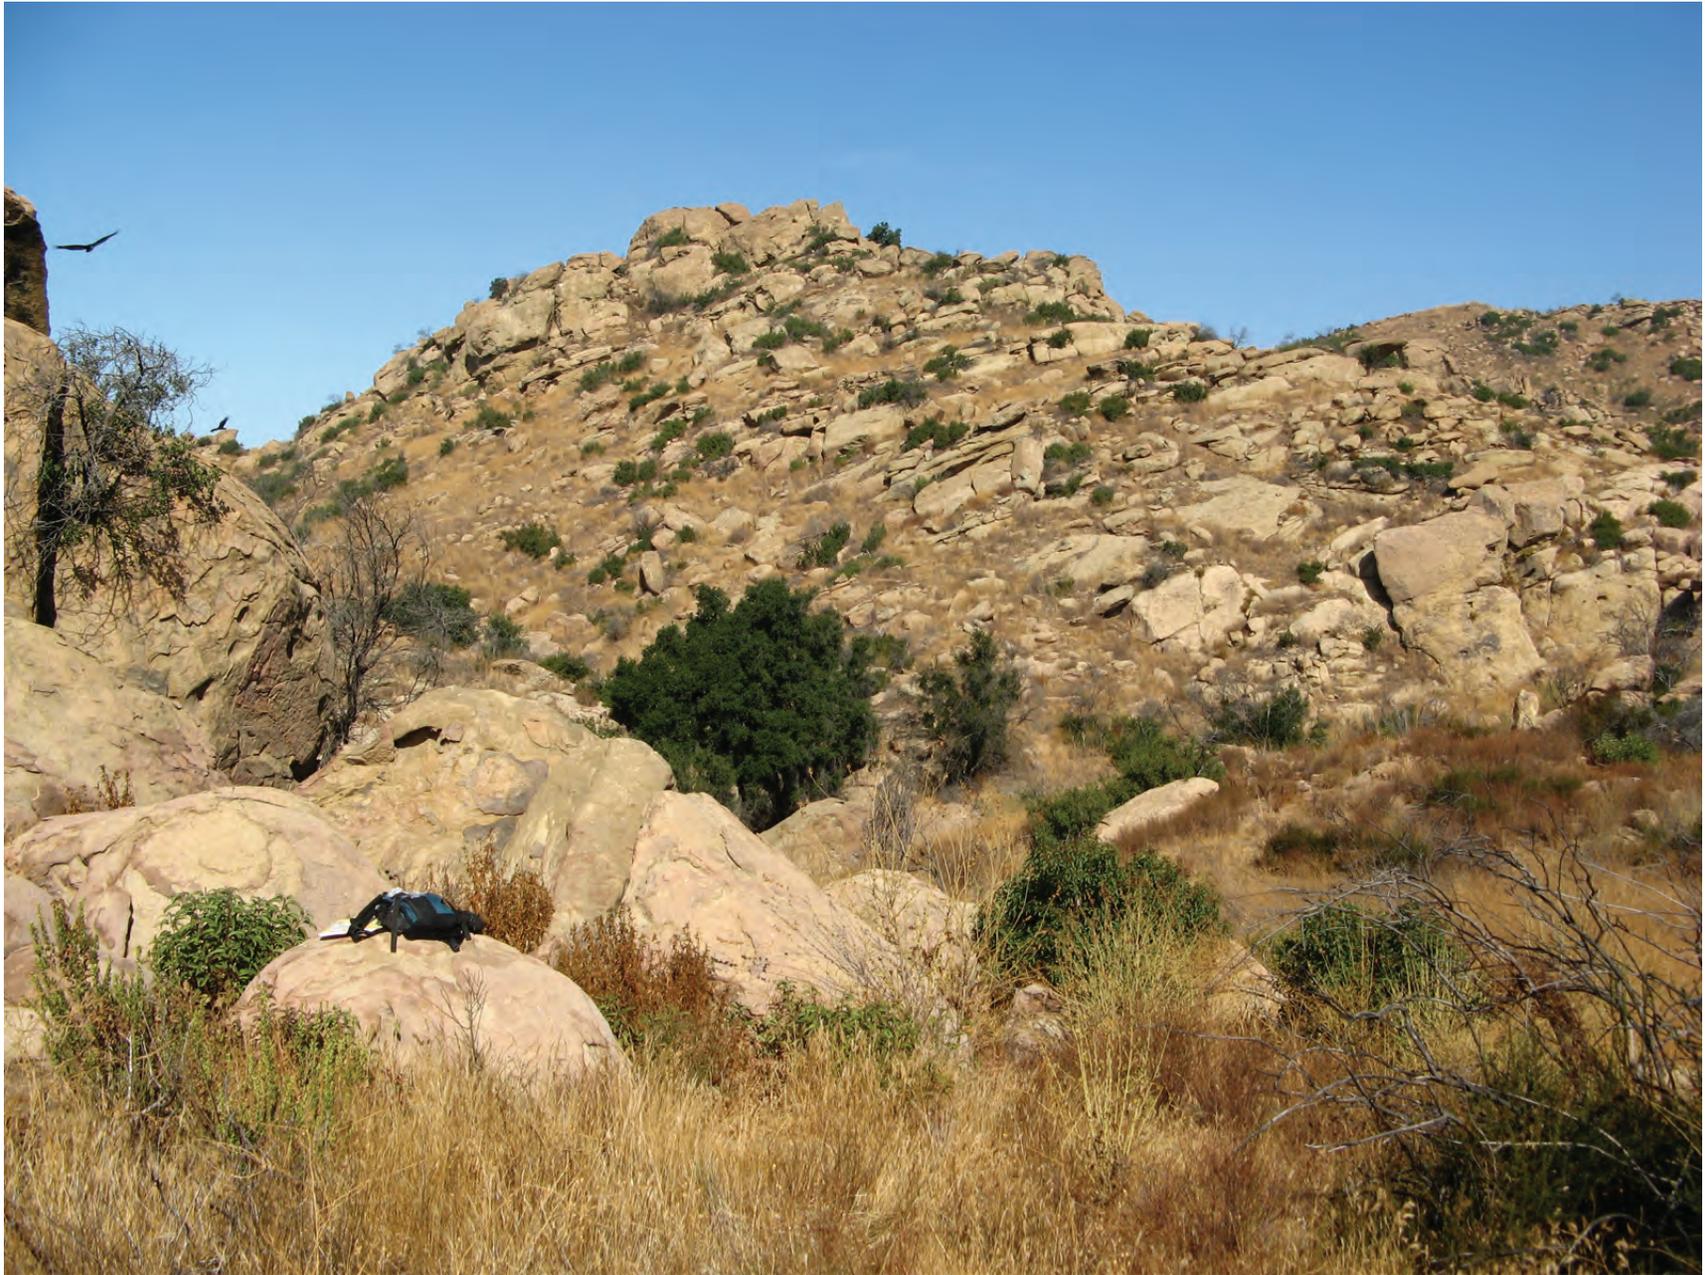
Figure 14. Field photo MP4037 showing medium to thick bedded Chatsworth Fm. sandstone south of the Burro Flats Fault. The view is N60W. The sandstone here has a high density of joints ($\geq 4.0/100$) but with joints generally confined to individual beds. Figure 11 shows the location and view direction of this photo.

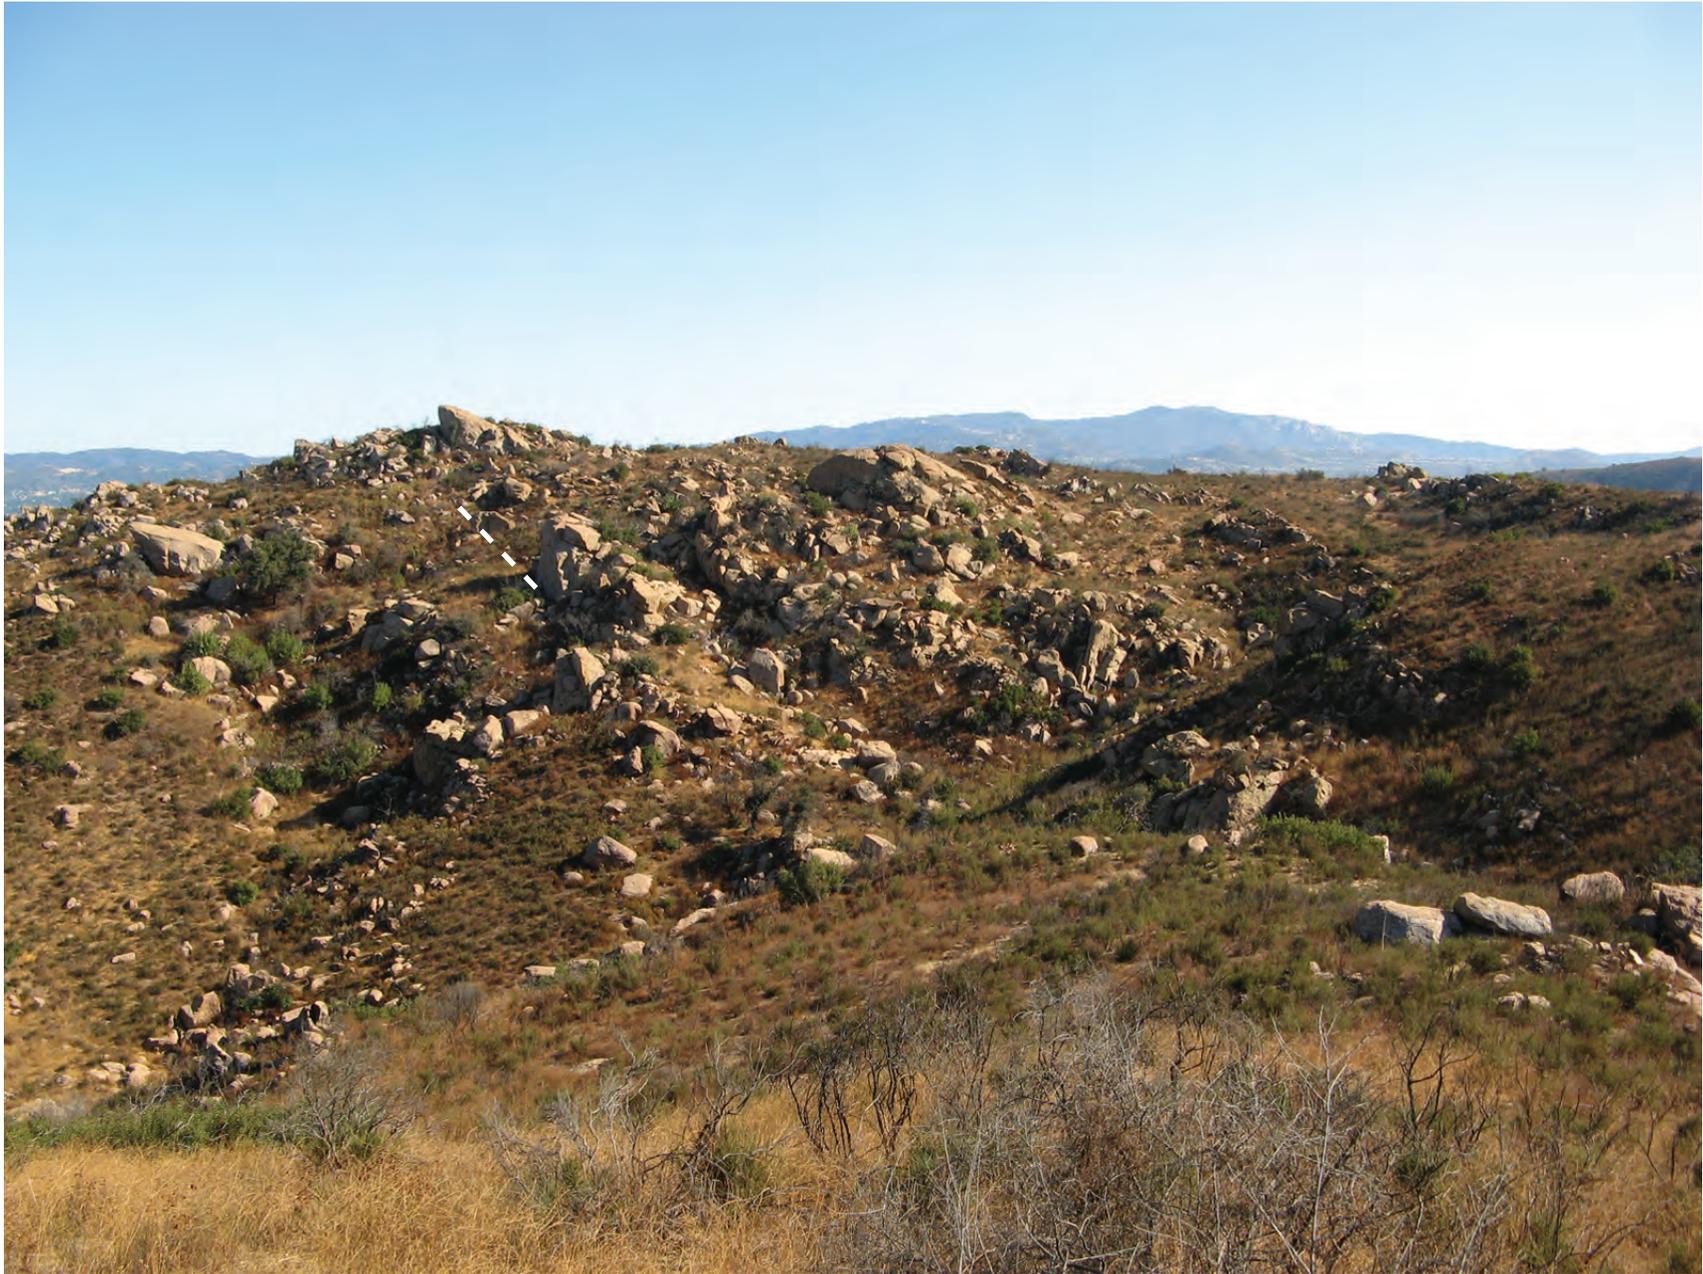
Figure 15. Field photo MP4255. View is to the SSE and looking nearly on edge of the west dipping Chatsworth sandstone across the gully. The trace of bedding, marked by the dashed lined, is obscured by the close-spaced joints in the sandstone. Such jointing is typical of the sandstone south of the western half of the Burro Flats Fault. See Figure 9 for the location of this photo.

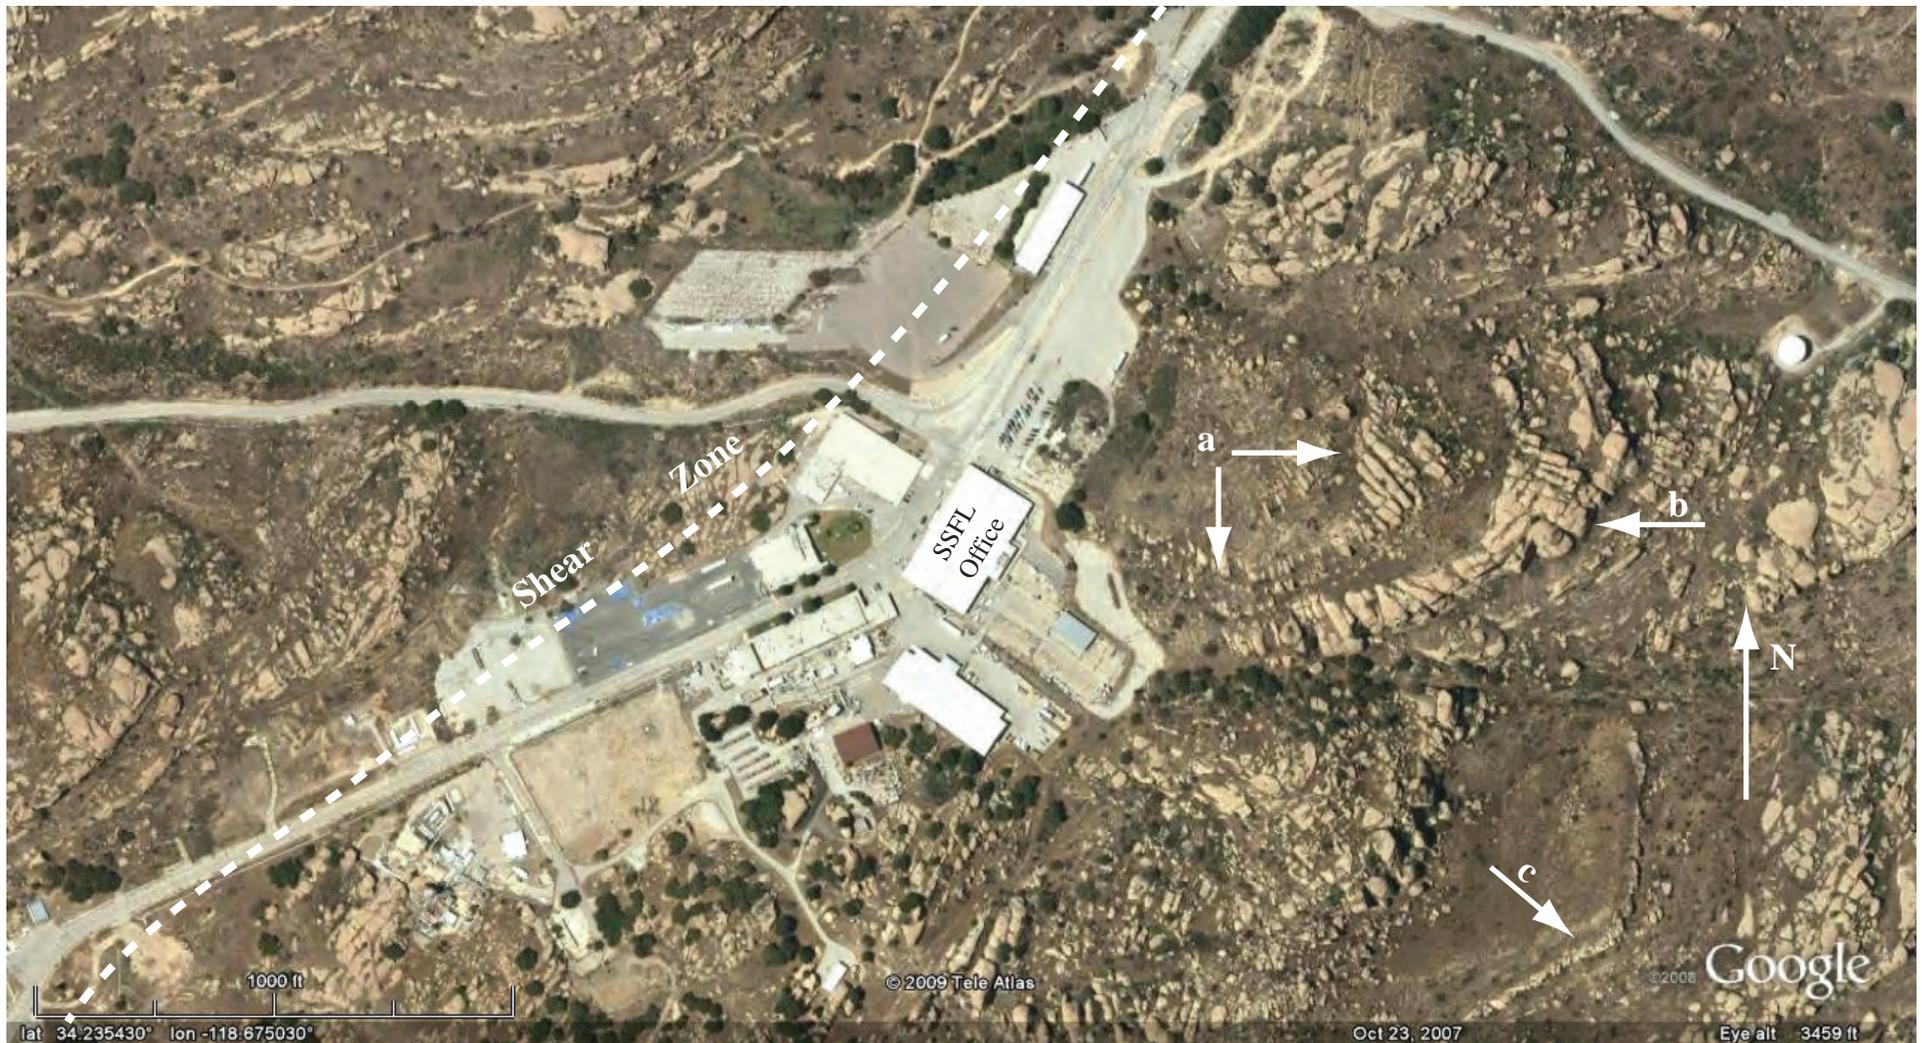
Figure 16. Google Earth™ image location 16 (see Fig. 5 for location). Image shows close-spaced joints in Chatsworth sandstone in the area around the SSFL office. Both NW and NE trending joints are evident in this Google Earth image. In detail there can be complexities in joint patterns as pointed out by the arrows at “a” where joints fan from an ~N45W trend to a N15W trend. Also there is an indication of inverse variation of joint density with bed thickness. The thicker bed arrow “b” has a joint density of ~2.5/100 ft while the joint densities at the thinner beds at arrows “a” and “c” have joint densities of ~4.5/100 ft.

Variable Joint Patterns Less uniform joint patterns are also common. One example is evident in the Google Earth™ image of the area around the main office of the SSFL. Here (**Fig. 16**) is a patchwork or mosaic distribution of joint trends in the Chatsworth sandstone. Just east of the office (arrows “a”), joints of the NW set are prominent and are expressed by the dark linear elements traversing light colored sandstone outcrops. In detail these joints are not parallel, as they might be in a simple set, but instead form a radiating pattern from NW on the east to N on the west. To the west and south of the office this pattern gives way to a less organized mix of NW and NE joints of varying direction and spacing along with joints of more random orientation.

Another type of mismatch is joint density mismatch. An example of such a mismatch is seen in **Figure 16**. Here the trend of the dominant joint set is parallel from bed to bed but thinner beds have higher joint densities. This again suggests a thin layer between beds, possibly shale, is limiting joint propagation from sandstone to sandstone with each sandstone bed jointing independently of other sandstone beds. Again, the bed to bed mismatch may limit connectivity from bed to bed.

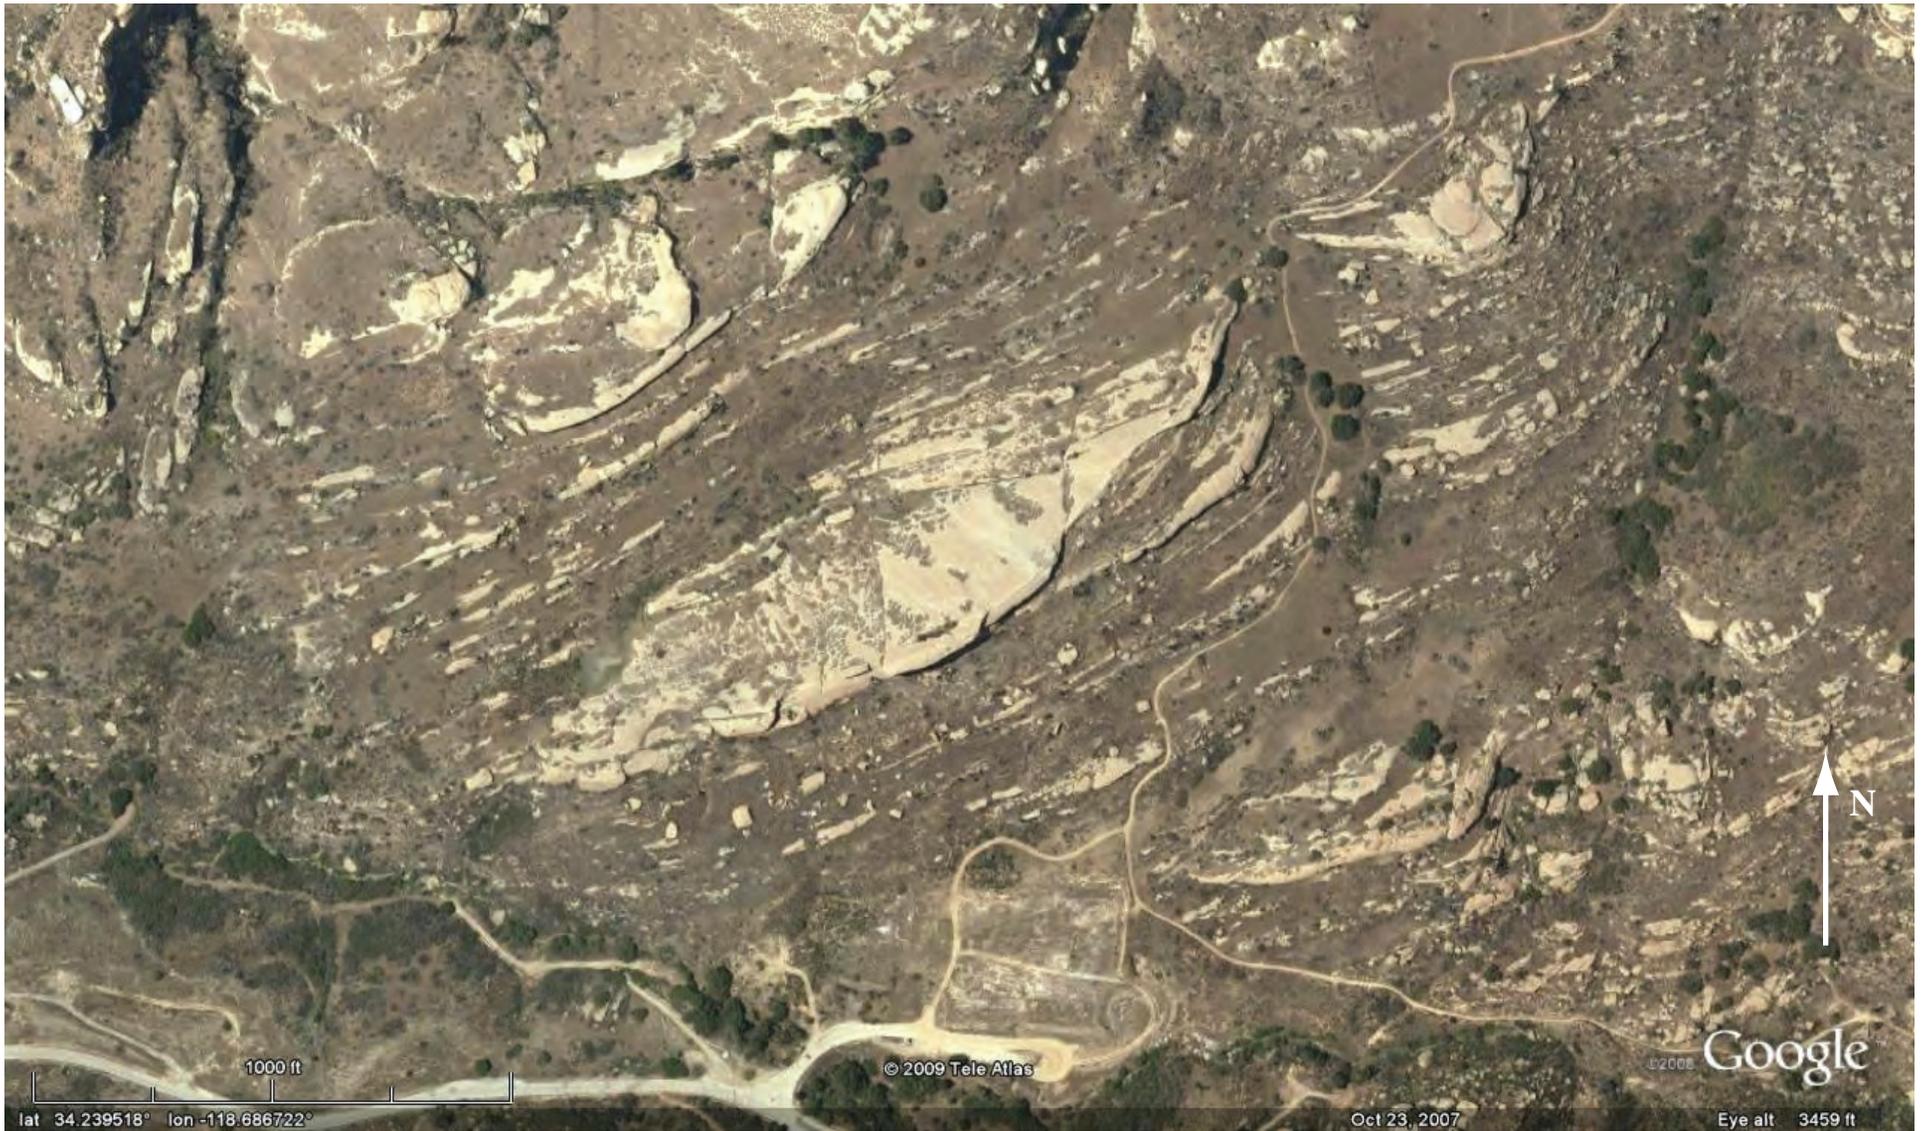
Figure 19. Google Earth image location 2 (see Fig. 5 for location). This image shows widely-spaced joints in Chatsworth sandstone. The dominant joint set here strikes northward, but a few ENE striking joints are visible in the thick sandstone bed in the center of this Google Earth image. In this 1600 ft wide sandstone channel only 2 throughgoing joints and one shorter joint are visible indicating a joint density of $<0.2/100$ ft.

Throughout much of the SSFL areas, two or more sets of intersecting joints are well developed. Several such areas are shown in **Figures 8, 11, 16, 19, and 20**. In such areas joints likely form a connected network.

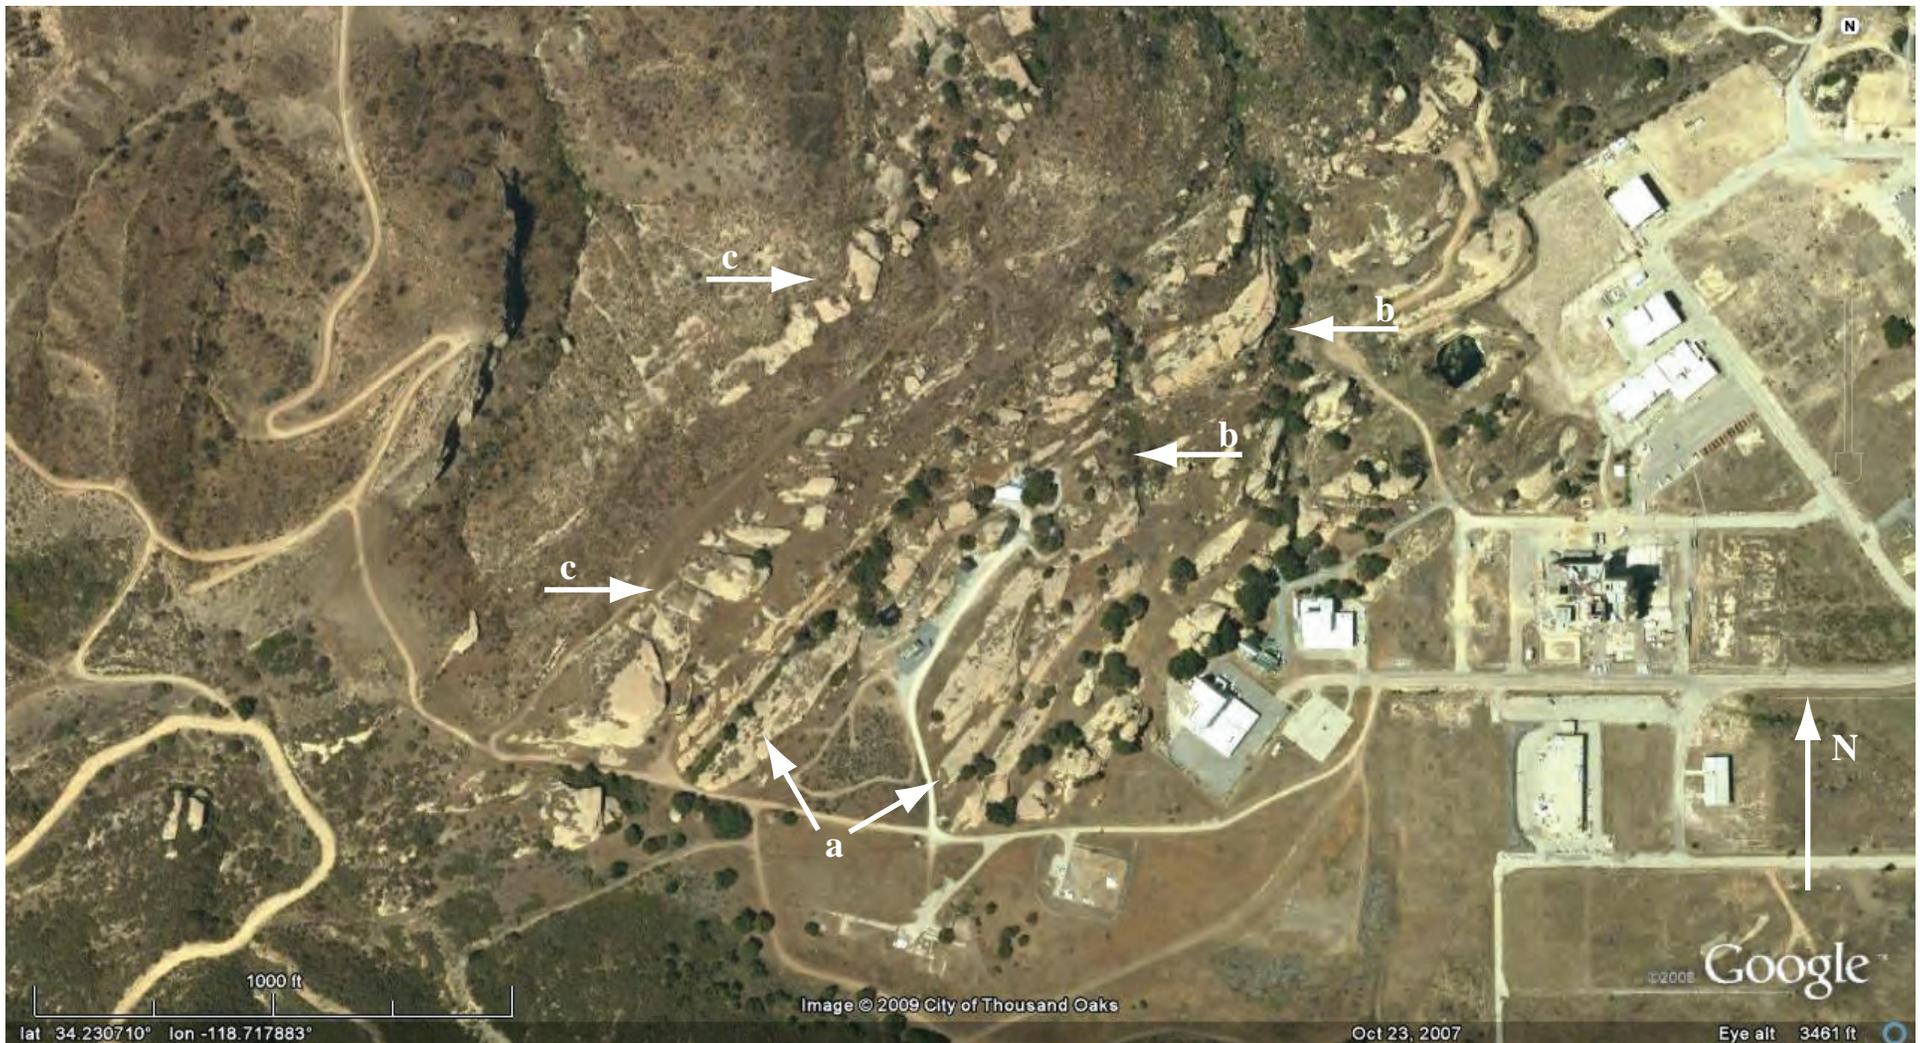
Figure 20. Google Earth™ image location 20 (see Fig. 5 for location). This image shows the variable joint density in thick bedded Chatsworth sandstone in this area. The NW dipping sandstone in the center of this area (“a” arrows) is largely unjointed, though two minor, north striking faults cut this sandstone in the east central part of the area (“b” arrows). Above (NW of) the unjointed sandstone are two thick sandstone layers (“c” arrow) with a moderate joint density (~1.0/100 ft).
