**20 ELEMENTS OF THE SANTA SUSANA FIELD LABORATORY
SITE CONCEPTUAL MODEL OF CONTAMINANT TRANSPORT**

SITE CONCEPTUAL MODEL ELEMENT DOCUMENT 4-1

Characteristics of Joints at the Santa Susana Field Laboratory, Simi, California

Date: December 10, 2009

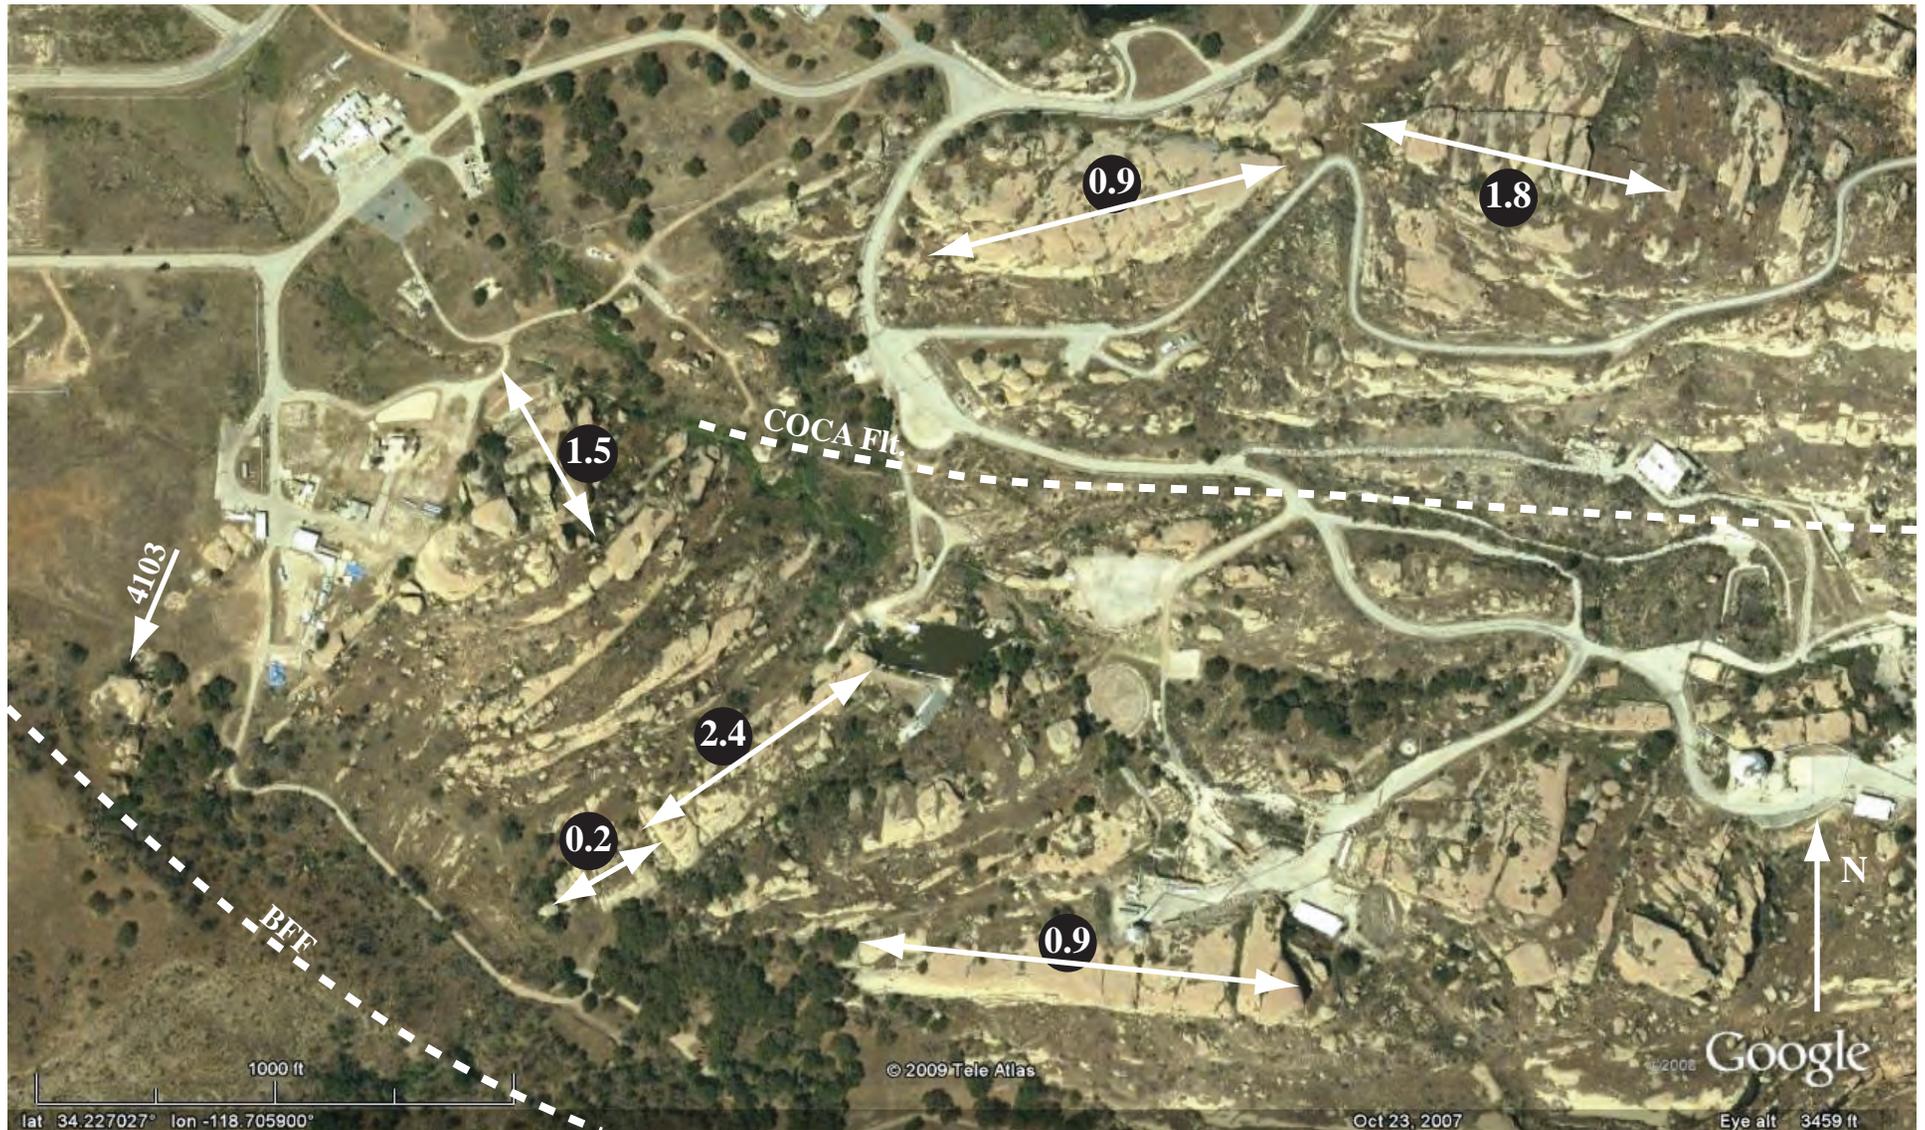
Figure 21. Google Earth™ image location #4 (see Fig. 5 for location). This image shows joints in thick bedded Chatsworth sandstone with low to moderate density ($\leq 2.5/100$ ft). Joints along individual traverses shown by circled numbers. The Burro Flats Fault (BFF) trends NW through the SW corner of this area. The COCA Fault trends WNW through the east-central part of this area with beds striking NE south of the western termination of the COCA Fault while striking ENE north of this termination.

Another characteristic of the sparsely-jointed sandstone is the mismatch of joint orientations from layer to layer. Examples of this are shown in **Figure 21**. This mismatch suggests that there are layers between individual beds of sandstone that have limited the propagation of joints from layer to layer. These layers may be separated by thin shale or some other layer resistant to joint formation. Such a mismatch in joint orientation may limit connectivity from bed to bed.

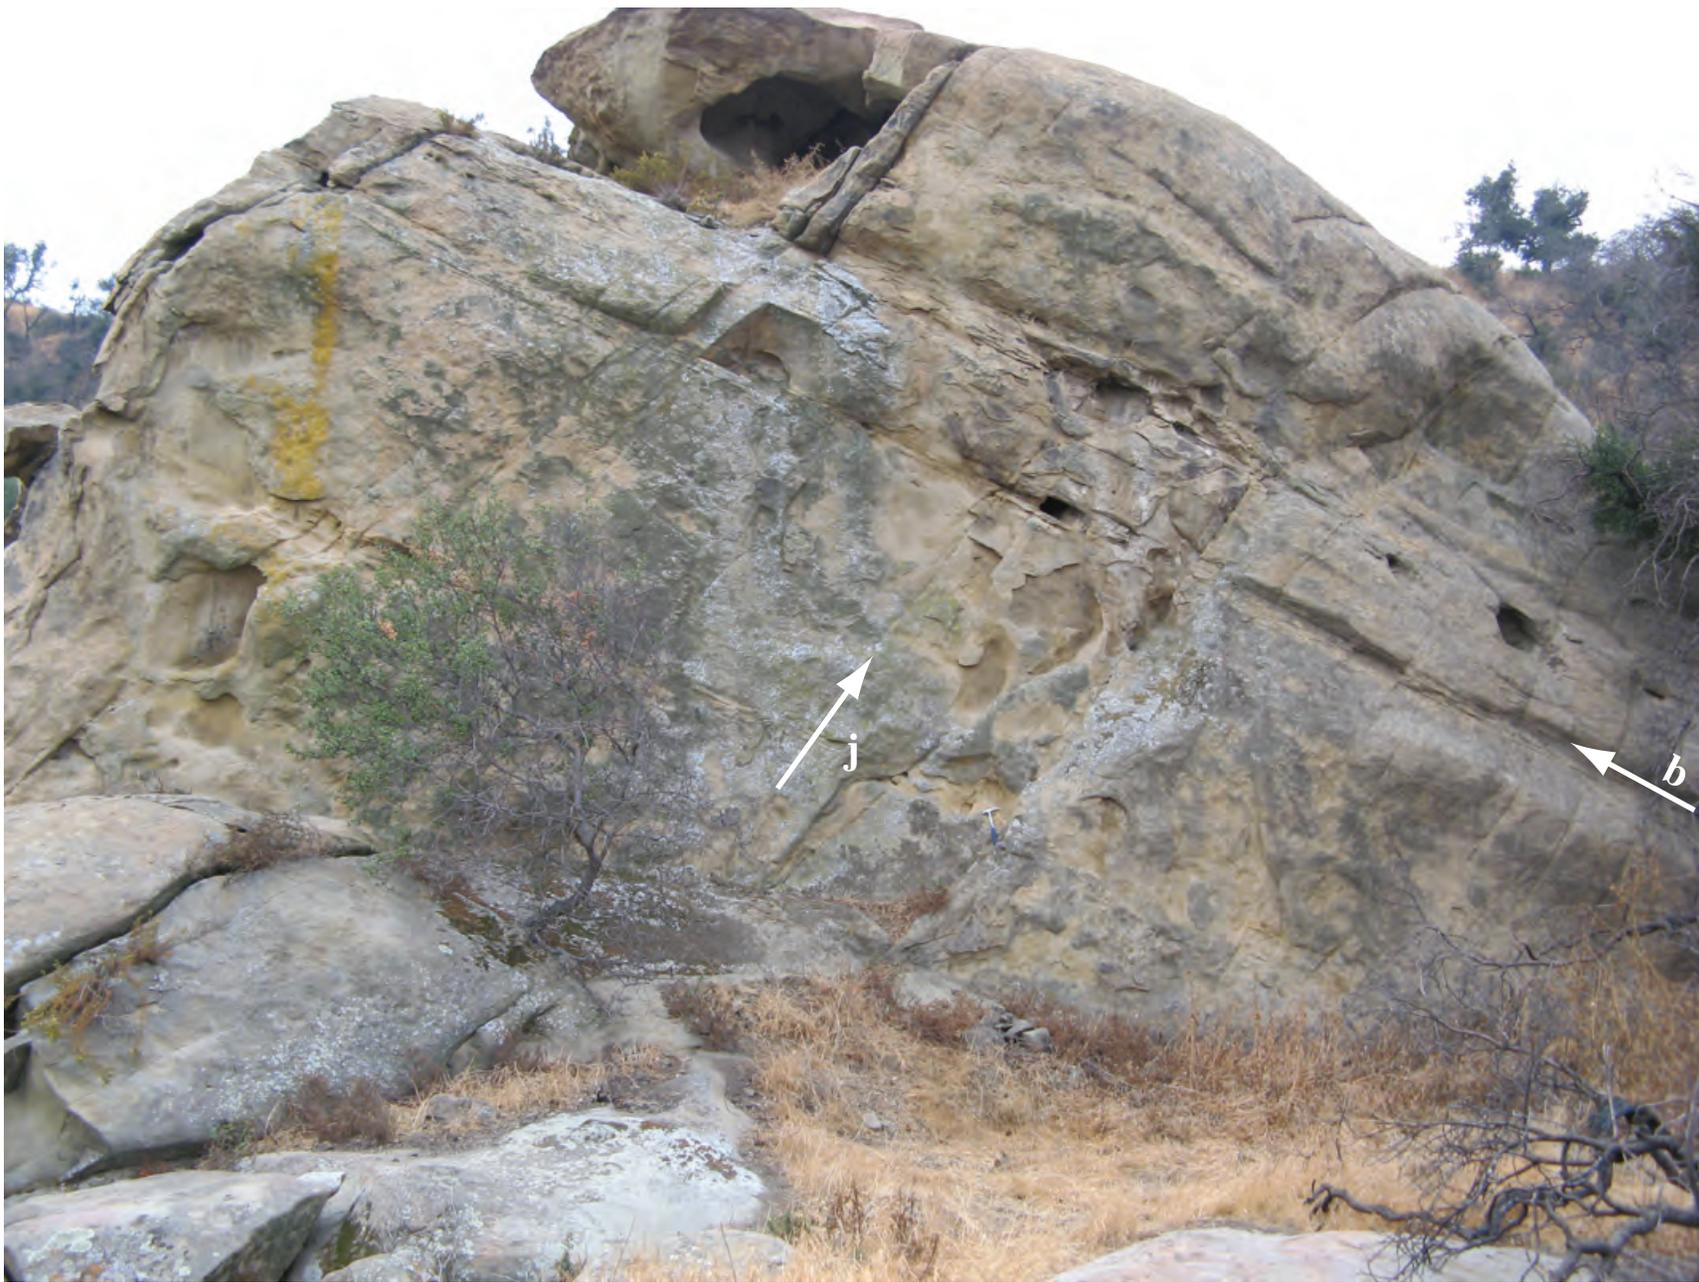
Figure 22. Field photo MP4103. View SSW showing a set of close-spaced bedding normal joints in an amalgamated Chatsworth sandstone. This locality is just north of the Burro Flats Fault as shown on Figure 21. This outcrop is ~20 ft high. Arrow “b” points to bedding and arrow “j” points to one of the joints. See Figure 23 for an enlargement of the area to the left of arrow b.

Figure 22 shows an exposure of an amalgamated sandstone layer just north of the Burro Flats Fault. The left (eastern) side of this outcrop follows an ENE trending SSE dipping joint that traverses the entire thickness of this amalgamated bed. This “master” joint is evident on detailed Google Earth™ views. The other joints seen in **Figure 22** all parallel the “master” joint but are not expressed in Google Earth™ views. Some of less well expressed joints also traverse the entire thickness of the exposure, but others appear to fade out downward in the bed (see joint marked by arrow “j” in **Fig. 22** and others seen in detail in **Fig. 23**). This “fading out” may be a

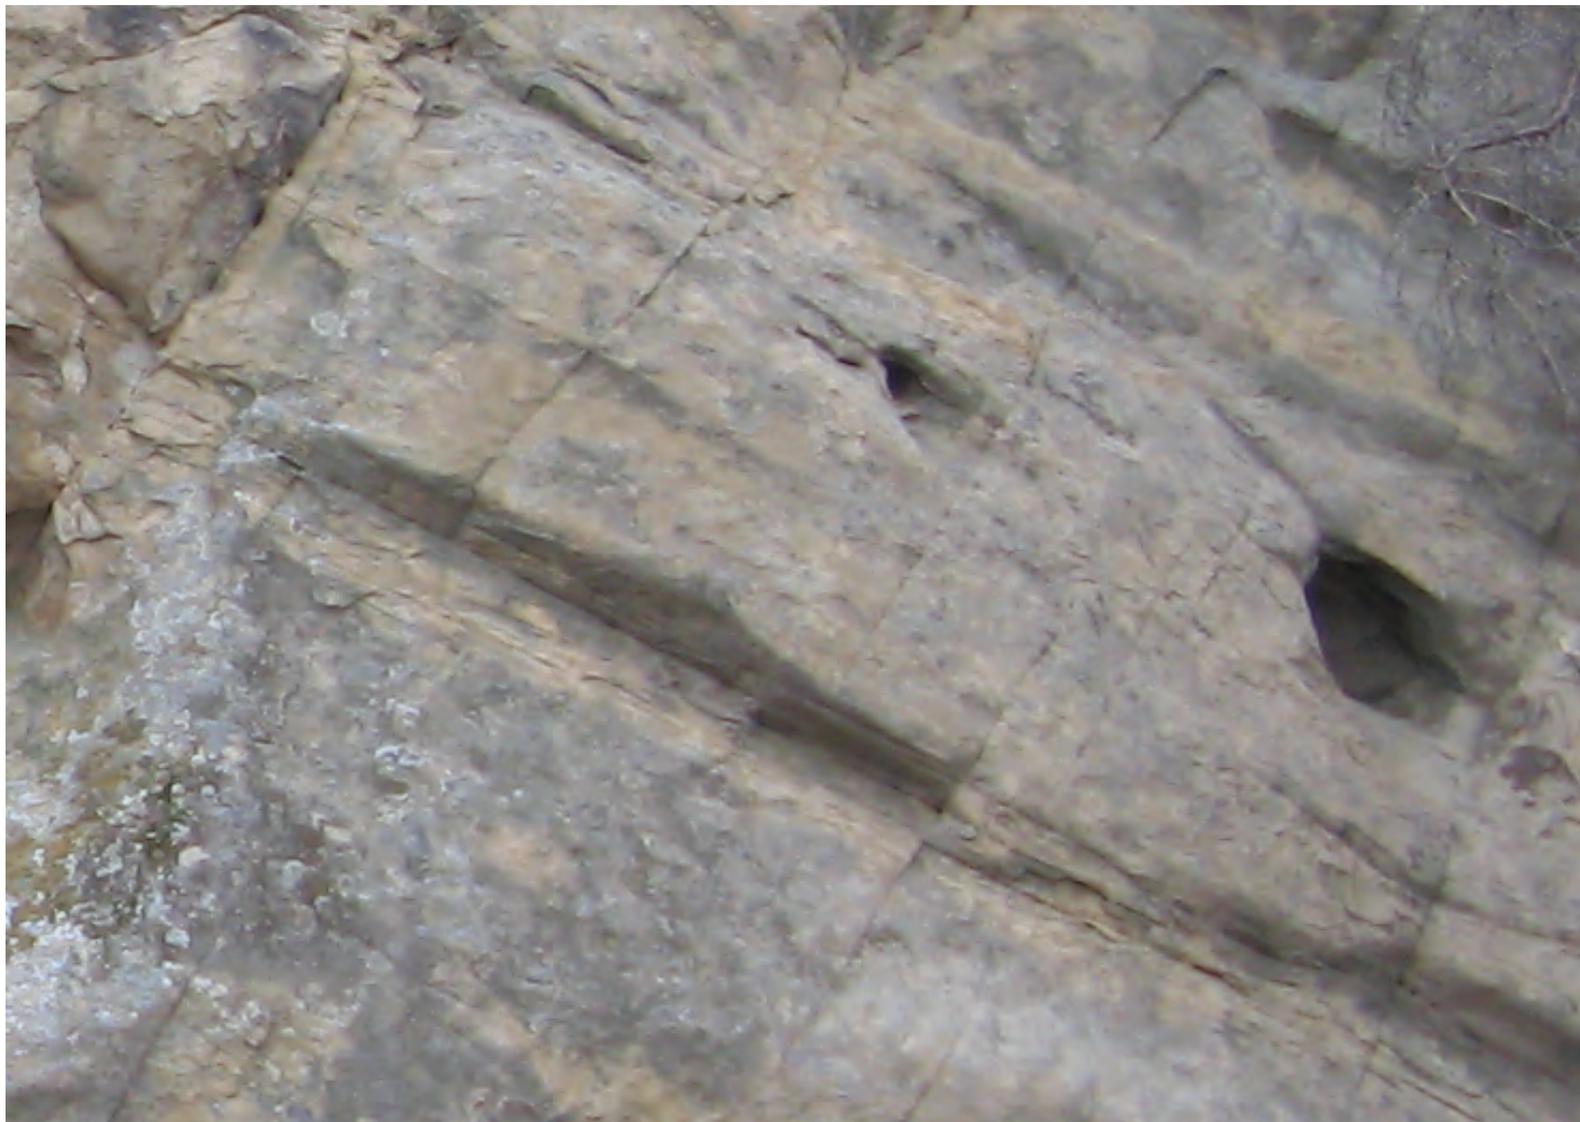
Figure 23. Field photo MP4103 detail. Area to the left of arrow “b” in **Figure 22.** Field photo MP4103. Note the short length of many of the joints in this outcrop.

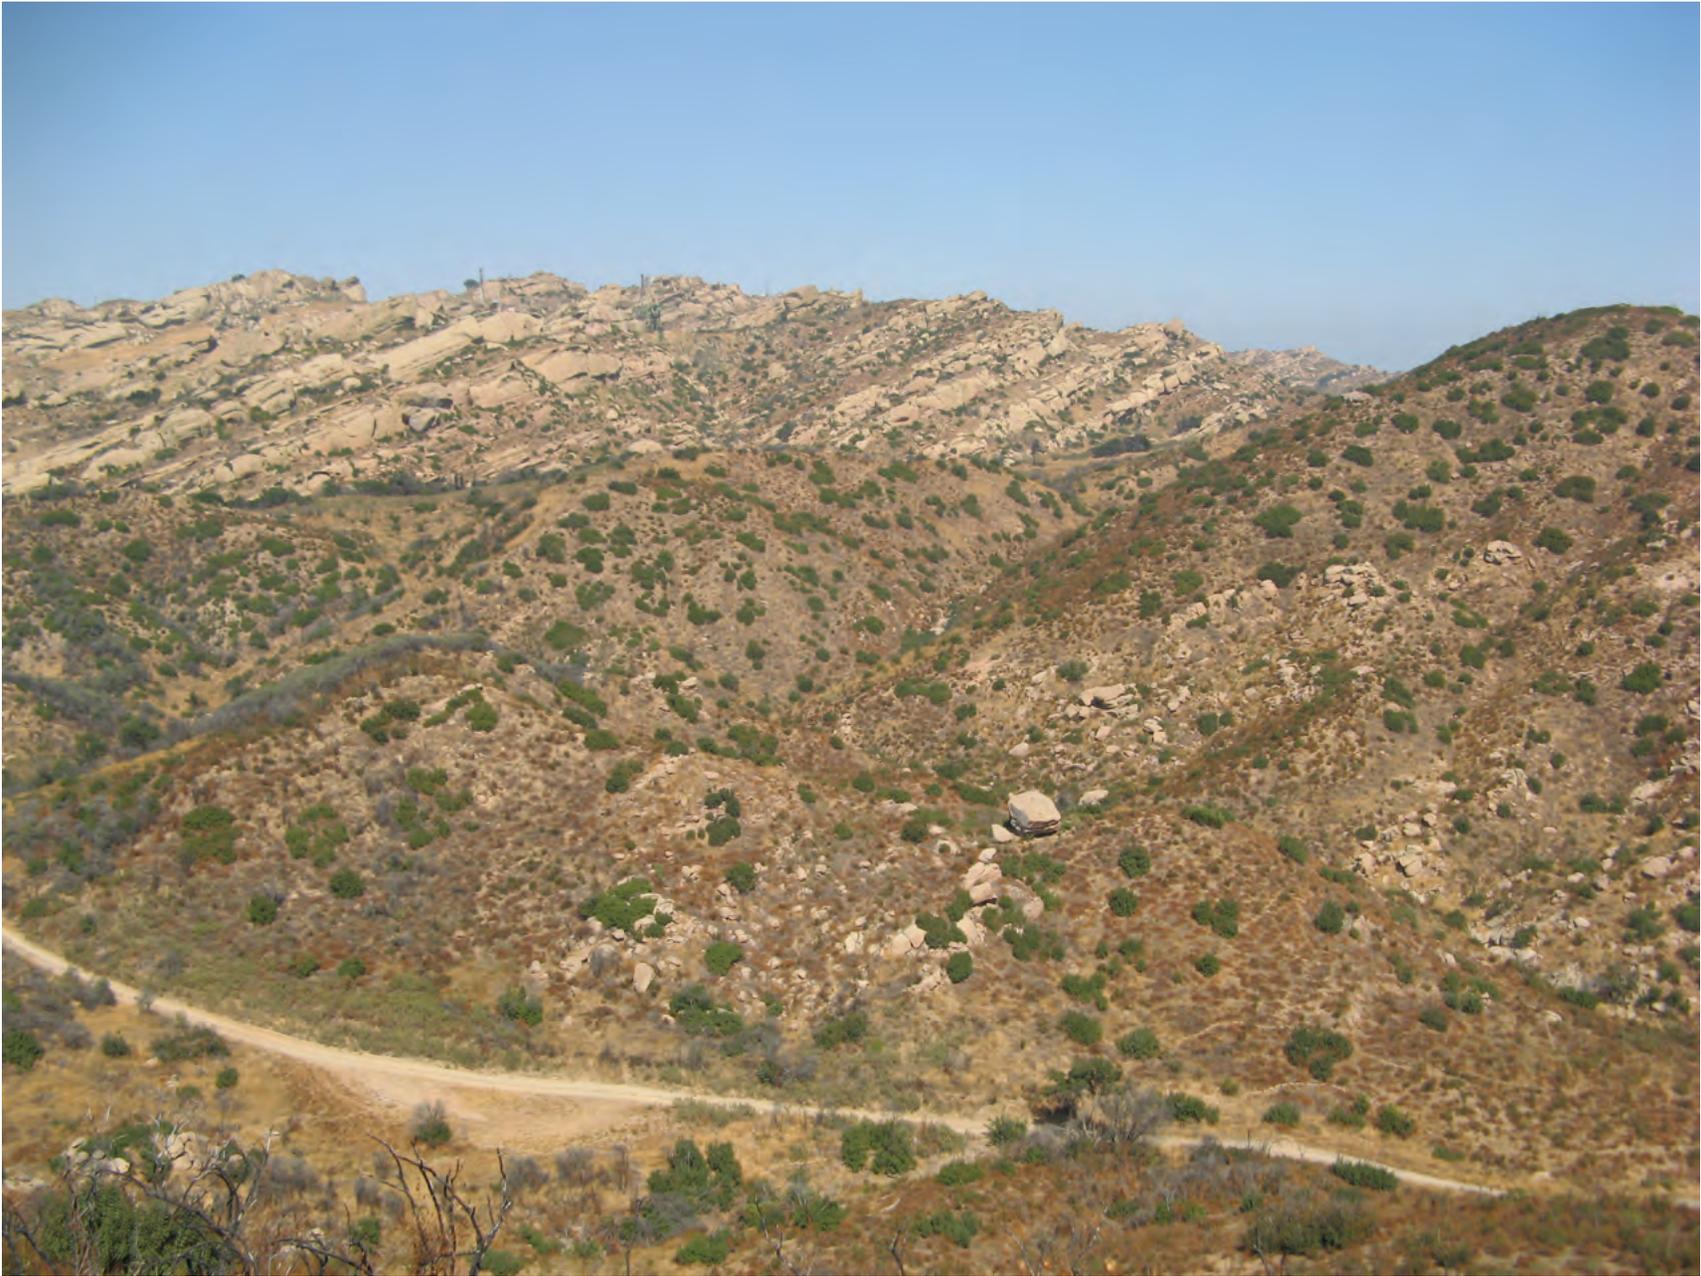
Figure 24. View northward showing thick sandstone/amalgamated sandstone beds (skyline ridge) in the Chatsworth Fm. north of the Burro Flats Fault. Note the wider spacing of joints in the thicker sandstone beds. The ridge in the middle ground is underlain by poorly exposed Chatsworth Fm. south of the Burro Flats Fault. The road in the foreground is in the bottom of Bell Canyon.

Figure 24 shows thick bedded, often amalgamated sandstone layers exposed just north of the Burro Flats Fault. While these beds have not been examined closely, the joint heights seem to be limited to either the height of individual beds or amalgamations of several beds. Also, joint spacing appears to be roughly proportional to bed/amalgamated beds thickness with relatively close spacing seen in the thinner beds on the right side of the sandstone outcroppings and much wider spacing in the very thick (~40 – 60 ft) beds to the left. Such a linear relationship of joint spacing to bed thickness is a common feature in layered sedimentary rocks. The possible implication of this relationship to joint connectivity will be brought up in closing discussions.

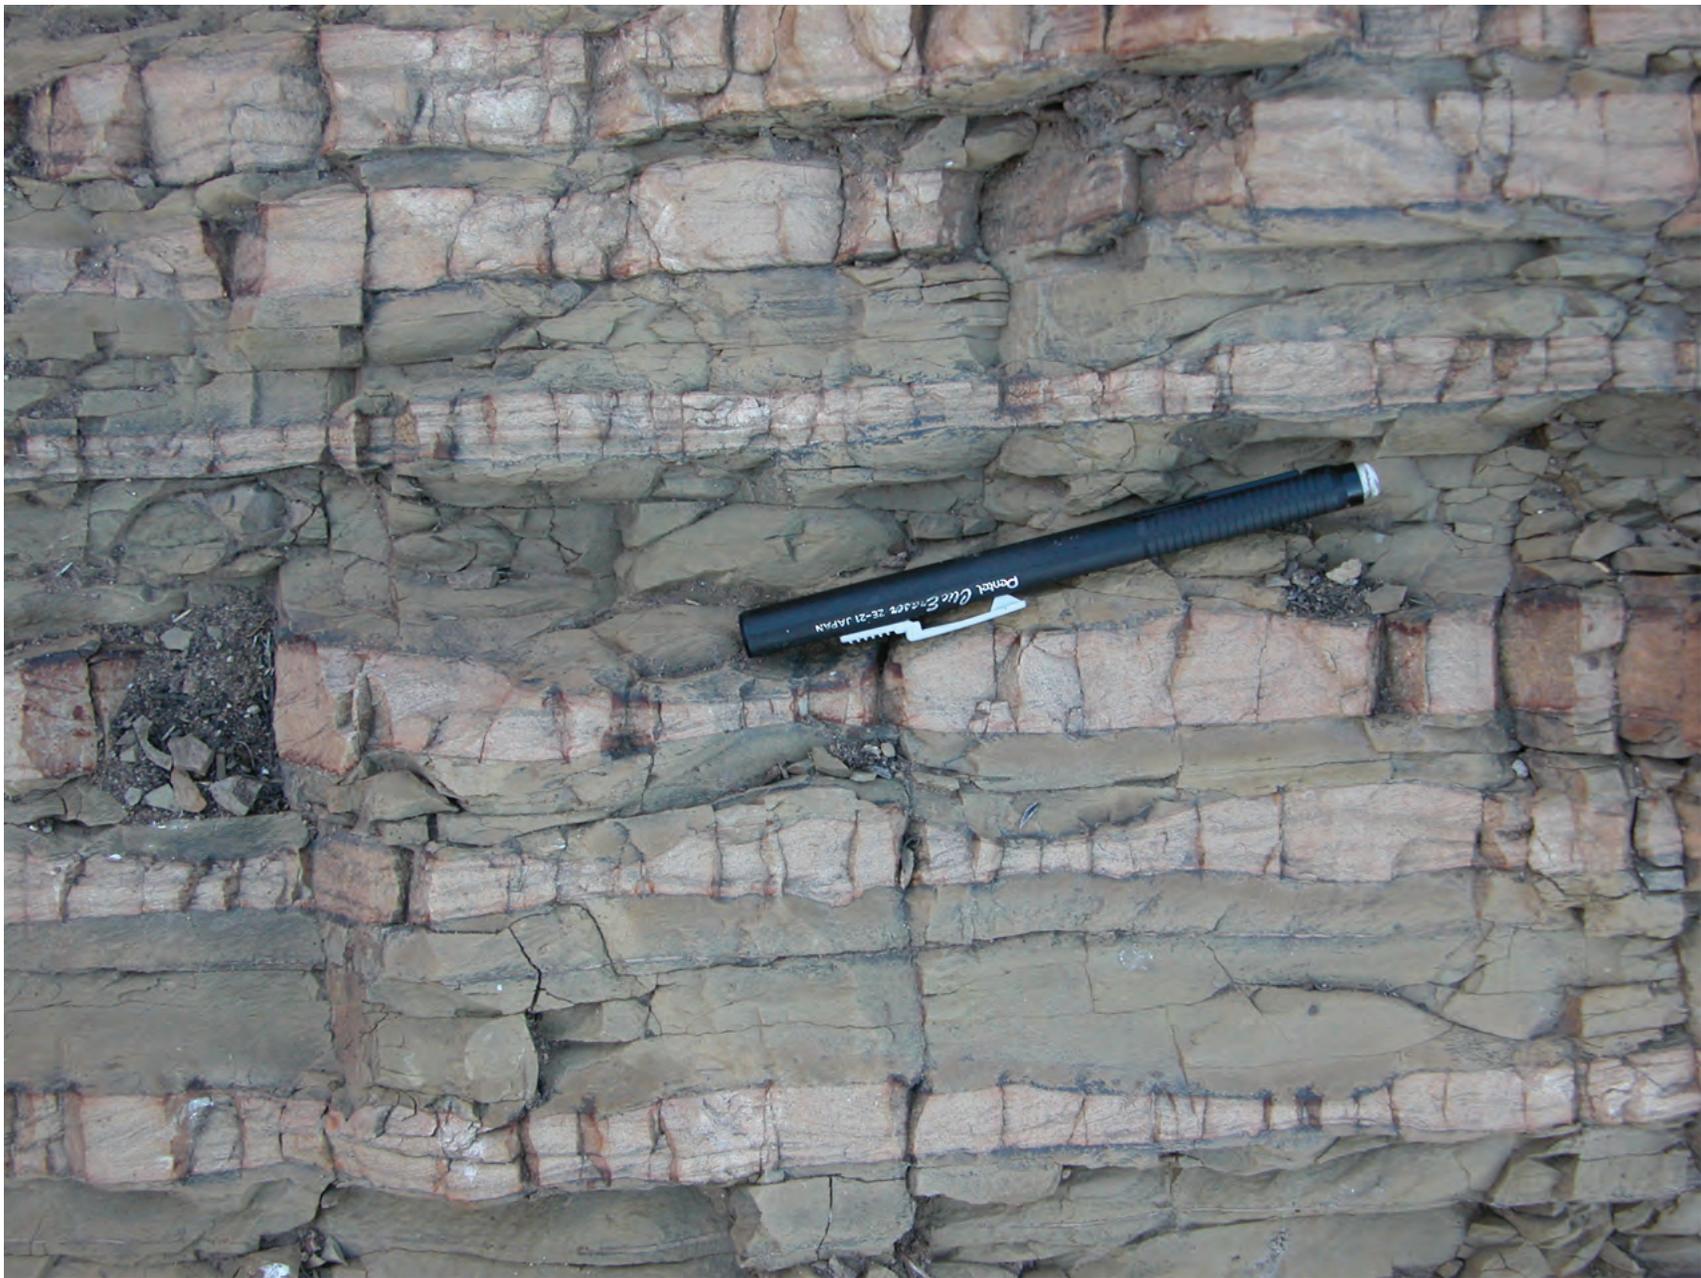
Figure 25. Field Photo 6/Oct/06-26. This photo shows a thin-bedded sandstone and shale unit in the Chatsworth Fm. Note the much higher density of joints in the sandstone (light colored layers). Less than 10% of the joints extend across more than one sandstone/shale couplet and many of the irregular fractures in the shale are likely shrink-swell fractures formed during the recent surface weathering of these rocks.

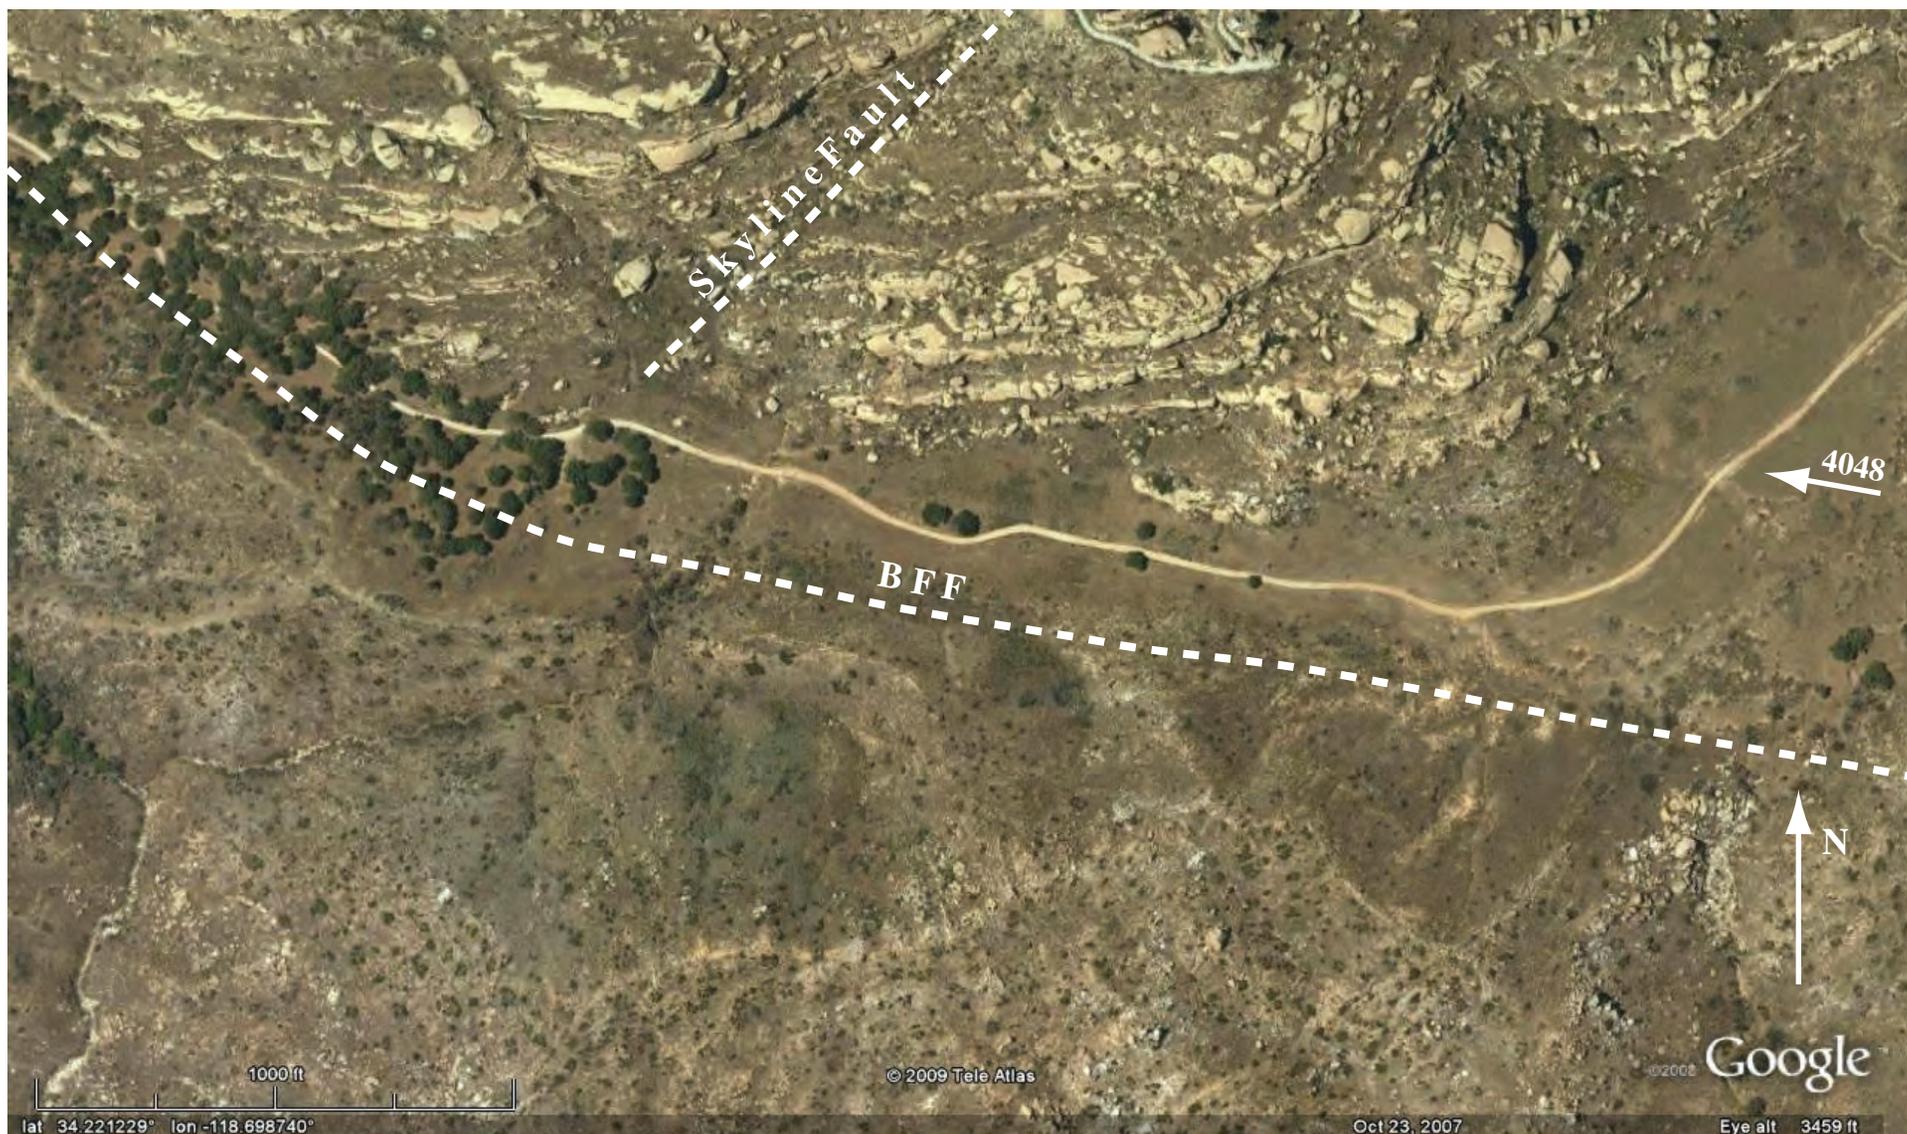
Figure 26. Google Earth™ image location 26 (see Fig. 5 for location). This image shows the contrast in Chatsworth sandstone exposures across the Burro Flats Fault (BFF). Thick-bedded sandstone with low to moderate joint densities is well-exposed north of the fault. In contrast only a few patchy outcrops of sandstone are present south of the fault. Field work in the area south of the fault indicates that the Chatsworth Fm. here is mainly sandstone, but with beds possibly thinner, on average, than those on the north side of the fault. The sparsity of exposures south of the fault may reflect a higher joint density in this area. Arrow on the right side shows the direction of view of field photograph MP4048 (see Fig. 27).

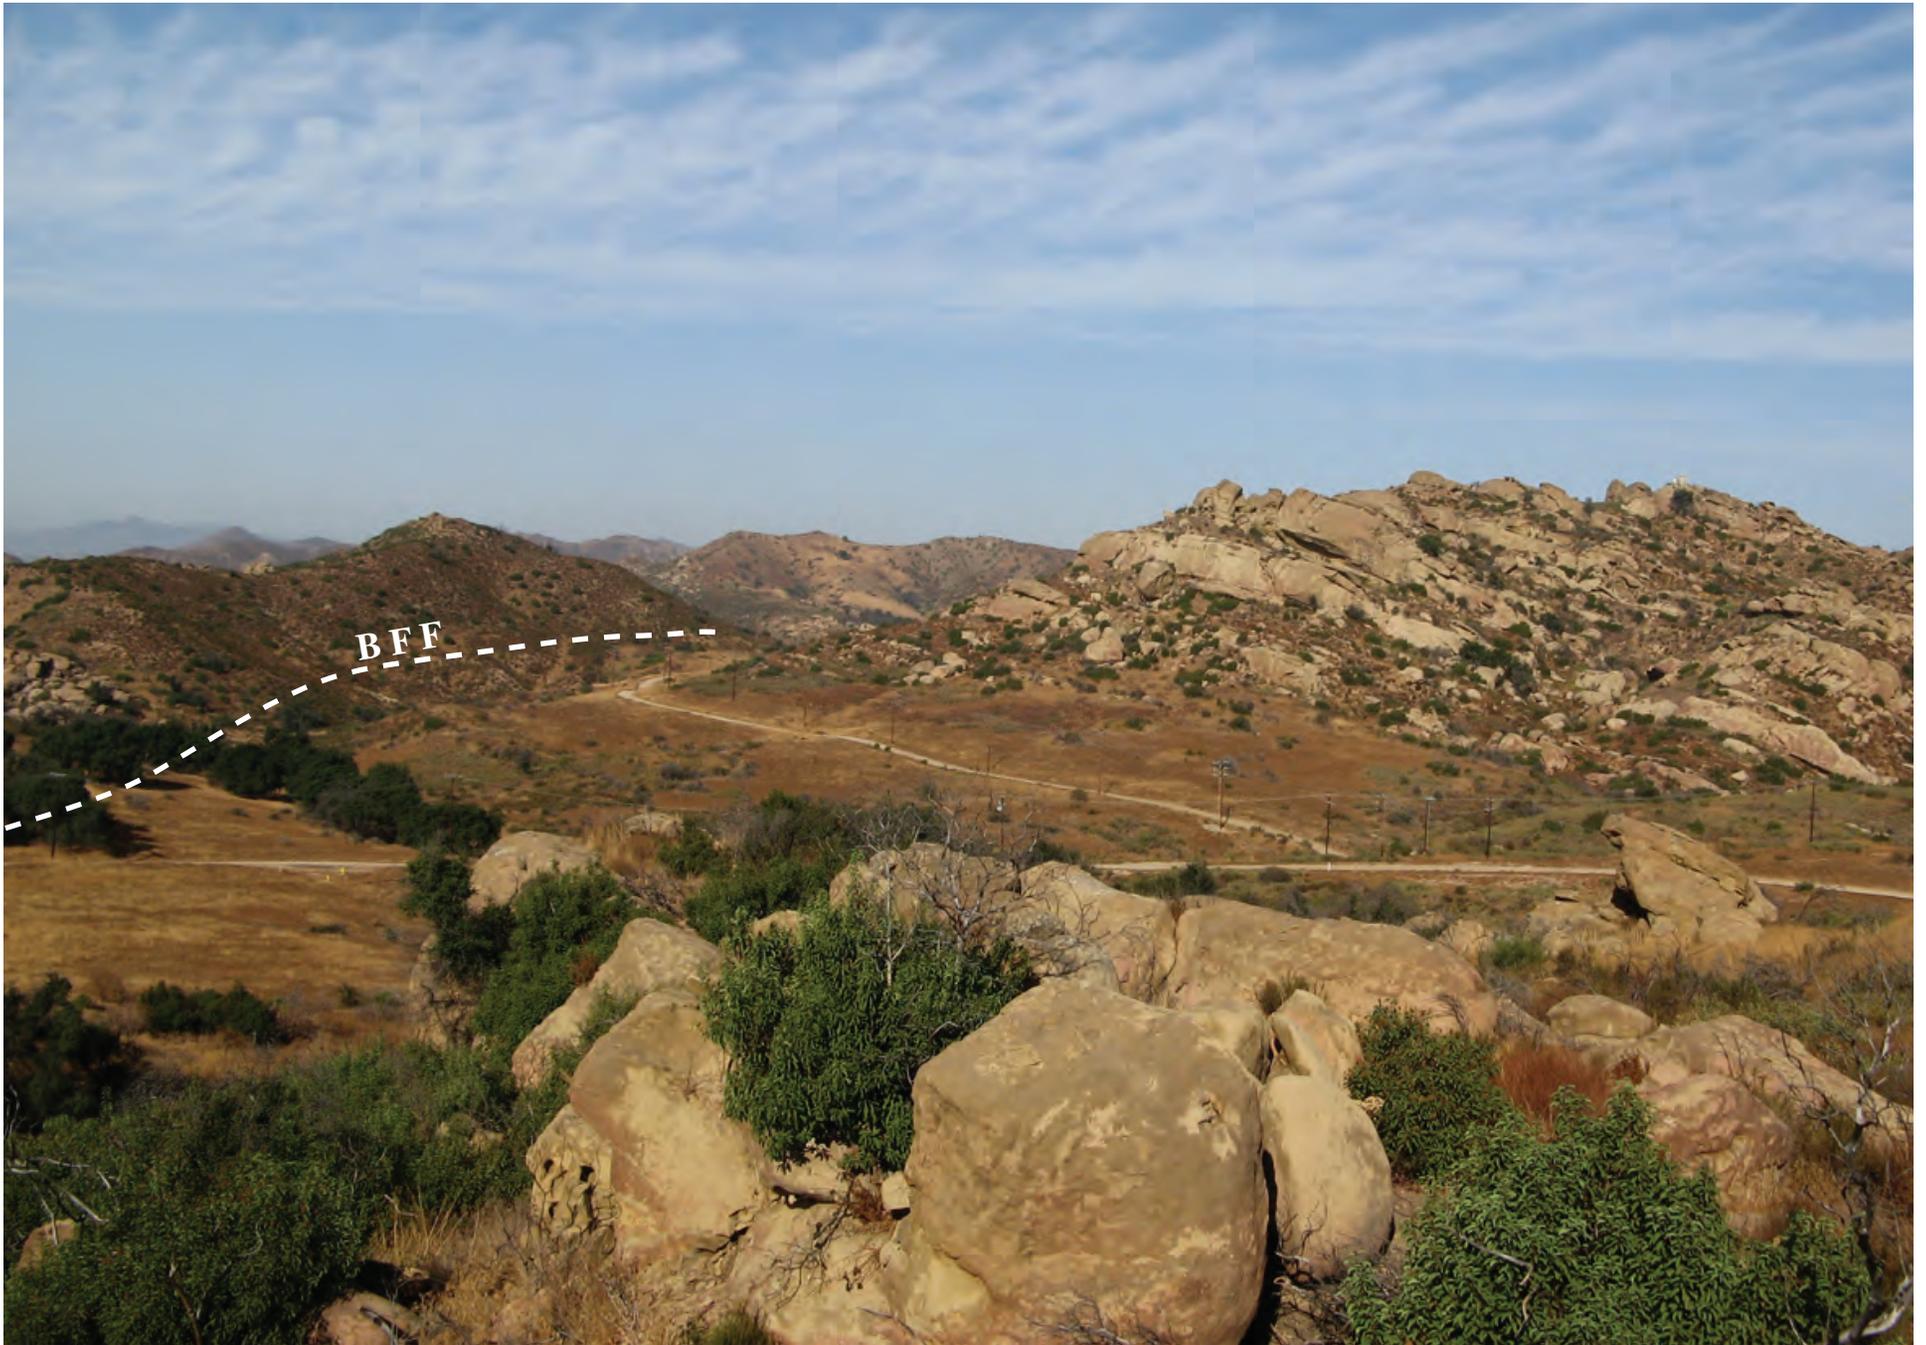
Figure 27. View N80W (field photo MP4048). This photo shows sparsely jointed, thick bedded Chatsworth sandstone in the NE part of Google Earth™ image 26 (see Fig. 26 for location). Dashed line marks the approximate location of the Burro Flats Fault (BFF).
