## Building America Efficient Solutions for New Homes

# Case Study: Ravenwood Homes and Energy Smart Home Plans, Inc. Cape Coral, Florida

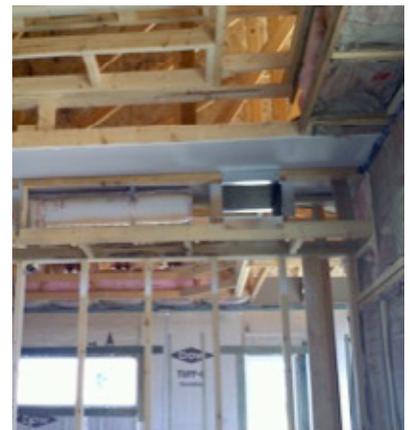
After the ceiling drywall was installed, the ducts were installed in chases beneath the ceiling providing a conditioned space for the HVAC ducts with a continuous air barrier above.

Ceilings that provide a continuous air barrier can be a key energy-saving feature of a home. In this home the builder installed the ceiling drywall as one continuous layer then installed duct chases in dropped ceilings beneath this drywall so that ducts were installed in conditioned space with an unbroken air barrier above. Interior walls were also attached to the underside of this continuous ceiling plane.

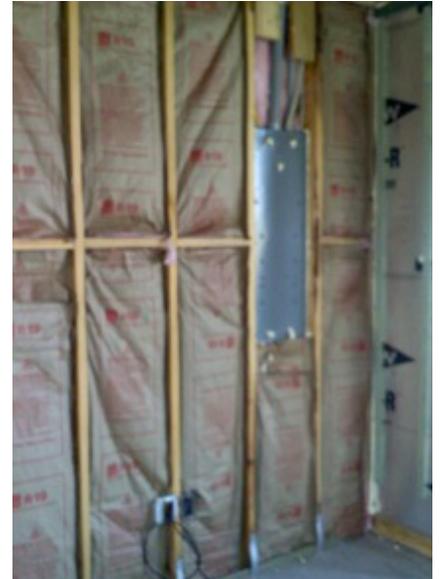
Inset stapling was used to fasten the insulation to the sides of framing, which created a thermal bypass. The builder restapled the kraft tabs to the stud faces to remedy this problem.

builder initially used inset stapling to secure kraft-faced insulation in the walls. Inset stapling creates creases in the face of the insulation that serve as potential pathways for air movement. This problem had to be corrected before drywall was installed.
