Biofuels Impact on DPF Durability

Oak Ridge National Laboratory

May 15th, 2012

PM040

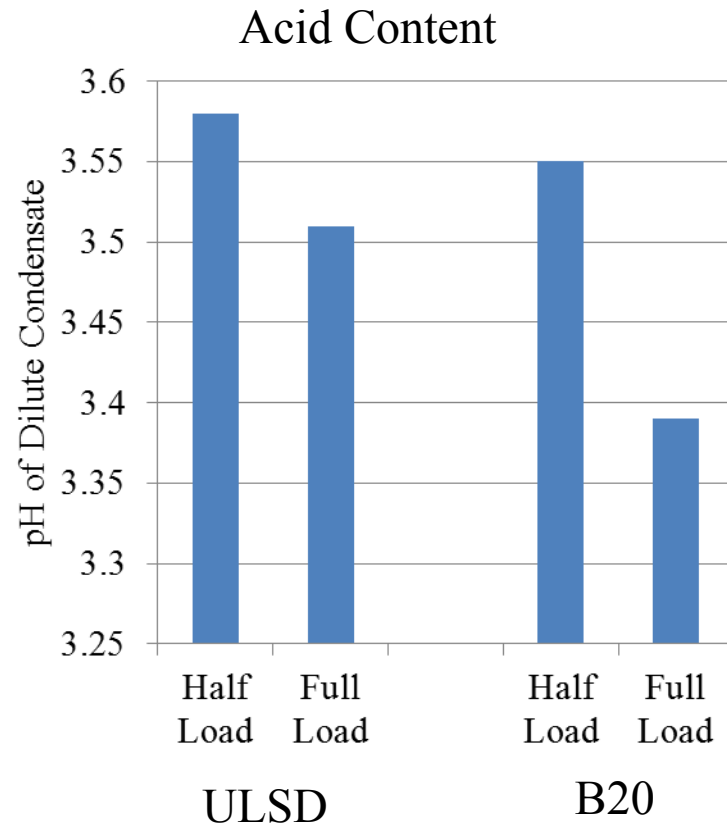
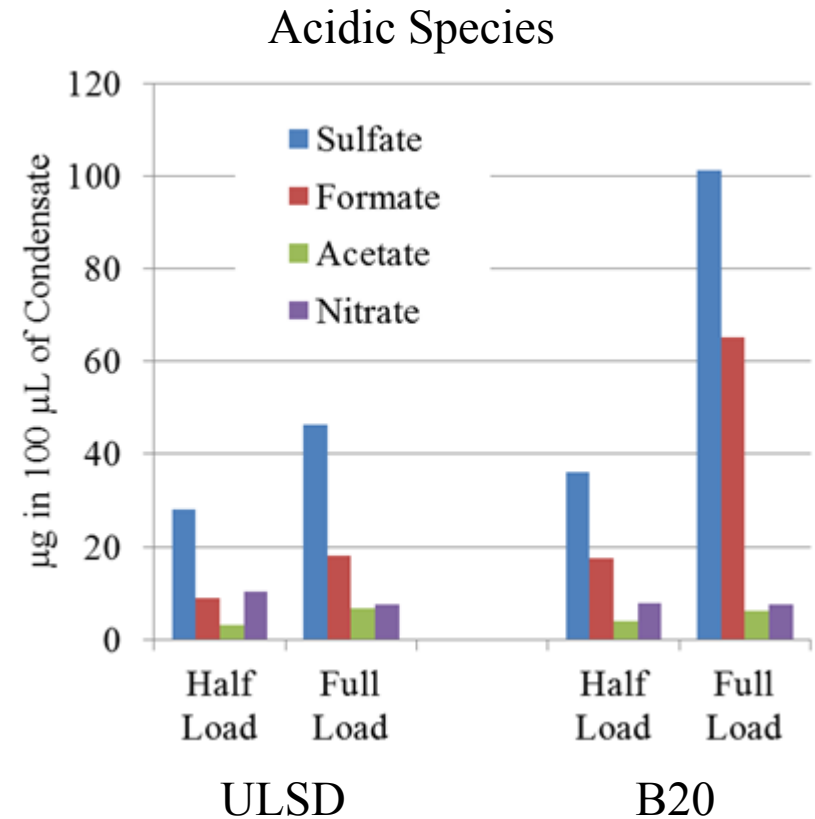
Acidic Content and Species in Condensate were Measured

- Condensates were collected from the exhaust of ULSD (B0) and B20 fuels run on an air-cooled light-duty, single-cylinder (high NO_x & PM) Hatz engine at half and full loads.
- B20 combustion results in a significant increase in sulfuric and formic acid and total moles of H⁺ in the exhaust gas, particularly under full-load conditions.

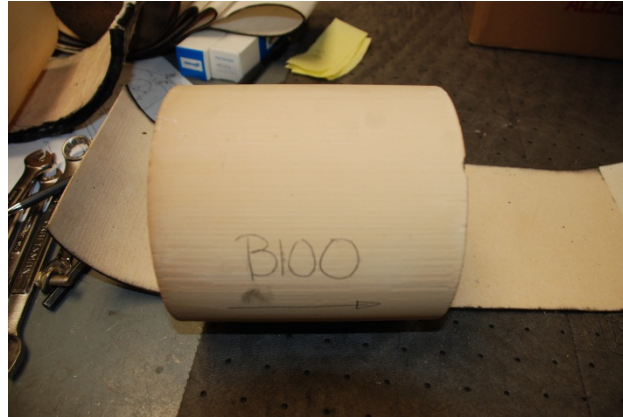
- Four DPFs were loaded with soot using the same Mercedes engine that produced initial DPF degradation. Engine was operated at 1500 rpm and 2.6 bar. SME fuel from Renewable Energy Group (REG) which was certified by Southwest Research Institute (SWRI) and GC-MS at Oak Ridge.
- The surface of the DPF after being exposed to certified B100 exhaust and storage for 3 months showed no degradation.
- Likely failure mode was reduction in binder tensile strength in the DPF skin due to biodiesel exposure. Original bricks were uncatalyzed and the skin had yet to be completely sintered.

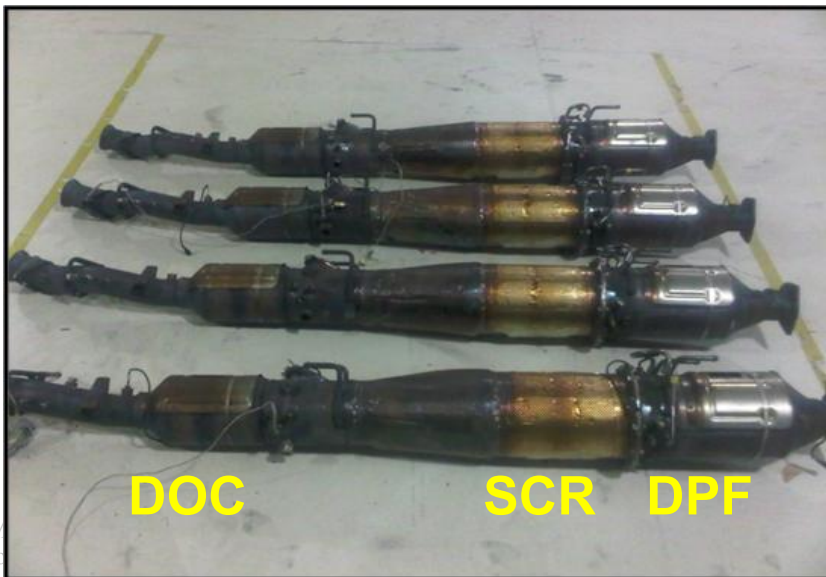
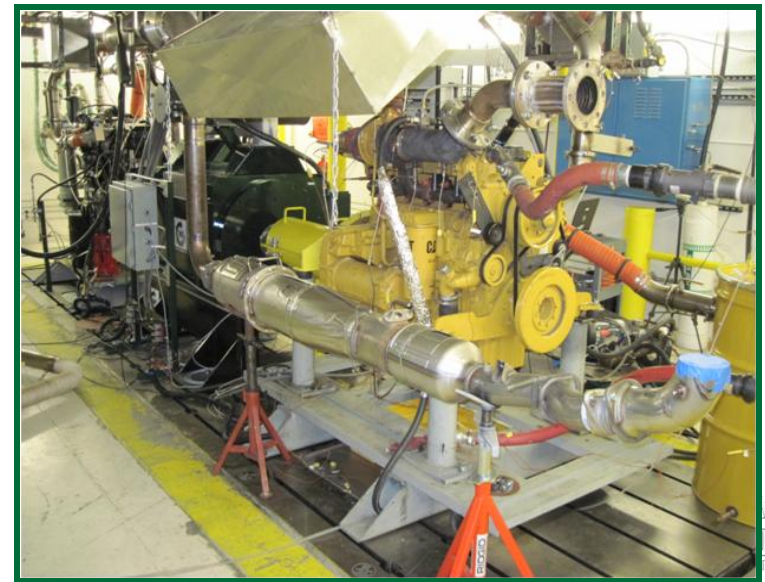
- Aging full production exhaust systems from 2011 Ford F250 pickup
- 4 separate tests were conducted. ULSD, B20 + 14ppm Na, B20 + 14ppm K and B20 + 14ppm Ca
- Aging conducted on Cat C9 engine
- 100 hour test simulated 150k miles of operation on SiC DPF
- A three-mode, one-hour test cycle was developed for catalyst aging (suggested by Ford).
 - **Low Temp** 15 minutes @ 200 C, **High Temp** 15 minutes @ 340 C, and **Regen** 30 minutes @ 700 C.

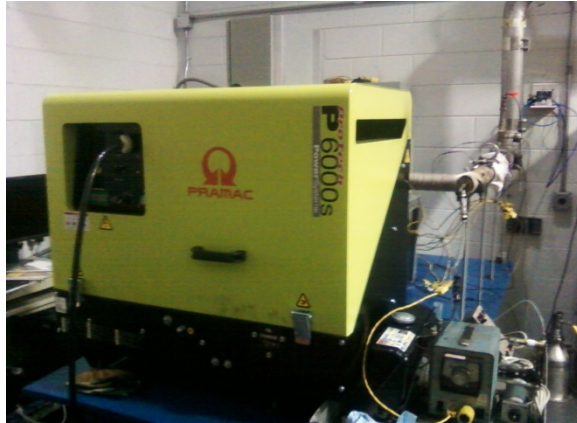
Diesel Gen-Set for 24/7 DPF Regeneration Cycling

- Pramac P6000S silenced diesel gen-set has been installed at the NTRC (National Transportation Research Center) building at ORNL. The engine is 10 hp and is rated for 4800 W and is connected to an Avtron K490 load bank.
- Shakedown testing indicated the need for a complete change of exhaust system due to the use of a glass-pack muffler which shed fibers and face-plugged the DPF and due to excess cooling of exhaust, which was done by the manufacturer for safety of outdoor installations.
- Thermal cycling of the diesel particulate filter is done by a combination of gen-set load and exhaust fuel injection and can reach temperatures up to 1200°C in a 15 minute cycle.
