Post-test Facility at Argonne

I. Bloom, J. Bareño, N. Dietz Rago

DOE Annual Merit Review

May 2012

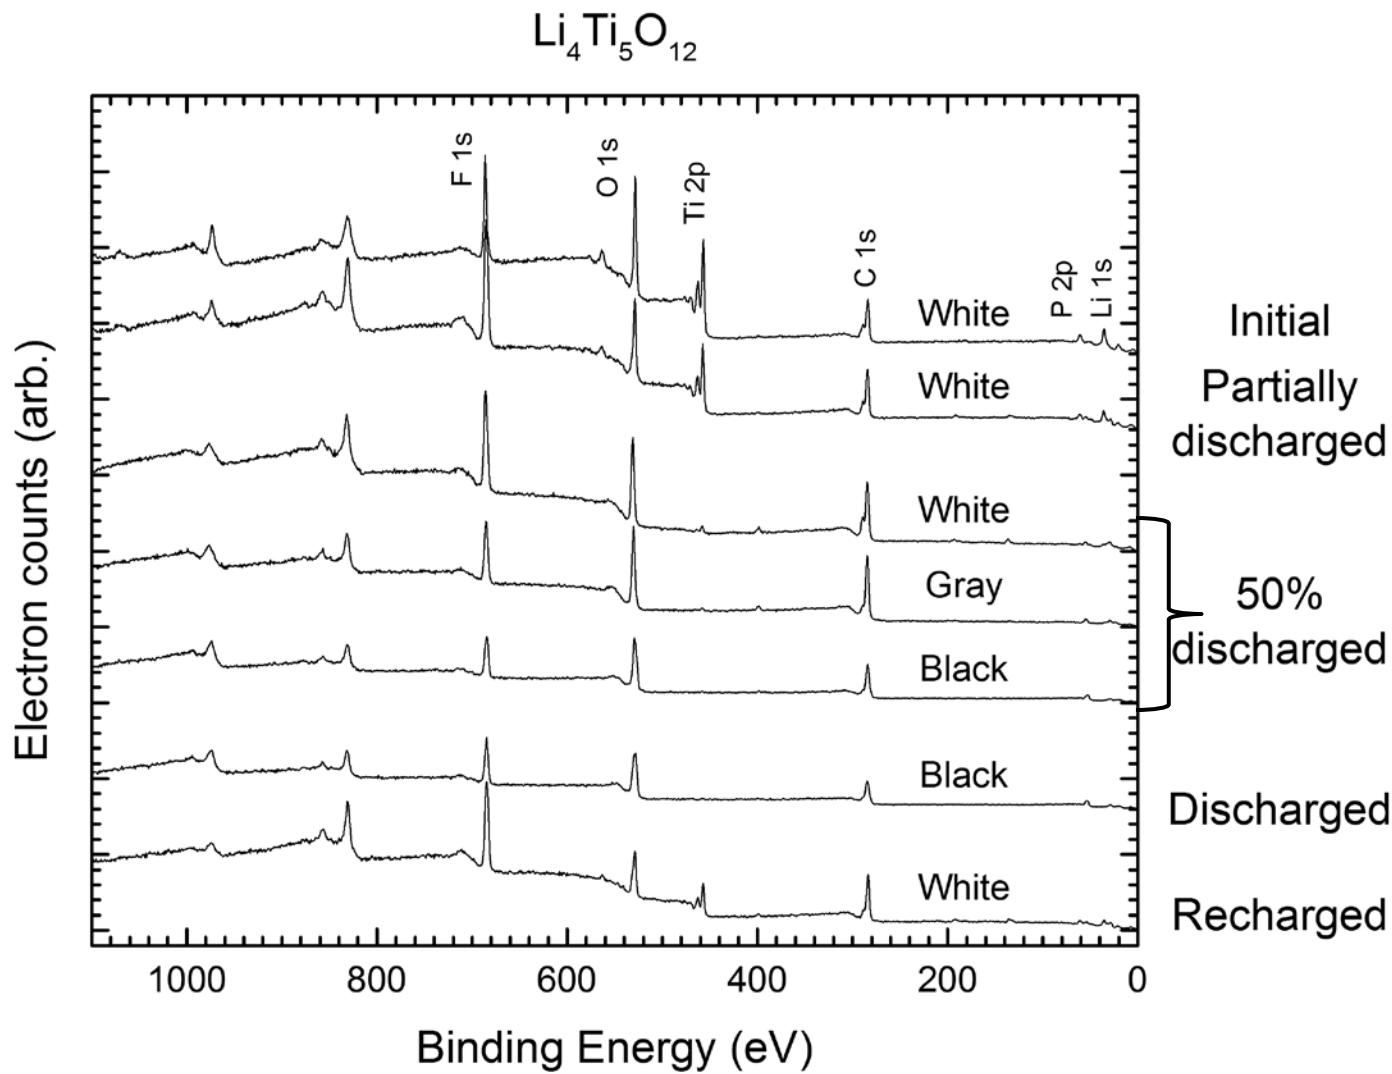
XPS Results from LTO Anodes

- Ti 2p peak disappears as material is discharged; it emerges upon recharge
- May indicate presence of an SEI layer which forms and dissolves with discharge and charge

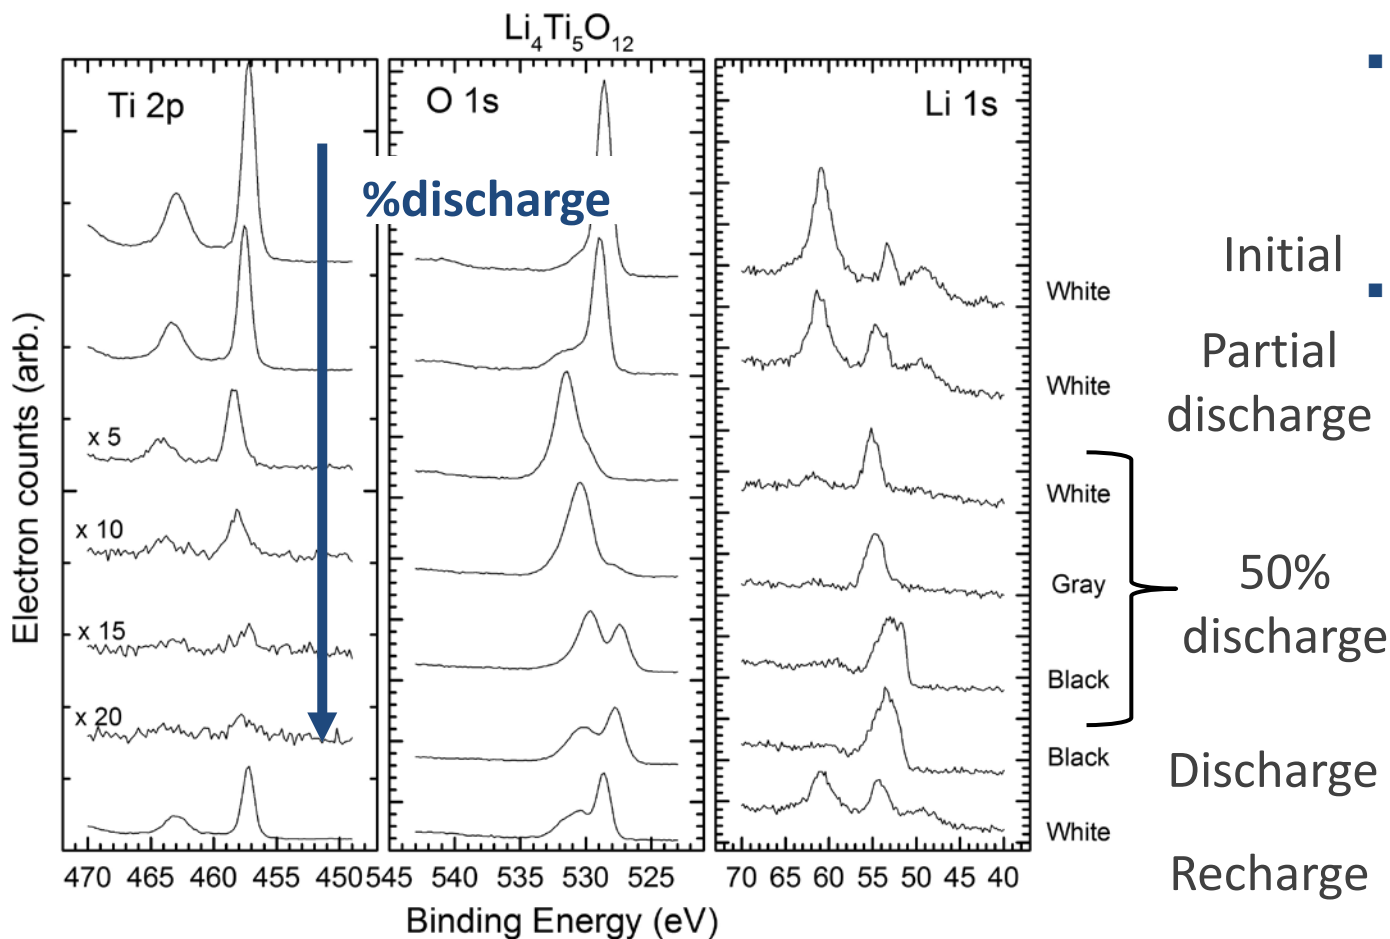
XPS Results: Ti 2p Intensity Correlates with %DOD

- Low energy component in O1s peak, which stays after recharge.
- The state of discharge (amount of additional lithium) increases downwards, except for the last curve which is the re-charged sample. The intensity of the Ti 2p peak is inversely correlated with the state of discharge, consistent with formation of SEI layer that dissolves upon recharge.

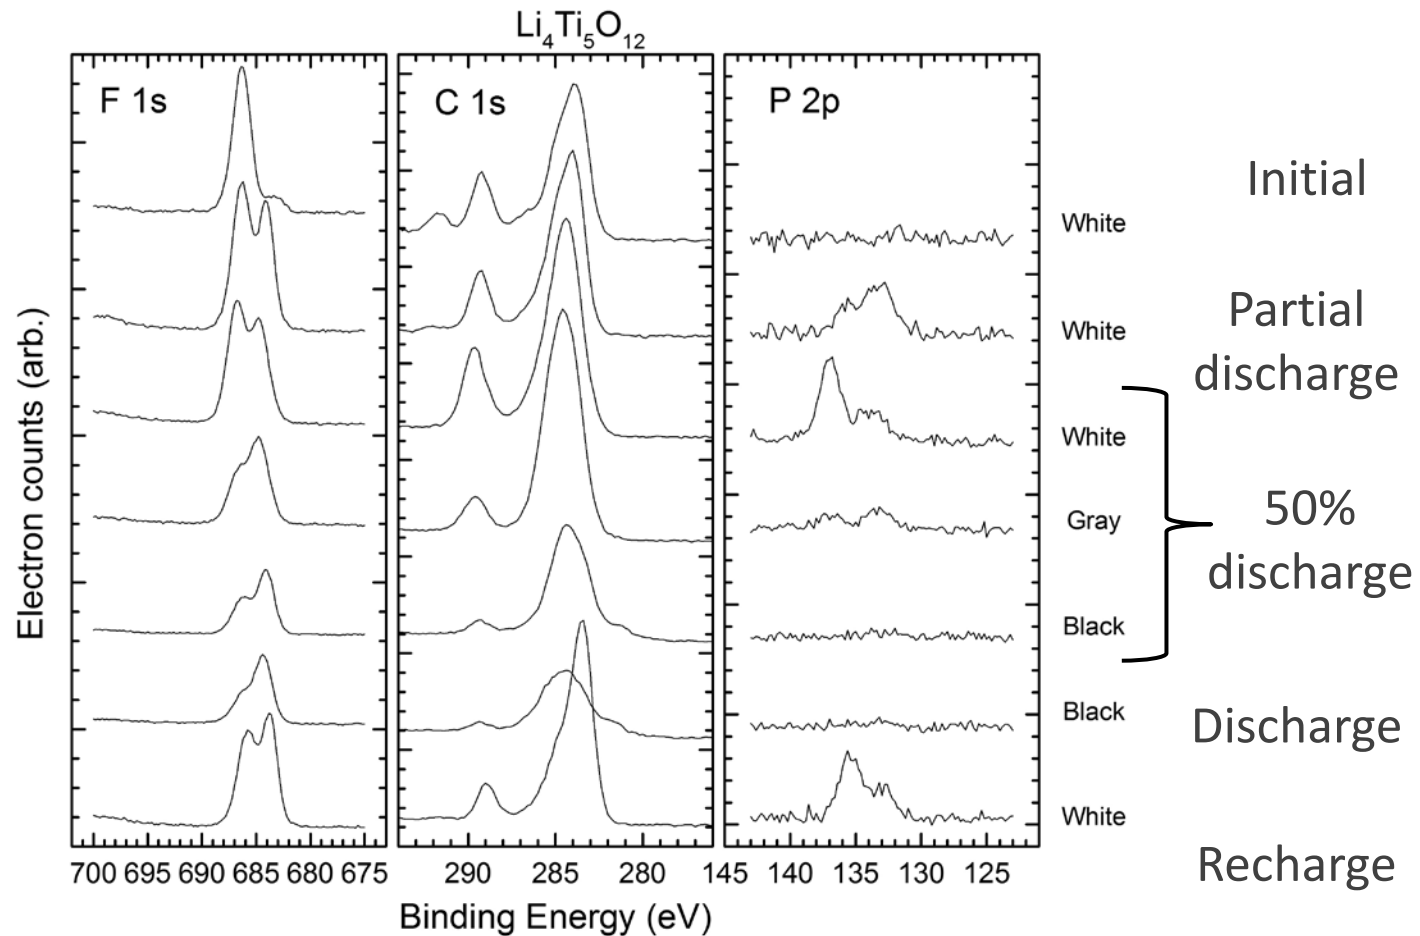
Other Changes Are Seen in XPS Results

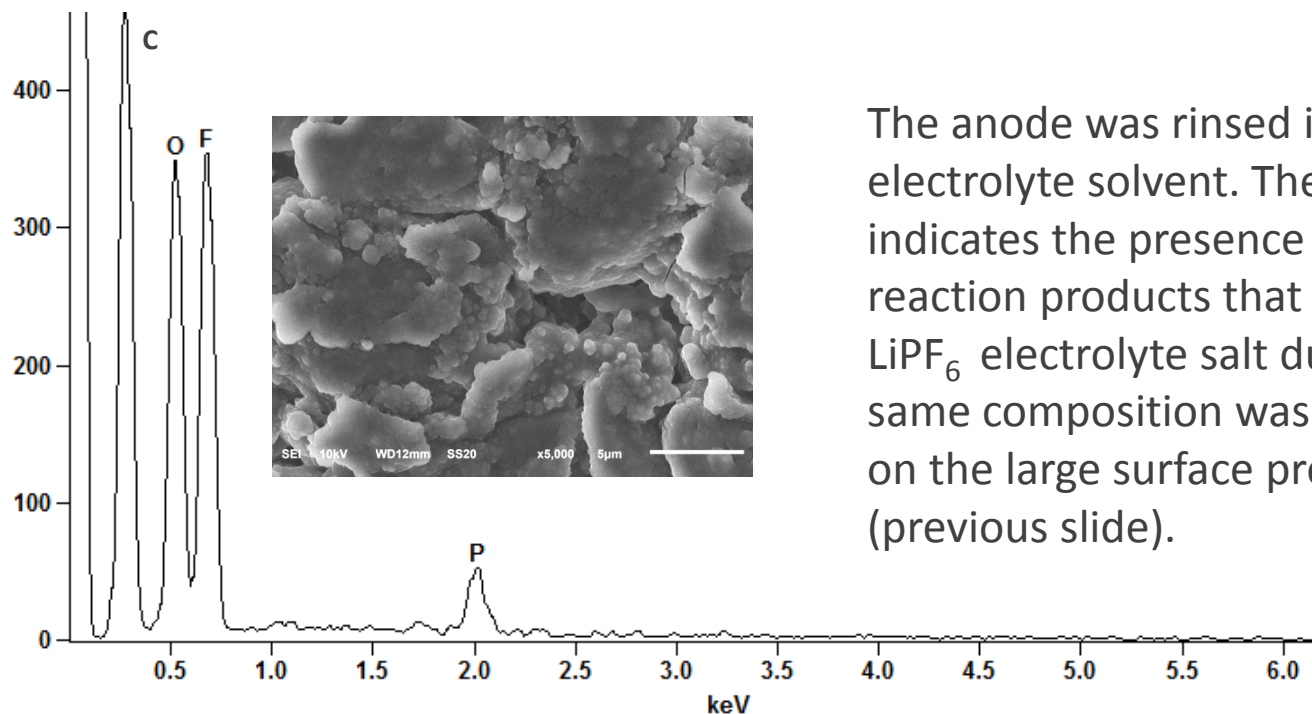
EDS Analysis of Rinsed Anode Shows Presence of Insoluble Deposits

The anode was rinsed in EMC, the electrolyte solvent. The EDS spectrum indicates the presence of insoluble reaction products that formed with the LiPF_6 electrolyte salt during cycling. The same composition was also detected on the large surface precipitates (previous slide).

Note: Li is not detected by EDS

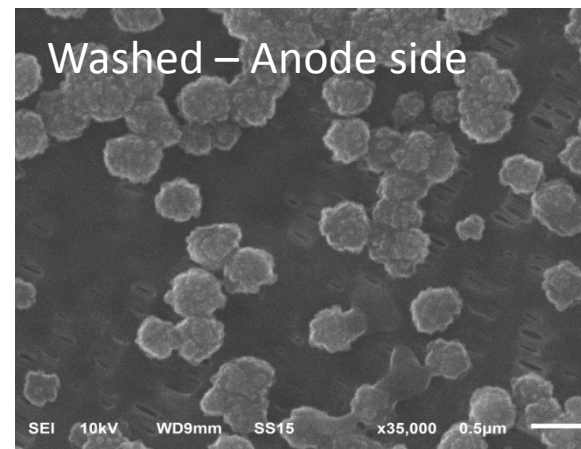
SEM/EDS Analysis of Separator Membrane Also Shows Presence of Insoluble Precipitates

- Celgard® microporous, 25 µm tri-layer (PP-PE-PP)
- Representative EDS spectrum from surface precipitates and "clean" appearing areas on the membrane. The membranes were rinsed in EMC, the electrolyte solvent. The reaction products formed during cycling are insoluble in EMC and have the same composition as the precipitates on the rinsed anode.

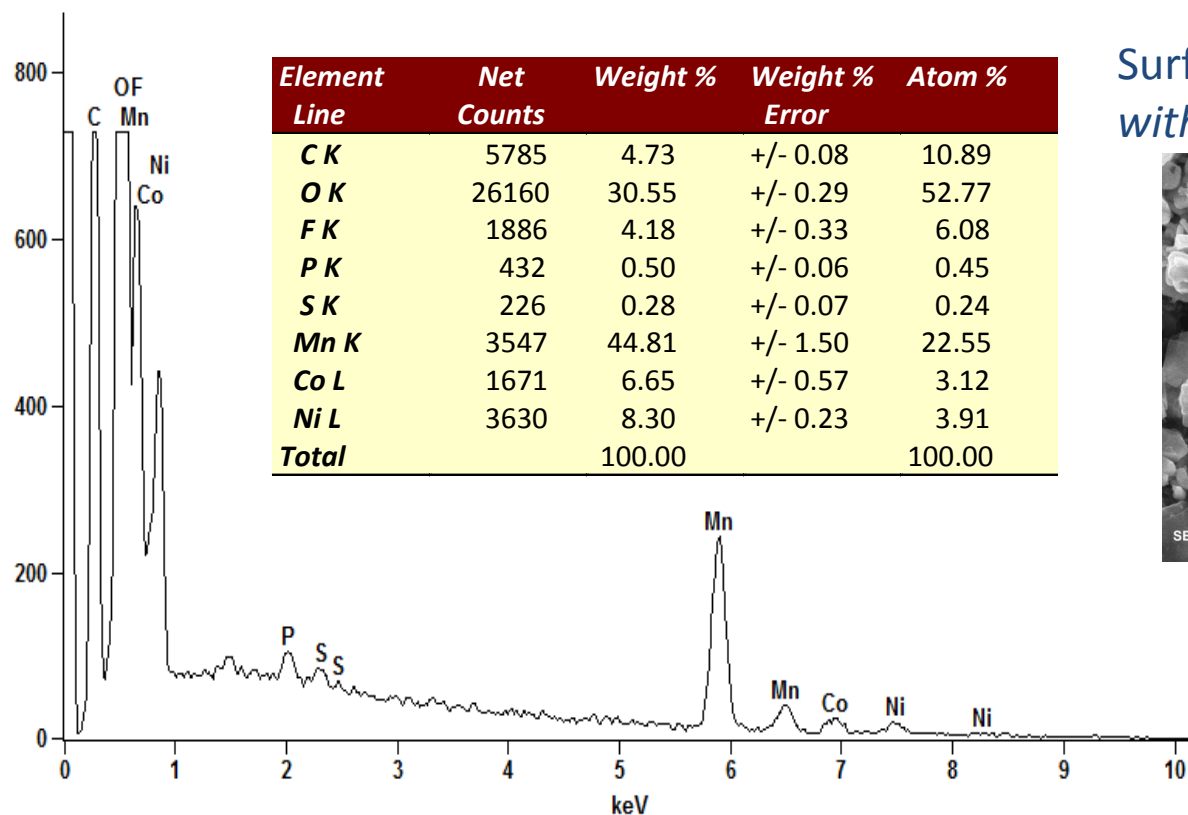
SEM/EDS of Rinsed Cathode Shows Presence of Insoluble Deposits

Representative EDS data indicates the presence of insoluble reaction products that formed with the LiPF_6 electrolyte salt during cycling. The oxide particles are produced in a sulfuric acid environment and, thus, is the most probable source for S.

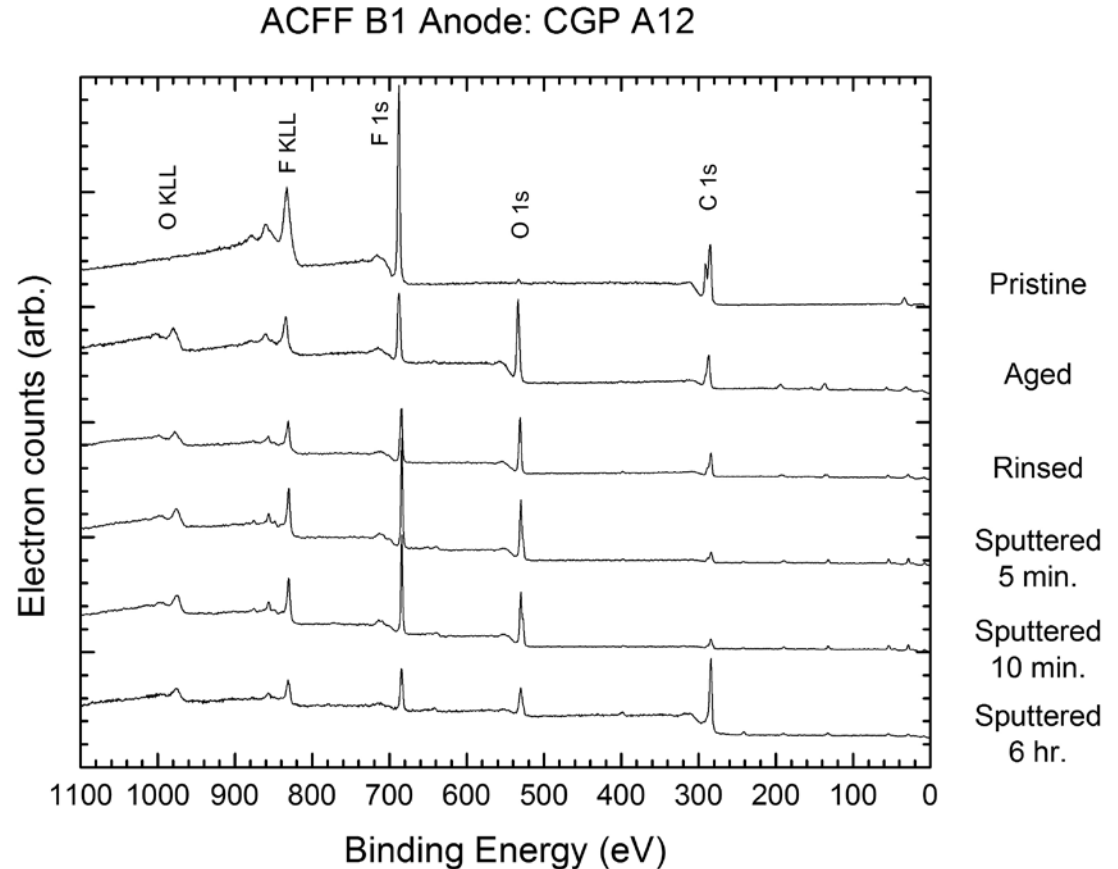
XPS Analysis of Anode Harvested from ACFF 1st Cell Build

- Intense F1s peak decreases upon aging and rinsing and drying; recovers upon sputtering
- Continuous decrease of C1s peak

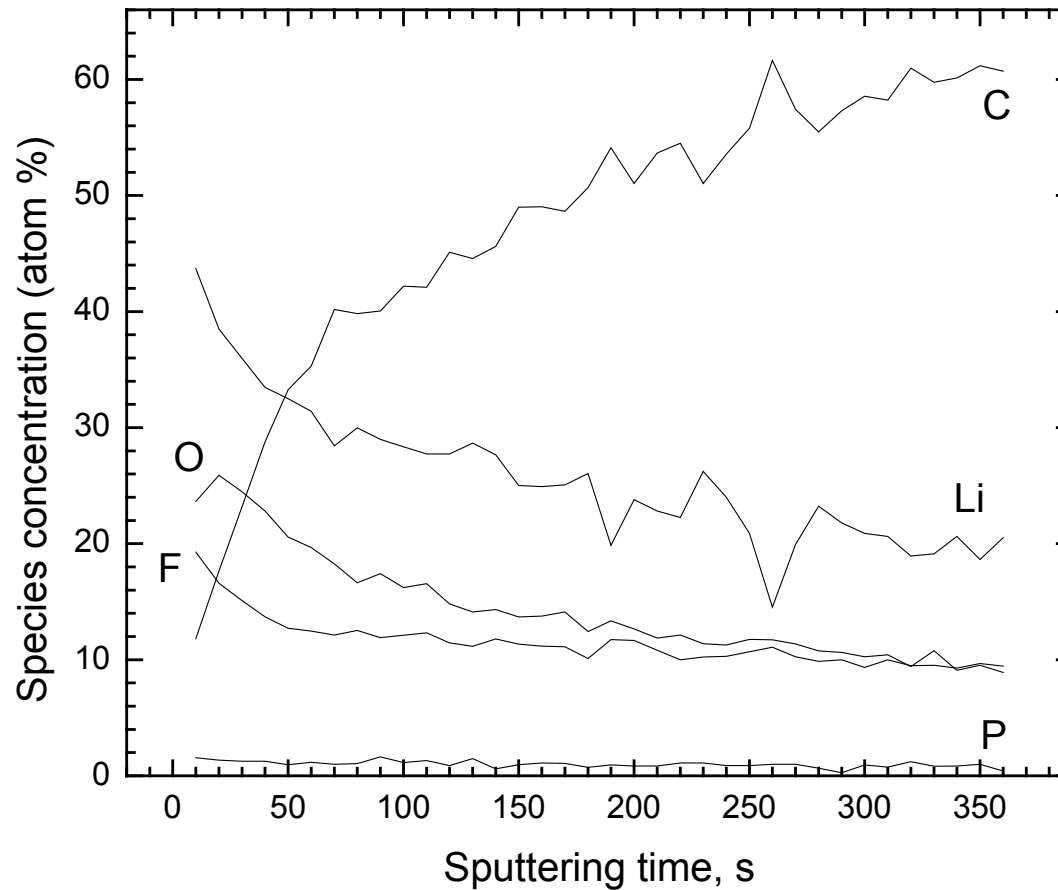
ACFF B1 Anode: CGP A12

Sputtering with 3-kV Ar⁺ Reveals Composition Gradients on Electrode Surface
