Mexican Hat, Utah, Disposal Site

An UMTRCA Title I site

This fact sheet provides information about the **Mexican Hat disposal site**. This site is managed by the **U.S. Department of Energy Office of Legacy Management** under Title I of the **Uranium Mill Tailings Radiation Control Act of 1978**.

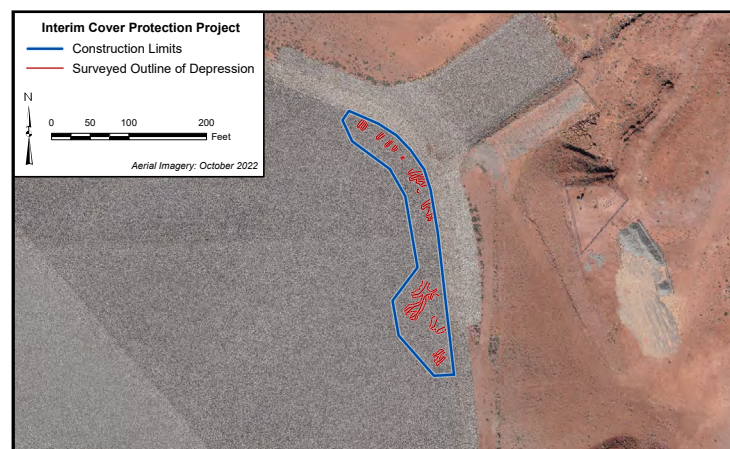
Depression Features on Northeast Side Slope and Approximate Area of Interim Cover Protection Project.

In 2016, multiple subtle depressions were identified in the rock cover along the toe and lower portions of the northeast side slope of the disposal cell. As a result of limited field investigations in 2017 and 2018, erosion into the surface of radon barrier was identified along the lower portions of the north and northeast side slopes of the disposal cell. These observations indicate the disposal cell erosion protection system is not performing as designed. Field observations and supporting radiological scans of the depression features show radioactive materials have neither been released nor exposed, and the disposal cell remains protective of human health and the environment.

and to determine the appropriate corrective measures needed to ensure that the design life of the disposal cell meets the requirements under UMTRCA. A comprehensive interim cover protection project was also performed in 2019, which restored a 20,000 square foot area on the northeast side slope back to the original design specifications to ensure protection of human health and the environment until a final long-term solution is implemented.

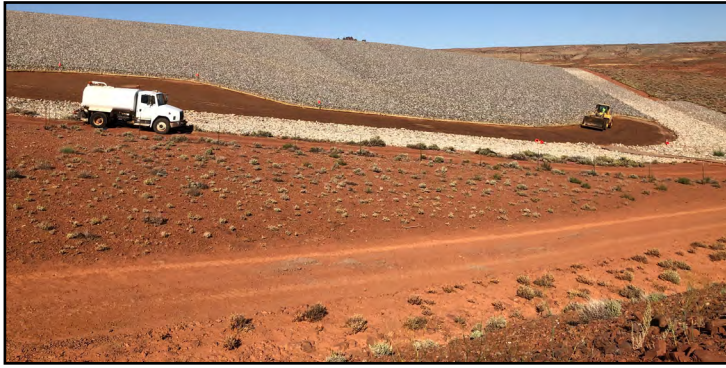
Mexican Hat Interim Cover Protection Project.
