Mexican Hat, Utah | Disposal Site

AN UMTRCA TITLE I SITE

This fact sheet provides information about the **Mexican Hat disposal site**. This site is managed by the **U.S. Department of Energy Office of Legacy Management** under **Title I** of the **Uranium Mill Tailings Radiation Control Act of 1978**.

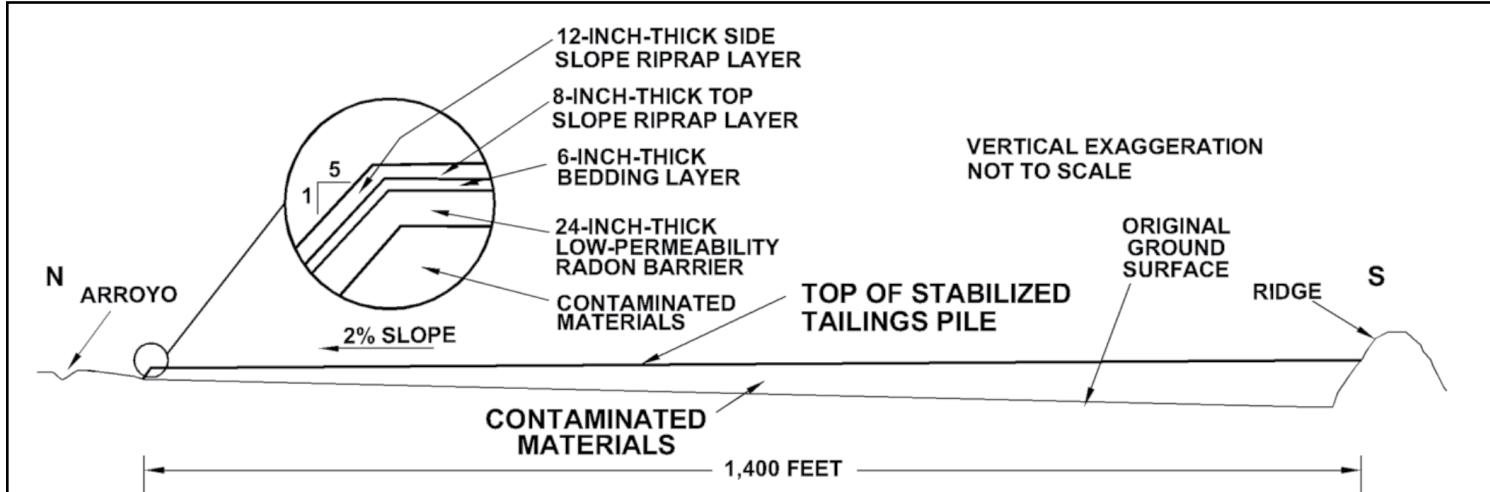
Typical north-south cross section of the Mexican Hat disposal cell.

The cover is composed of (1) a low-permeability radon barrier (first layer placed over compacted tailings), (2) a bedding layer of sand and gravel placed as a capillary break, and (3) a rock (riprap) erosion protection layer. The cell design promotes rapid runoff of precipitation to minimize leachate. The cell cover was constructed with a 2 percent grade sloping to the north and east. Runoff water flows down the 20 percent side slopes into the surrounding rock apron and exits the cell via three engineered toe drains that drain into existing arroyos north and east of the cell.

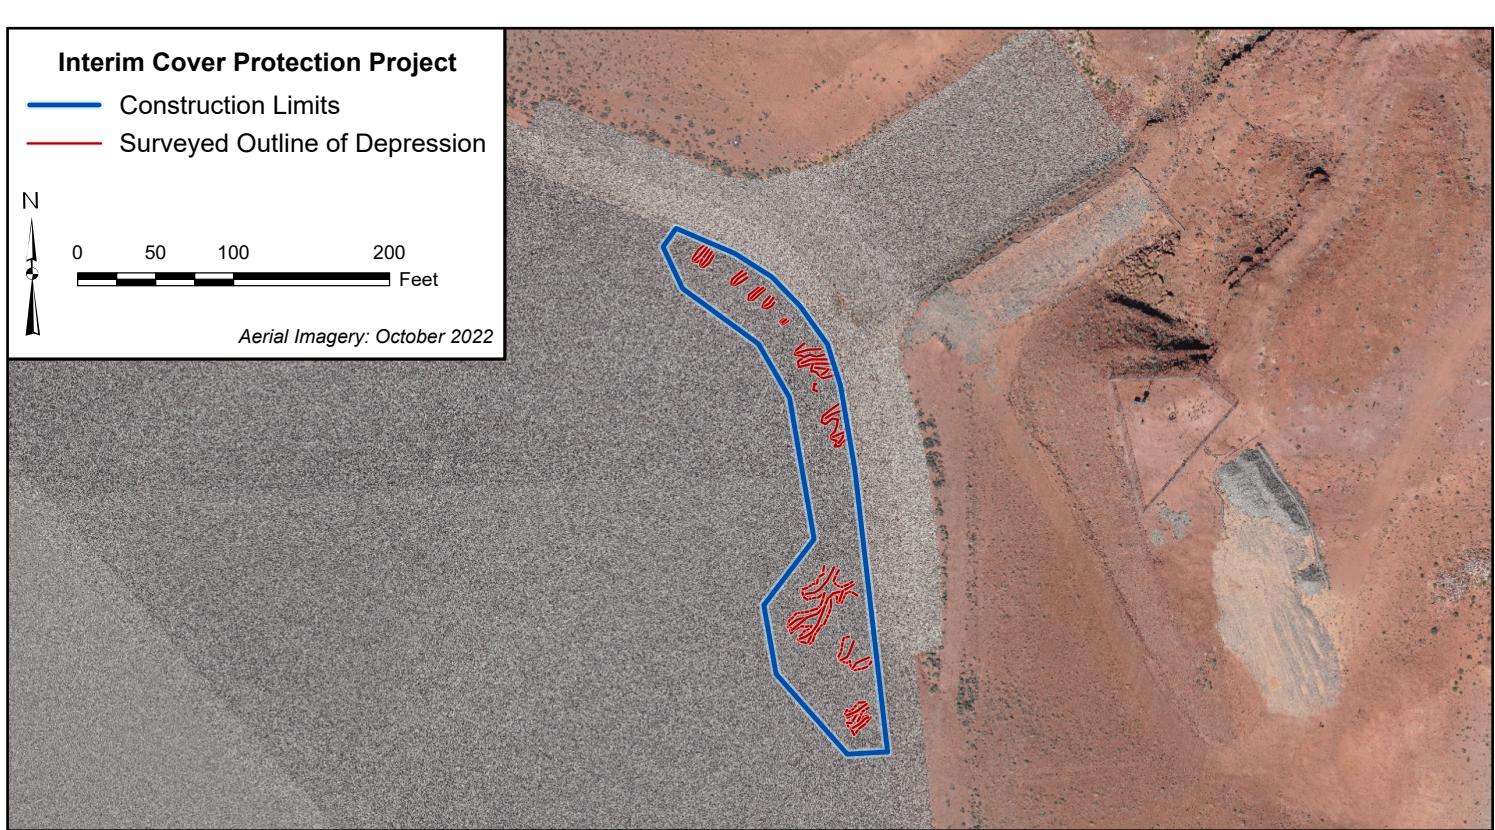
Depression features on northeast side slope and approximate area of interim cover protection project.

In 2016, multiple subtle depressions were identified in the rock cover along the toe and lower portions of the northeast side slope of the disposal cell. As a result of limited field investigations in 2017 and 2018, erosion into the surface of radon barrier was identified along the lower portions of the north and northeast side slopes of the disposal cell. These observations indicate the disposal cell erosion protection system is not performing as designed. Field observations and supporting radiological scans of the depression features show radioactive materials have neither been released nor exposed, and the disposal cell remains protective of human health and the environment.

and to determine the appropriate corrective measures needed to ensure that the design life of the disposal cell meets the requirements under UMTRCA. A comprehensive interim cover protection project was also performed in 2019, which restored a 20,000 square foot area on the northeast side slope back to the original design specifications to ensure protection of human health and the environment until a final long-term solution is implemented.

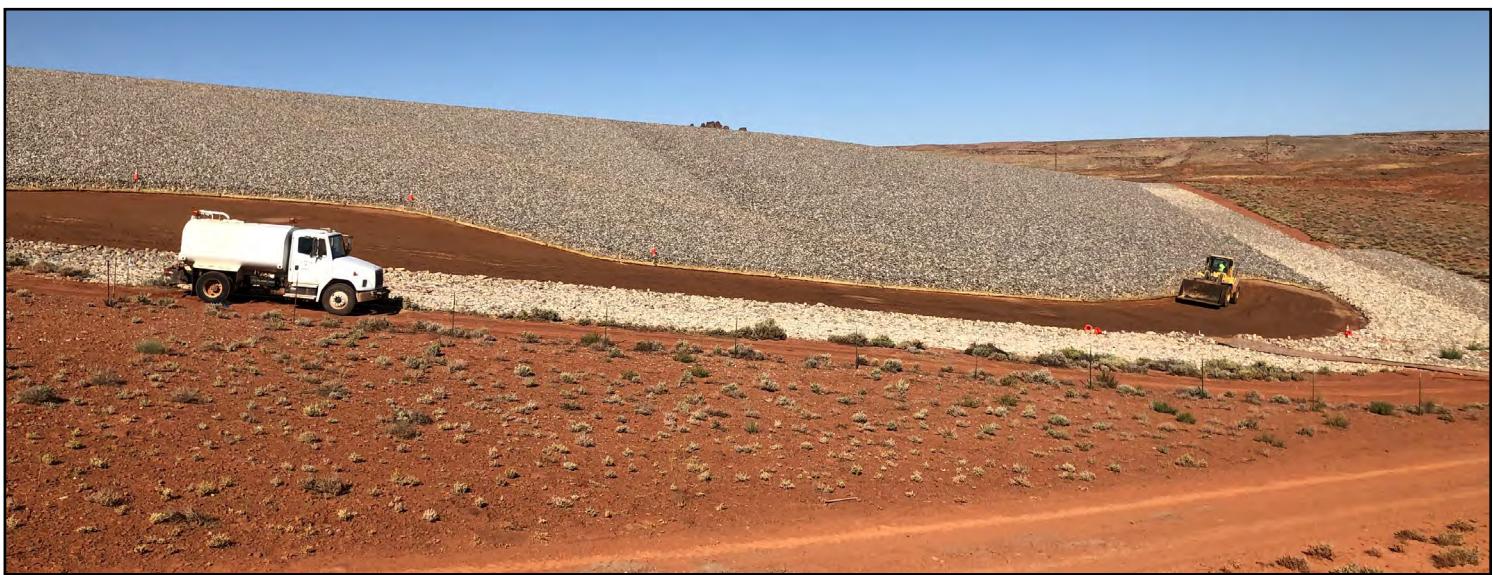
Mexican Hat Interim Cover Protection Project.
