## SITE CERTIFICATION SUMMARY

This Site Certification Summary provides information about the **Tonawanda, New York, Site**. The U.S. Department of Energy Office of Legacy Management is responsible for long-term stewardship of the site under the **Formerly Utilized Sites Remedial Action Program**.

The Tonawanda, New York, Site (formerly known as the Linde Site) is located at 175 East Park Drive in Tonawanda, about 9 miles north of downtown Buffalo. Originally, Praxair, Inc. owned the 135-acre industrial facility. In November 2018, Praxair merged with the German-based Linde, keeping the former's name. Later research verified that the property owner was still listed as Praxair, Inc. as of January 28, 2019. Linde Air Products Division of Union Carbide processed uranium ores under contract with the Manhattan Engineer District between 1942 and 1946. These processing activities resulted in elevated levels of radionuclides in portions of the property and buildings. The site contaminants of concern (COCs) were radium-226 (Ra-226), thorium-230 (Th-230), and total uranium (U; U-234, U-235, and U-238). The current Praxair property contains office buildings, fabrication facilities, warehouse

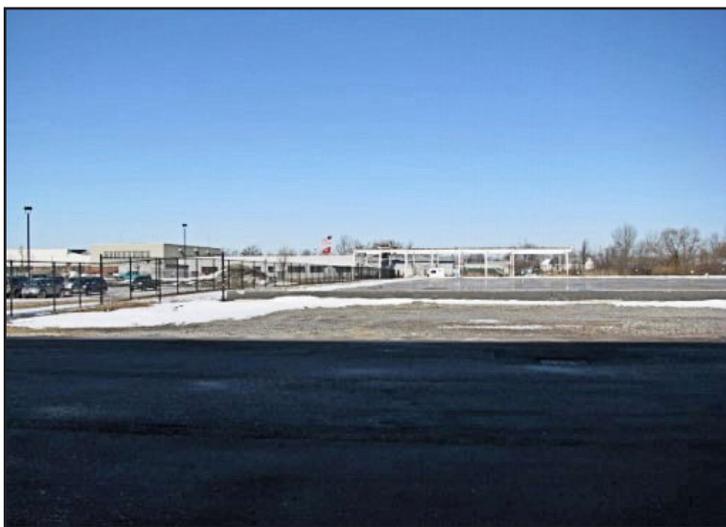
Looking north at the concrete pad where Building 30 once stood (January 2010).
