# **Design Optimization of Piezoceramic Multilayer Actuators for Heavy Duty Diesel Engine Fuel Injectors**

**2014 Vehicle Technologies Annual Merit Review  
and Peer Evaluation Meeting  
Washington, DC  
June 19, 2014**

**Project ID #:  
PM051**

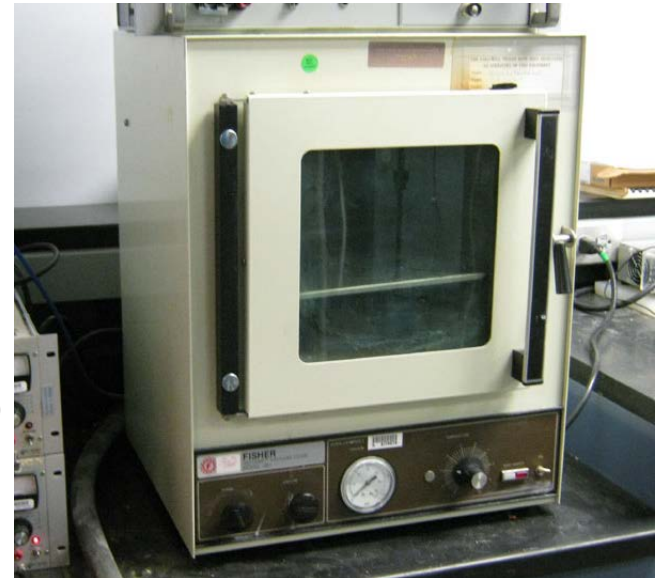
- A vacuum oven (Fisher 281) was used along with KBr solution for environmental control: 79% R.H. at 80°C
- 12 10-layer PZT specimens were treated 30 days.

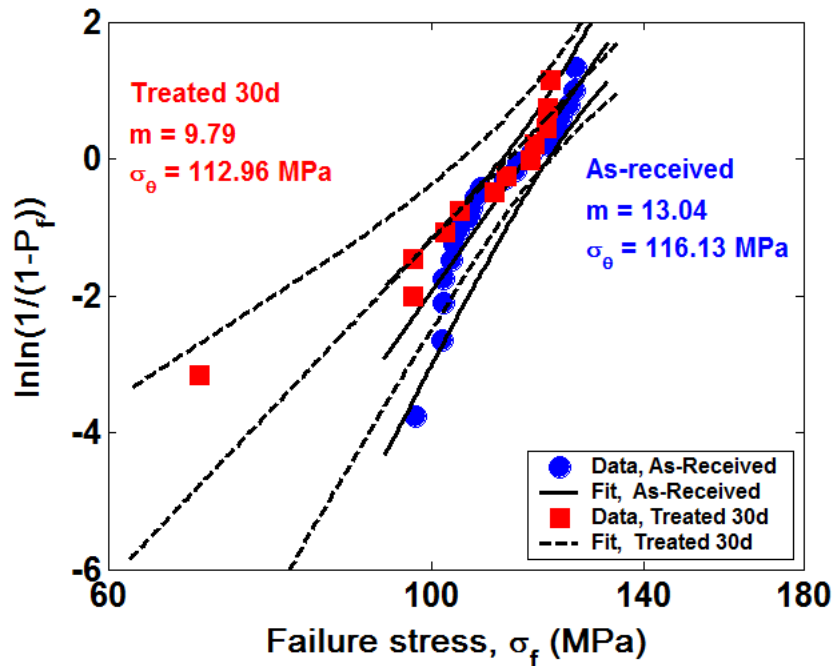
**No Significant Difference Was Found in Mechanical Strengths Between the As-Received and the Treated**

- Mechanical strength of PZT was studied using ball-on-ring testing.
- The two data sets overlap to a great extent. Performance of PZT subjected to long-term humidity and temperature exposure remains to be investigated.

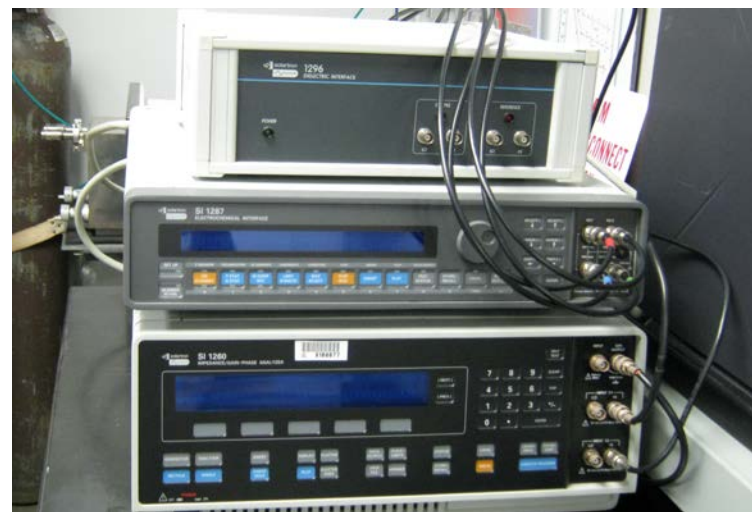
## Pre-Fatigue Condition of Extracted PZT Plates Was Examined by Impedance Analysis

- 10- and 20-layer specimens were electrically wired at first.
- Impedance data were collected using an impedance analyzer (Solartron 1260): 50mV AC, 10 mHz - 100 KHz.

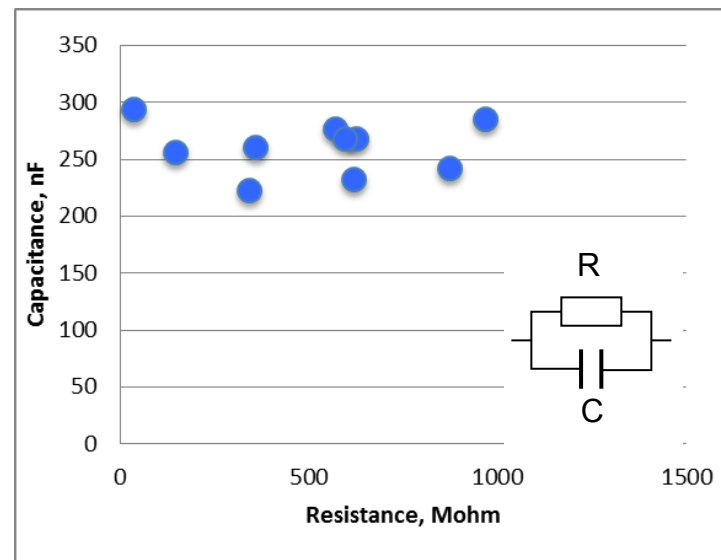
## Impedance Analysis-Based Capacitances Were Approximately 250 nF for 20-Layer PZT Specimens

- Nyquist plots are given for a set of 20-layer specimens on the left.
- Parallel RC element was used in the analysis of impedance data.
- Large scattering in resistance (37 to 970 Mohm) was observed also.

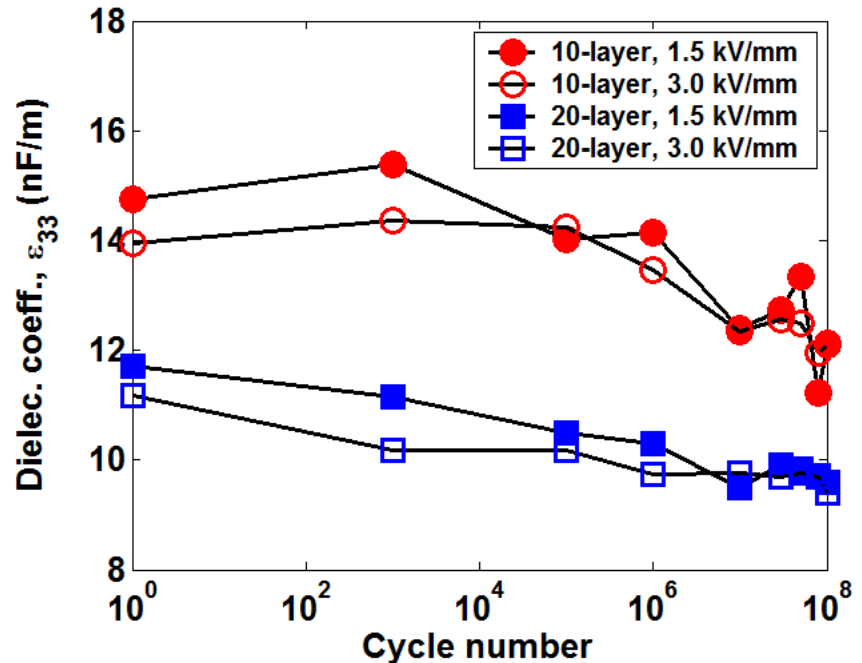
## Substantial Degradation Occurred in Both Piezoelectric and Dielectric Coefficients

- The number of layers plays an important role in fatigue of piezoelectric coefficient, and the dielectric itself largely depends on the number of layers also.
- The results are critical input for further analysis of PZT stacks. No relevant data are available now.

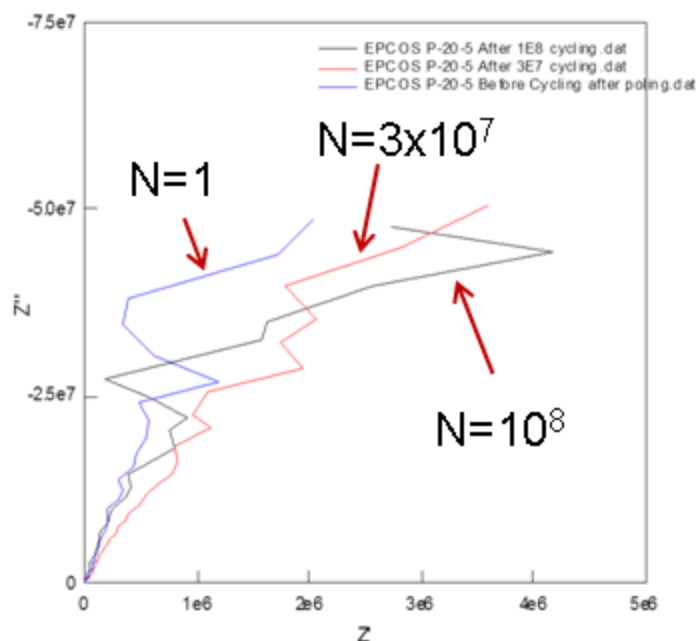
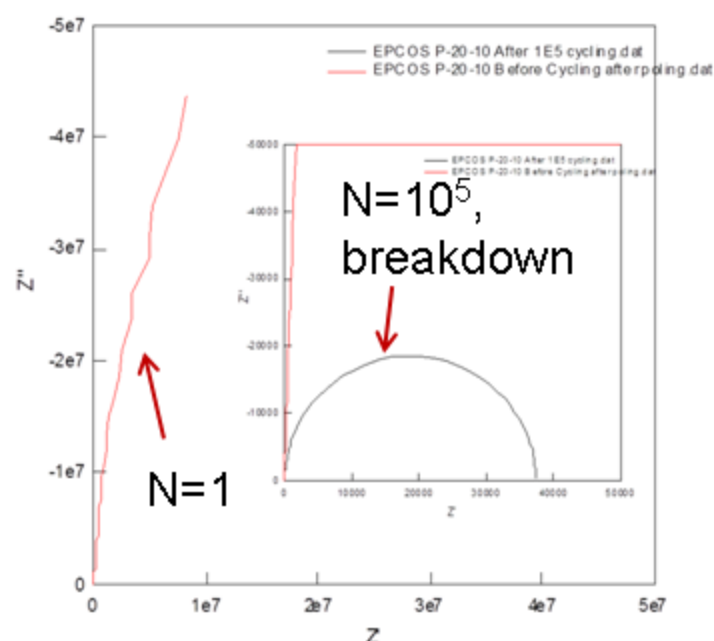
## Significant Difference Was Seen in Impedance Responses Between Fatigued and Failed Specimens

- The Nyquist plot fluctuated in the cycle test of a 20-layer specimen (left side).
- The Nyquist plot changed into a well-defined semi-circle after breakdown in another 20-layer specimen (right side).

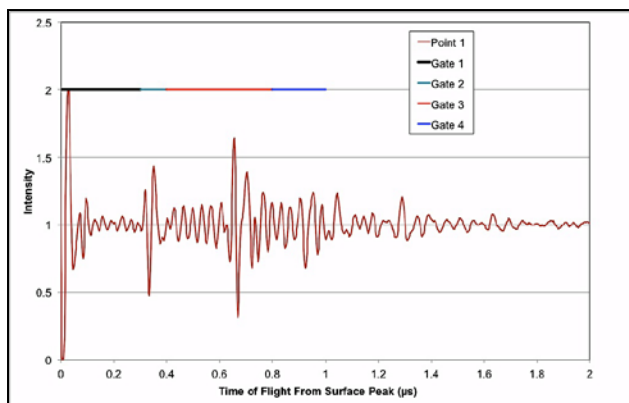
## Damages within Tested Stacks Were Revealed by Scanning Acoustic Microscopy (SAM)

**Localized structural damages were shown in the gray areas of images on a tested 20-layer specimen.**

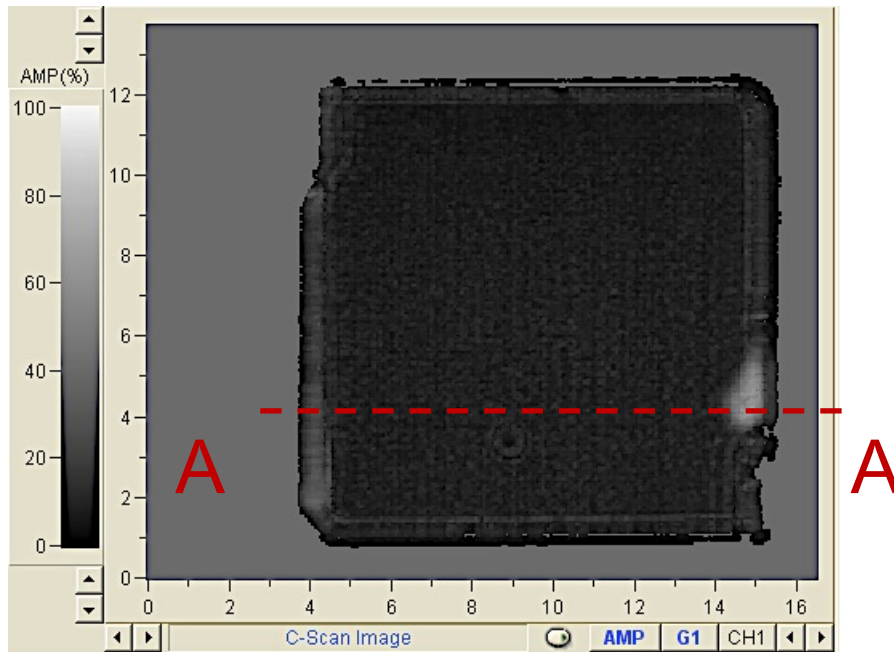
**The 20-layer specimen imaged by SAM was sectioned and polished.**
