Study of Multifamily Energy Retrofit using Flexible, Multizone Building Simulation Model

Presented at
Building America Technical Update Meeting

April 29-30, 2013

Case Study Maplewood Apartment

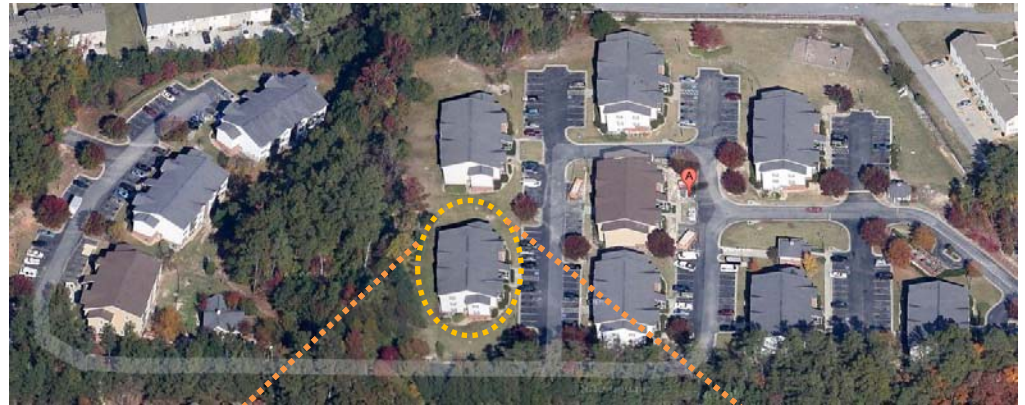
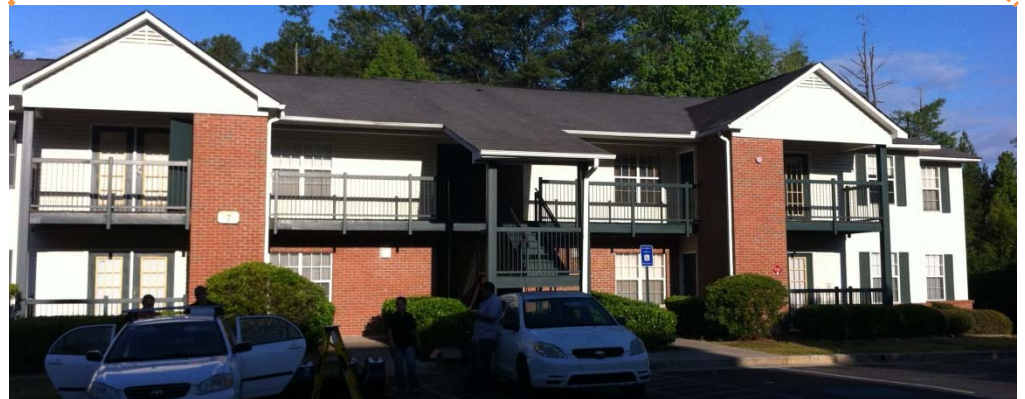
- Case Study: Building #7

- Three story, 11,545 sq.ft.
- 10 units
- Two different plan (5 - two bedrooms & 5- three bedrooms)
- Unit A: Two bedrooms (1,049 ft²)
- Unit B: Three bedrooms (1,260 ft²)
- Partial Slab-On-grade & vented crawl space
