Kohta Ueno

Hybrid Foundation Retrofits

Building America Webinar
November 30, 2011

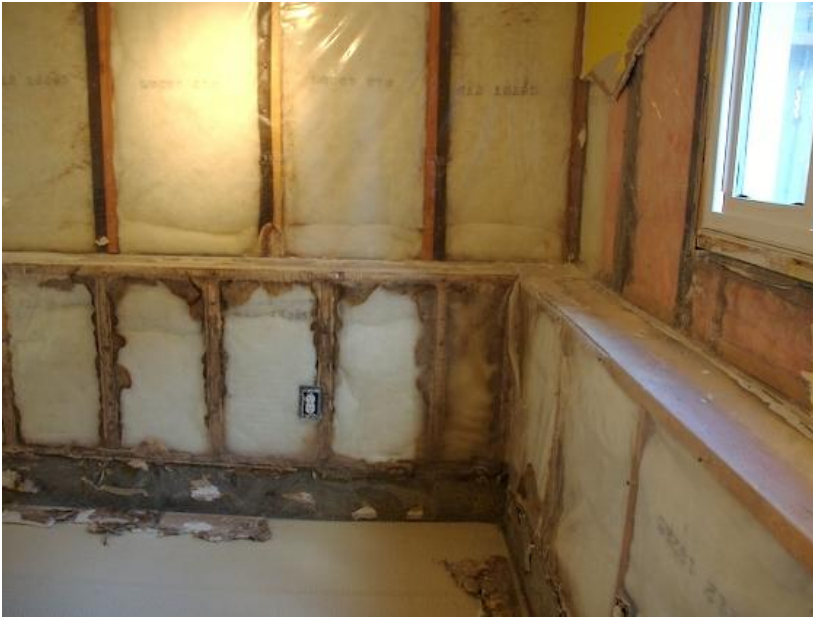
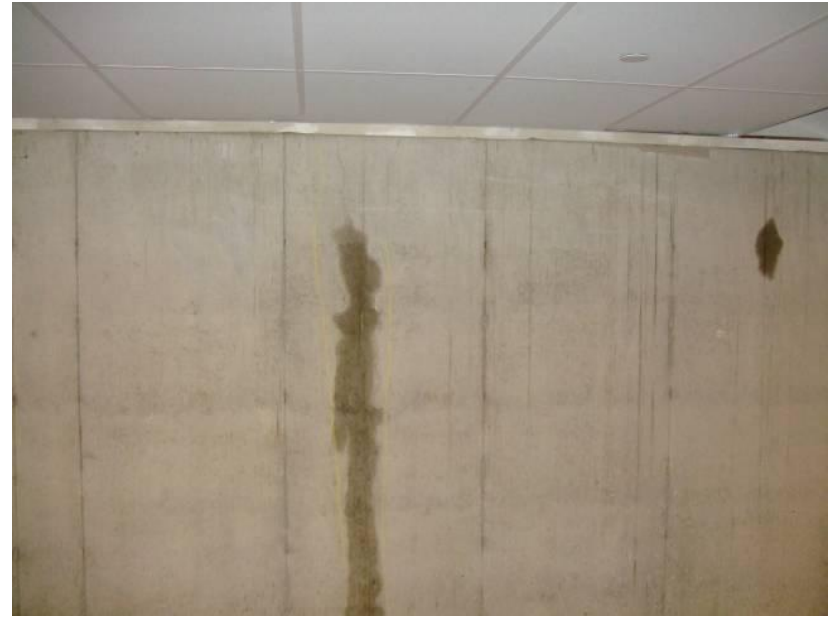
Foundations w. bulk water issues

- Severe and rapid damage to interior insulation and finishes due to bulk water intrusion

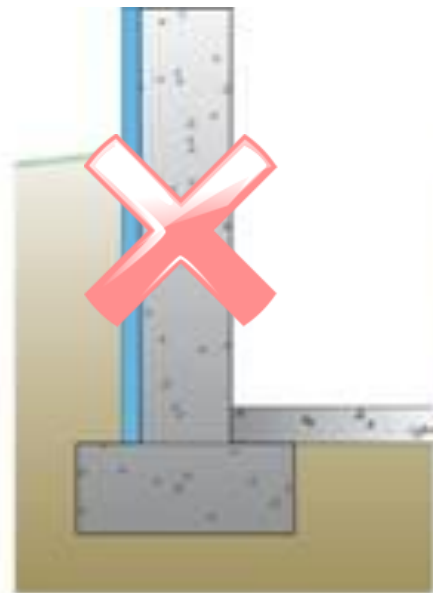
**Externally Insulated
Basement**

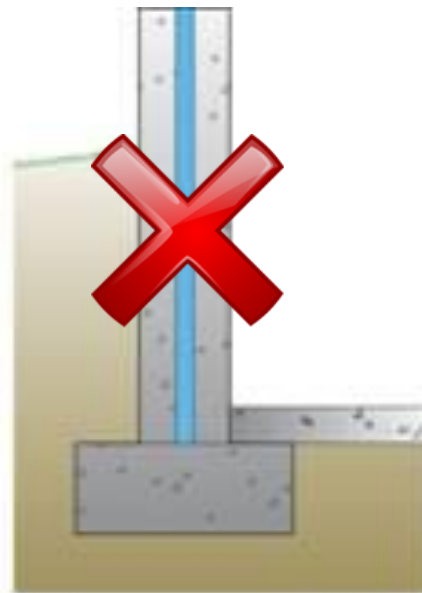
**Basement Insulated in
the Middle**

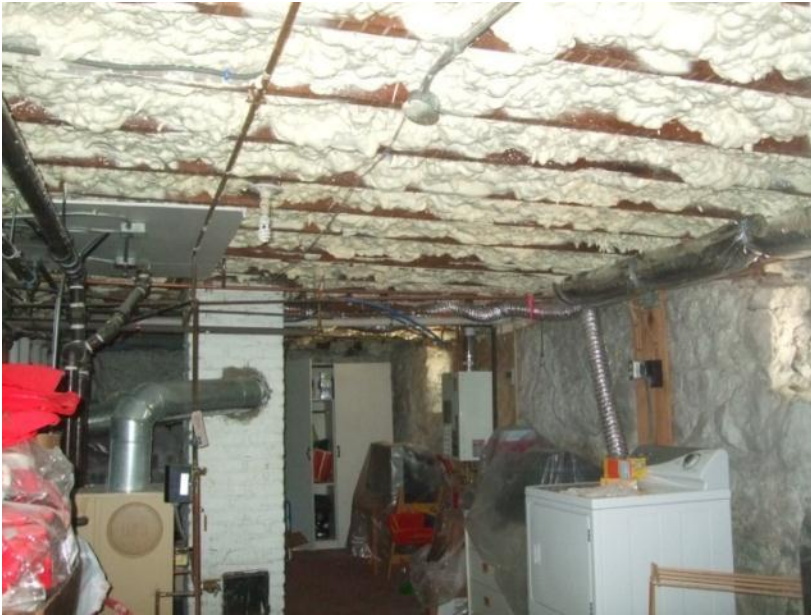
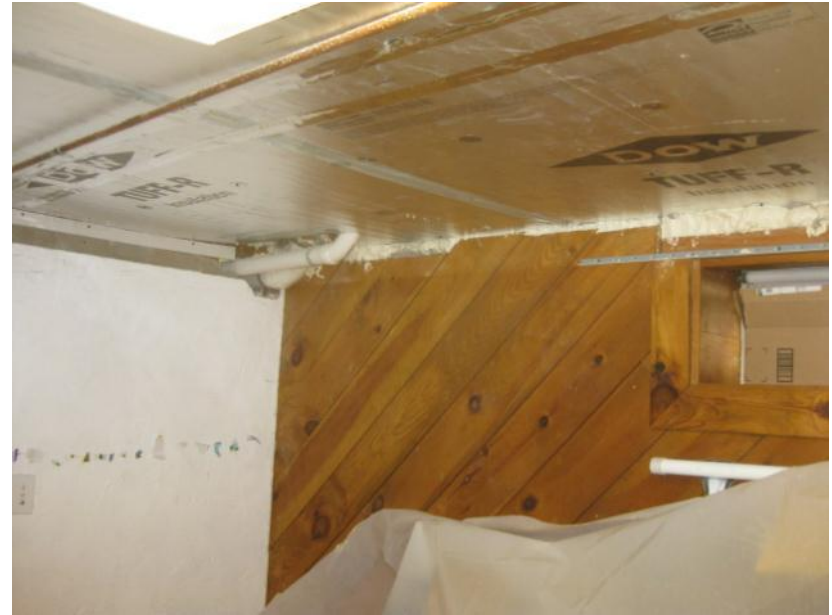
Basement Insulation Location

- 4.6 ACH50; 2129 CFM 50 total;
1100 CFM 50 through floor
- 8.5 ACH50; 3590 CFM 50 total;
1740 CFM 50 through floor

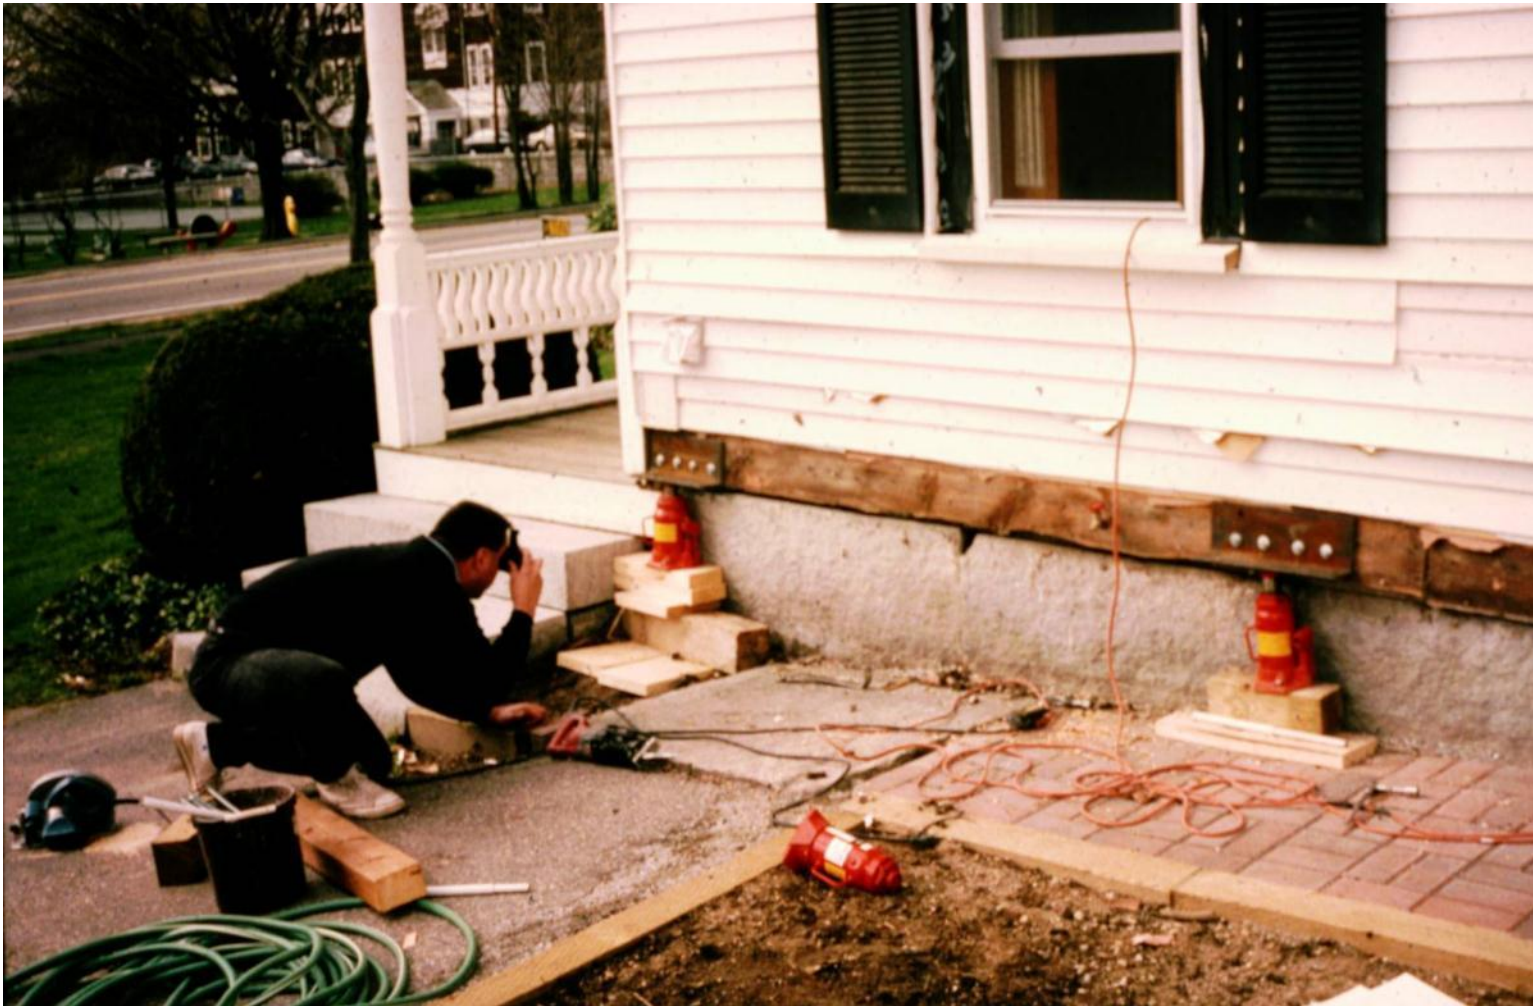
Interior Rubble Retrofit

Perimeter can be "jacked-up" 1-inch to insert membrane capillary break; angle iron brackets can be lagged into rim assembly for lifting points (stagger points internally and externally to control "roll" of rim assembly)

Spray foam insulation

Membrane waterproofing extending under perimeter framing (acting as capillary break between framing and foundation wall)

Drainage occurs to the interior between the structural foundation wall and the membrane water protection

Metal stud framing (cavity left uninsulated)

Gypsum board thermal barrier (protecting spray foam insulation)

Thermal break ($\frac{1}{4}$ " foam sill seal)

Interior perimeter drain retrofit (cut existing slab, excavate trench, line trench with filter fabric - geotextile, install perimeter drain and stones, connect to interior sump)

Concrete patch

Paint top of slab with sealer

Existing slab

Filter fabric

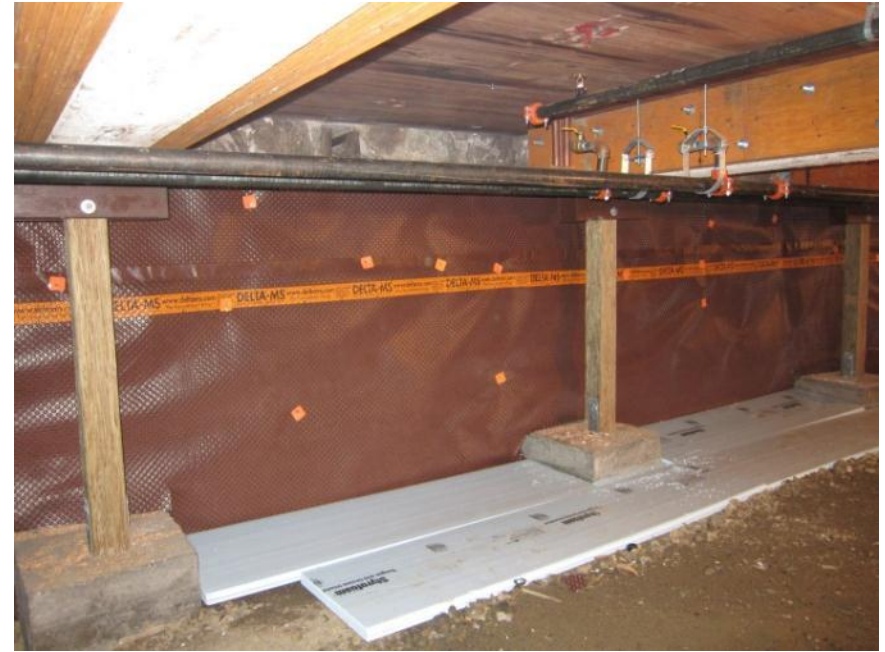
Air Gap Membrane Variant

- Spray foam sufficiently stiff at typ. thickness (2" +)
- XPS basement slab perimeter insulation
- Spray foam forms concrete slab thermal break

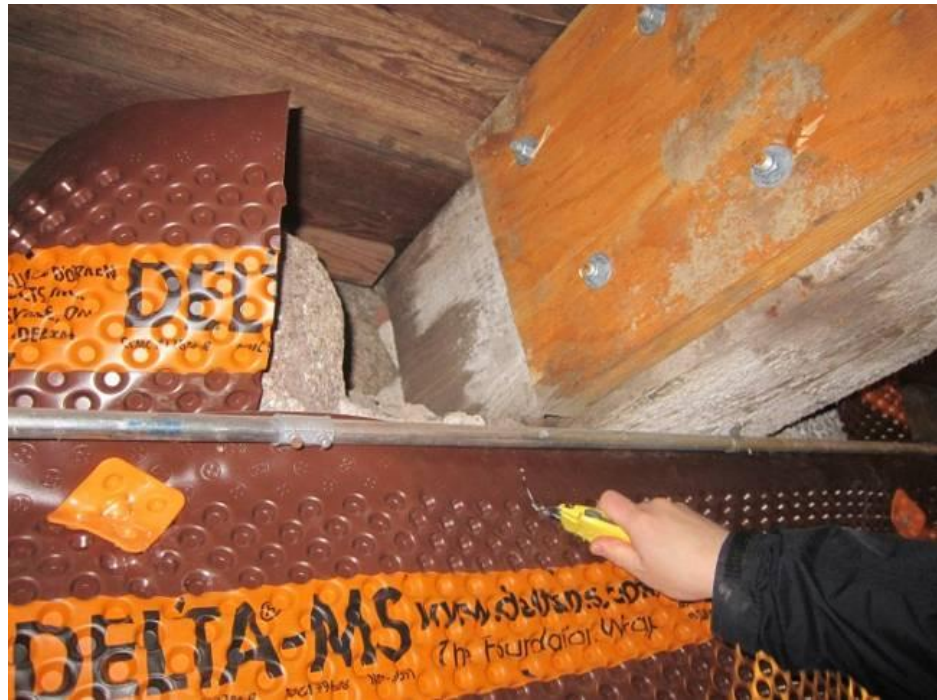
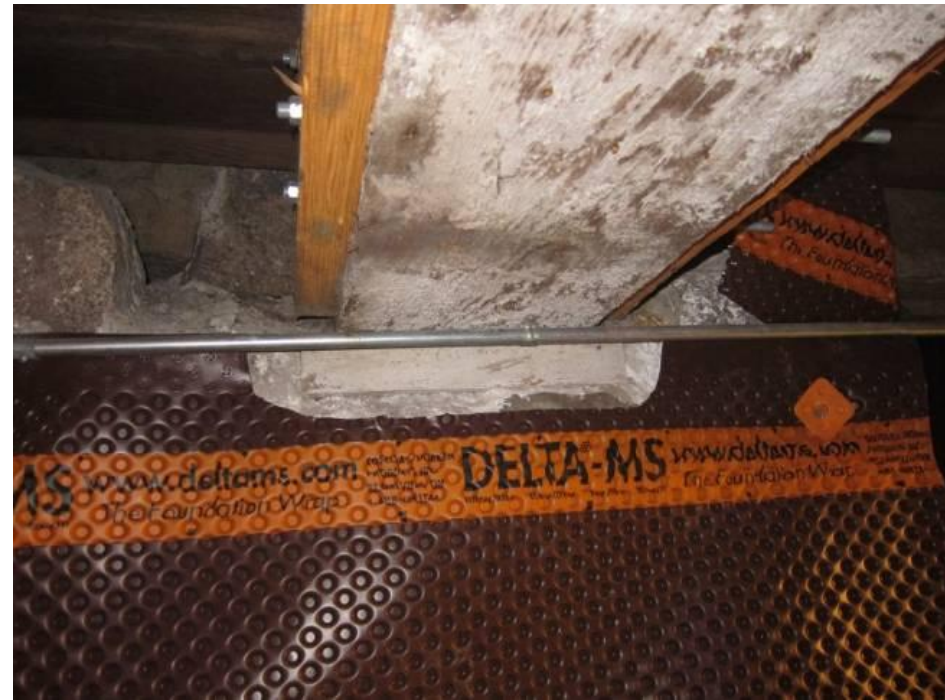
Beam pocket detail (air seal)

- Beam pocket detail (air seal from subslab)

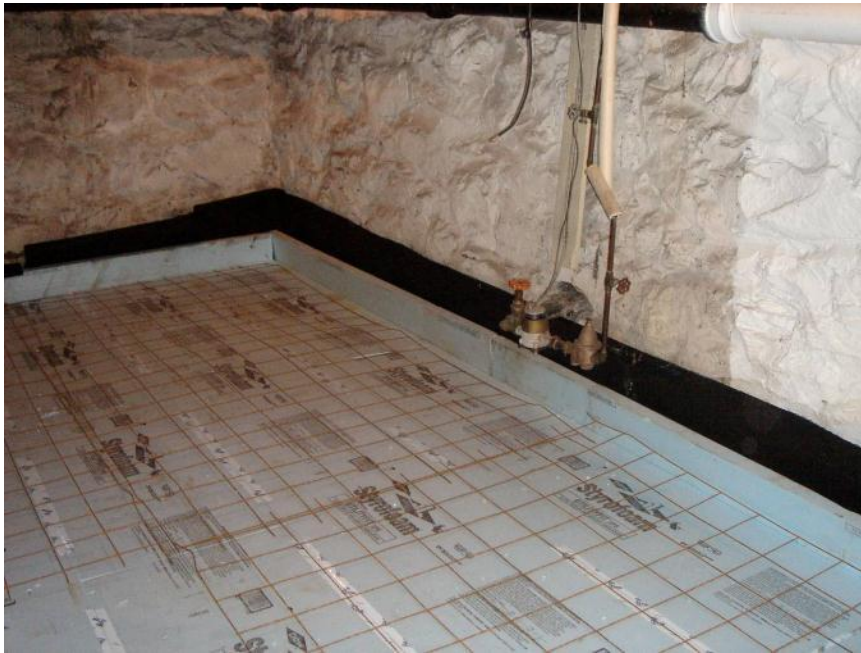
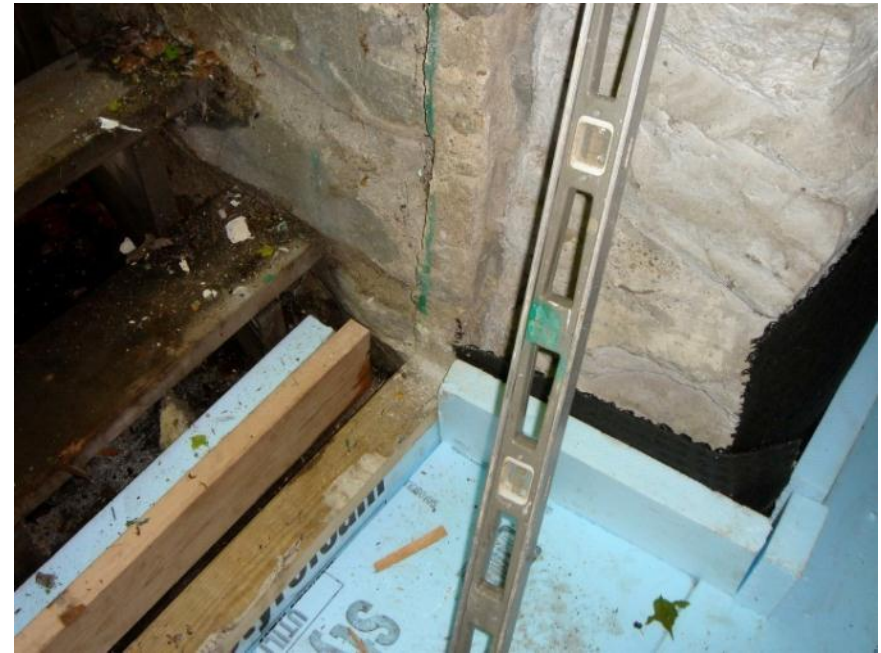
Partial Drainage Detail

- Sump must be connected to drainage mesh
- Air leakage around drainage space termination (interior chimney)

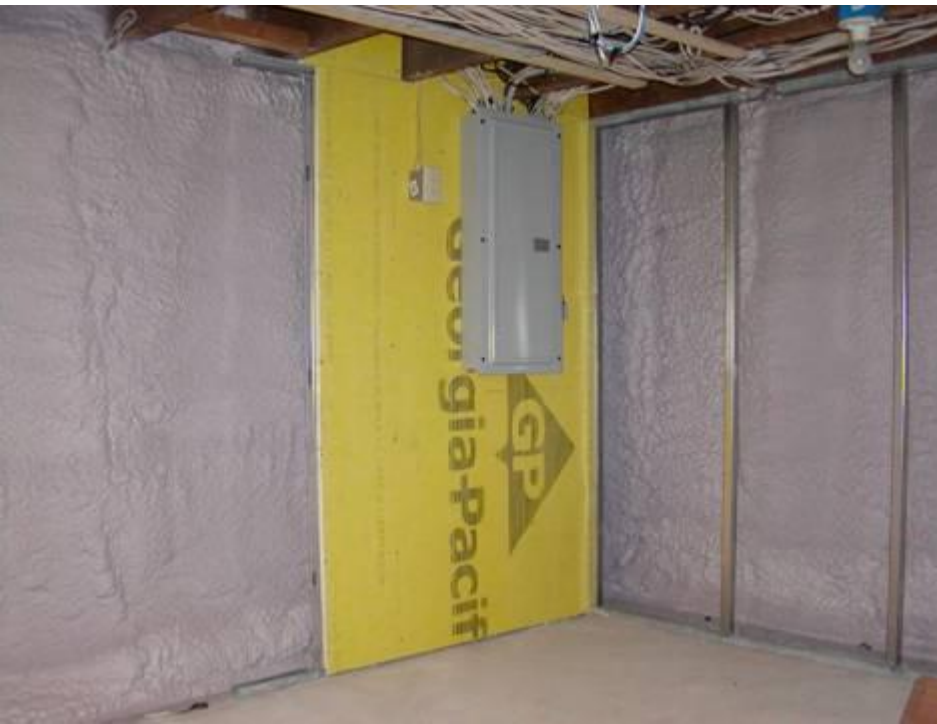
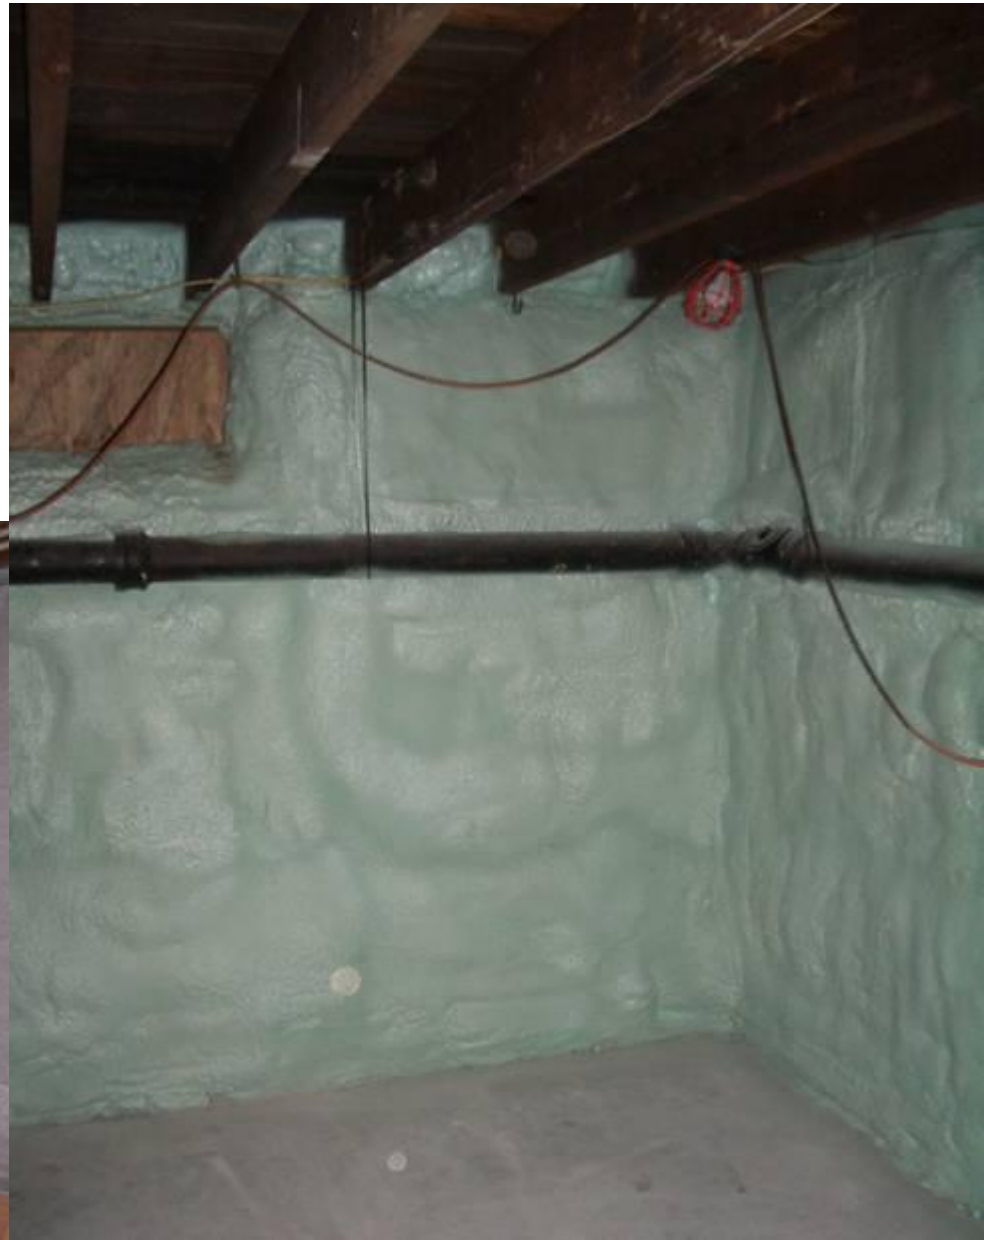
Guidance Flowchart

Spray foam basement insulation

- Open cell
 - Climate specific
- Closed cell

- Rough guidelines
- User judgment required

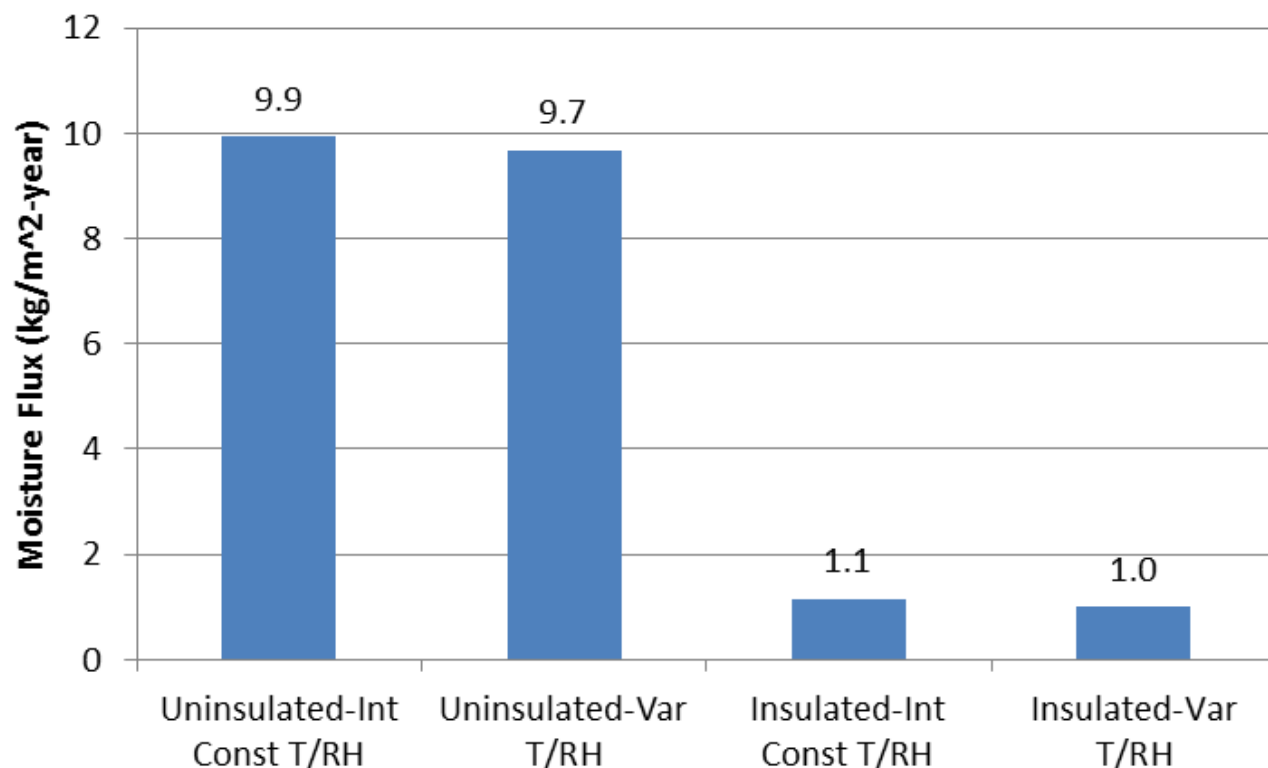
Hygrothermal Simulations

- Moisture emissions before/after interior ccSPF
 - No drainage layer—spray foam only
 - kg/m²·year
 - Constant and variable interior T/RH

2.8 liters day uninsulated
vs. 0.3 l/day insulated

Family 4 = 10-15 l/day

Slows down capillary
mortar erosion?

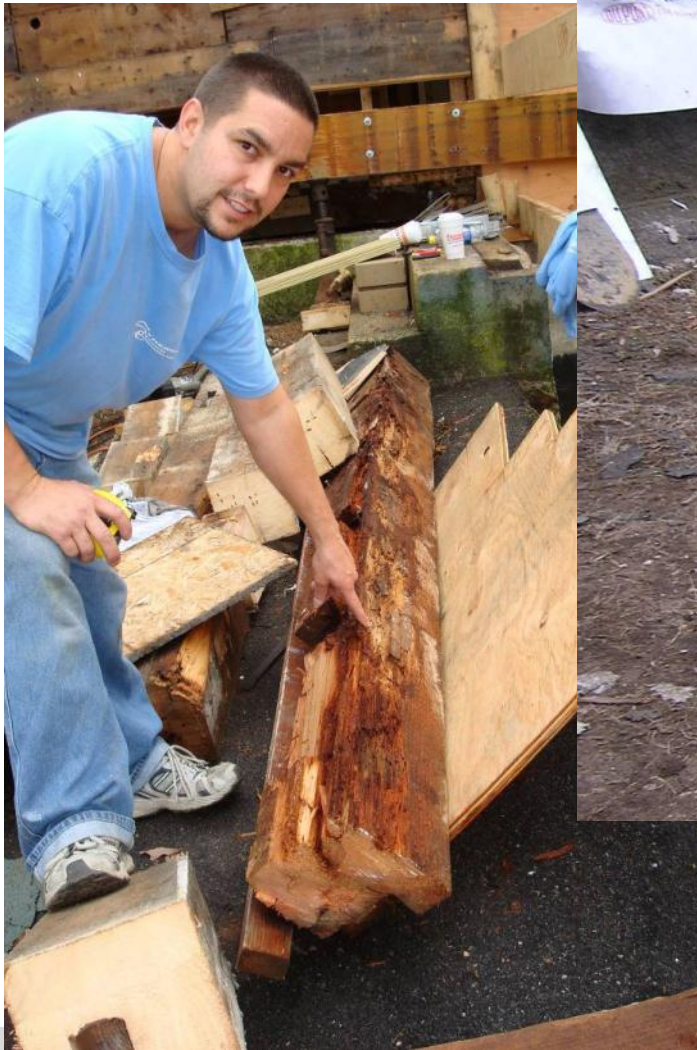
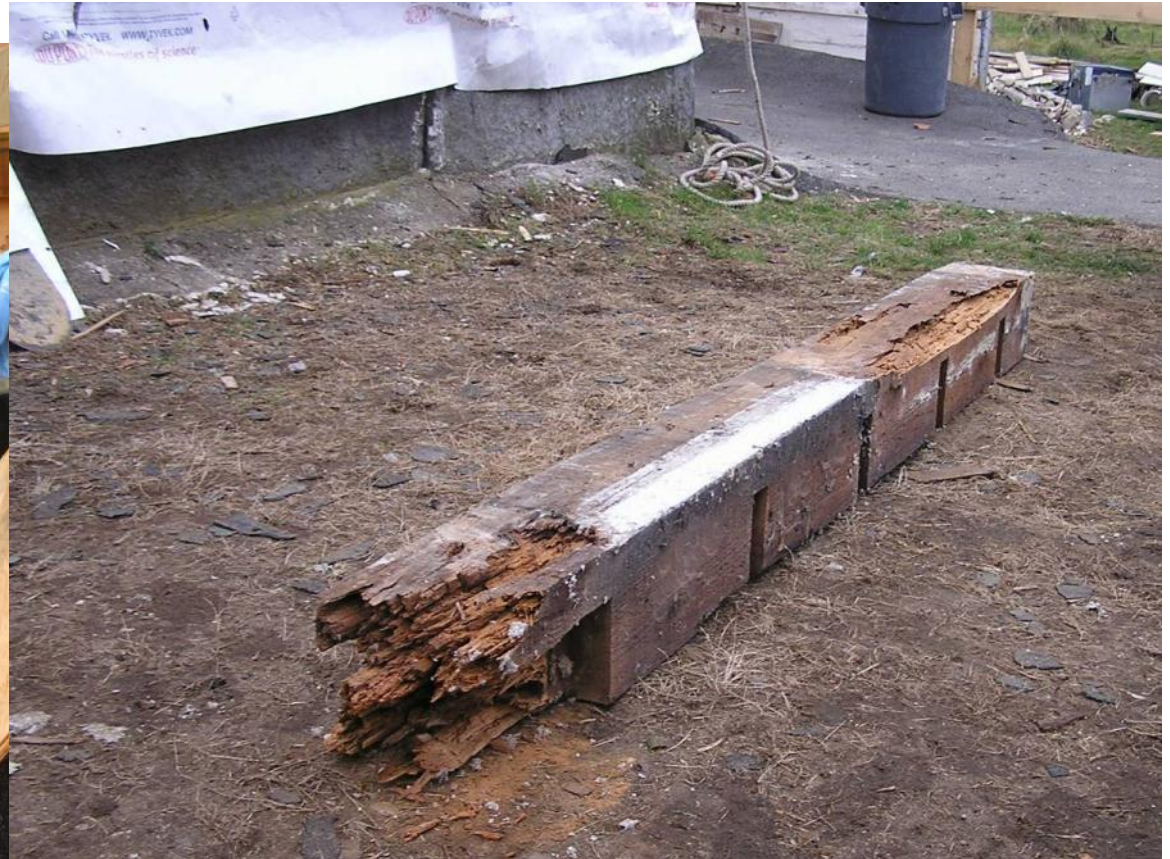
Sill Beam Moisture Durability

“This building has been around for the last 100 years...”

- Sill-to-foundation surface colder
- Less drying available
- Permeable insulation detail?

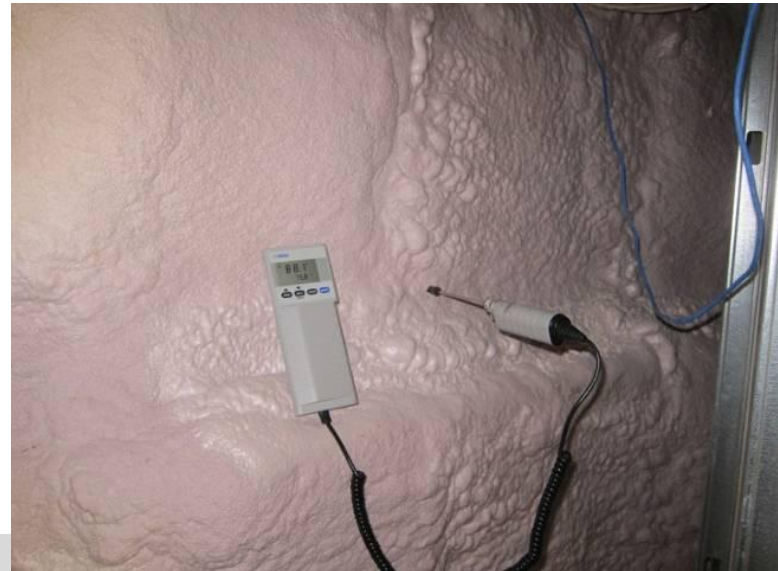
Field Survey Work

- Existing foundation 1996 to 2009, Zone 5A
- Variety of interior ccSPF foundation insulation
- Temperatures and RHs
 - Basement/crawl space dewpoint vs. above grade
 - Behind foam ~80-90% consistently (not 100%)

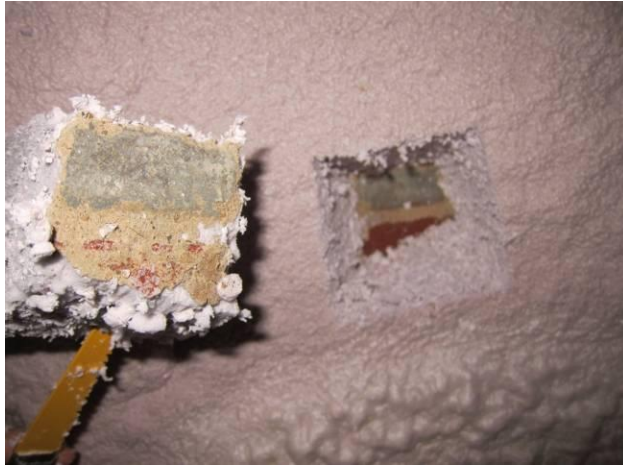
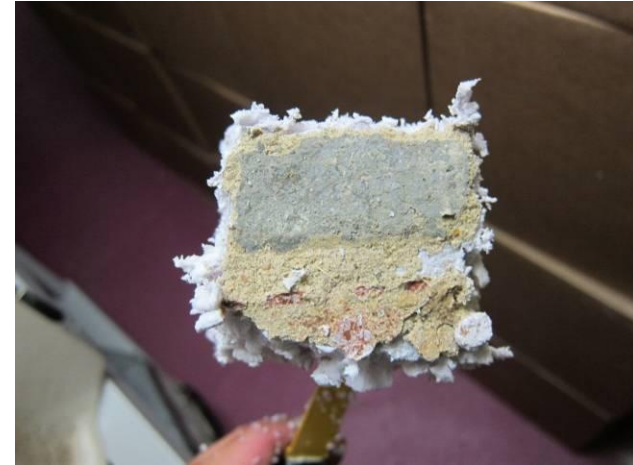
Field Survey Work

- Disassembly: no damage seen

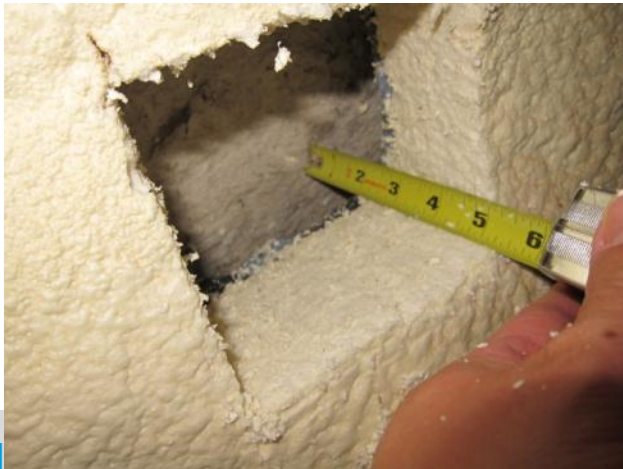
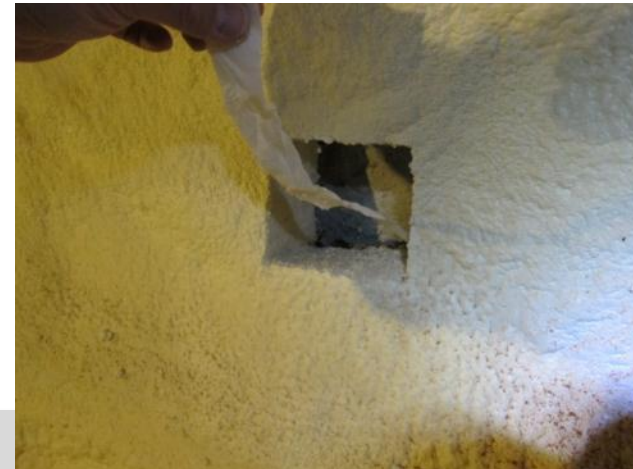
- Rubble stone walls are not air barriers!

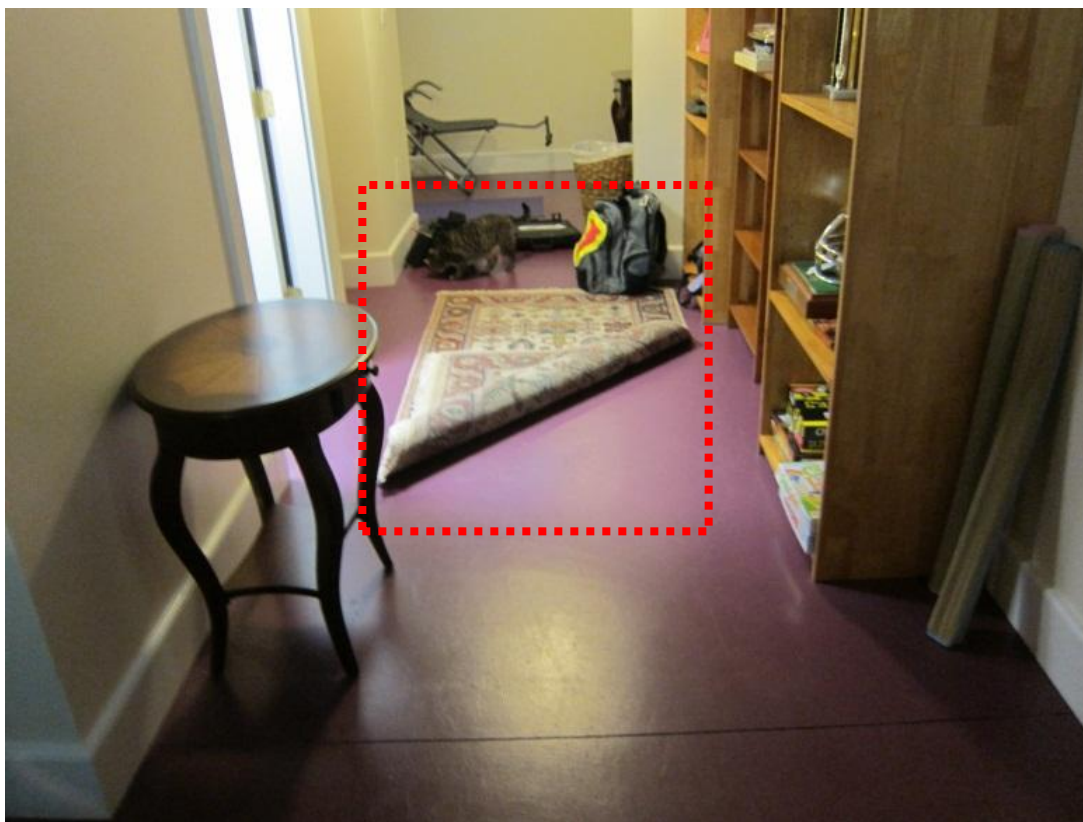
Field Survey Work

- Sub slab insulation reduces risk of moisture issues (carpets on slabs; cardboard boxes)

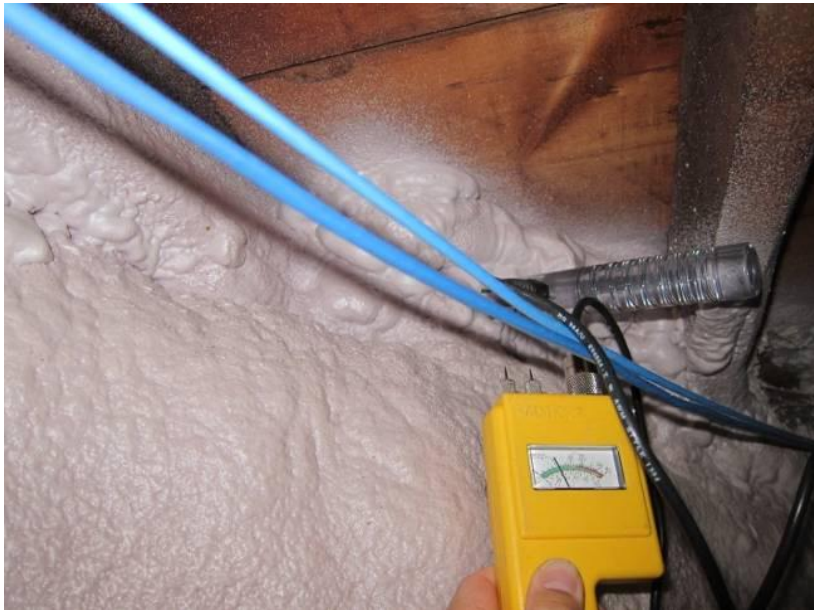
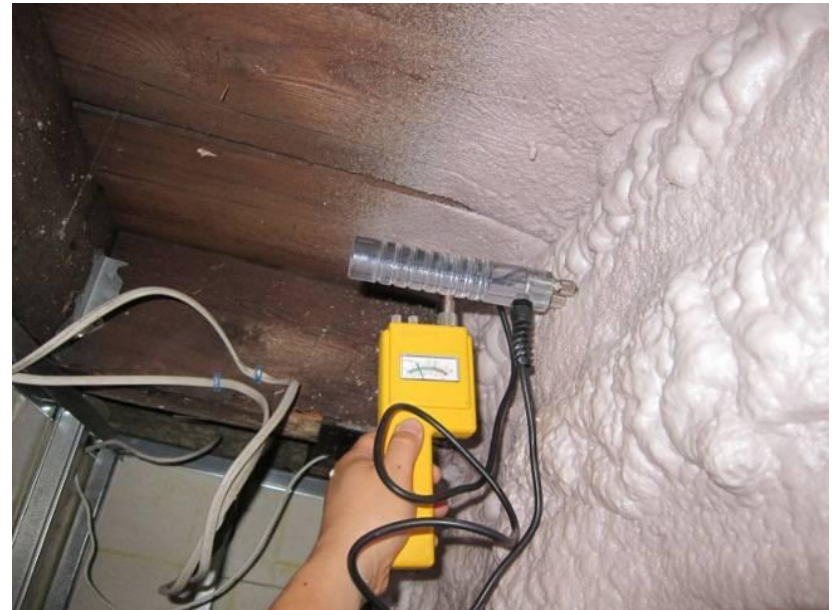
Field Survey Work

- Moisture contents uniformly in 8-13% range
- Limited survey

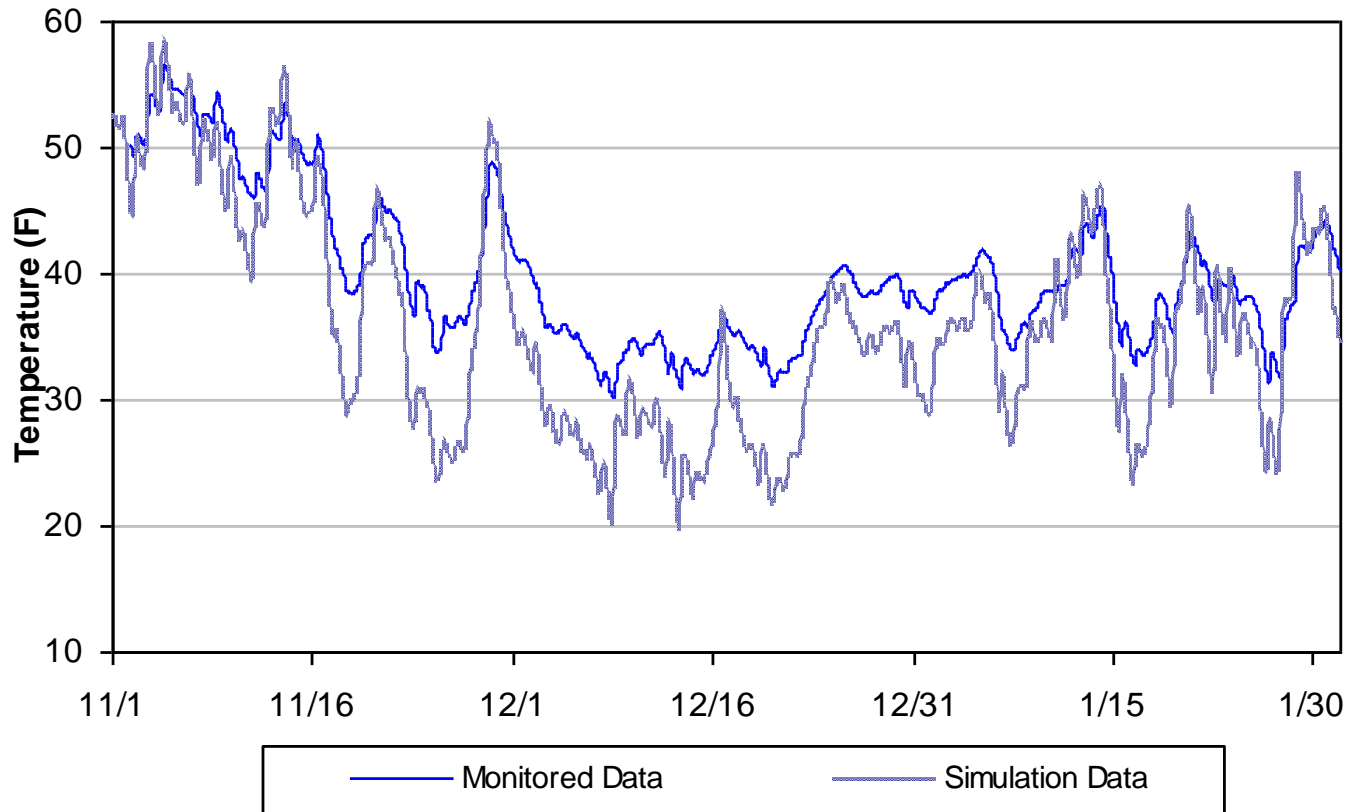
Concrete Surface Temperature

Wintertime temperature moderated by soil coupling
