Upgrading Below-Grade Spaces: Assessing Priorities

Sam Breidenbach
[Cold climate bias]

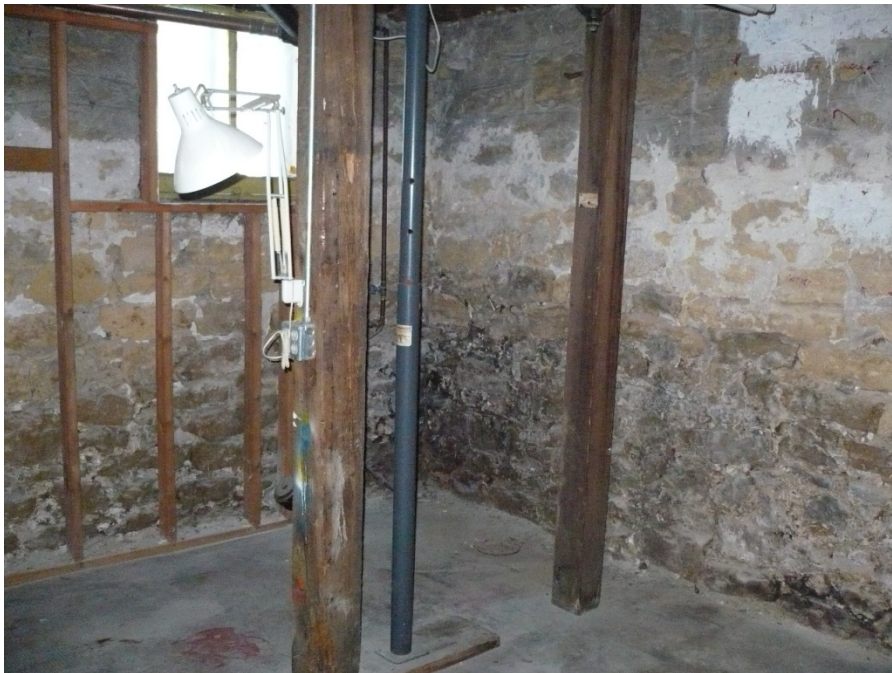
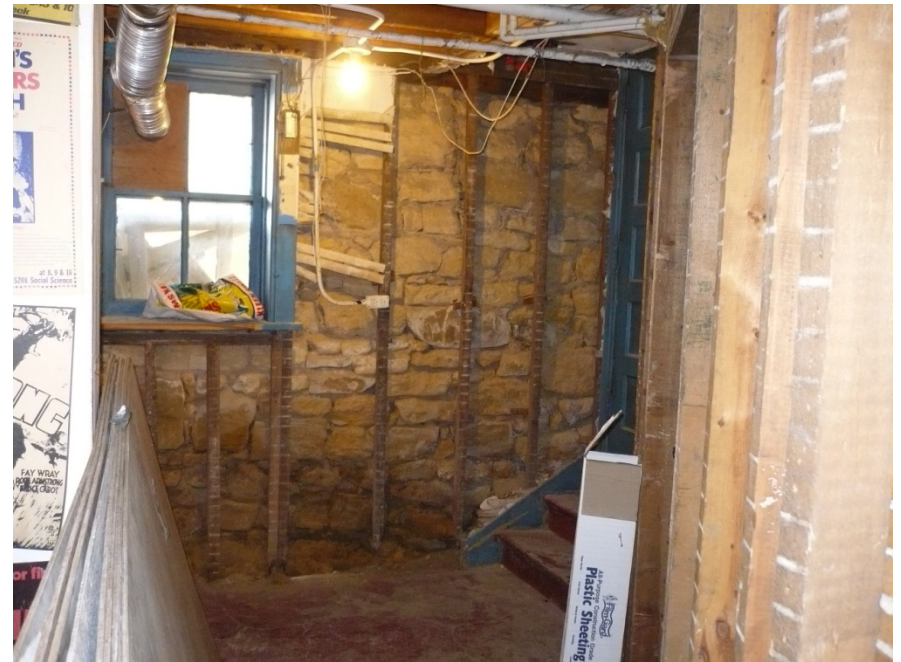
Case #1—1916 Victorian

- Retrofit drain tile sump and pump
- Two Part Spray foam over dimpled matt over rubble walls
- New perimeter wood Stud wall

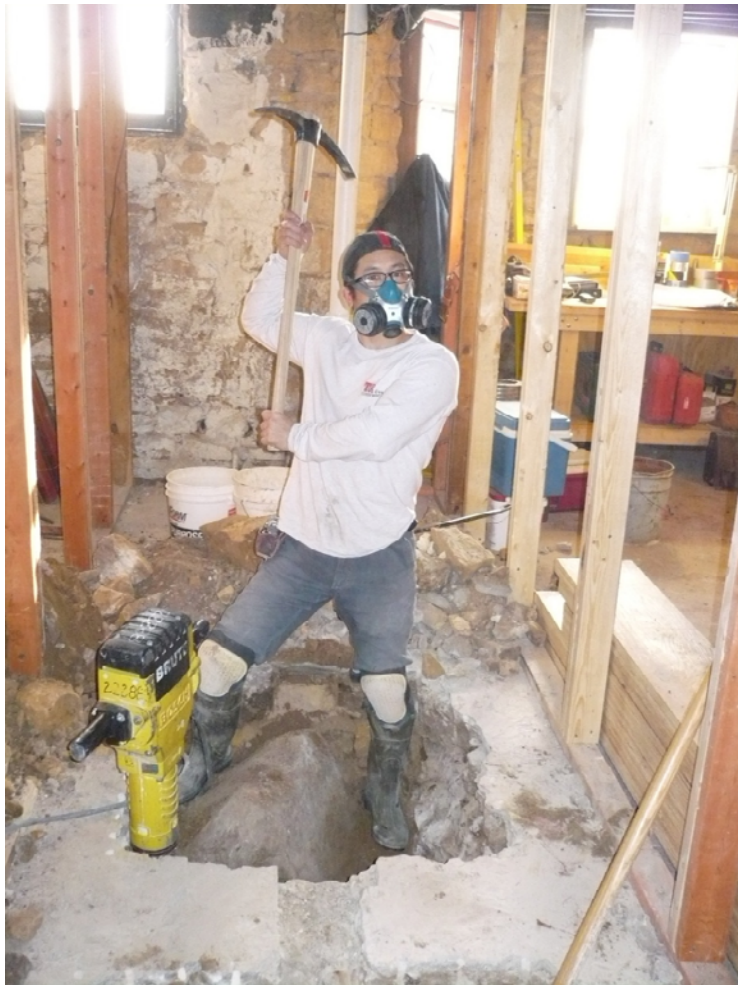
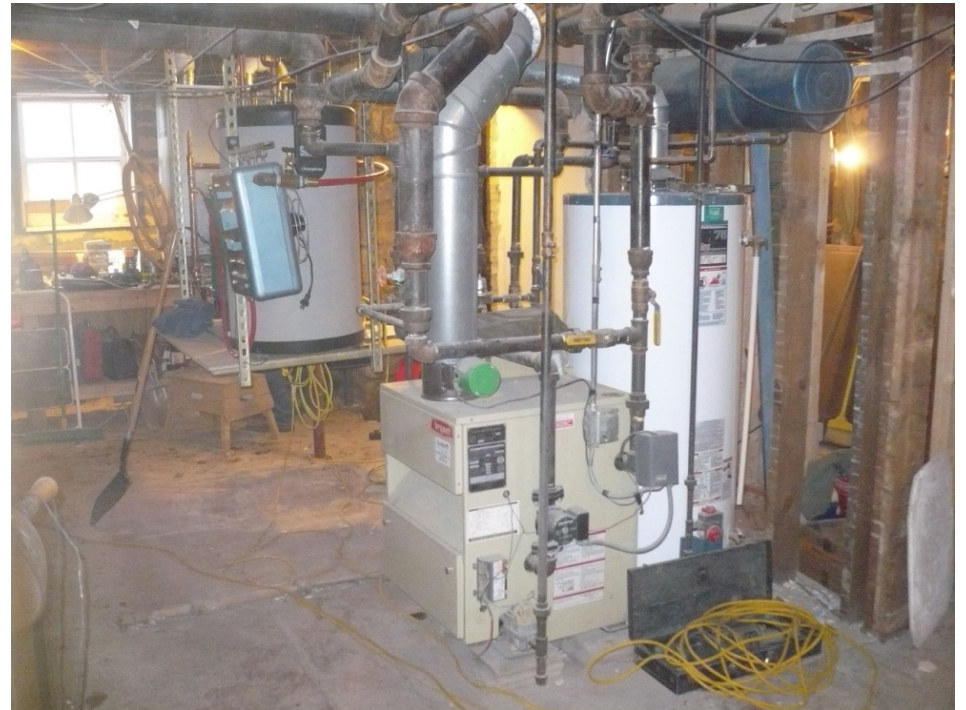
Case #1—

- New Mechanicals
- Extensive re-structuring of main support beams and columns.
- 6050 CFM50—VERY leaky house—20% reduction

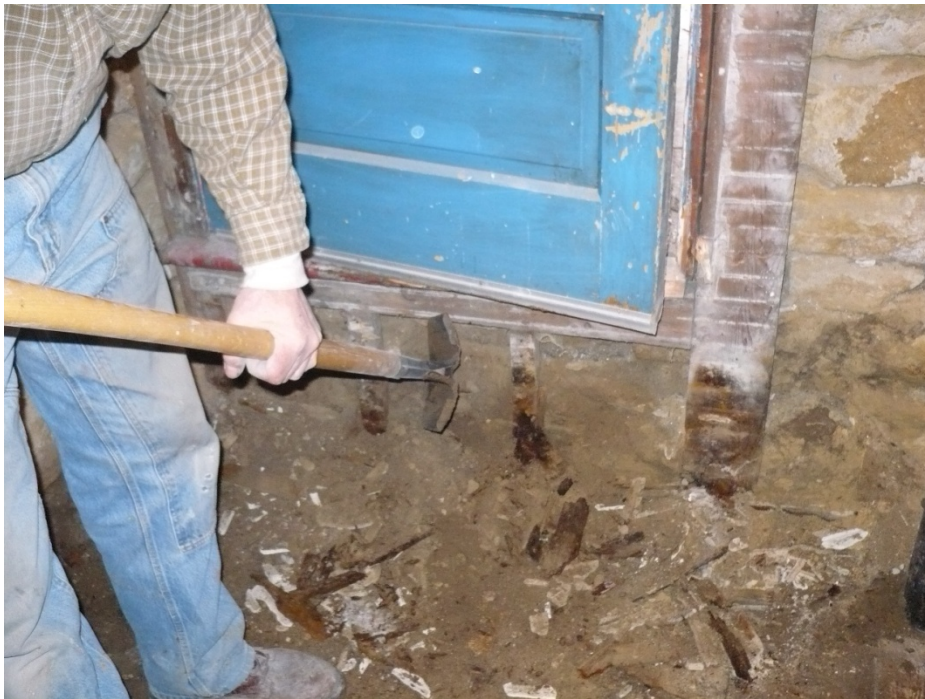
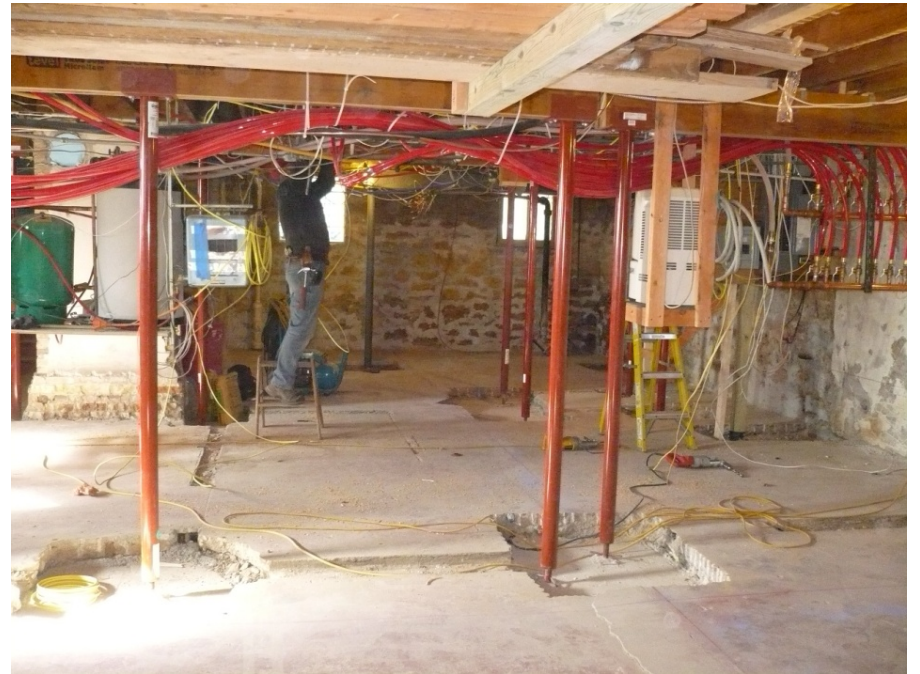
CASE #1

- Replaced existing uneven and broken up concrete floor
- Excavated approximately 8" of soil
- 4" granular fill for future radon mitigation
- 2" Two-part spray foam over fill
- Radiant heat tubes over foam
- New concrete

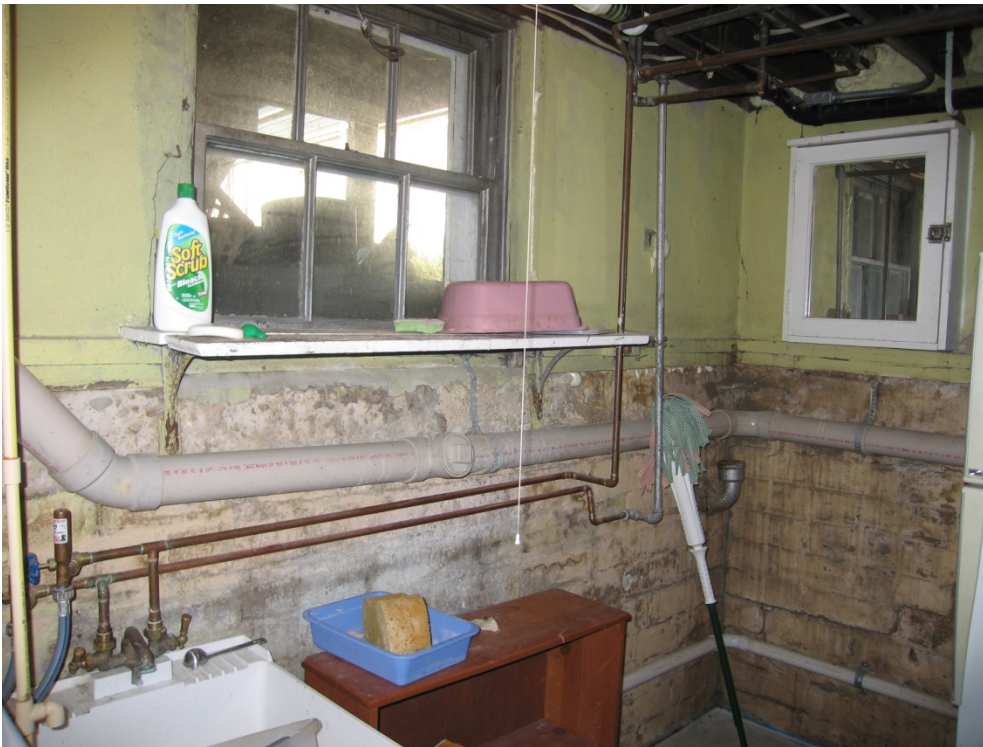
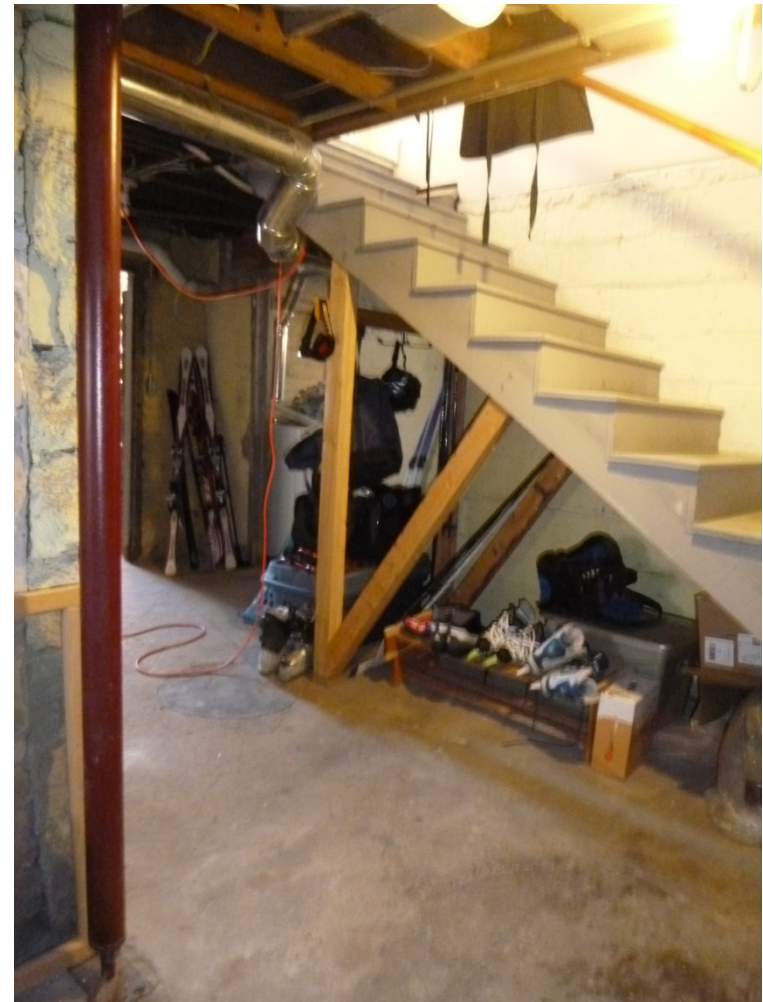
Case #2--

- New Perimeter wood frame walls
- 2" Two-Part Spray foam over dimpled mat on walls
- Existing drain tile

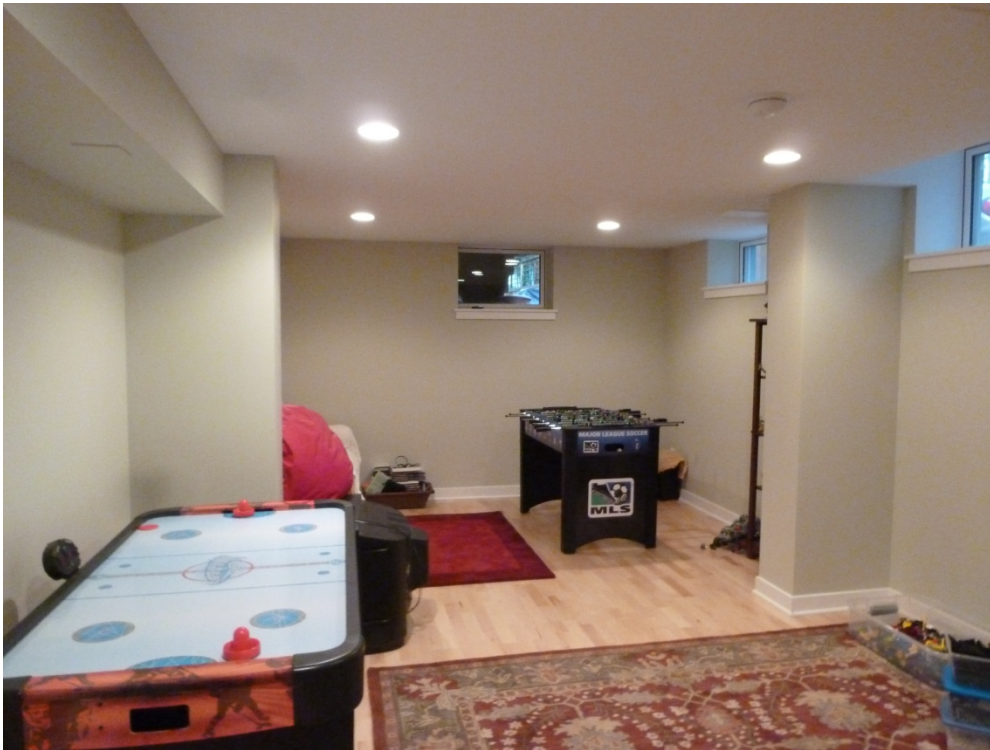
Case #2--

- Lots of self leveling concrete
- Engineered wood flooring over ½" OSB over dimpled matt on existing slab

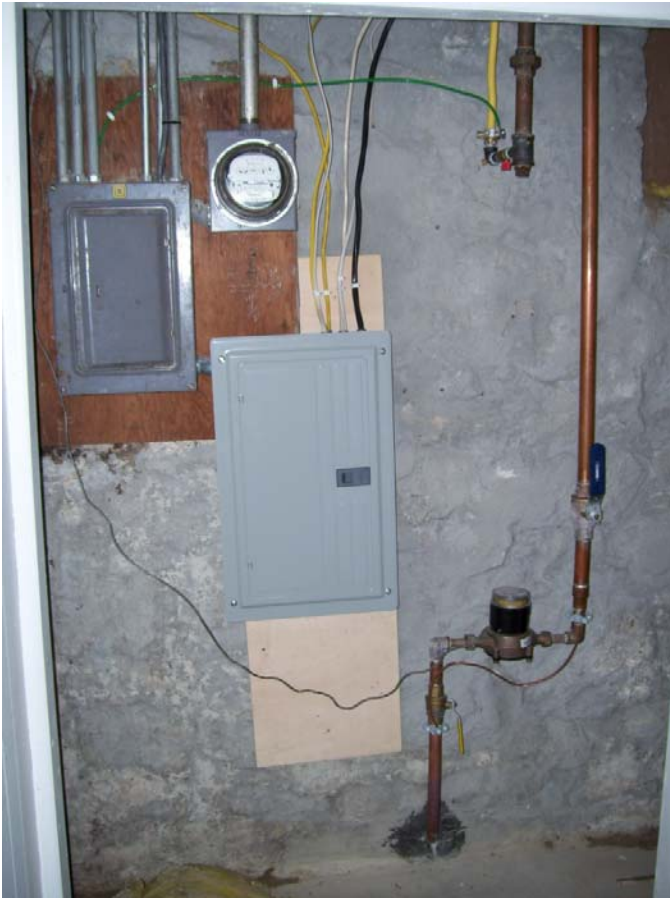
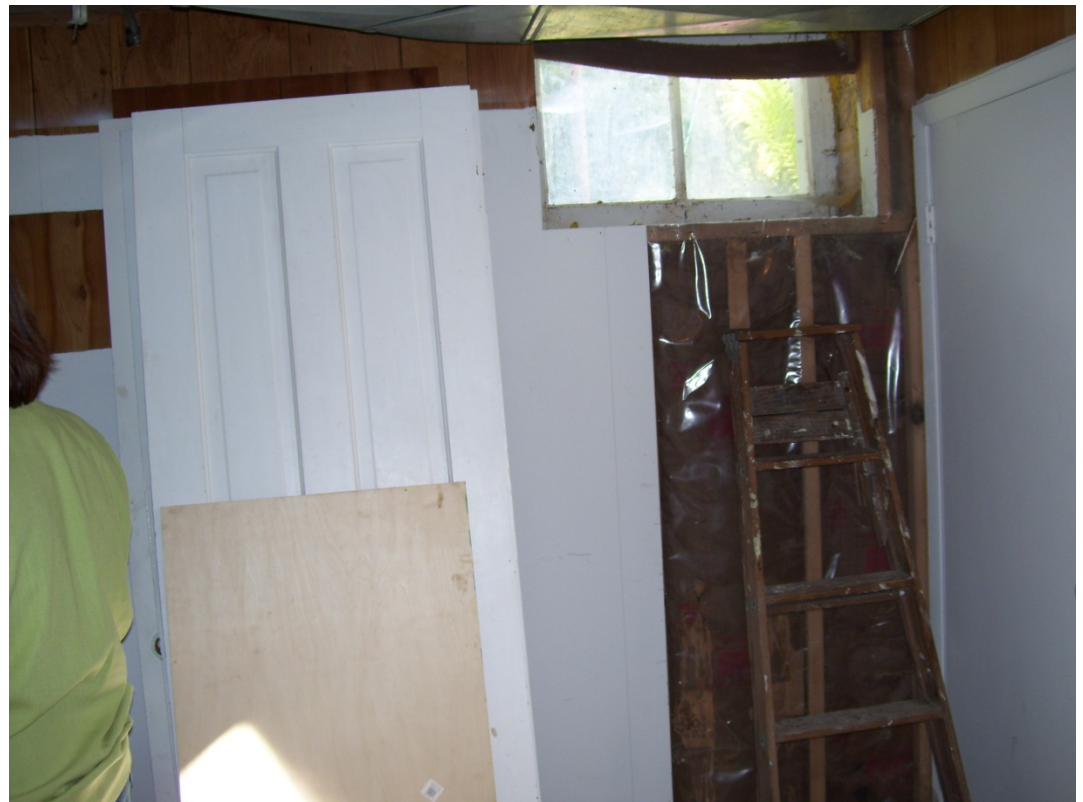
Case #3- Old Queen Anne's- Circa 1920

- Two Part spray foam over existing rubble between existing framing—(No dimple mat-- owner didn't want to pay for it!!)
- No drain tile or floor treatment—Carpet over existing concrete
- 1-1/2 years later basement flooded- We were not held liable

NOTE: Old basements are inherently at risk for moisture problems. We do not advise installing carpet or vinyl directly over the existing concrete floor. We recommend the following items to mitigate the potential for future water damage to newly installed materials.

~Drain tile and sump pit retrofit into existing floor.

~A dimpled drainage mat over existing stone walls to allow bulk water to drain into new drain tile in floor. Spray Foam insulation would be applied over dimpled mat

~Floor: A dimpled drainage mat with plywood secured to existing concrete with 1" rigid foam over drainage mat

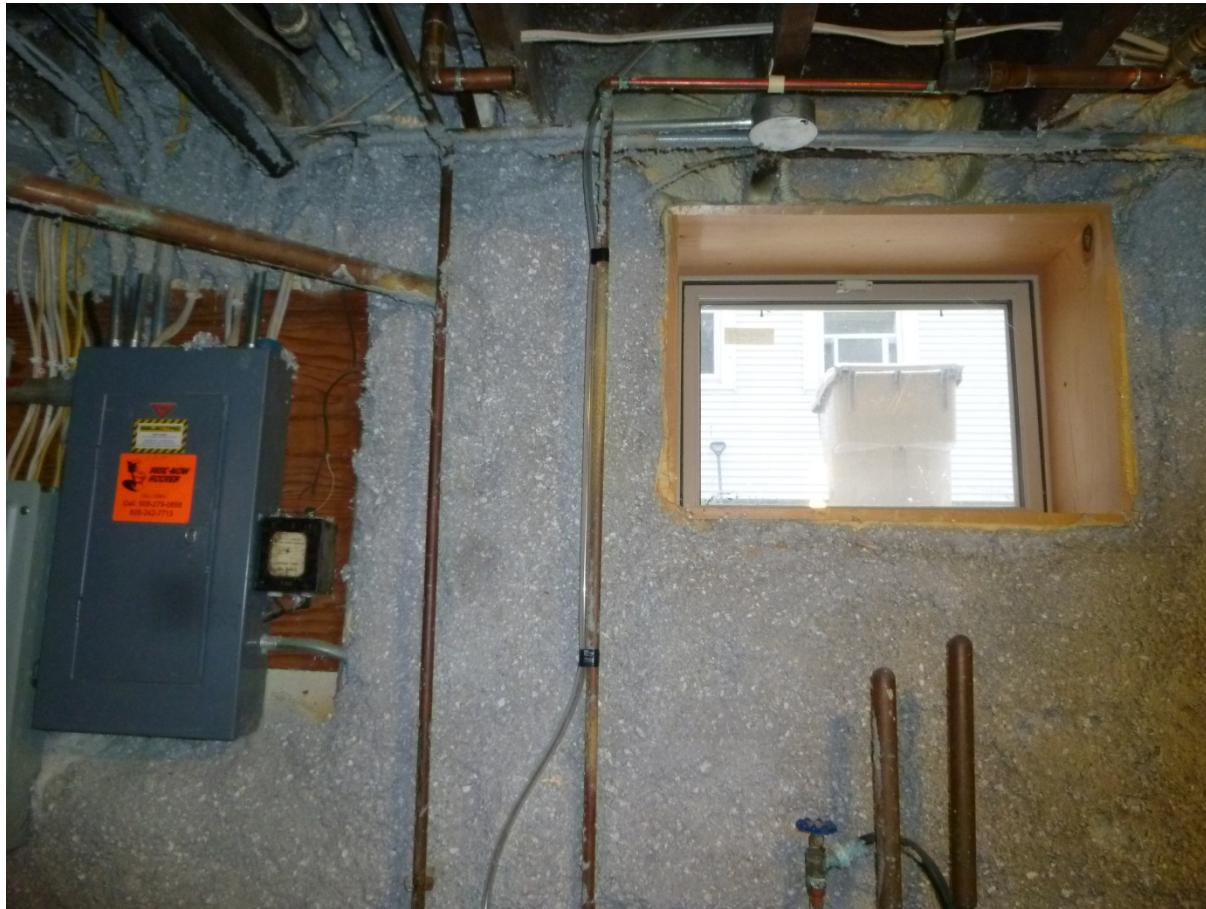
CASE #4—1917 Victorian--(2004 project- 45% reduction in air infiltration)

- No Finishes or drain tile included
 - 3" Two-Part Spray foam over rubble
 - “Thermo-Con” as fire retardant sprayed over urethane foam
- foam

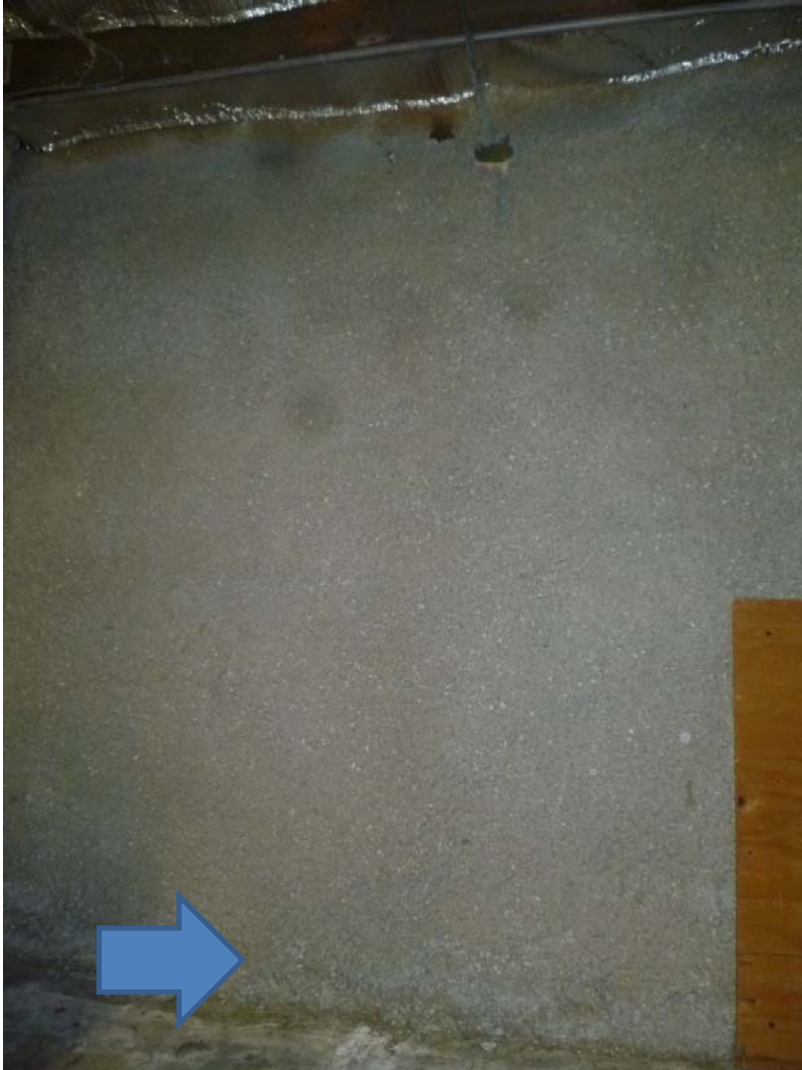
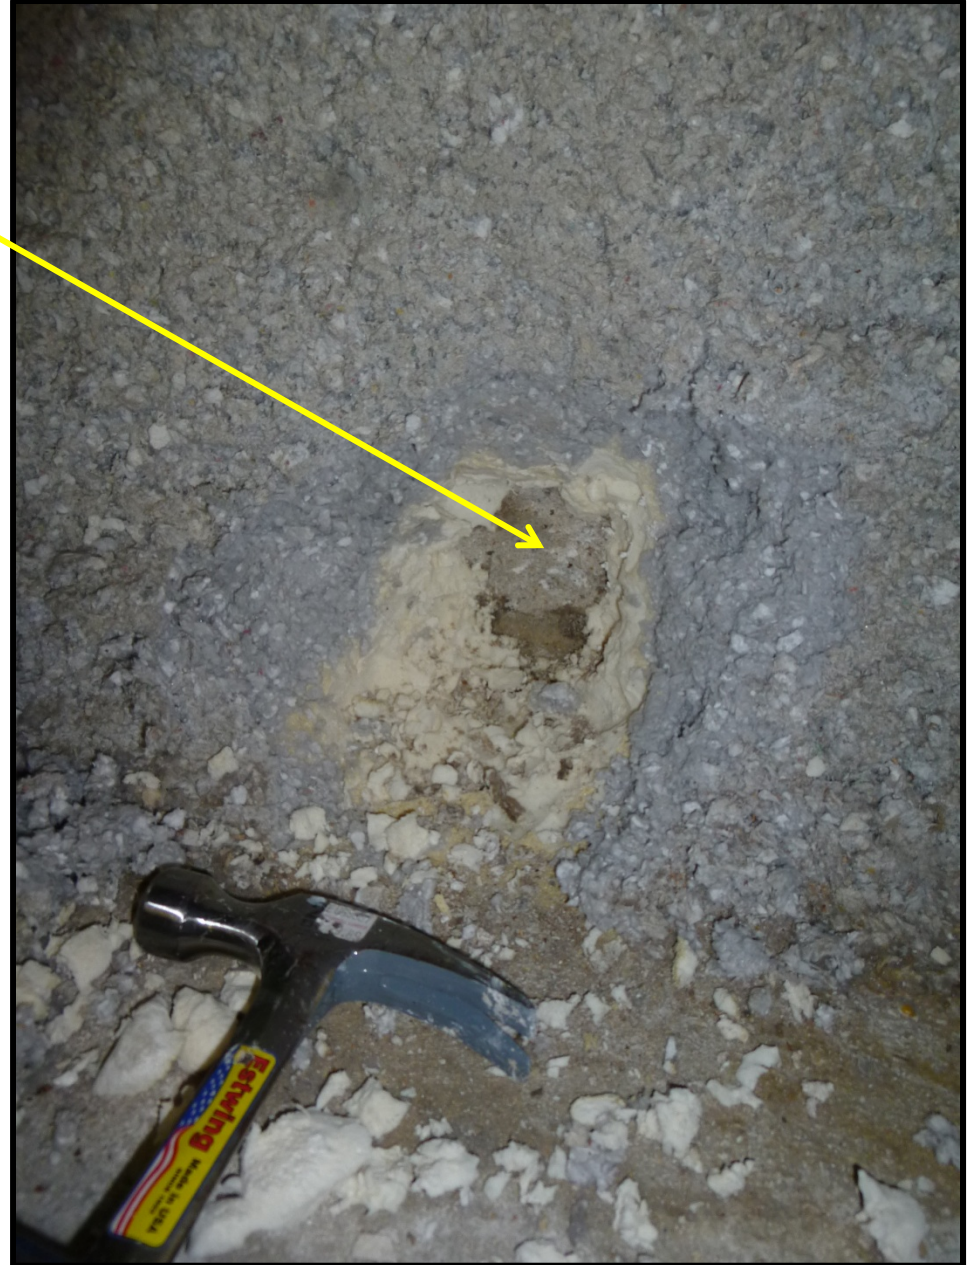
Case #4

- Rubble Foundation
- Opened 7 years later

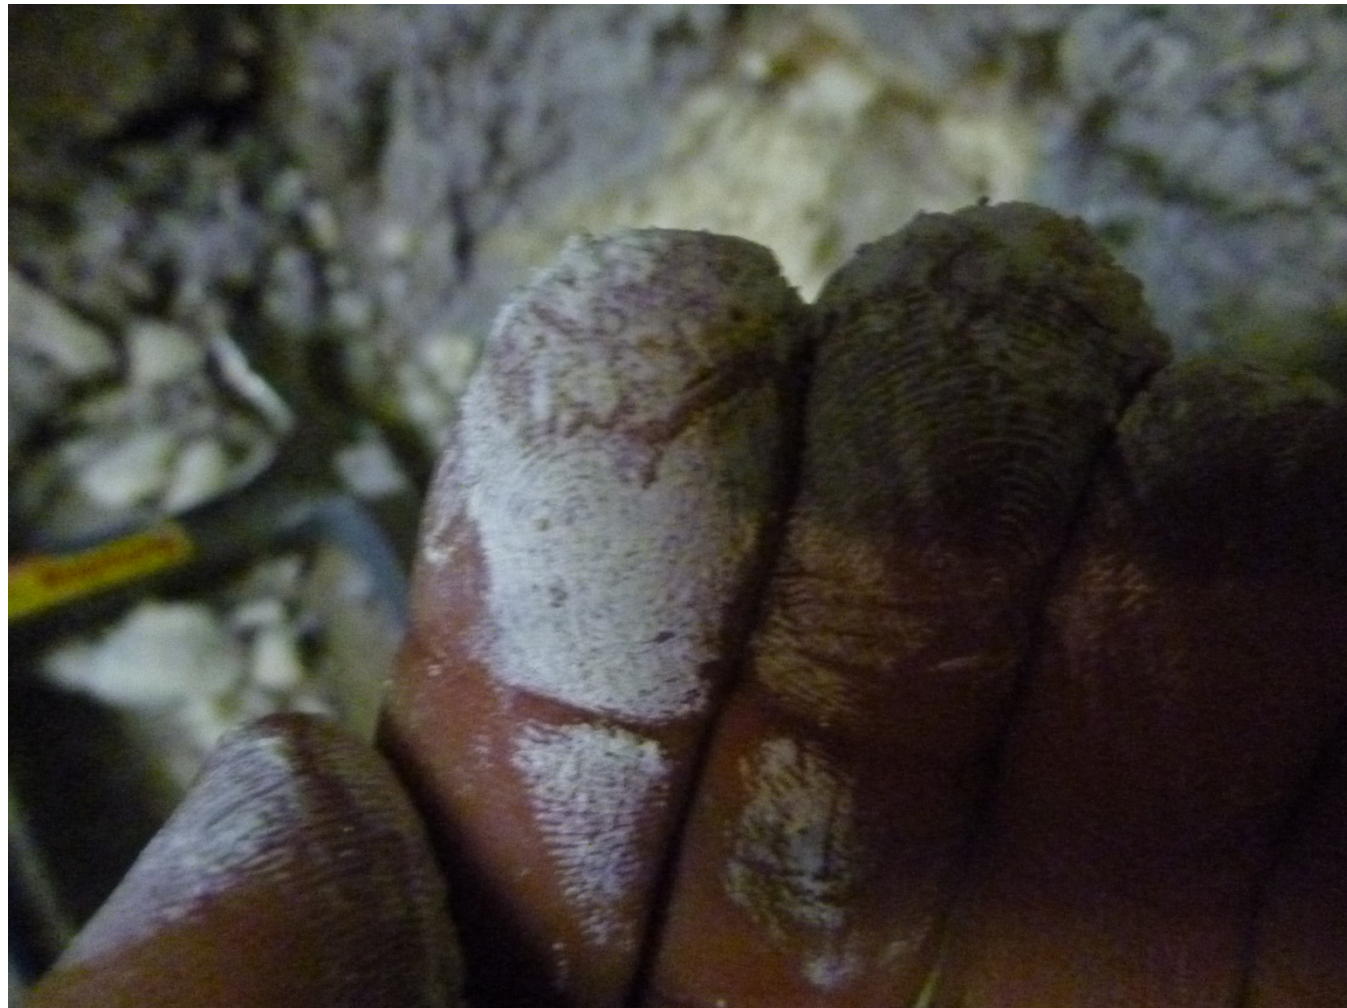
CASE #4

- Moist calcium pocket discovered at rubble face (size of dime)
- Wall was quite cold 3" above floor / floor itself was noticeably warmer
