Post-Test Analysis of Lithium-Ion Battery Materials at Argonne National Laboratory

DOE Annual Merit Review

Project ID: ES166

Case study: Effect of Fast Charge on NMC/graphite Lithium-Ion Cells

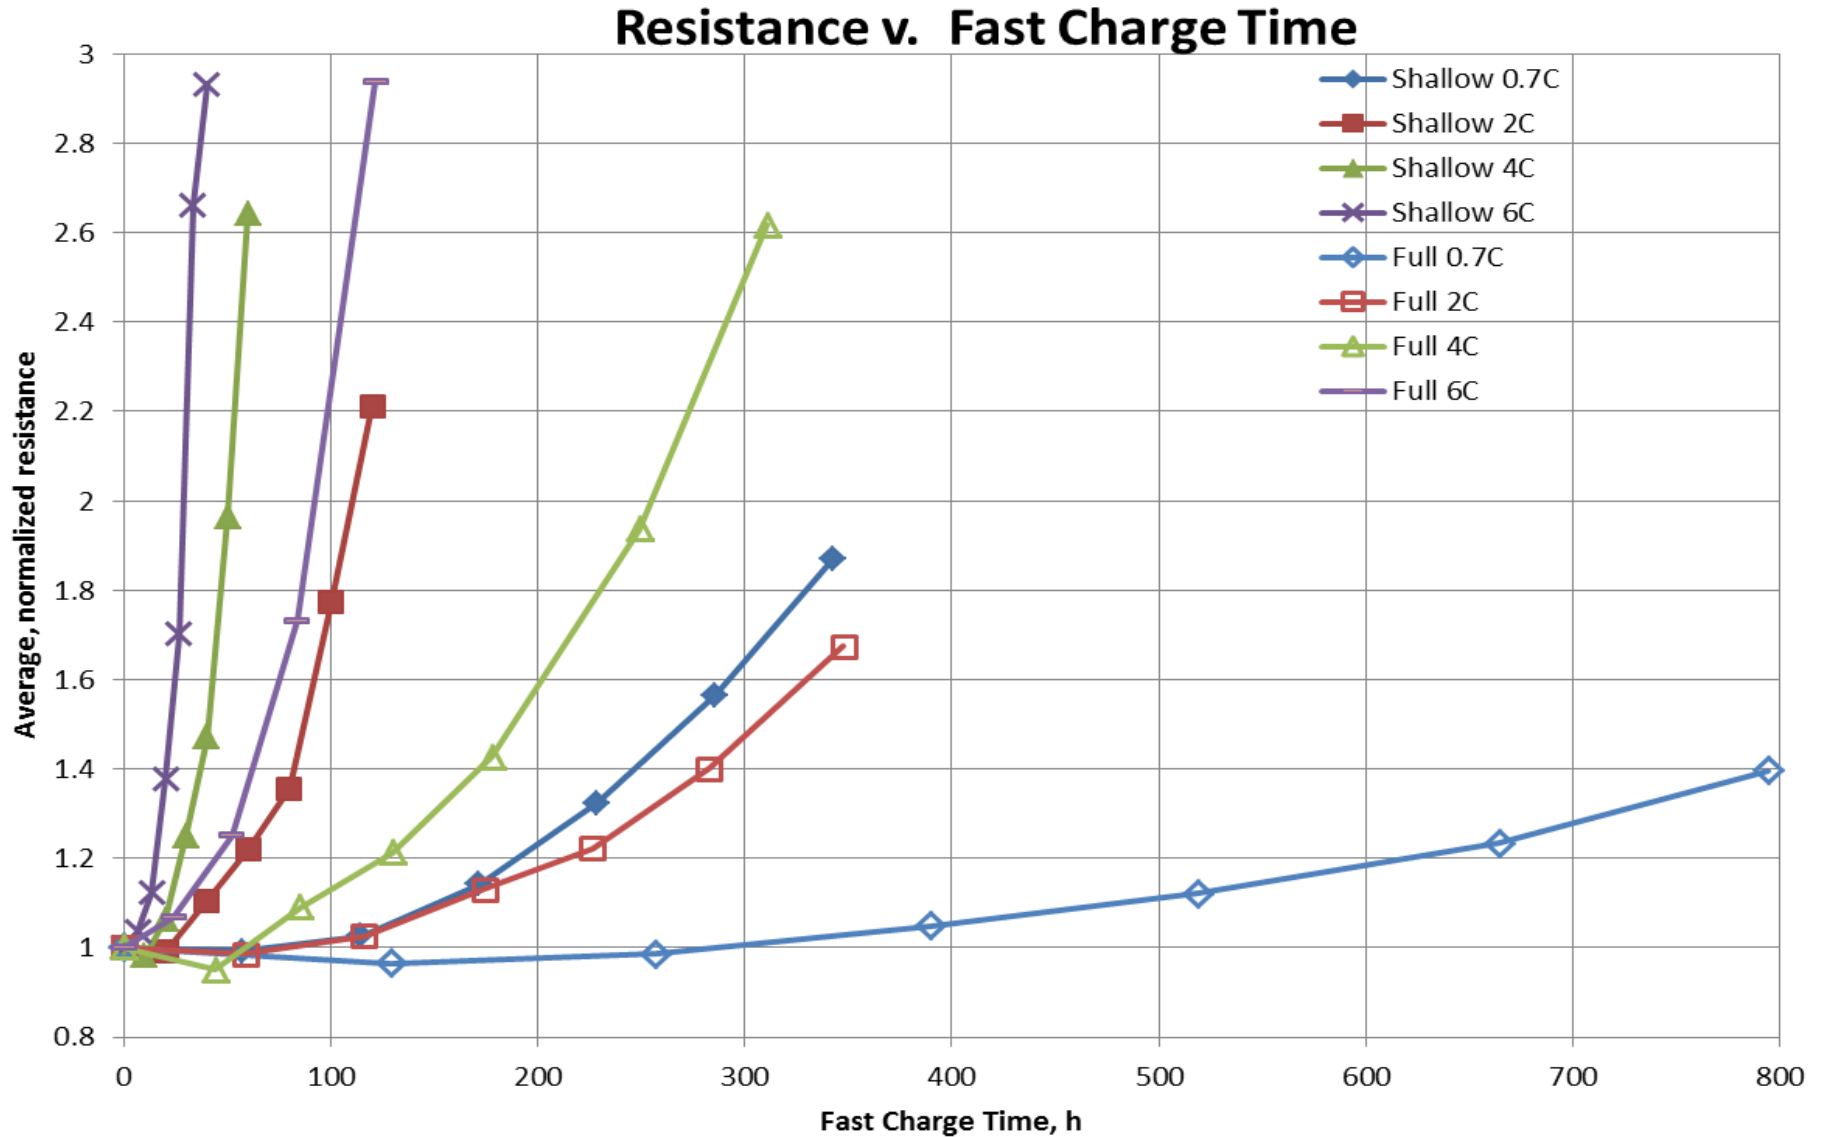
Faster Degradation at Higher Rates and Shallow Cycles

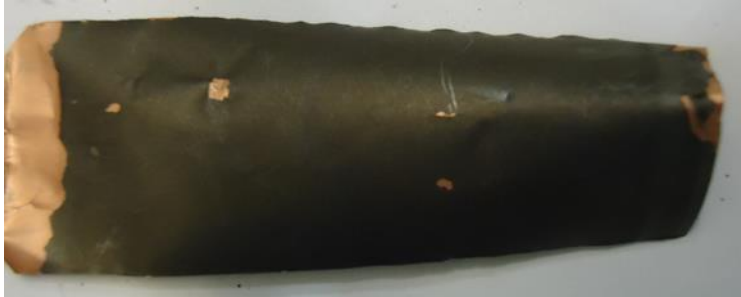
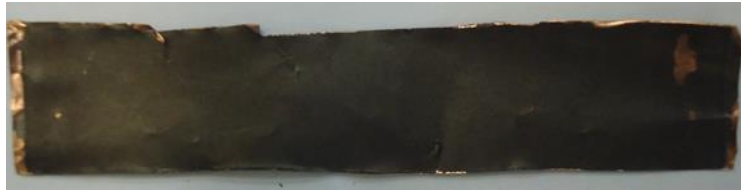
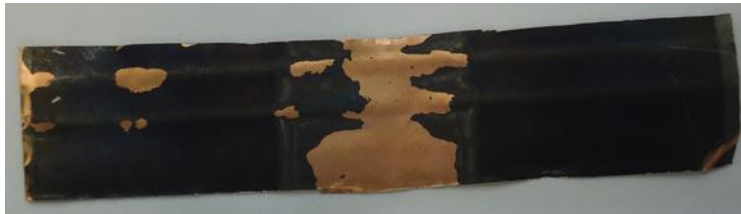
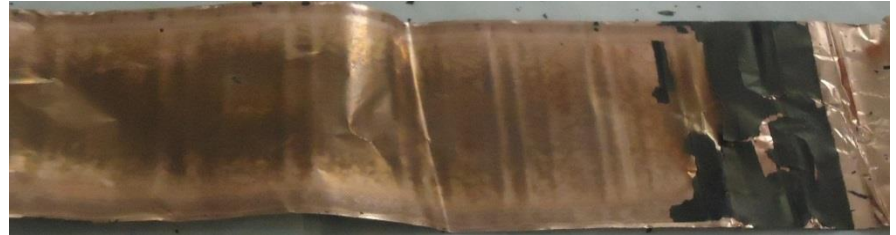
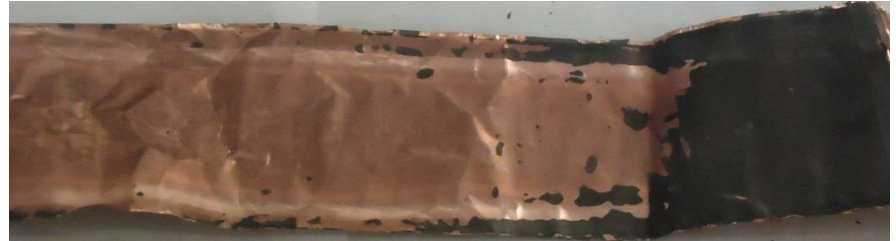
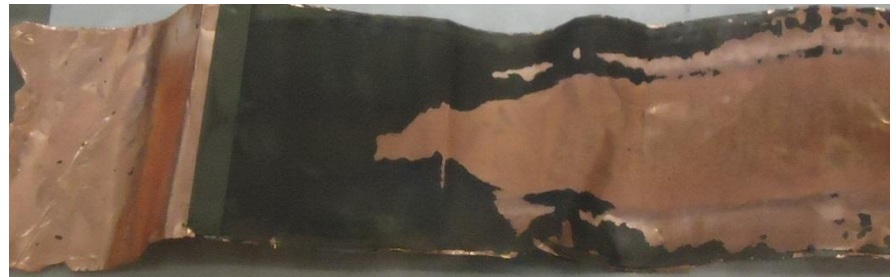
Fast Charging Causes Physical Damage on Cell Anodes

Full Charge

Shallow Charge

0.7 C

2 C

4 C

6 C

- Fast charging causes performance decline in lithium-ion batteries
- The extent of decline is proportional to charge rate and dependent on SOC window, strongly suggesting relation to i^2R heating
- Post-test examination of these cells indicates that one cause of performance decline is from the degradation of the binder in the anode, causing loss of contact between the current collector and active materials
- In the field, infrequent fast charging of electrified vehicles, while not to the extent observed here, may also accelerate degradation
- It may be possible to lessen these effects through effective thermal management of the vehicle battery pack, which we will seek to study

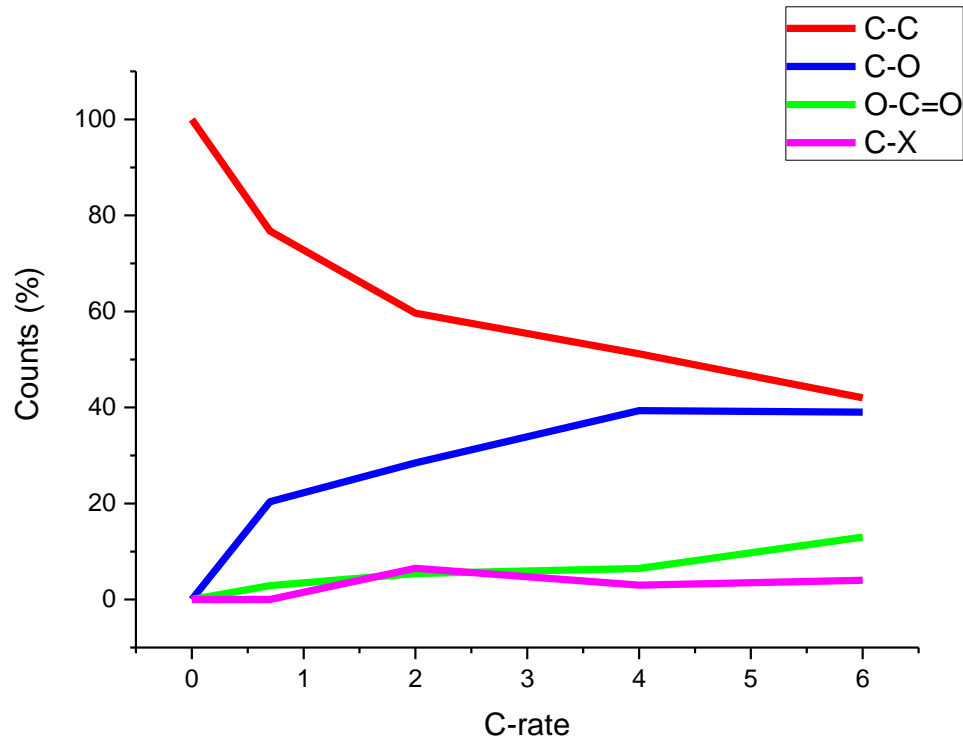
XPS Indicates Changes in Surface Chemistry

- C1s XPS data , after Ar⁺ sputtering
- Higher C-rates associated with more oxidized C species

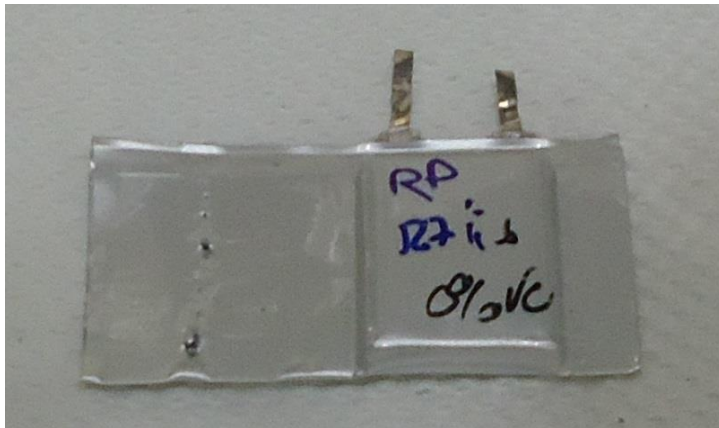
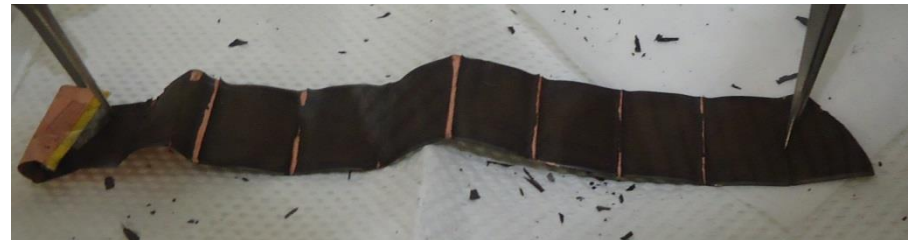
Case study: Effect of Washing on Anode SEI

- A series of LCO/graphite cells with varying contents of VC additive were made and cycled at Dalhousie University to study the effect of VC on aging properties
- Cells were sent to PTF to characterize SEI's at end of test
- Washing anodes in DMC significantly altered the observed surface films

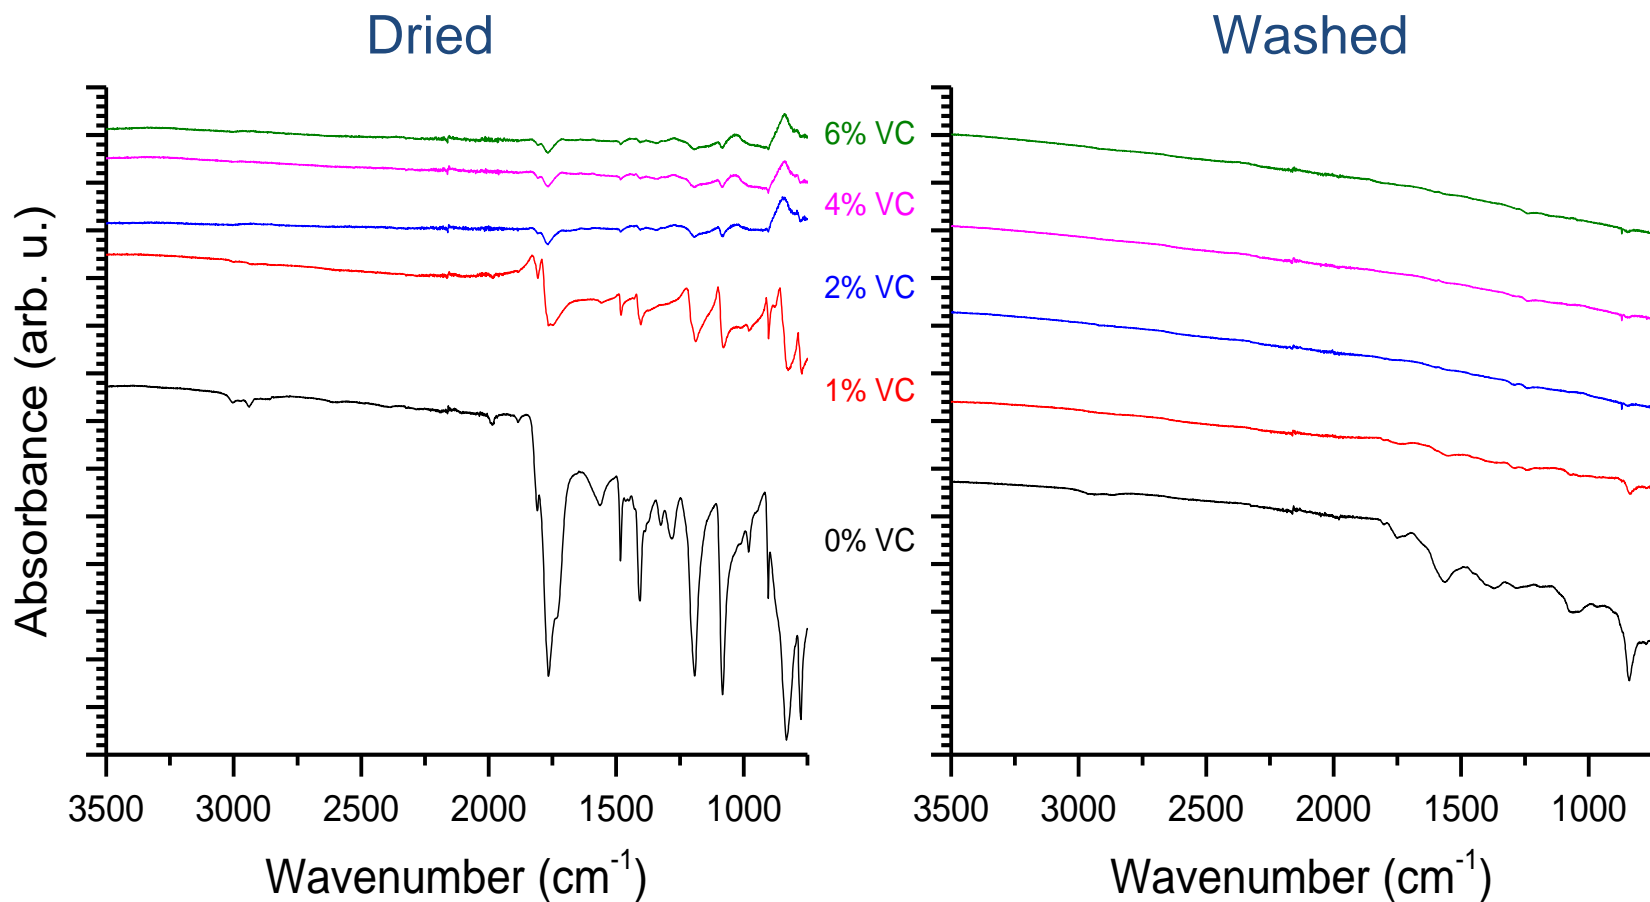
FTIR Reveals Thinner Films on Washed Anode

- Absorption bands are more pronounced in dried cells, indicating thicker film
- Composition of film on 0% VC cell changes upon washing

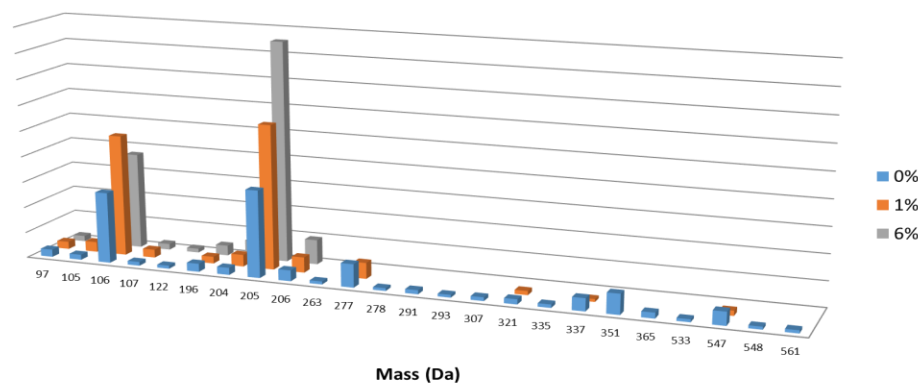
HPLC of Electrode Washings Contains Species Heavier than Electrolyte Components
