# DOE/OE Transmission Reliability Program

## Powerline Conductor Accelerated Testing (PCAT)

**Oak Ridge National Laboratory**

**June 13, 2017**

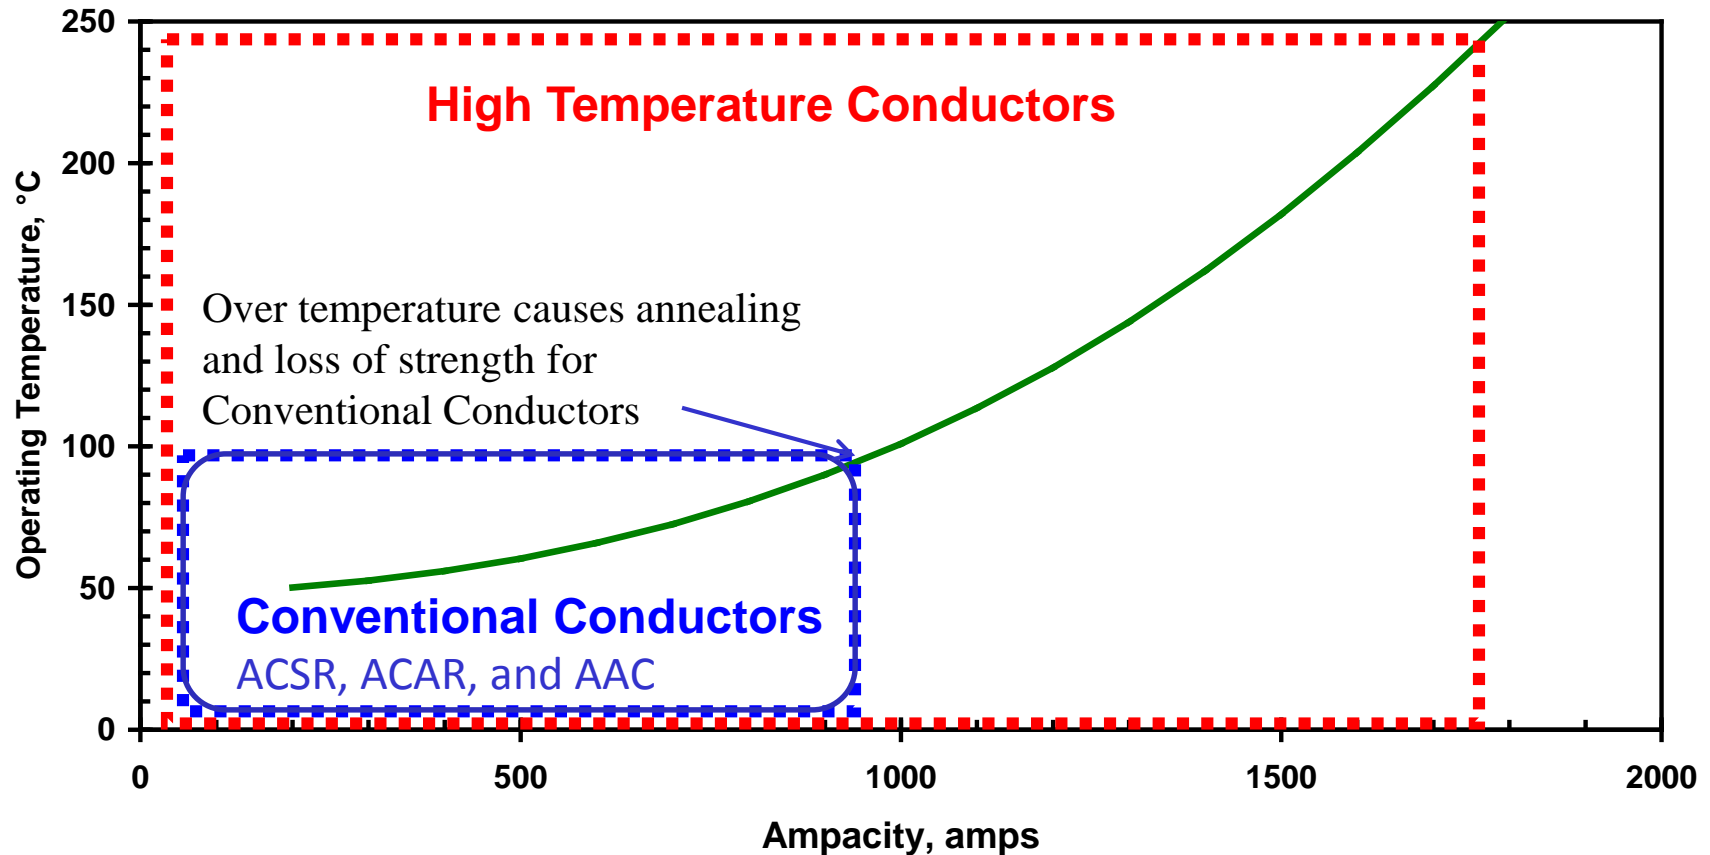
# Recap: Driver of higher operating temperatures is higher current ratings

***Need to test / verify new conductors over entire operating range***

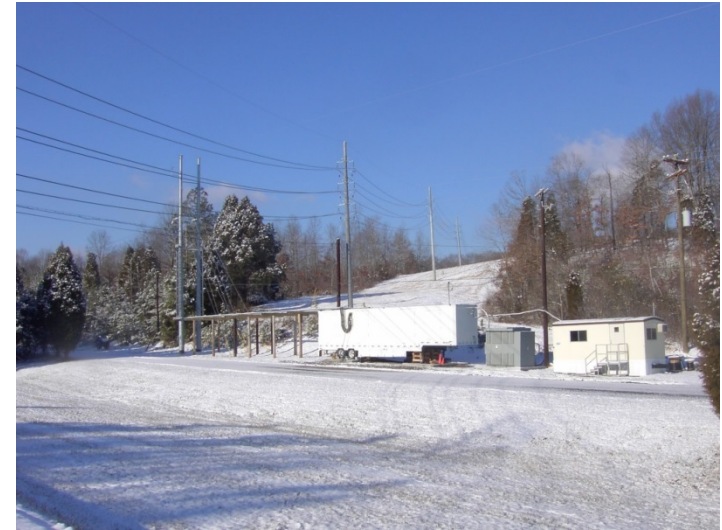
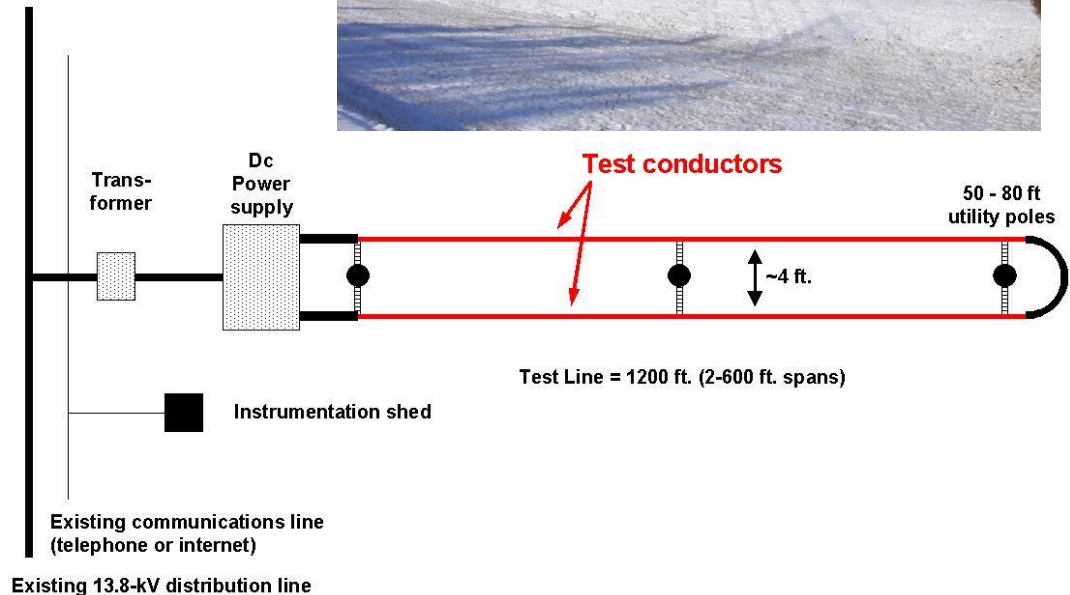
# Recap - Capabilities: Powerline Conductor Accelerated Testing Facility

- Testing Capabilities
  - Thermal / Mechanical Cycling
  - Current / Temperature Ramp
  - Current / Temperature Steps and Hold
  - Controlled current testing
  - Controlled temperature testing
- Facility
  - 2400 feet of conductor
    - two 600 foot spans
    - 3 towers
  - 0 to 400 Vdc
  - 0 to 5,000 Adc
  - Conductor and accessories
  - Tested up to 300°C
    - can go higher if needed

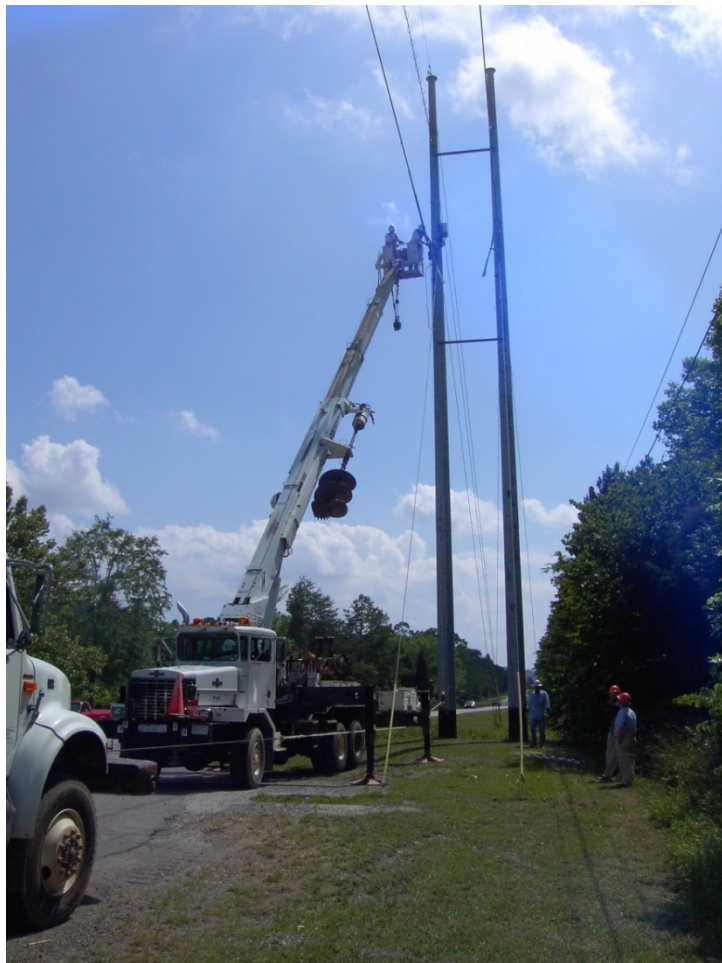
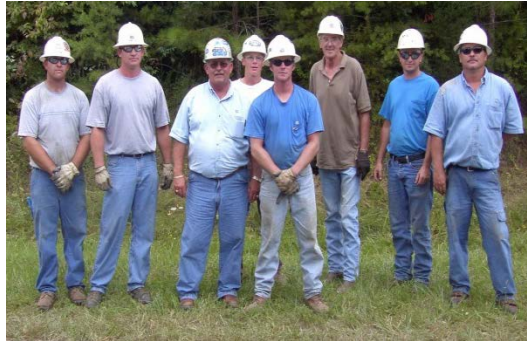
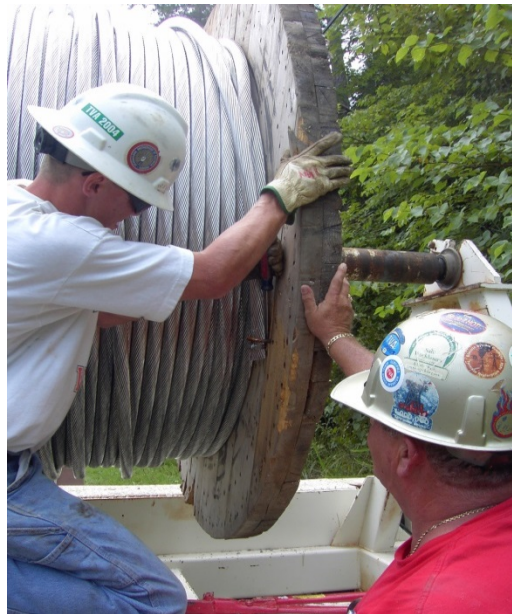
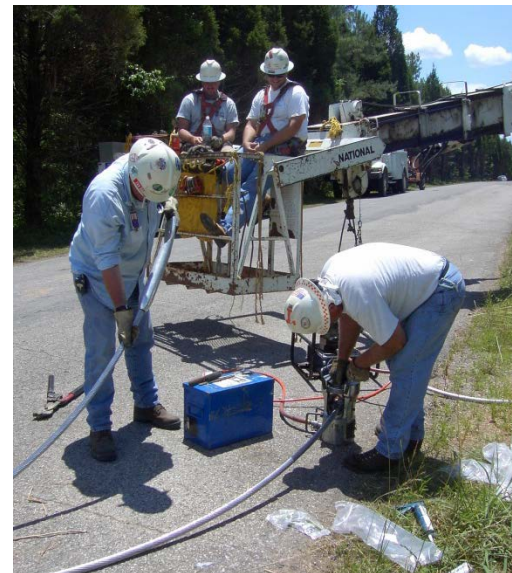
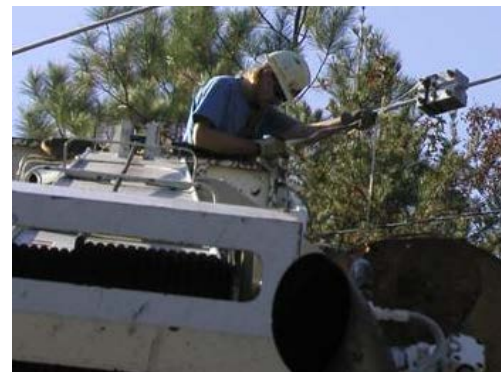
# Recap: Conductors are installed by TVA using conventional industry practices

Typical installation is ~ 3-4 days

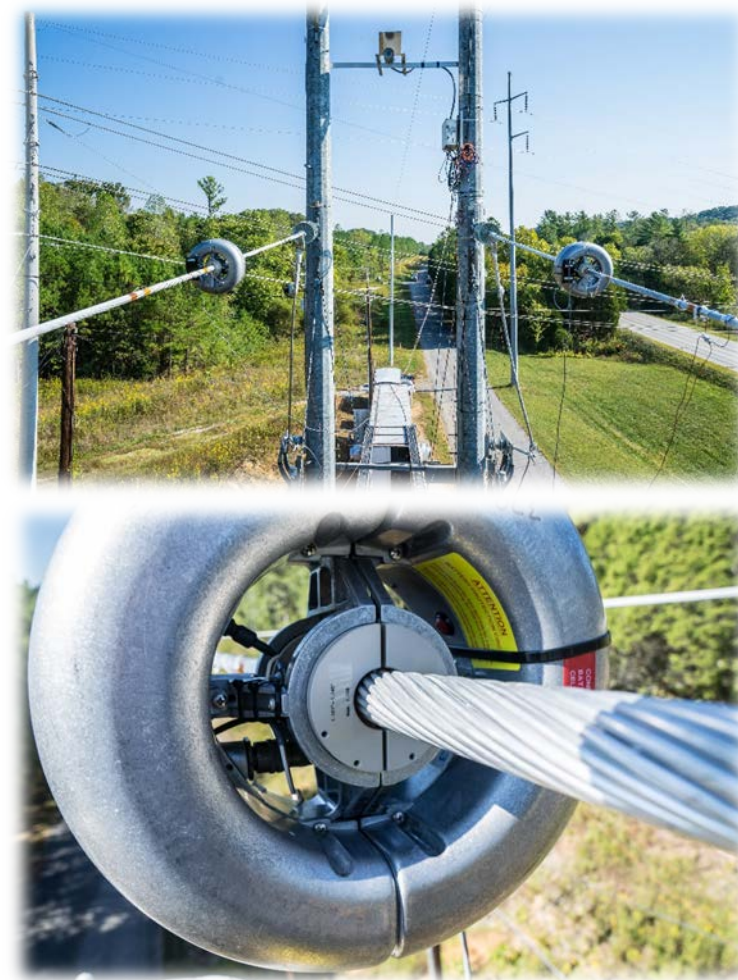
# USi's Power Donut Testing

- ORNL successfully ran through a series of tests including:
  - Constant temperature
  - Constant Current
  - Rapid cycling of the conductor
  - Extreme temperatures (250 C on the Power Donut)

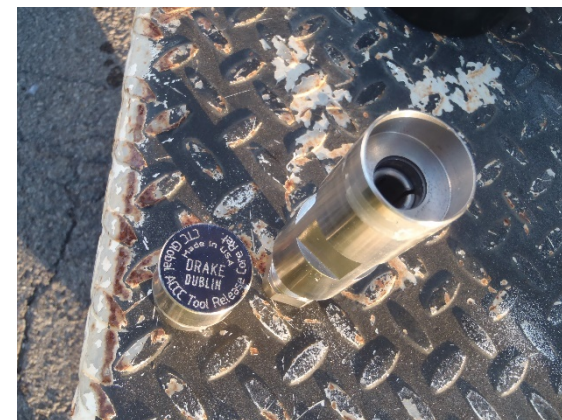
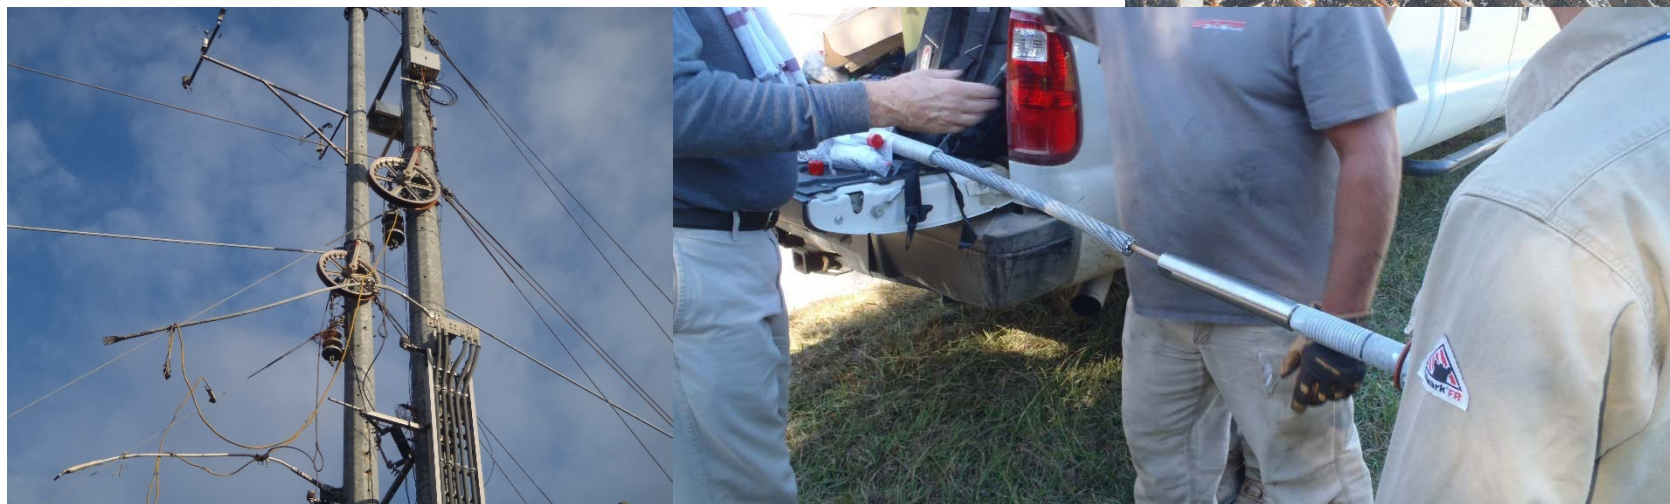
# General Cable/CTC ACCC Installation

- Installation completed successfully
  - 10/2016
  - Included removal of existing General Cable ACSS Conductor

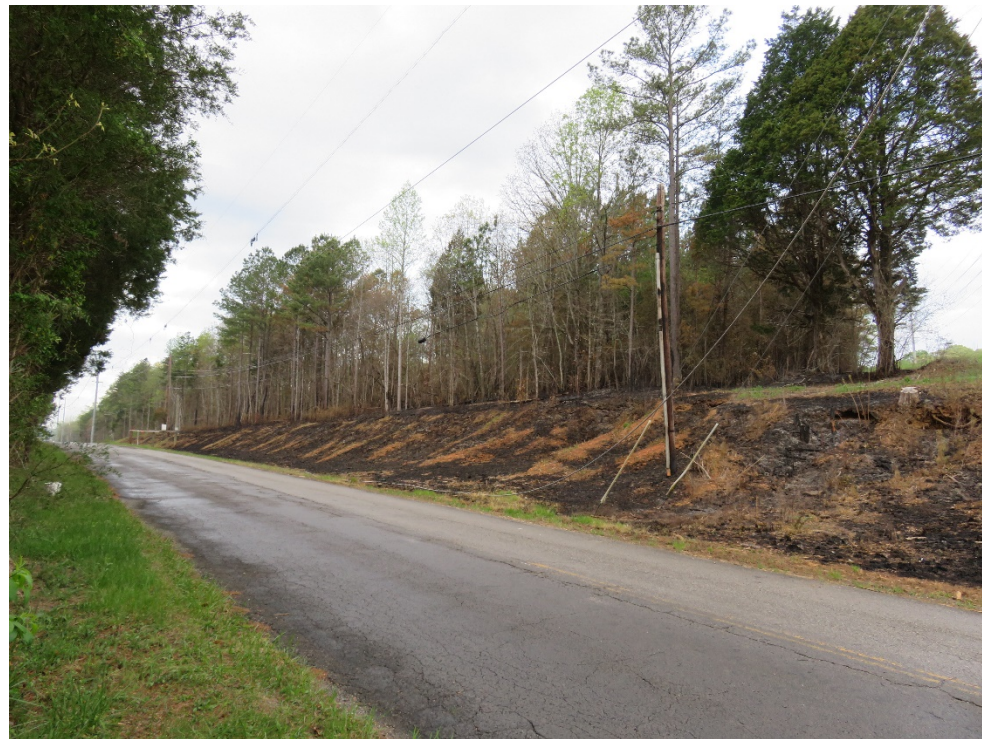
# System Failure – What Happened

- A failure in the overall control system caused a continuous high current which caused the conductor to burn through.
- When the conductor failed, it resulted in a fire at the test-site

Note: The conductor was not the cause of the failure

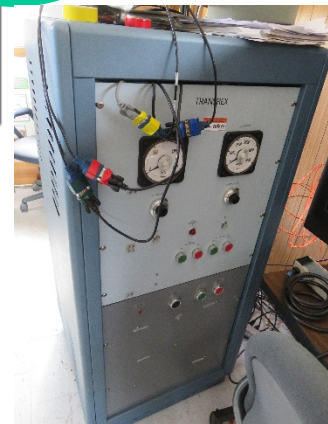
# System Failure – Why this happened

- Analog Output module (+/- 10V output) failed in an unusual way (-7Vdc).
  - Results in 5000Amp setpoint
- 12Vdc supply for control modules decreased from 12Vdc down to 7Vdc
  - Below the power-on value for the control modules which shut them all down disabling their watchdog feature and ability to open the relays for the DC supply.

Note: This sequence of failures was highly unforeseeable

1. Module fails without pulling down the 12Vdc supply
  - Software would've detected communication failure to the one module and opened the relay.
2. Module failed in a 0V mode instead of -7Vdc
  - This would be a 0 current set-point
3. Module failed in a +7Vdc mode instead of -7Vdc
  - This would also be a 0 current set-point
4. 12Vdc supply fails completely
  - Analog output would've been a 0 current set-point
5. Main application exits in a bad state
  - Modules have built-in watchdogs that would've opened the relay
6. Failure occurred 3 minutes later
  - We would've been in an off cycle

Note: Software attempted to open all relays, but with no power was unable to.
