# **Integrated Waste Treatment Unit Update**

Idaho Cleanup Project

**February 17, 2016**

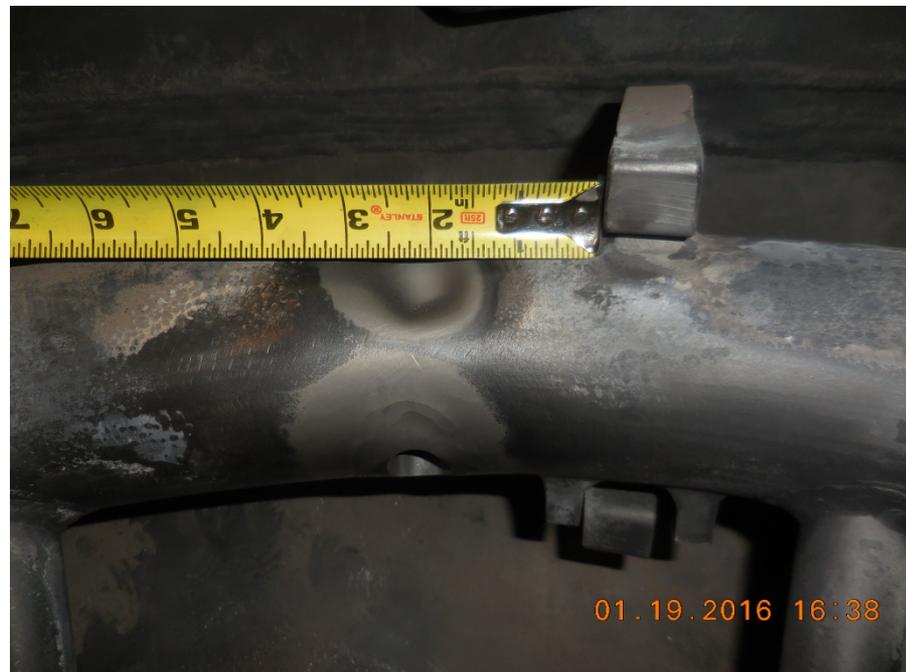
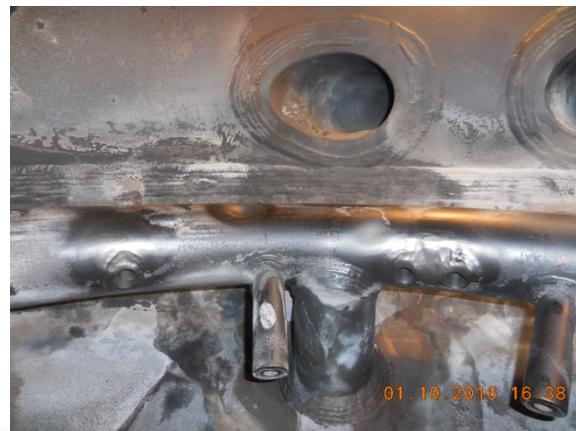
- Post-shutdown inspection confirmed that all systems, other than the DMR, behaved as expected and components were found in acceptable condition.
- Detailed inspection after removal of the materials from the DMR revealed significant wear on the four fluidizing rails and the ring header. The cause for this erosion remains under investigation.
- Inspection of the Super Heater revealed warping of a heat exchanger requiring repair.

Photos show evidence of erosion on DMR ringheader and nozzles.

- Complete current inspection and maintenance “Outage G,” respond to any issues identified.
- Auger-grinder enhancements.
- Replace super heater element and heat exchanger shell
- Resolve chemistry issues related to bark formation and erosion.
  - “Chemistry Summit,” featuring experts from IWTU, other national laboratories and industry, held this week to address bark and erosion issues.
- Conduct simulant run to test recommendations from summit
- Carry out maintenance and inspection “Outage H.”
  - Replace DMR ringheader.
  - Address any issues from simulant run

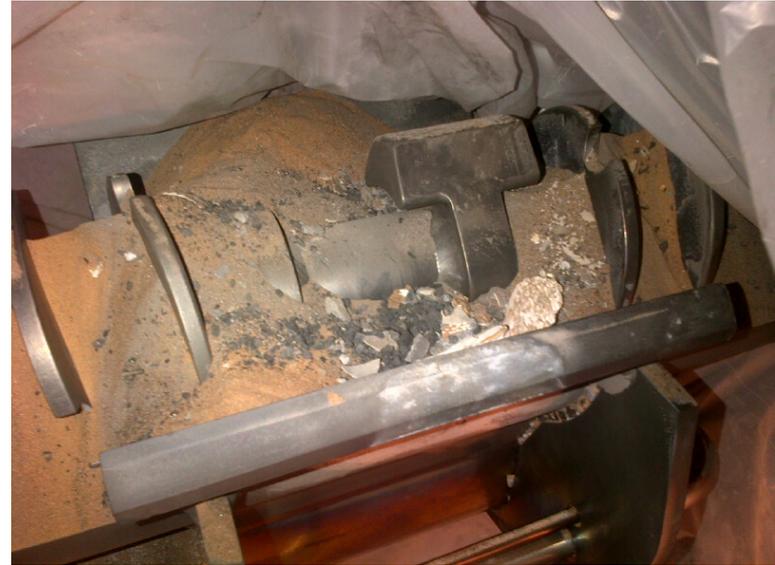
- Wall scale – referred to as “bark,” was found on the internal surfaces of the DMR, and in the bed material after shutdown.
- The bark coating was not as extensive, nor as firmly bound to the equipment (it was flaking off and more easily removed) as that found in January 2015.

Wall scale – “bark” material – found in the DMR.

1. “Bark” (wall scale) Formation in the Denitration/Mineralization Reformer (DMR): Changed DMR bed material from bauxite to alumina and adjusted operating parameters. Bark formation, while significantly reduced, is still a concern and under investigation.
2. Carbon Reduction Reformer (CRR) Refractory Lining: Repairs and curing of refractory lining completed. Inspection of refractory complete: no issues.
3. Off-Gas Filter (OGF) Material Transfer: Installation of a larger transfer jet, and air flow upgrades to CRR ATG nozzles, have resolved OGF problems.
4. Off-Gas Blowers: Vendor has replaced three of the four blower shafts and completed testing. Fourth shaft satisfactory and will not be replaced. All blowers running satisfactorily.
