*Integrated Waste Treatment Unit  
Citizens Advisory Board Presentation  
September 19<sup>th</sup>, 2012*

# Event Description

# Event Investigation

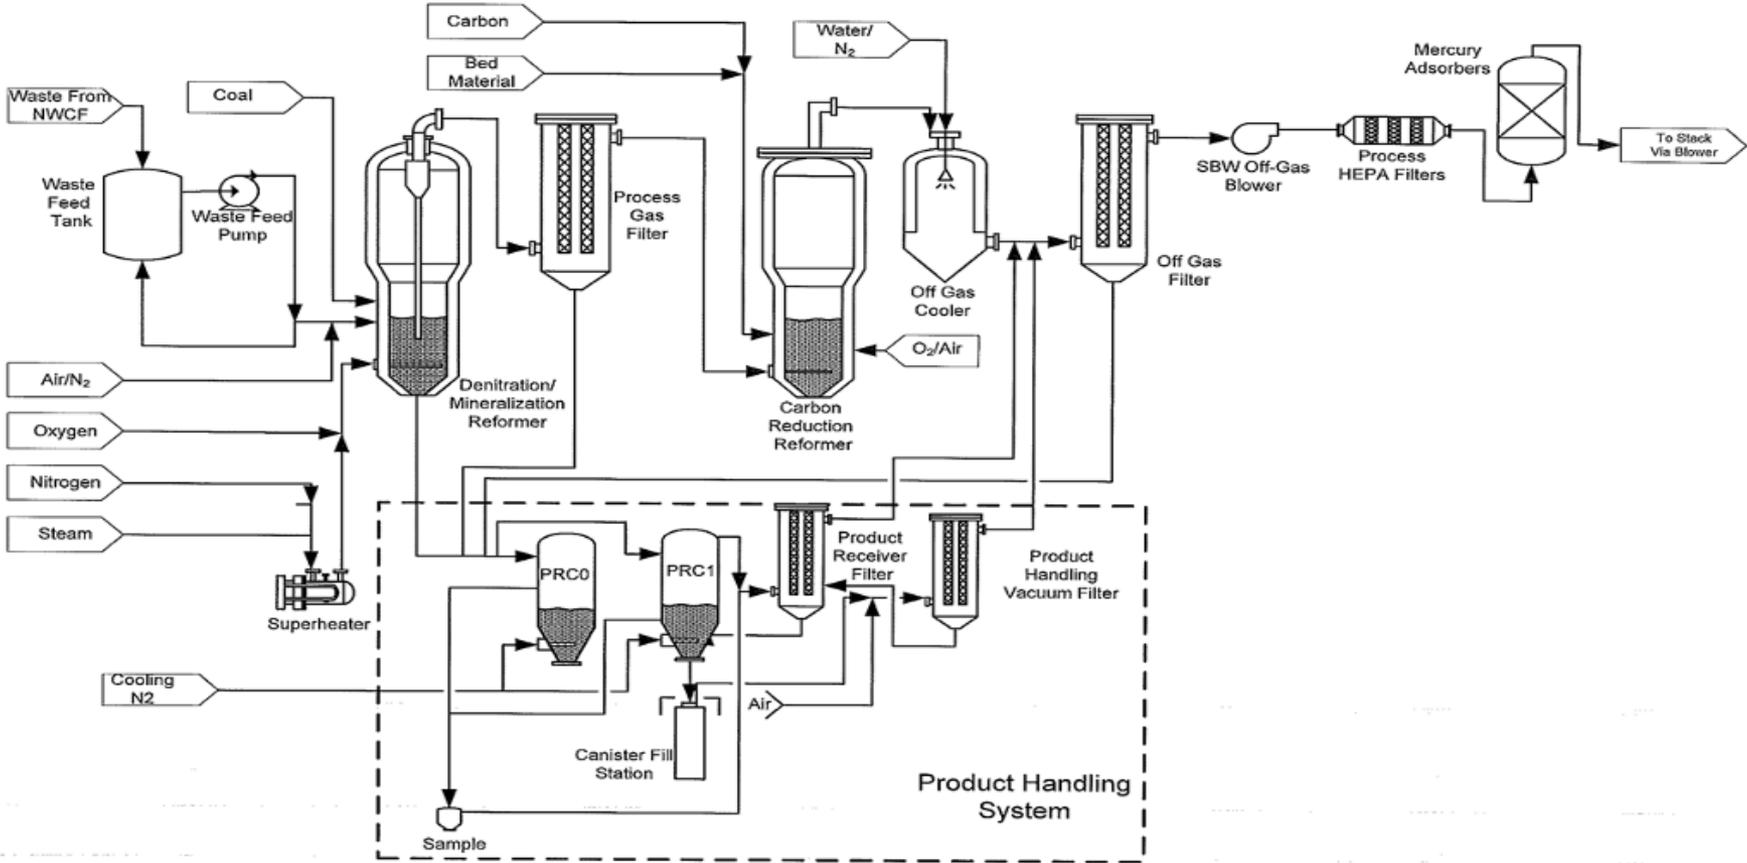
# Integrated Waste Treatment Unit Process

- **New Hazard Category 2 Nuclear Facility:**
  - Process Building with reinforced concrete process cells inside a structural steel building, along with a Product Storage Building
- **Steam Reforming Process:**
  - First of its kind, full scale steam reforming process; reformer vessels use superheated steam and nitrogen gas, along with coal and coke, to convert acidic radioactive liquid waste to solid carbonate particles
- **Reformer Vessels:**
  - Denitration Mineralization Reformer (DMR)
  - Carbon Reduction Reformer (CRR)
- **Process Filters:**
  - Off-Gas Vessel Filters: Process Gas Filter (PGF) and Off-Gas Filter (OGF)
  - Product Filters: Product Receiver Filter (PRF) and Product Handling Vacuum Filter (PHVF)
  - Process Off-Gas High Efficiency Particulate Air (HEPA) Filters

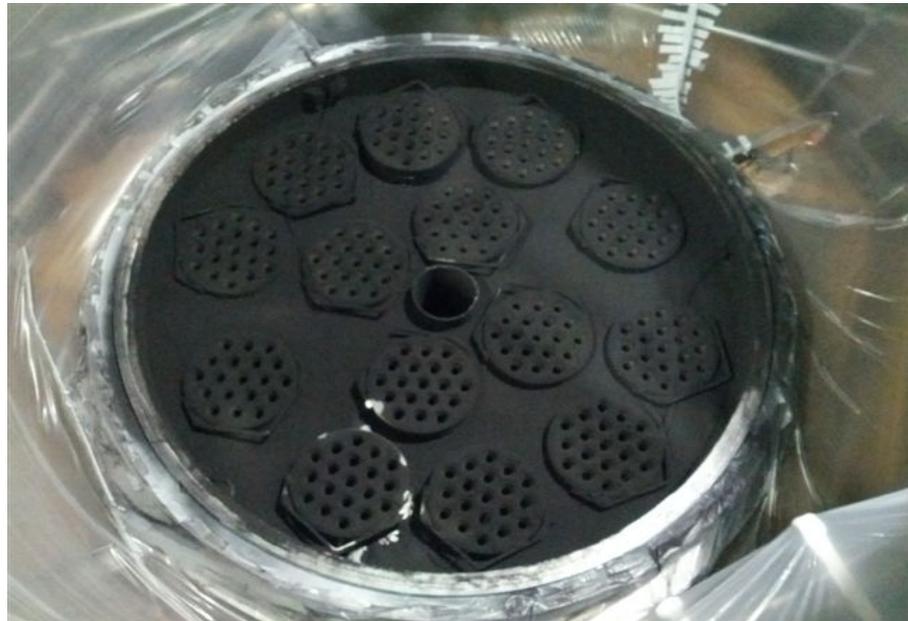
- Late May 2012--IWTU plant heat-up began as part of the post-CD-4 startup testing program
- June 9, 2012--PGF filter D/P spikes, causing filter bundles to lift; contractor continued operations—convinced filter bundles re-seated, based on process parameters, without investigation; DOE management was not informed and was unaware of the June 9 event
- June 16, 2012—
  - OGF filter bundles lift
  - Coal fines and bed material are released from the OGF
  - Process HEPA filters load up and fail
  - Coal fines and bed material are released from the stack

Off-Gas Filter Photo—Top of Filter Bundle Tubesheet, Post-Event

- June 25 thru July 6, 2012—Event investigation team conducted reviews, led by H. Handfinger, URS
- August 2, 2012—Report issued; causes:
  - **Direct Cause:**
    - OGF filter bundle lift due to excessive wood-based charcoal fines carryover, blinding the OGF filters, allowing solids to pass through the OGF to the HEPA filters, causing their loading and breach
  - **Root Causes:**
    - Lack of adequate technical direction on expected operating envelope, parameters, and indications
    - Design deficiencies
    - Inadequate oversight and management systems (technical inquisitiveness)

- Process filter bundle restraints to prevent lifting
- Product Receiver Filter and Product Handling Vacuum Filter pressure reliefs
- Process filter fuse removal
- Carbon Reduction Reformer modification to inject oxygen lower in vessel
- Install process off-gas High Efficiency Particulate Air Filter pre-filter differential pressure transmitters (allows Rapid Shutdown System trip)
- Evaluate and modify the Rapid Shutdown System alarm and trip strategy
