FUSRAP VICINITY PROPERTY ASSESSMENTS TO SUPPORT CLOSEOUT AND TRANSFER

USACE Kansas City District

USDOE Long Term Stewardship Conference

22 August 2018

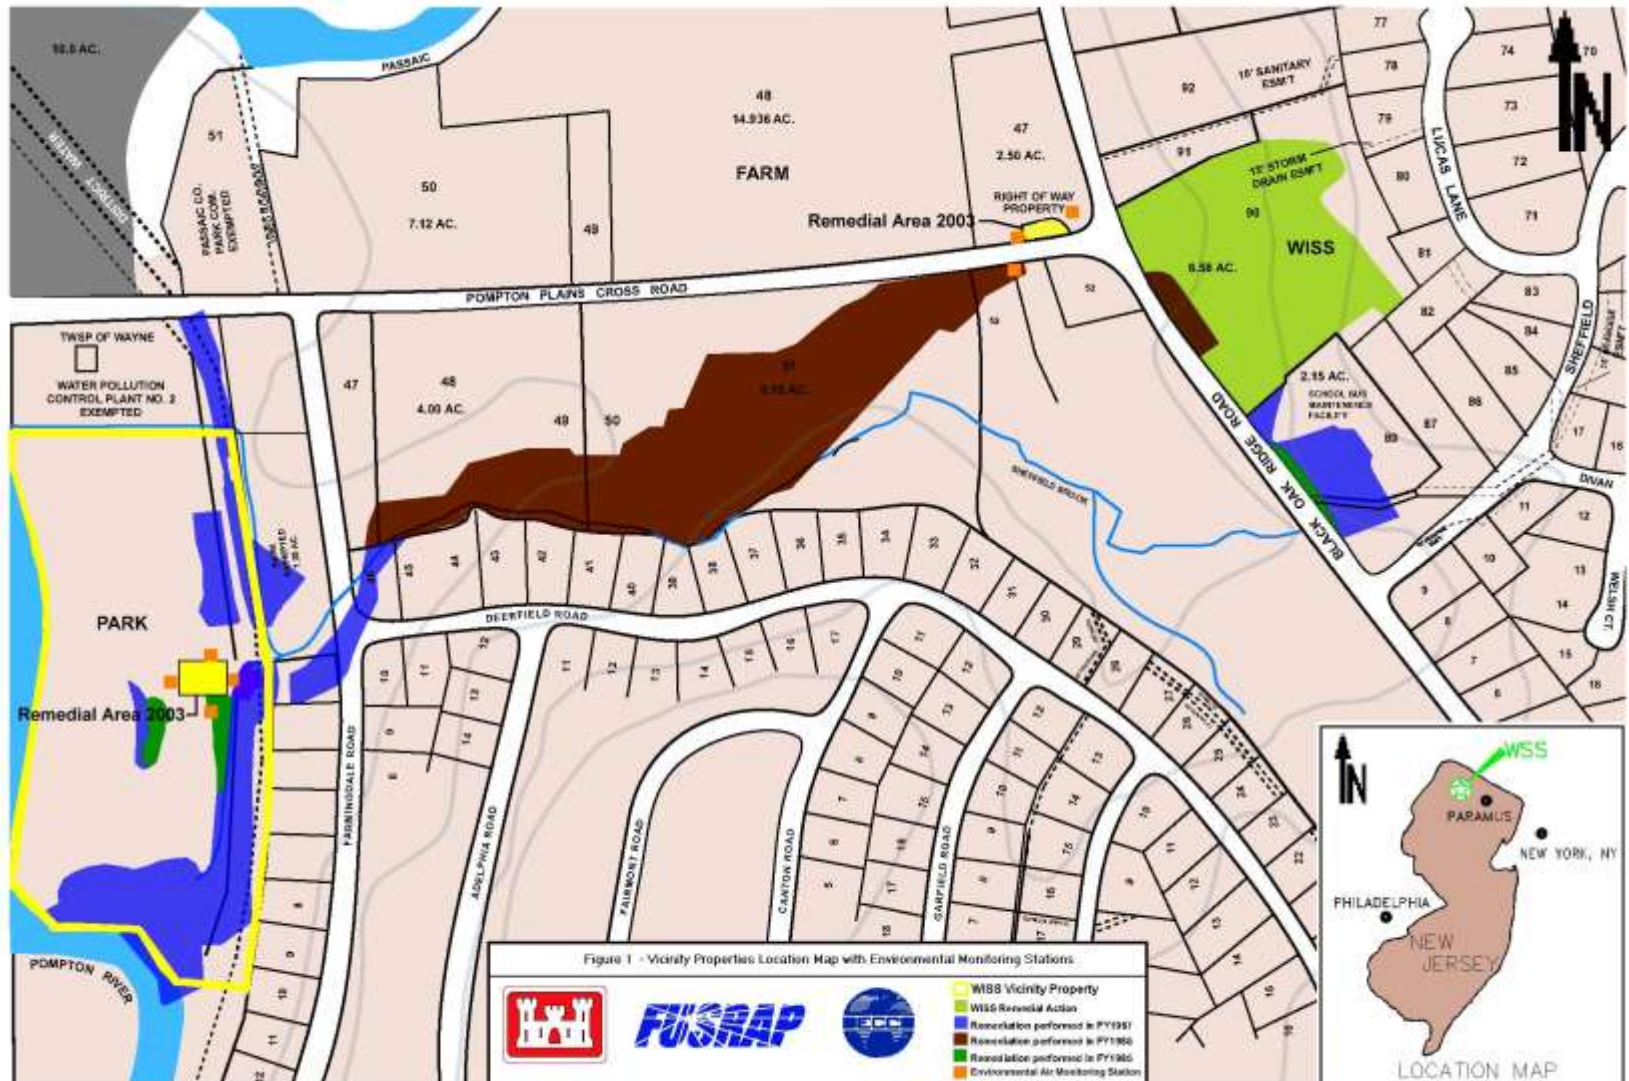
WAYNE FUSRAP RE-ADDRESSED

- Reviewed all Characterization, Remedial Action, and Independent Verification Reports
 - Verified identified contamination was addressed by excavated areas
 - Compared Post RA data to current ROD criteria
 - Past hot spot criteria similar to current EMC
 - Some past data and IVC identified 200 pCi/g Th-232 spots
 - Used past data and organized to be MARSSIM like
 - “Floating” SU used (any 2000 sq. meters had to pass)
 - Used area factors from WISS FSS plan
 - Stated if not identified as an issue then meets ROD

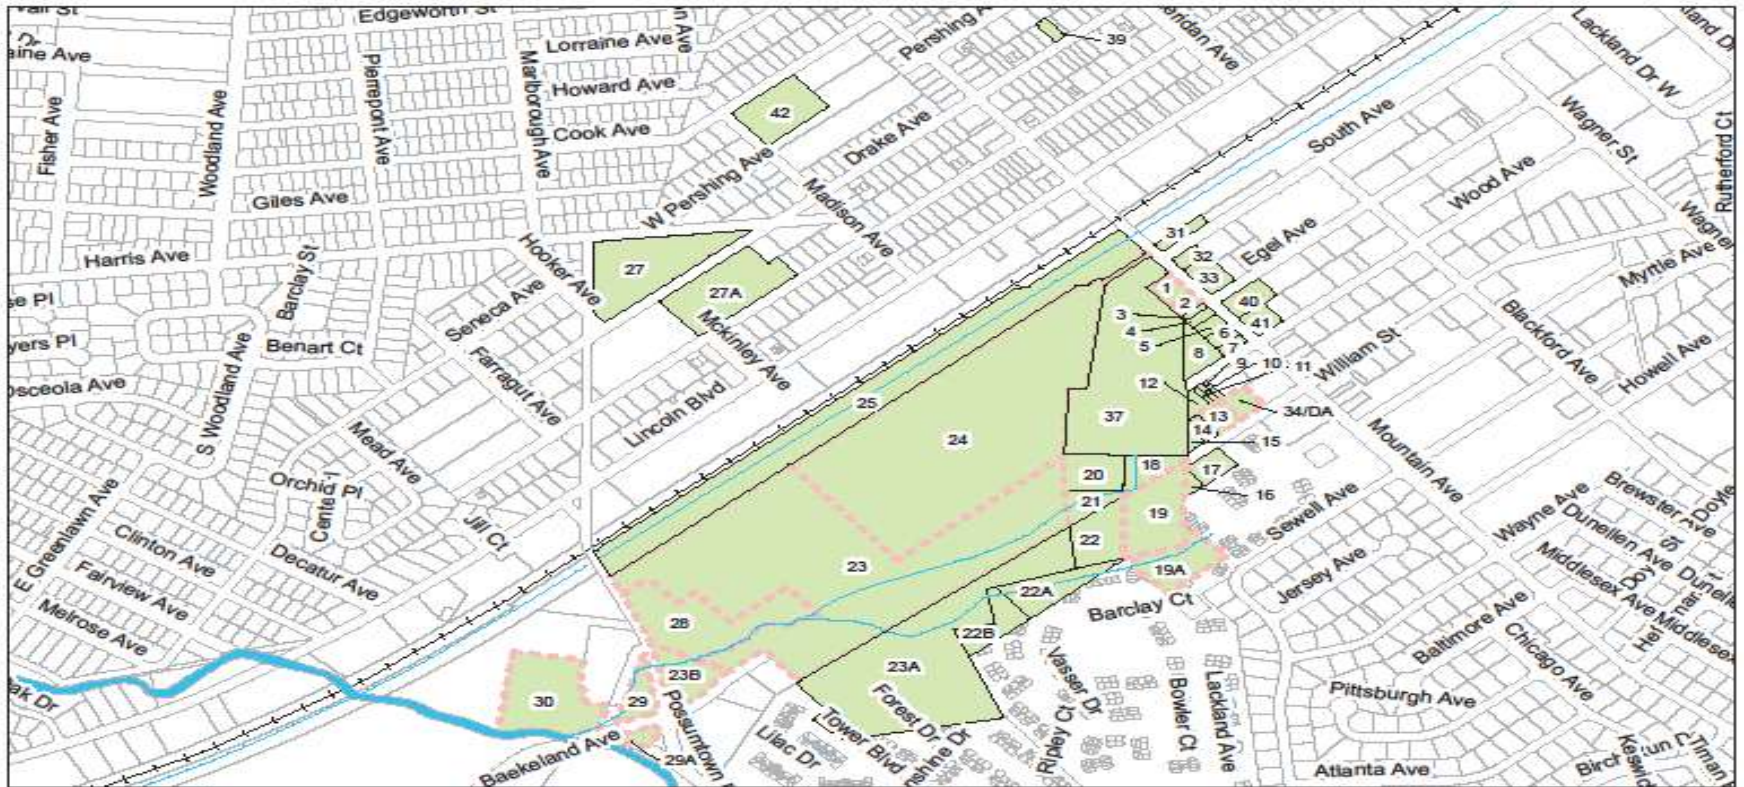
FIGURE 1-1
PRIMARY GROUP PARCELS

MSP SITE LOCATION
AND VICINITY PROPERTIES

FUSRAP SITE
MIDDLESEX, NJ

- Review of 49 VPs
- Additional aerial survey based on NJDEP comment to be conducted prior to TM being completed.
- Further assessment of 11 VPs lead to 1 VP requiring further remediation.
