Final Report – Vacuum Sanitation Energy Efficiency Retrofits

Type of Award: Energy Efficiency Retrofits for Rural Alaskan Vacuum Sewer Systems

Project Title: Vacuum Sanitation Energy Efficiency Retrofits Project

Project Location: Alakanuk, Alaska; Kotlik, Alaska; Noorvik, Alaska

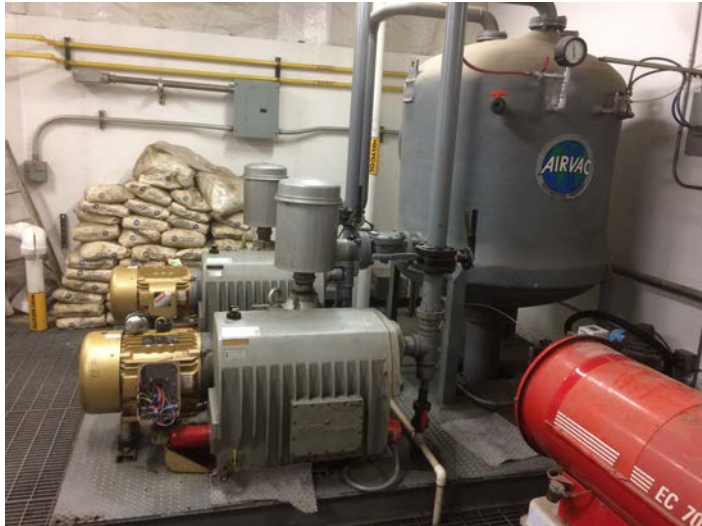
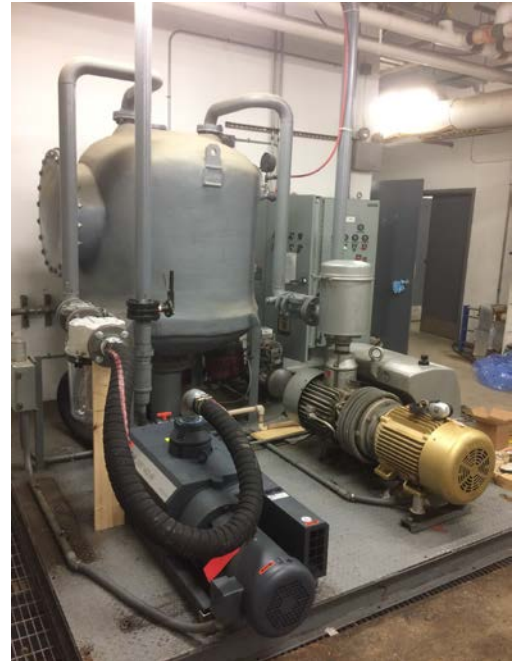
Shown here is the Alakanuk vacuum pumps being upgraded in October 2017. Clockwise from the top left: original installation; partially upgraded installation; upgrades completely installed.

The most important improvements to the energy consumption of the facilities was to install newer vacuum pumping technology. Vacuum sewer service in these communities is used because the active layer of permafrost and the flat topography of the community impose limitations on burying pipes in the ground and make that practice exceedingly difficult, in some cases near impossible. All pipes are above ground and in order to induce the flow of sewage, a pair of central vacuum pumps are used to move sewage from homes to a central collection point. This system uses an incredible amount of electricity. ANTHC utilized innovations in pumping and controls technology to upgrade the sewage collection system and drastically reduced electricity consumption.

This effort included the installation of new pumps, new variable frequency drive controls, and vacuum valves and seals. The effect of these improvements allows the vacuum system to perform more efficiently. Other retrofits included minor weatherization such as weather stripping, window repair, and reducing excessive air transfer and ventilation. Installation of light-emitting diode (LED) lighting at each facility, improvements to the fuel oil boiler heating system, minor modifications in pumping rates, and training in best practices in the water treatment system were also a key component to the retrofits in each system.

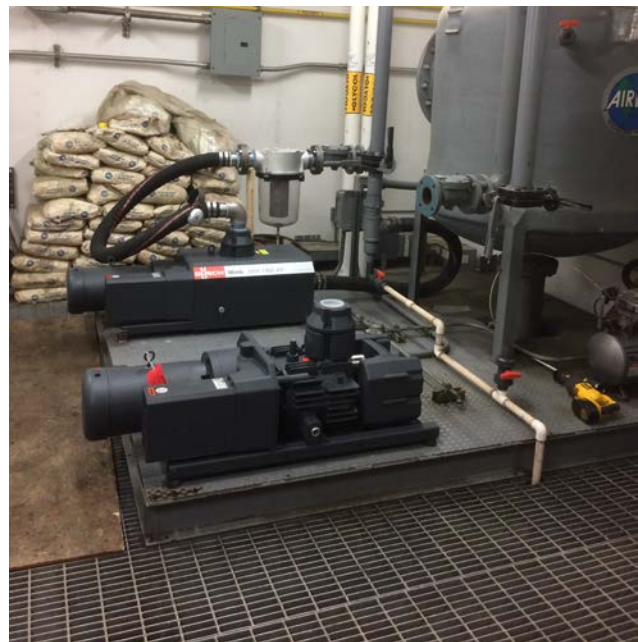
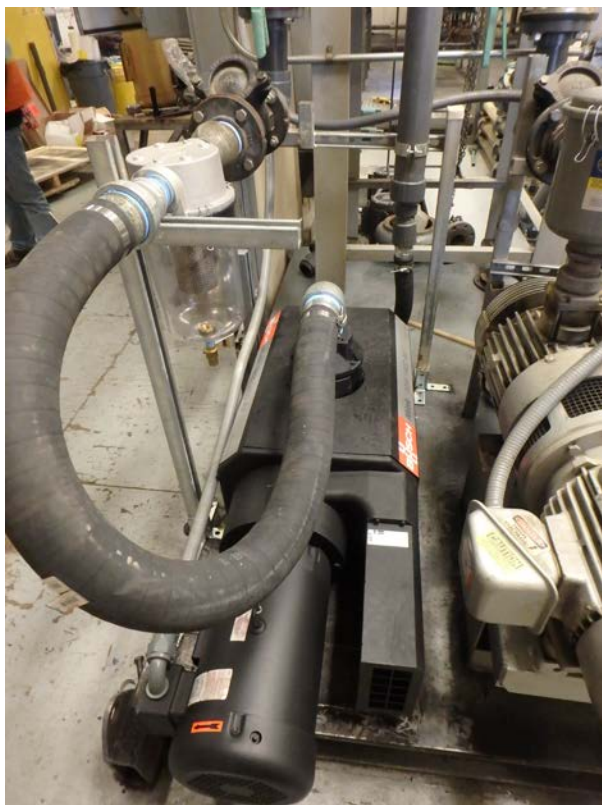
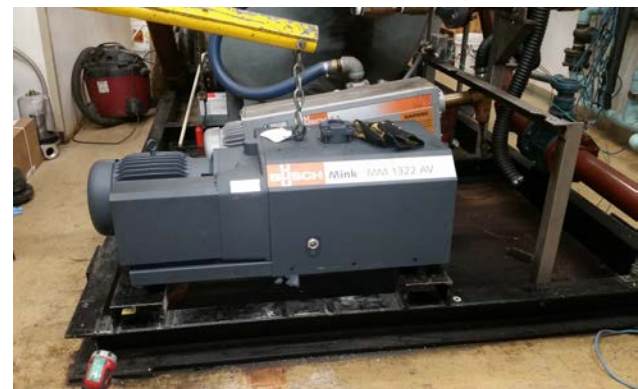
Bottom left is the completed Noorvik vacuum pump installation. Bottom right is the Kotlik installation in progress.

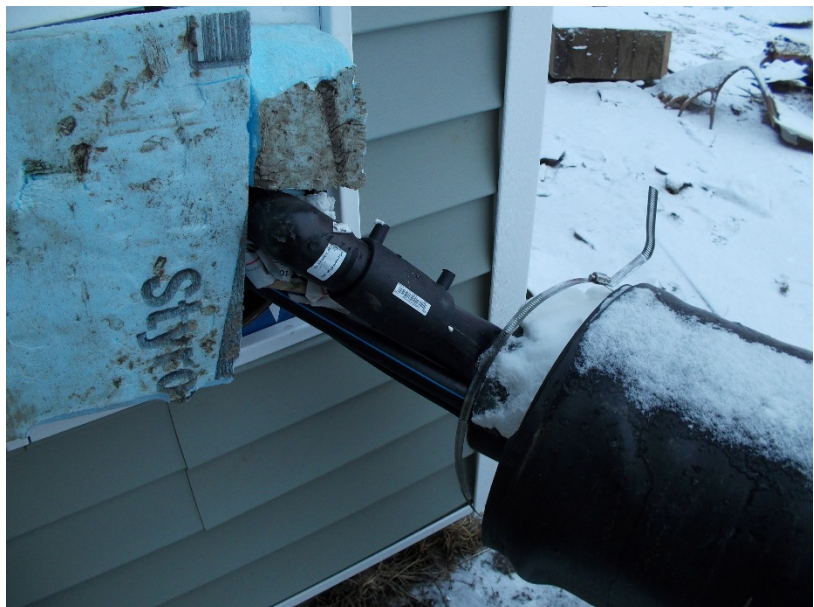
In rural Alaska, water and sewer connections enter the home above grade in arctic boxes; an insulated covering that prevents exterior weather from penetrating the building envelope where the water and sewer system connections enter/leave the building. One of the major weak points in any rural Alaskan sewer system, vacuum or otherwise, is the connection point. In future projects, it is recommended that tasks be included to assess and repair faults and deficiencies in these connections prior to failure. However, on individual residences this may prove to be a complex task; coordination with individual homeowners must be closely monitored to ensure the construction/implementation of upgrades to arctic box connection points has a minimum impact on the daily life of the resident(s) therein.

Pictured: Arctic box separating from structure
