Under-Tank-Bottom Inspection Demonstration

Kayle Boomer Closure Forum September 10, 2019

NDE Technology Engineering Program for Tank Bottom Inspection

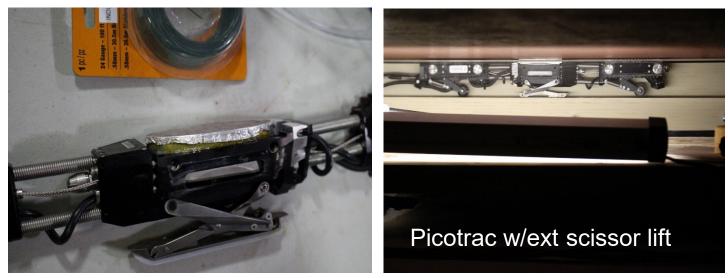
The ability of the vehicle to properly positon the UT probe and apply it to the underside of the tank with 150 lbs. of force.

Expected Test Result: Actuator should press the UT probe up against the top plate with 150 lbs. of force. Difference between the shipping scale and on-board force sensor should not exceed 5%.

TEST RESULT						
Shipping scale reading (lbs)	147	134	214	175.5	150	190
On-board force sensing reading	159	146	214	175.6	152	199
Percent difference	7.8	8.6	0	0.06	1.34	4.6

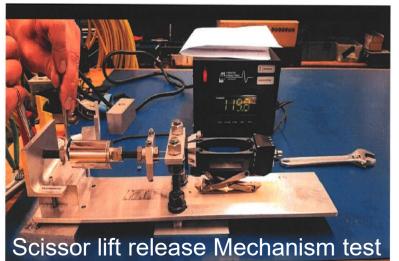
The ability of the vehicle to be retrieved in the event of a power loss by pulling on the tether and activating the linkage release mechanism.

- Build UT probe Kart Test Assembly
- Pressurize Probe Kart with 80 psi nitrogen
- Place Probe Kart into a 2.5 in tall channel
- Restrain Kart from movement by blocking rear spring hanger plates
- Connect interconnect cables to a tension load cell via turnbuckle
- Tension the interconnects until the pin shears on the bearing cap anchor and the linkage is retracted tension

Expected Test Result: force to shear pin should be 60-90 lbs

Test Result: Typical values were 80 lbs. per pin

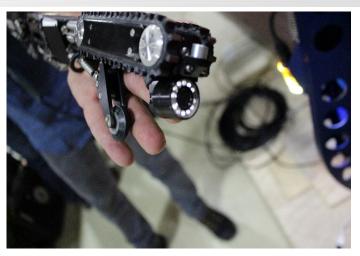
Camera mounted to picotrac

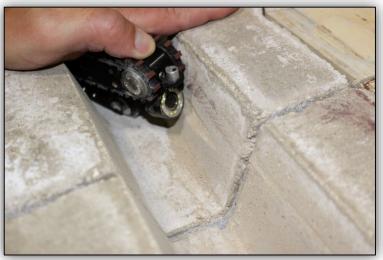
Traversed junctions only after gouging (8/7) Exposed Air Channel Page 9

The ability of the vehicle to navigate the air slots, Verify the vehicle can maneuver through the air-slots and actuate the probe to the bottom of the tank

Test Result: Crawler was successfully able to deploy, traverse the air slot from both front and rear video cameras (after gouging)

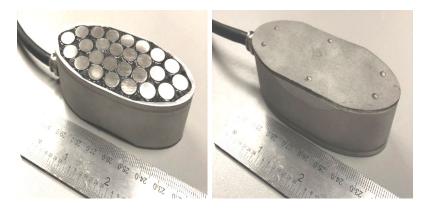
Top and Bottom of the A-Prime Probe

- Two primary tank mockups at the Pacific Northwest National Laboratory (PNNL)18-21 June 2019.
 - Flaw Detection and;
 - Rust and Dirt interference with signal transmission
- Guidedwave worked with Olympus Scientific Solutions Americas to modify the Hanford A probe design to correct the resonant frequency issues experienced during FY18;
- New probe was deemed Hanford A' (Aprime). Additional changes to the probe design included
 - > a slimmer elliptical housing profile,
 - > a groove for a membrane retention wire,
 - > and a stiffer steel cap;

These mechanical modifications were made to integrate the Hanford A' probe with the Inuktun deployment robot.

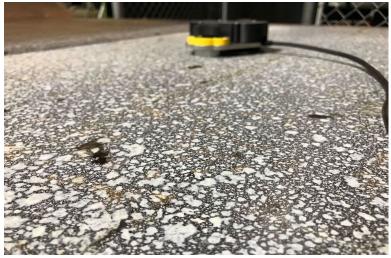
Kaolite dust on the surface of the mockup for the dirt testing.
