## **Appendix C**

### **Ecological Restoration**

## C.1.0 Ecological Restoration Monitoring

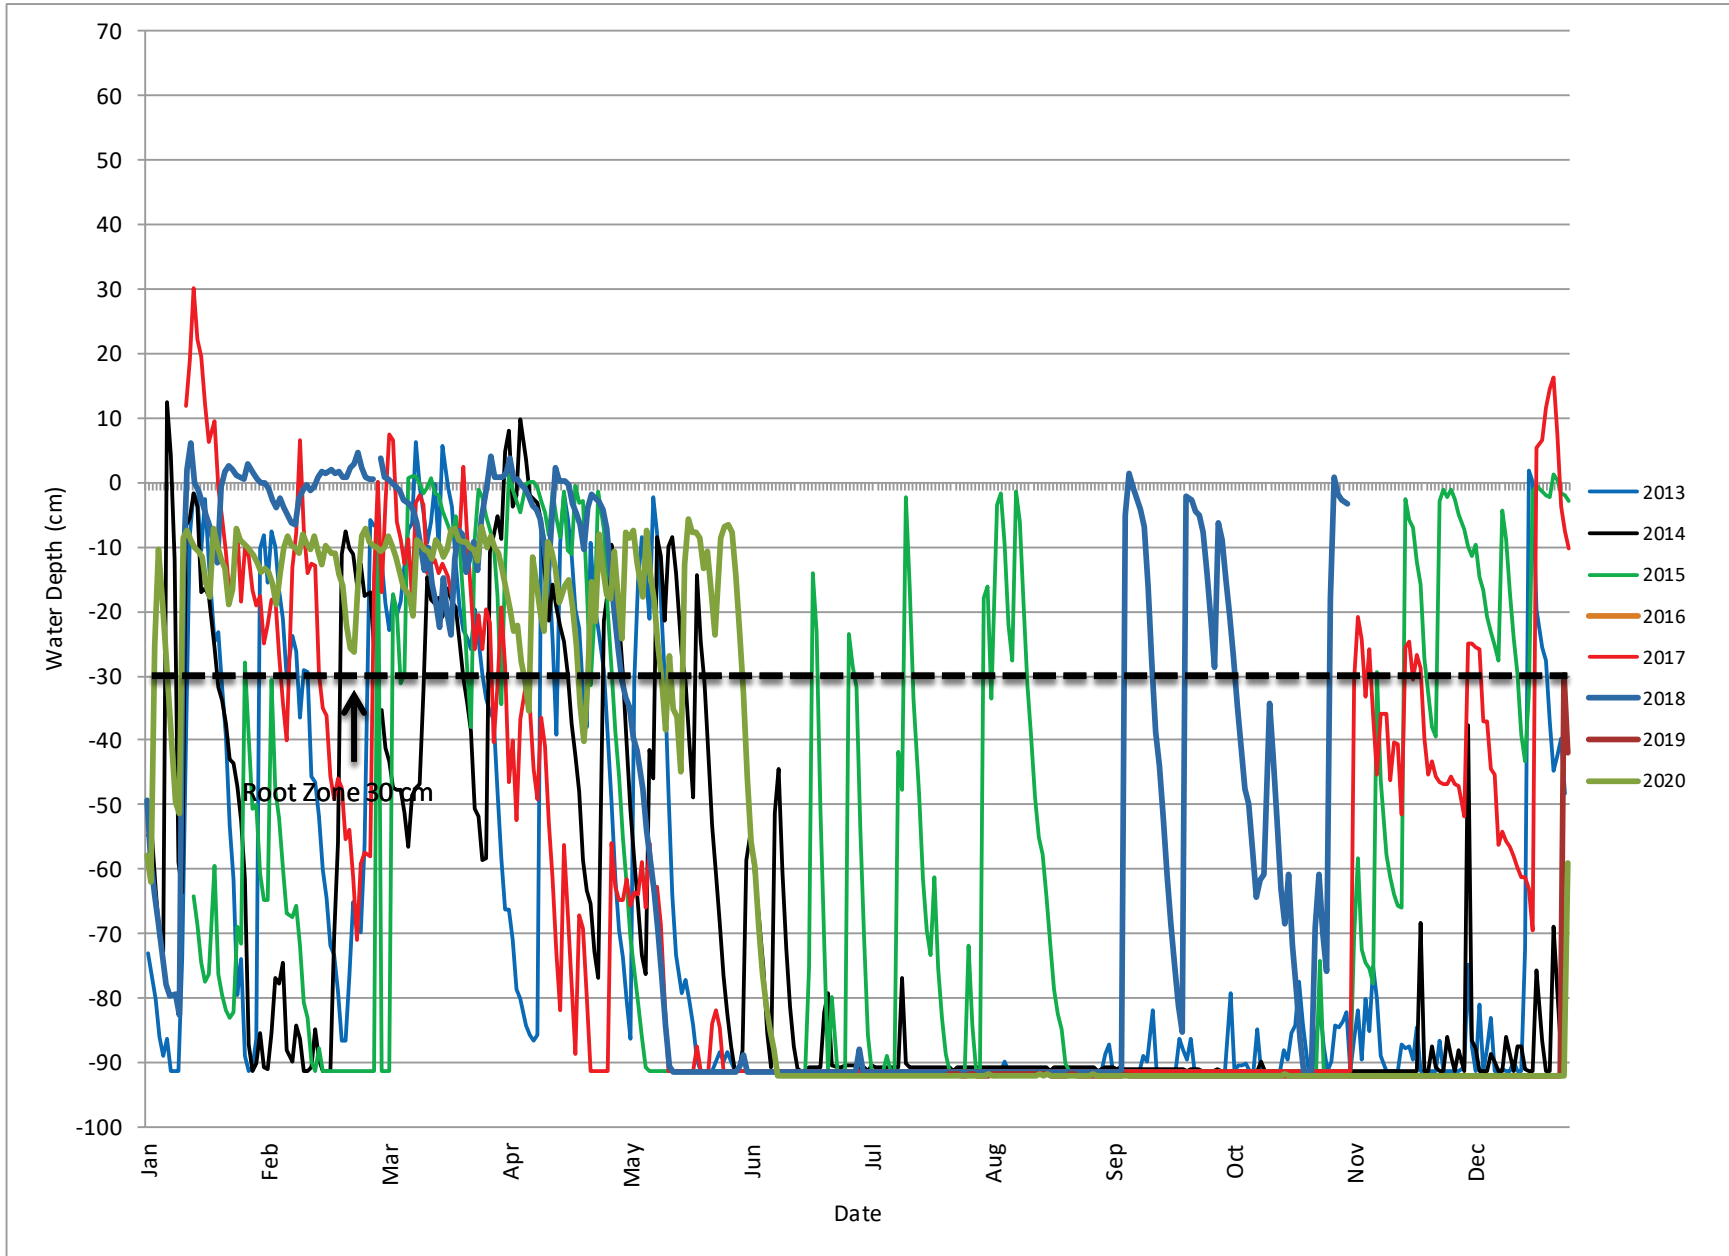
Figure C-2A. Wetland Area PRTW1 Hydrograph

Ambystomatid salamanders appear to be established in the Paddys Run West Natural Resource Trustee Project wetlands (Table C-9). In 2020, 12 ambystomatid salamanders were observed in basin PRTW1 indicating continued breeding activity in these relatively young wetlands.

Results were mixed in 2020, but still have not met performance standards (Table C-11). The two piezometers that recorded complete datasets throughout the year showed a pattern similar to that of previous years, with saturated conditions observed through the winter and spring, followed by drier conditions in the summer and fall. These findings are also similar to those at other emergent wetlands in Ohio. The influence of surface water is evident, as spikes in water elevations are usually observed (Mack et al. 2004) following precipitation events in summer months. Due to a transducer failure in area PRTW2 only data for December 2020 was collected, resulting in a very limited dataset for this basin (Figure C-2B). Hydrologic monitoring will continue in this area.
