# **Operating Experience Level 3**

OE-3: 2021-03 June 2021

### Lawn Mowing Safety Amid Peak Mowing Season

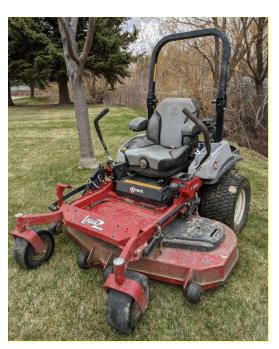
The most recent event occurred at the Idaho National Laboratory on the Research and Education Campus. On April 26, 2021, a service subcontractor was mowing a section of lawn between a building driveway and a small creek that runs adjacent to the building. As they were driving north near the creek bank, they encountered a change in terrain which caused the mower's right drive wheel to lose traction. This

loss of traction caused the mower to quickly turn and begin sliding down the slope towards the creek. The mower slid off the bank into the creek, ending upside down in the water. Safety systems built into the mower shut down the engine as the mower tipped over into the creek. The mower was equipped with a roll-over protective structure (ROPS). After unbuckling their seatbelt, the operator crawled out from under the mower and climbed out of the creek. Fortunately, there were no injuries that occurred from this event. (NE-ID--BEA-REC-2021-0001, Near Miss to Injury When Lawn Mower Tips Over)

Photo 1. Zero Turning radius riding lawn mower at Idaho National Laboratory.

- Use and maintain all available safety equipment including seat belts and ROPS, where equipped by the manufacturer or required by consensus standards;
