Mexican Hat, Utah, Disposal Site

An UMTRCA Title I site

This fact sheet provides information about the **Mexican Hat disposal site**. This site is managed by the **U.S. Department of Energy Office of Legacy Management under Title I of the Uranium Mill Tailings Radiation Control Act of 1978**.

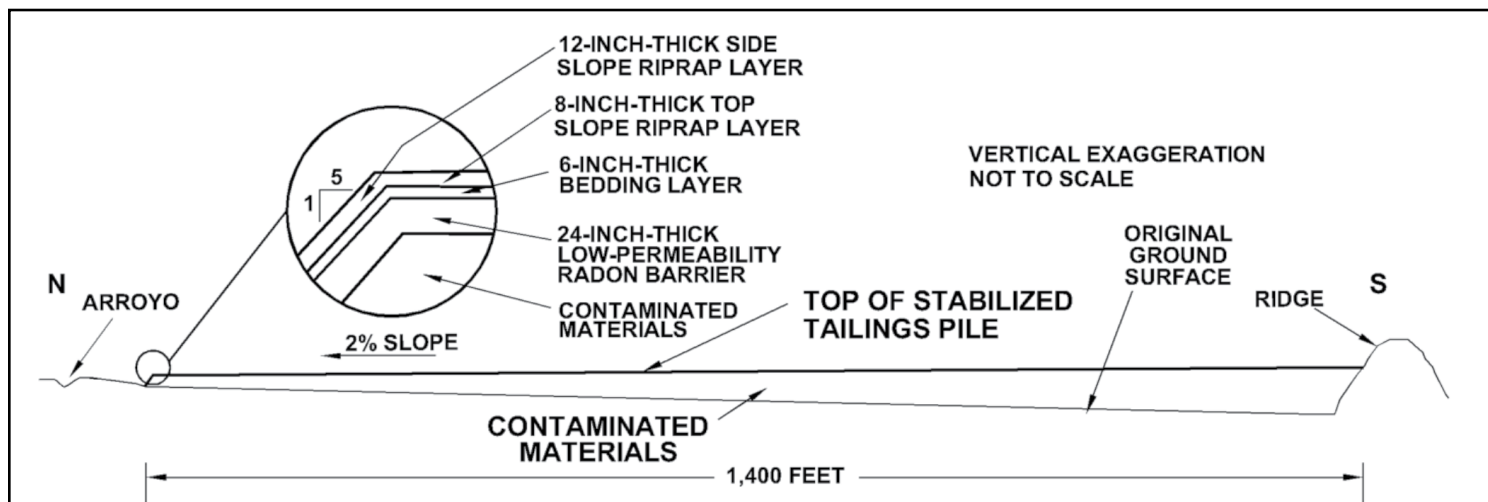
Typical North-South Cross Section of the Mexican Hat Disposal Cell.

The cover is composed of (1) a low-permeability radon barrier (first layer placed over compacted tailings), (2) a bedding layer of sand and gravel placed as a capillary break, and (3) a rock (riprap) erosion protection layer. The cell design promotes rapid runoff of precipitation to minimize leachate. The cell cover was constructed with a 2 percent grade sloping to the north and east. Runoff water flows down the 20 percent side slopes into the surrounding rock apron and exits the cell via three engineered toe drains that drain into existing arroyos north and east of the cell.

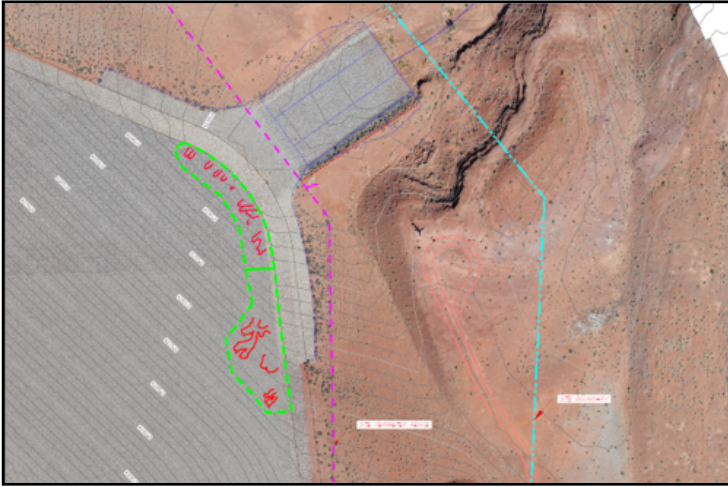
Aerial photograph depicting depression features on the northeast side slope.

In 2016, multiple subtle depressions were identified in the rock cover along the toe and lower portions of the northeast side slope of the disposal cell. As a result of limited field investigations in 2017 and 2018, erosion into the surface of radon barrier was identified along the lower portions of the north and northeast side slopes of the disposal cell. These observations indicate the disposal cell erosion protection system is not performing as designed. Field observations and supporting radiological scans of the depression features show radioactive materials have neither been released nor exposed, and the disposal cell remains protective of human health and the environment.

In 2019 an in-depth field investigation was performed to collect information needed to identify the causes of the depression features and associated radon barrier erosion,

and to determine the appropriate corrective measures needed to ensure that the design life of the disposal cell meets the requirements under UMTRCA. A comprehensive interim cover protection project was also performed in 2019, which restored a 20,000 square foot area on the northeast side slope back to the original design specifications to ensure protection of human health and the environment until a final long-term solution is implemented.
