# 2021 Monitoring Report, Dolores River Restoration on Lease Tract C-SR-13

March 2022

Legacy  
Management

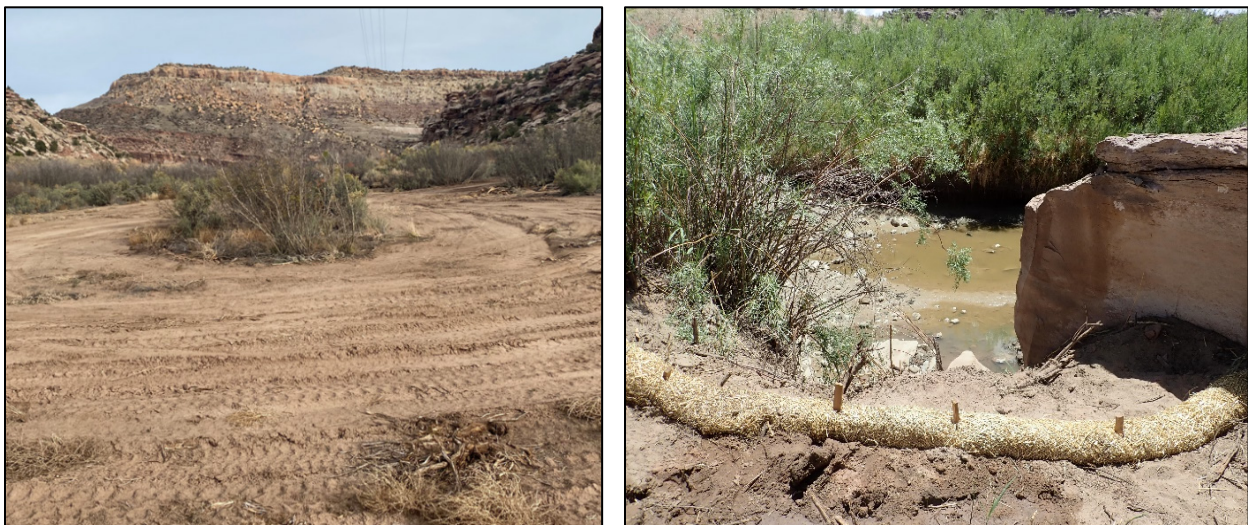
Two areas of disturbance were identified within the riparian zone of the Dolores River (Figure 1, Photos 1 and 2). These areas will be monitored and treated as part of LM's efforts supporting DRRP.

*Photos 1 and 2. Disturbed Areas Within the Dolores River Riparian Zone*

- Evaluate installation of wire mesh exclosures around the base of trees to discourage damage from beaver activity.
- Establish new monitoring locations within the two disturbed areas to document revegetation success.

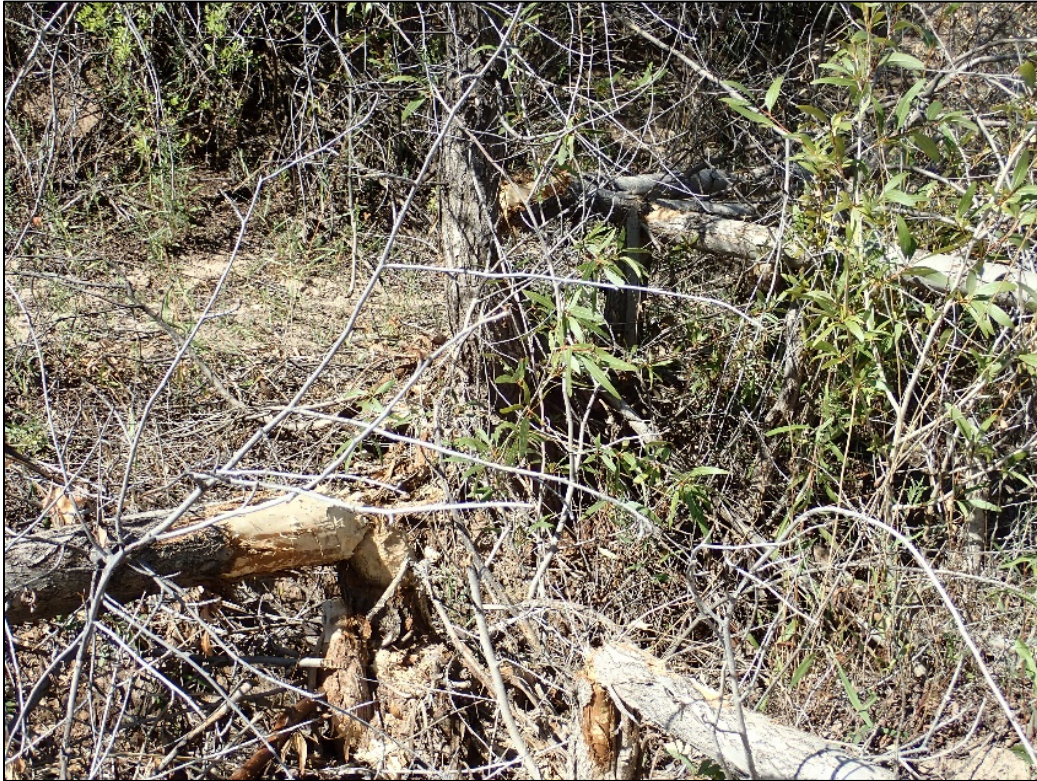
Ecologists observed evidence of beaver activity including several downed trees, which can impact progression of restoration goals (Photo 3).

*Photo 3. Downed Cottonwood Trees from Beaver Activity*

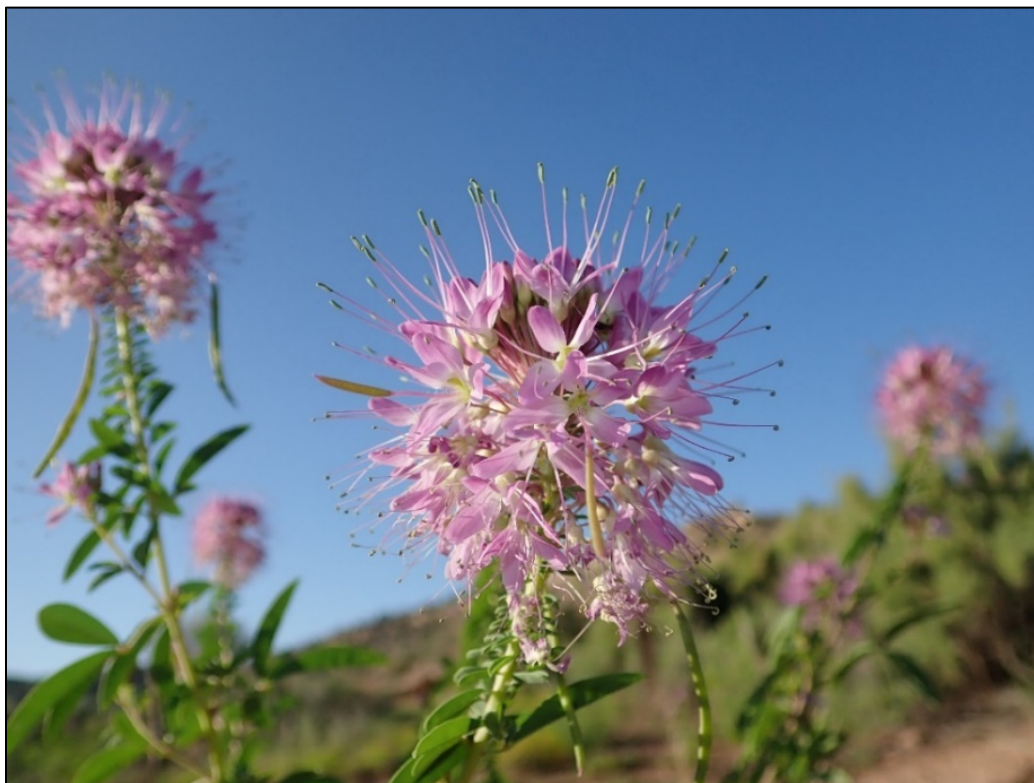
Ecologists continually identify new species within the riparian corridor of the lease tract. Some species have populated through seeding efforts (e.g., Rocky Mountain beeplant, Photo 4). Additionally, ecologists have begun to document more observed species within the monitoring regions to better understand the entire floral community. In 2021, the mean species richness at the 16 monitoring points was 21. Since monitoring began in 2012, ecologists have identified and documented 151 different plant species within the lease tract.

*Photo 4. Seeded Species, Rocky Mountain Beeplant (Cleome serrulata), at Monitoring Point 14*

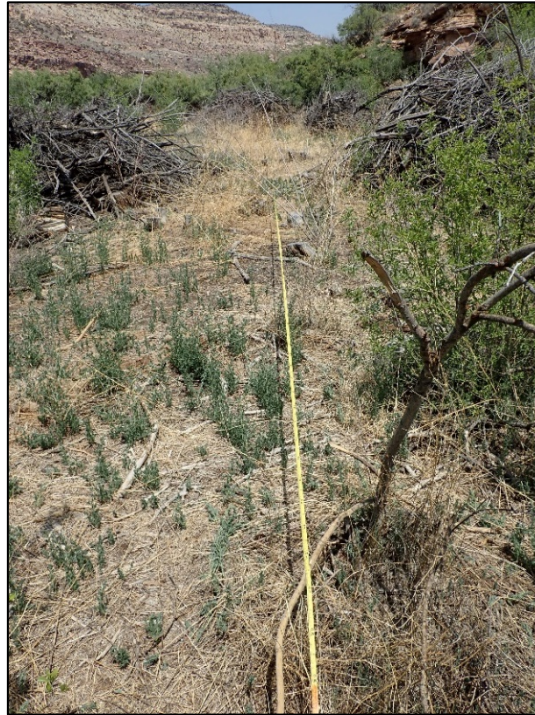
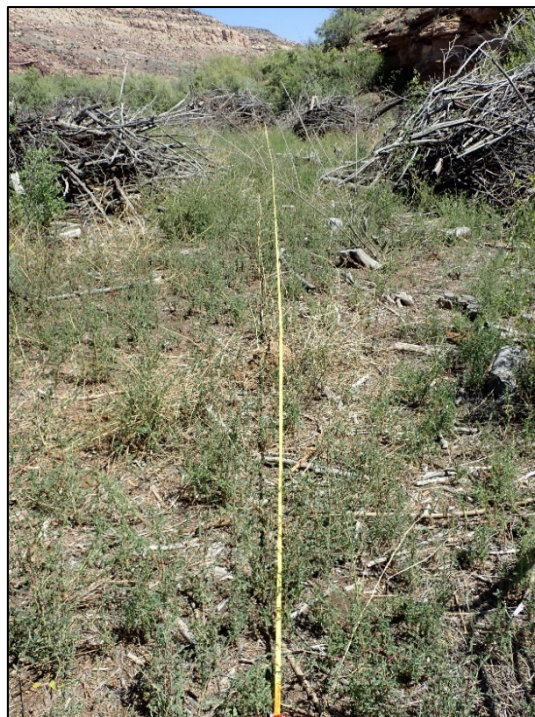
## Monitoring Point 31A, View to the Southeast

*Photo 5a. 2020—Saltcedar Debris Piles and Minimal Foliar Cover  
(4% Total Foliar Cover Comprised Entirely of Burningbush, an Invasive Weed)*

*Photo 5b. 2021—Increase of Foliar Cover  
(42% Total Foliar Cover Comprised Almost Entirely of Burningbush)*

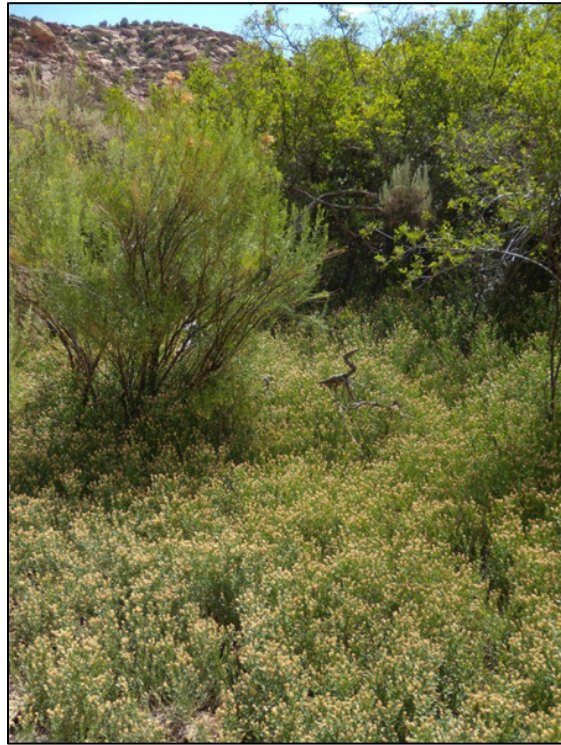
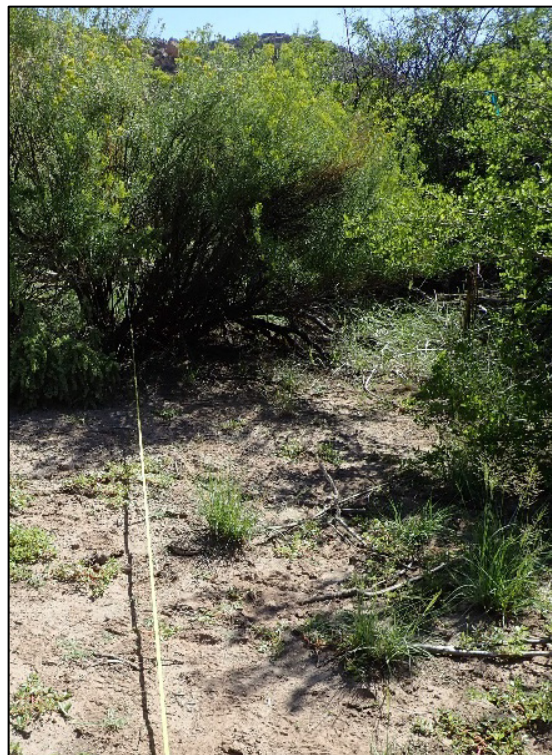
**Monitoring Point 3A, View to the East**

*Photo 6a. 2012—Understory Dominated by Hardheads*

*Photo 6b. 2021—Hardheads Have Been Nearly Eliminated*

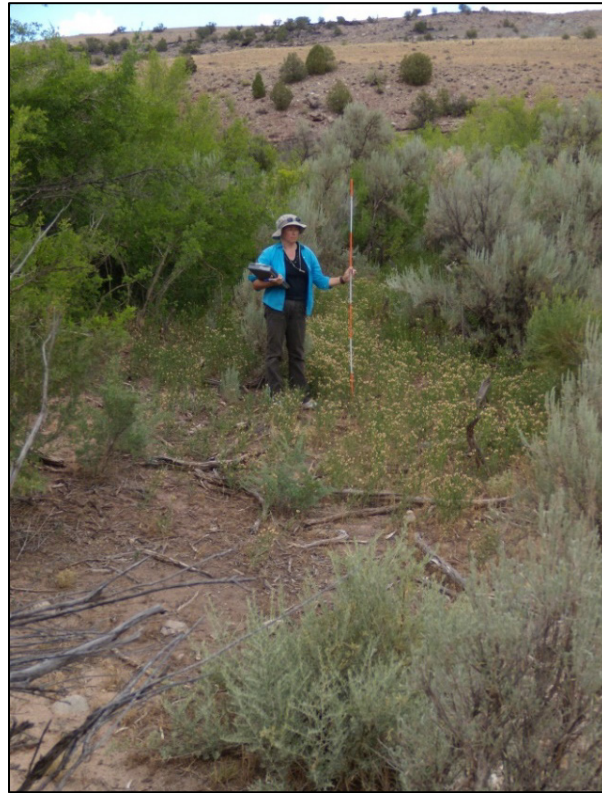
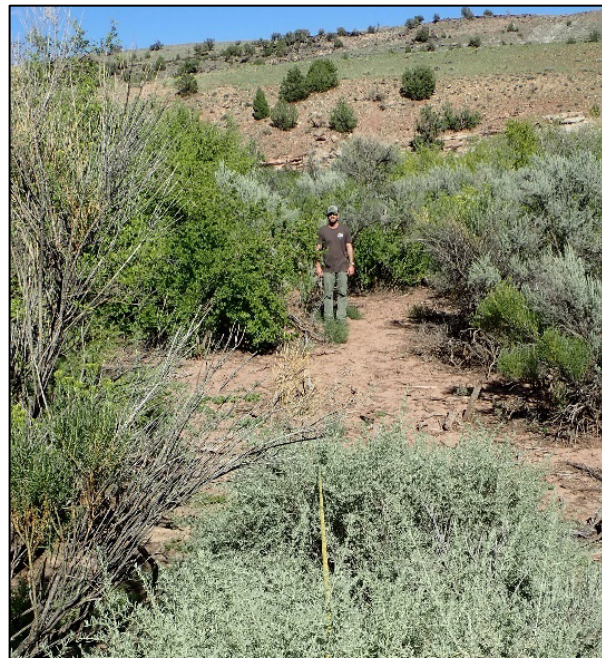
**Photo Point 6A, View to the North-Northeast**

*Photo 7a. 2012—Understory of Hardheads Surrounding Observer*

*Photo 7b. 2021—Reduction of Hardheads;  
Native Fourwing Saltbush in Foreground*

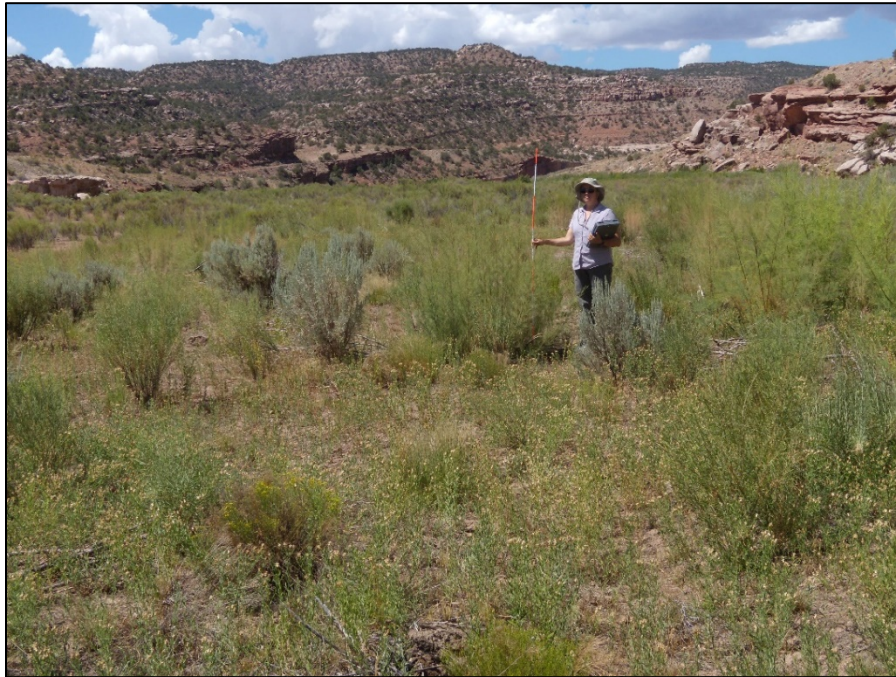
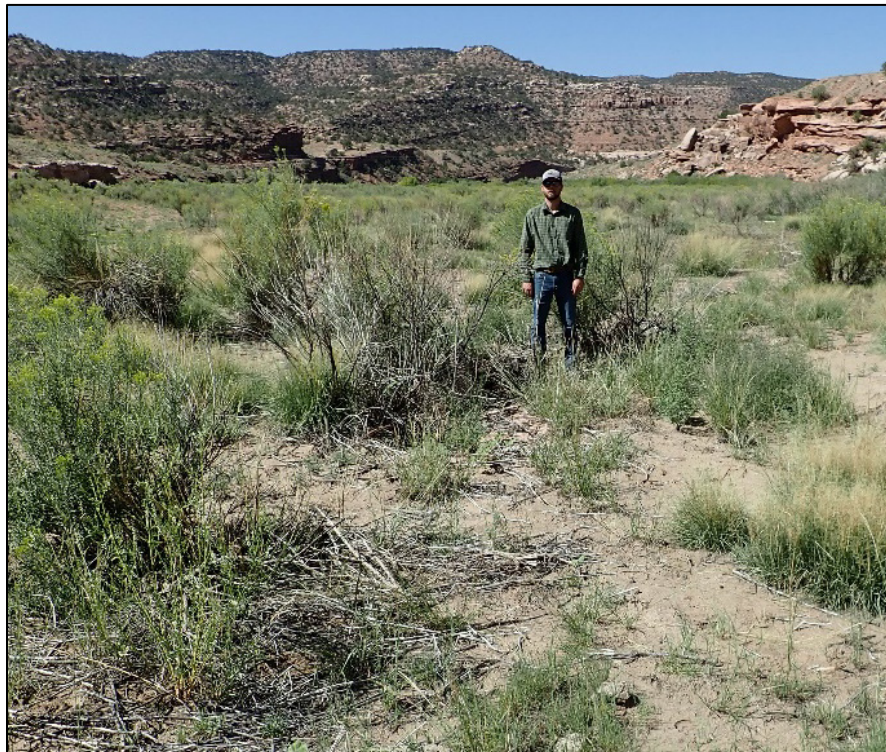
**Photo Point 26, View to the West**

*Photo 8a. 2012—Understory Dominated by Hardheads  
(Appears as Small White Flowers in Foreground)*

*Photo 8b. 2021—Reduction of Hardheads;  
Understory is Now Dominated by Native Saltgrass and Alkali Sacton*

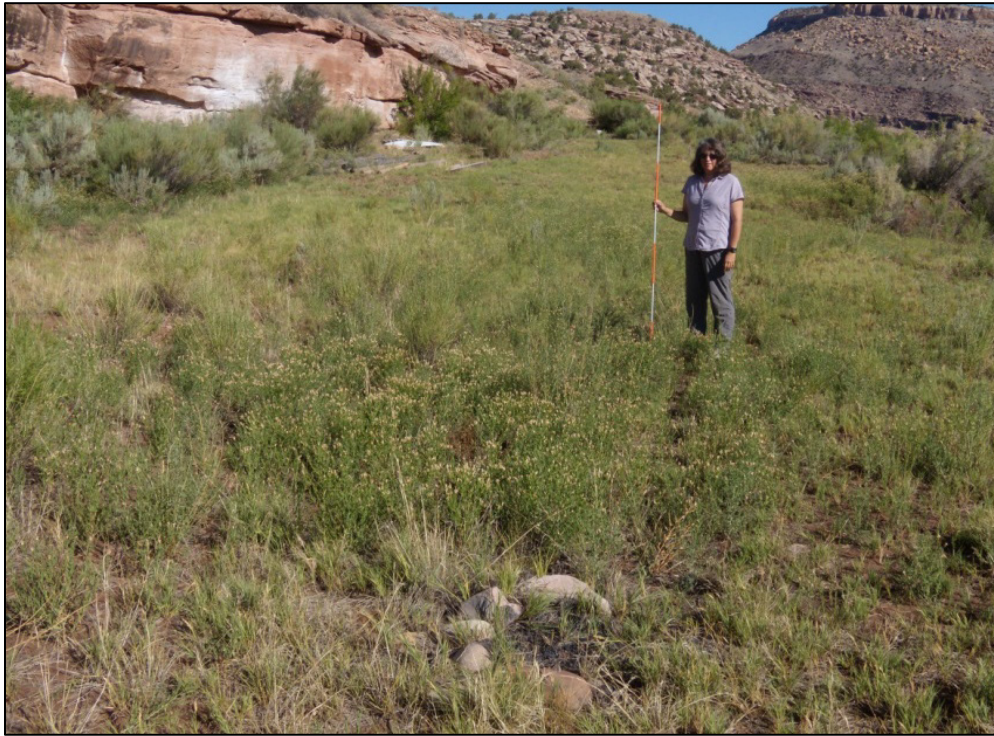
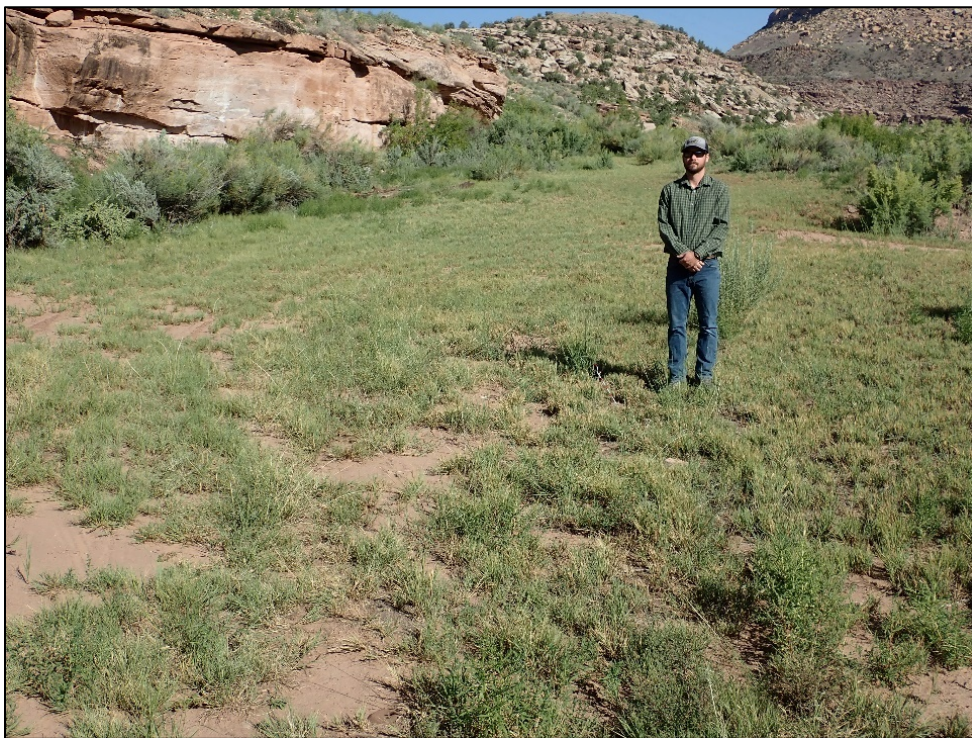
**Photo Point 14N, View to the North**

*Photo 9a. 2012—Flowering Plants in Foreground Are Hardheads*

*Photo 9b. 2021—A Few Hardheads are Present, But Native Inland Saltgrass Is the Dominant Ground Cover; Visible Decrease in Foliar Cover and Closely Grazed Vegetation*

- Ecologists have observed an increase in evidence of heavy livestock grazing on the lease tract since 2020. Although properly managed grazing can be compatible with LM restoration goals, overgrazing can cause setbacks. Additionally, ecologists believe that the continuing drought in the Slick Rock area may be adversely affecting plant cover. If heavy grazing appears to continue in 2022, it is recommended that ecologists meet with DRRP representatives, BLM, and local landowners to discuss this issue.

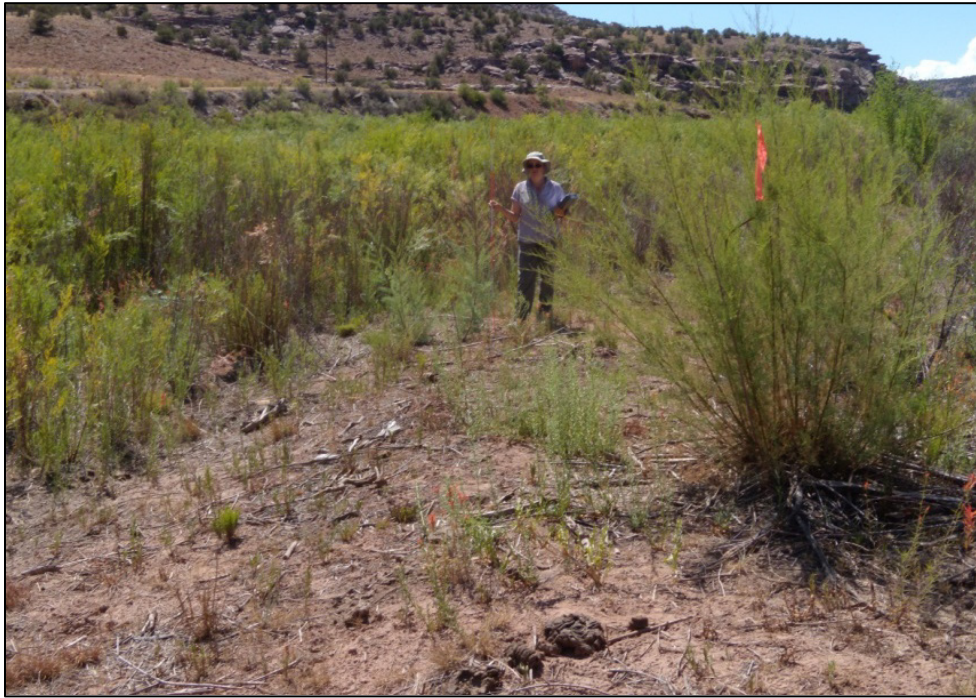
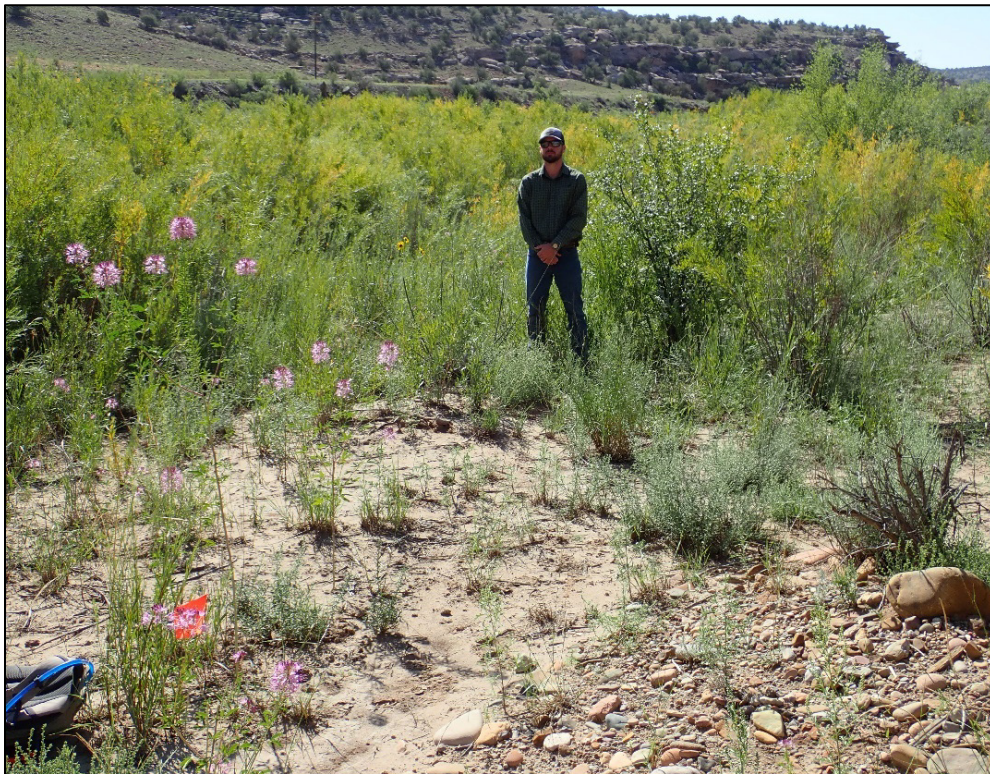
**Photo Point 25P, View to the South**

*Photo 10a. 2012—Saltcedar (Shrub with Orange Flagging), Not Yet Treated*

*Photo 10b. 2021—Same Saltcedar After Treatment (Now Woody Debris on the Ground) and Recruitment of Several Native Species*
