## 7.5.4 HOISTING BAY

### 7.6 Building G2 348-Foot Level

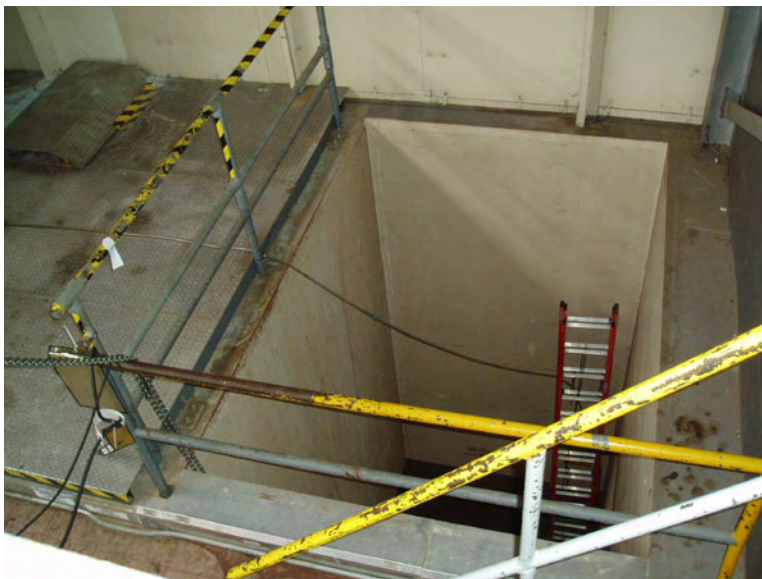
**Figure 7-37. Photo G2-164, G2 Overlooking Hoisting Bay from 357-Foot Level, November 2004**

The Hoisting Bay is shown in Figure 7-37.

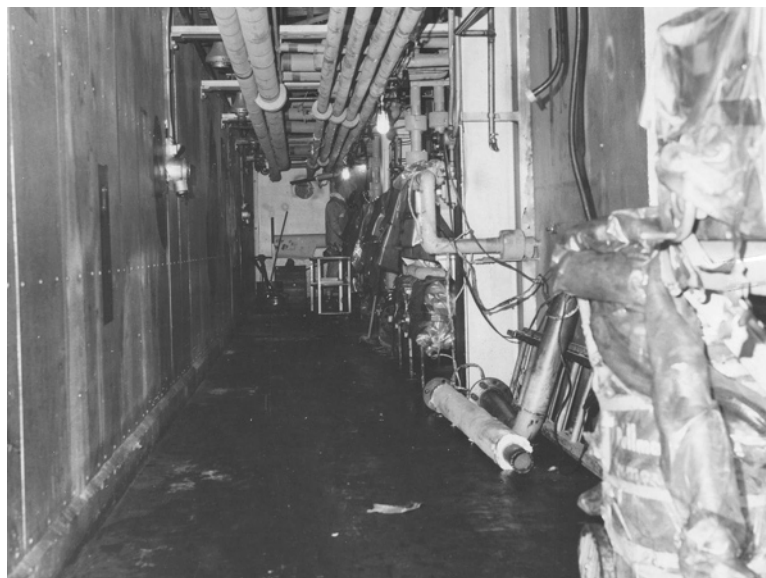
**Figure 7-39. Photo G2-59, Lower Sample Aisle – Looking South (KS-60544), Post-SPRU Decommissioning, undated**

Lower Sample Aisle contents include deactivated valves, piping, and components for hot and cold water, process cooling water, vacuum, breathing air, nitrogen, oxygen, carbon dioxide (for fire protection), compressed air, de-ionized water, concentrated nitric acid, and concentrated sodium hydroxide. Electrical service wiring and switches were isolated (fuses pulled, breakers opened, and wires disconnected) in April 1984 (C-000164, p. 8) (Figure 7-39).

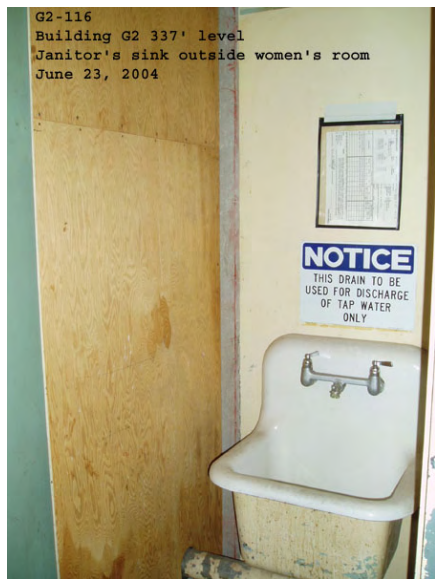
Figure 7-41. Photo G2-116, G2 337-Foot Level, Janitor's Closet, November 2004

On April 28, 1984, a radiological technician performing a survey supporting radiological work in a nearby area, observed a suspicious substance (oily dust) and decided to survey the Janitor’s Closet door. A direct probe measured 2,250 picoCuries (with a portable beta-gamma frisker) and no detectable alpha (with a portable alpha frisker). The area was secured, a controlled surface contamination area established, and the door removed and disposed as radiological waste. Additional surveys indicated that the top of the door was contaminated (1,125 picoCuries per 100 square centimeters swipe) and closet ceiling was contaminated (450-1,350 picoCuries per direct probe fixed) with beta-gamma activity. Swipes sent to radiochemistry for isotope identification indicated predominantly Cs-137 (R-001126, G2 Janitor’s Closet Northwest Corner).

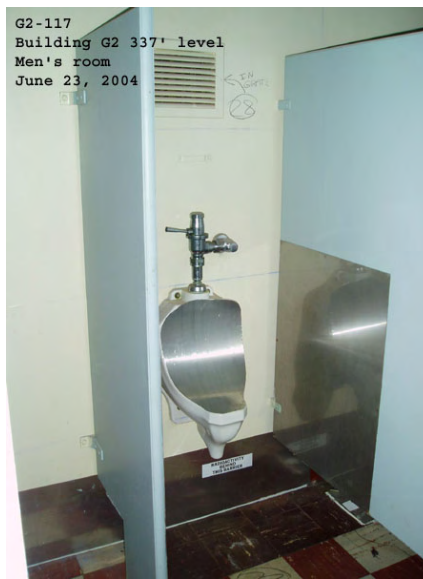
Figure 7-42. Photo G2-117, G2 337-Foot Level, Men's Room, November 2004

Current Change and Wash Room configurations are shown in Figures 7-41, 7-42, 7-43, and 7-44.

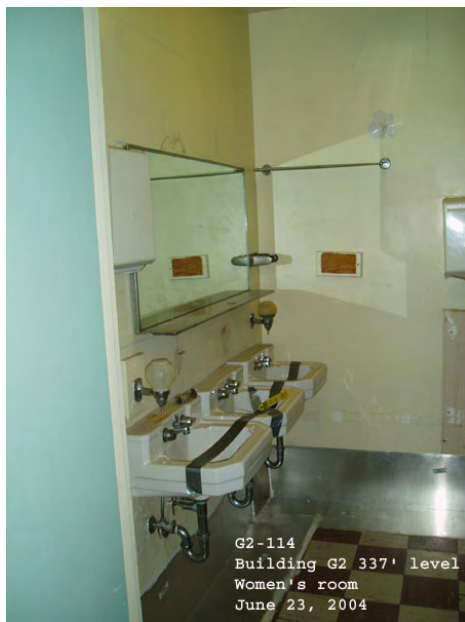
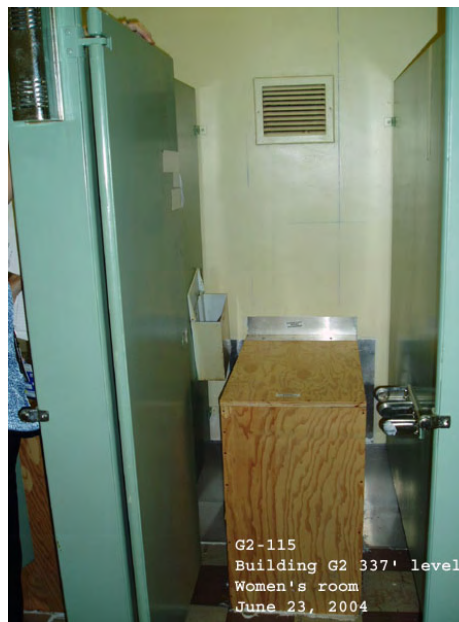
Figure 7-43. Photo G2-114, G2 337-Foot Level, Women's Room, View 1, November 2004

Figure 7-44. Photo G2-115, G2 337-Foot Level, Women's Room, View 2, November 2004

In 1964 or 1965, a Building G2 radioactive drain backed up and radioactive liquid overflowed in the women’s room (the former Contaminated Change Room). The facility record shows that radioactivity behind partitions, above ceilings, in pipe chases, and in other areas is presumed because of improper decontamination following this incident (R-001126).

On July 5, 1983, a radiological control technician performed a survey of the women’s room fluorescent light fixture before ballast replacement. Ballast exterior results were less than 450 picoCuries beta-gamma per direct probe and less than 100 counts per minute per large area swipe, with no detectable alpha. A direct probe survey after removing the ballast cover yielded no indication of radioactivity; however, a large area swipe measured 500 counts per minute above background (2,250 picoCuries/ large area swipe) beta-gamma, and no detectable alpha. The area was isolated and additional internal ballast cover surface swipes measured 560 picoCuries per 100 square centimeters beta-gamma with no detectable alpha. Gamma multi-channel analysis determined the radioactivity to be Cs-137. On July 7, 1983, the other women’s room light fixture was disassembled and determined to be in approximately the same condition. Additional surveys identified 4,500 picoCuries per direct probe beta-gamma (1,000 counts per minute) and 450 picoCuries per beta-gamma (measured by tape press) at the floor and wall juncture of a removed baseboard. Lavatory sink drain wall penetrations measured 1,800 picoCuries per 100 square centimeters (R-001126).

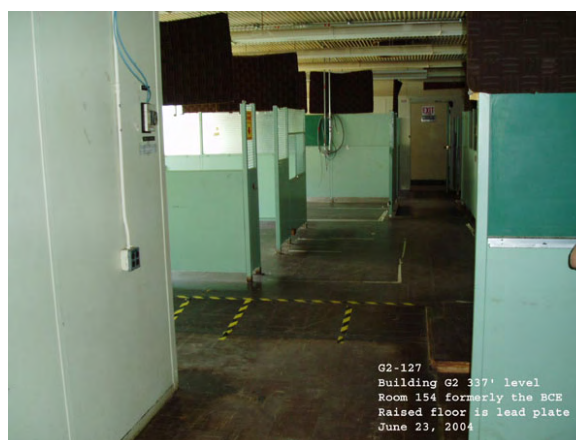
**Figure 7-48. Photo G2-127, G2 337-Foot Level, Room 154 formerly the BCE, June 2004**

Figure 7-48 shows the raised lead floor area in the former BCE area. The lead has been covered over with tile. Figure 7-49 shows the room north of the former BCE area. This room's recent modifications (in 2004) include a floor plan that can be seen in Figure 7-49.

The 1958 decontamination work failed to eliminate all of the contaminated spots in the Room 154 concrete floor. The fixed contamination in the concrete was reported to be 0.2 milliCuries of mixed fission products. Rooms 151 and 152 and the BCE equipment were dismantled and decontaminated during the second half of 1958 and early 1959. The effort involved removing walls, partitioning, equipment, piping, and additional measures (C-000082, p. 1; C-000084, p. 1; C-000085, p. 1; C-000086, p. 1; C-000087, p. 1; C-000088, p. 1), including:

On July 1, 1977, a radiological controls technician reported that paint on a known contamination area on the east wall of Rooms 154 and then named Room 156 (in the southeast corner of the 337-foot level) was blistering and peeling. The paint chips indicated less than 450 picoCuries of loose surface radioactive contamination; however, peeled areas indicated 2,000 counts per minute of fixed beta-gamma radioactivity greater than background levels. A detailed area survey identified approximately 1 teaspoon of rubble in a not readily accessible 2-inch space between a beam and the building wall. The material measured 2,700 picoCuries, determined to be a combination of cesium-137 and strontium-yttrium-90. The material was cleaned up and the area painted with latex paint (R-001126, pp. G2-154/156).

On May 10, 1984, a direct probe (alpha, beta) survey meter indicated 6,750 picoCuries (1,500 counts per minute above background) near the bottom of three metal U-shaped window frames in Room 154. No alpha contamination was detected. The contamination was determined to be loose. Repeated washing of the area showed consistent levels of about 1,800 picoCuries (400 counts per minute) loose activity, while the direct probe reading of the same area showed no decrease from the initial indications (R-001126, pp. G2-154/156).

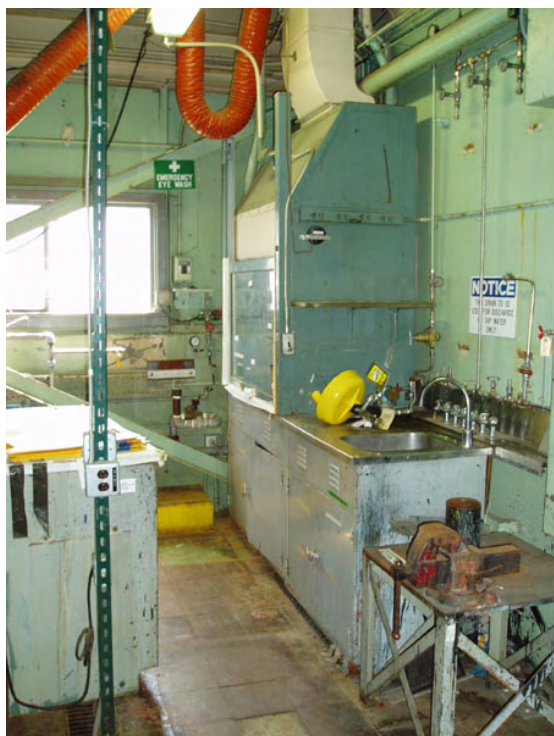
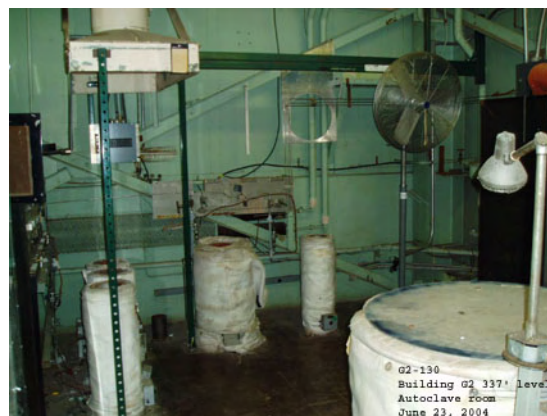
Room 174 operations ended in January 1999, followed by an inspection in March 1999. Control panels, a resin loop cabinet, two sinks, one hood, one bench vise, and an old 300-liter autoclave heater located in the pit remained in the room. Chemical hazards were identified in the pickling sink area and possible asbestos and radiological hazards were identified with the sinks, hood, bench vise, and the 300-liter autoclave heater and heater jacket located in the pit. The pit was identified as requiring Confined Space Entry (C-001950, Appendix A) (Figures 7-52 and 7-53).

**Figure 7-52. Photo G2-148, G2 337-Foot Level, Room 174 (Southeast Corner), November 2004**

**Figure 7-53. Photo G2-130, G2 337-Foot Level, Room 174 (Northeast Corner), November 2004**

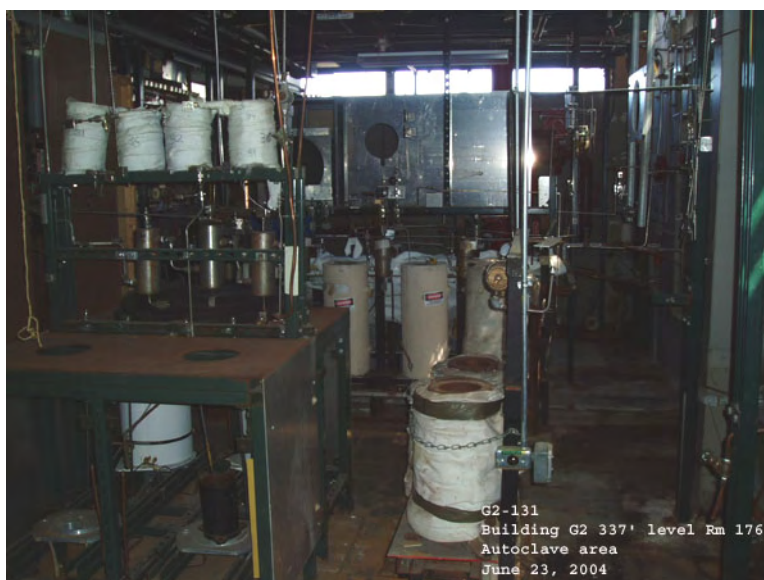
**Figure 7-55. Photo G2-131, G2 337-Foot Level, Room 176 Lower Deck, November 2004**

Contamination was found on a door handle and multiple internal surfaces of the sink cabinet in the southeast corner of Room 176 during an annual radiological survey, on January 23, 1986. The contaminated areas counted between 100 and 300 counts per minute (450-1,350 picoCuries) beta-gamma and 20 to 30 counts per minute (50-75 picoCuries) alpha. One area inside of the left hand cabinet door measured approximately 200 counts per minute (500 picoCuries) alpha and 200 counts per minute (500 picoCuries) beta-gamma by direct probe. The survey was terminated because loose contamination exceeded KAPL release limits and the sink cabinet was sealed and stabilized with yellow plastic sheeting (facilon) and white cloth tape. A swipe was transferred to radiochemistry for isotopic analysis (R-001126, p. G2-176).

No property was left on the upper deck, but control panels, a sink, and all autoclave stands with heaters remained on the Room 176 lower deck following turnover of the laboratories in 1999. Chemical hazards were identified around the caustic autoclave; possible asbestos hazards were identified at the autoclave heaters, cooling water pipes, autoclave stands, and control panels; and possible radiological hazards were identified at the control panels and autoclave stands with heaters.

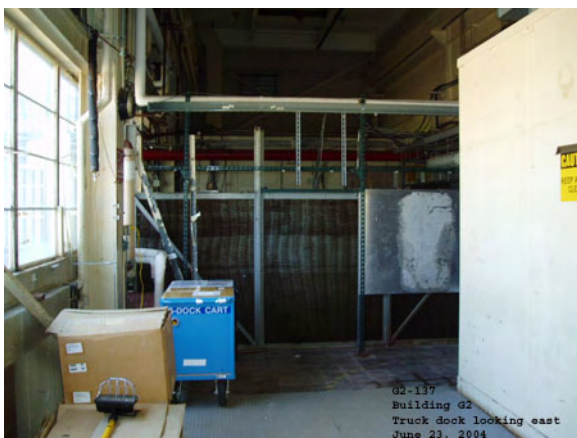
**Figure 7-57. Photo G2-137, G2 337-Foot Level, Truck Dock, November 2004**

The Truck Dock area (Figure 7-56) used an electrically operated 5-ton crane for loading and unloading trucks (R-001932, p. 3). A motor-generator control system for centrifuge operation also was located in the truck dock area (see Figure 7-57) (R-000059, p. 8).

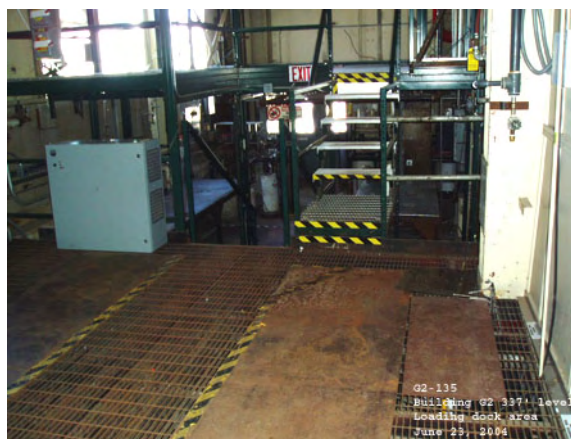
**Figure 7-58. Photo G2-135, G2 337-Foot Level, Room 178 Upper and Lower Decks, November 2004**

In January 1999, activities in Room 178 and 180 ended. An inspection was performed in March 1999. Room 178, lower deck, was identified as part of the autoclave test area for the Experimental Engineering Laboratories (Figure 7-58) (see Drawing No. G2-E-3820, Autoclave Facility Area Equipment Plan, October 30, 1964.)

Control panels, autoclave stands and heaters, two workbenches, and one bench vise remained on the lower deck in 1999. An old floor fan with unknown history and ruptured disk assemblies remained on the upper deck. No chemical hazards were identified during the walkthrough. Possible asbestos and radiological hazards associated with the control panels, autoclave stands and heaters, and bench vise were identified (C-001950, Appendices D and E).

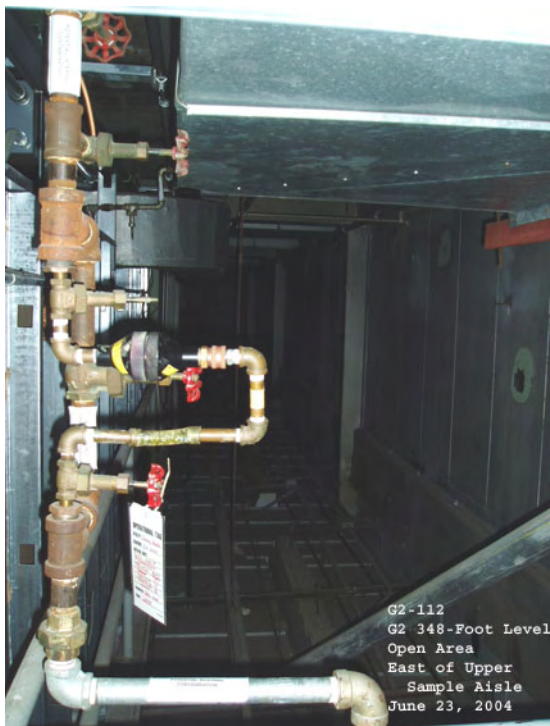
**Figure 7-61. Photo G2-112, G2 348-Foot Level Open Area East of Upper Sample Aisle, undated**

The open areas are areas that have no floor on this level. Figure 7-61 shows the narrow open area east of the Upper Sample Aisle and Figure 7-62 shows the suspended ceiling above the 337-foot level, as seen from the 348-foot level.

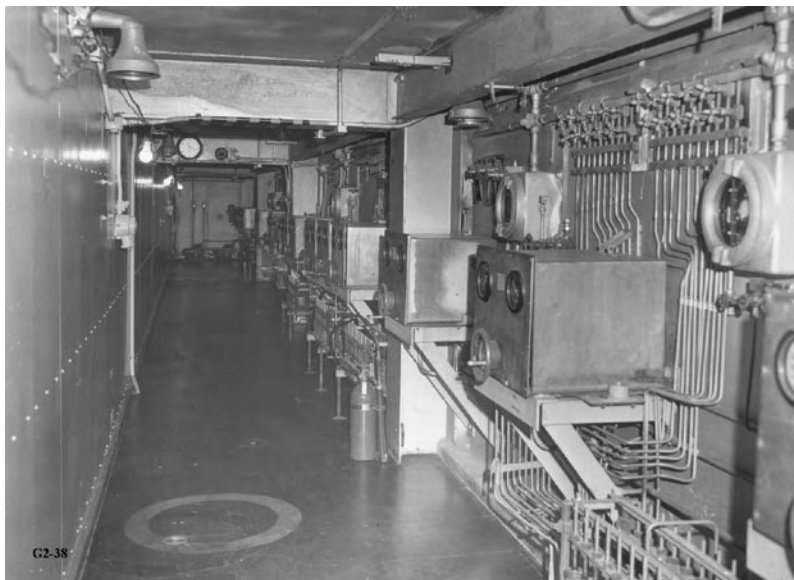
**Figure 7-65. Photo G2-38, G2 348-Foot Level, Upper Sample Aisle Looking South, undated**

The Upper Sample Aisle is shown in Figure 7-65 as it looked during SPRU research activities.

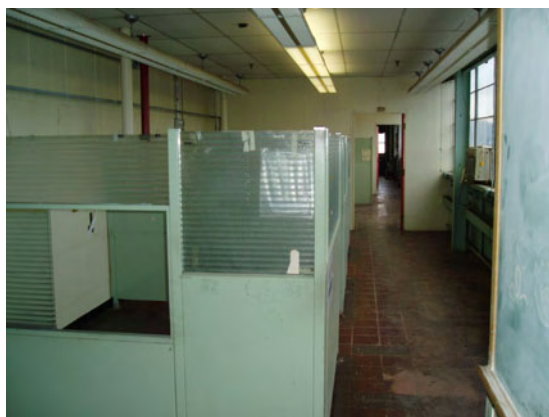
**Figure 7-71. Photo G2-152, G2 357-Foot Level, Room 199, November 2004**

The remainder of Room 199 (west of the Crane Gallery) is shown in Figures 7-71 and 7-72. Other former Crane Gallery areas, as of November 2004, are shown in Figures 7-73 through 7-76.

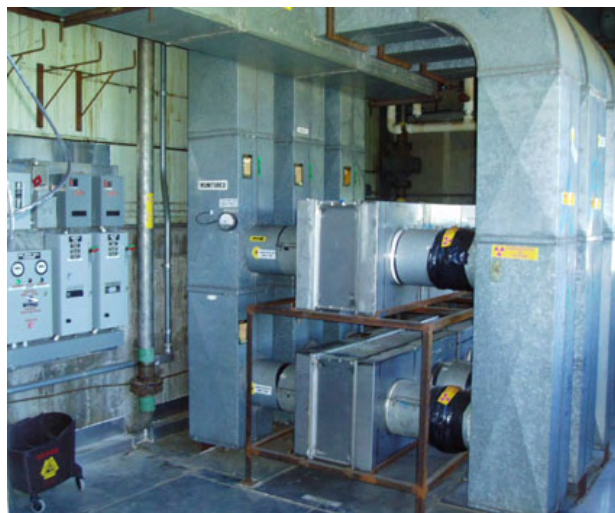
**Figure 7-78. Photo G2-105, G2 357-foot Level, Equipment Room, November 2004**

Equipment Room components in November 2004 are shown in Figure 7-78.

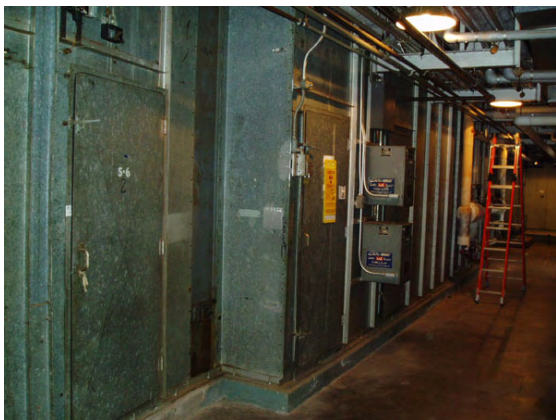
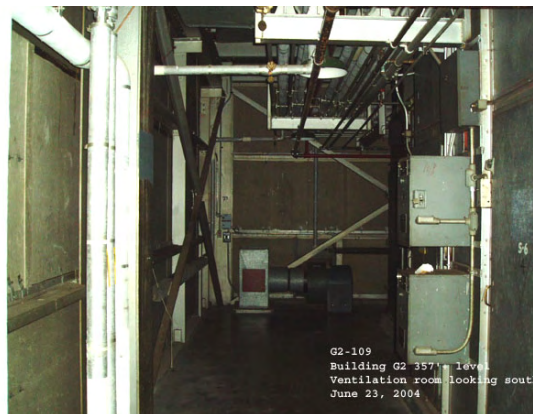
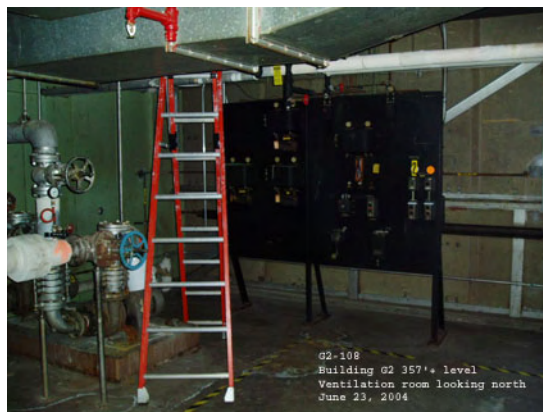
The Ventilation Room contains a large air handler unit located between column lines three and four and extending from the east Crane Gallery wall to the G2 east exterior wall (Figures 7-80 through 7-82). The air handler supplies heat and ventilation to office and library areas throughout the building.

**Figure 7-80. Photo G2-162, G2 357-Foot Level Ventilation Room, Looking West, November 2004**

**Figure 7-81. Photo G2-109, G2 357-Foot Level Ventilation Room, Looking East, November 2004**

**Figure 7-82. Photo G2-108, G2 357-Foot Level Ventilation Room, Looking North, November 2004**

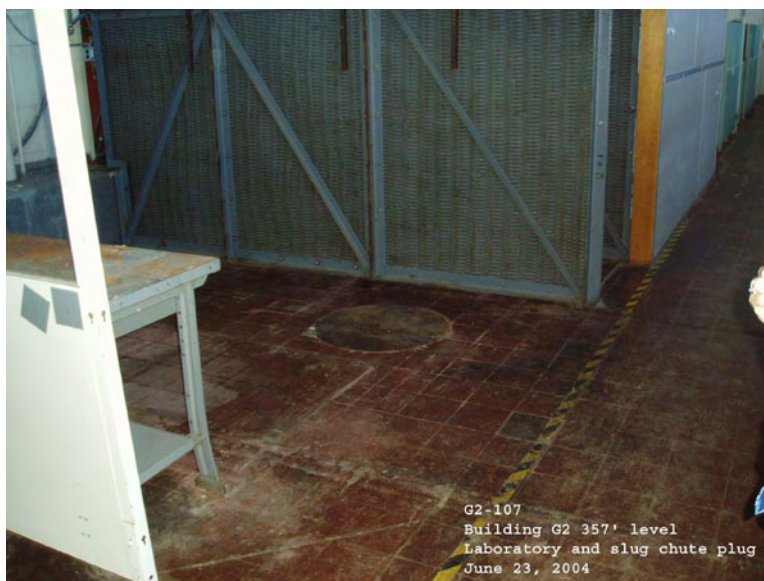
**Figure 7-85. Photo G2-107, G2 357-Foot Level Laboratory and Slug Chute Plug, June 2004**

Slug Chute access was sealed at the Crane Gallery floor but remains intact in Cell No. 2 (Figure 7-85).

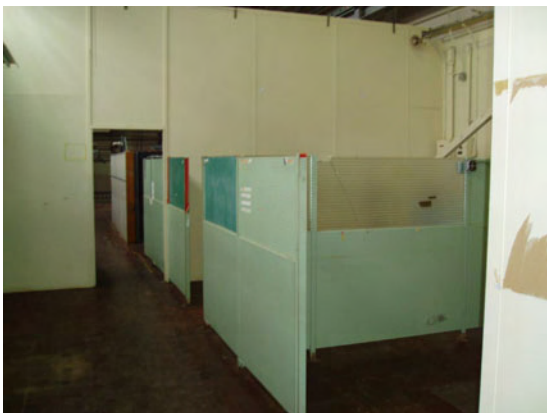
**Figure 7-87. Photo G2-159, G2 357-Foot Level, Office Space Center-West, November 2004**

On April 3-4, 1993, swipes were taken on an I-beam above the Room 310 ceiling. One indicated 8.9 picoCuries gross alpha activity. Alpha spectrometry analysis indicated 13.2 picoCuries plutonium-239/240 present, exceeding the limit of 9 picoCuries (R-001126, p. G2-310). Office space near Room 310 is shown in Figure 7-87. The corridor is shown in Figure 7-88.
