8 BUILDING H2, H1 COOLING TOWER, AND H2 PIPE TUNNEL CURRENT CONDITIONS

The H2 waste processing building, H1 Evaporative Cooling Tower and Pump House, and the H2 Pipe Tunnel were used for processing liquid radioactive waste from Building G2, but also waste from the Hot Incinerator (located on the north side of Building F1), Building F2 drain lines, scrubber water, K4 laundry and laundry lines, and some laboratory wastes (R-001949). Most of the original equipment and tanks remain in H2, and some portions are still used for processing liquid waste.

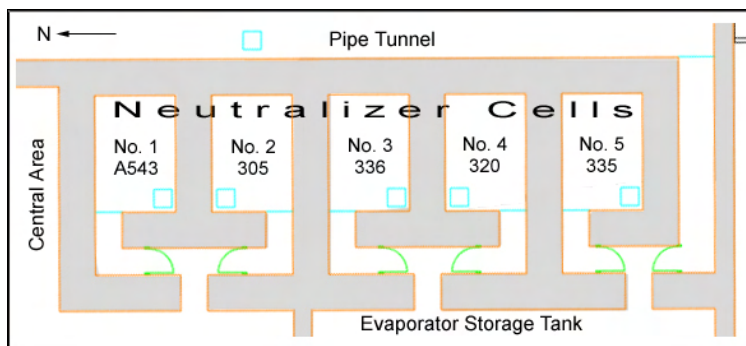
Figure 8-3. Building H2 Neutralizer Cells 309-Foot Level

Five waste stream neutralizer cells are arranged in a north-south row in the southeast corner of H2 (Figure 8.3). The concrete walled cells extend from the 309-foot level to the 332-foot level. They can be accessed through doors on the 309-foot level or concrete hatches at the 332-foot level. The cells are shielded by 4 feet of concrete (C-000142, Figure 14).

The neutralizer cells and equipment are currently intact. The stainless steel equipment consists primarily of jacketed neutralizer collection tanks, separator columns, condensers for distillate, and distillate receiver tanks. Originally, the neutralizer cells had separate dedicated pipes from sources in G2. However, the current state of piping is not known because the Pipe Tunnel is an inaccessible area.

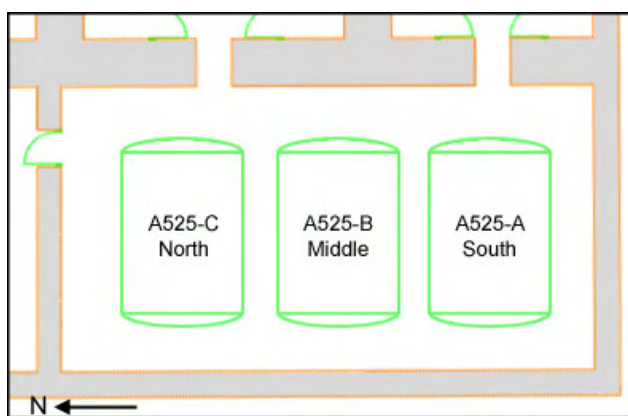
Figure 8-6. 10,000-Gallon Storage Tank Area, 309-Foot Level

The Evaporator Storage Tank Area (Figure 8-6.) consists of three 10,000-gallon storage tanks (Tanks A525-A South, A525-B Middle, and A525-C North) located in the southeast corner of the 309-foot level and extending to the 319-foot level. The tanks received liquid waste from Building G2 for processing in hot or cold evaporators and subsequent discharge (R-001949).

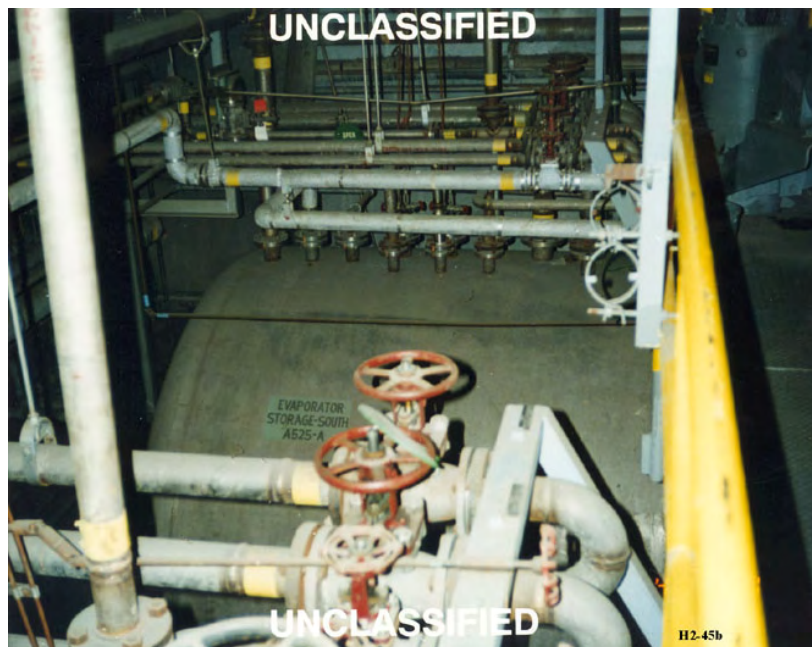
Figure 8-7. Photo H2-45b, Evaporator Storage Tank A525-A, undated

During visual inspection in 2004, non-SPRU-related drums containing KAPL waste were stored near the north tank (A525-C). A plywood box approximately 14- to 15-feet long containing refueling equipment was observed on the floor area next to the north and middle tanks (A525-B and A525-C).

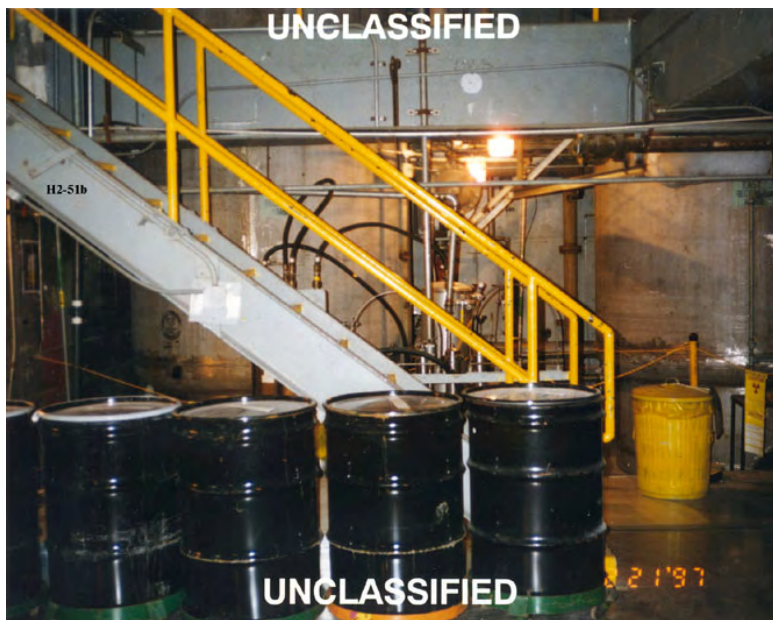
Figure 8-9. Photo H2-51b, East Evaporator Area 309-Foot Level, undated

The East Evaporator Cell, like the West Evaporator Cell, extends from the 309-foot level to the 332-foot level. Figure 8-9 is a photo showing the bottoms of the two 5,000 gallon receiver/reuse tanks in the cell. The 5,000-gallon tanks are used to store treated water from Tank Vault pump down events prior to discharge.

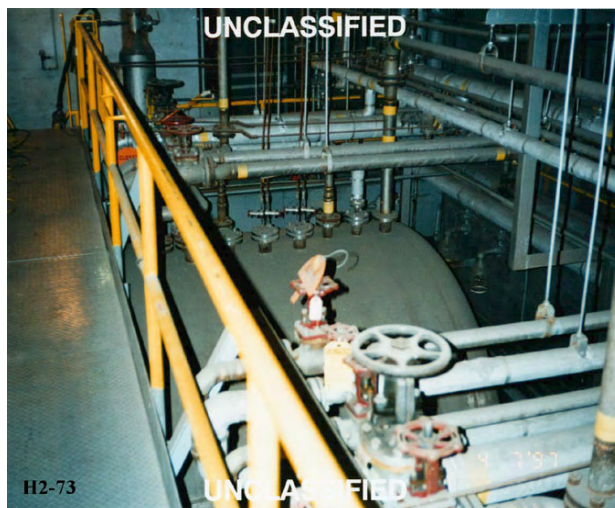
Figure 8-20. Photo H2-73, Evaporator Storage Tank Area, 319-Foot Level Looking South, 1997

Date/Area	Visual Impressions	Summary Findings	Reference
10/5/04 319' South Tank Bay	None	Contamination survey results: <450 pCi beta-gamma Radiation survey results of various readings around the tops of the tanks (moving from the north tank to the south tank): <0.2 mRem /hr, 0.4 mRem /hr, 1.2 mRem /hr, 1.4 mRem /hr, 1.5 mRem /hr, 3.5 mRem /hr, 6.0 mRem /hr, 12 mRem /hr, 13 mRem /hr, 14 mRem /hr, 28 mRem /hr, and 30 mRem /hr	R-000525

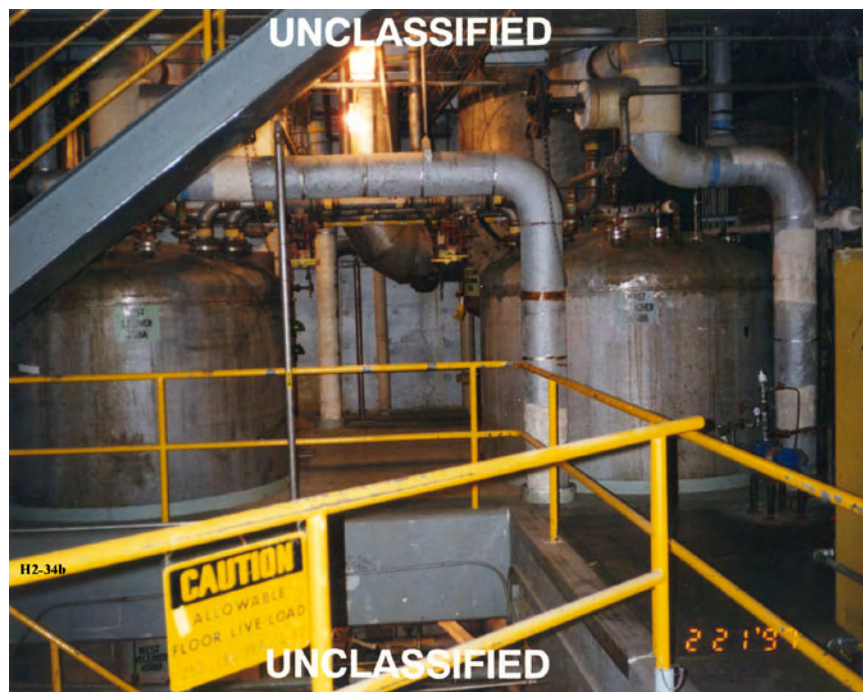
Figure 8-26. Photo H2-34b, 319-Foot Level East and West Receiver Tanks, undated

The East Evaporator Cell extends from the 309-foot level to the 332-foot level (Figure 8-25). Figure 8-26 shows the top of the two 5,000 gallon receiver/reuse tanks. The bottom of the evaporator that extends to the 332-foot level is behind the tanks.

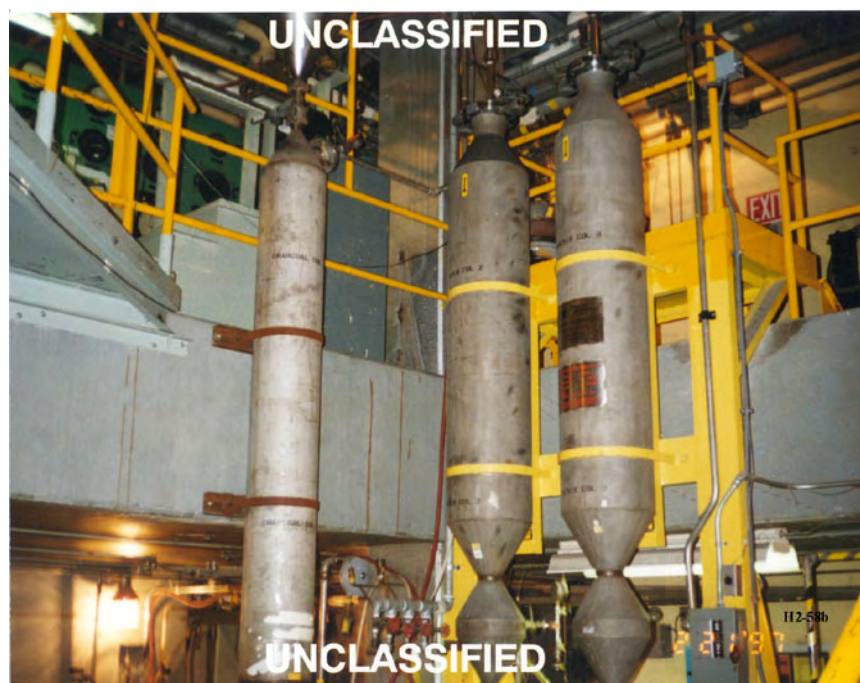
Figure 8-27. Photo H2-58b, Radioactive Materials Laboratory Reuse System Ion Exchange Tanks, 309- and 319-Foot Levels, undated

The two evaporators were used to reduce radioactive liquid waste volume prior to solidification for disposal. Currently, two 5,000-gallon stainless storage tanks formerly used for evaporator condensate storage on the 309- and 319-foot levels are also used for waste processing purposes. Ion exchange resin beds are periodically disposed as low-level solid waste (I-000418). Figure 8-27 is a photo of the ion exchange resin tanks extending from the 309- to the 319-foot level.

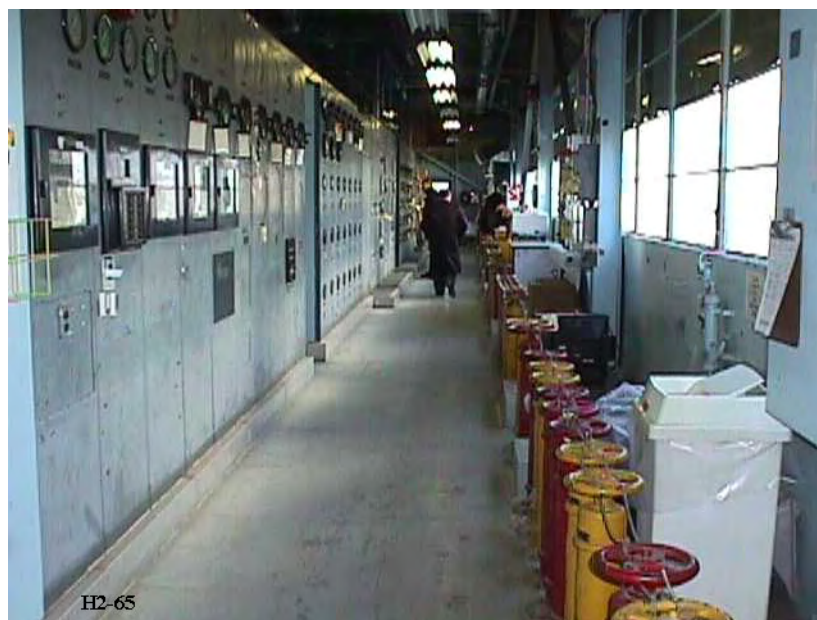
Figure 8-31. Photo H2-65, H2 Control Room and Entryway, 332-Foot Level, undated

Building H2 is entered from the southeast corner onto the 332-foot level, directly into a Control Room extending the entire north-south length of the building. The Control Room contains instruments and electrical panels (Figure 8-30). The Change Rooms are accessed from the Control Room corridor. They were modified to include an office, Contaminated Change Room, Clean Change Room, restrooms, and standby laundry facilities. Figure 8-31 is a 2004 photo of the Control Room looking north from the Building Access Door.

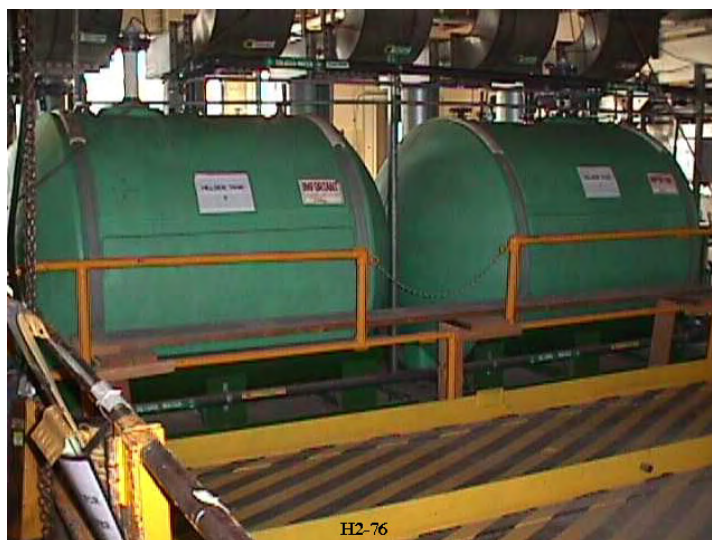
Figure 8-35. Photo H2-76, Hillside Drain System Tanks and Neutralizer Hatch, undated

Figure 8-35 is a photograph showing Hillside Drain Treatment System tanks. The ventilation system is in the background, and a hatch cover is in the foreground.

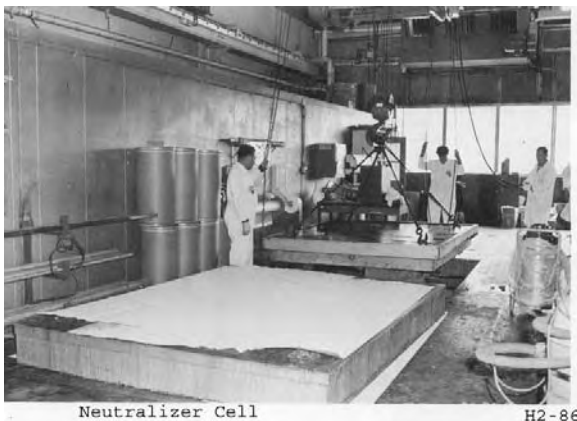
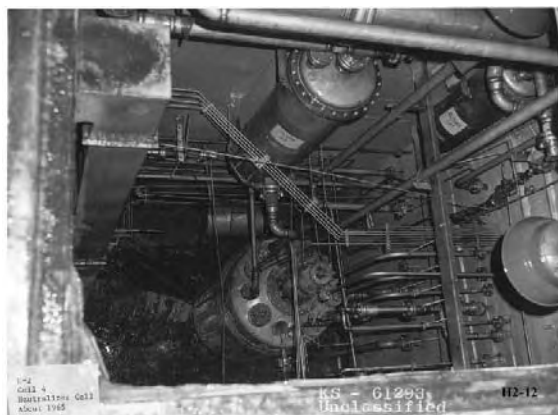
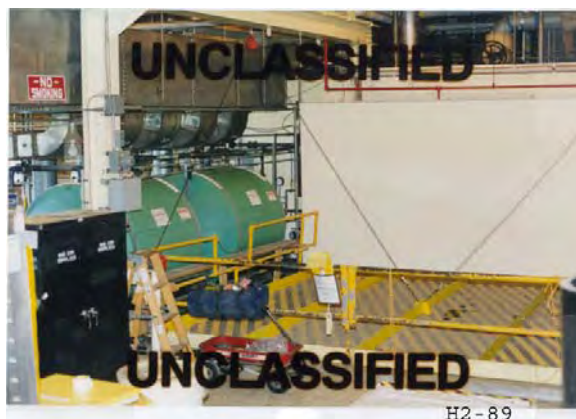
Figure 8-36 is a view of the 332-foot level Neutralizer Cell concrete hatch covers (circa 1965). Figure 8-37 is a view of a Neutralizer Cell as seen from a 332-foot level open hatch. Figure 8-38 is a photograph showing a current hatch cover.

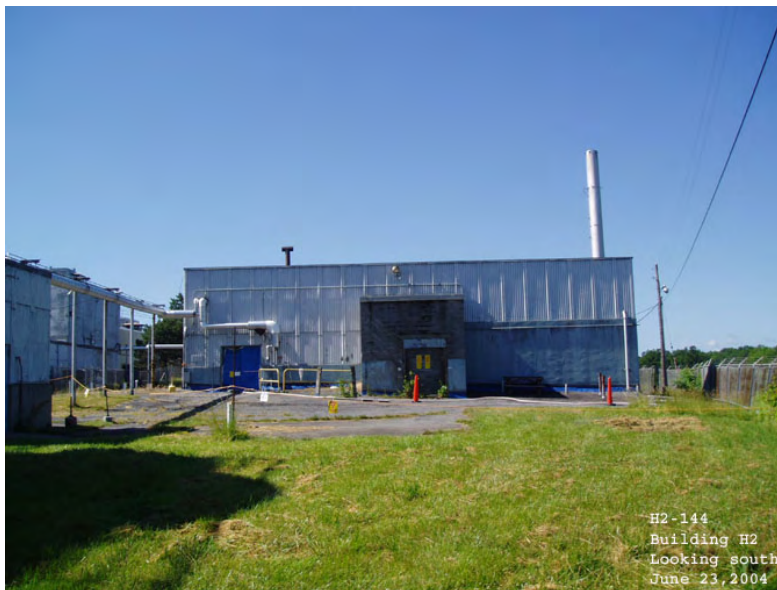
Figure 8-39. Photo H2-144, Slurry Drum Facility, North Side of H2, June 23, 2004

The Slurry Drum Facility is adjacent to the East (Cold) Evaporator Cell, attached to the north side of Building H2 exterior. The facility received slurry from the evaporator area for holding and transfer to storage facilities or disposal. Figure 8-39 shows the Slurry Drum Facility.

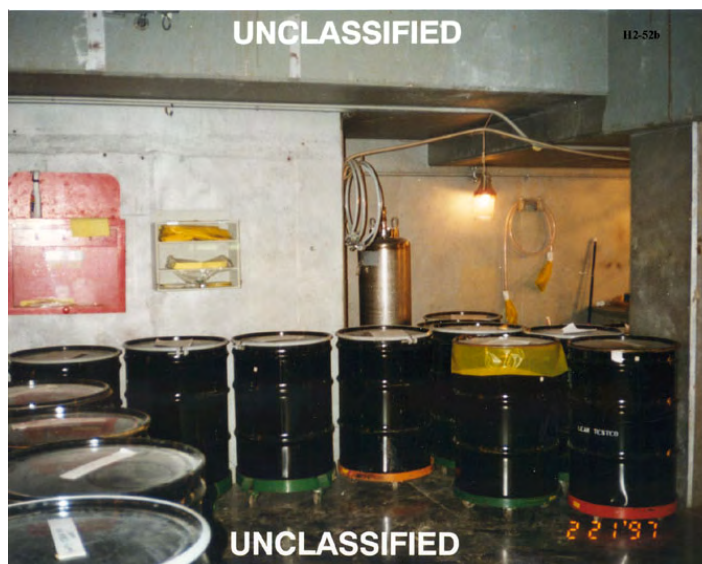
Figure 8-41. Photo H2-52b, 309-Foot Level Viewing the North Door and Waste Drums, undated

Figure 8-41 is a 1997 photo of waste drums stored in H2 on the 309-foot level near the entrance to the pipe tunnel.

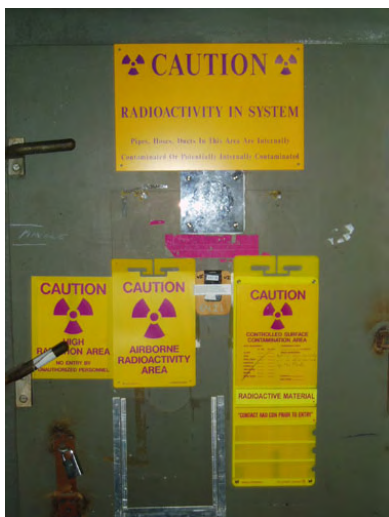
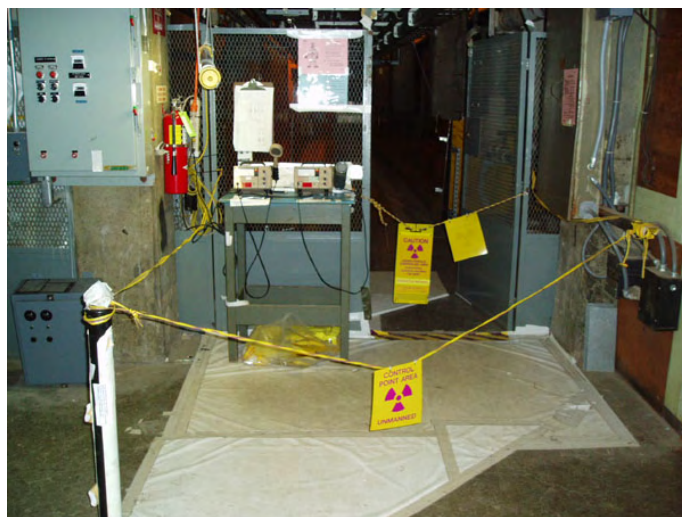
Figure 9-3. Photo TNL-7, E1 North Side Tunnel Steel Door, 2004

The E1 tunnels consist of two concrete pipe tunnels (process and hot). Tunnel walls, ceilings, and foundations are at least 1 foot thick reinforced concrete. The pipe tunnels are separated by a tunnel-aisle walkway to allow personnel access. Waste and process piping is mounted along the walls or suspended from ceiling supports. North and south tunnel and tunnel-aisle pipes are made of stainless steel (R-000255). Tunnel sumps are interconnected under the floors. Welded steel doors are located at the end of each tunnel. The E1 tunnels are under restricted radiological control access. Figure 9-2 is a plan view of the E1 Tunnel area. Figures 9-3 and 9-4 are photographs of the E1 welded steel door and radiological control warnings at the access to the tunnel aisle.

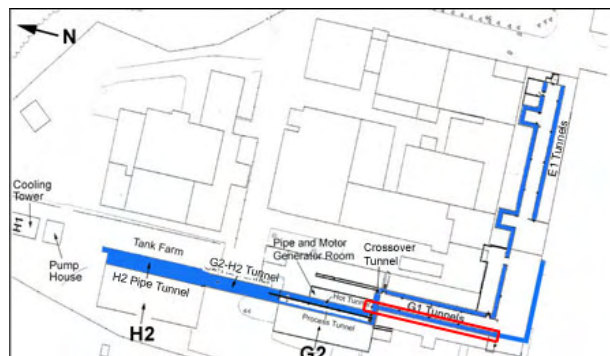
Figure 9-5. G1 West Tunnel

G1 West Tunnel piping transported liquid waste from the E1 and D4 interceptors through the G2 Hot Tunnel and into H2 waste processing tanks (Figure 9-5).

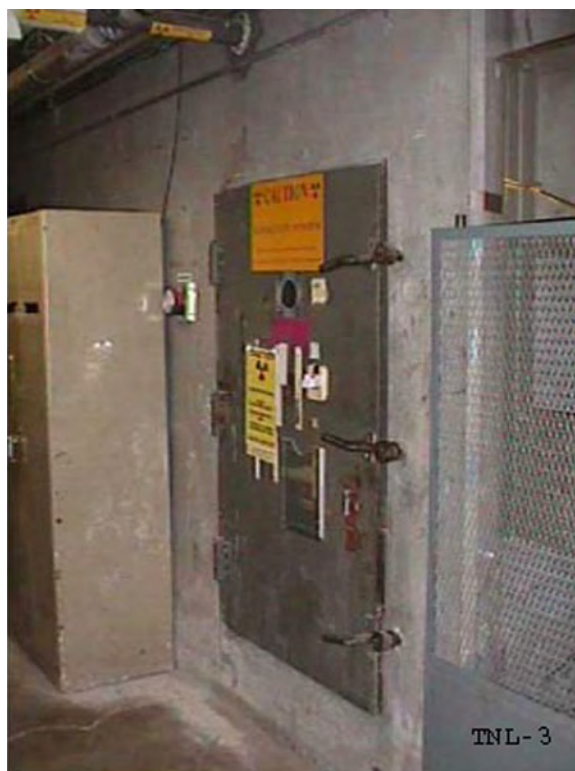
**Figure 9-6. Photo TNL-3,
G1 West Tunnel Door, 2004**

No tunnel aisle information has been collected to date beyond this point. Figure 9-6 shows a G1 West Tunnel door with caution labels. Steel access hatches along each process and hot tunnel are welded shut. Figure 9-7 shows a welded hatch in the G1 East Tunnel.

G1 drain lines had p-traps and vent lines that penetrated the tunnel ceiling. The vent lines have corroded. The p-traps, which are disconnected and capped, are in close proximity to the piping connection. They are approximately 6 inches high and potentially contaminated. Waste lines from the G1 West Tunnel to the G2 Hot Tunnel are cut and capped at the G1 basement wall. Figure 9-8 shows a G1 Capped Drain Pipe. A disconnected interceptor with two 55-gallon vessels is just inside the steel door shown in Figure 9-6. An interceptor placed in Tunnel G1 in the early 2000s is shown in Figures 9-9 and 9-10.

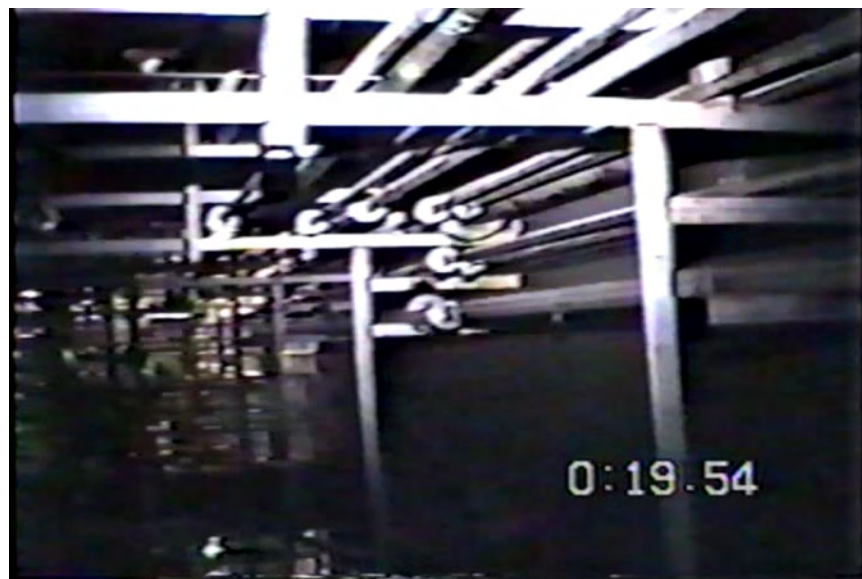
Figure 9-13. G2-H2 Tunnel Structure and Piping, July 1989 (V-002008)

Figure 9-13 is a snapshot of the tunnel from the 1989 inspection video. Figure 9-15, Drawing No. 2828-703-16 is a cross section of the tunnel and piping.

The G2-H2 Tunnel originally housed 46 stainless steel industrial and liquid process waste lines ranging up to 8 inches in diameter. The tunnel also contains original fire protection lines and a gas analyzer system. Most tunnel piping has been deactivated and abandoned in place (R-000255), and there is no evidence that original piping has been removed (V-002008). In 1992, it was reported that only four G2-H2 lines remained active. Two stainless steel drain lines provided pumped (but non-pressurized) Radioactive Materials Laboratory, Chemistry, and D4 complex radioactive waste to the H2 liquid waste collection tanks; the other two heavy duty plastic supply lines pump clean processed reuse water at 60 psig to the same laboratories (R-001949, p. 69).

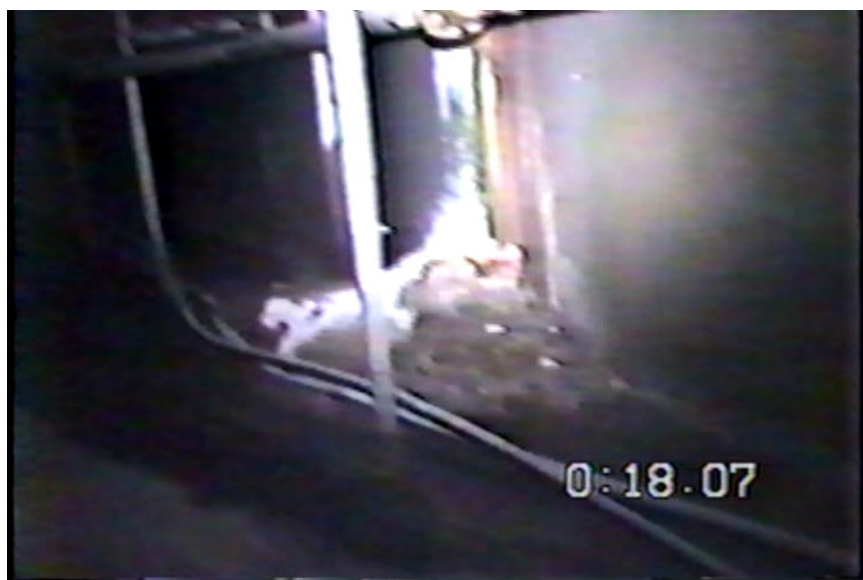
Figure 9-14. G2-H2 Tunnel Debris Pile, July 1989 (V-002008)

- A pile of concrete and debris, approximately 3 feet high, is on the floor along the east wall of the sloped portion of the tunnel. Directly above the pile is a piece of plywood, behind which concrete has been poured to patch the wall. Figure 9-14 is an excerpt of the 1989 inspection videotape.

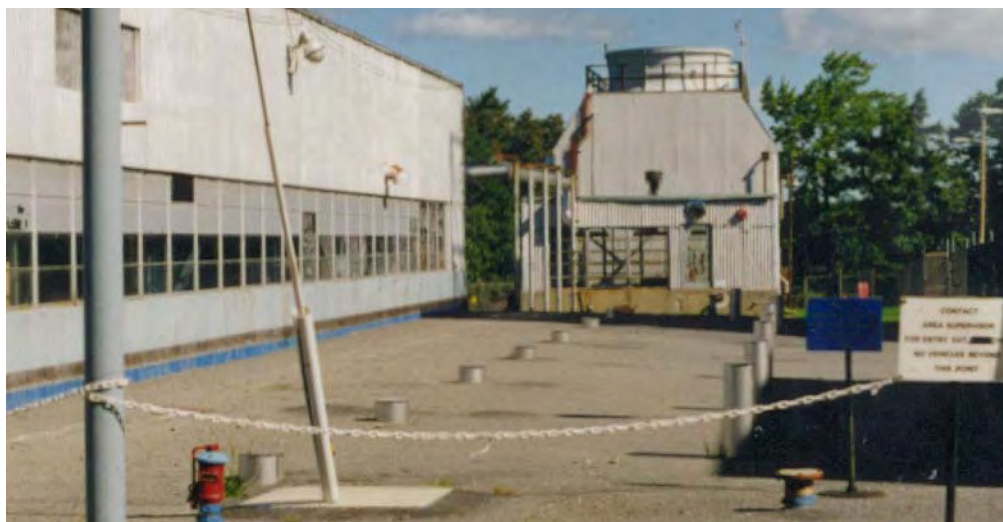
Figure 10-1. Photo H2-93, Tank Farm Area East of Building H2, Looking North, 2004

The Tank Farm waste storage and processing facility was used from 1949 to 1978. Located below-grade (304-foot level) on the east side of the H2 Pipe Tunnel, the Tank Farm consists of one 5,000-gallon waste transfer tank and six 10,000-gallon stainless steel waste storage tanks arranged in a north-south row. The Tank Farm was designed for storing concentrated radioactive liquid waste, but waste could be transferred from the Tank Farm to the H2 evaporator system (R-000255, p. 15). Tank Farm use was terminated shortly after the Radioactive Materials Laboratory Reuse System was brought online in 1978 (C-000396, p. 2). Figure 10-1 is a photograph of the Tank Farm area, looking north. The east side of H2 is on the left; vault hatches and tank vents protected with metal covers are visible above ground. Figure 8-2 in Section 8 displays an isometric view of the Tank Farm. The current radiological conditions of the Tank Farm are indicated on Figure 8-4 in Section 8 (Building H2), Current Radiological Conditions for the 309-Foot Level.

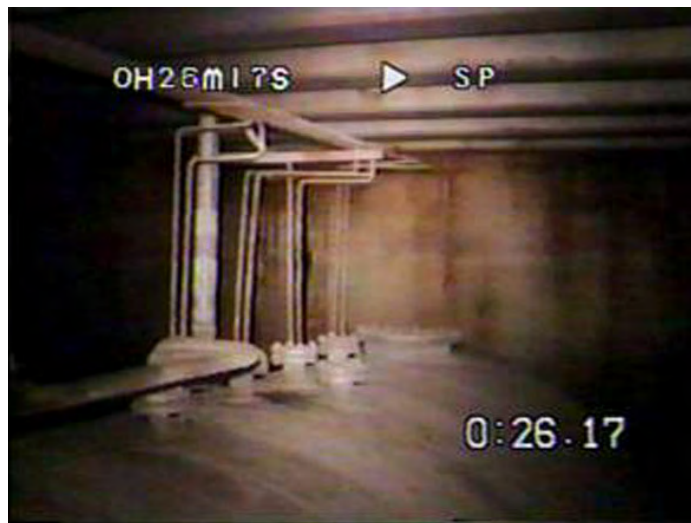
Figure 10-4. Tank Top in Tank Farm Vault, Looking East, undated

Tank residue quantities and depth, gamma radiation levels, and estimated total Curie contents were documented during the 1989 inspection (C-000203, Part II, p. 4). No waste has been added to or removed from the tanks since the 1989 inspection.

Figure 10-4 is a photograph of a tank top, looking east.
