RSI-KES-DLV-TO3-001

Historical Site Assessment for the F-Complex

December 2022

Prepared for:
U.S. Department of Energy
Environment Management Consolidated Business Center –
New York Project Office

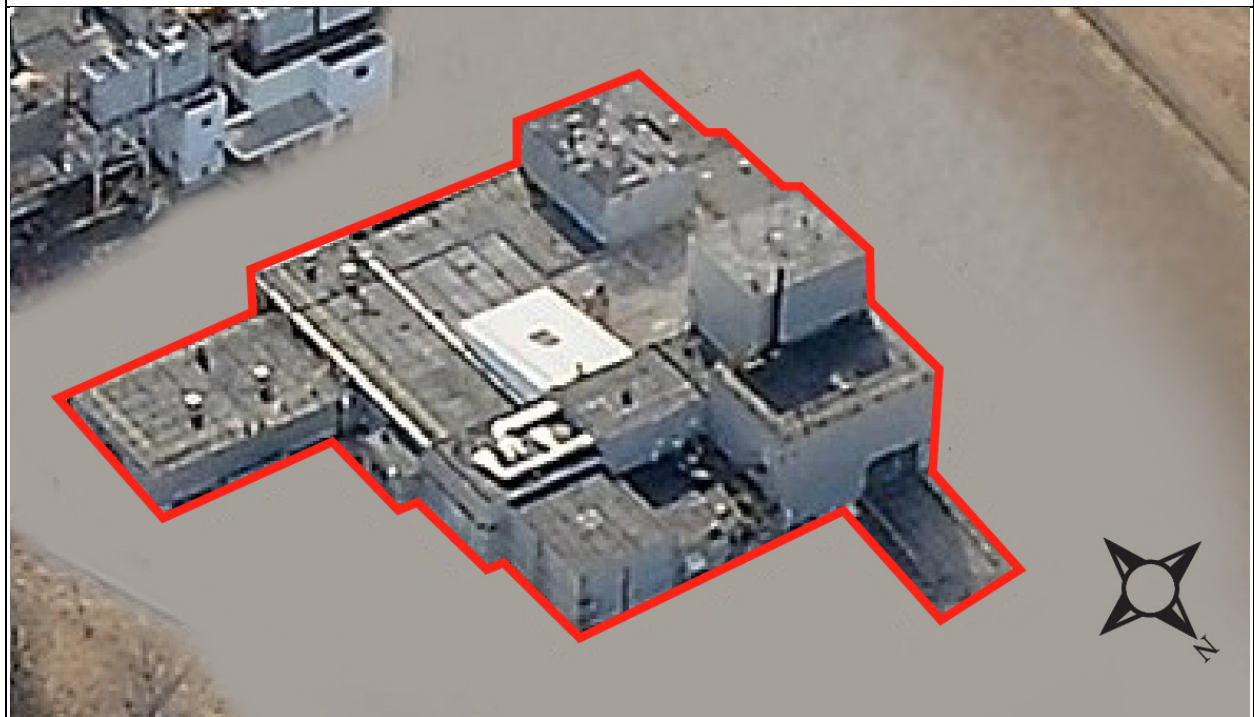
Figure 4-1. Aerial View of the F-Complex

The F-Complex, shown in Figure 4-1, was constructed between 1951 and 1970 and operated as a nuclear reactor testing facility until 1995 to generate physics and design information in research areas such as critical mass, reactivities, power distribution, temperature coefficients, and experimental information in high-temperature physics. Currently covering a footprint of 31,094 SF, the F-Complex originally comprised six facilities designated F1 through F6 (structure F5 was demolished) and housed nine test reactors over the course of the complex's lifetime.

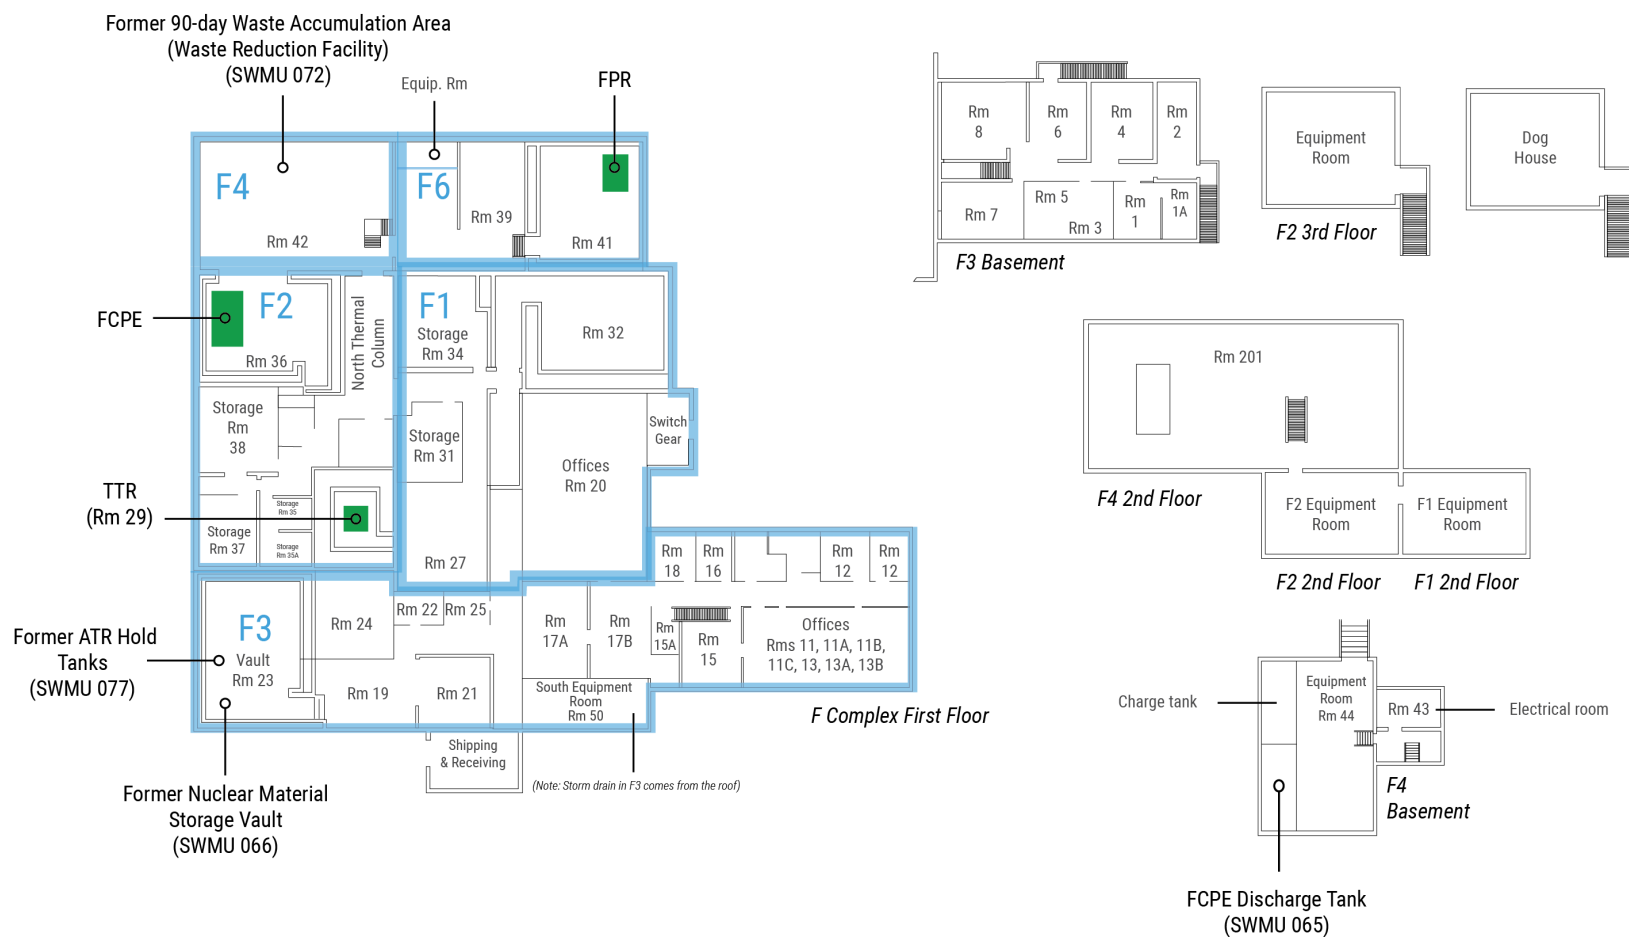
Figure 4-2. F-Complex Current Layout

Following the cessation of test reactor operations in 1995, portions of the complex were repurposed for multiple uses such as office space, storage, a RADIAC calibration facility, and a machine shop. As of completion of this document, there are no active areas remaining in the F-Complex. Figure 4-2 depicts the F-Complex current layout.

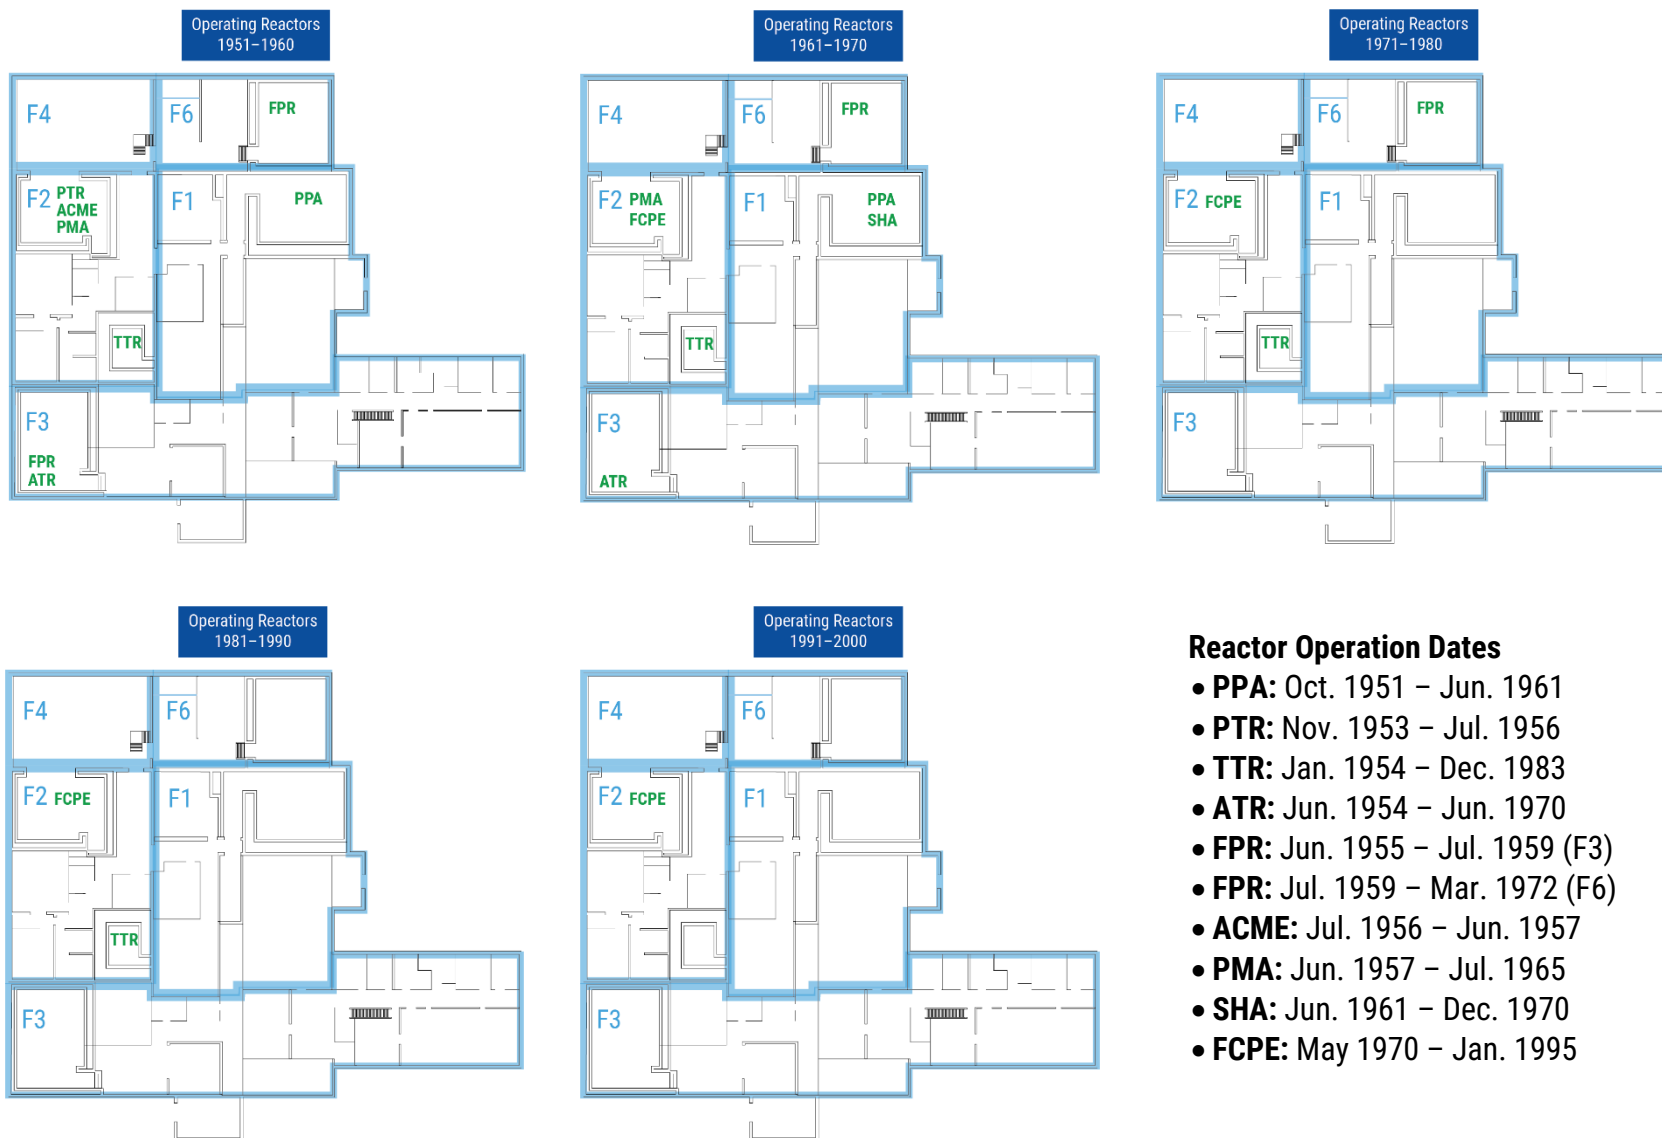
Figure 4-3. F-Complex Reactor Assembly History

During the early decade of F-Complex operations, reactors were regularly installed and then removed and replaced with different reactors. For example, the PTR was installed in Room 36 of F2 in November 1953 and removed in July of 1956. Following the removal of the PTR, the ACME reactor was installed in the same location and operated until June 1957. A similar arrangement occurred in Room 32 of F1, where the PPA was installed in October 1951, removed in June of 1961, and followed by the placement of the SHA reactor in June 1961.

Figure 4-3 illustrates the F-Complex reactor location history over the decades from 1951 to 2000.

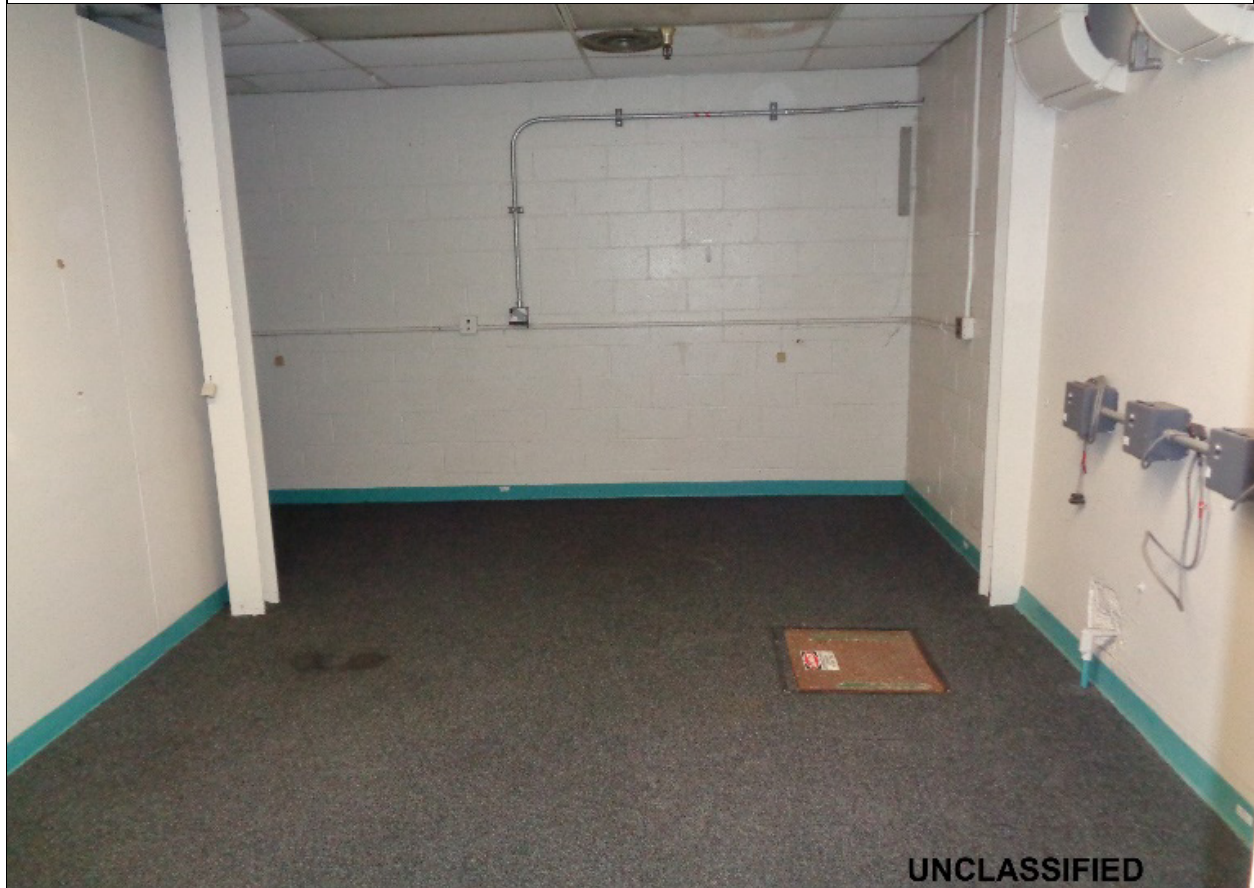
Figure 4-4. F1, Room 17-A, Looking South

IFE preparation activities for turnover to the DOE-EM have included clearing the complex of all items designated for removal. Figures 4-4 through 4-8 depict the present condition of the buildings.

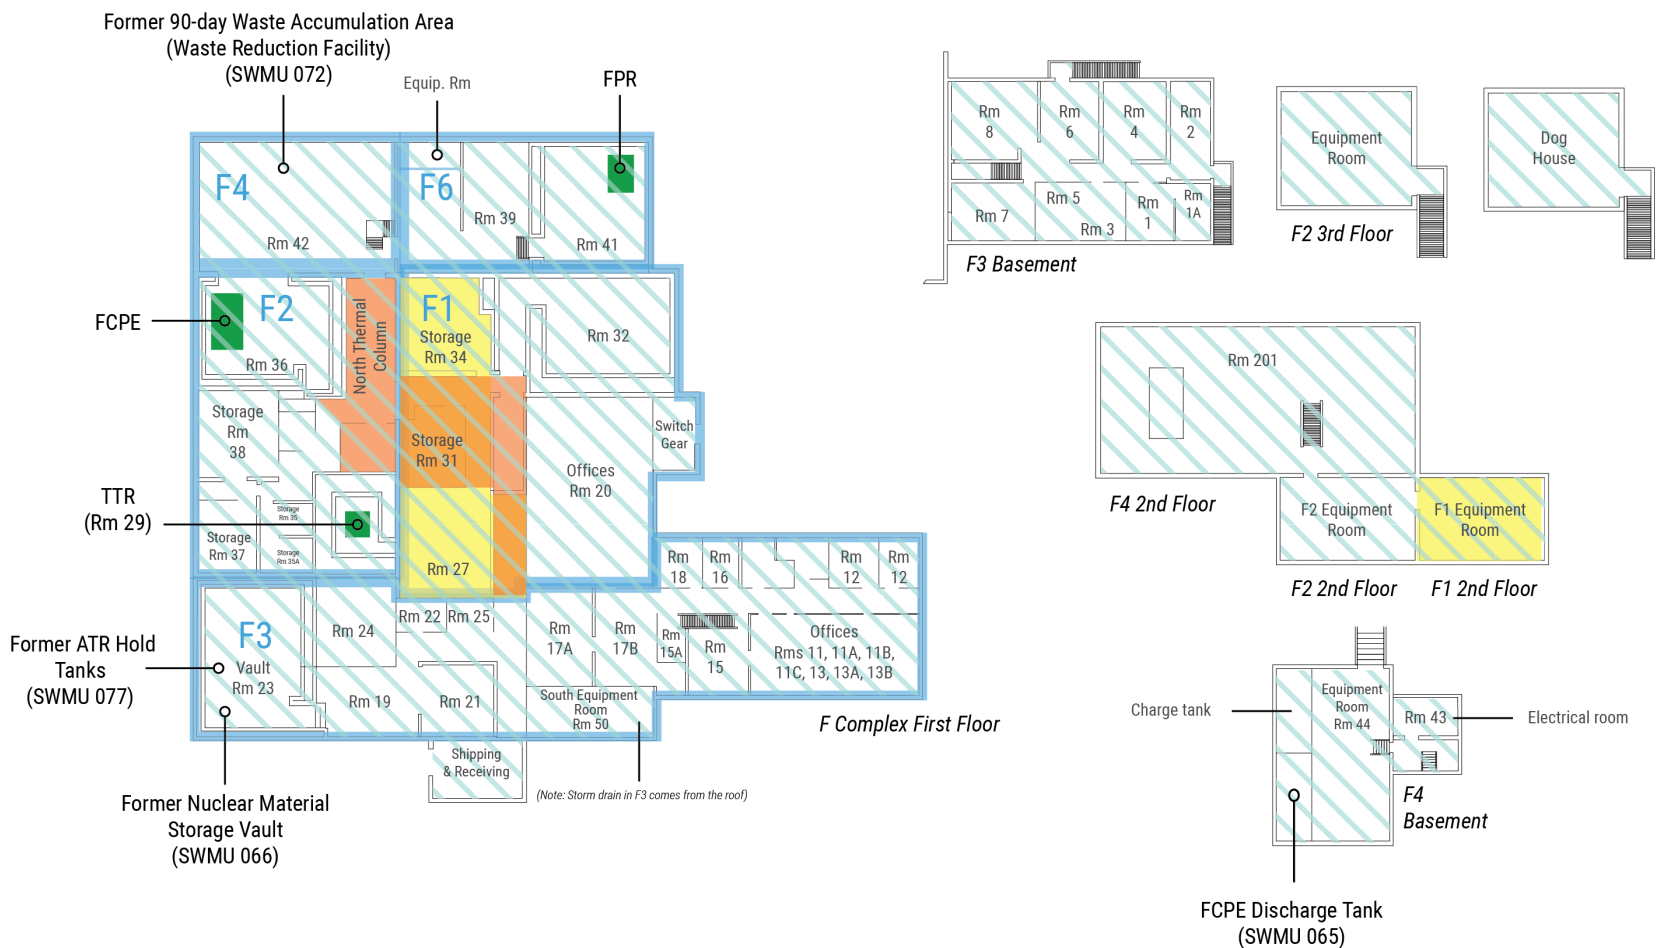
Figure 5-1. General Location of Chemical Contamination Within F-Complex

Beryllium dust contamination is located above the main hallways of F1 and F2 and in overhead areas in Room 31. Beryllium machining operations caused suspended dust particles to be deposited on overhead ducts and the floor, with subsequent tracking from the room to the hallways.

Figure 5-1 depicts the areas of chemical contamination within the F-Complex.

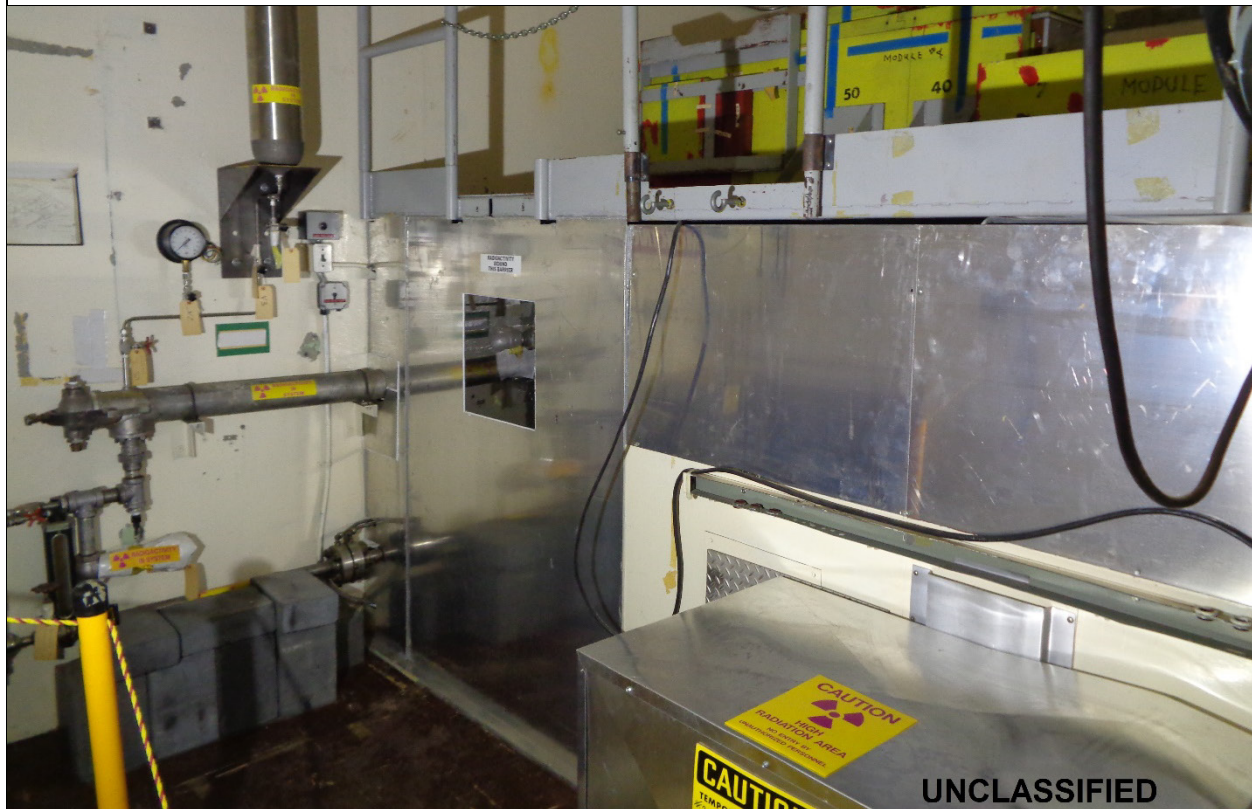
Figure 5-3. F2, Room 29, TTR

Table 5-2 identifies hazards and impacted areas within the F-Complex with radioactive contamination above background levels. Figures 5-3, 5-4, and 5-5 show the location of the remaining F-Complex research reactor assemblies, including FCPE and TTR in F2 and FPR in F6.

Table 5-2. Location of Radiological Hazards Within F-Complex	
F-Complex Building	Radiological Hazards Within Building
F2	<ul style="list-style-type: none"> Room 29 (TTR cell) has two localized High Radiation Areas (≥ 100 mrem/hr) around the TTR end cap and ion exchangers Room 29 contains two high radiation components that are shielded in place, a loading plug (4 R/hr unshielded, 0.3 mrem/hr shielded) and two resin columns (3 R/hr unshielded, 2.5 mrem/hr shielded). Nearly one-half curie of radiation is contained within these two resin columns. $>200,000$ pCi/100 cm² beta-gamma contamination levels remain within core structural housing North Thermal Column (unnumbered room, north of Room 29) is a Radioactive Material Storage Area Room 36 houses the FCPE assembly and is a Radiologically Controlled Area (uranium control system) and Radioactive Material Storage Area
F3	<ul style="list-style-type: none"> Plutonium-alpha TRU isotopes were identified on the original concrete floor of the F3 South Equipment Room (Room 50) from contaminated tools/equipment Concrete floor was initially painted, covered with plywood, and permanently covered with tiles

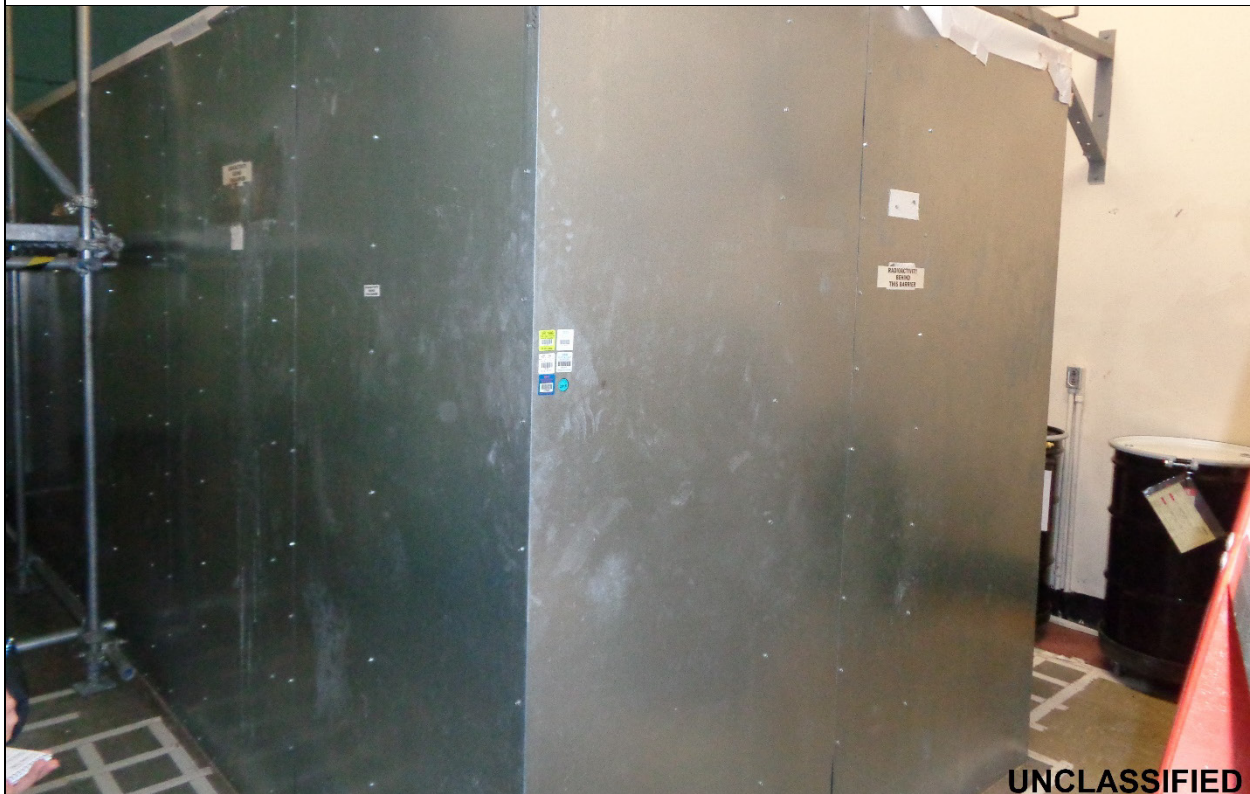
Figure 5-5. FPR Enclosure in Building F6, Room 41

F6	<ul style="list-style-type: none"> Room 41 houses the FPR core structural assembly believed to contain up to 1,000 pCi/100 cm² of loose alpha surface contamination
