FINAL
Depleted Uranium Slug Search
Santa Susana Field Laboratory
Ventura County, California

Cabrera Project No.08-1011.00

June 2008

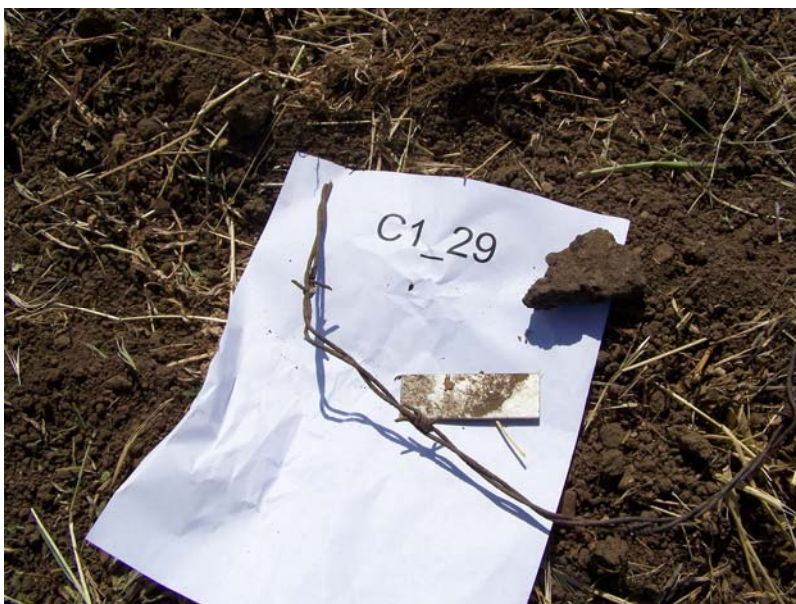
Figure 4.1-5 Photograph of Metal Wire Removed at Anomaly C1_29

Descriptions of metal objects found during the intrusive investigations were recorded on the dig sheets included in Appendix B. Most of the objects were iron or steel, although there were also pieces of aluminum and copper identified. The most commonly found objects were wire (Figure 4.1-5), scrap metal (Figure 4.1-6), nails (Figure 4.1-7), and beverage cans (Figure 4.1-8). Photographs of metal objects recovered from each of the intrusive investigations are included electronically in Appendix C.

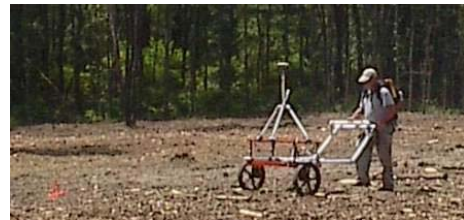
The EM61 was coupled with the Leica DGPS in a “cart” configuration. Ruggedized non-metallic wheels supported the Electromagnetic Coil (Figure 2 shows an example of the configuration). The GPS antenna was mounted directly above the center of the coil.

Figure 2: Example of an EM61 coupled with a Leica 1200 DGPS.
