GO Number 97055	S/A Number 75300	Page 1 of 12	Rev. Ltr/Chg. No. See Summary of Chg. NEW	Document Number EID-04725
Program Title ETEC Closure R21-RF				
Document Title Operations Report for 17th Street Decontamination				
Document Type Engineering Information Document			Related Documents	
Original Issue Date 08/21/00	Release Date RELEASE 08/28/00 TV		Approvals R. Meyer	Date
Prepared By/Date Christina Ortega / 08-21-00		Dept. 694	Mail Addr. T038	
IR&D Program? Yes <input type="checkbox"/> No <input checked="" type="checkbox"/> If Yes, Enter Authorization No.				
Distribution		<u>Abstract</u>		
Name	Mail Addr.	<p>This document summarizes the decontamination and survey process for the 17th Street Drainage Area at Boeing's Santa Susana Field Laboratory (SSFL).</p> <p>The Metaphase on-line procedure system contains the latest revision of this document.</p> <p>Responsible Person: Rodney E. Meyer</p>		
Amar, Ravnesh	T038

This report summarizes the decontamination and survey process for the 17th Street Drainage Area at Boeing's Santa Susana Field Lab (SSFL) in Southern California. The area consisted of a natural rainwater channel where a berm was constructed in 1962 to permit the area to s

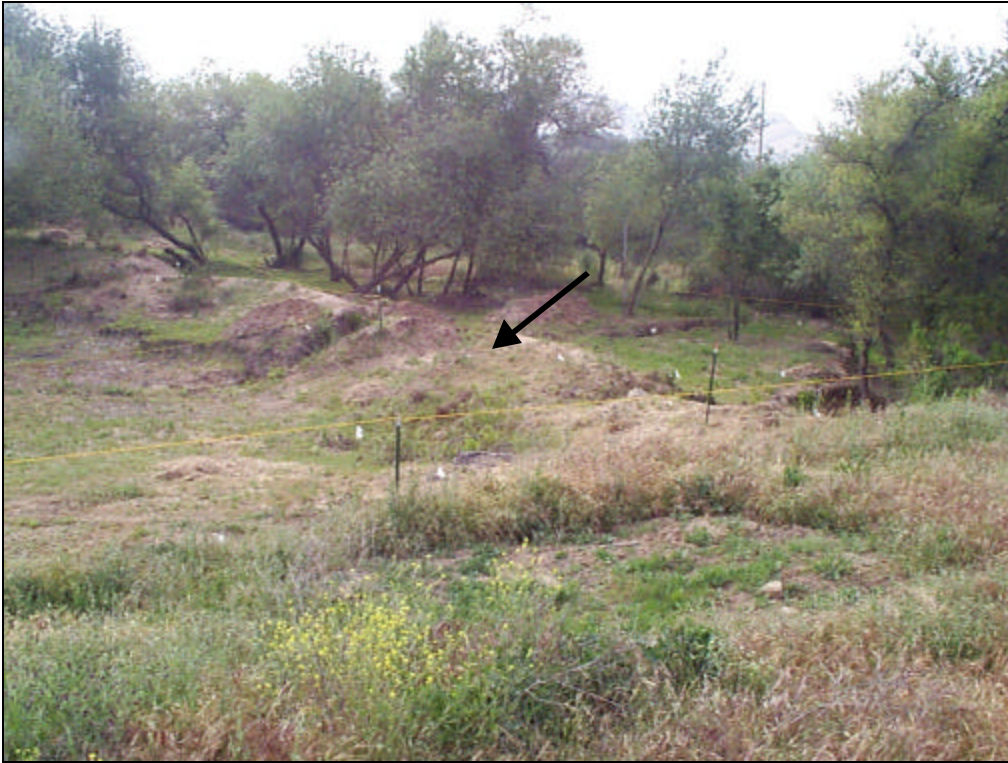
Figure 4. Berm

The 17th Street Drainage Area is the site of a natural rainwater channel where a berm was constructed in 1962 to permit the area to serve as a hold-up pond (Figs. 4&5). The pond was functional for many years. It cycled through periods of evaporative drying in summer seasons and refilled during rainy seasons, causing the low-lying area to be marshy. Since that time, the area filled with silt and became overgrown with shrubs and trees. The hold-up pond area measured approximately 85 m².
