Group C Map Site 4583, Old ESG Storage Yard Building 4320 Building 4731

Site 4583 Conservation Yard Old ESG Storage Yard

Building 4320 Fuel Oil Control/Pump Building

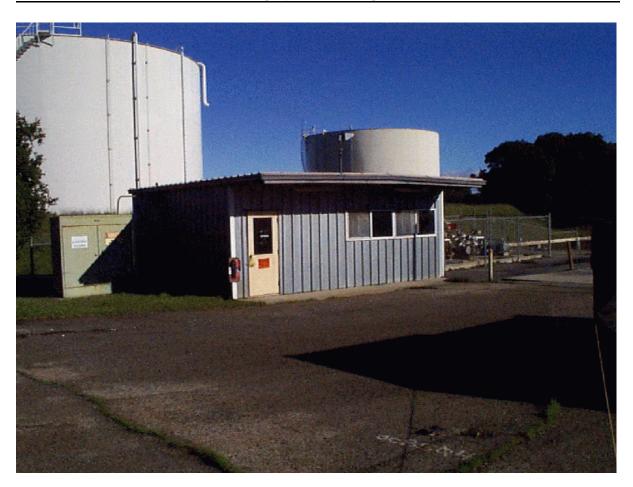
Photograph – Building 4320

• Building 4320 was a 500-square-foot structure constructed of prefabricated steel. It sat on a concrete pad and was connected to the tanks by carbon steel pipes ranging from three to six inches in diameter. The entire area was fenced and paved.

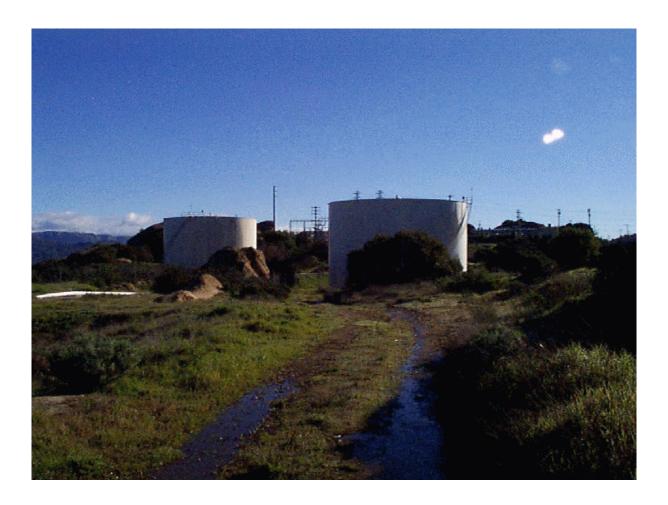
Building 4731 1.5 Million Gallon Fuel Oil Storage Tank

• Building 4731 had a capacity of 1.5 million gallons, and measured 74 feet in diameter and 48 feet high. It was above ground, vented and constructed of carbon steel. The Fuel Tank Farm also contained a pump station and interconnecting piping systems, a control building, concrete supports and foundations, asphalt paving and chain link fencing.²

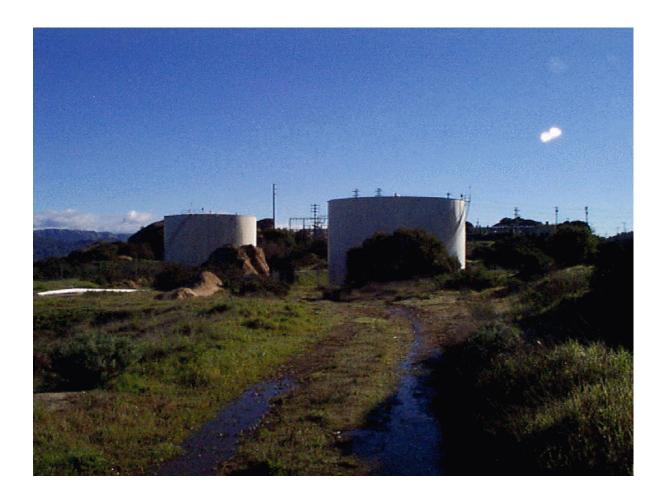
Building 4732 1.5 Million Gallon Fuel Oil Storage Tank

• Building 4732 had a capacity of 1.5 million gallons, and measured 74 feet in diameter and 48 feet high. It was above ground, vented and constructed of carbon steel. The Fuel Tank Farm also contained a pump station and interconnecting piping systems, a control building, concrete supports and foundations, asphalt paving and chain link fencing.²
