Site Summary Group EE
AREA IV
Santa Susana Field Laboratory, CA

Site Summary – Building 4885

Site Summary – Building 4886

Sodium Disposal Facility (Sodium Burn Pit)
Building 4886

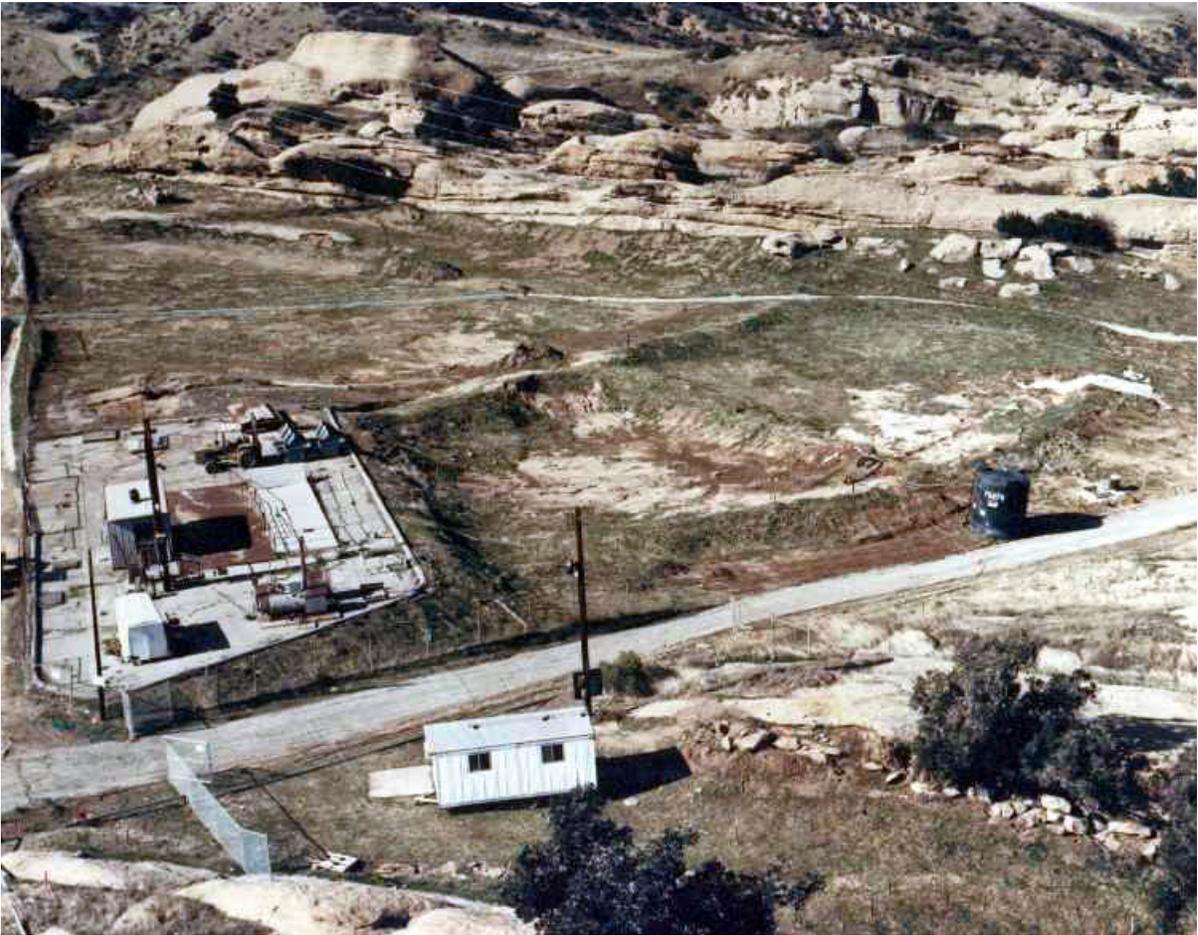
Photograph – Building 4886 and Surroundings

- Building 4886 consisted of a large, rectangular pit filled with water. This pit was surrounded by a concrete slab; shallow water-filled, unlined basins; a small building; and steam lance cleaning equipment.²
