Site Summary Group FF
AREA IV
Santa Susana Field Laboratory, CA

Site Summary – Building 4701

Building 4701
Water Tank (Deer Flats)

Site Summary – Building 4702

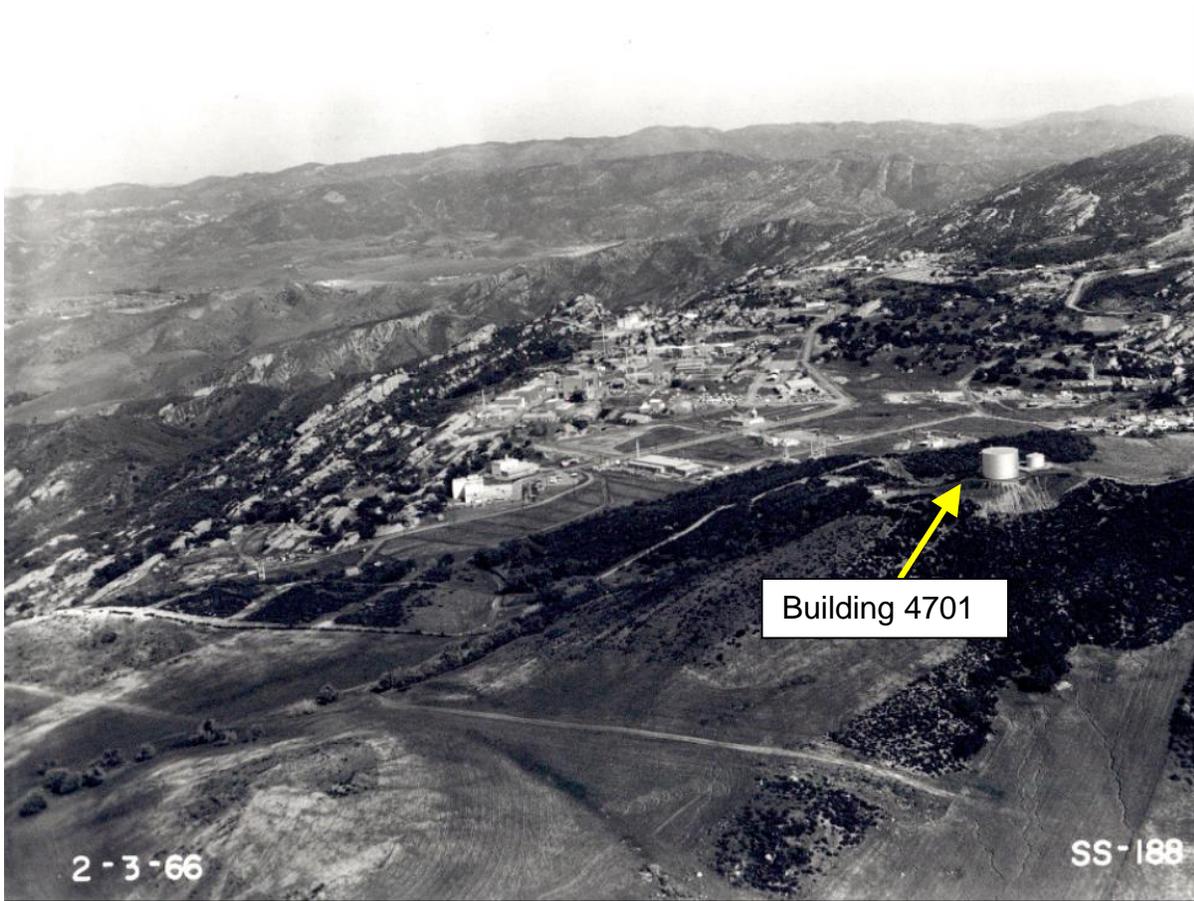
Photograph – Building 4701

- Building 4701 sits on the ridgeline along the southern edge of Area IV.

- Radiological surveys specific to Building 4701 have not been conducted.
- This area was covered as part of the 1994-1995 Area IV Radiological Characterization Survey.⁴
 - Background: 15.6 μ R/hr.
 - Acceptable Limit: Less than 5 μ R/hr above background.
 - Survey results were below the acceptable limits.

- Building 4701 is still standing.

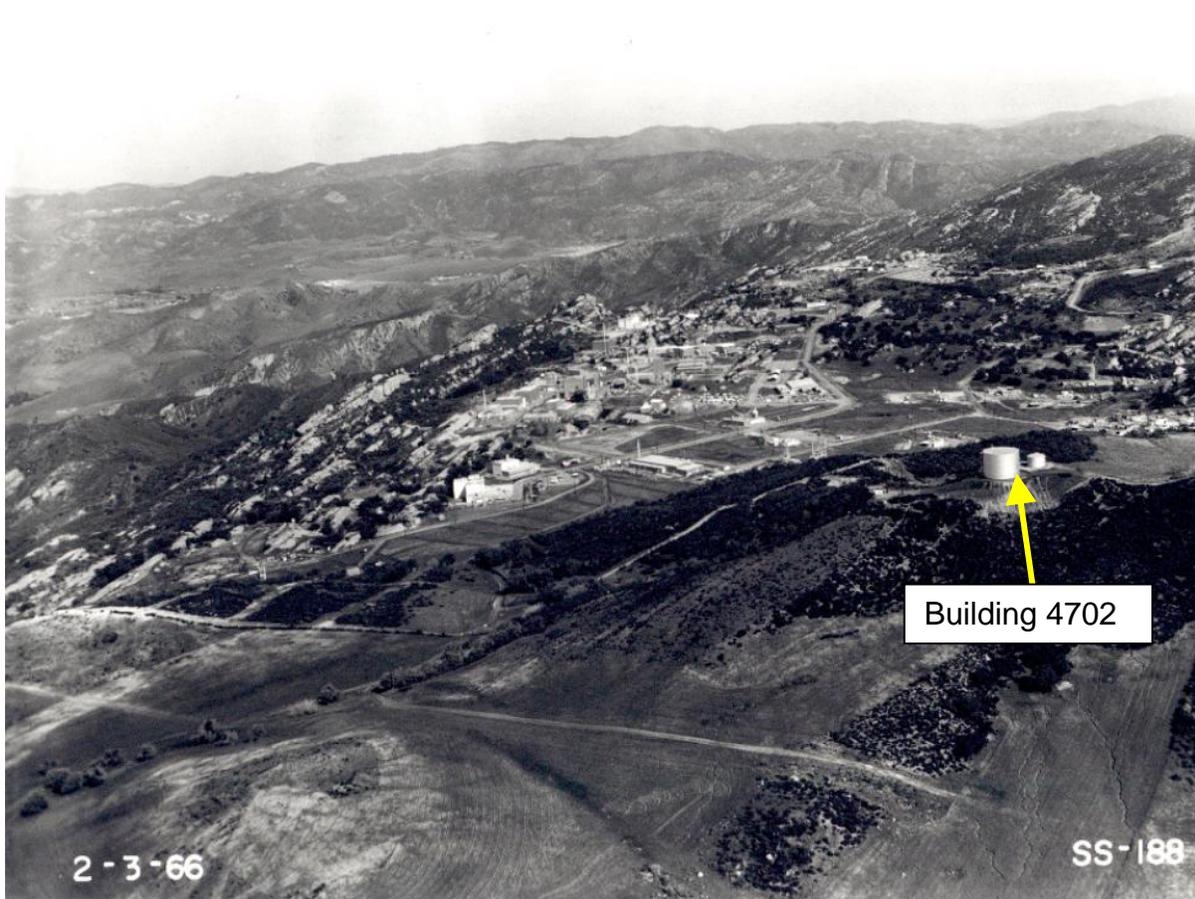
Photograph – Building 4702

- Building 4702 sits on the ridgeline along the southern edge of Area IV.¹

- Radiological surveys specific to Building 4702 have not been conducted.
- This area was covered as part of the 1994-1995 Area IV Radiological Characterization Survey.⁴
 - Background: 15.6 μ R/hr.
 - Acceptable Limit: Less than 5 μ R/hr above background.
 - Survey results were below the acceptable limits.

- Building 4702 is still standing.
