Group W

Site Summary Group W
AREA IV
Santa Susana Field Laboratory, CA

Site Summary – Building 4015

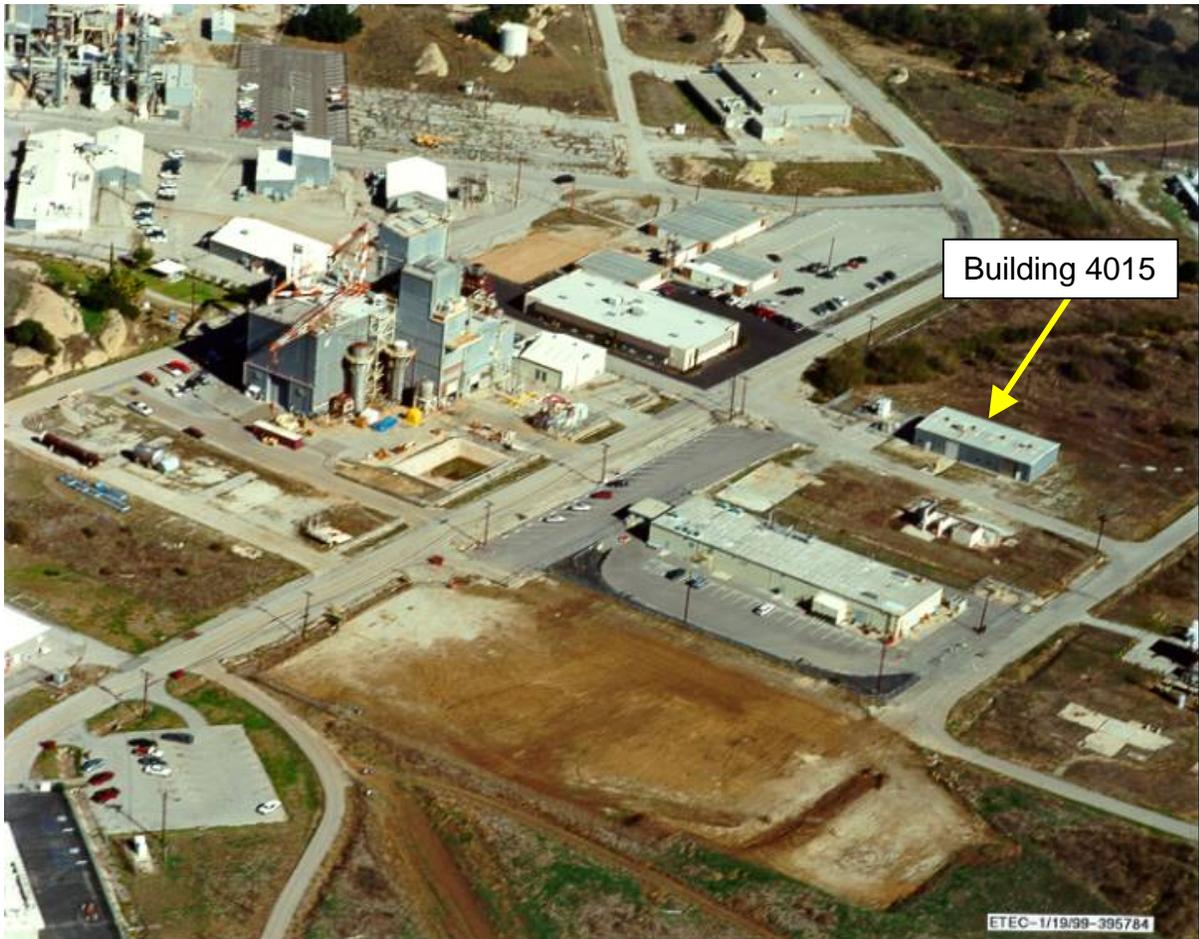
Photograph – Building 4015

- Building 4015 is a warehouse with 13-foot ceilings, a steel frame, and sheet metal siding and roof. It is located east of Building 4373.¹
- Serviced by Substation 4707, which was demolished in August 2003.²

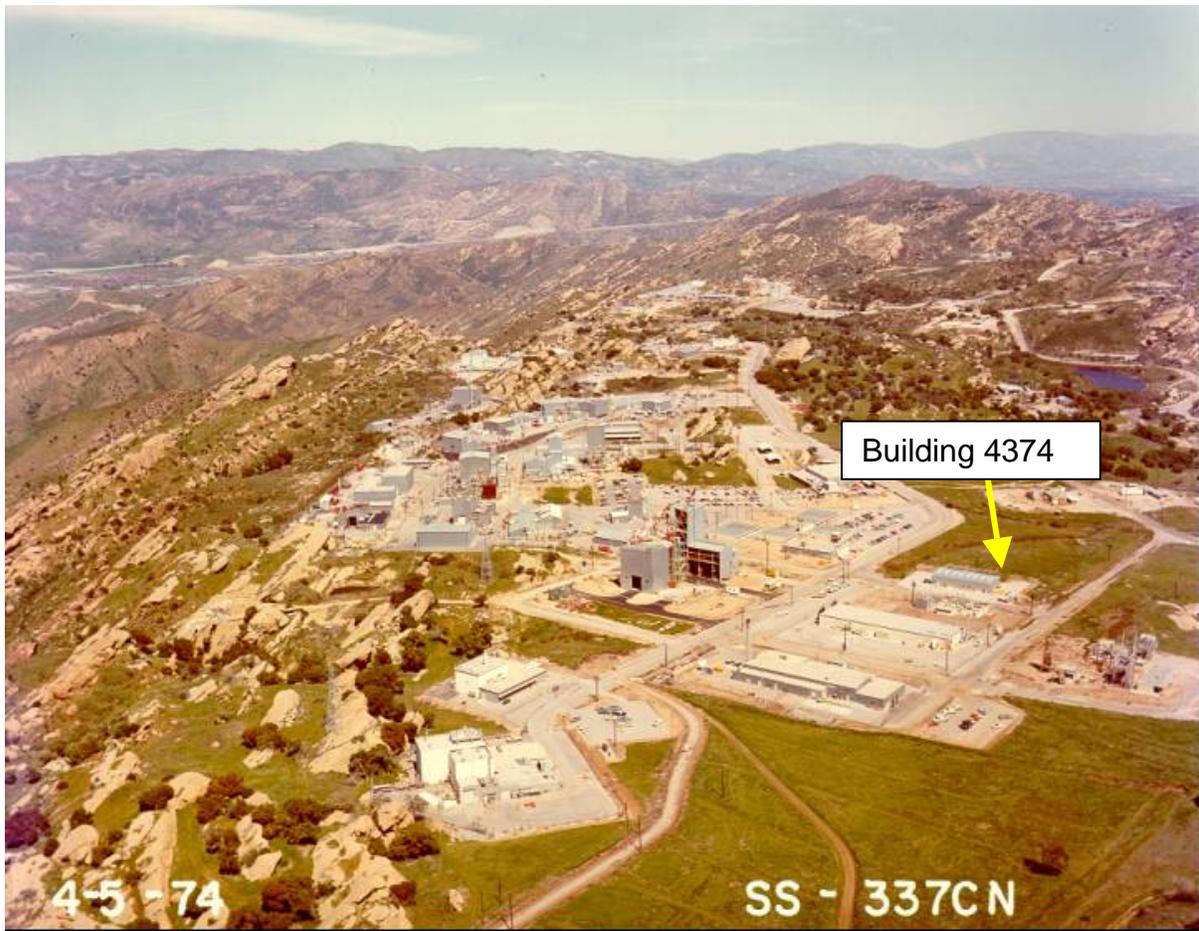
Photograph – Building 4374

- Building 4374 is a steel frame and sheet metal covered Butler-type building measuring 600 square feet located north of Building 4373.¹

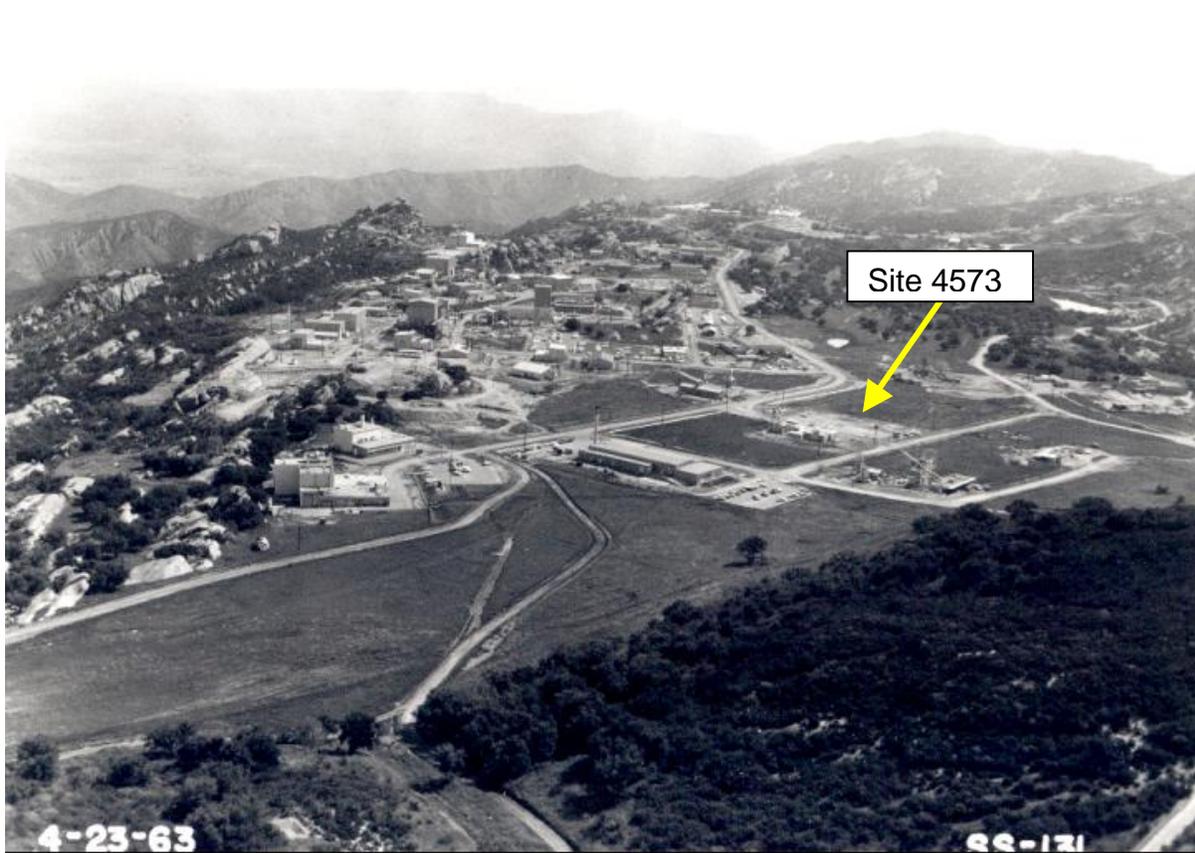
Photograph – Site 4573

- Site 4573 was located at the corner of J and G Streets.¹
- Serviced by Time Clock 4343.
