**Chemical Data Summary Report
Santa Susana Field Laboratory
Ventura County, California**

U.S. Department of Energy
EM Consolidated Business Center
Contract DE-EM0001128
CDM Smith Task Order DE-DT0003515

January 2017

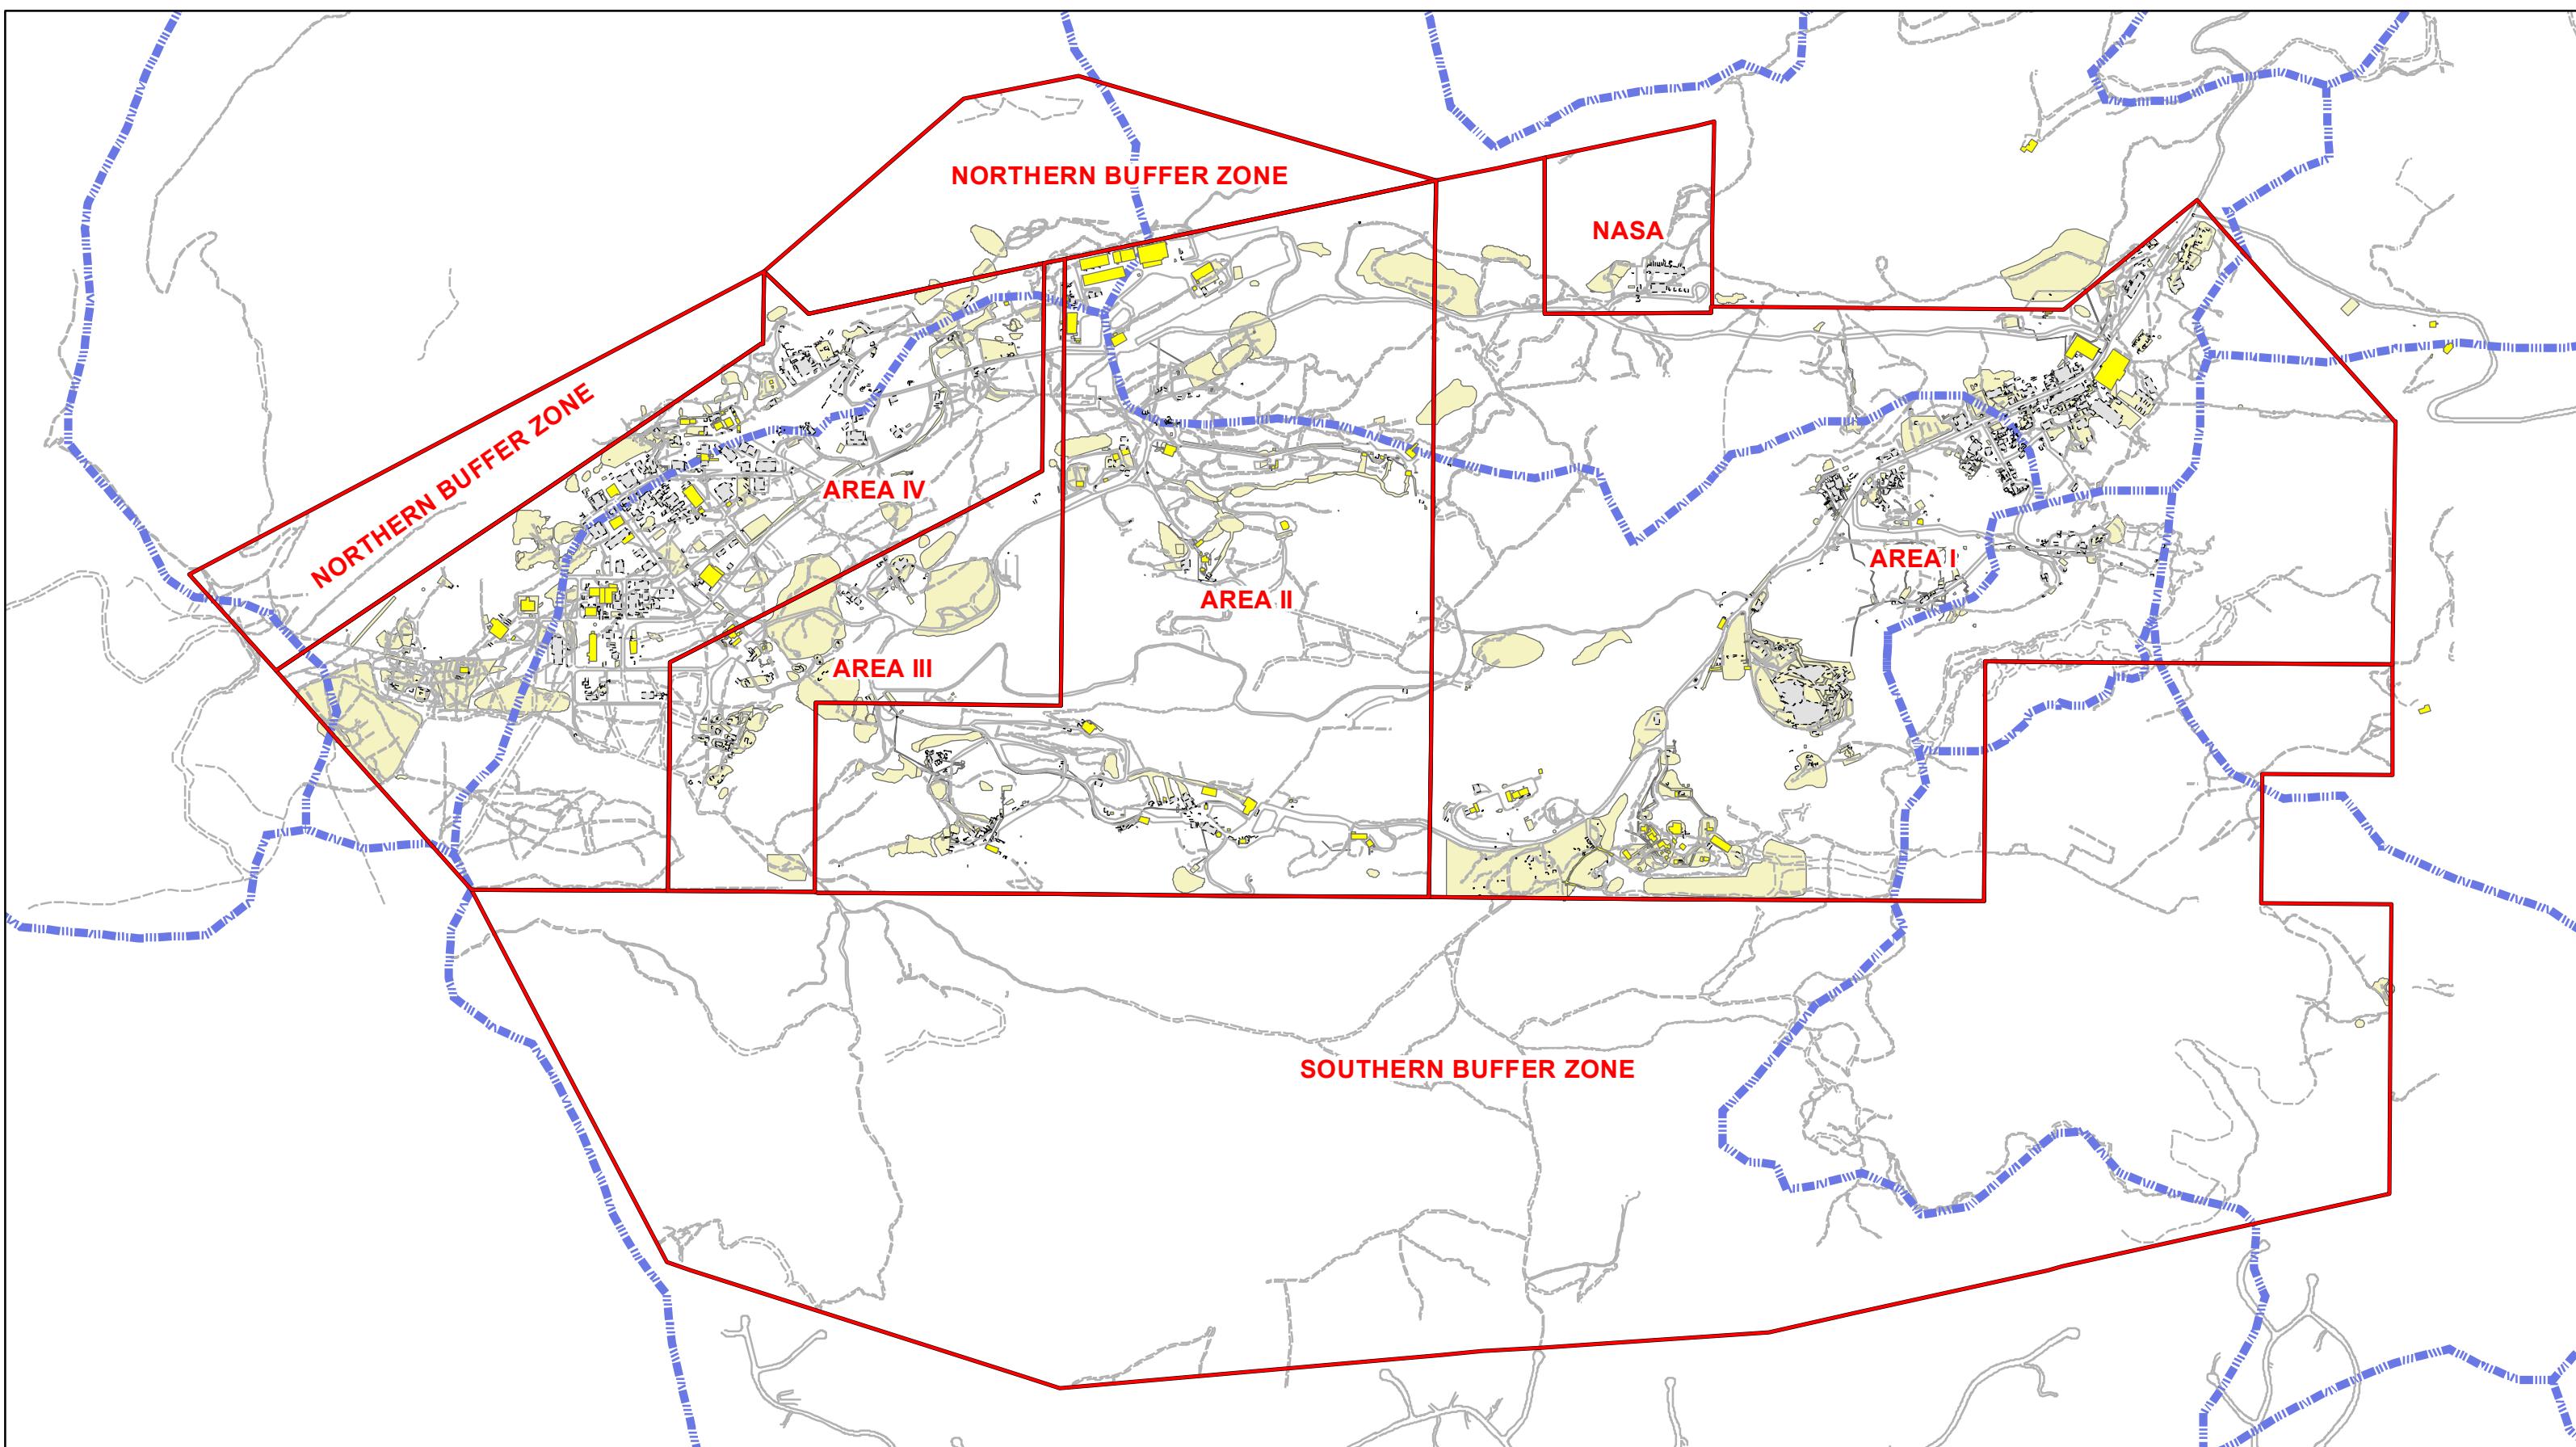
Santa Susana
Ventura County, California
Figure 1-2

Santa Susana Field Laboratory Layout

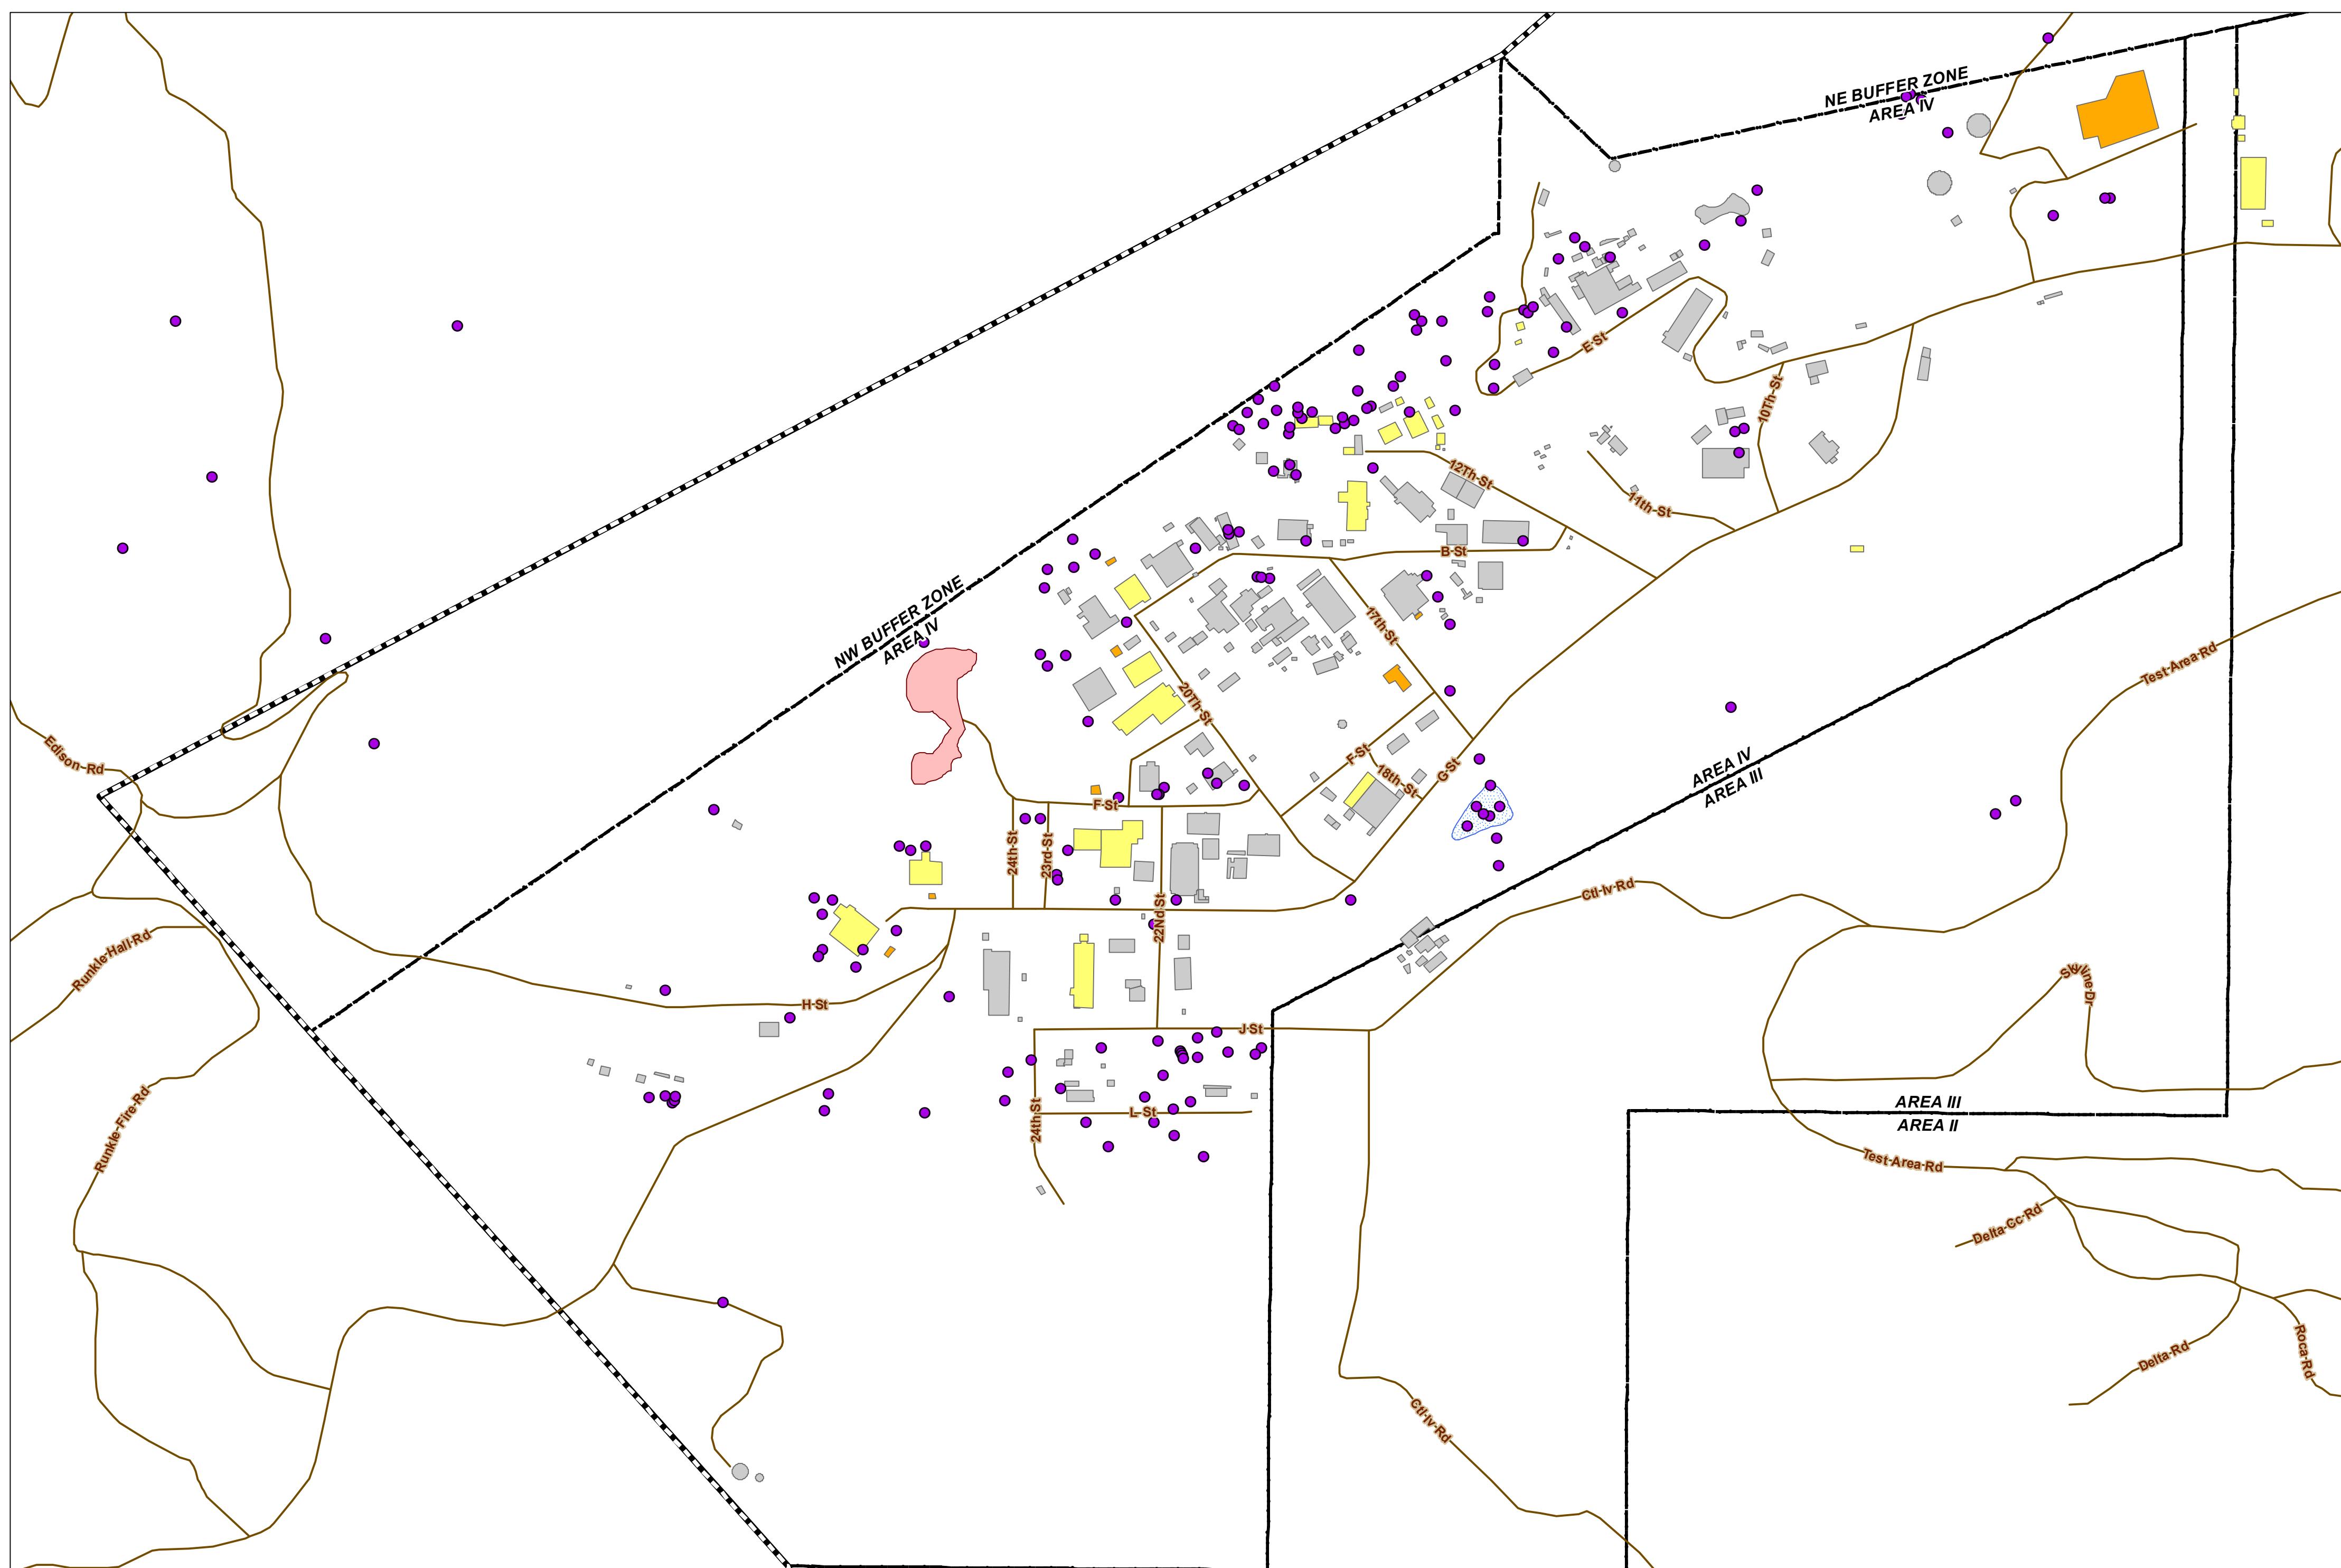
Figure 4-1

Metals: Antimony Exceeding LUT Values Surface Soils

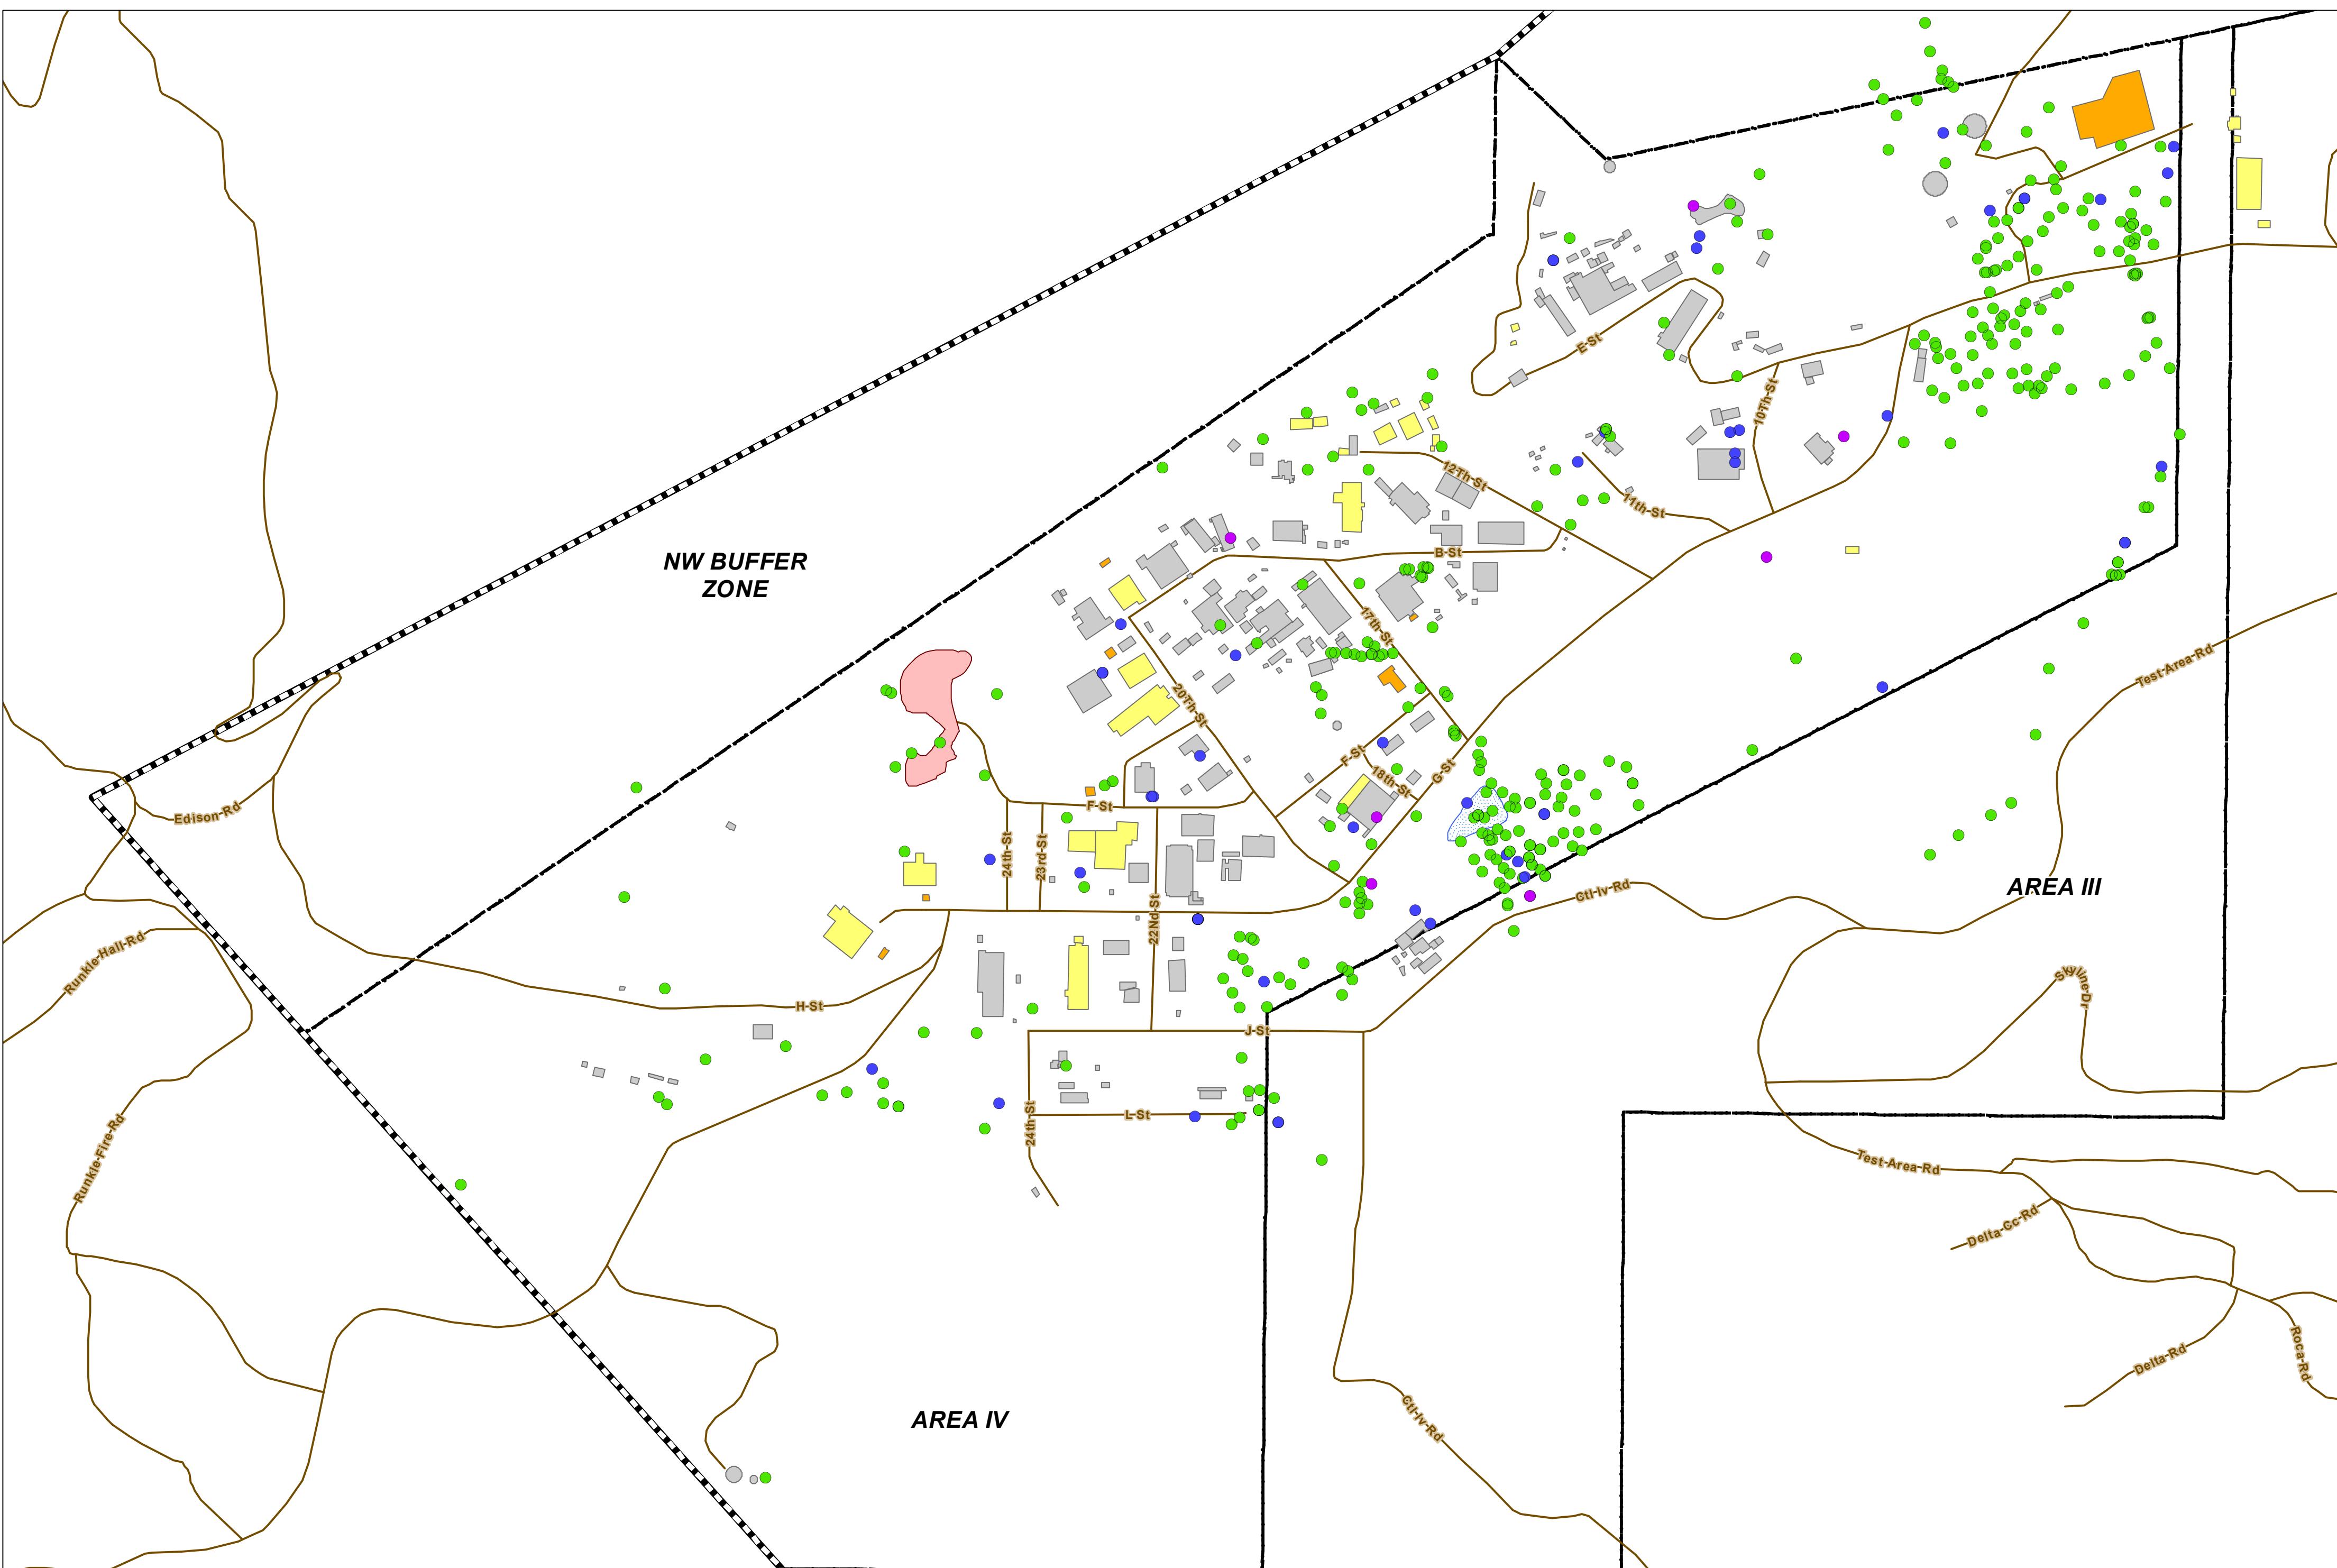
Santa Susana Field Laboratory
Ventura County, California
Figure 4-10

Metals: Silver Exceeding LUT Values by Depth

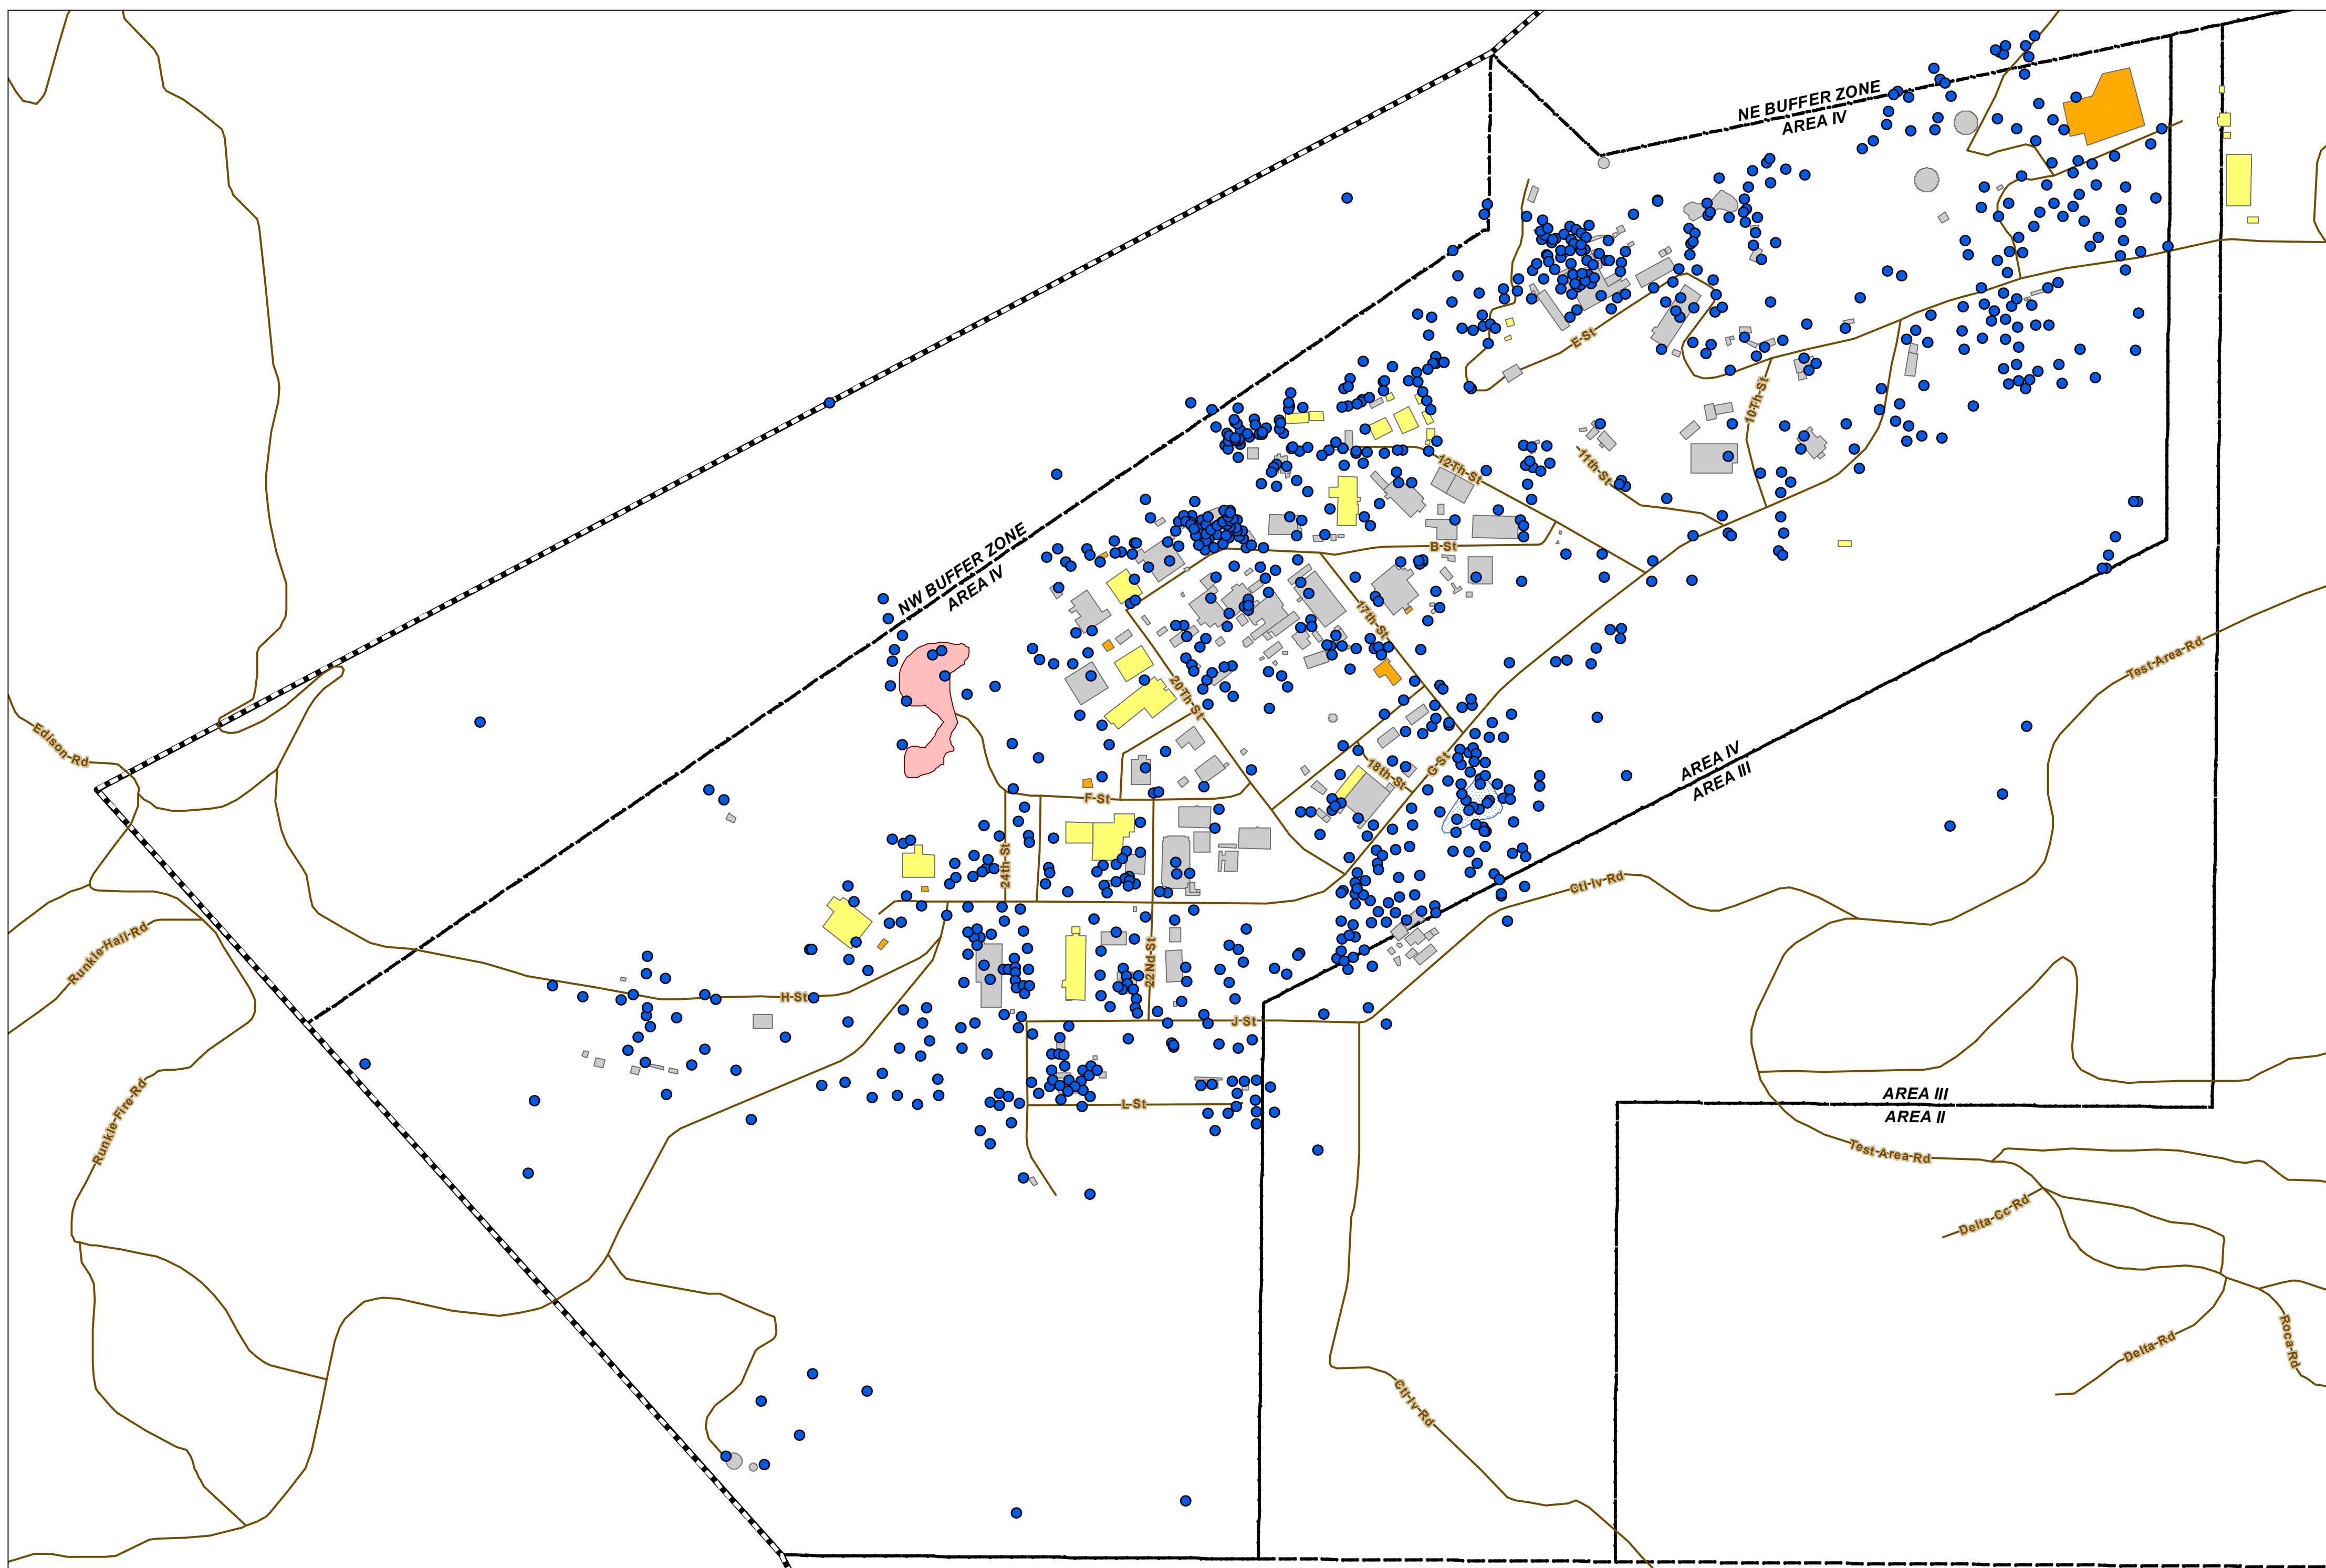
Santa Susana Field Laboratory
Ventura County, California
Figure 4-18

**PAH Carcinogens: BaP TEQ
Exceeding LUT Values
Surface Soils**

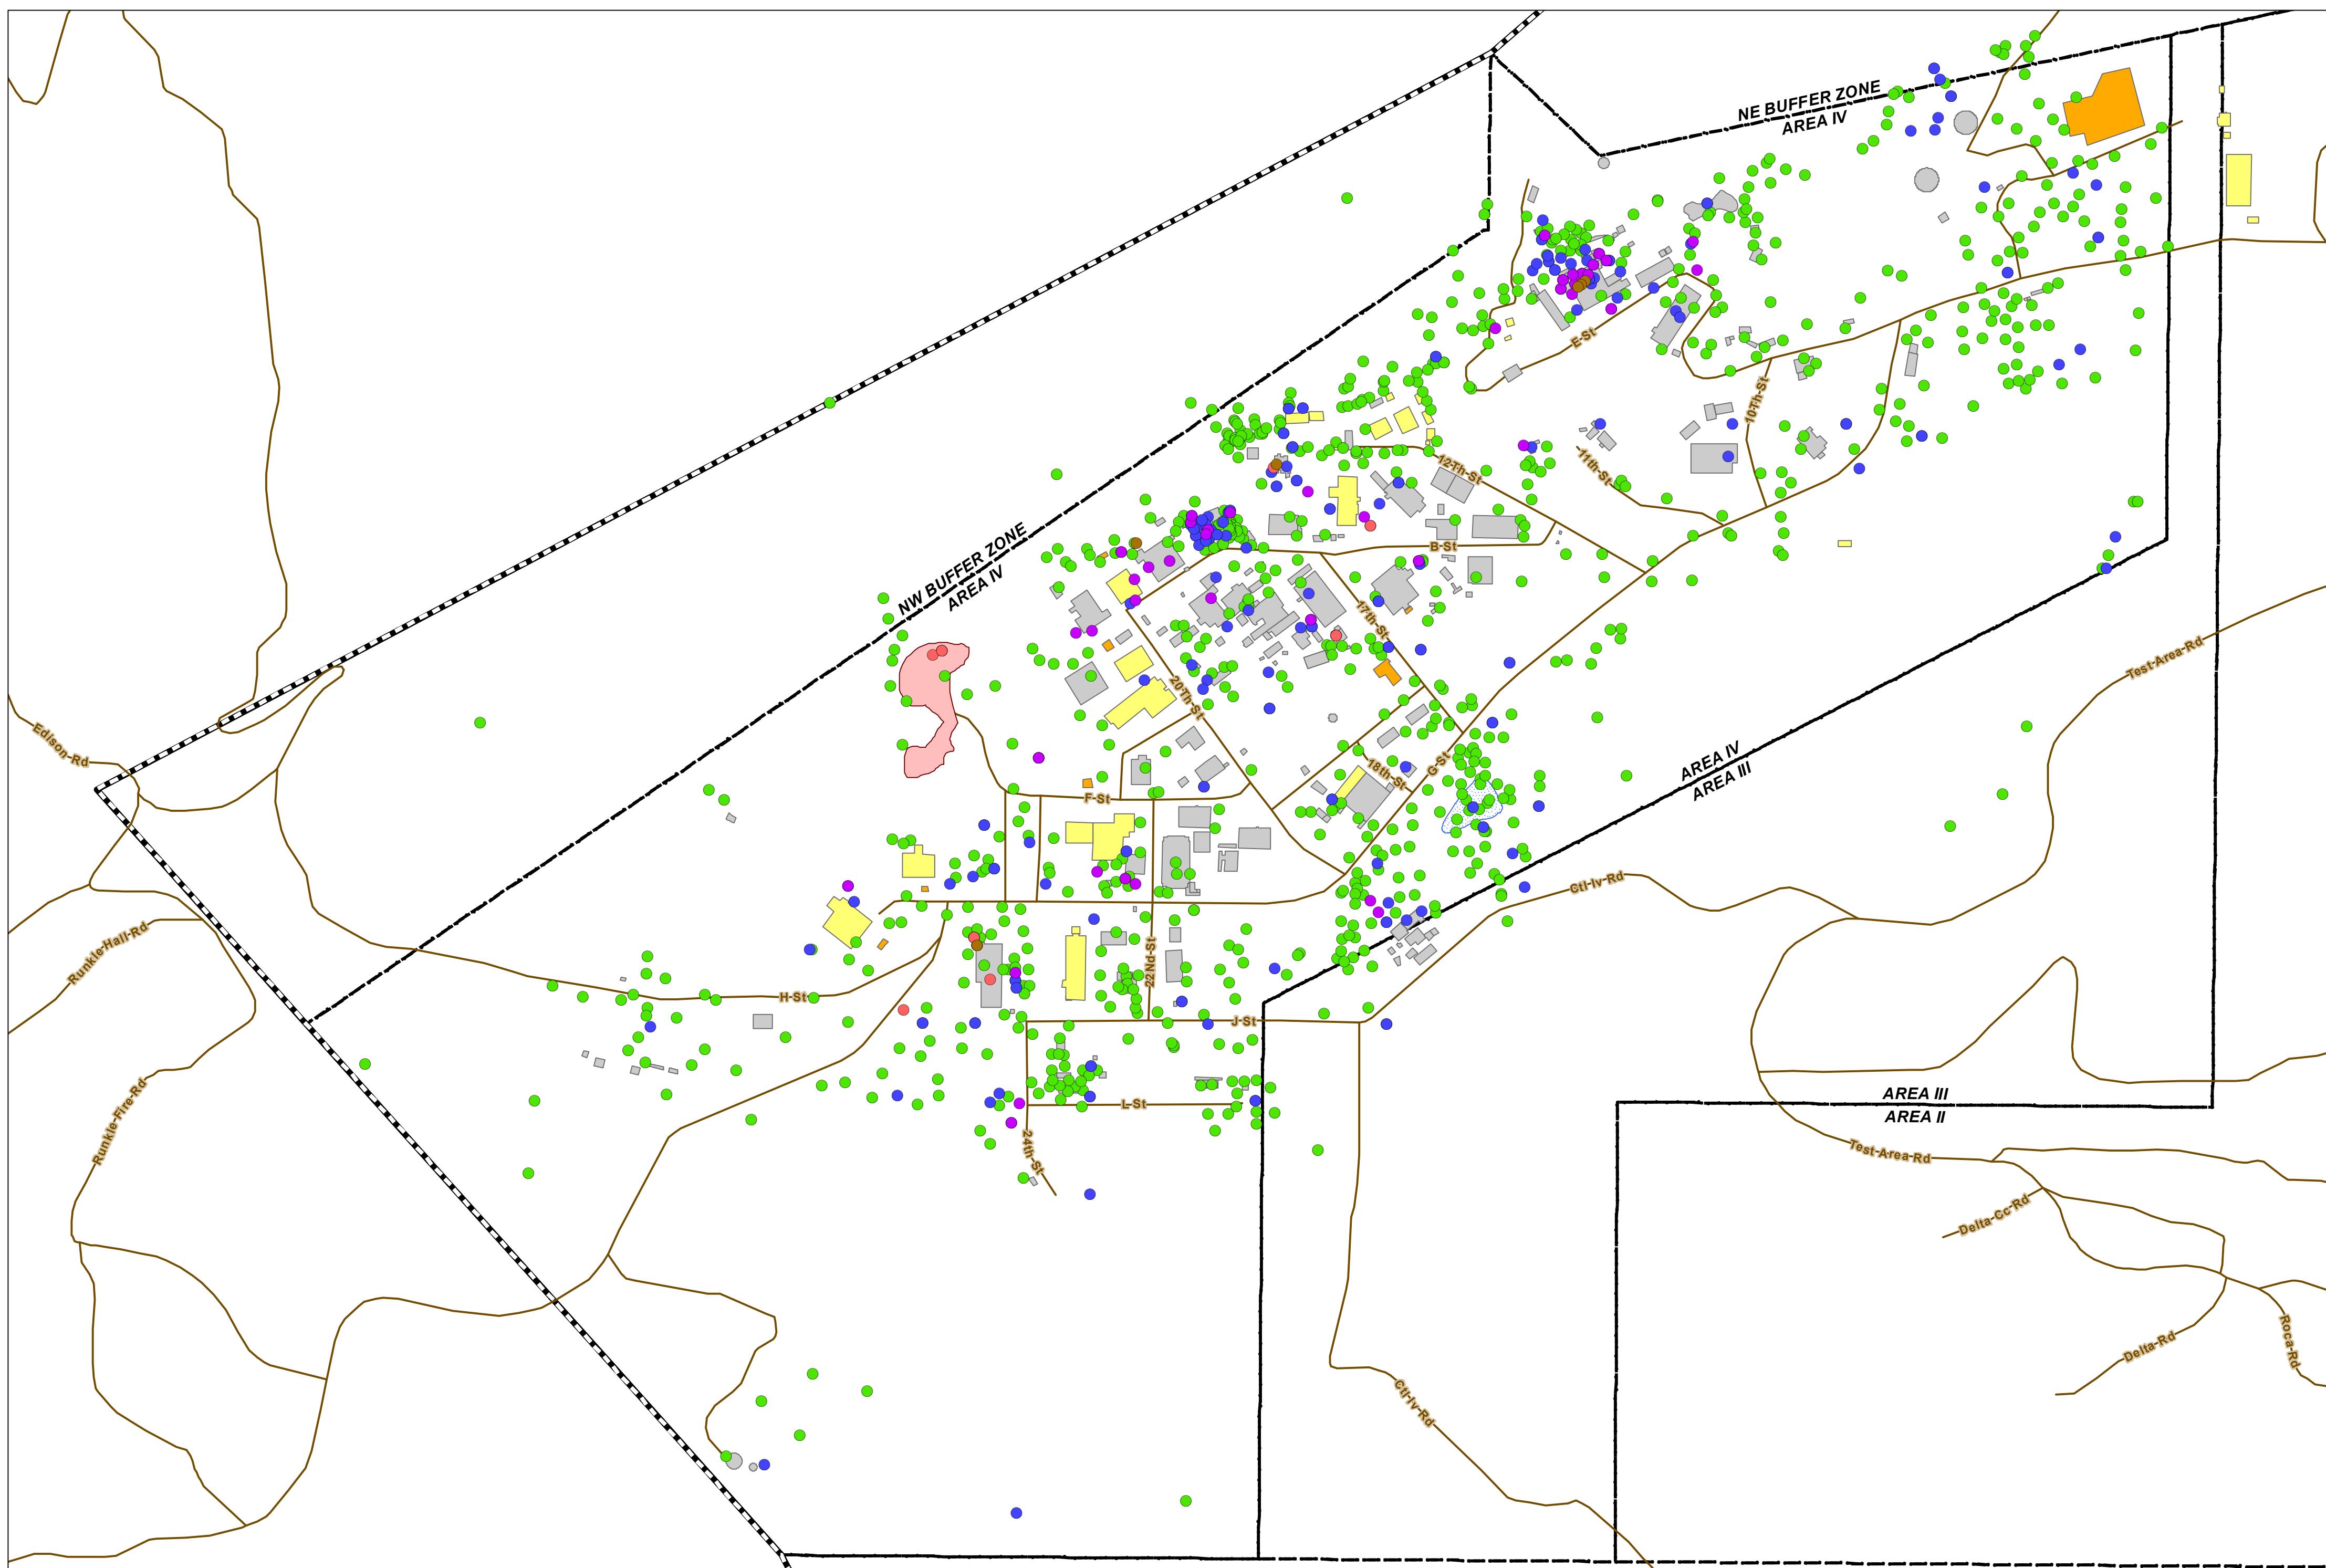
Santa Susana Field Laboratory
Ventura County, California
Figure 4-19

**PAH Carcinogens: BaP TEQ
Exceeding LUT Values by Depth**

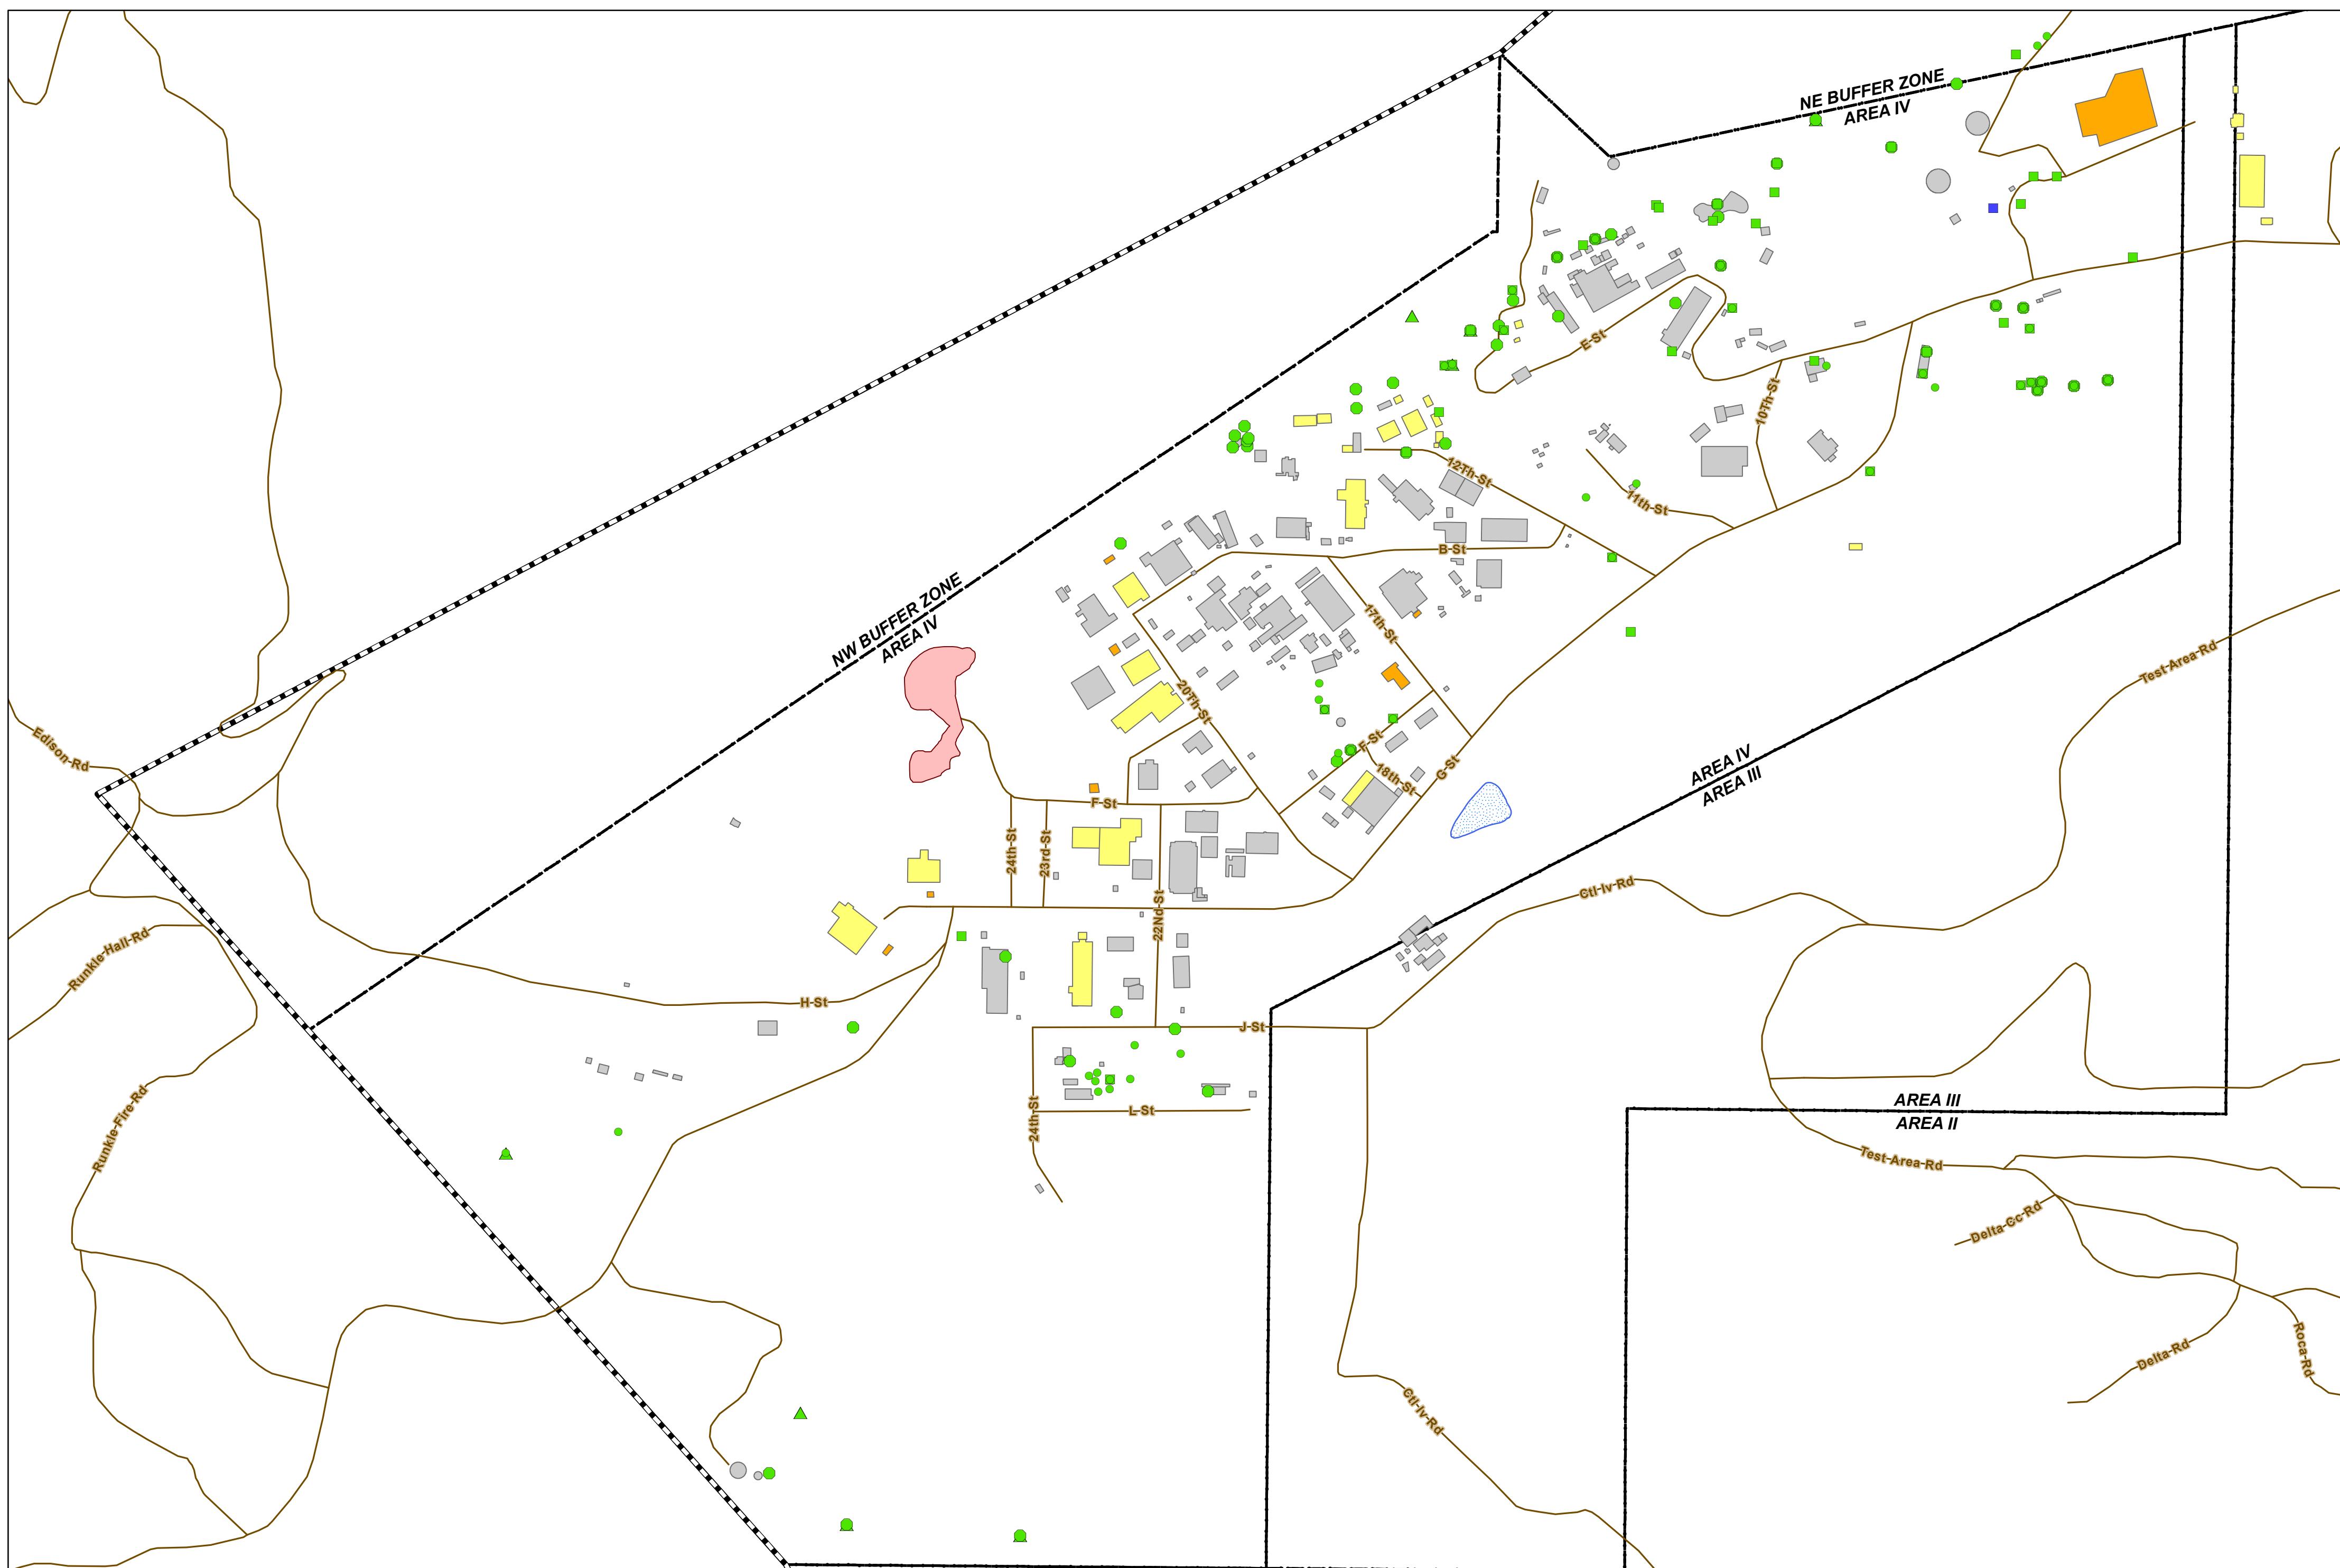
Santa Susana Field Laboratory
Ventura County, California
Figure 4-23
CDM Smith

**Pesticides: 4,4'-DDE, 4,4'-DDT,
Chlordane, and Toxaphene Exceeding
LUT Values by Depth**
